Your Ref: TP/IP/39647/2018  
Our Ref : CI/TPD18014219/Z

**Fatal Accident Investigation Team**  
Traffic Police Department  
Singapore Police Force  
10 Ubi Avenue 3  
Singapore 408865

#### **MECHANICAL INSPECTION REPORT OF MOTOR TAXI SHA 7941M**

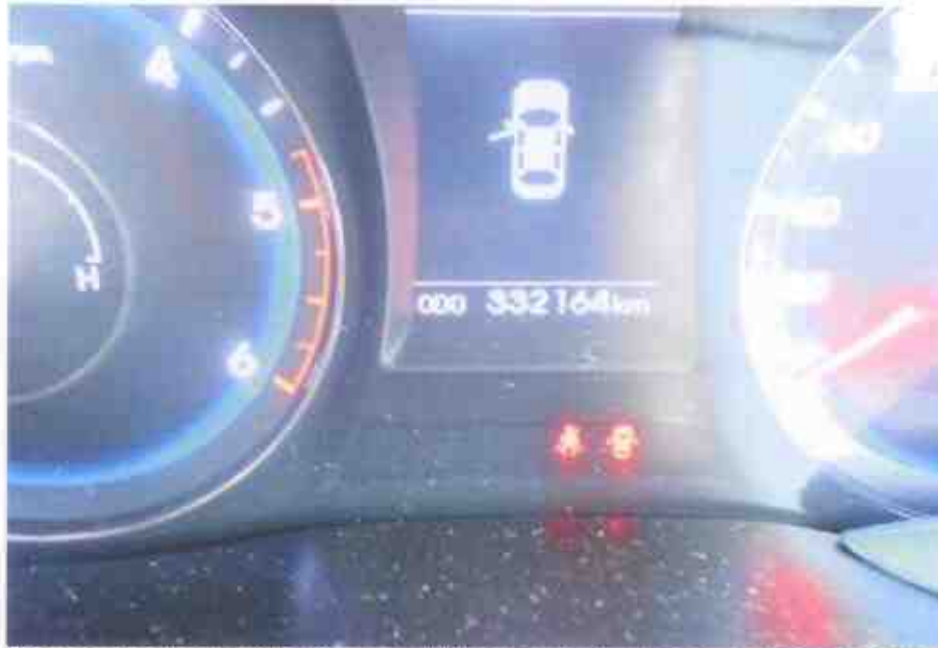
**Photo 1** shows the mileage of the Motor taxi at the time of our inspection was recorded at 332164km.

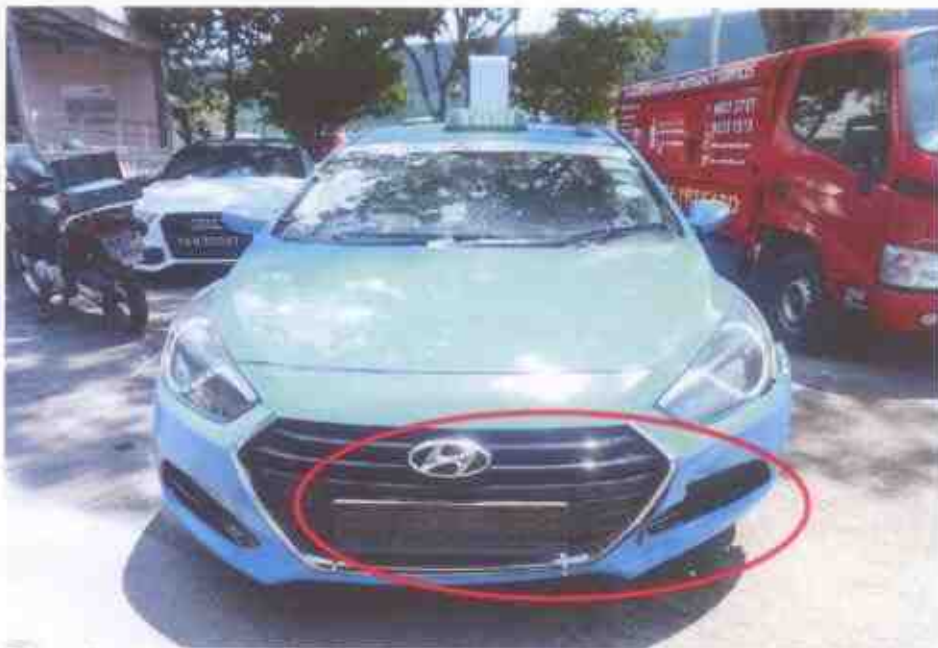
4. The mileage of the Motor taxi at the time of our inspection was recorded at 332164km.
5. The Motor taxi had sustained a relatively minor impact damages that was confined to its frontal left portion. Its front lower bumper was observed to be pushed inwards; its front licence plate was found missing & its front left fog light cover was cracked likely due to the accident's collision impact.

**Photo 2** shows a general view of the front body of the Motor Taxi at the time of our inspection. The Motor Taxi was observed to have sustained a relatively minor impact damages that was confined to its frontal left portion. Its front lower bumper was observed to be pushed inwards likely due to the accident's collision impact.

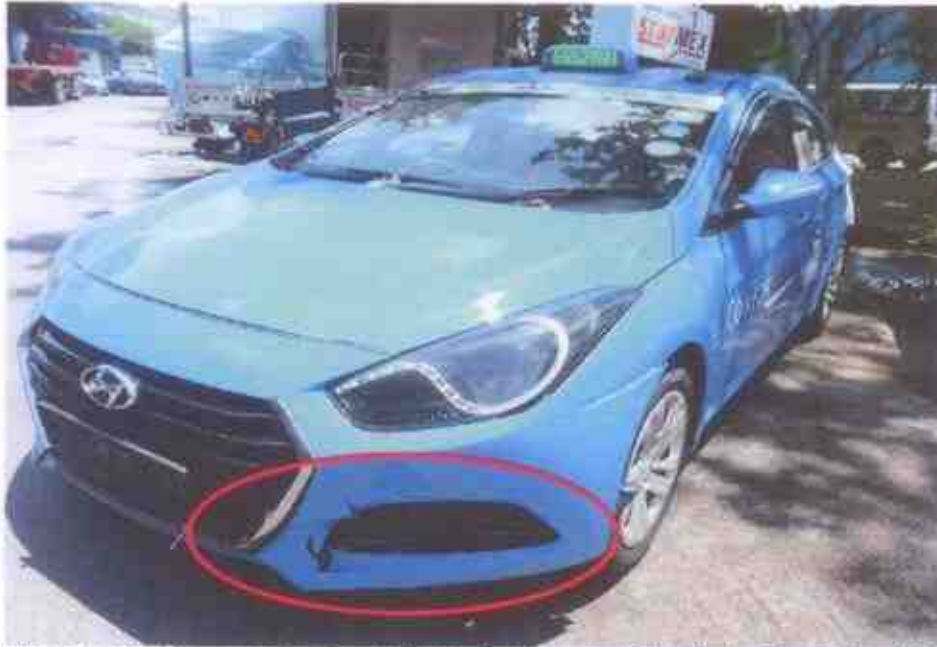
**Photo 3** shows a general view of the front left body of the Motor Taxi at the time of our inspection. The Motor Taxi was observed to have sustained a relatively minor impact damages that was confined to its frontal portion.

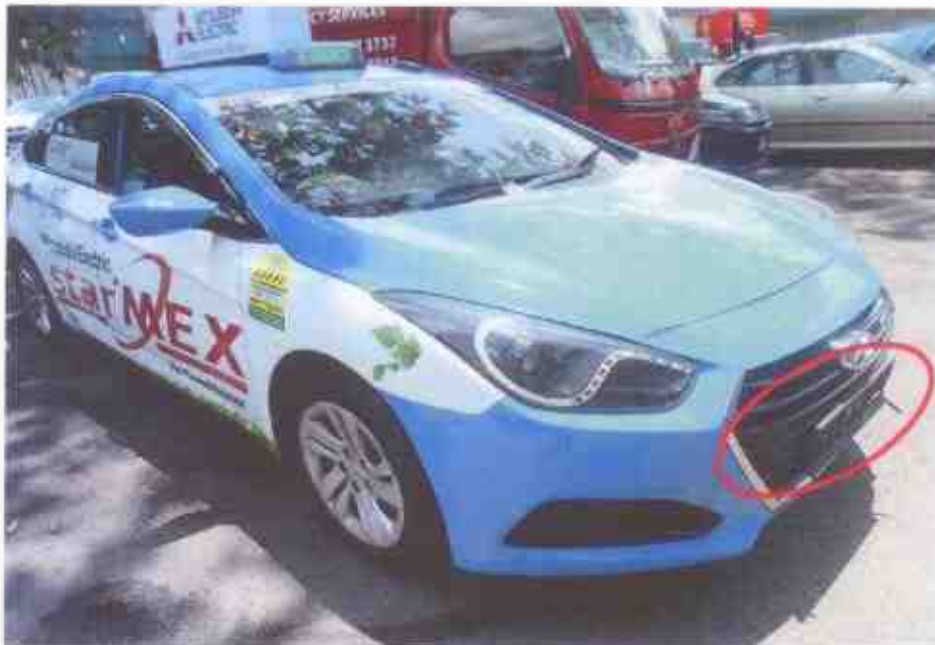
**Photo 4** shows a general view of the front right body of the Motor Taxi at the time of our inspection. The Motor Taxi was observed to have sustained a relatively minor impact damages that was confined to its frontal portion.

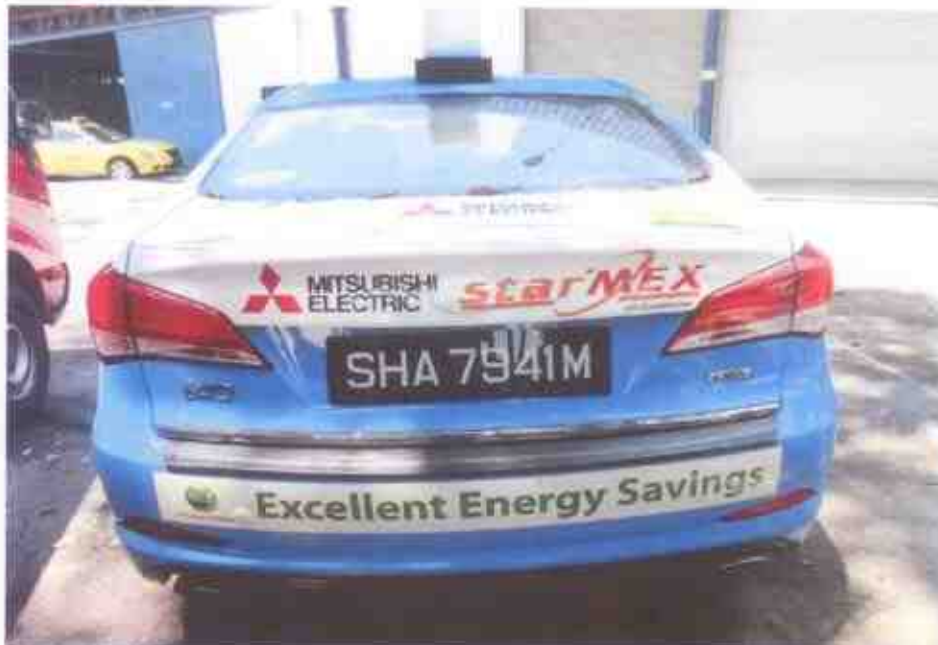
Photo 5 shows a general view of the rear body of the Motor Taxi at the time of our inspection. The Motor Taxi was observed to be in good general condition.

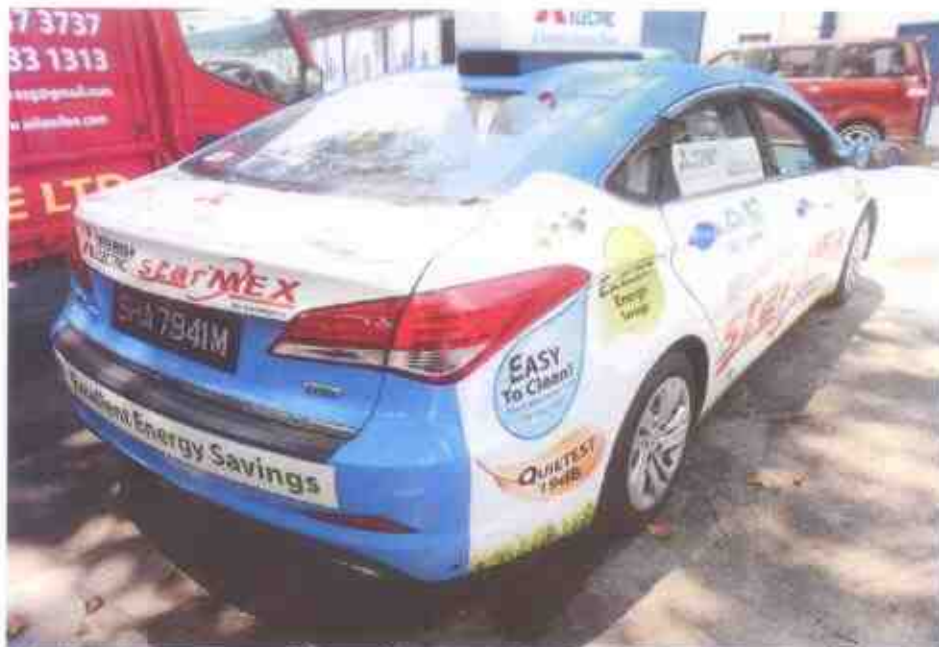
Photo 6 shows a general view of the rear right body of the Motor Taxi at the time of our inspection. The Motor Taxi was observed to be in good general condition.

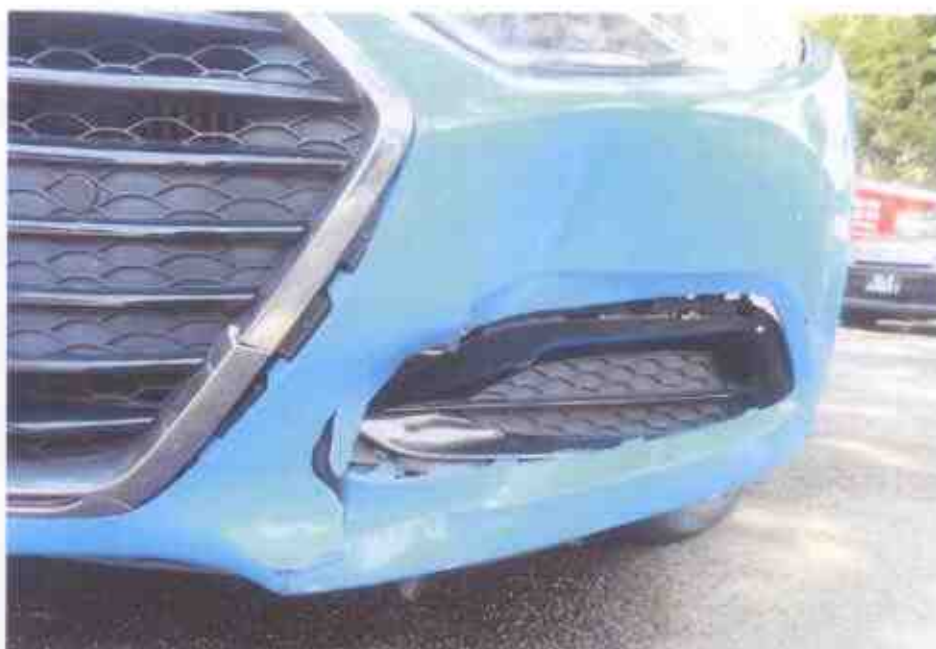
**Photo 7** shows a semi close up view of the front left portion of the Motor Taxi at the time of our inspection. The Motor Taxi had sustained relatively minor damages at the front left lower bumper portion likely due to the accident.

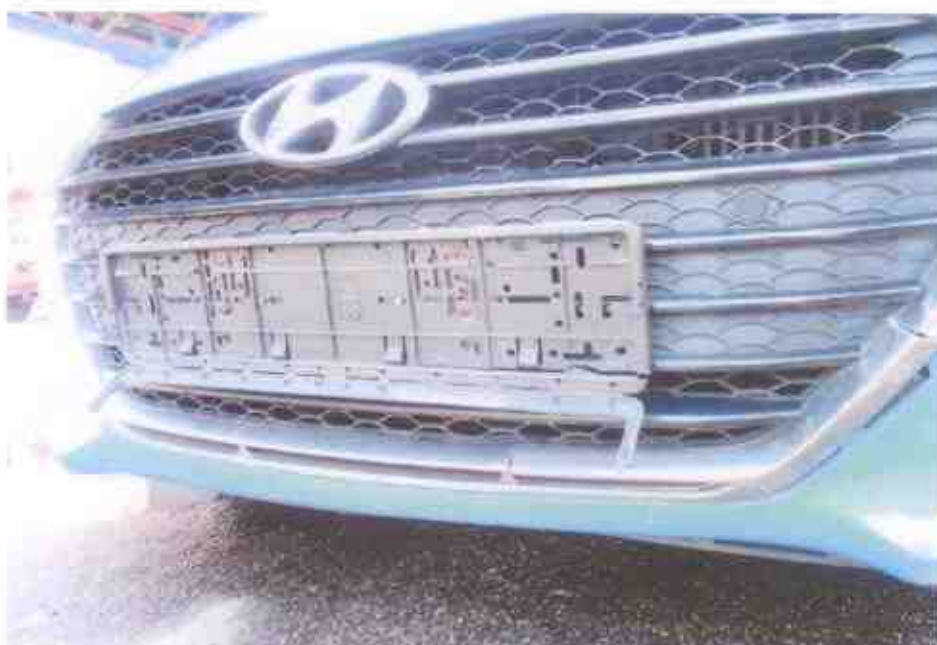
**Photo 8** shows a close up view of the front portion of the Motor Taxi. Missing licence plate was observed at the time of our inspection.

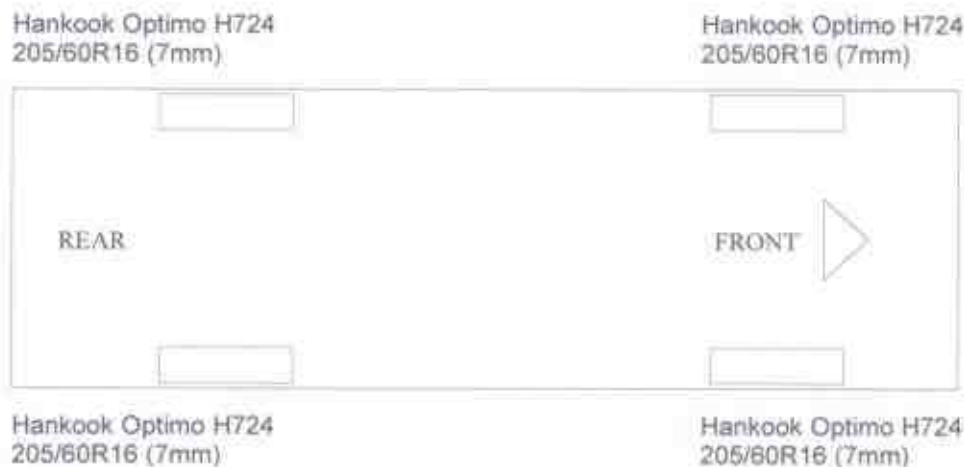
7. The condition of the Motor Taxi's 4 tyres was observed to be in serviceable condition. We did not find any tear, cut or burst mark(s) on the outer and the inner sidewalls as well as across the tread of the 4 tyres. The 4 tyres were also observed to be sufficiently inflated for vehicular operation. The tyre brand, tyre size and remaining tread depth of the 4 tyres were recorded as follows:-

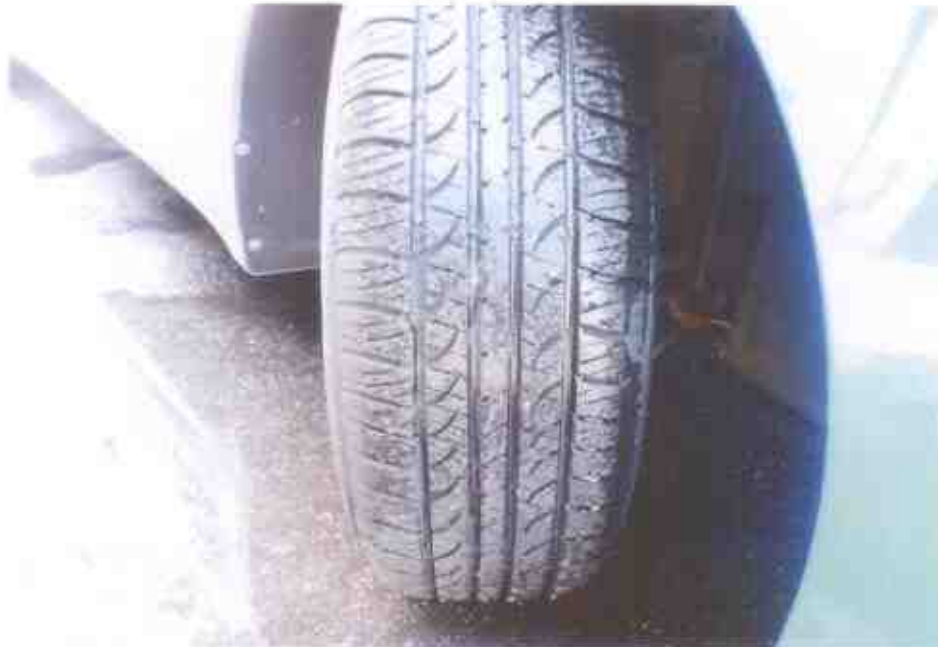
**Photo 9** shows the condition of the front right tyre of the Motor Taxi, which was observed to be in serviceable condition with remaining tread depth of approximately 7mm. There was no tear, cut or burst mark(s) on the outer and the inner sidewalls.

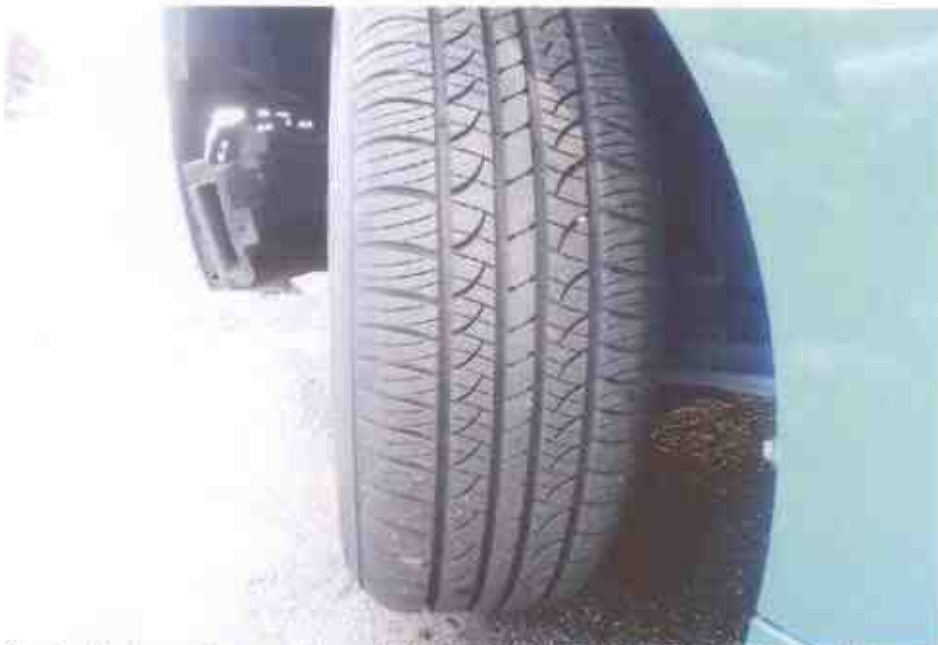
**Photo 10** shows the condition of the front left tyre of the Motor Taxi, which was observed to be in serviceable condition with remaining tread depth of approximately 7mm. The tyre, which was wrapped around alloy wheel rim, was also observed to be sufficiently inflated for vehicular operation.

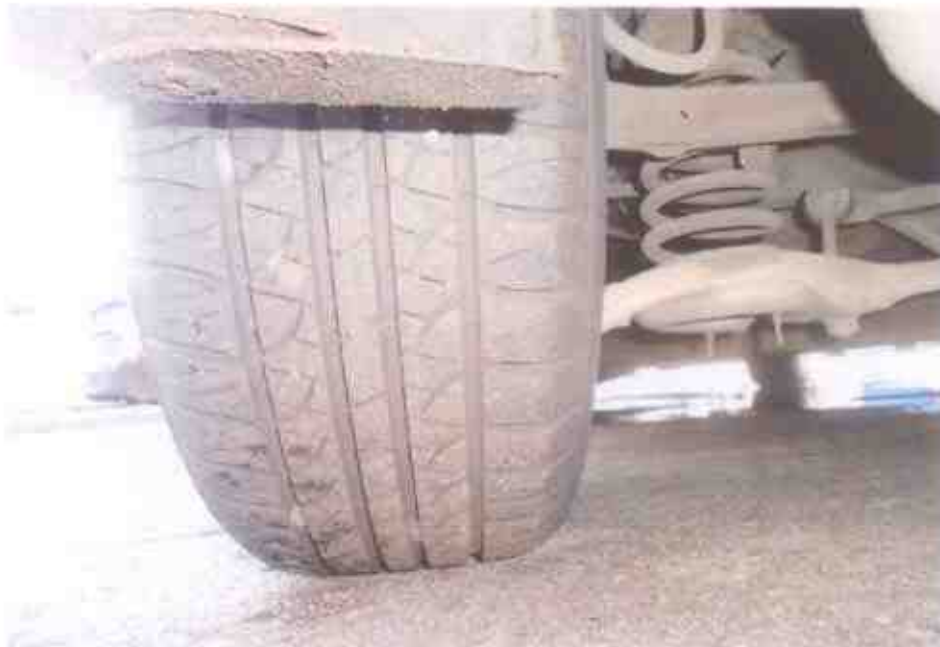
**Photo 11** shows the condition of the rear left tyre of the Motor Taxi, which was observed to be in serviceable condition with remaining tread depth of approximately 7mm.

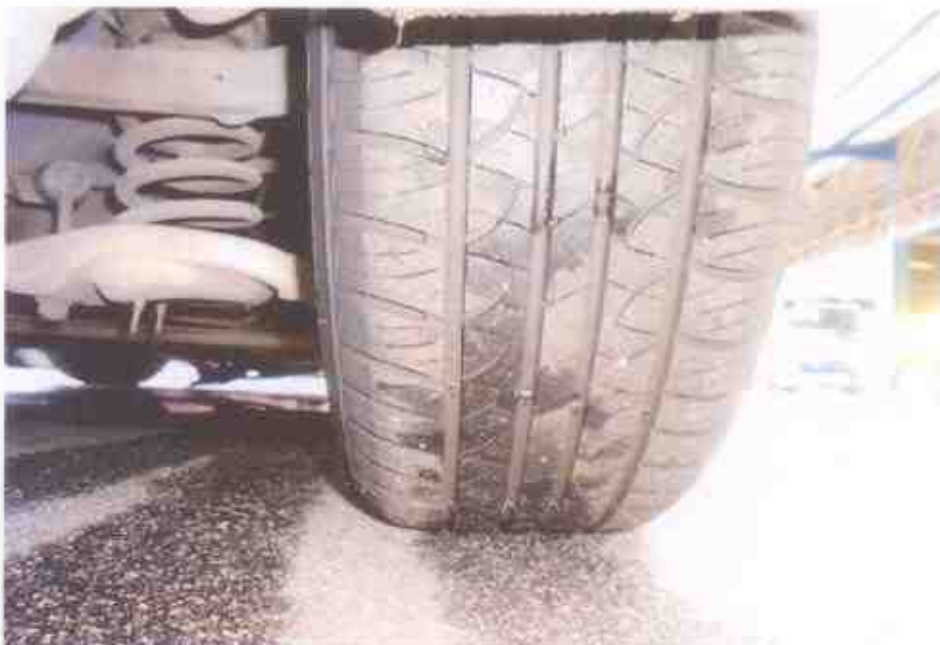
**Photo 12** shows the condition of the rear right tyre of the Motor Taxi, which was observed to be in serviceable condition with remaining tread depth of approximately 7mm.

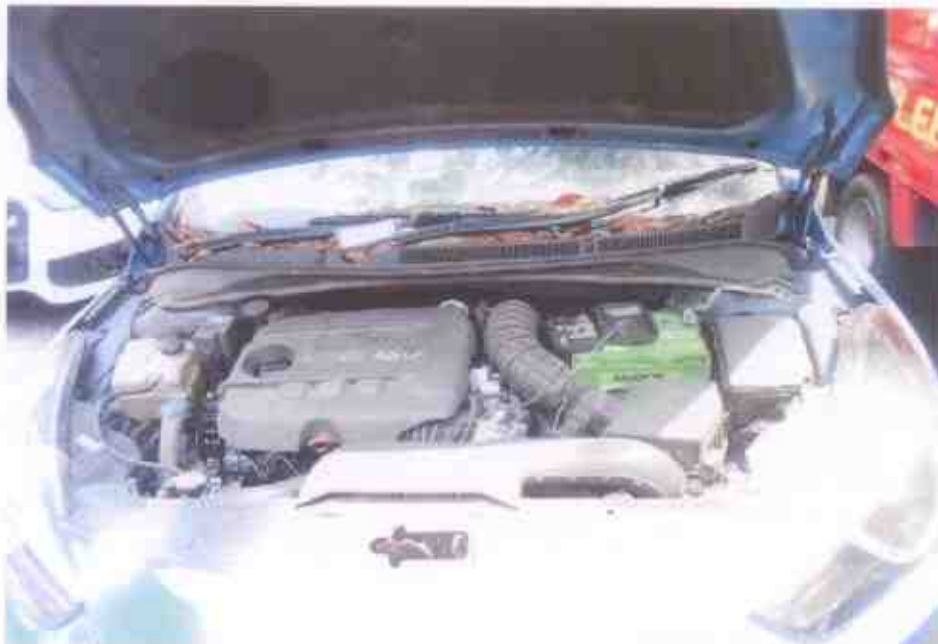
**Photo 13** shows a general view of the Motor Car's engine compartment. The various parts and components inside the engine compartment were unaffected by the accident. There was also no sign(s) or indication(s) of fluid leakage and/or fluid stain within the engine compartment.

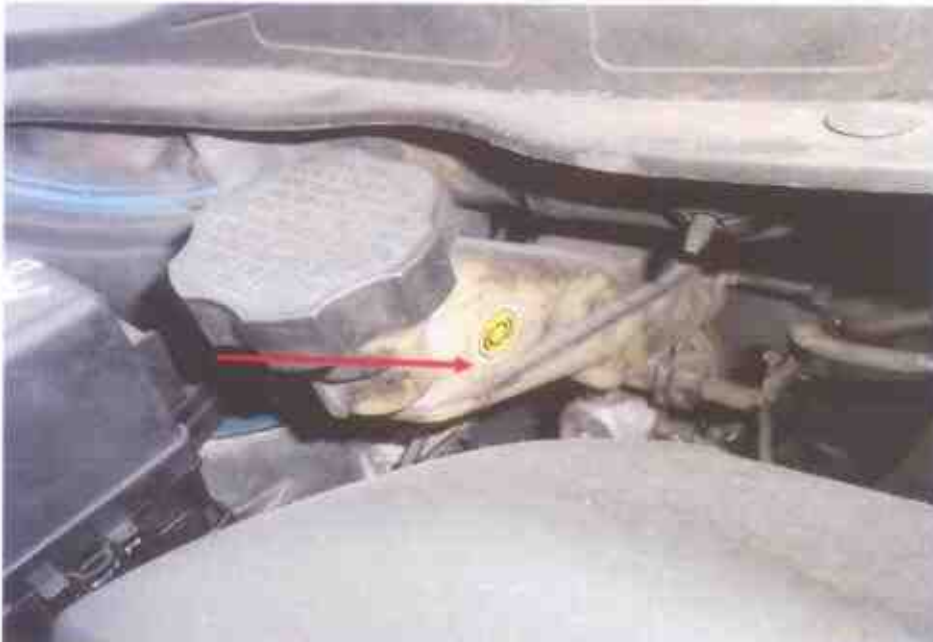
**Photo 14** shows the brake fluid reservoir of the Motor Taxi at the time of our inspection. The brake fluid was observed to be of sufficient level (arrowed) and without any visible contamination.

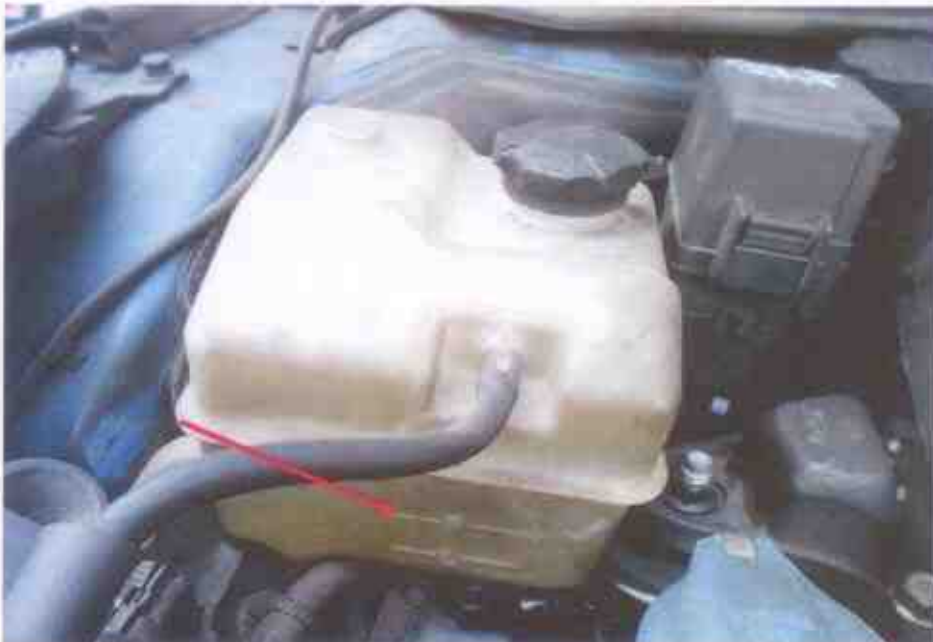
**Photo 15** shows the engine coolant fluid reservoir of the Motor Taxi at the time of our inspection. The engine coolant fluid was observed to be of sufficient level and without any visible contamination.

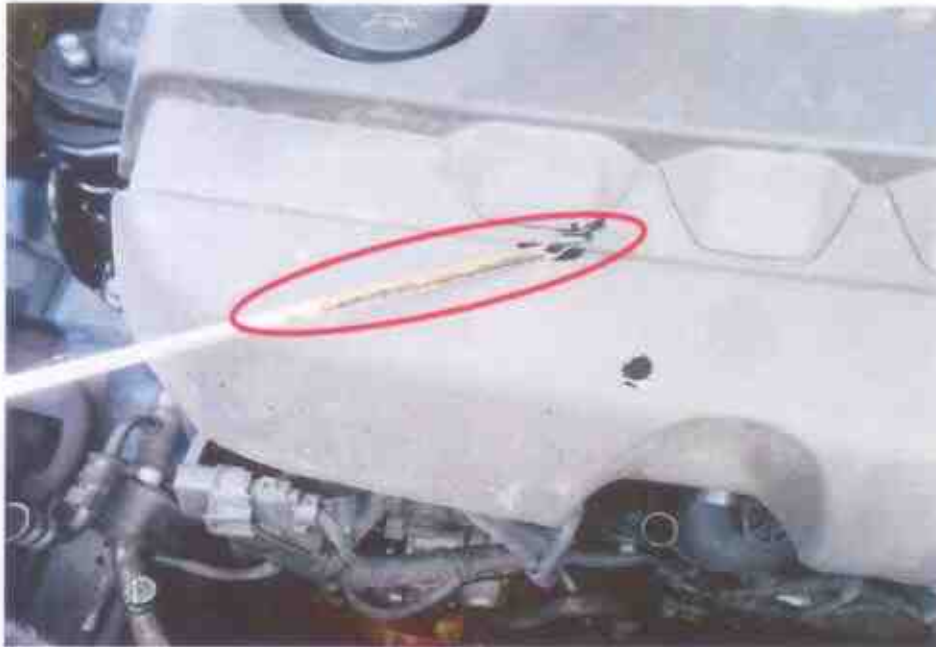
**Photo 16** shows the engine oil dip stick of the Motor Taxi at the time of our inspection. The engine oil was observed to be of sufficient level and without any visible contamination.

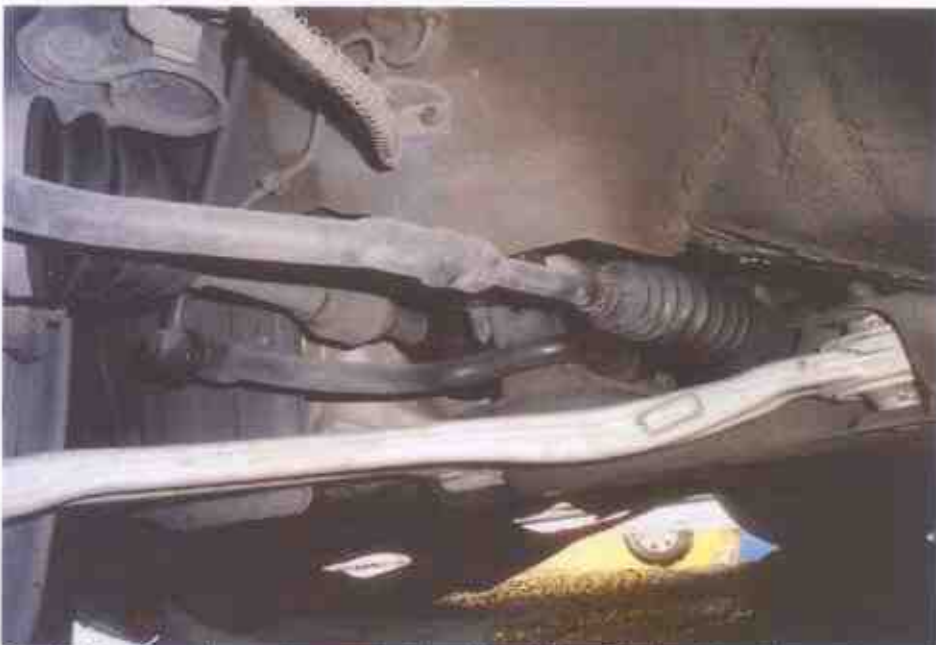
**Photo 17** shows the engine underside of the Motor Taxi engine. The engine was observed to be free from fluid leakage at time of our inspection.

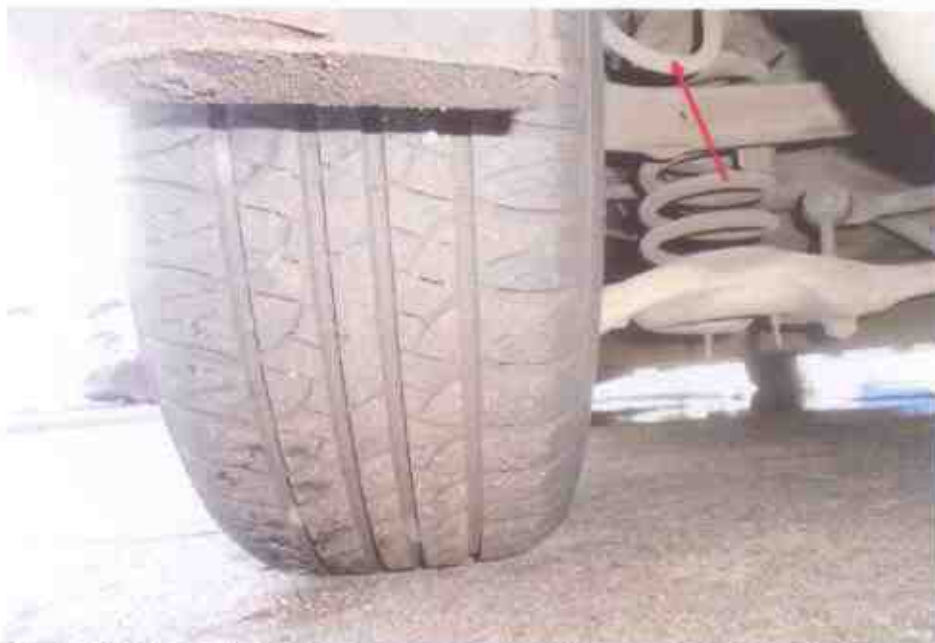
**Photo 18** shows the brake hose (arrowed) at the rear left wheel of the Motor Taxi. We did not observe any leakage of brake fluid at the time of our inspection of the Motor Taxi. Our visual inspection of the various mechanical components of the Motor Taxi's braking system revealed all to be intact without visible damage.

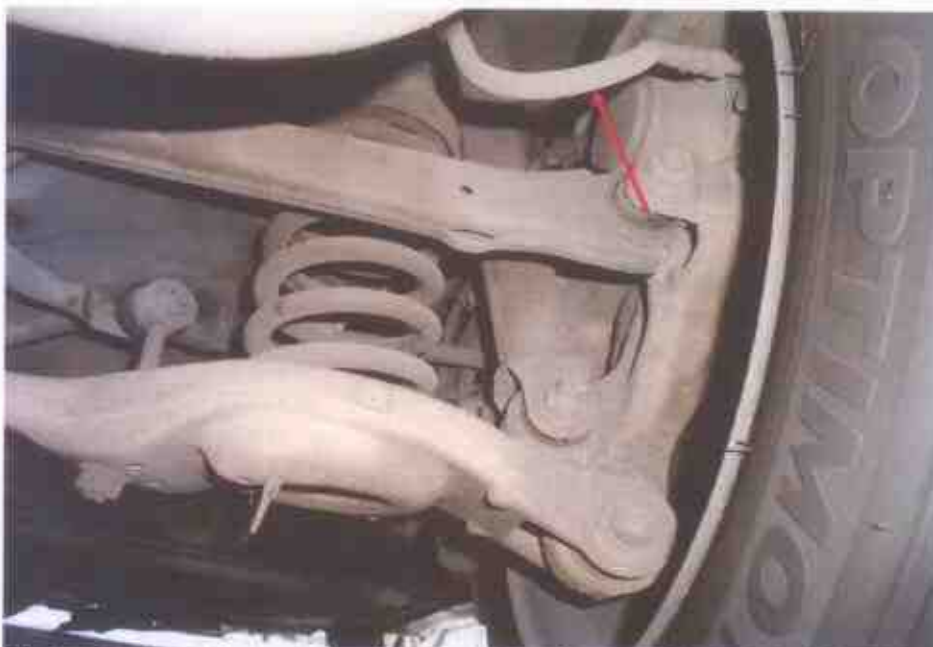
Photo 19 shows the brake hose (arrowed) at the rear right wheel of the Motor Taxi. We did not observe any leakage of brake fluid at the time of our inspection of the Motor Taxi. Our visual inspection of the various mechanical components of the Motor Taxi's braking system revealed all to be intact without visible damage.

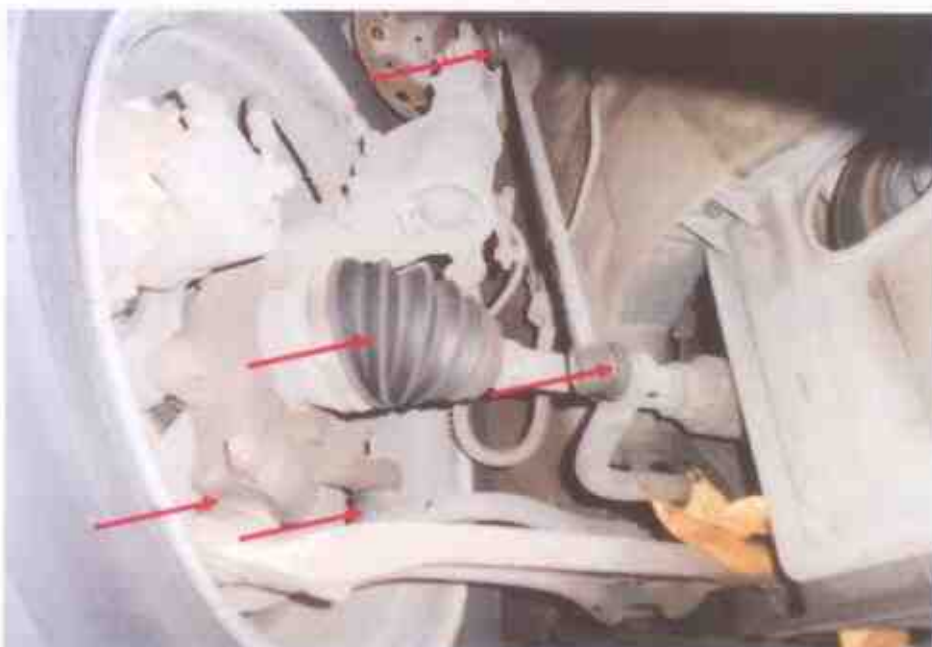
Photo 20 shows the various undercarriage components at the front right wheel of the Motor Taxi, in particular the steering tie rod (arrowed). The various steering components were all found to be intact, suggesting that the steering system of the Motor Taxi was likely to be in serviceable condition.

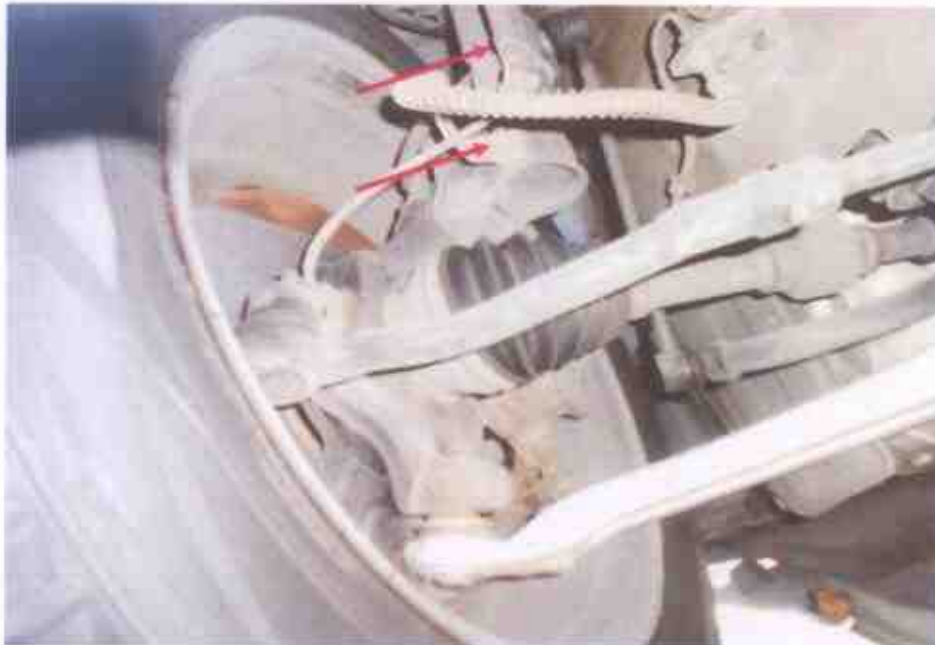
**Photo 21** shows the various undercarriage components at the front left wheel of the Motor Taxi. We did not observe any leakage of brake fluid (arrowed) at the time of our inspection of the Motor Taxi. Our visual inspection of the various mechanical components of the Motor Taxi's braking system revealed all to be intact and without visible damage, indicating that the braking system was likely to be in serviceable condition at the material time of accident.

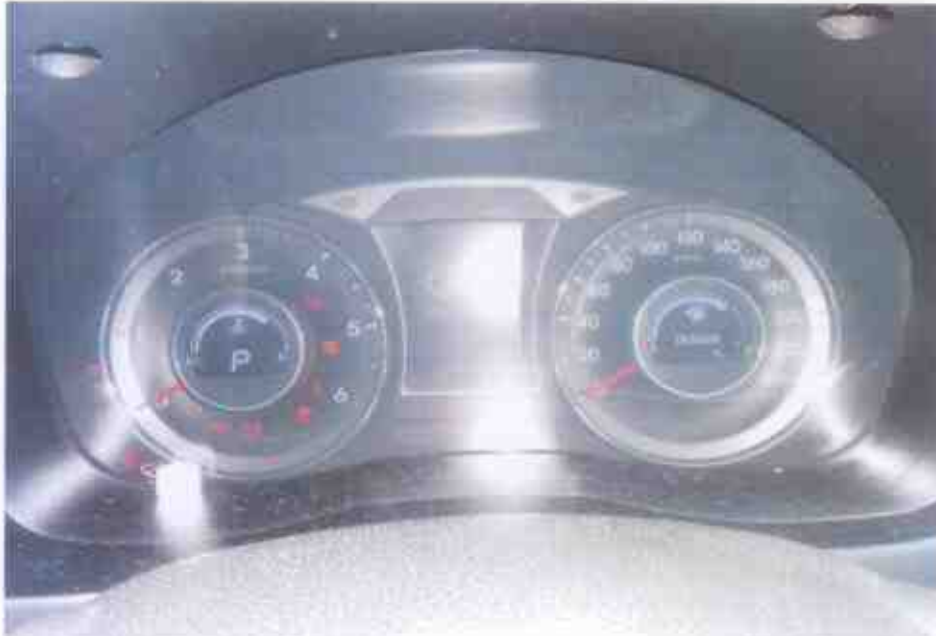
**Photo 22** shows the warning lights for the various electronic operating systems of the Motor Taxi appearing on its instrument panel during the self-test when the engine is cranked, in particular the ABS light, SRS light, engine check light, battery light and diesel glow plug amongst others.

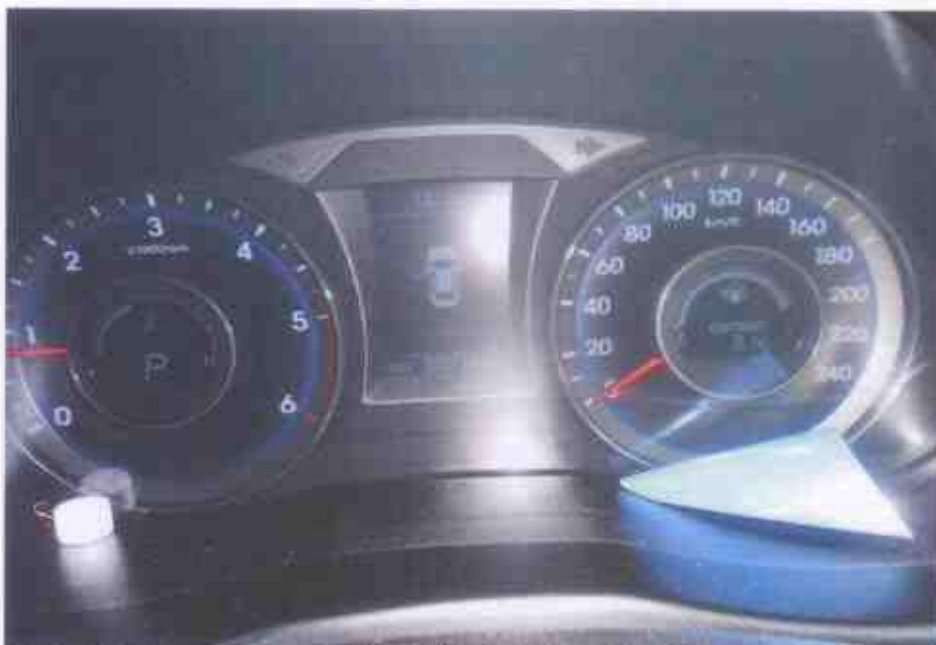
**Photo 23** shows no warning lights illuminated on the instrument panel of the Motor Taxi after the engine was cranked. This would suggest that there was no abnormality to the various electronic operating systems of the Motor Taxi, like the ABS light engine check light, battery light and diesel glow plug.

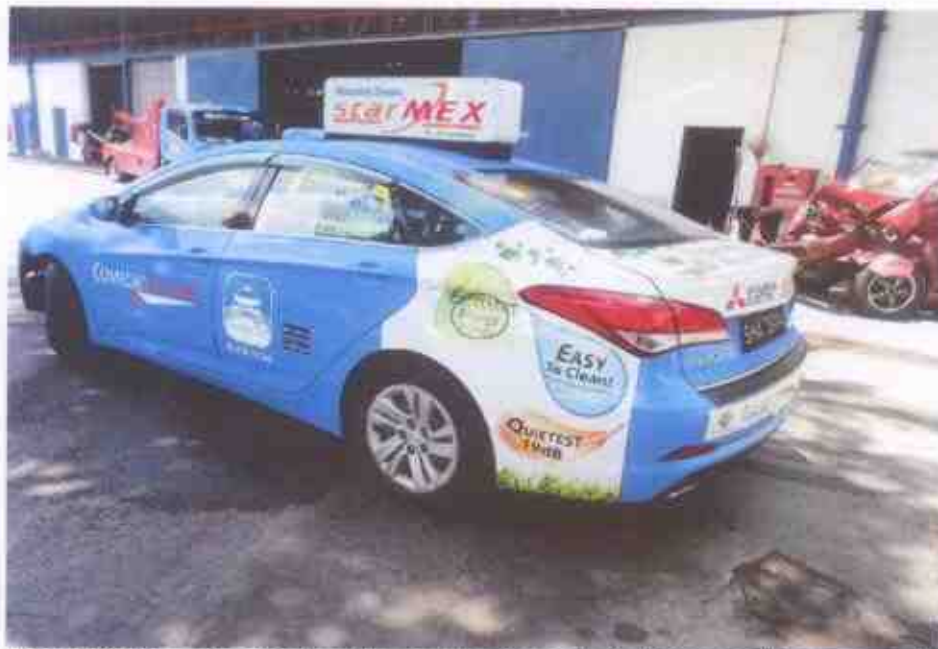
Photo 24 shows an operational test of the Motor Taxi. We were able to move the vehicle reverse, forward and backward normally.

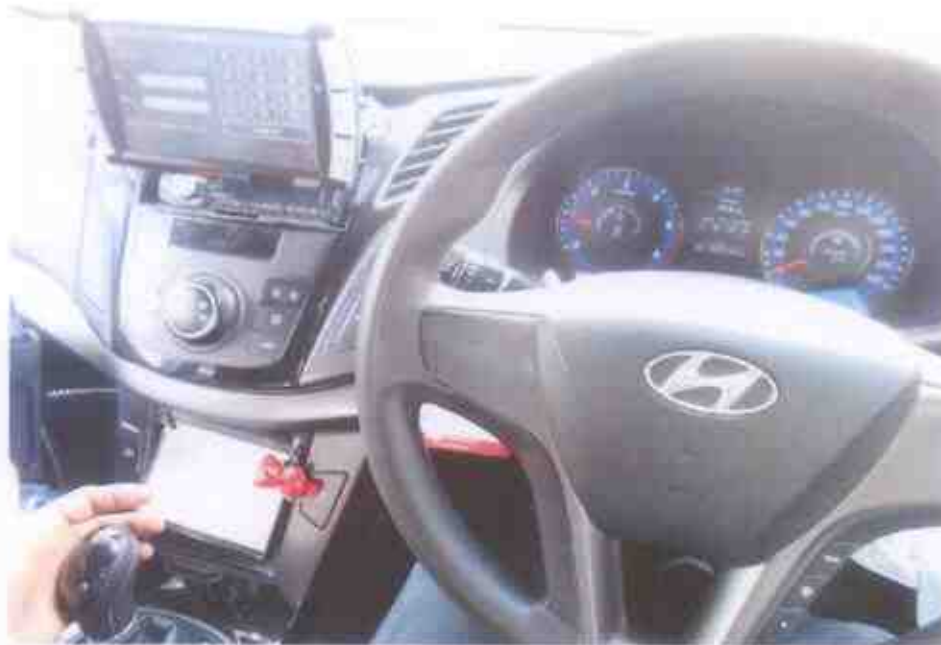
Photo 25 shows an operational test of the Motor Taxi. We were able to move the vehicle reverse, forward and backward normally.
