Your Ref: TP/IP/39647/2018
Our Ref : CI/TPD18014220/Z

Fatal Accident Investigation Team
Traffic Police Department
Singapore Police Force
10 Ubi Avenue 3
Singapore 408865

MECHANICAL INSPECTION REPORT OF MOTORCYCLE NCY 1262

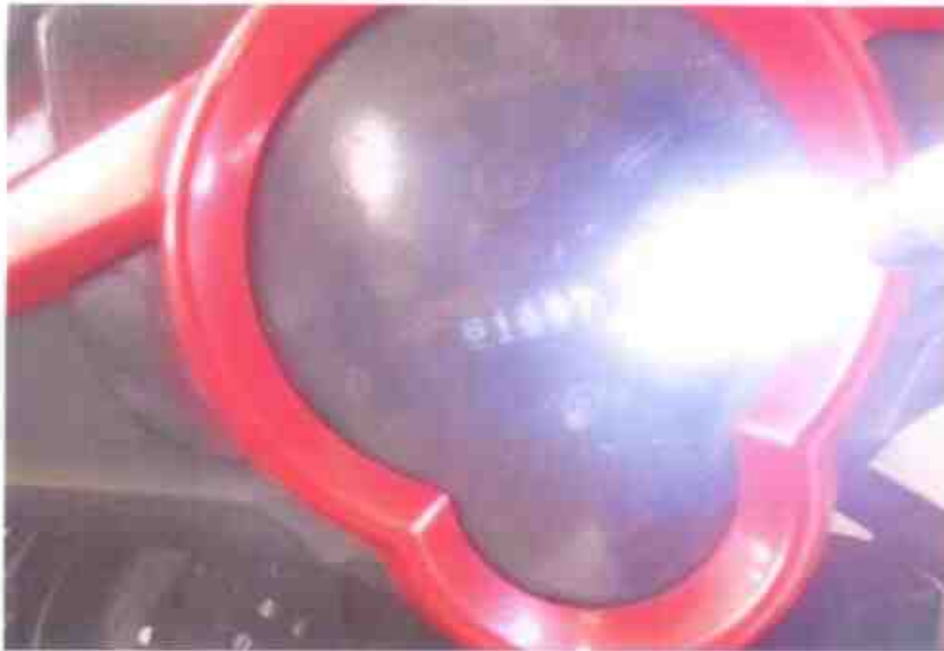
Photo 1 shows a close-up view of the mileage meter at time of our inspection. The mileage was recorded at 61497.3km.

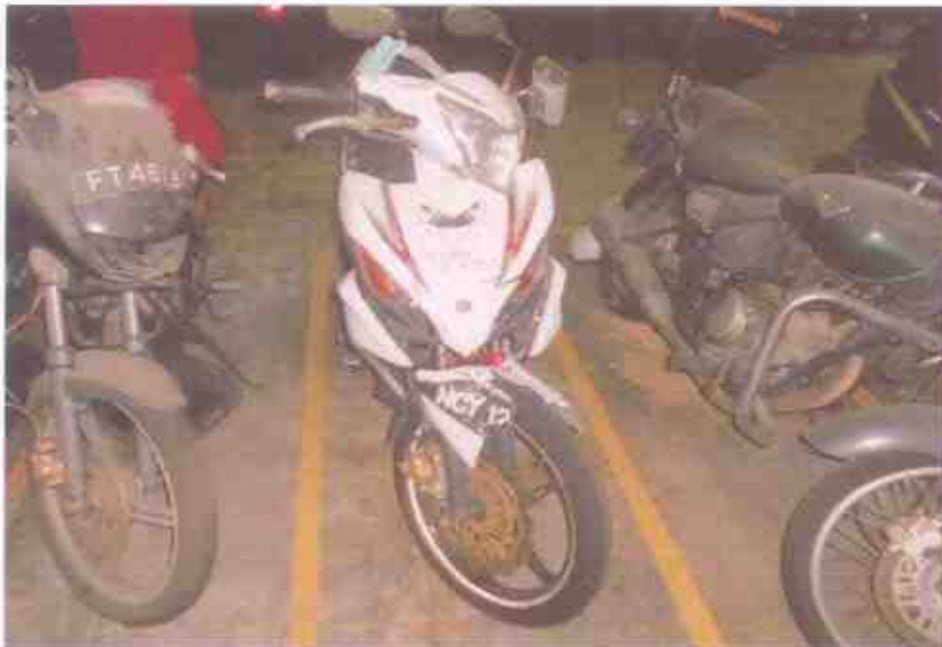
4. The mileage of the Motorcycle recorded at time of our inspection was 614973km.
5. The Motorcycle was observed to have sustained minor damages at the frontal portion. The body parts that were found to have been damaged include its front fairing cover, headlamp, wing mirror, front left signal lamp, front mudguard and rear tail lamp amongst others as a result of the accident.

Photo 2 shows a general view of the front body of the Motorcycle at the time of our inspection. The Motorcycle was observed to have sustained relatively minor damages as a result of the accident's impact.

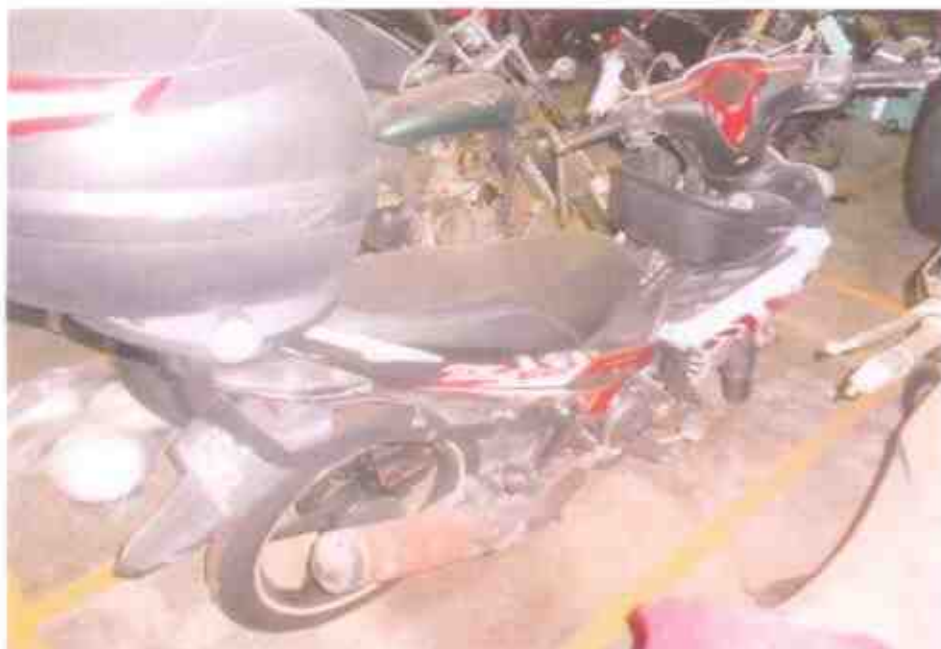
Photo 3 shows a general view of the right body of the Motorcycle at the time of our inspection. The Motorcycle was observed to have sustained relatively minor damages on the front right side fairing at time of our inspection.

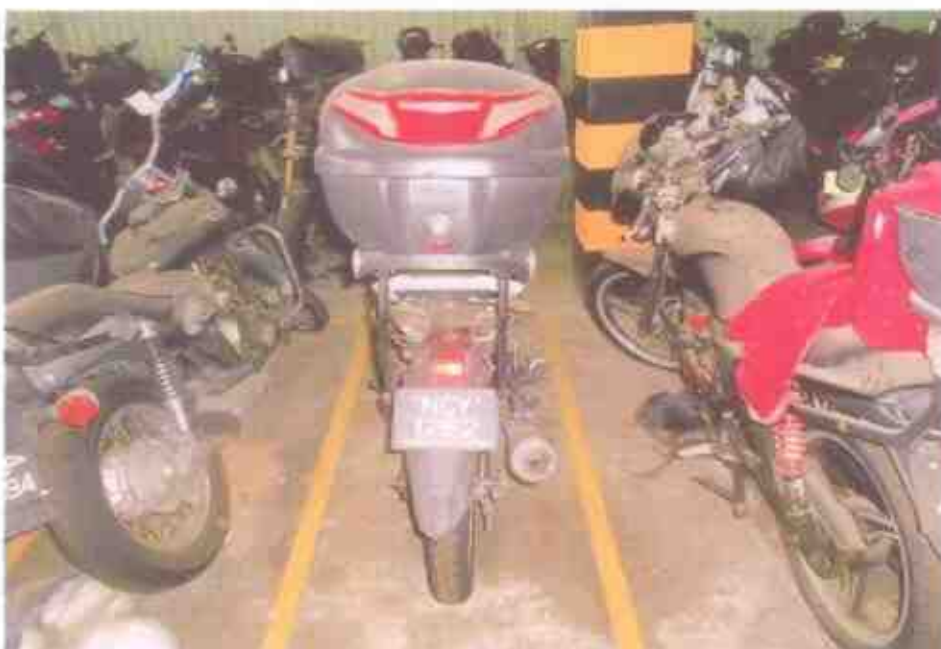
Photo 4 shows a general view of the rear body of the Motorcycle at the time of our inspection. The Motorcycle was observed to be in good condition unaffected by the accident's impact collision.

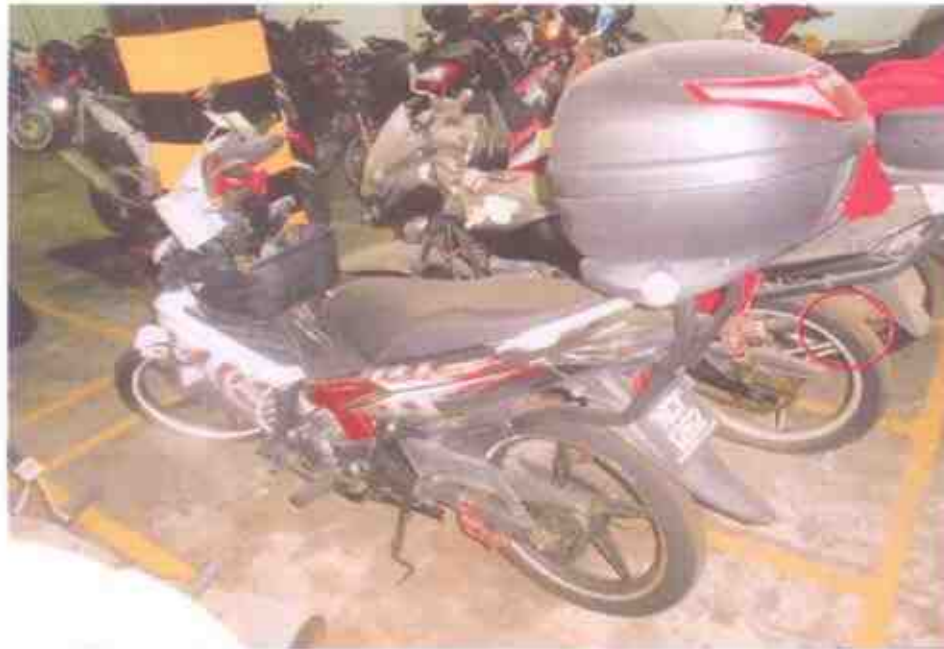
Photo 5 shows a general view of the left body of the Motorcycle at the time of our inspection. The Motorcycle was observed to have sustained relatively minor damages on the front left side fairing at time of our inspection.

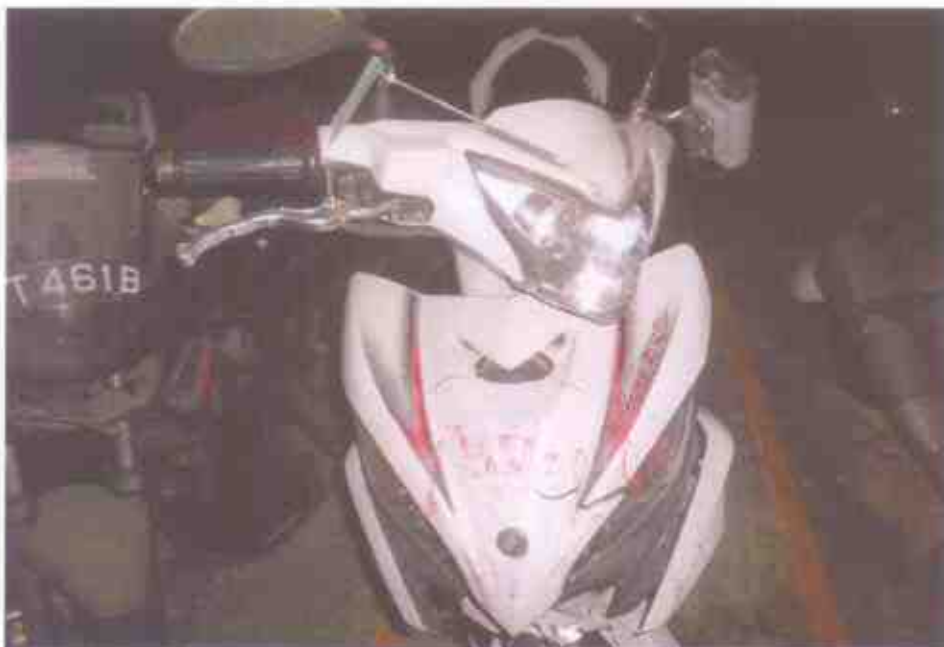
Photo 6 shows a closer view of the front fairing cover of the Motorcycle at the time of our inspection. The Motorcycle was observed to have sustained with relatively minor damages due to the accident collision.)

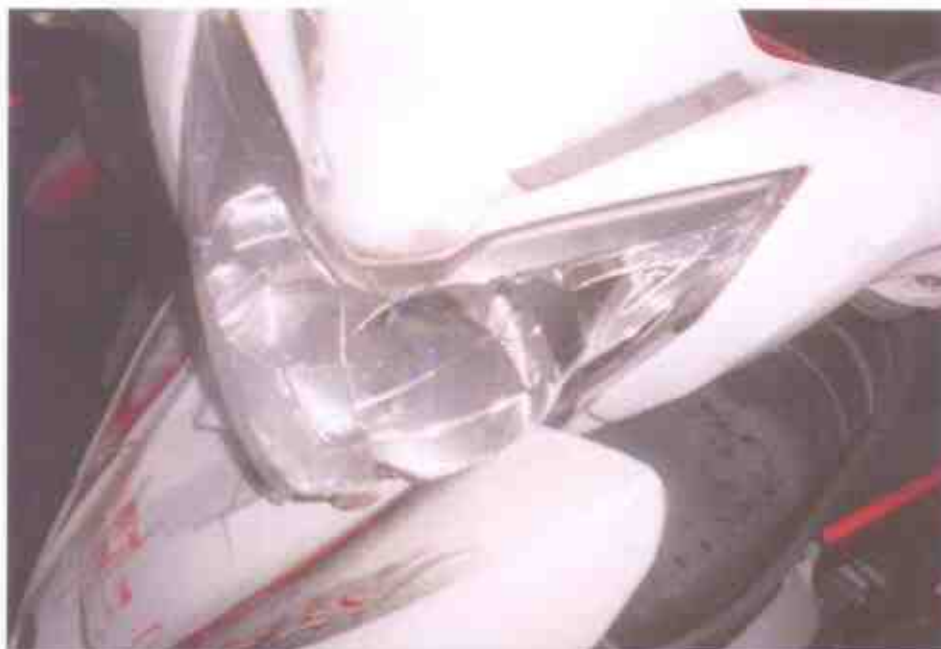
Photo 7 shows a closer view of the front headlamp of the Motorcycle at the time of our inspection. It was observed to have sustained with relatively minor damages due to the accident collision.

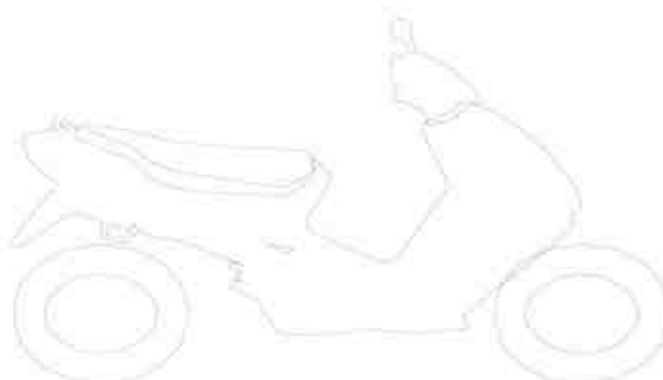
7. The condition of the Motorcycle's 2 tyres was observed to be in serviceable condition. The tread pattern of the 2 tyres was clearly visible. We did not observe any tear, burst mark(s) and/or punctured hole(s) on the sidewalls as well as across the tread of the 2 tyres. The 2 tyres were both observed to be sufficiently inflated for vehicular operation. The tyre brand, tyre size and remaining tread depth of the 2 tyres were recorded as follows:-

Maxxis Diamond MA-3D 80/90 - R17 (3mm)

Maxxis Diamond MA-3D 70/90 - R17 (4mm)

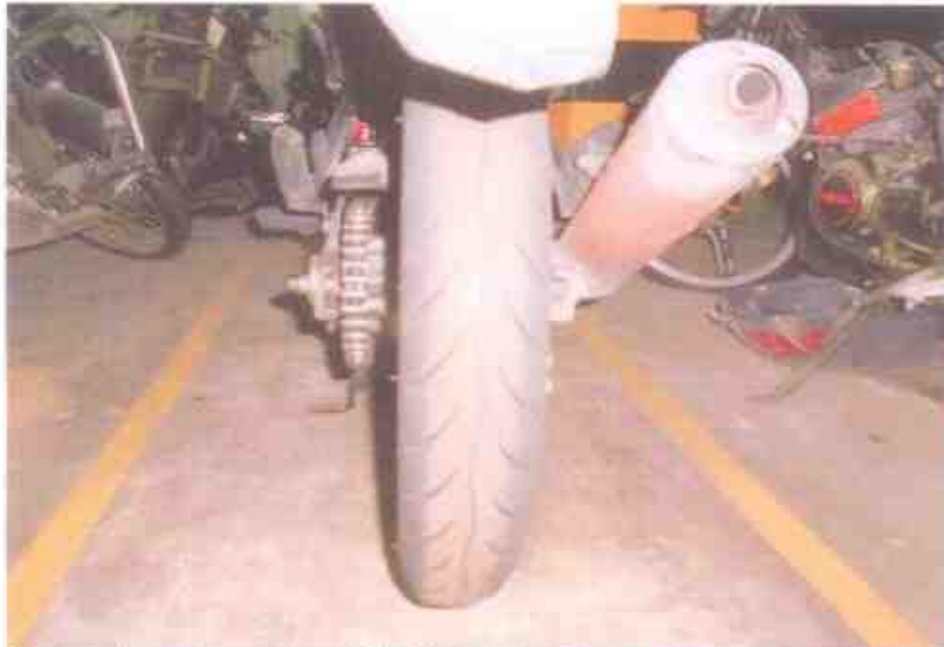
Photo 8 shows the rear tyre of the Motorcycle. The rear tyre was observed to be in serviceable condition with remaining tread depth of approximately 3mm. The tyre was also observed to be sufficiently inflated for vehicular operation.

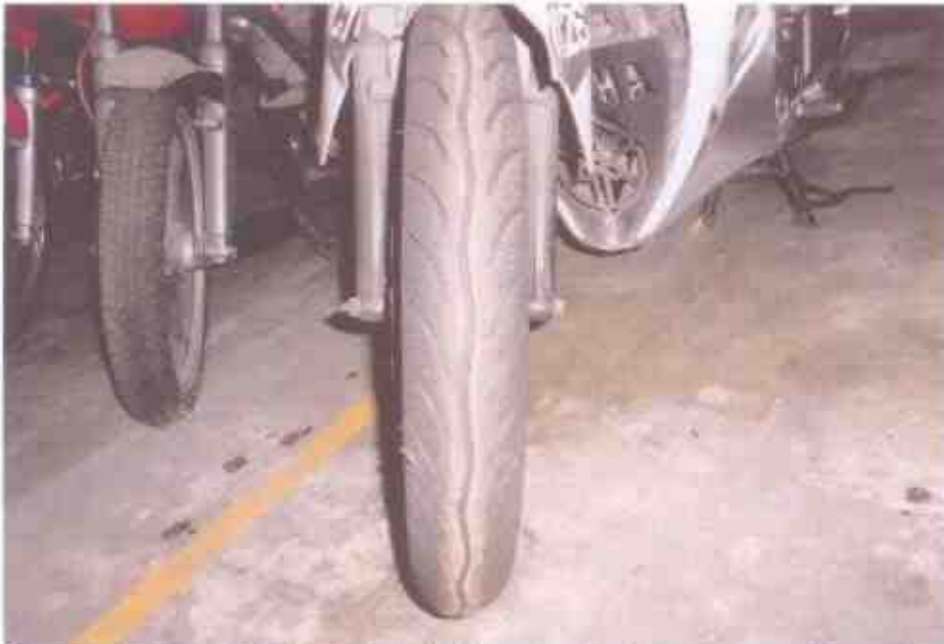
Photo 9 shows the front tyre of the Motorcycle. The front tyre was observed to be in serviceable condition with remaining tread depth of approximately 4mm. The tyre was also observed to be sufficiently inflated for vehicular operation.

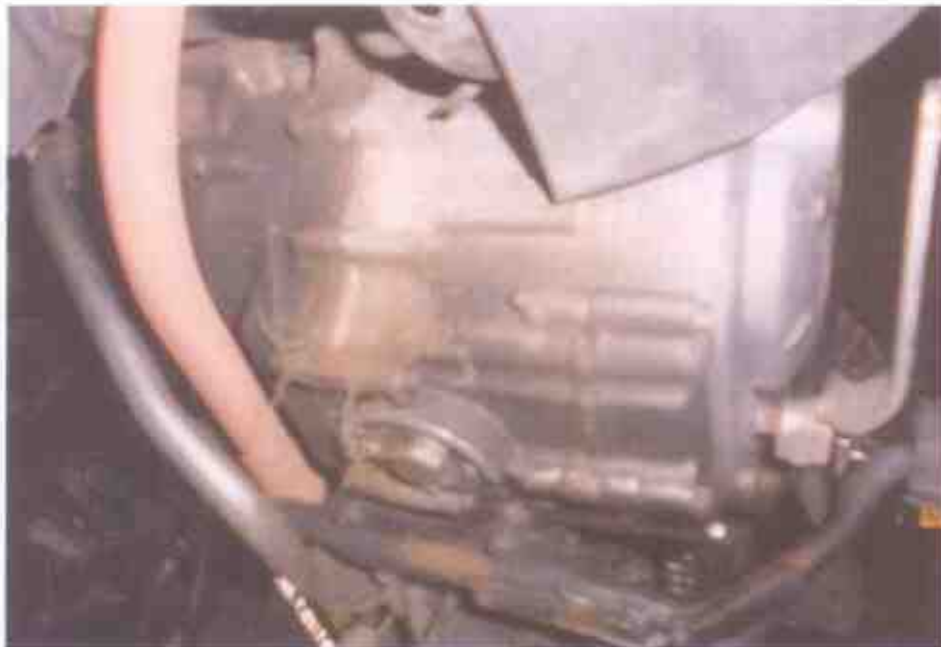
Photo 10 shows no sign(s) or indication(s) of fluid leak observed around the underside of the engine area of the Motorcycle.

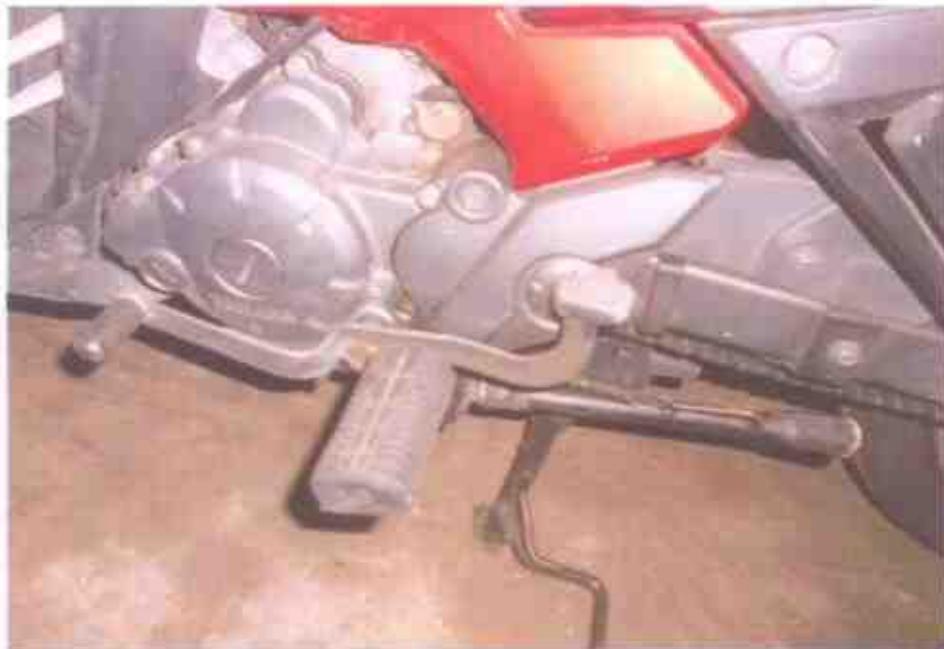
Photo 11 shows no sign(s) or indication(s) of fluid leakage stain observed around the engine area of the Motorcycle.

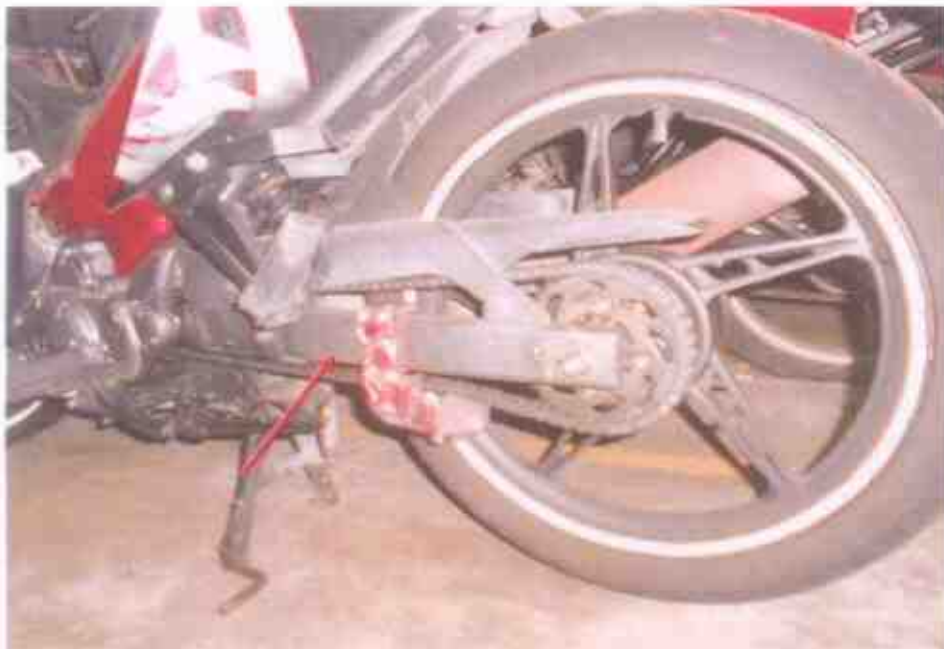
Photo 12 shows the general view of the gear train (arrowed) of the Motorcycle, which was observed to be intact with no misalignment. It was also adequately lubricated for operating purposes.

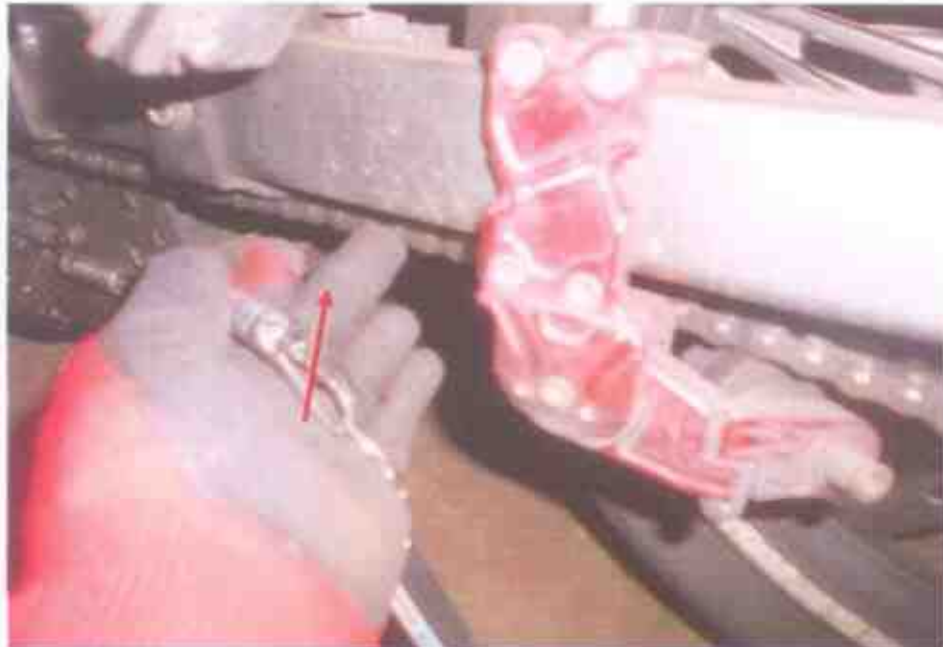
Photo 13 shows the general view of the gear train (arrowed) of the Motorcycle, which was observed to be intact with no misalignment. It was also adequately lubricated for operating purposes. Free play tension was also observed & found adequately acceptable.

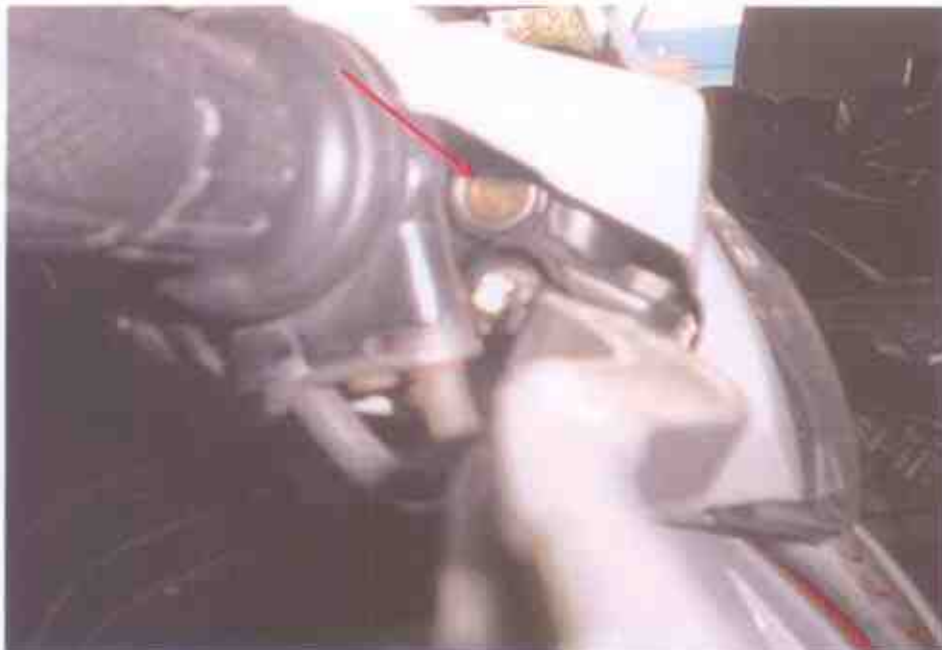
Photo 14 shows our checks on the brake fluid (front) reservoir had also indicated that the brake fluid was of sufficient level for operational purposes, and without contamination.

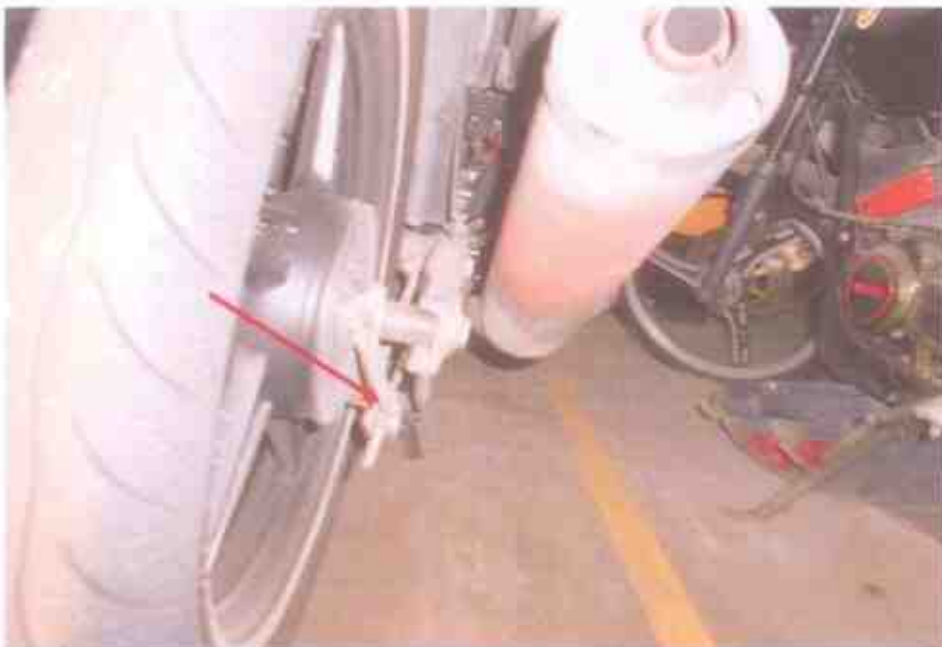
Photo 15 shows our checks on the rear brake mechanical components. It was observed to be unaffected by the accident's impact.

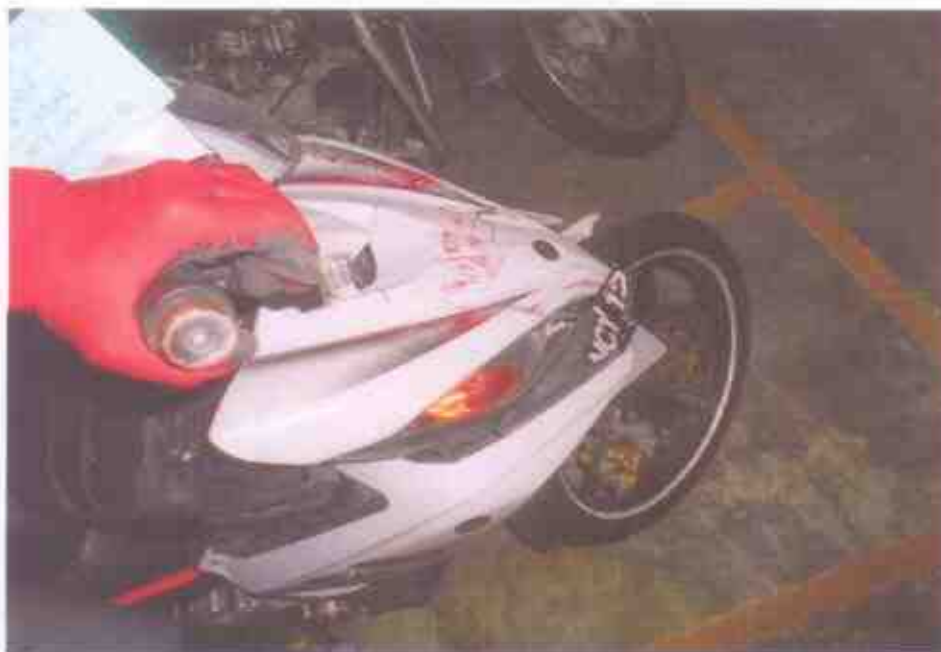
Photo 16 shows testing of the braking of the front brake in progress. There was some resistance felt (spongy like feel) upon pressing the brake lever.

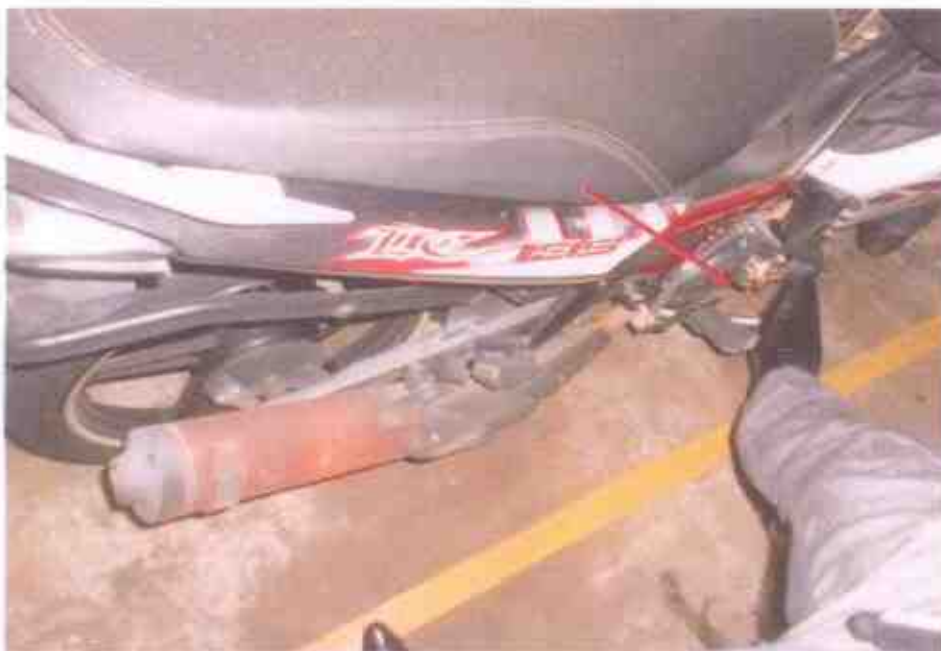
Photo 17 shows testing of the braking of the rear brake in progress. There was some resistance felt (spongy like feel) upon stepping on the brake pedal.

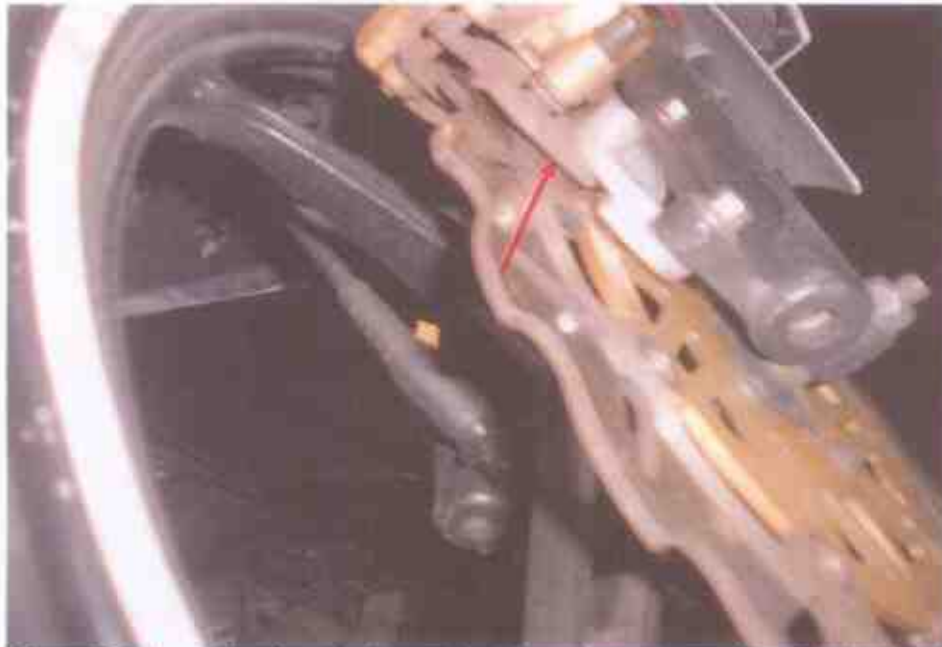
Photo 18 shows the front brake pad at time of our inspection. The frictional material was observed to be sufficient for operational purposes.
