AUTOMOBILE ASSESSMENT REPORT

Assessment of Vehicle No : SKV 7870 M
Date of Accident : 19/04/2018
Date of Inspection : 20/04/2018

1. Policy Particulars :- THIRD PARTY CLAIM (RESURVEY INSPECTION)				
Insured Veh.	SHD 6930K	Veh. Inspected	SKV 7870M	
Policy No.		Coverage (\$)	0.00	
Claim No.	D18003069MFSH	Excess (\$)	0.00	
Assign From	MAY CHUA	Assign Date	27/07/2018

ADJUSTMENT ON REPAIR COST FOR VEHICLE NO. SKV 7870M

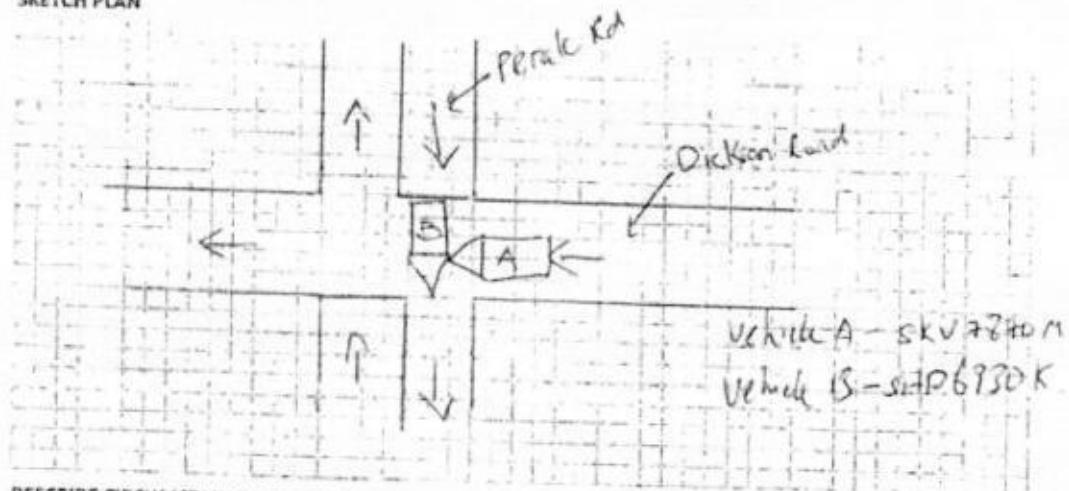
SKETCH PLAN

However, I would like to add that the taxi SHP 6930 K did not stop at the stop line and just dash out without checking that lead to this accident and my injuries.
