Your Ref: Mercedes Benz GLC 200
(chassis number WDC2539422F283560)
Our Ref : CI/TP18014298/D

**INSPECTION REPORT OF AN UNREGISTERD MERCEDES BENZ GLC 200
MOTOR CAR WITH CHASSIS NUMBER WDC2539422F283560**

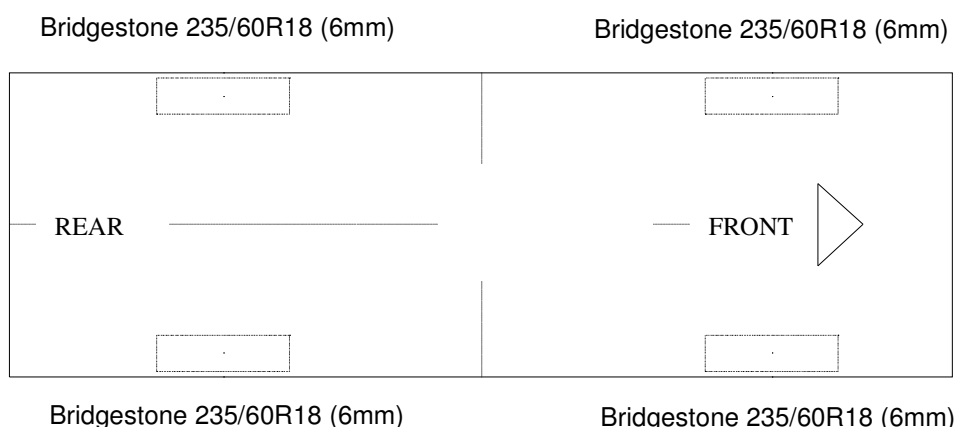
8. It was fitted with 18inch sport wheel rims that were wrapped with tyres that were observed to be of serviceable condition. The tyres were also sufficiently inflated for vehicular operation. The tyre brand, tyre size and approximate remaining tread depth of the 4 tyres of the Motor Car were recorded as follows: -

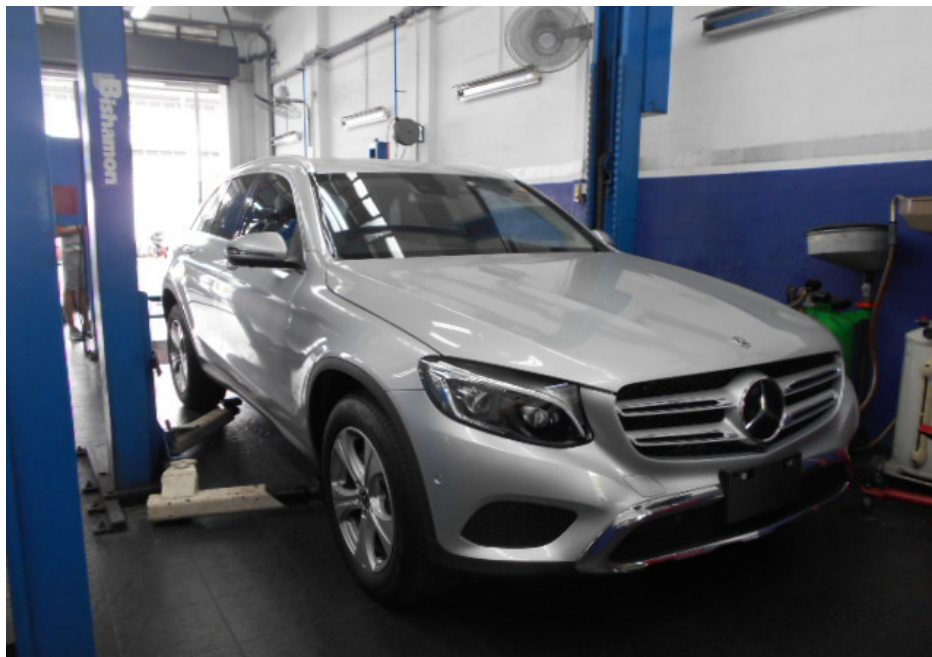
Photo 1 shows a general view of the front right body of the Motor Car at the time of my inspection. The Motor Car was observed to be in relatively good general condition with no loose exterior fittings observed.

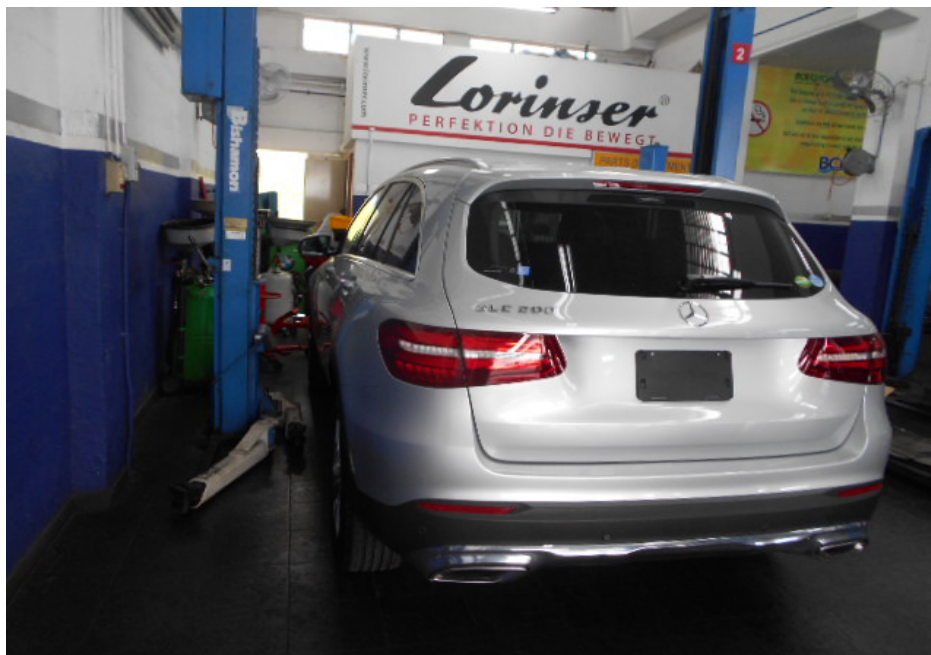
Photo 2 shows a general view of the rear left body of the Motor Car at the time of my inspection. The Motor Car was observed to be in relatively good general condition with no loose exterior fittings observed. It was also hoisted up during my inspection for checks on its underside.

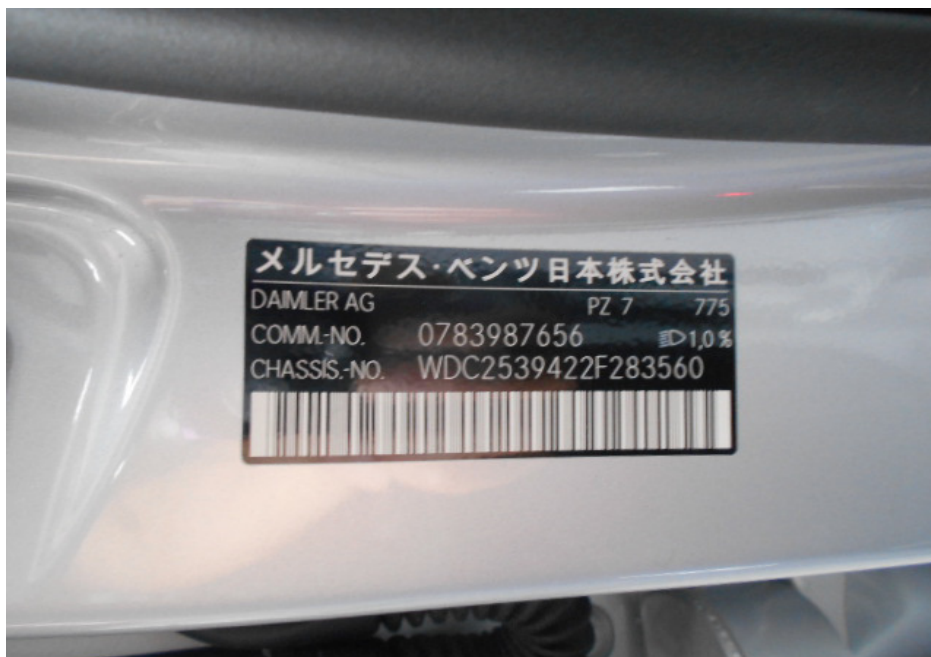
Photo 3 shows the chassis number of the Motor Car. The chassis number recorded was WDC2539422F283560.

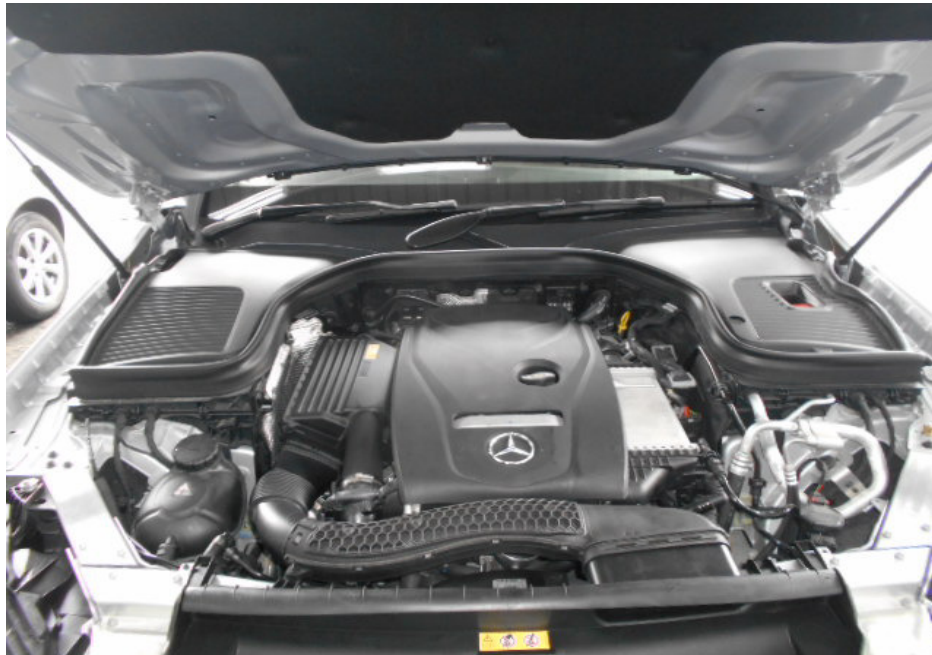
14. My examination of the Motor Car's engine compartment revealed that the various parts and components inside the engine compartment were all intact and properly fitted. The engine oil, brake fluid and engine coolant were all found to be of sufficient level for operating purposes. Visually, there was also no contamination found to these fluids.
15. My checks on the underside of the Motor Car revealed no sign(s) or indication(s) of fluid leakage and/or fluid stain(s). The engine block and automatic transmission assembly were both secured properly. They were not mounted onto the chassis body or any integral body part of the Motor Car. All undercarriage components of the Motor Car were also observed to be intact and secured in an appropriate manner.

Photo 4 shows the engine compartment of the Motor Car. The various parts and components inside the engine compartment were all observed to be intact and properly fitted. There was also no sign(s) or indication(s) of fluid leak and/or fluid stain found inside the engine compartment. The engine oil, brake fluid and engine coolant were all checked and found to be of sufficient level for operating purposes. Visually, there was also no contamination found to these fluids.

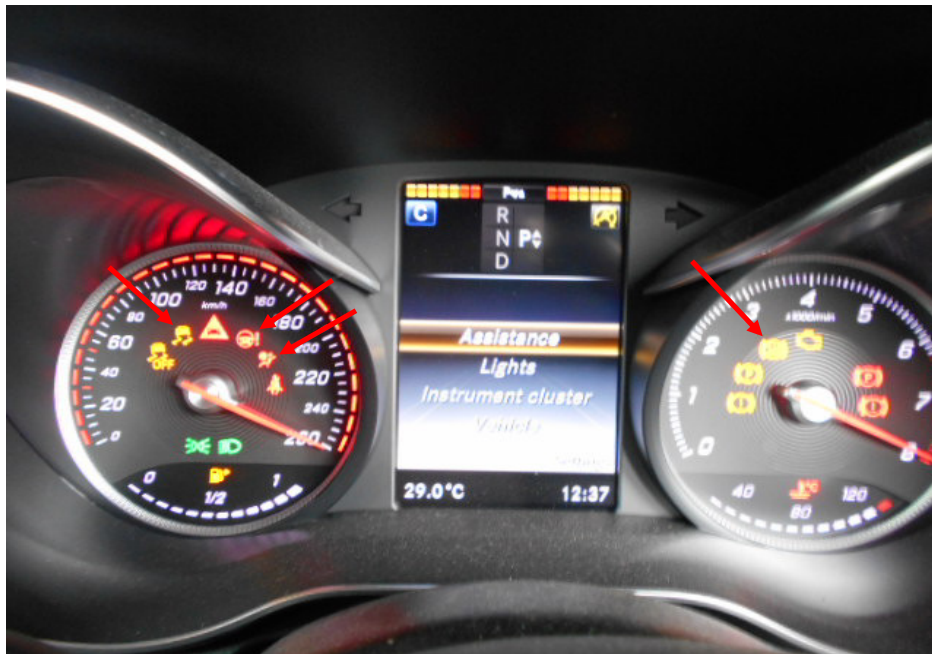
Photo 5 shows the warning lights for the various electronic safety features appearing on the instrument panel of the Motor Car during its self-test when the engine is cranked, in particular the Anti-Brake Lock System (ABS), Supplemental Restraint System (SRS), Power Steering Assist (PSA) and Electronic Stability Program (ESP) (arrowed).

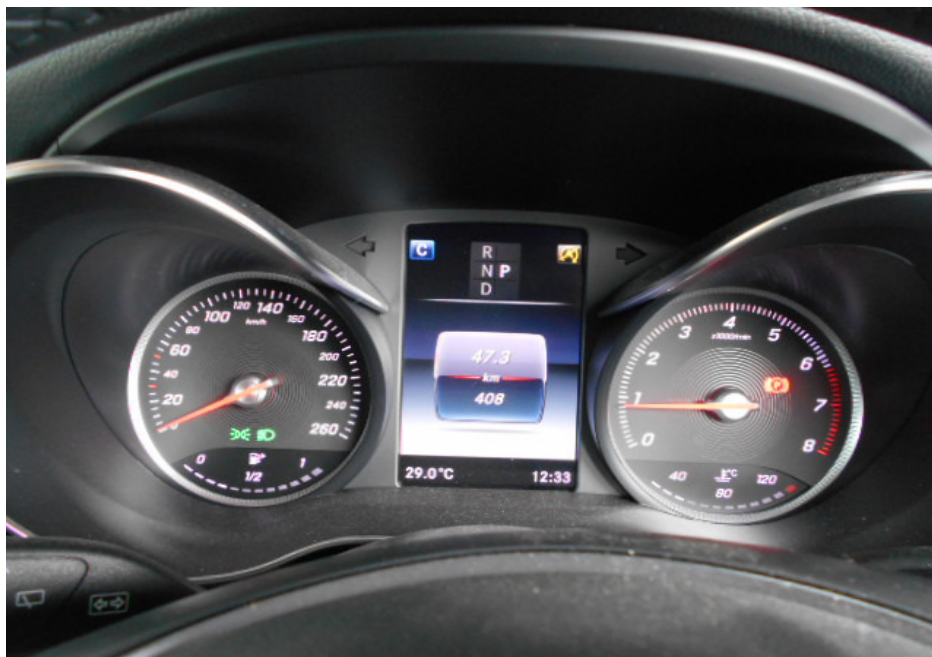
13. The Motor Car's automatic self-test of the functionality of its various electronic safety features like the Anti-Brake Lock System (ABS), Supplemental Restraint System (SRS), Power Steering Assist (PSA) and Electronic Stability Program (ESP) during cranking of the engine had indicated that these systems were in working condition. This was determined from the respective warning lights disappearing from the instrument panel after the self-test.

Photo 6 shows the respective warning lights no longer illuminated, indicating that there is no fault detected to the ABS, SRS, PSA and ESP systems of the Motor Car during the self-test. These electronic safety features were hence in working condition at the time of my inspection.

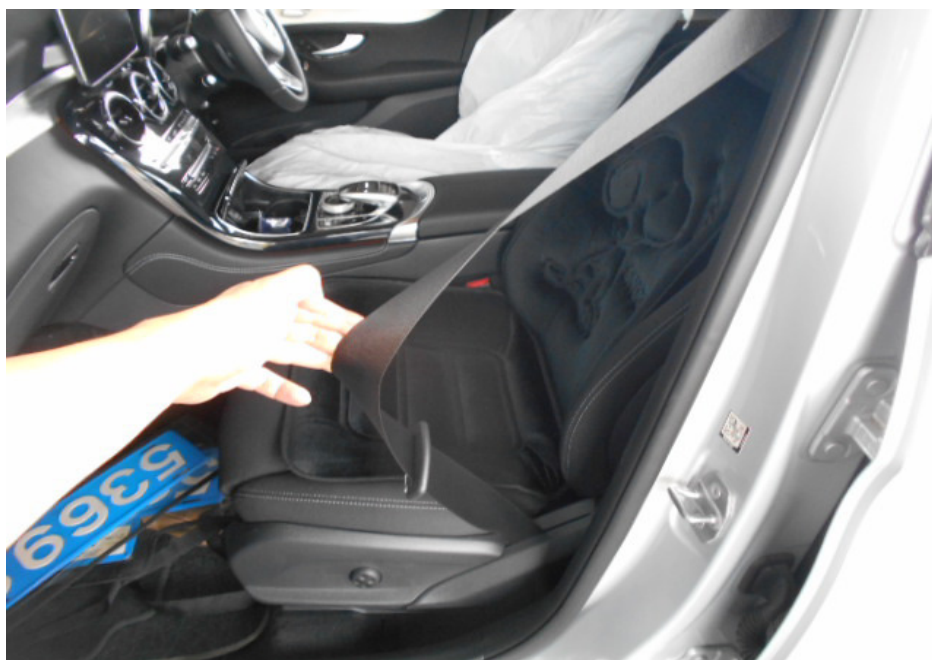
12. The seats of the Motor Car were found to be secured to the floor panel of the Motor Car via seat rails bolted onto the floor board. Retractable seat belt reels and pre-tensioners were fitted on all seats of the Motor Car. The seat belt reels were able to be fastened securely to the respective pre-tensioner that is fixed to the side of all the seats.

Photo 7 shows the interior compartment of the Motor Car. The seats of the Motor Car were found to be secured to the floor panel of the Motor Car via seat rails that were bolted onto the floor board. Retractable seat belt reels and pre-tensioners were fitted on all seats of the Motor Car. The seat belt reels were able to be fastened securely to the respective pre-tensioner that is fixed to the side of all the seats.

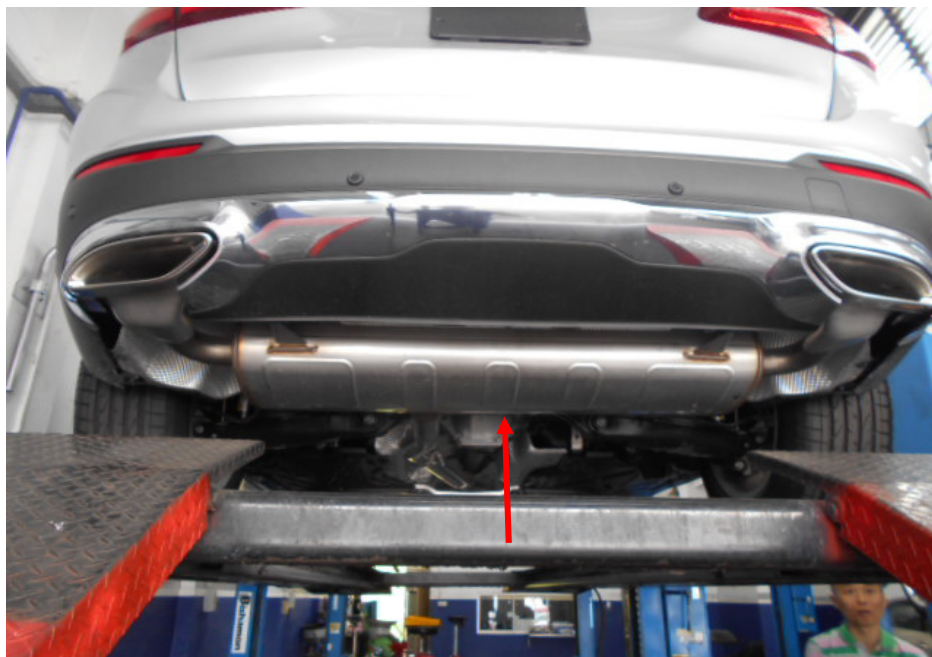
Photo 8 shows the Motor Car hoisted up for checks on its undercarriage. My examination of the Motor Car's exhaust system revealed no sign(s) or indication(s) of any cut or weld marks along its exhaust pipes and on its rear muffler (arrowed).

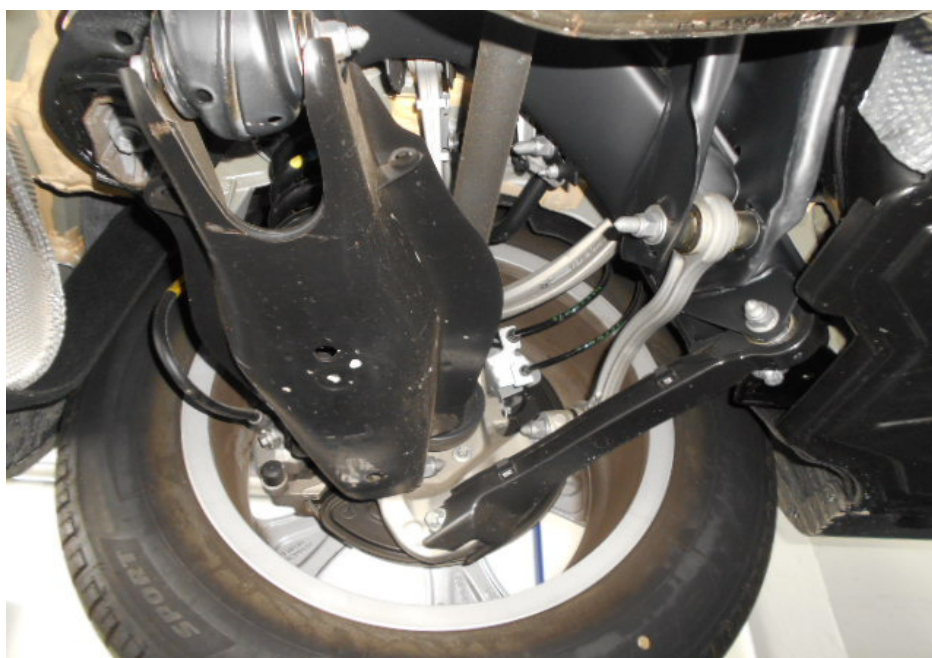
Photo 9 shows the various undercarriage components at the rear left wheel of the Motor Car. The mechanical components, control arms and linkages were all found to be intact and secured in an appropriate manner. There was also no sign(s) or indication(s) of fluid leakage and/or fluid stain(s).

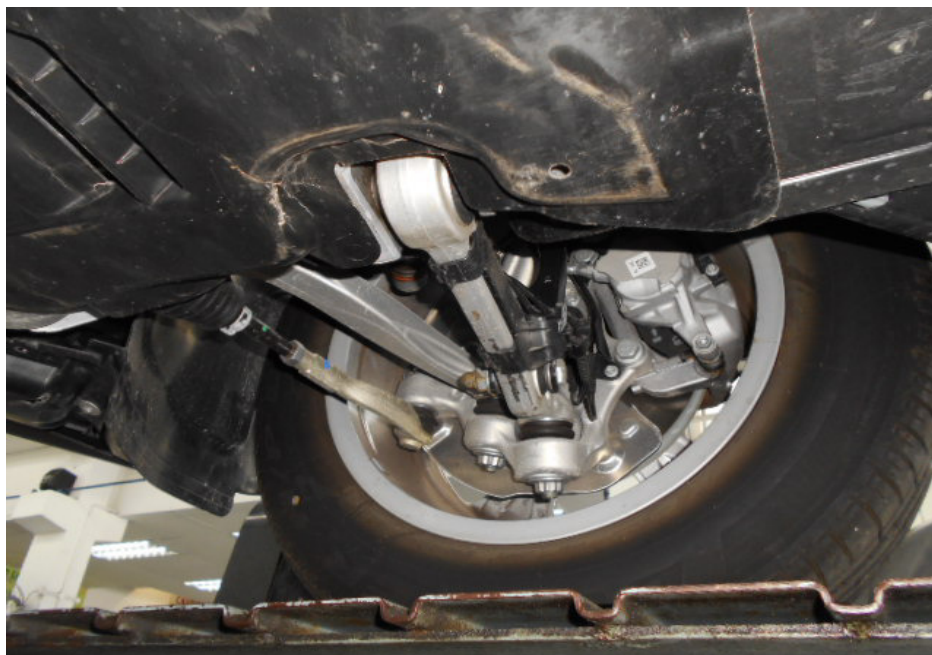
Photo 10 shows the various undercarriage components at the front right wheel of the Motor Car. The mechanical components, control arms and linkages were all found to be intact and secured in an appropriate manner. There was also no fluid leak and/or fluid stain observed on the underside of the Motor Car.

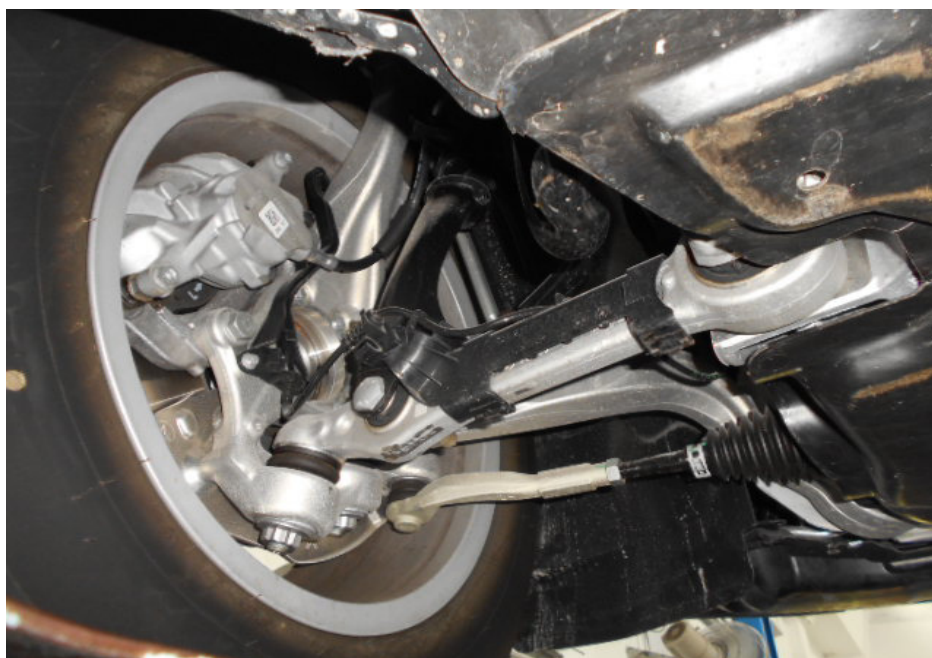
Photo 11 shows the various undercarriage components at the front left wheel of the Motor Car. The mechanical components, control arms and linkages were all found to be intact and secured in an appropriate manner. There was also no fluid leak and/or fluid stain observed on the underside of the Motor Car.

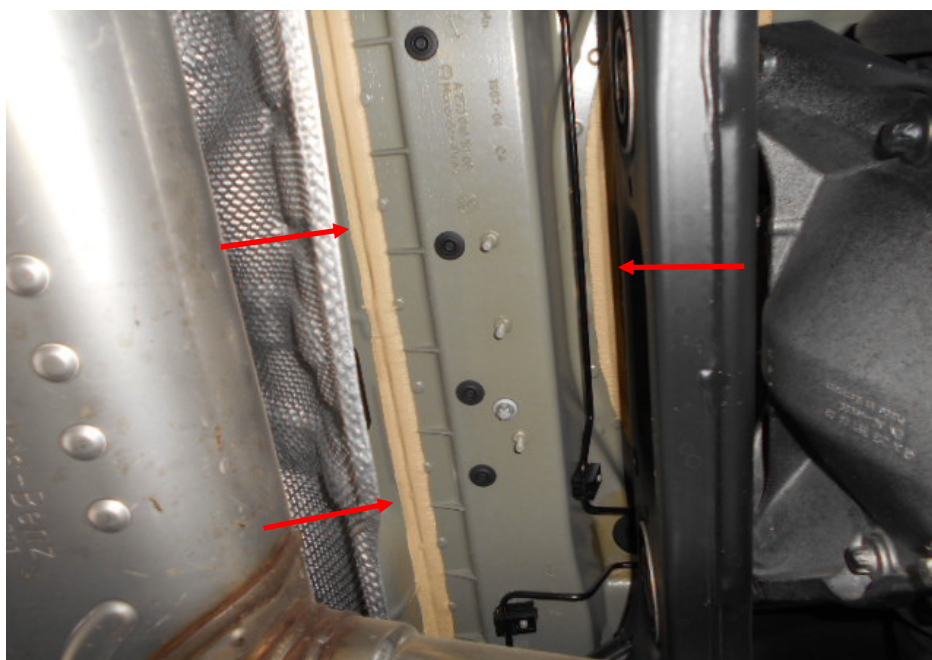
Photo 12 shows the structural body/floor panel at the rear of the Motor Car. The original factory sealant (arrowed) at the joints along the body panels were observed to be untouched, indicating no work was done on the rear structural body/floor panel of the Motor Car and that the structural body was originally fitted.

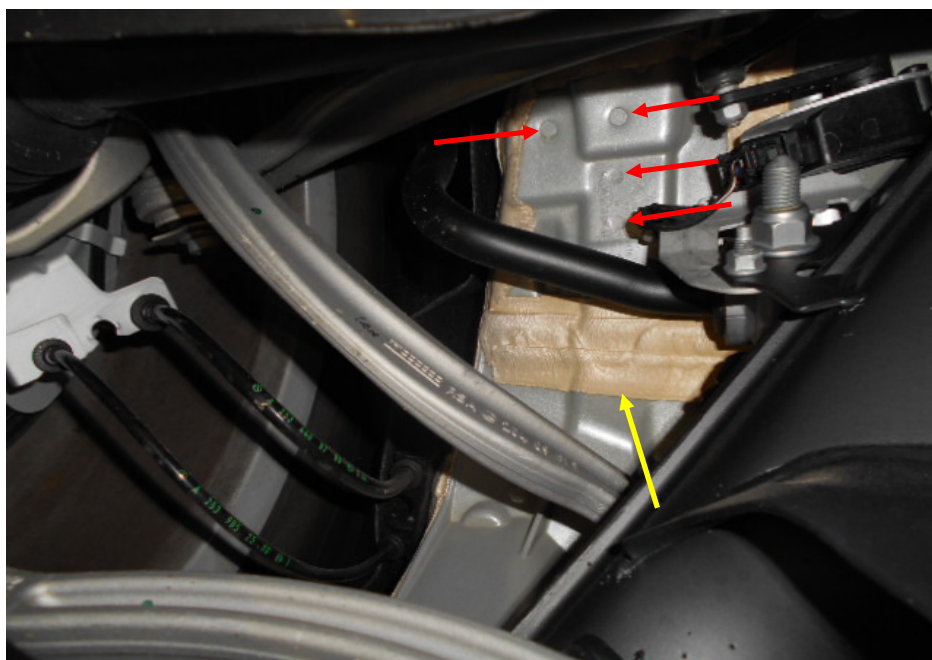
Photo 13 shows the structural body/floor panel at the rear left wheel house panel of the Motor Car. I did not find any weld marks, other than original spot weld marks (red arrow), on the rear left wheel house panel of the Motor Car. The original factory sealant (yellow arrow) at the joints along the body panels were also untouched, indicating no work was done on the rear left wheel house panel of the Motor Car and that the structural body was originally fitted.

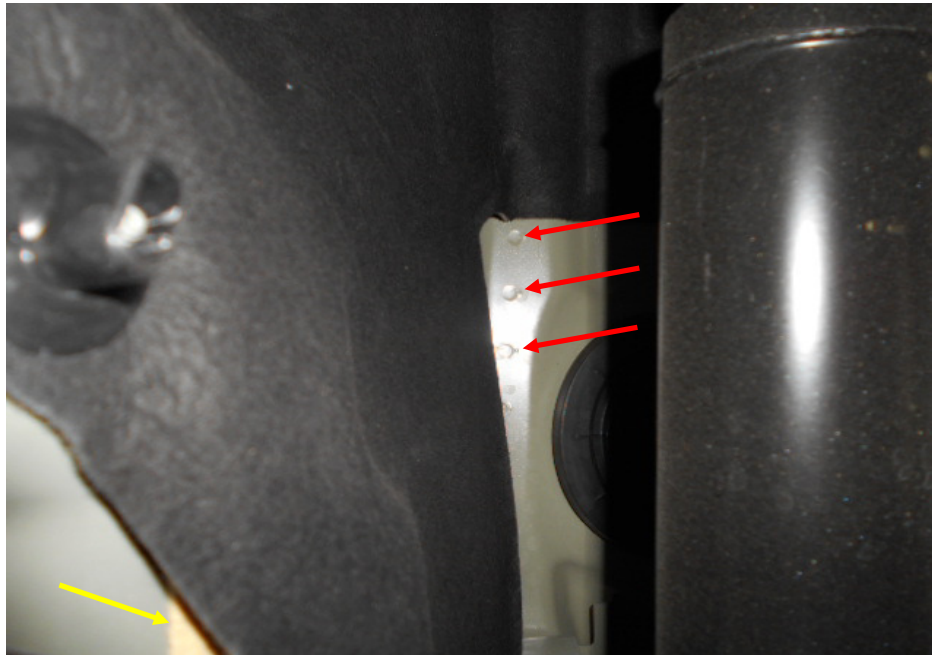
Photo 14 shows the structural body/floor panel at the centre of the Motor Car. I did not find any weld marks, other than original spot weld marks (red arrow), on the body panels of the Motor Car. The original factory sealant (yellow arrow) at the joints along the structural body/floor panel were also untouched, indicating no work was done on the structural body/floor panel of the Motor Car and that the structural body was originally fitted.

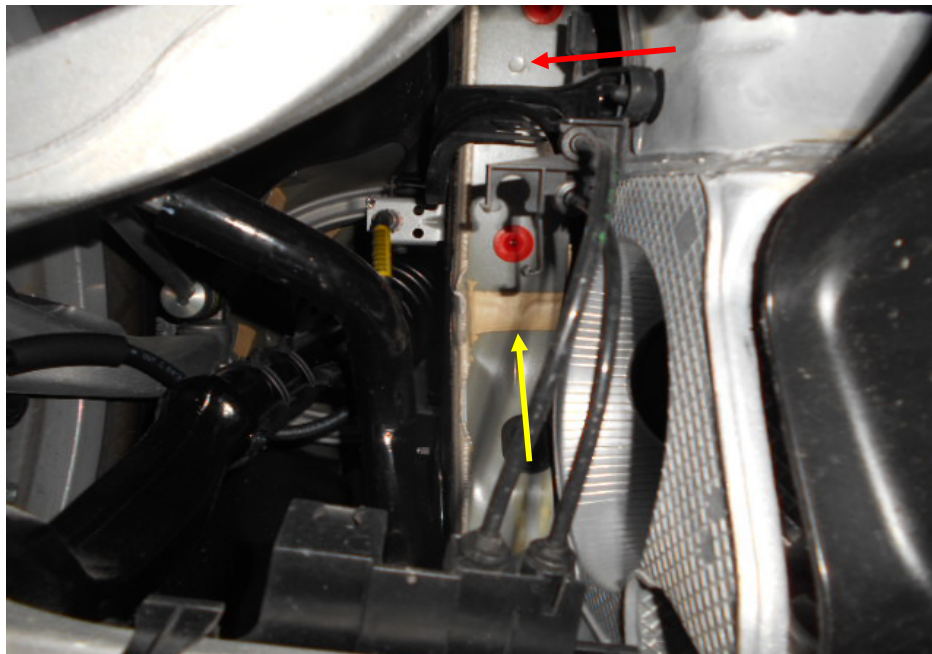
11. Visually, I did not find any weld marks, other than the original spot weld marks, on the chassis body of the Motor Car. The original factory sealant at the joints along the chassis was also untouched, again indicating that no replacement of the chassis body was carried out; and that the chassis body was originally fitted.

Photo 15 shows the chassis body at the front left of the Motor Car. The original factory sealant (yellow arrow) and original spot weld marks (red arrow) at front left chassis body were observed to be untouched, indicating no work was done on the front left chassis body of the Motor Car and that the structural body was originally fitted.

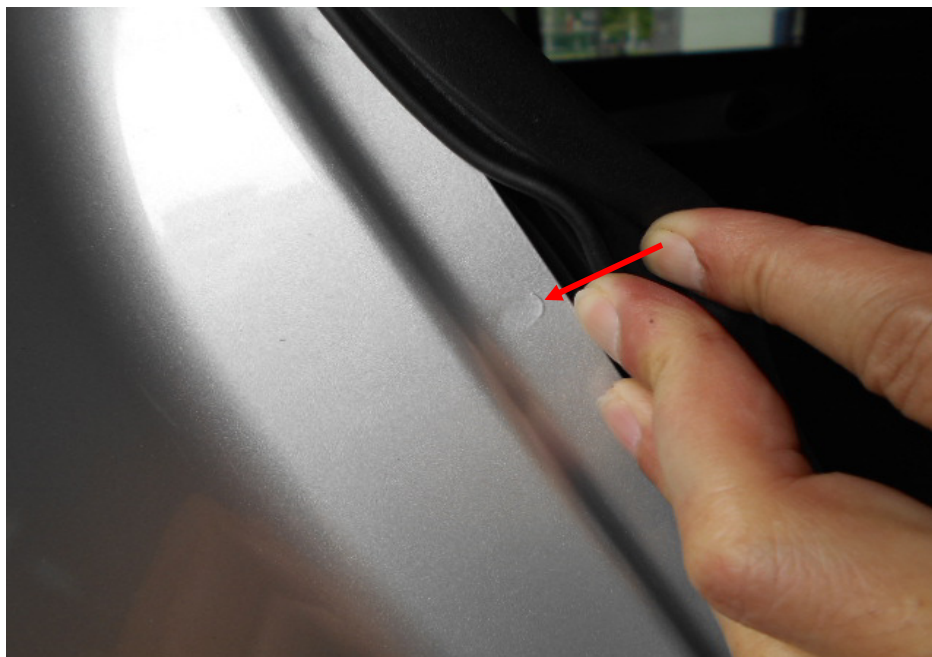
Photo 16 shows the rear right body panel of the Motor Car. I did not find any weld marks other than original spot weld marks (arrowed) on the non-detachable body panels of the Motor Car, indicating that there was no re-welding works carried out; and that the non-detachable body panels of the Motor Car were originally fitted.

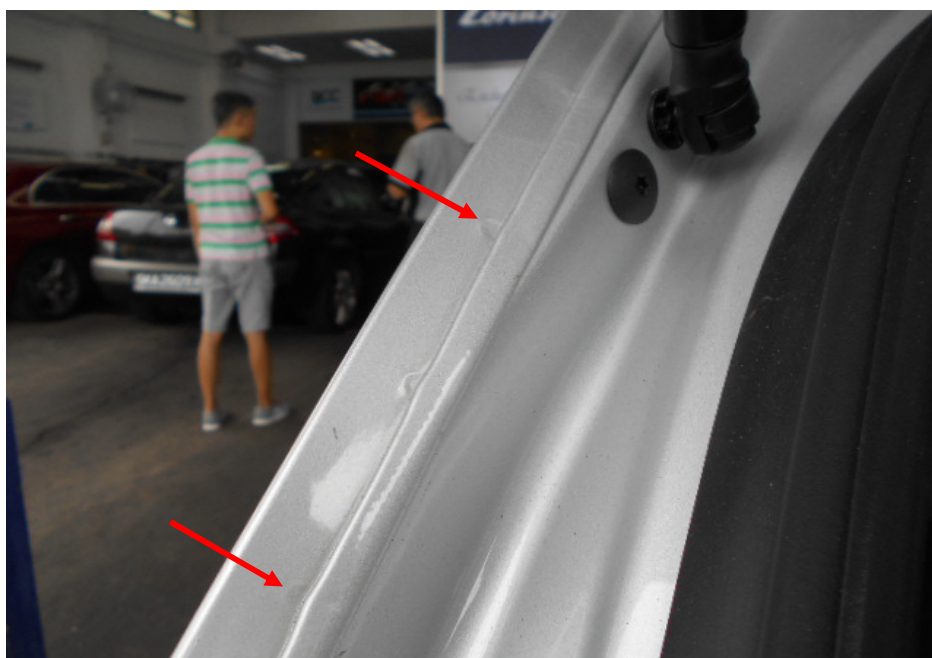
Photo 17 shows the rear left body panel of the Motor Car. I did not find any weld marks other than original spot weld marks (arrowed) on the non-detachable body panels of the Motor Car, indicating that there was no re-welding works carried out; and that the non-detachable body panels of the Motor Car were originally fitted.

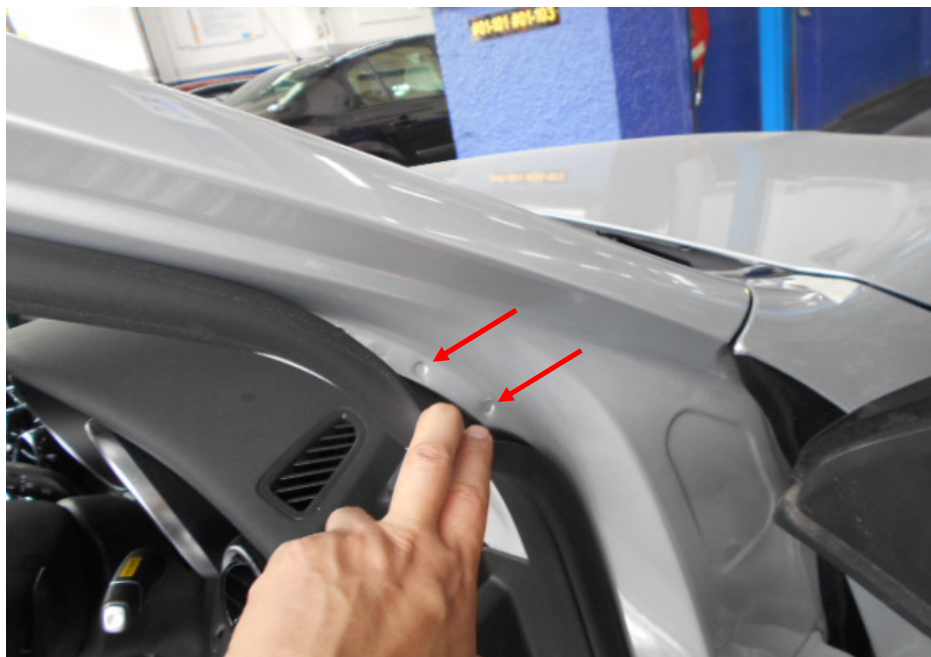
Photo 18 shows the front right “A” pillar of the Motor Car. I did not find any weld marks other than original spot weld marks (arrowed) on the non-detachable body panels of the Motor Car, indicating that there was no re-welding works carried out; and that the non-detachable body panels of the Motor Car were originally fitted.
