06 August 2018

Our Ref : CI/TP18014306/D

INSPECTION REPORT OF A HONDA ENGINE WITH NUMBER B16A6200358

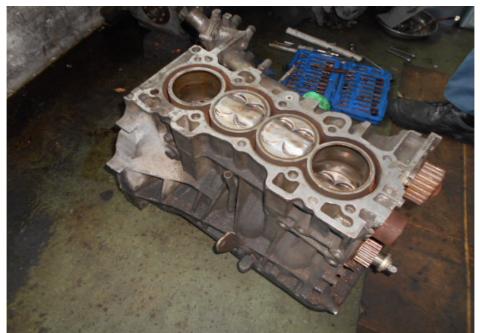
Photo 1 shows a general view of the Honda engine that I had inspected. The Honda engine was observed to be a used engine and was not fitted on any motor car. The top block of the Honda engine was separated from its bottom block. This was to enable me to carry out measurements of its cylinders, in particular the bore and stroke measurements of each cylinder, which typically can be used to determine the engine displacement or more commonly referred to as engine cc.

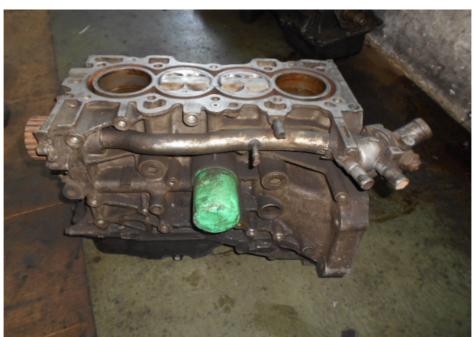
Photo 2 shows a general view of the Honda engine that I had inspected. My visual examination of the engine housing revealed the housing to be of serviceable/satisfactory condition. There was no crack and/or hole observed on the engine housing.

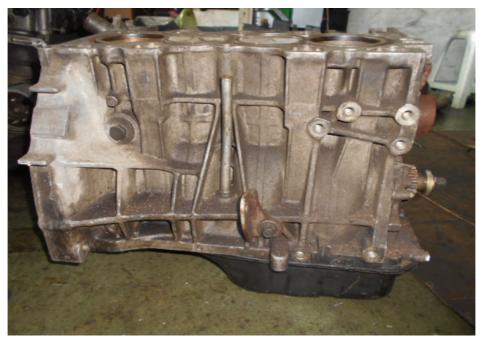
Photo 3 shows a general view of the Honda engine that I had inspected. My visual examination of the engine housing revealed the housing to be of serviceable/satisfactory condition. There was no crack and/or hole observed on the engine housing.

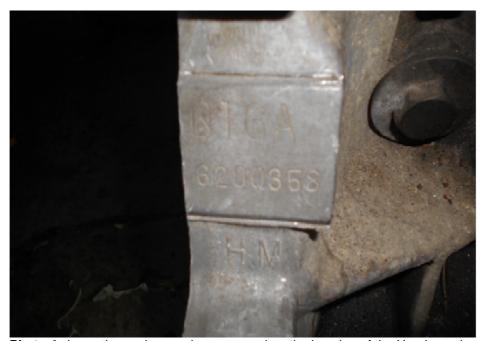
Photo 4 shows the engine number engraved on the housing of the Honda engine that I had inspected. The engine number was B16A6200358.

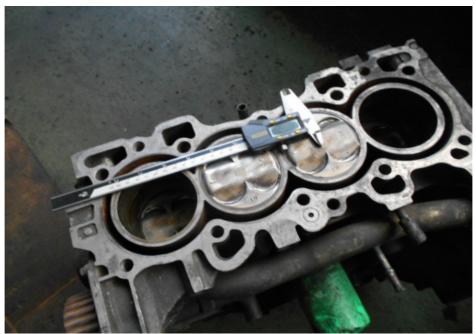
Photo 5 shows the bottom block of the Honda engine and the digital Vernier Caliper that was used to measure the bore and stroke of the Honda engine. The digital Vernier Caliper was calibrated before the start of the measurements.

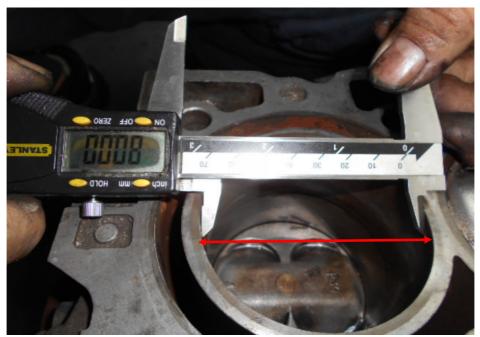
Photo 6 shows measurement being carried out to the bore (arrowed) of cylinder 1 of the Honda engine. The bore measurement of cylinder 1 was recorded to be 80.00mm.

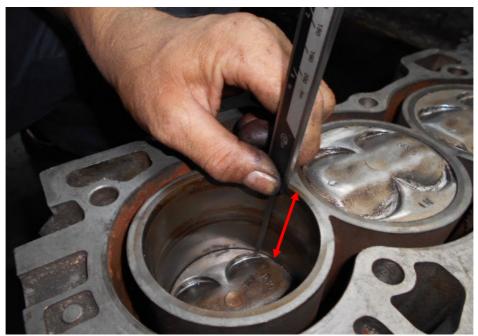
Photo 7 shows measurement being carried out to the stroke (arrowed) of cylinder 1 of the Honda engine. The bore and stroke measurements of the Honda engine were carried out using a digital Vernier Caliper.

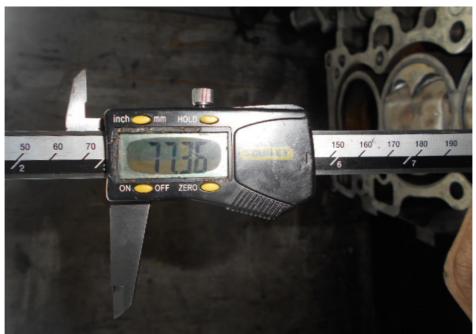
Photo 8 shows the stroke measurement of cylinder 1, which was recorded to be 77.36mm.

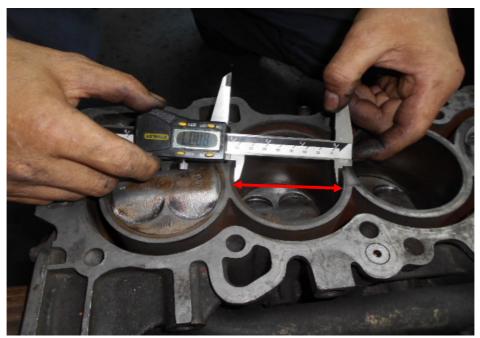
Photo 9 shows measurement being carried out to the bore (arrowed) of cylinder 2 of the Honda engine. The bore measurement of cylinder 2 was recorded to be 80.07mm.

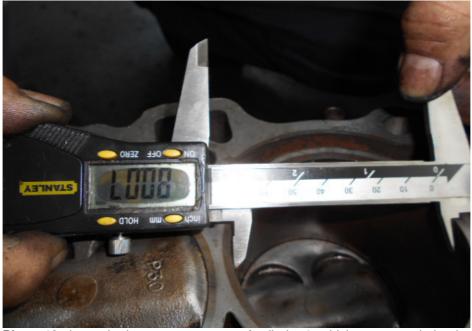
Photo 10 shows the bore measurement of cylinder 2, which was recorded to be 80.07mm.

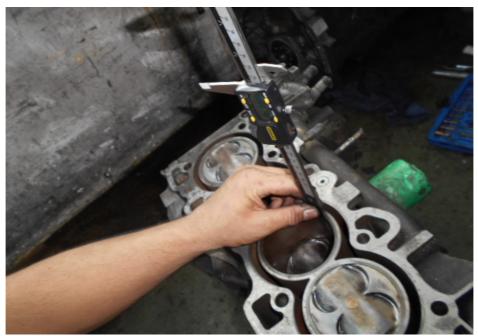
Photo 11 shows measurement of the stroke of cylinder 2 of the Honda engine that I had inspected. The bore and stroke measurements of the Honda engine were carried out using a digital Vernier Caliper, which was calibrated before the start of measurements.

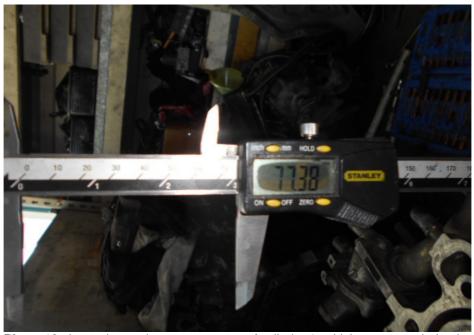
Photo 12 shows the stroke measurement of cylinder 2, which was recorded to be 77.38mm.

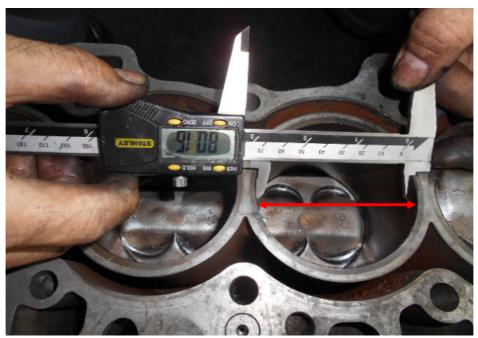
Photo 13 shows measurement being carried out to the bore (arrowed) of cylinder 3 of the Honda engine. The bore and stroke measurements of the Honda engine were carried out using a digital Vernier Caliper. The bore measurement of cylinder 3 was recorded to be 80.16mm.

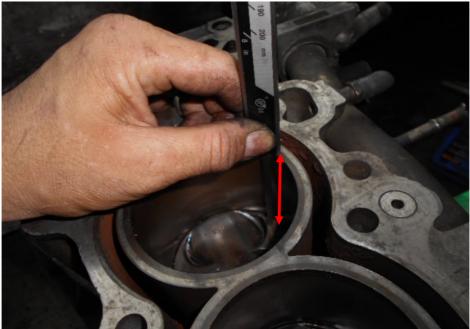
Photo 14 shows measurement of the stroke (arrowed) of cylinder 3 of the Honda engine that I had inspected. The bore and stroke measurements of the Honda engine were carried out using a digital Vernier Caliper that was calibrated before the start of measurements.

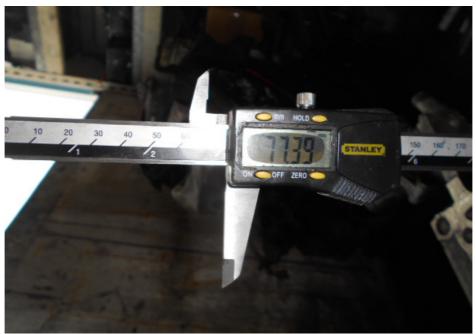
Photo 15 shows the stroke measurement of cylinder 3, which was recorded to be 77.39mm.

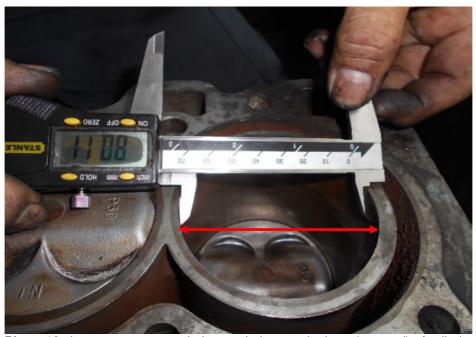
Photo 16 shows measurement being carried out to the bore (arrowed) of cylinder 4 of the Honda engine. The bore and stroke measurements of the Honda engine were carried out using a digital Vernier Caliper. The bore measurement of cylinder 4 was recorded to be 80.11mm.

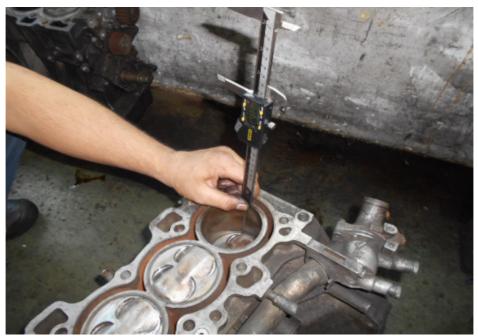
Photo 17 shows measurement being carried out to the stroke of cylinder 4 of the Honda engine. The bore and stroke measurements of the Honda engine were carried out using a digital Vernier Caliper that was calibrated before the start of measurements.

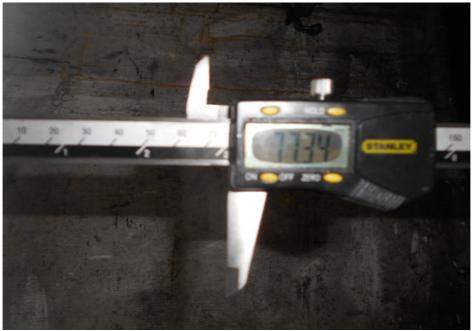
Photo 18 shows the stroke measurement of cylinder 4, which was recorded to be 77.34mm.
