Your Ref: 4646479085SG  
Our Ref : CI/AIG18014311/D

**AIG Asia Pacific Insurance Pte Ltd**  
78 Shenton Way #08-16  
AIG Building  
Singapore 079120  
(Motor Claims Department)

**TECHNICAL INVESTIGATION REPORT OF FIRE INCIDENT INVOLVING THE  
INSURED VEHICLE SBZ 3318D ON 16 JULY 2018**

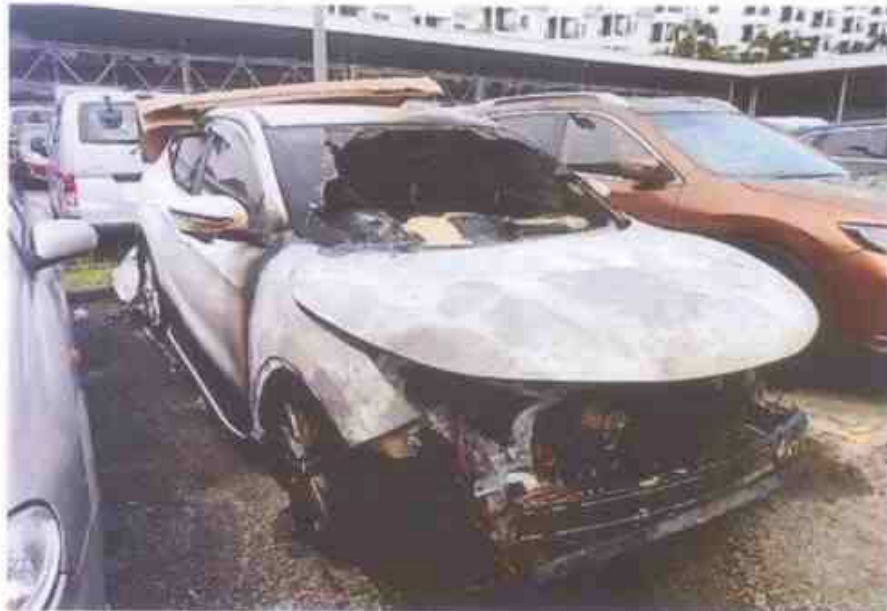
**Photo 1** shows a general view of the front right body of the Insured Vehicle at the time of inspection. The Insured Vehicle was observed to have sustained severe fire damage at its frontal body. Its front bumper, front bonnet, front grille, front right headlamp and front right fender were amongst the body parts that were found to have been burnt as a result of the fire.

20. For this case, the severe fire damage at the engine compartment suggests that the fire to the Insured Vehicle had originated from within its engine compartment. Intense burn marks found on the front bonnet and both front fenders of the Insured Vehicle indicate that the frontal portion of the Insured Vehicle was exposed to prolong high heat intensity. Following, the characteristic of heat (hot air rises), the origin of fire can then be determined to be from the engine compartment of the Insured Vehicle as the engine compartment is covered by the front bonnet and front fenders. Flames from the confined spaces of the engine compartment would travel outwards and upwards, exposing the front bonnet and front fenders of the Insured Vehicle to high heat intensity hence leaving the intense burn marks as seen.

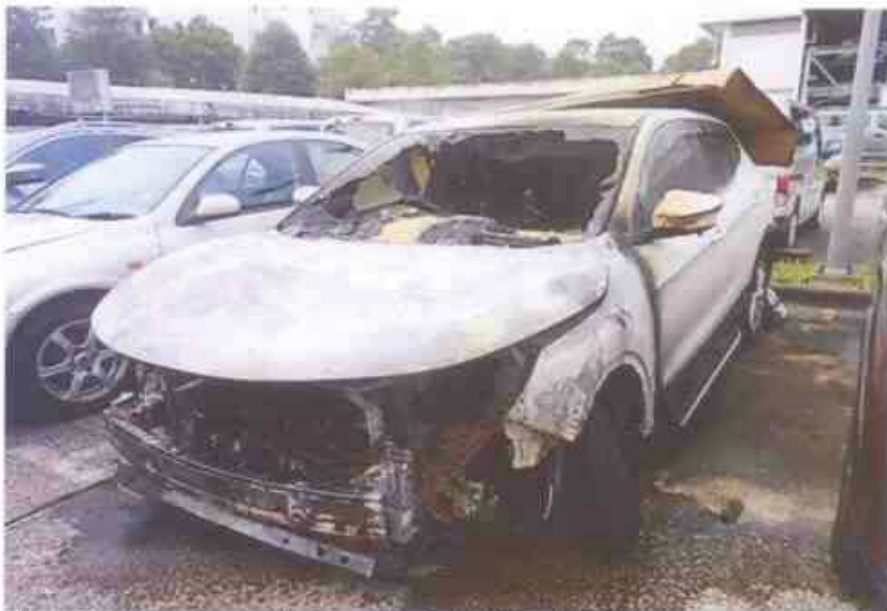
**Photo 2** shows a general view of the front left body of the Insured Vehicle at the time of inspection. The Insured Vehicle was observed to have sustained severe fire damage at its frontal body. Its front bumper, front left fender, front left headlamp, front bonnet, front left tyre and front windscreen were amongst the body parts that were found to have been burnt as a result of the fire.

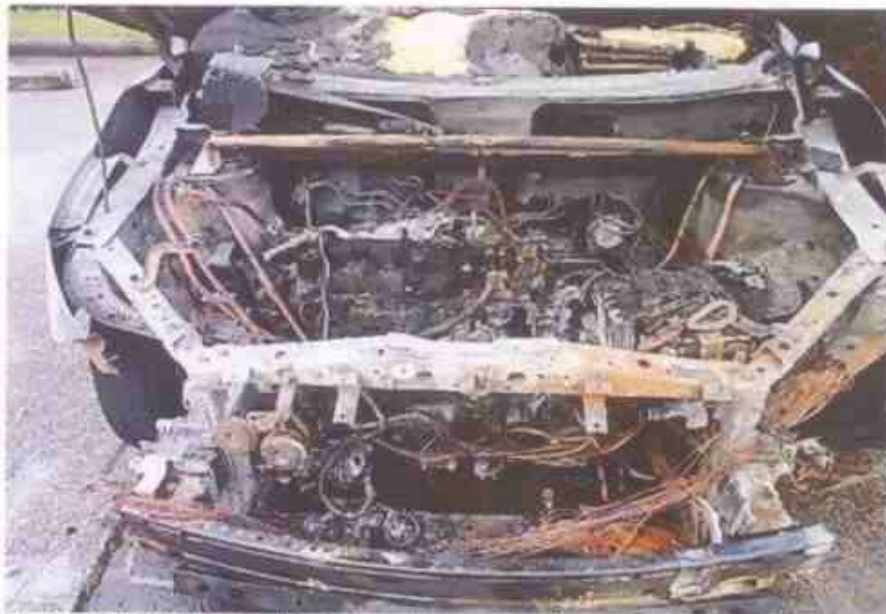
**Photo 3** shows the engine compartment of the Insured Vehicle at the time of inspection. All the parts inside the engine compartment were observed to be burnt and/or melted as a result of the fire. These parts had included the radiator, air condenser, cooling fan, intake manifold, fuse box, battery, air duct, hoses and pipes amongst others.

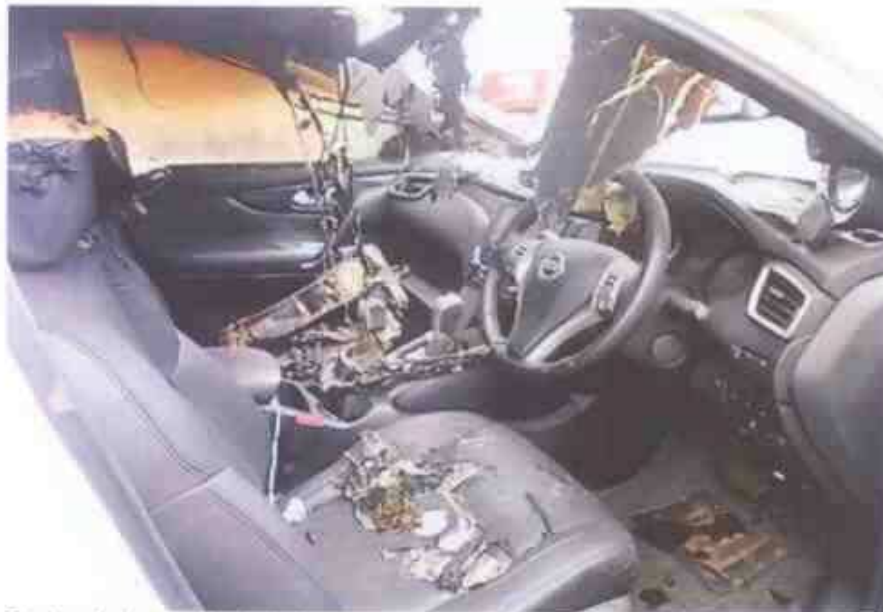
**Photo 4** shows the interior compartment of the Insured Vehicle, which was affected at the front area. The front seats, upholstery, carpet and various plastic trims were partially burnt and/or melted by the incident.

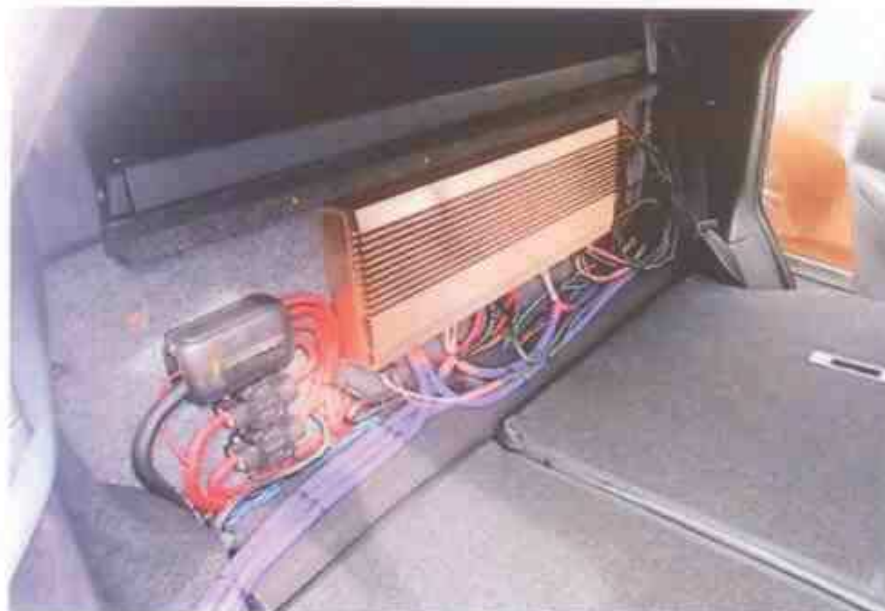
Photo 5 shows the audio amplifier, wire cables and fuses that were found to have been additionally fitted on the Insured Vehicle at the time of my inspection. These were fixed behind the rear seats of the Insured Vehicle, as part of the enhanced car audio system.

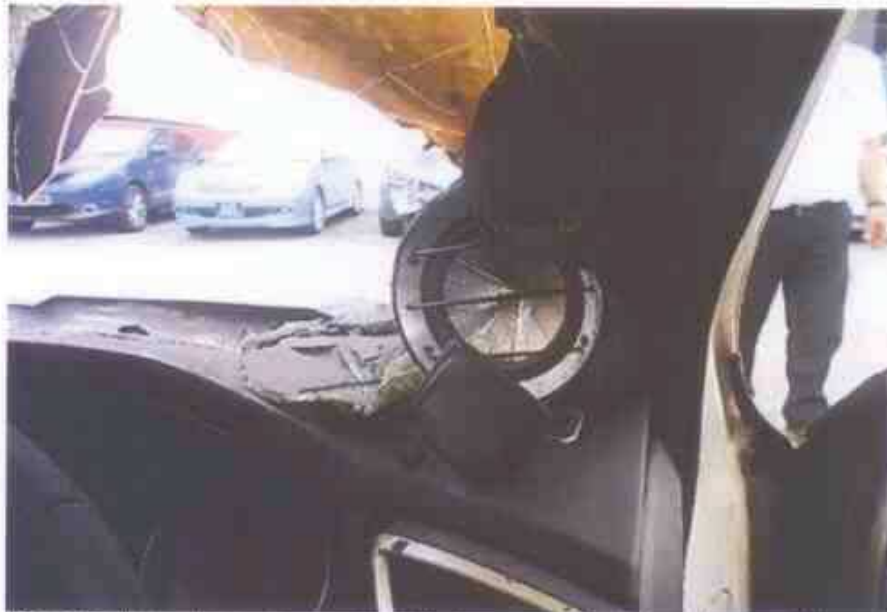
Photo 6 shows the audio speakers that were found to have been additionally fitted on the "A" pillar trim of the Insured Vehicle at the time of my inspection.

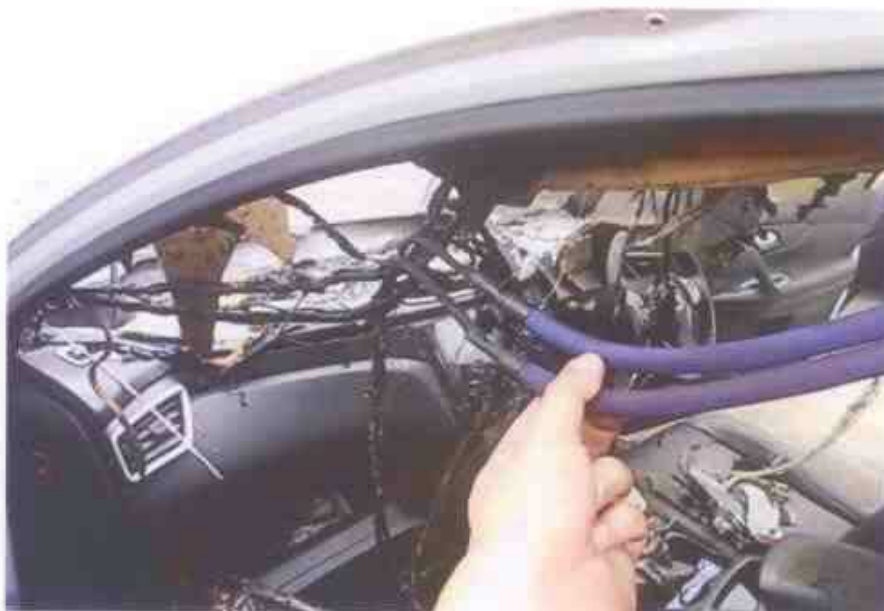
Photo 7 shows the wire cables that were additionally fitted from the rear to the front of the Insured Vehicle, as part of the enhanced car audio system.

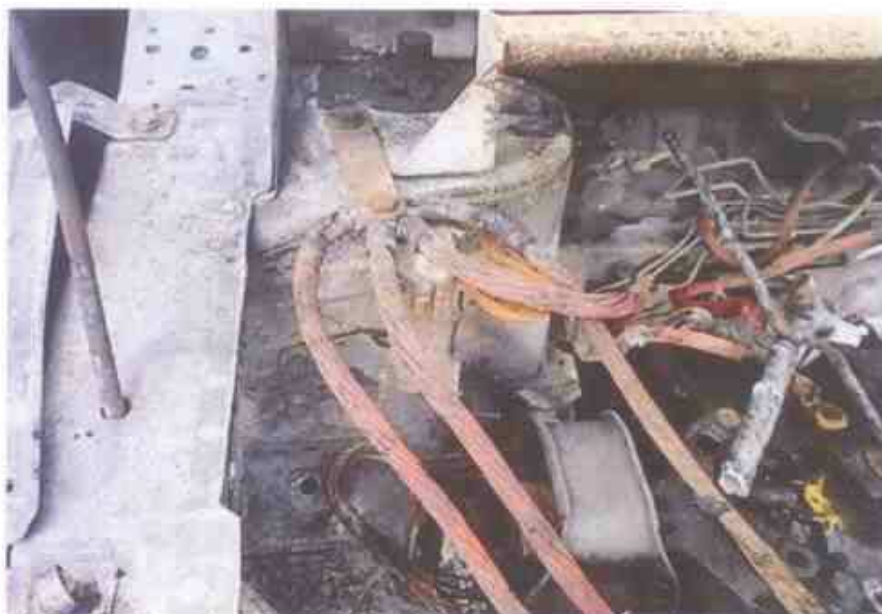
**Photo 8** shows the wire cables that were additionally fitted in the engine compartment of the Insured Vehicle. These wire cables appear to be grounding cables for the enhanced audio system that was fitted on the Insured Vehicle.

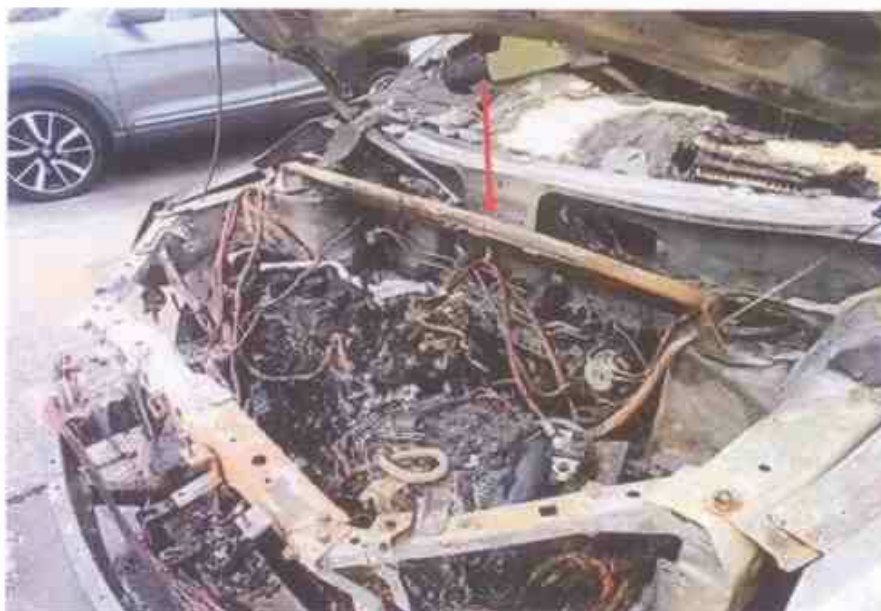
**Photo 9** shows the front strut bar (arrowed) that was additionally fitted in the engine compartment of the Insured Vehicle. This strut bar is not a standard item for the Insured Vehicle. The fitting of this strut bar enhances the road stability and handling of the Insured Vehicle.

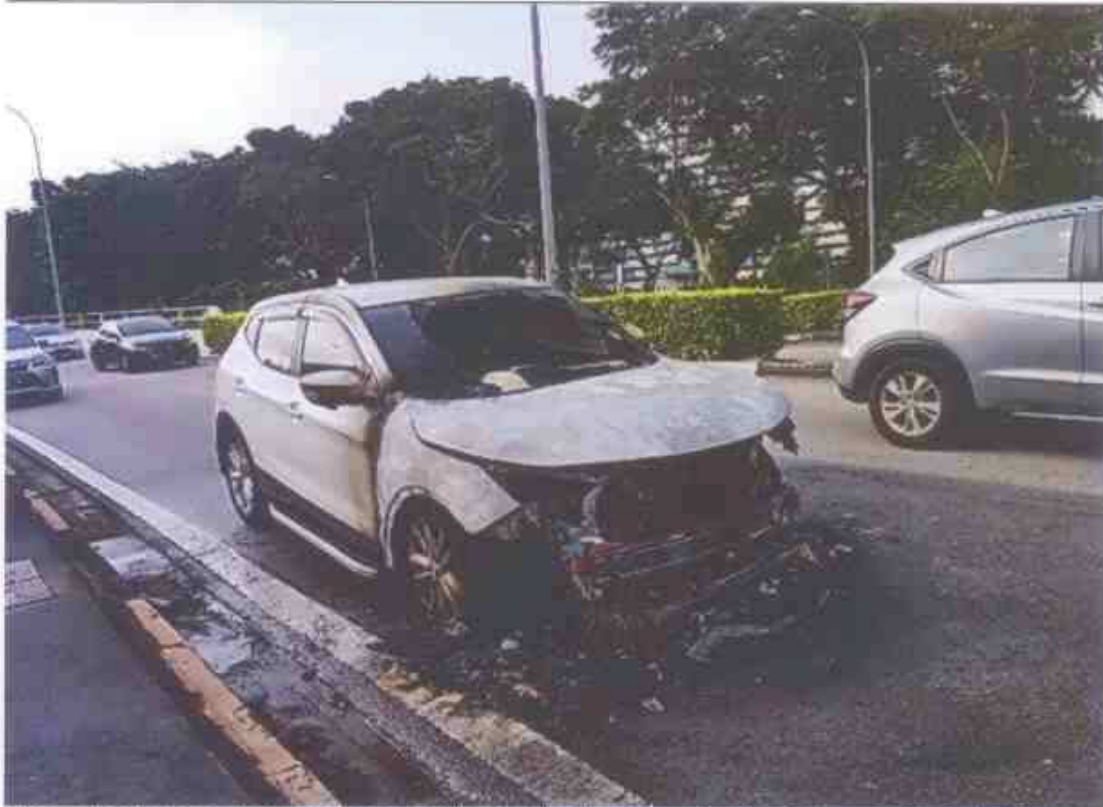
Photo 10 shows the Insured Vehicle at the incident location after the fire was extinguished. It was observed to have stopped on the right lane of a 2-lane roadway. The damage of burnt nature to the Insured Vehicle immediately after the fire was put out had corresponded to the damage as seen by me during my inspection of the Insured Vehicle.

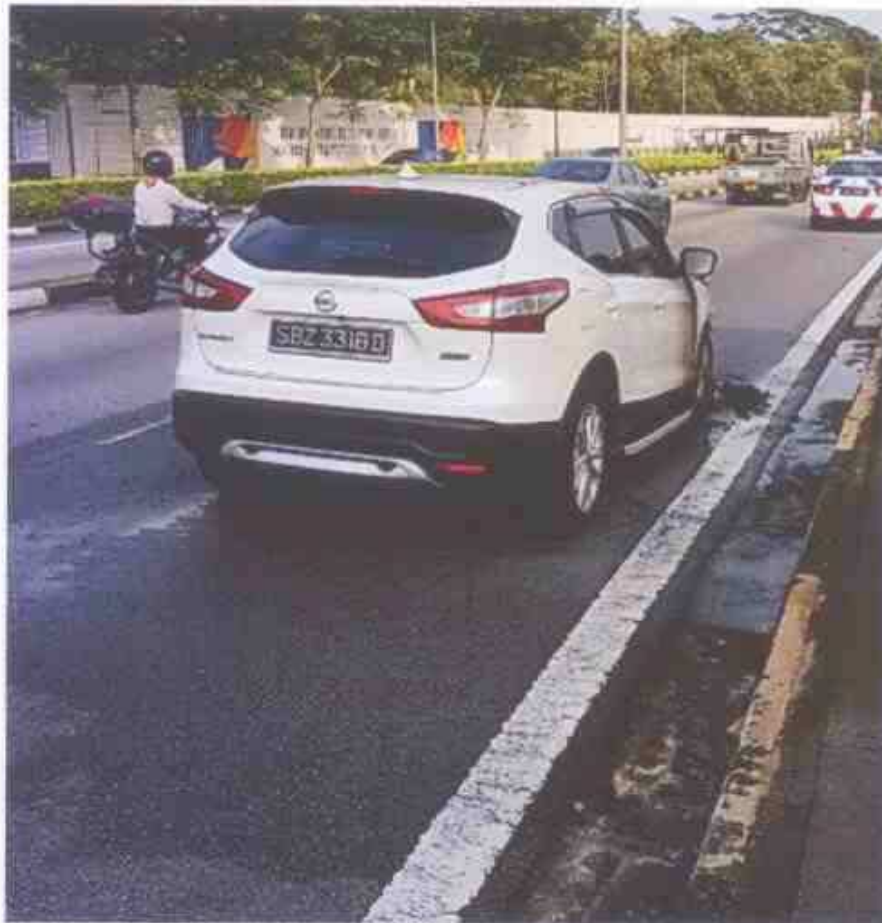
Photo 11 shows the Insured Vehicle at the incident location after the fire was extinguished. In general, the observations gathered from my review of the incident scene photographs had corresponded to Madam Chew's description of the events that she had related to me during our meeting on 26 July 2018.

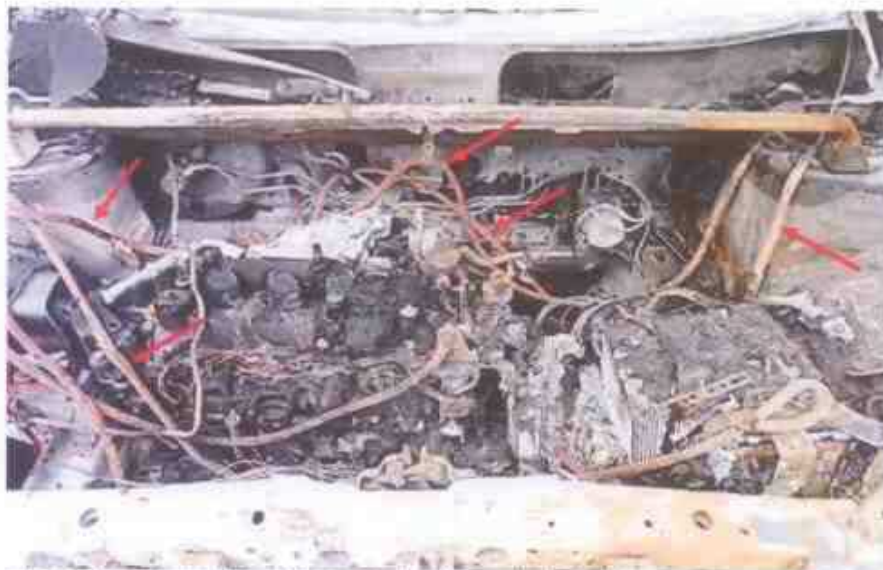
21. My examination of the Insured Vehicle's engine compartment, which was where the fire had originated, revealed wirings that were completely burned to its bare copper state. The bright reddish colour of the copper wires suggest that the wirings were exposed to high heat. Such condition normally indicates internal heating of copper wires, which is a sign of an electrical short circuit occurring. Hence the physical condition of the wirings at the engine compartment indicates that the cause of fire to the Insured Vehicle was due to electrical in nature. These bright reddish wirings were wire cables (grounding cables) that were additionally fitted for the enhanced audio system that was fitted on the Insured Vehicle. See photo 12 - 14 below.

Photo 12 shows the wirings at the Insured Vehicle's engine compartment. Several stretches of wirings (arrowed) were found to be completely burned to its bare copper state. The bright reddish colour of the copper wires suggest that the wirings were exposed to high heat, which is a sign of an electrical short circuit.

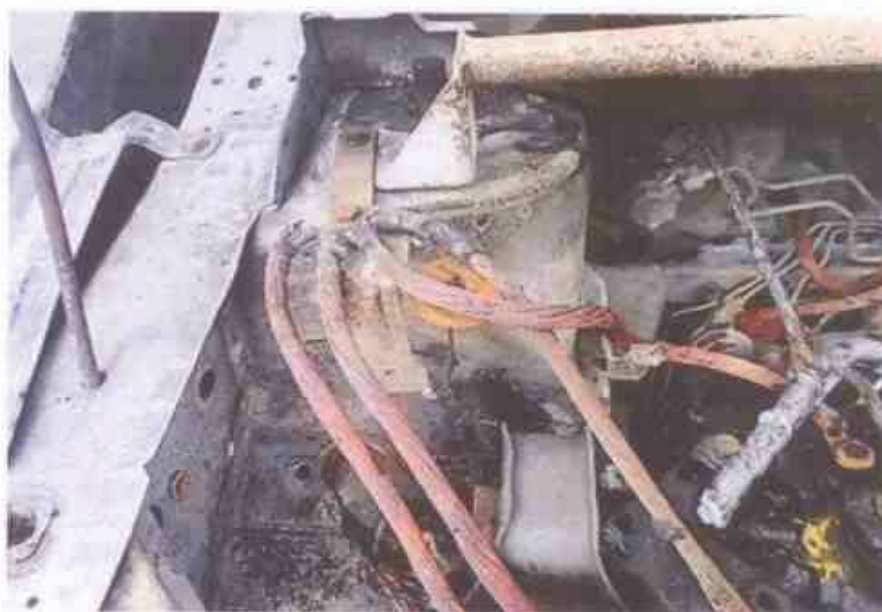
**Photo 13** shows a closer view of the wirings at the right rear area of the Insured Vehicle's engine compartment. The wirings were found to be completely burned to its bare copper state. The bright reddish colour of the copper wires suggest that the wirings were exposed to high heat, which is a sign of an electrical short circuit occurring. These wirings were wire cables (grounding cables) that were additionally fitted for the enhanced audio system that was fitted on the Insured Vehicle.

23. Having investigated and technically analysing the damages of burnt nature to the Insured Vehicle, I am of the view that the cause of fire to the Insured Vehicle was of electrical in nature. For this particular case, the fire had originated along the wirings inside the engine compartment. These wirings were wire cables (grounding cables) that were additionally fitted for the enhanced audio system of the Insured Vehicle.

24. The enhanced audio system that was fitted on the Insured Vehicle by the owner, soon after purchasing the Insured Vehicle in 2015, could have caused overloading to the electrical system of the Insured Vehicle, leading to the electrical short circuit. Although LTA compliant, the components of the enhanced audio system like the amplifiers, speakers and wire cables amongst others, had therefore contributed to and/or led to the occurrence of the fire to the Insured Vehicle.

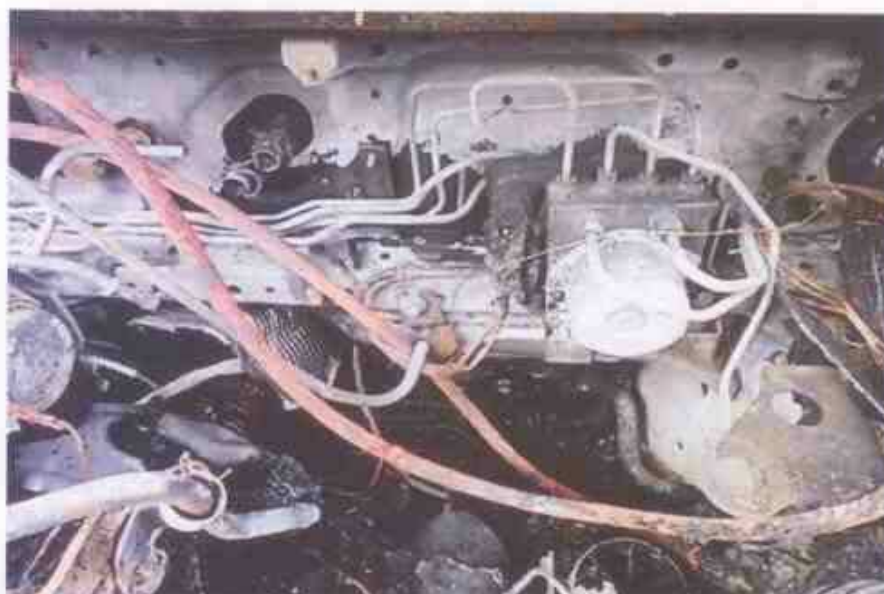
**Photo 14** shows another stretch of wirings at the rear centre area of the Insured Vehicle's engine compartment that were bright reddish colour and completely burned to its bare copper state. These wirings were wire cables (grounding cables) that were additionally fitted for the enhanced audio system that was fitted on the Insured Vehicle.
