Your Ref: S8M00RSX  
Our Ref :CS/ASM18014762/D

07 September 2018

**TECHNICAL INVESTIGATION REPORT OF FIRE INCIDENT INVOLVING THE  
INSURED VEHICLE SJU 6831A ON 11 AUGUST 2018**

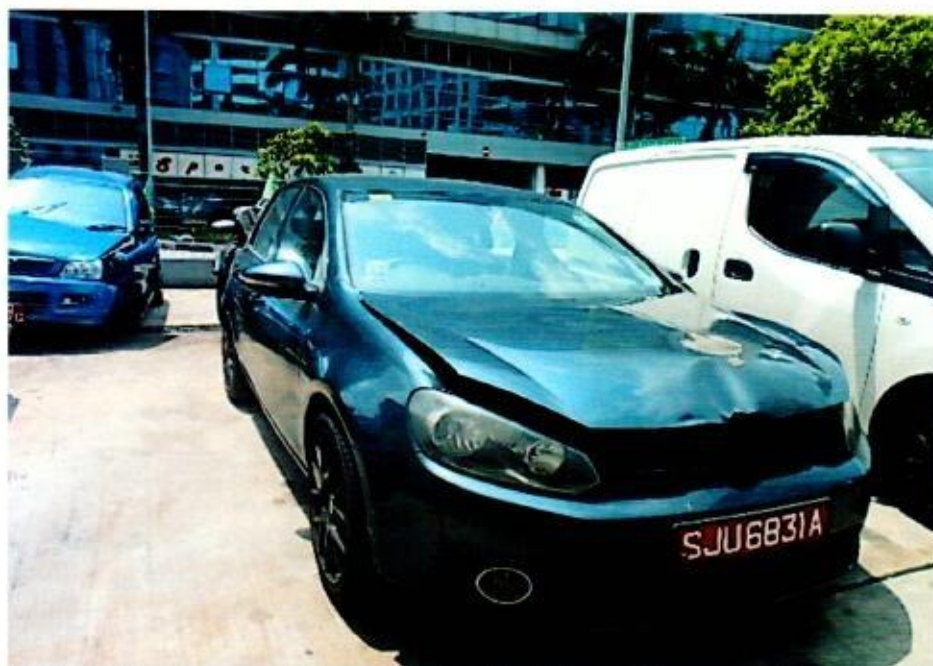
**Photo 1** shows a general view of the front right body of the Insured Vehicle at the time of inspection. The Insured Vehicle was observed to have sustained fire damage that was confined to its frontal body. Its front bonnet, front radiator grille, front right headlamp and front right fender were amongst the body parts that were found to have been burnt as a result of the fire.

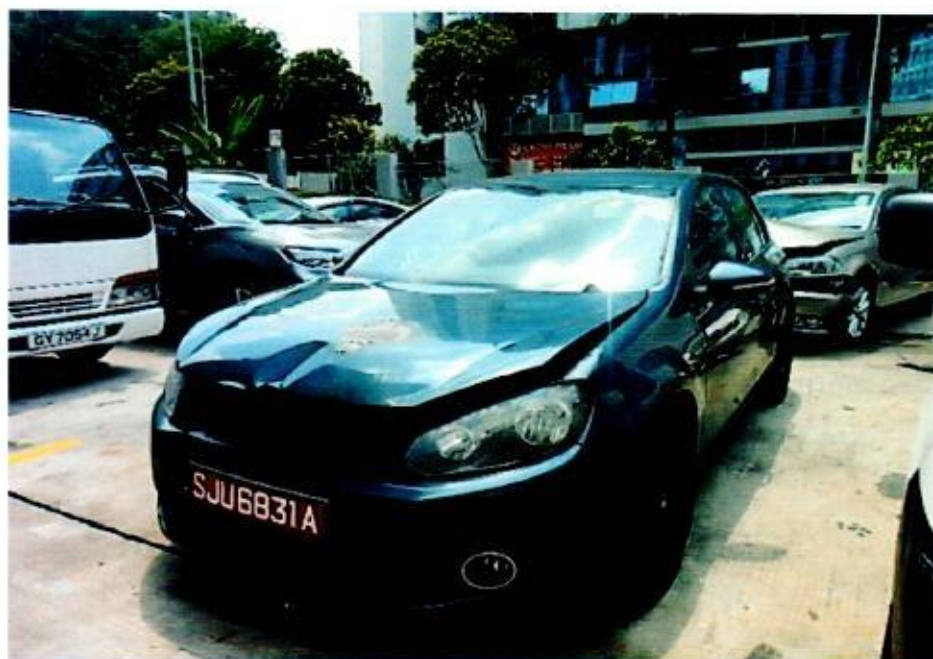
**Photo 2** shows a general view of the front left body of the Insured Vehicle at the time of inspection. The Insured Vehicle was observed to have sustained fire damage at its frontal body. Its front left fender, front left headlamp and front bonnet were amongst the body parts that were found to have been burnt as a result of the fire.

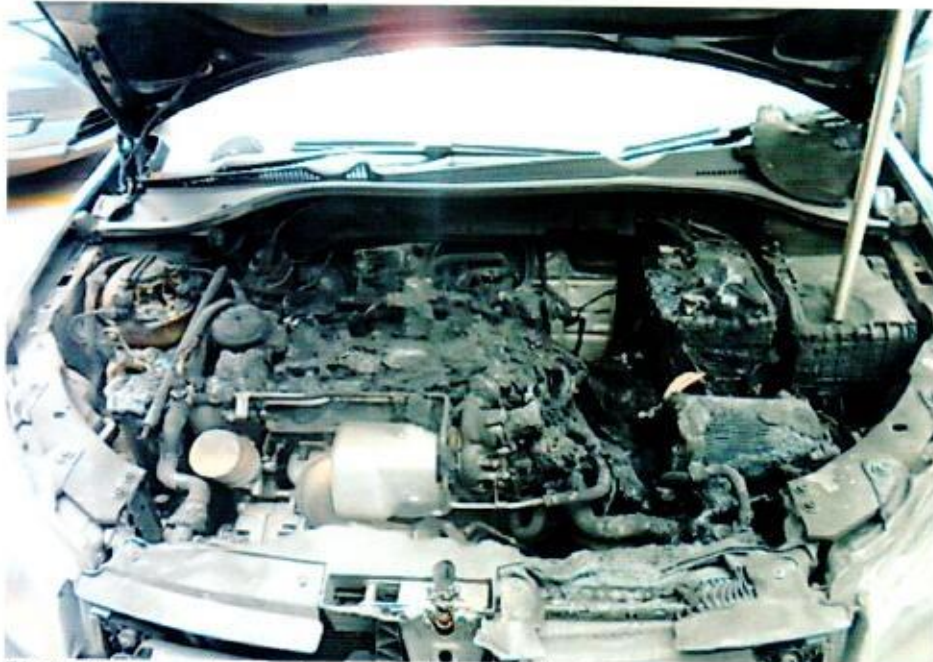
**Photo 3** shows the engine compartment of the Insured Vehicle at the time of inspection. Almost all the parts inside the engine compartment were observed to have been burnt and/or melted as a result of the fire. These parts had included its radiator, air condenser, cooling fan, intake manifold, fuse box, battery, air duct, rubber hoses and pipes amongst others.

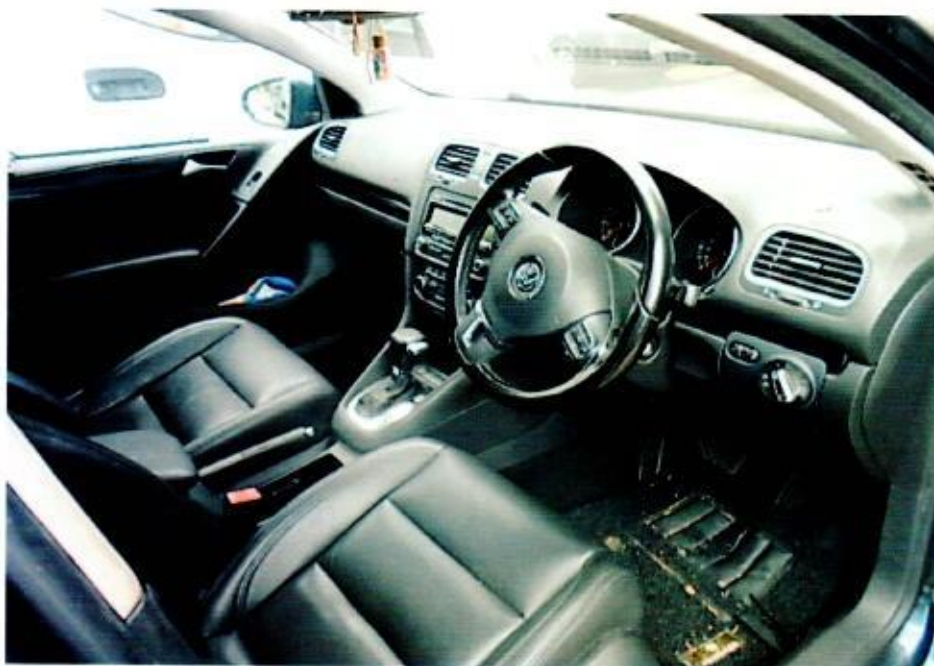
**Photo 4** shows the interior compartment of the Insured Vehicle. The interior compartment and rear body of the Insured Vehicle were both unaffected by the incident.

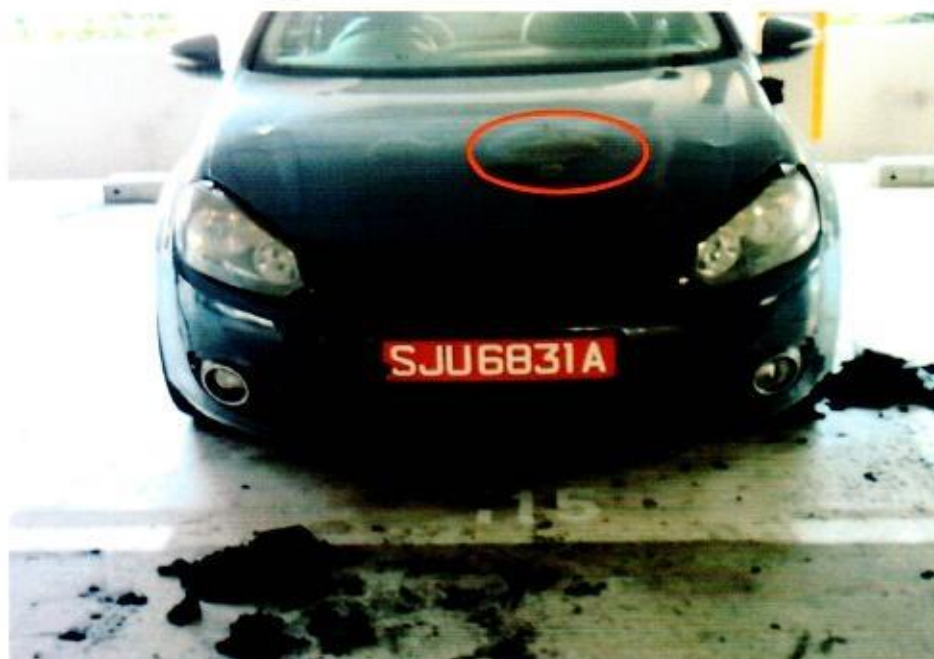
16. From the photographs, I note the same intense burn mark, which was seen during my inspection of the Insured Vehicle, was formed on the centre of the front bonnet. The same burned to copper wire cable was also seen in the engine compartment of the Insured Vehicle. Generally, the damage of fire nature to the Insured Vehicle, as seen from the photographs provided, was observed to be similar to what I had observed during my inspection of the Insured Vehicle.

17. Upon closer examination of the photographs provided, I had also noted that there was no unusual foreign material(s), object(s) and/or fluid accumulation on the ground where the Insured Vehicle was parked. The observations gathered from my review of the photographs that was taken by Mr Lee at the incident scene had corresponded to the description of events that he had related to me during our conversation on 17 August 2018. See photo 5 & 6 below.

**Photo 5** shows the Insured Vehicle at the incident location. The same intense burn mark (circled), that I had observed during my inspection of the Insured Vehicle, can be seen similarly formed on the centre of the front bonnet. My close examination of the photographs provided had also showed no unusual foreign material(s), object(s) and/or fluid accumulation on the ground where the Insured Vehicle was parked.

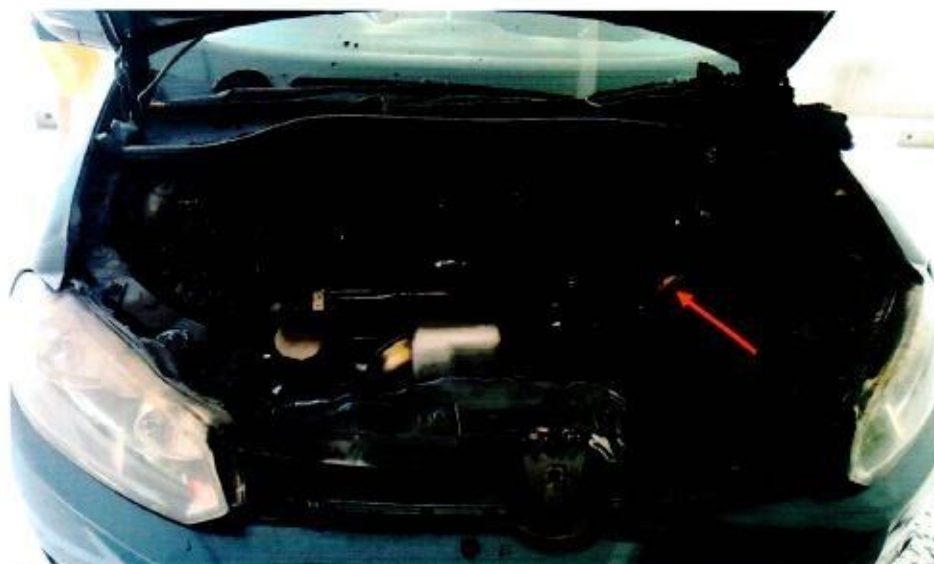
**Photo 6** shows the engine compartment of the Insured Vehicle when it was still at the incident location. The damage of fire nature to the Insured Vehicle, as seen from the photographs provided, was observed to be similar to what I had observed during my inspection of the Insured Vehicle. This had included the same burned to copper wire cable (arrowed). In general, the observations gathered from my review of the photographs that were taken by Mr Lee at the incident scene had corresponded to the description of events that he had related to me during our conversation on 17 August 2018.

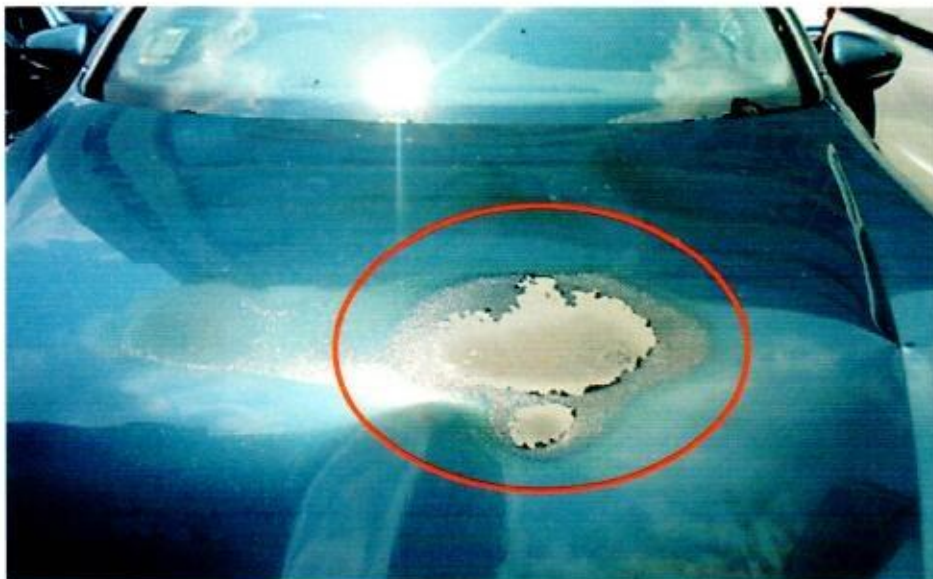
18. For this case, intense burn marks were found on a single area on the Insured Vehicle. This was at the centre of the front bonnet. Such marks are normally formed on steel/metal material body parts that had been exposed to prolong high heat intensity and can usually be used to determine the origin of the fire. Given the characteristic of heat (hot air rises), the origin of fire can then be determined to be at the centre area of the engine compartment, below the area where the intense burn marks were found on the Insured Vehicle's front bonnet.

**Photo 7** shows the intense burn marks (circled) that were found on the centre of the Insured Vehicle's front bonnet. Such marks are normally formed on steel/metal material body parts that had been exposed to prolong high heat intensity and can usually determine the origin of the fire.

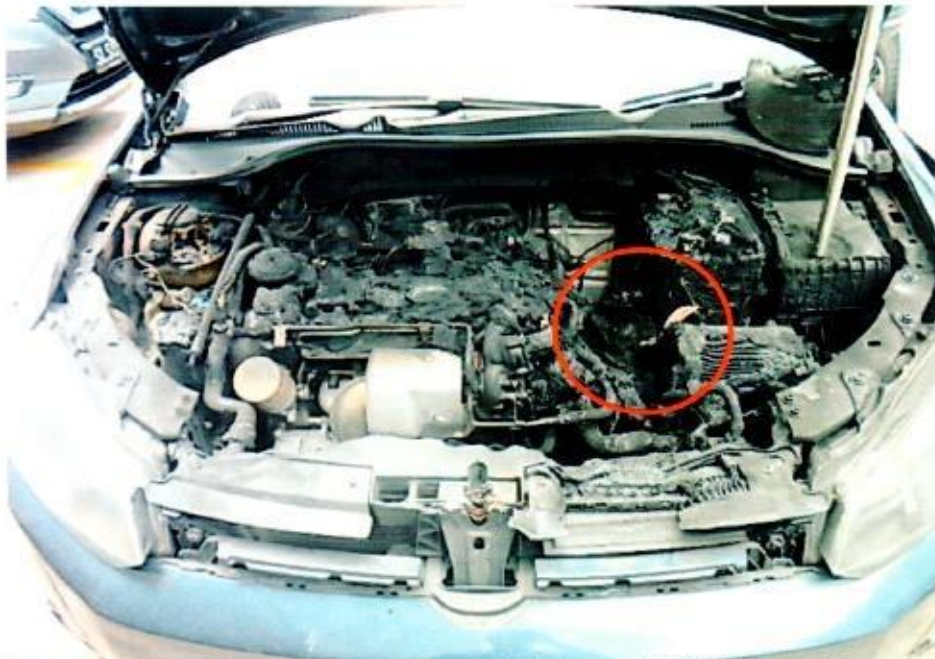
**Photo 8** shows the engine compartment of the Insured Vehicle at the time of my inspection. Following the location where intense burn marks were found and the characteristic of heat (hot air rises), the origin of fire was determined to be at the centre area (circled) of the Insured Vehicle's engine compartment.

23. Having investigated and technically analysed the damages of burnt nature to the Insured Vehicle, I am of the view that the fire had originated inside the engine compartment of the Insured Vehicle, at the centre area of the engine compartment. For this particular case, the cause of fire was of electrical in nature to the wire cable for the battery. The wire cable was original factory fitted.

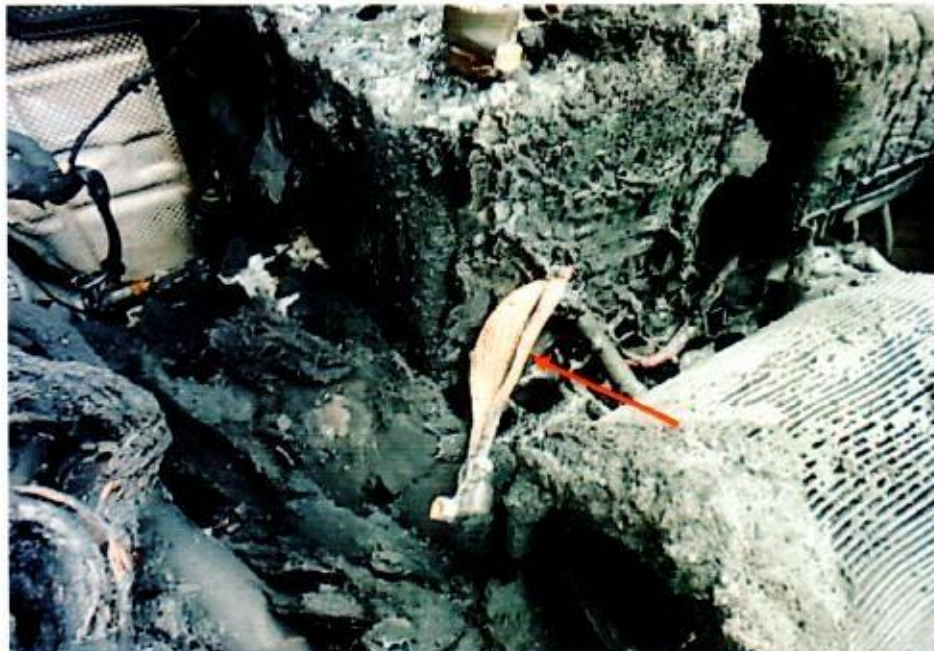
19. My examination of the centre area of the engine compartment, during my inspection of the Insured Vehicle, revealed the wire cable for the battery to be completely burned to its bare copper state. This wire cable is an original factory fitted wire cable. The bright reddish colour of the copper wires suggest that the wirings were exposed to high heat. Such condition normally indicates internal heating of copper wires, which is a sign of an electrical short circuit occurring. Hence the physical condition of the wire cable at the area where the fire had originated indicates that the cause of fire to the Insured Vehicle was due to electrical in nature. See photo 7 - 10 below.

20. Although the engine of the Insured Vehicle was switched off at the material time of incident, some electrical current would still be flowing within the electrical system as several electrical and/or electronic components on the Insured Vehicle would require current to remain in operation and/or in standby mode. These components include the alarm system, clock, radio, cabin light amongst others.

**Photo 9** shows the completely burned to copper wire cable (arrowed) for the battery of the Insured Vehicle. This wire cable is an original factory fitted wire cable and is located at the centre area of the engine compartment, which was where the fire had originated. The bright reddish colour of the copper wires suggest that the wirings were exposed to high heat. Such condition normally indicates internal heating of copper wires, which is a sign of an electrical short circuit occurring.

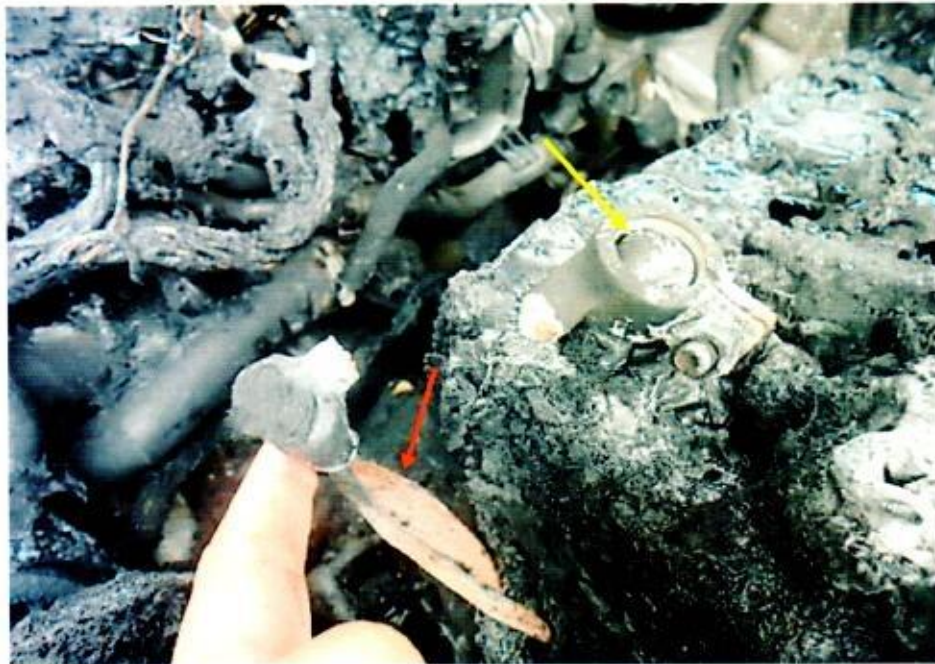
**Photo 10** shows a closer view of the burned to copper wire cable (red arrow). The wire cable connects to the battery terminal (yellow arrow) of the Insured Vehicle.
