Your Ref: S8M00RSX  
Our Ref :CS/ASM18014762/D

07 September 2018

**TECHNICAL INVESTIGATION REPORT OF FIRE INCIDENT INVOLVING THE INSURED VEHICLE SJU 6831A ON 11 AUGUST 2018**

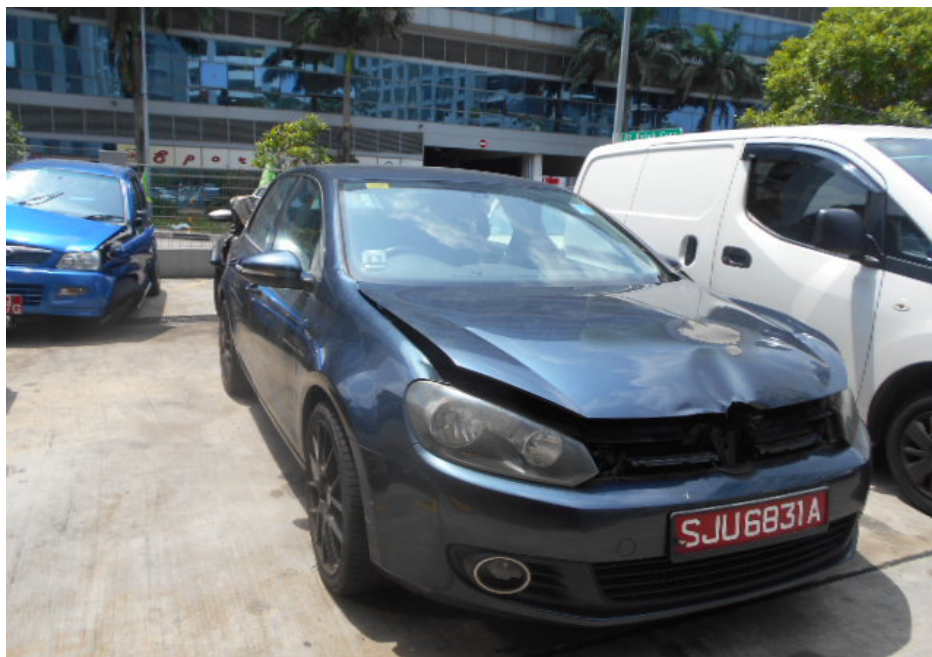
**Photo 1** shows a general view of the front right body of the Insured Vehicle at the time of inspection. The Insured Vehicle was observed to have sustained fire damage that was confined to its frontal body. Its front bonnet, front radiator grille, front right headlamp and front right fender were amongst the body parts that were found to have been burnt as a result of the fire.

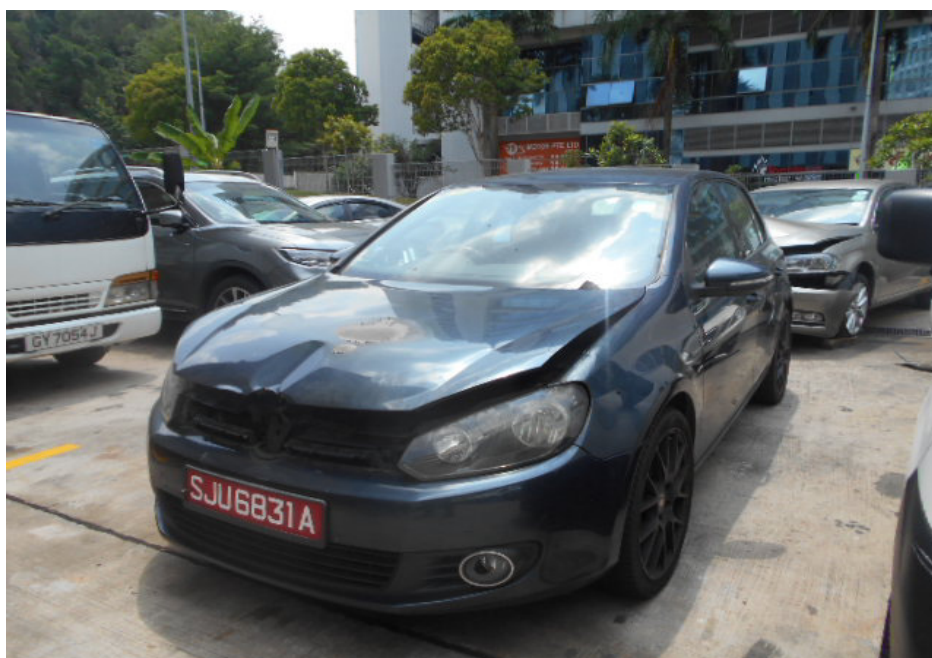
**Photo 2** shows a general view of the front left body of the Insured Vehicle at the time of inspection. The Insured Vehicle was observed to have sustained fire damage at its frontal body. Its front left fender, front left headlamp and front bonnet were amongst the body parts that were found to have been burnt as a result of the fire.

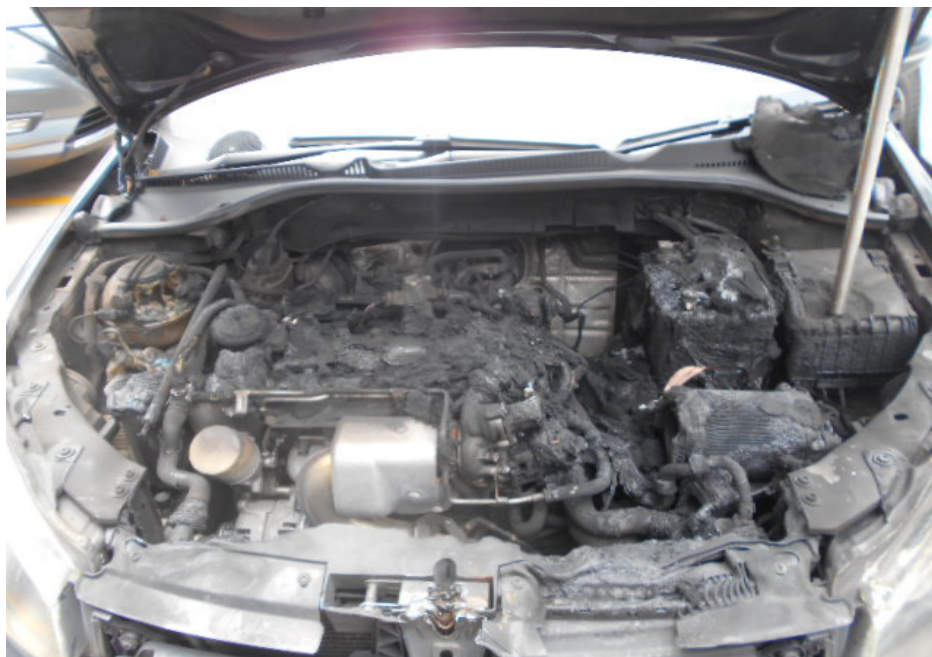
**Photo 3** shows the engine compartment of the Insured Vehicle at the time of inspection. Almost all the parts inside the engine compartment were observed to have been burnt and/or melted as a result of the fire. These parts had included its radiator, air condenser, cooling fan, intake manifold, fuse box, battery, air duct, rubber hoses and pipes amongst others.

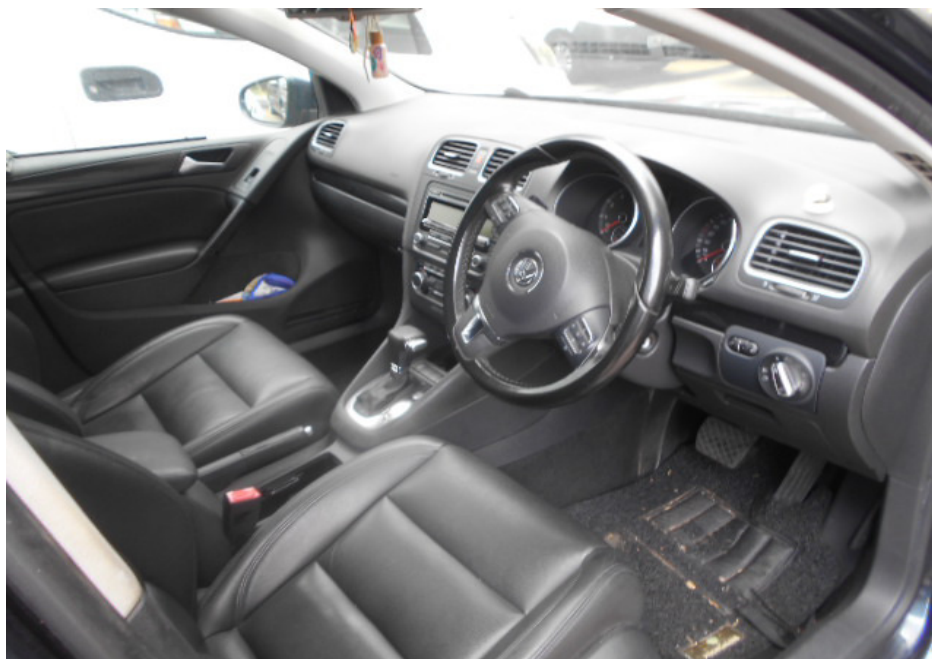
**Photo 4** shows the interior compartment of the Insured Vehicle. The interior compartment and rear body of the Insured Vehicle were both unaffected by the incident.

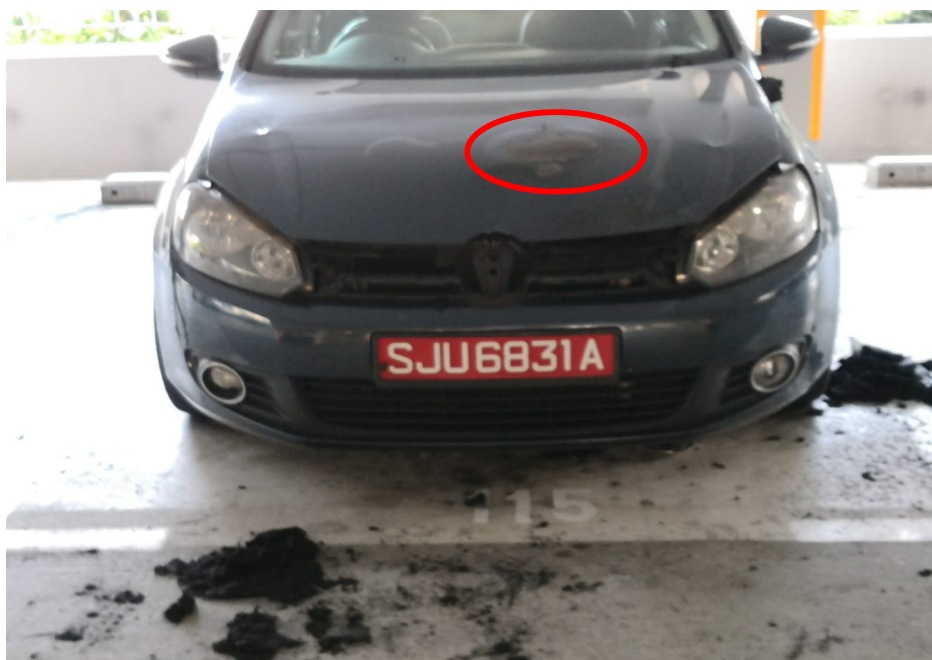
**Photo 5** shows the Insured Vehicle at the incident location. The same intense burn mark (circled), that I had observed during my inspection of the Insured Vehicle, can be seen similarly formed on the centre of the front bonnet. My close examination of the photographs provided had also showed no unusual foreign material(s), object(s) and/or fluid accumulation on the ground where the Insured Vehicle was parked.

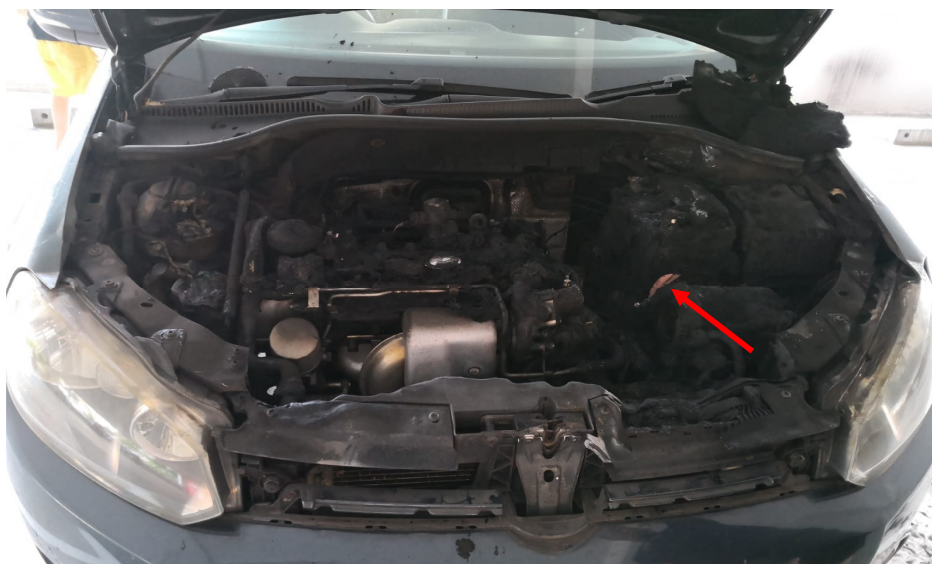
**Photo 6** shows the engine compartment of the Insured Vehicle when it was still at the incident location. The damage of fire nature to the Insured Vehicle, as seen from the photographs provided, was observed to be similar to what I had observed during my inspection of the Insured Vehicle. This had included the same burned to copper wire cable (arrowed). In general, the observations gathered from my review of the photographs that were taken by Mr Lee at the incident scene had corresponded to the description of events that he had related to me during our conversation on 17 August 2018.

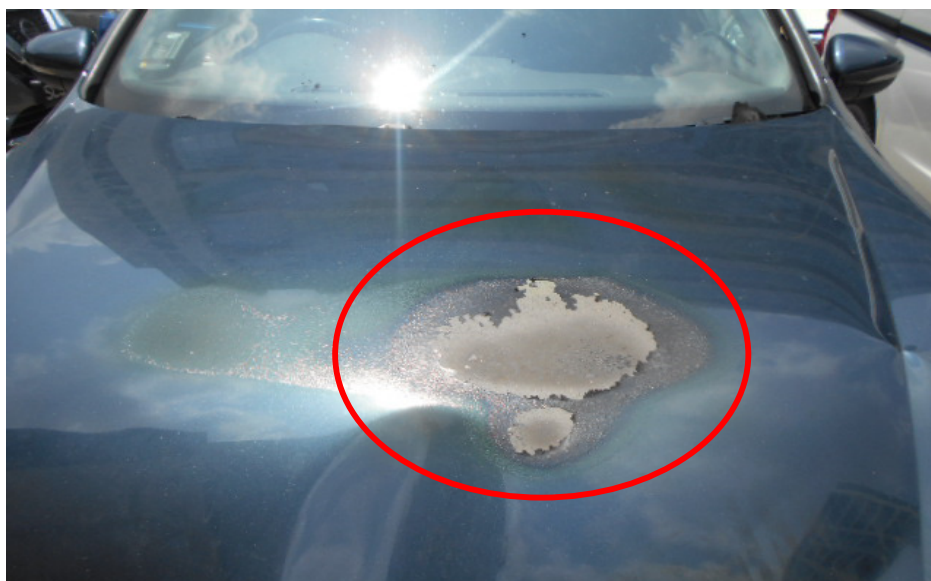
18. For this case, intense burn marks were found on a single area on the Insured Vehicle. This was at the centre of the front bonnet. Such marks are normally formed on steel/metal material body parts that had been exposed to prolong high heat intensity and can usually be used to determine the origin of the fire. Given the characteristic of heat (hot air rises), the origin of fire can then be determined to be at the centre area of the engine compartment, below the area where the intense burn marks were found on the Insured Vehicle's front bonnet.

**Photo 7** shows the intense burn marks (circled) that were found on the centre of the Insured Vehicle's front bonnet. Such marks are normally formed on steel/metal material body parts that had been exposed to prolong high heat intensity and can usually determine the origin of the fire.

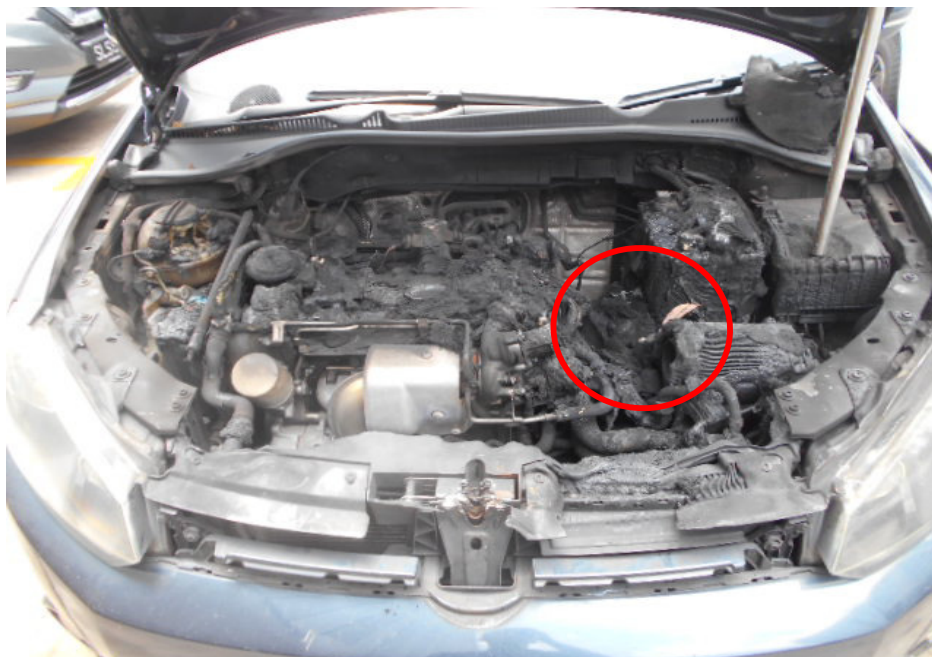
**Photo 8** shows the engine compartment of the Insured Vehicle at the time of my inspection. Following the location where intense burn marks were found and the characteristic of heat (hot air rises), the origin of fire was determined to be at the centre area (circled) of the Insured Vehicle's engine compartment.

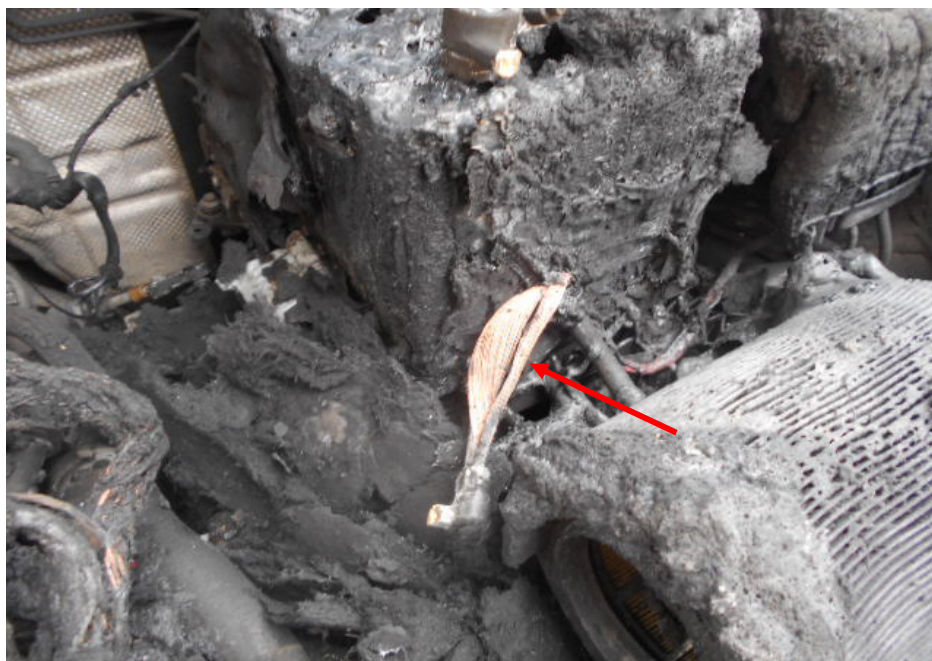
19. My examination of the centre area of the engine compartment, during my inspection of the Insured Vehicle, revealed the wire cable for the battery to be completely burned to its bare copper state. This wire cable is an original factory fitted wire cable. The bright reddish colour of the copper wires suggest that the wirings were exposed to high heat. Such condition normally indicates internal heating of copper wires, which is a sign of an electrical short circuit occurring. Hence the physical condition of the wire cable at the area where the fire had originated indicates that the cause of fire to the Insured Vehicle was due to electrical in nature. See photo 7 - 10 below.

**Photo 9** shows the completely burned to copper wire cable (arrowed) for the battery of the Insured Vehicle. This wire cable is an original factory fitted wire cable and is located at the centre area of the engine compartment, which was where the fire had originated. The bright reddish colour of the copper wires suggest that the wirings were exposed to high heat. Such condition normally indicates internal heating of copper wires, which is a sign of an electrical short circuit occurring.

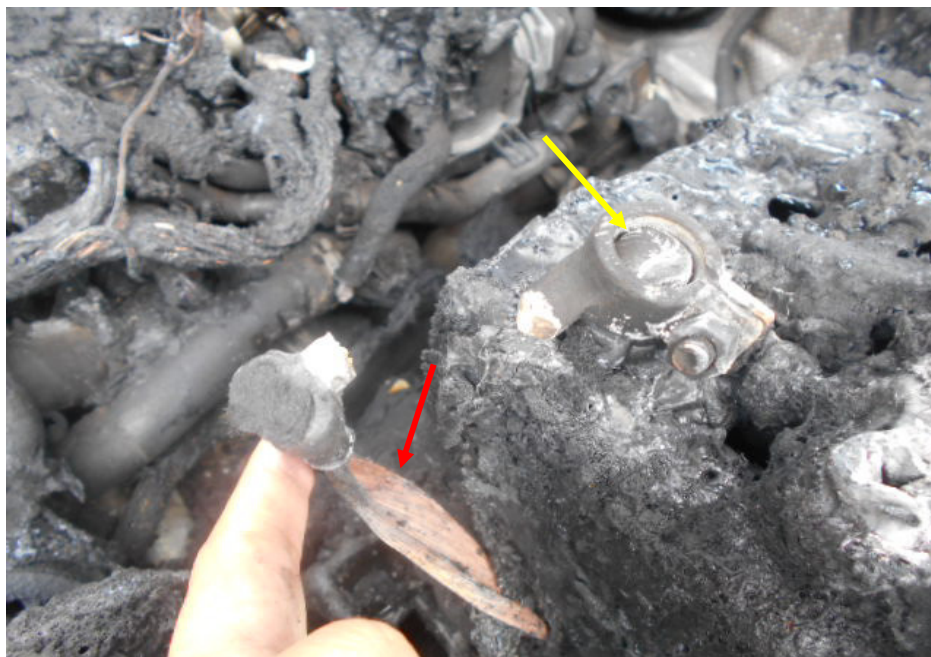
**Photo 10** shows a closer view of the burned to copper wire cable (red arrow). The wire cable connects to the battery terminal (yellow arrow) of the Insured Vehicle.
