Your Ref: PR1807035209
Our Ref : CI/BSH18015014/D

20 August 2018

**TECHNICAL INVESTIGATION REPORT OF ENGINE OIL LEAKAGE TO AN
UNREGISTERED VOLKSWAGEN GOLF MOTOR CAR**

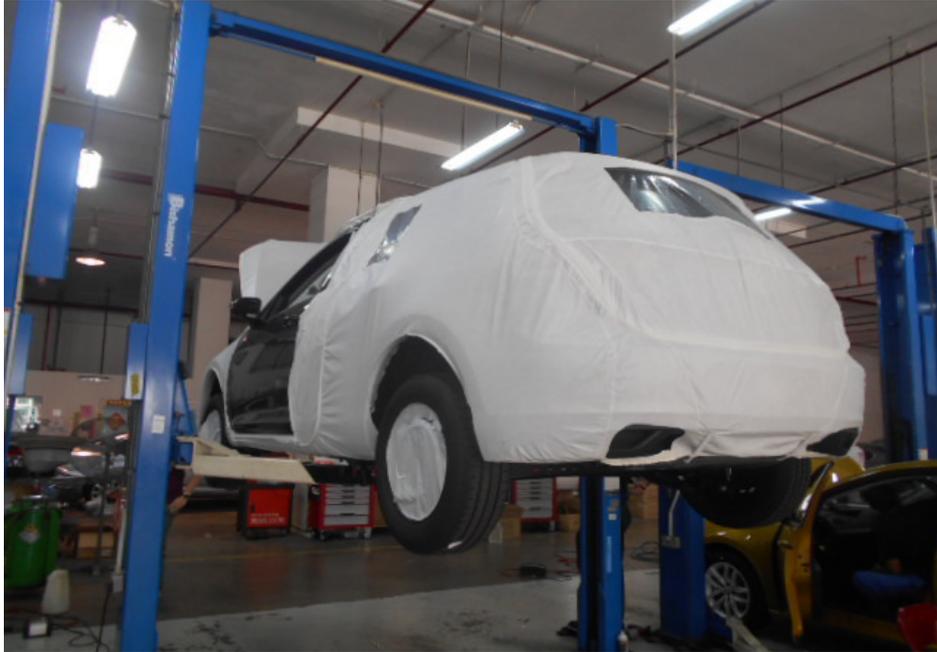
Photo 1 shows a general view of the rear left body of the damaged VW Golf during my inspection. The VW Golf was observed to be still wrapped with its protection cover.

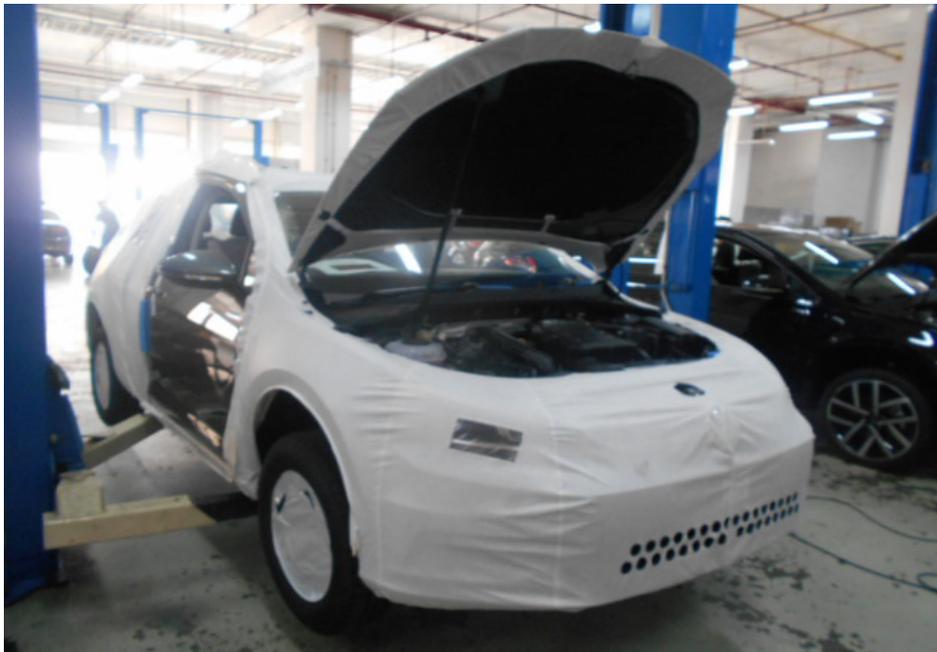
Photo 2 shows a general view of the front right body of the damaged VW Golf during my inspection. The VW Golf was observed to be still wrapped with its protection cover. It was also hoisted up during my inspection to facilitate checks to be carried out to the underside.

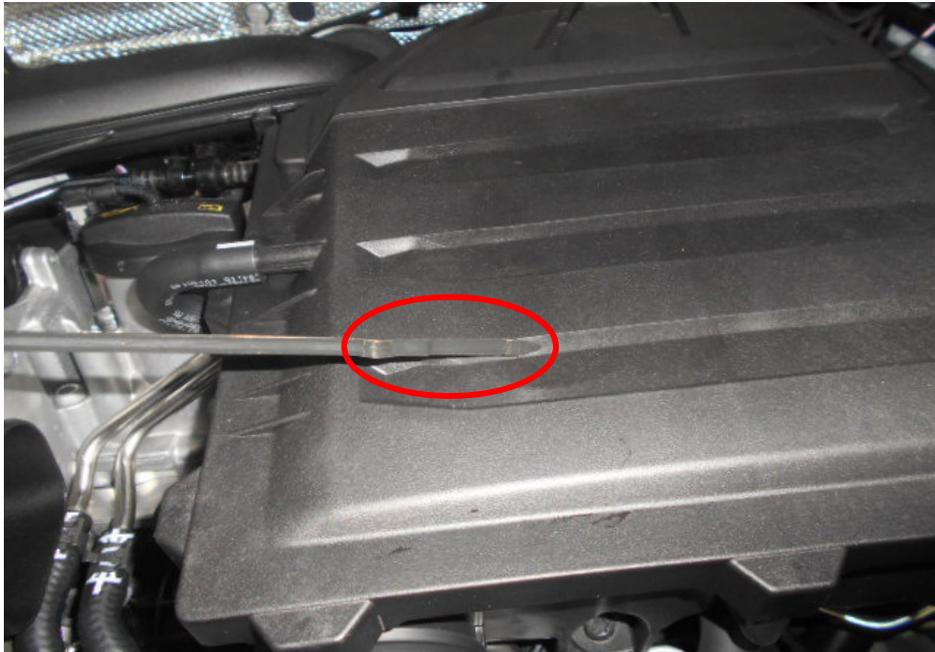
4. The VW Golf was observed to be still wrapped with its protection cover. Upon checking the engine oil dip stick, I had found no engine oil covering the dip stick. This would indicate that there was no engine oil within the engine assembly of the VW Golf.

6. Although the engine assembly was not dismantled, the mechanical parts like the piston(s), connecting rod(s) etc, inside the engine assembly were likely to be seized. This was established when attempts to manually turn the crankshaft of the engine was not successful. See photo 1 - 10 below.

Photo 3 shows the engine oil dip stick of the VW Golf. I had found no engine oil covering the dip stick (circled). This would indicate that there was no engine oil within the engine assembly of the VW Golf. Subsequent attempts to manually turn the crankshaft of the engine was not successful, indicating that the mechanical parts like the piston(s), connecting rod(s) etc, inside the engine assembly were likely to be seized.

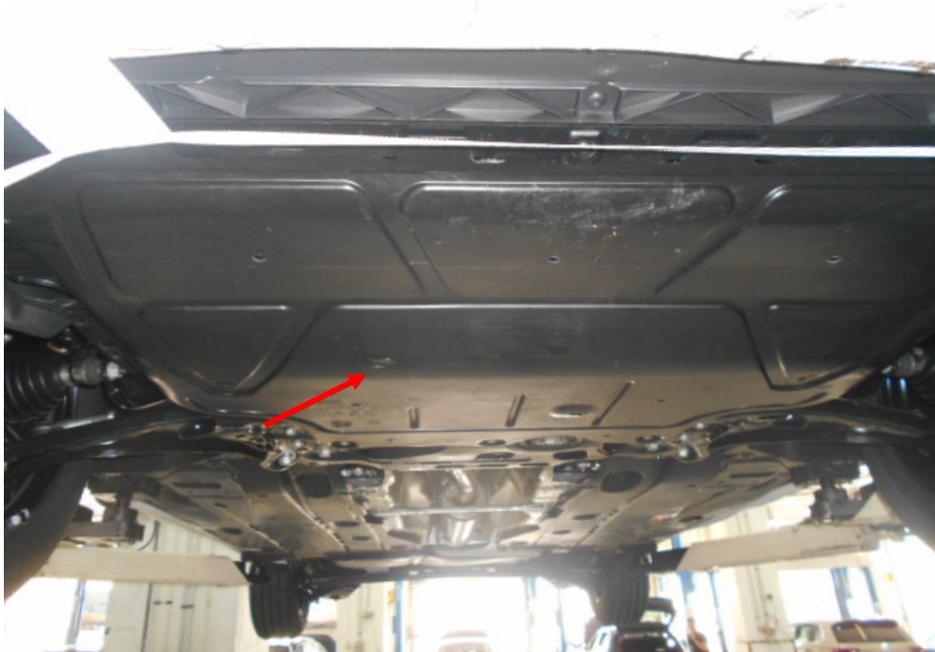
5. My checks on the underside after the VW Golf was hoisted up revealed a tear/cut mark on the underside of the engine undercover. Upon removal of this engine undercover, a hole/puncture was observed on the underside of the engine oil sump. Engine oil stains were also found, from the hole/puncture at the engine oil sump stretching towards the rear of the VW Golf.

Photo 4 shows the front underside of the VW Golf after it was hoisted up. A tear/cut mark (arrowed) was observed on the underside of the engine undercover. This was slightly towards the right from the centre of the VW Golf.

7. From the damage pattern of the engine undercover and engine oil sump of the VW Golf as shown in photograph 4 to photograph 8 above, the front underside of the VW Golf had sustained a single direct impact that was caused by a sharp edge object. The lack of grazed marks found surrounding the area of damage and on the entire underside of the VW Golf would seem to suggest that the impact was not of grazing nature, hence unlikely to be from the VW Golf mounting a road kerb or other similar flat surface type of structure/object. The damage pattern would correspond more to an object, like a stone or rock, where the edge of this object had directly impacted the front underside (single impact) of the VW Golf, causing the tear/cut on the engine undercover and hole/puncture on the underside of the engine oil sump simultaneously.

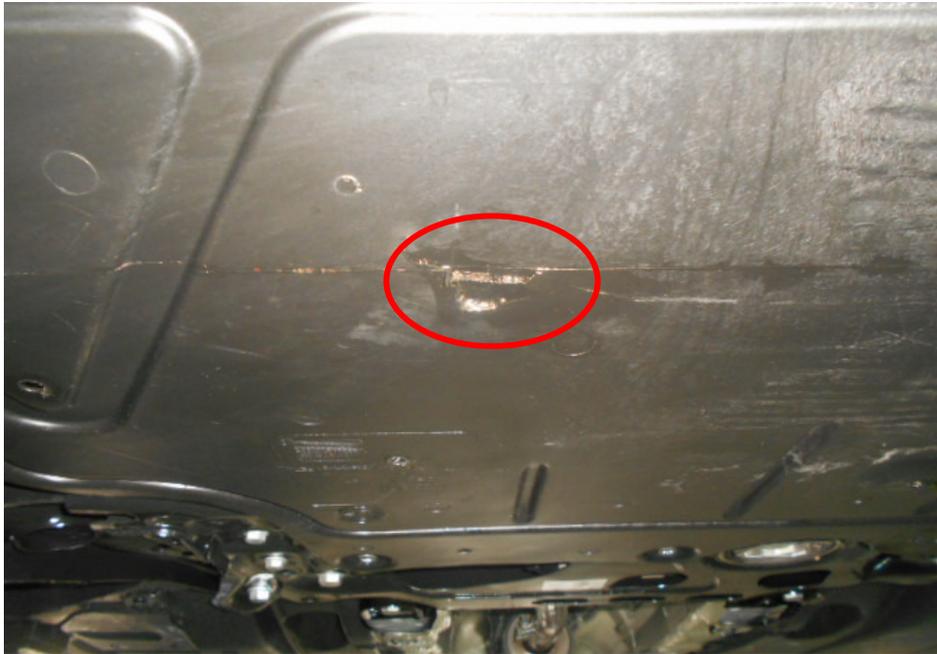
Photo 5 shows a closer view of the tear/cut mark (circled) that was found on the underside of the engine undercover.

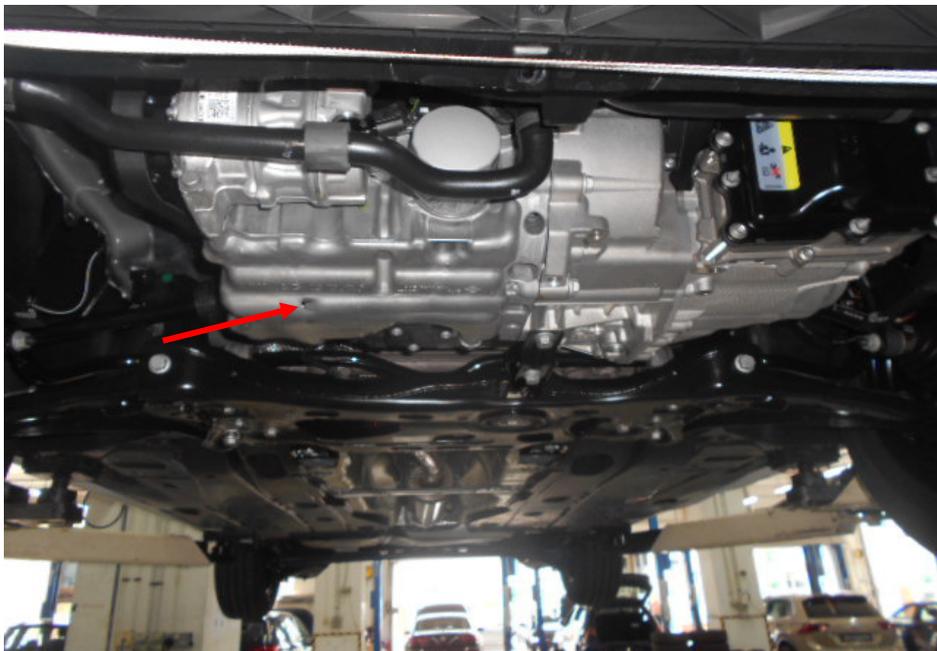
Photo 6 shows the front underside of the VW Golf after its engine undercover was removed. A hole/puncture (arrowed) was observed on the underside of the engine oil sump. The location of this hole/puncture was directly above the location where the engine undercover was torn/cut. Refer to photograph 4 above.

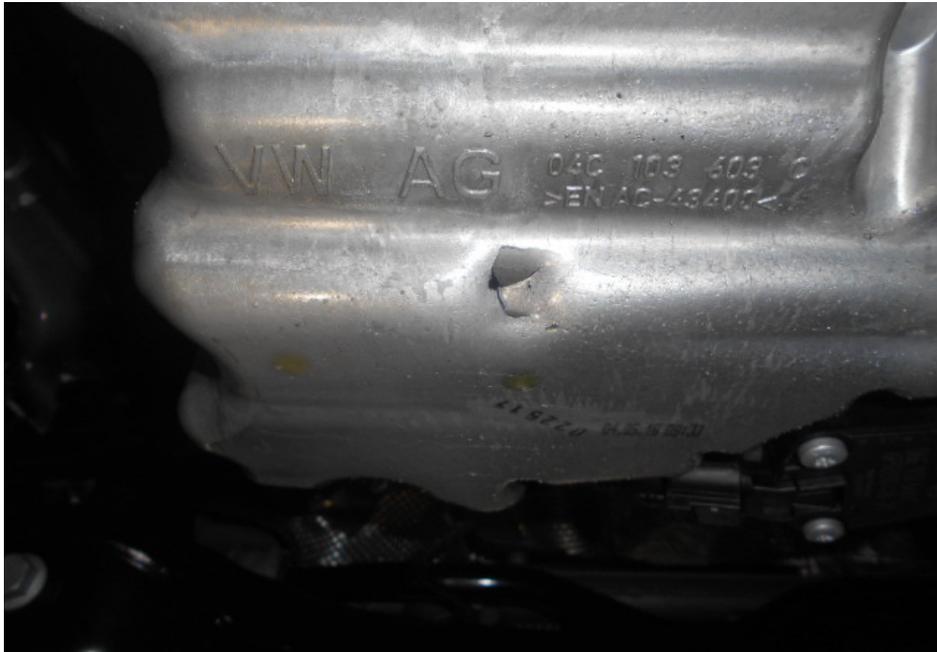
Photo 7 shows a closer view of the hole/puncture that was observed on the underside of the engine oil sump. The entire engine oil within the engine assembly of the VW Golf had leaked from this hole/puncture.

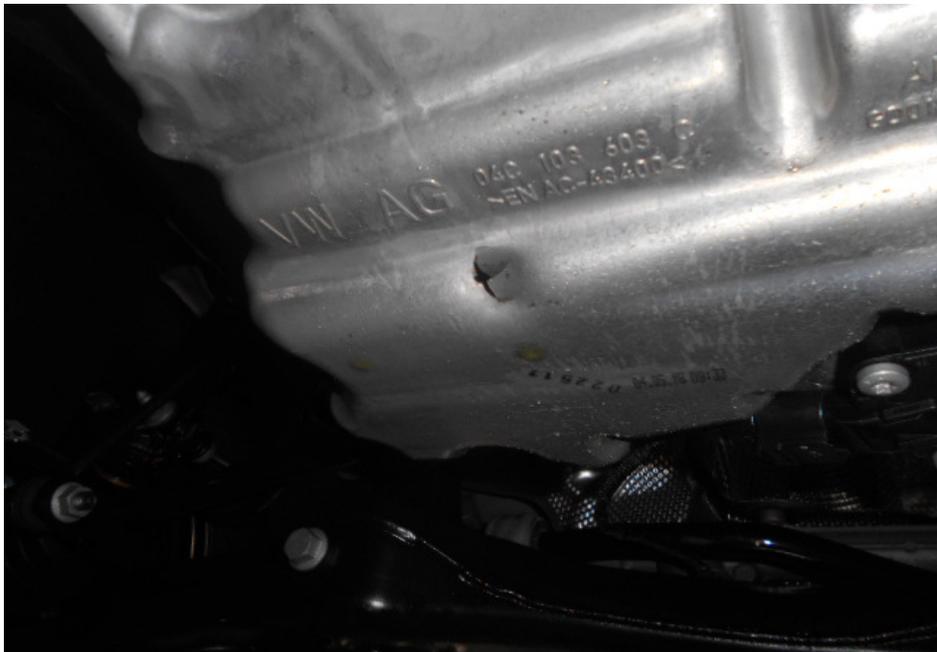
Photo 8 shows a closer view of the hole/puncture that was observed on the underside of the engine oil sump. The engine oil of the VW had leaked from this hole/puncture.

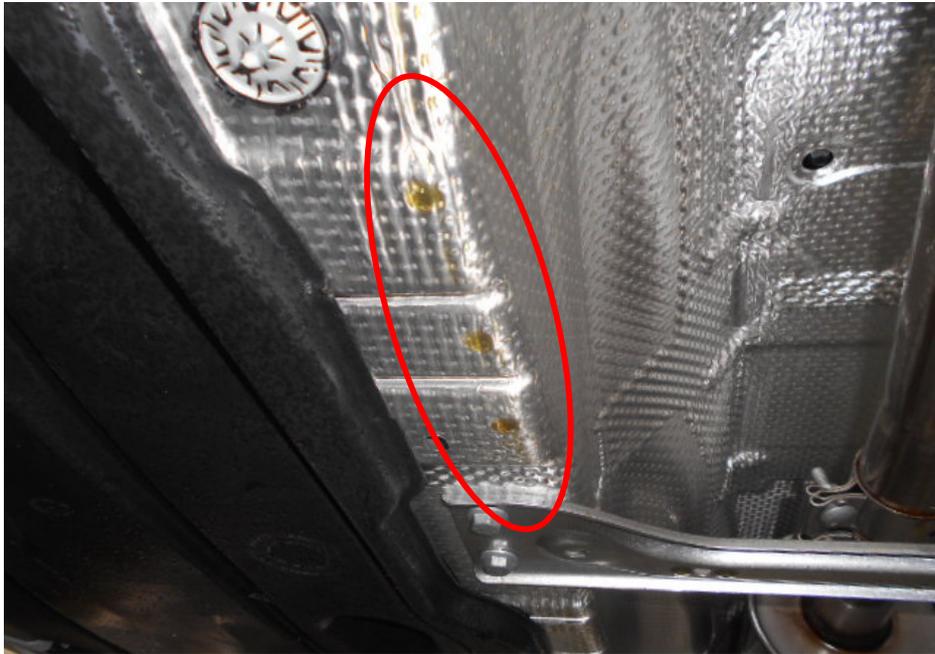
Photo 9 shows the engine oil stain (circled) that was found on the underside, from the hole/puncture at the engine oil sump stretching towards the rear of the VW Golf. This was at the right centre of the VW Golf.

8. The engine oil stains found from the hole/puncture of the engine oil sump stretching towards the rear of the VW Golf was formed by air flow travelling along the underside of the VW Golf. The flow of air would have to be relatively strong to cause the leaked engine oil to be blown all the way towards the rear of the VW Golf. Common scenarios where there is strong air flow along the underside of a motor vehicle includes when the motor vehicle is being driven at relatively high speed or while it is being towed by normal fork method or by king dolly method, where the air flow along its underside is unrestricted.

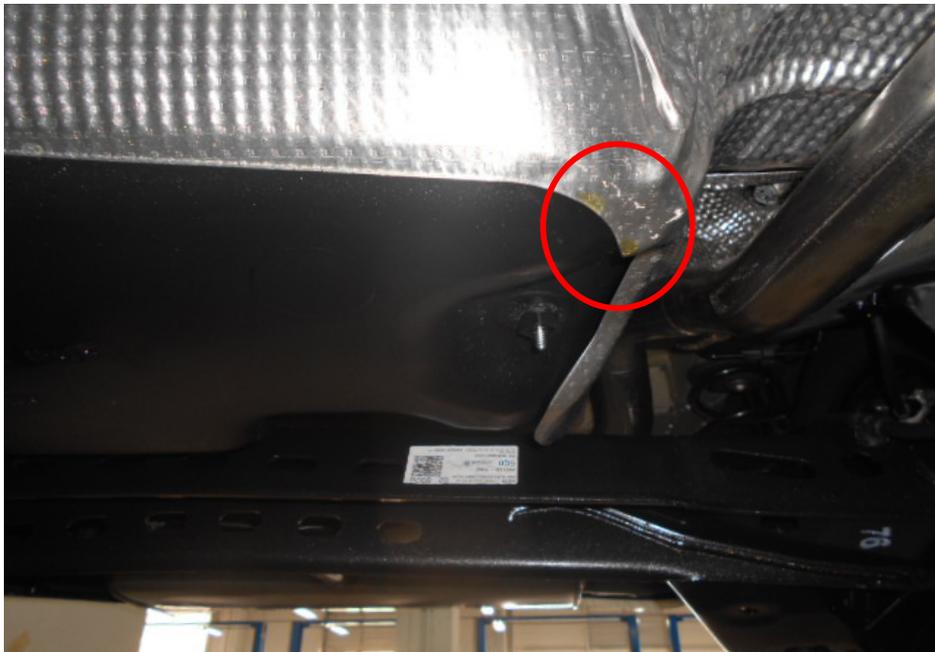
Photo 10 shows the engine oil stain (circled) that was found on the heat shield of the fuel tank. This was towards the left rear of the VW Golf. The undercarriage components at the rear of the VW Golf were also observed to be covered with engine oil stain that had leaked from the hole/puncture at the engine oil sump.

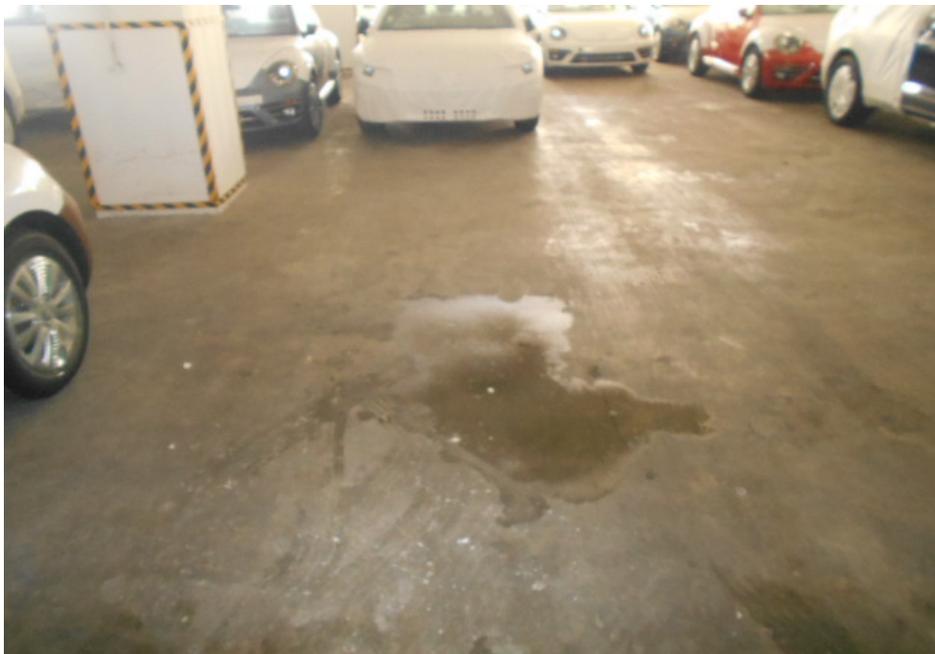
11. Based on these events that I was able to gather, I had first visited the location where the VW Golf was parked after its delivery to Toll Logistics at 17 Tuas Avenue 9. This was at pillar B on level 2. At this location, a pool of oil stain was observed on the ground. A lesser pool of oil stain was also found on the driveway leading to the exit of level 2, near pillar F. This was where the VW Golf broke down. Faint oil trail was also seen on the driveway between pillar B and pillar F. The approximate distance between pillar B to pillar F was about 50m to 80m.

Photo 11 shows the pool of oil stain that was found on the ground where the VW Golf was parked before it was driven to the preparation centre at the ground floor. This was at pillar B on level 2 of 17 Tuas Avenue 9.

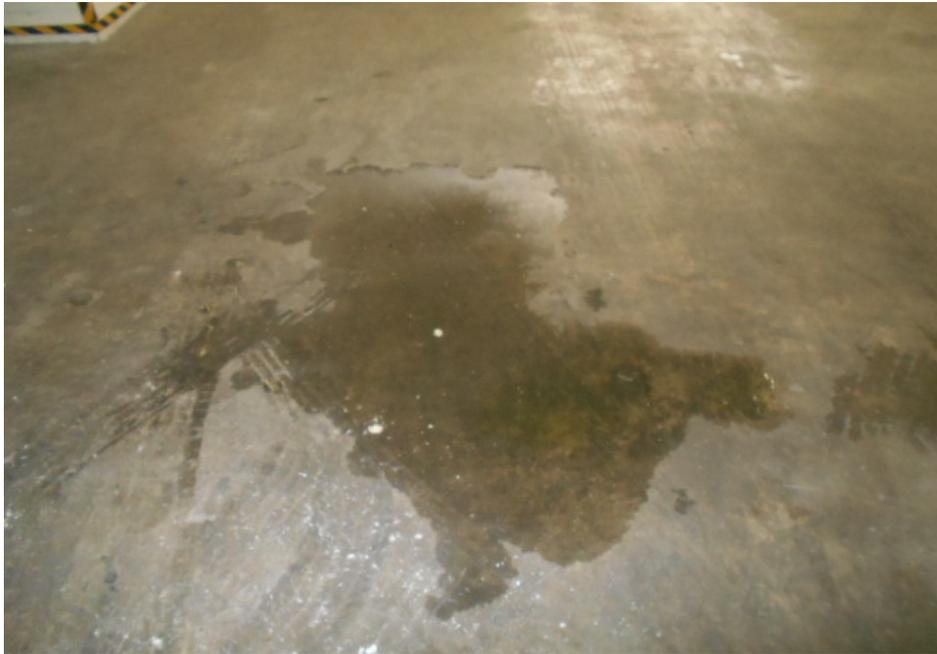
Photo 12 shows a closer view of the accumulation of oil stain that was found on the ground where the VW Golf was parked.

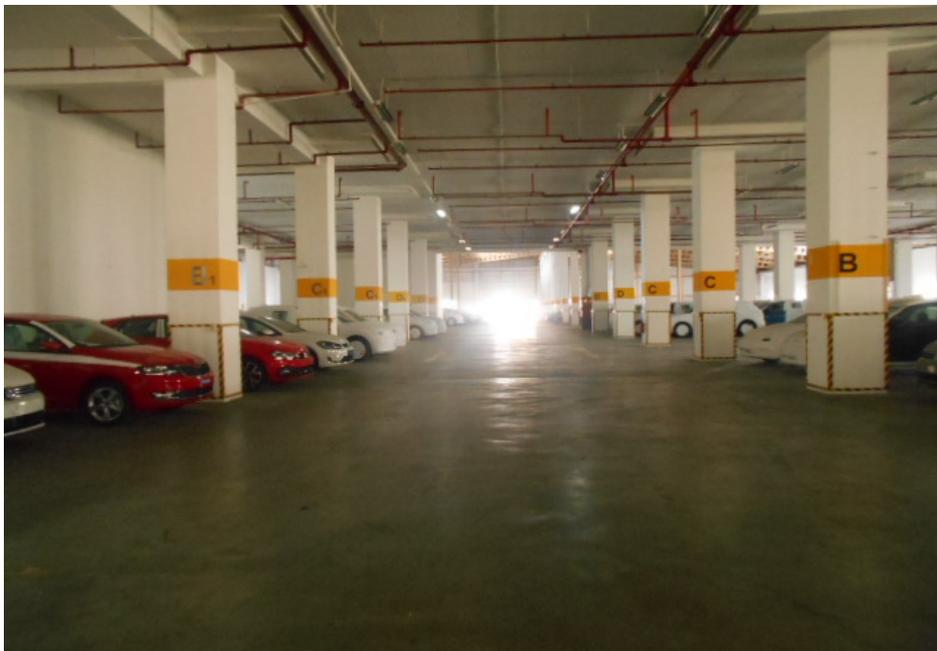
Photo 13 shows a general view of the driveway of level 2, towards the exit. The VW Golf was being driven along this driveway when it broke down, leading to the discovery of the engine oil leakage.

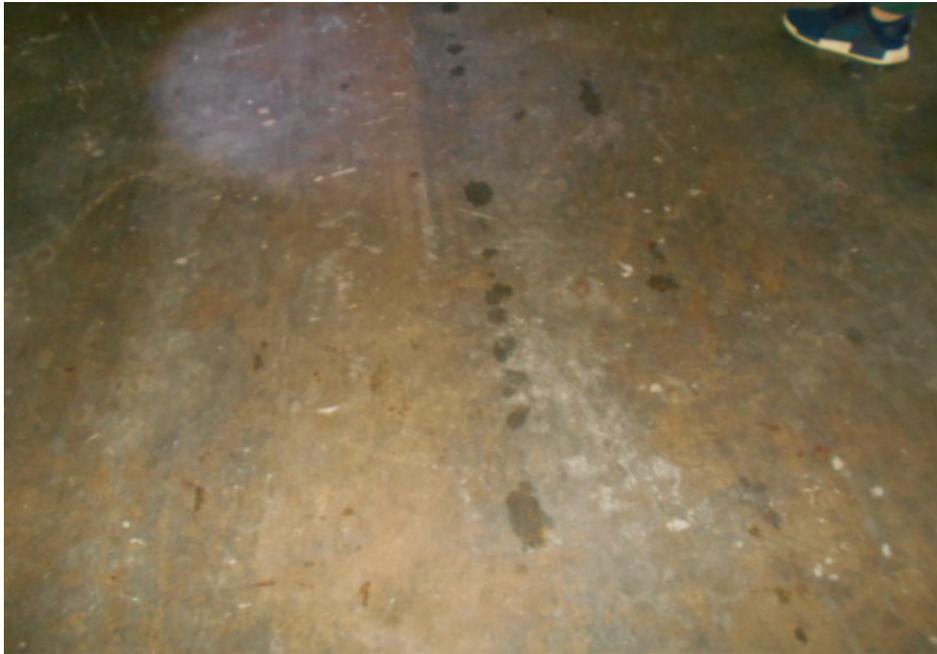
Photo 14 shows some of the oil stain that was found on the ground of the driveway leading to the exit of level 2.

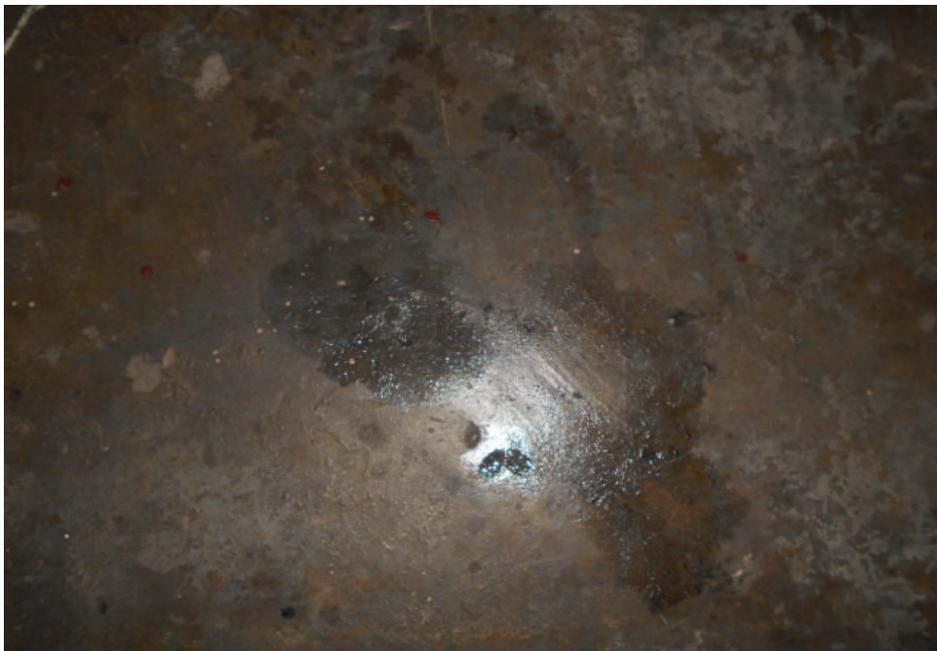
Photo 15 shows the second pool of oil stain that was found on the ground, near pillar F. This was on the driveway leading to the exit of level 2. The VW Golf broke down at this location after being driven for about 50m to 80m, from pillar B to pillar F. Basing on my observations, the oil stain that was seen on the entire level 2 does not seem to indicate that the engine oil leakage to the VW Golf had occurred at level 2.

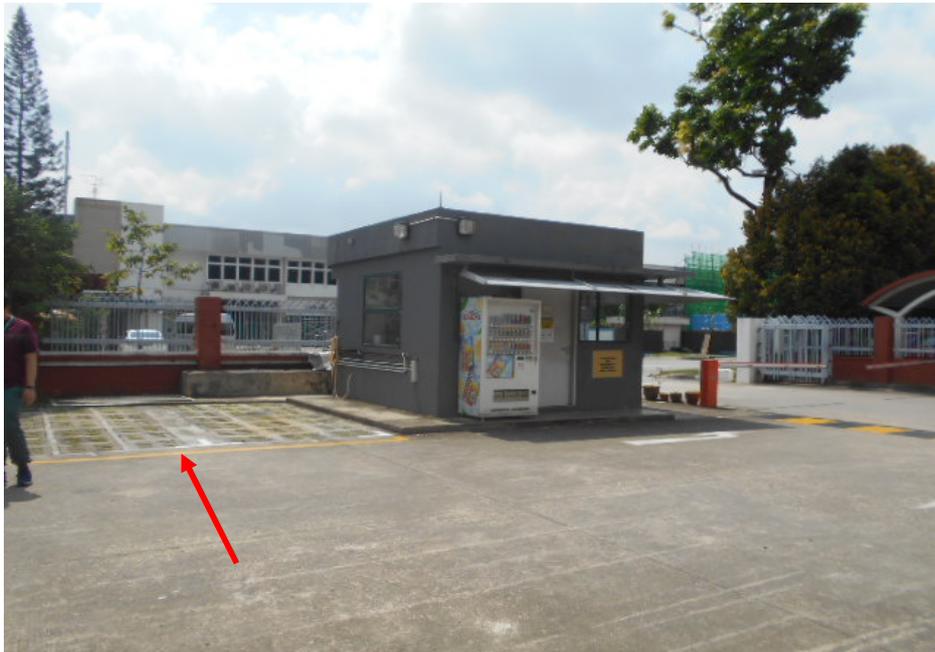
15. At one of the parking lots, I had observed a patch of dry oil stain. This was the second lot parking lot adjacent to the guardhouse at 17 Tuas Avenue 9. The location of the patch of dry oil stain relative to the front of the parking lot appears to correspond to the location of the hole/puncture on the engine oil sump relative to the front of the VW Golf. Trail of dried oil stain was also found curved towards the right from this parking lot, which is typically the route taken by employees of Toll Logistics driving newly arrived motor vehicles to the holding area at level 2. See photo 16 – 20 below.

Photo 16 shows a general of parking lot 2 (arrowed), which was the second parking lot adjacent to the guardhouse at 17 Tuas Avenue 9. A patch of dry oil stain was found on the ground of this parking lot.

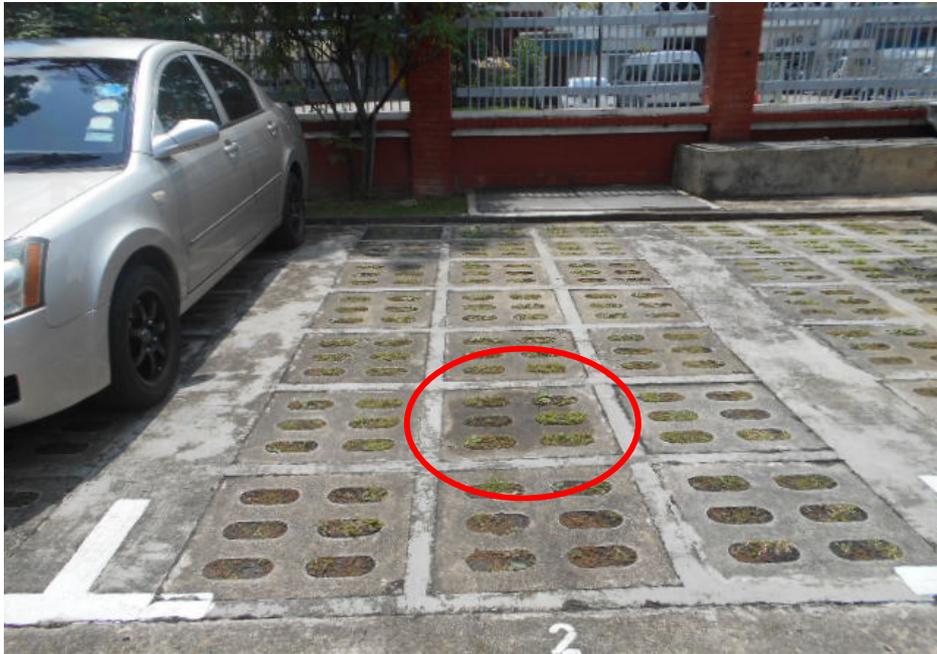
Photo 17 shows a closer view of the patch of dry oil stain (circled) that was found on the ground at parking lot 2. The location of the patch of dry oil stain relative to the front of the parking lot appears to correspond to the location of the hole/puncture on the engine oil sump relative to the front of the VW Golf. Refer to photograph 4 above.

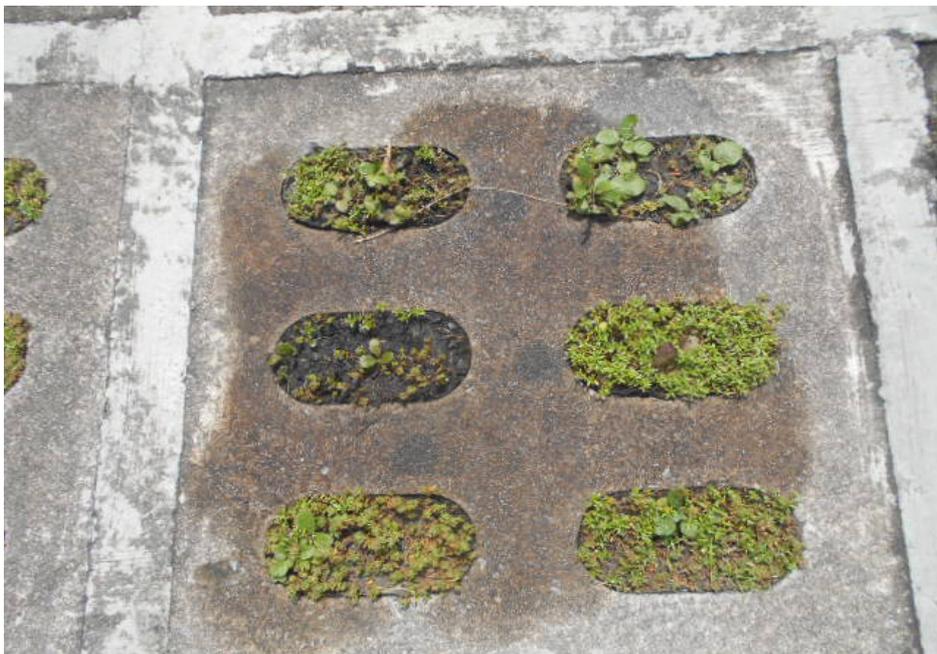
Photo 18 shows a closer view of the patch of dry oil stain that was found on the ground at parking lot 2.

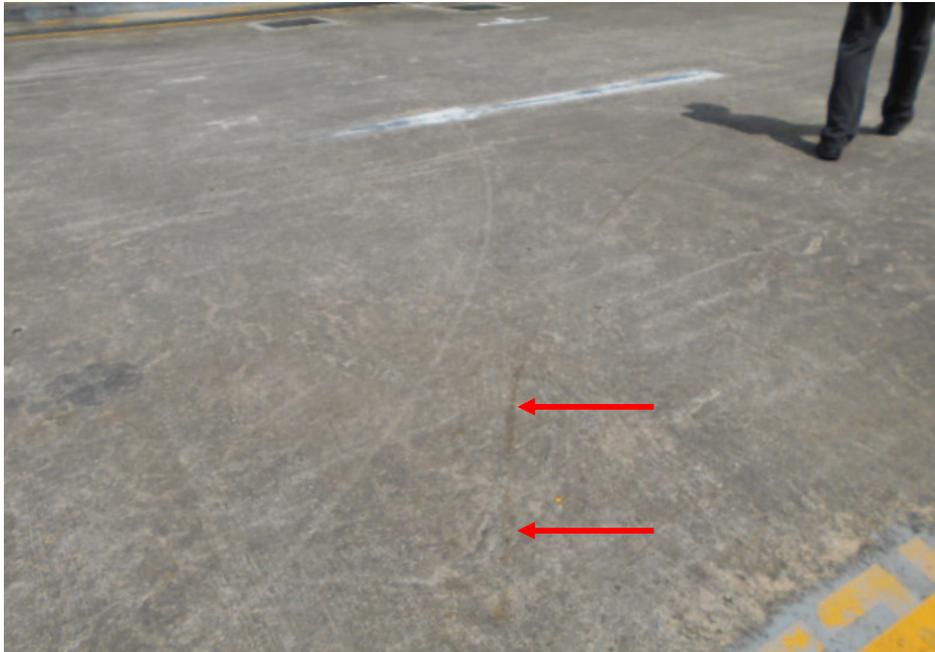
Photo 19 shows a dry oil trail (arrowed) curved towards the right from parking lot 2. The same oil trail was also found on the driveway that employees of Toll Logistics would use when driving newly arrived motor vehicles to the holding area at level 2.

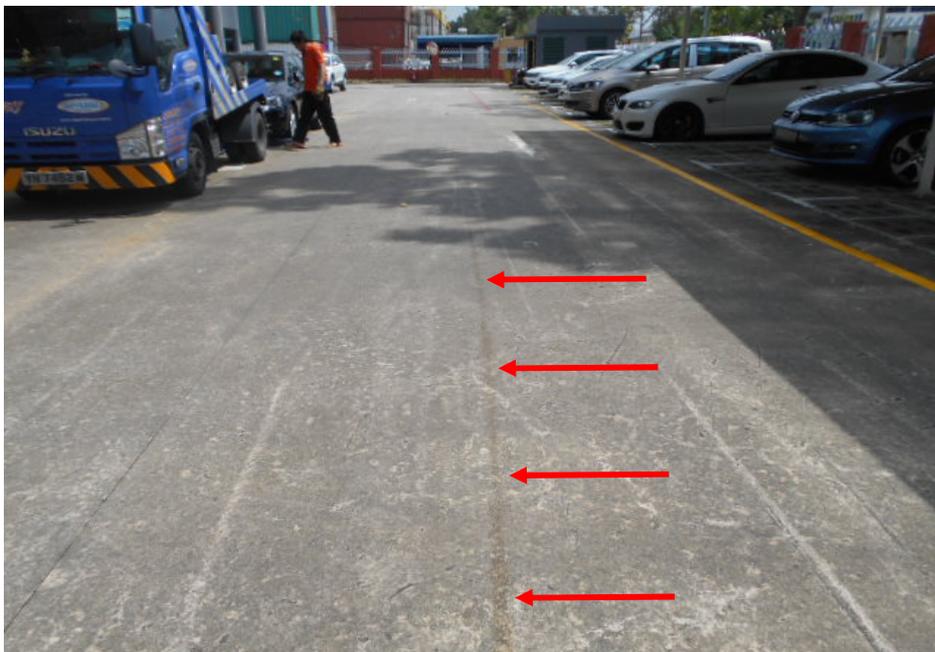
Photo 20 shows a dry oil trail (arrowed) along the driveway of 17 Tuas Avenue 9. This oil trail had commenced from parking lot 2 onto this driveway which is typically the route taken by employees of Toll Logistics driving newly arrived motor vehicles to the holding area at level 2.

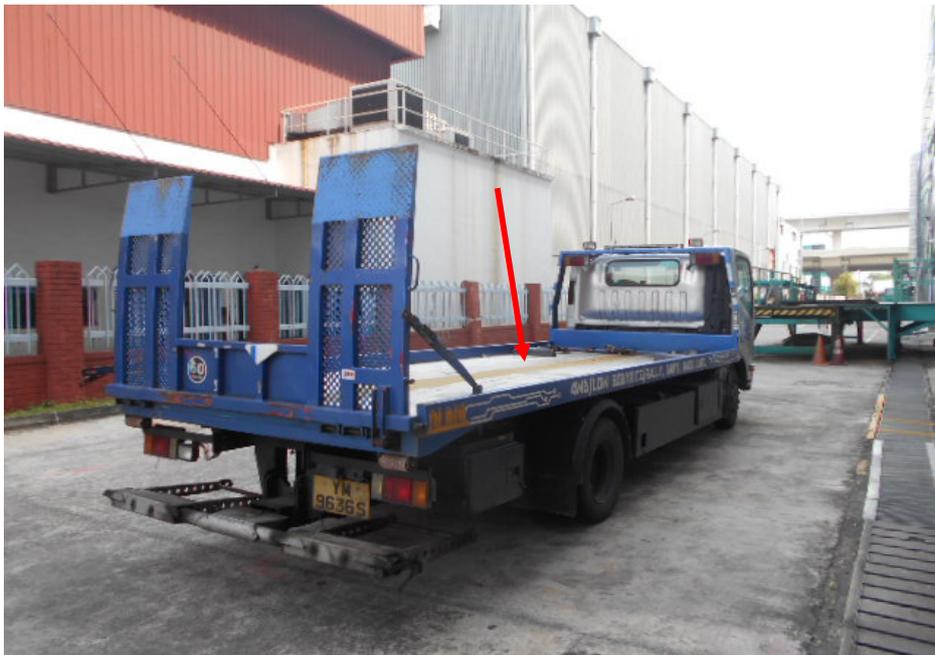
Photo 21 shows the flat-bed tow truck that was used to deliver the VW Golf to 17 Tuas Avenue 9. The company that collected the VW Golf from the port and carried out the delivery was AJ Towing (S) Pte Ltd. The VW Golf was secured on the flat-bed (arrowed) during the delivery.

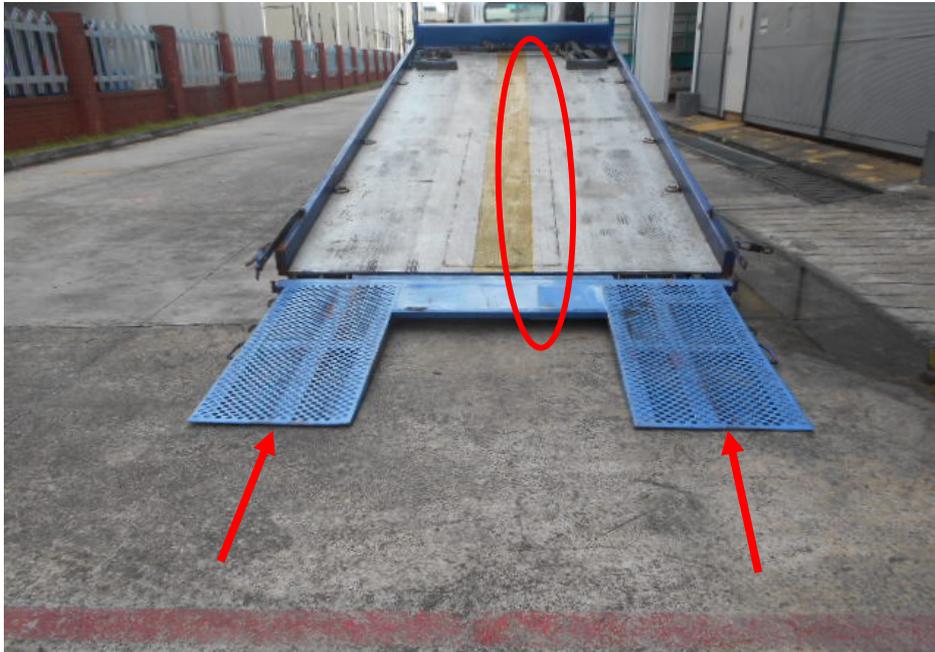
Photo 22 shows the flat-bed tow truck that was used to deliver the VW Golf to 17 Tuas Avenue 9. During the delivery, the VW Golf was driven up onto the flat-bed via a ramp (arrowed). Given the area of damage to the VW Golf (slightly towards the left from the centre), any sharp edge object(s) or body part(s) on the flat-bed tow truck that could possibly cause the single point of impact damage to the VW Golf would be located at or around the area highlighted by the red circle.

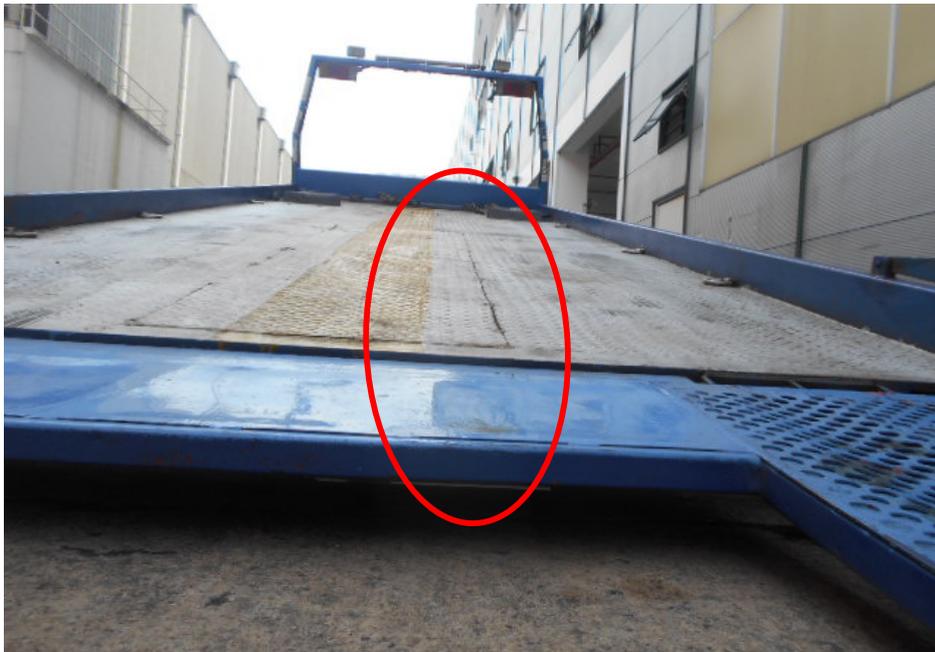
Photo 23 shows a closer view of the flat-bed. I did not find any sharp edge object(s) or body part(s) on the flat-bed tow truck (circled) that could possibly cause the damage to the VW Golf.

18. Earlier in paragraph 7, I had commented that the damage to the VW Golf was unlikely to be caused by the VW Golf mounting a road kerb or other similar flat surface type of structure/object given that there were no marks of grazing nature found on the underside of the VW Golf. The possible area on the flat-bed tow truck (shown in photograph 23) was noted to be of flat surface type, hence the damage pattern to the VW Golf does not seem to suggest that the damage was caused during the delivery of the VW Golf from the port to 17 Tuas Avenue 9.

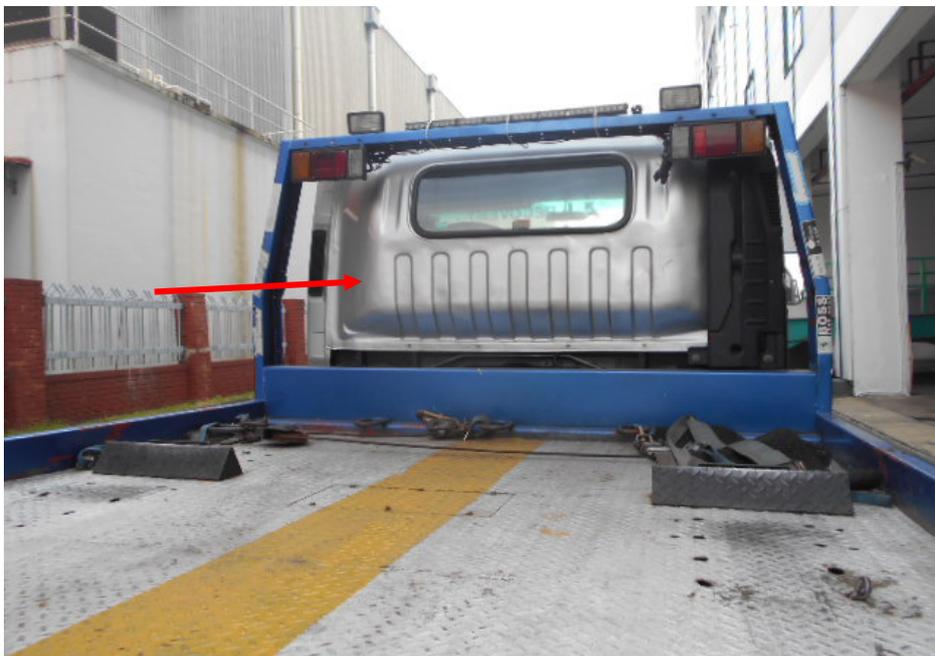
19. The engine oil stains that were found on the underside, from the hole/puncture at the engine oil sump stretching towards the rear of the VW Golf would seem to also support my comment that the damage to the VW Golf was not caused during the delivery. During the delivery, the VW Golf was secured on the flat-bed. The air flow (wind) generated by the movement of the flat-bed tow truck during the journey would bypass the underside of the VW Golf as the front cabin of the flat-bed tow truck would block the air flow, causing the wind to flow along the sides of the VW Golf. See photo 24 below.

Photo 24 shows the view of the front from the flat-bed of the tow truck. The front cabin (arrowed) of the flat-bed tow truck would block the wind generated from movement of the flat-bed tow truck. The air flow (wind) during the journey would bypass the underside of the VW Golf due to blockage from the front cabin of the flat-bed tow truck. The air flow (wind) would instead flow along the sides of the VW Golf.
