### ADJUSTMENT ON REPAIR COST FOR VEHICLE NO. SGA 4493X

## ACCIDENT VEHICLE SURVEY REPORT

Vehicle Reg No.:	SGA4493X	Odometer:	116865km
Make & Model:	Kia Cerato Forte 16SX AT	Colour:	Red
Chassis number:	KNAFW411MA5242742	Date of accident:	01/04/2018
Year of Regn.:	12/10/2010	Date inspected:	16/04/2018
Repairer at:	EM Solution Pte Ltd	Date inspected (After Repair):	20/04/2018
	160 Sin Ming Drive #03-19 Sin Ming Autocity		
	Singapore 575722

## ADJUSTMENT ON REPAIR COST FOR VEHICLE NO. SGA 4493X

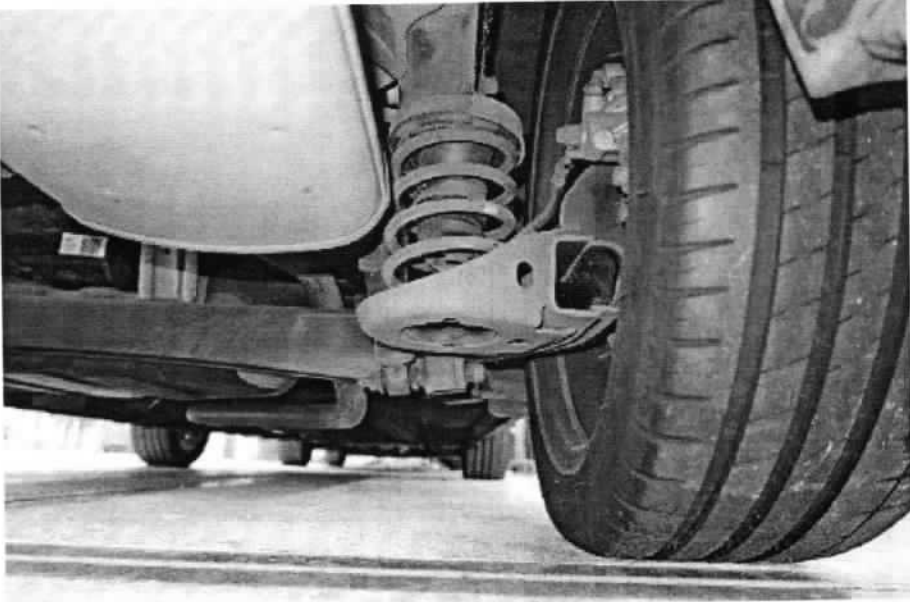
PRS photo	Re-inspection Photo

For shock absorber RH and rear wheel hub c/w bearing RH, are these two items has been replaced or not necessary?

It seems like there is no replacement.

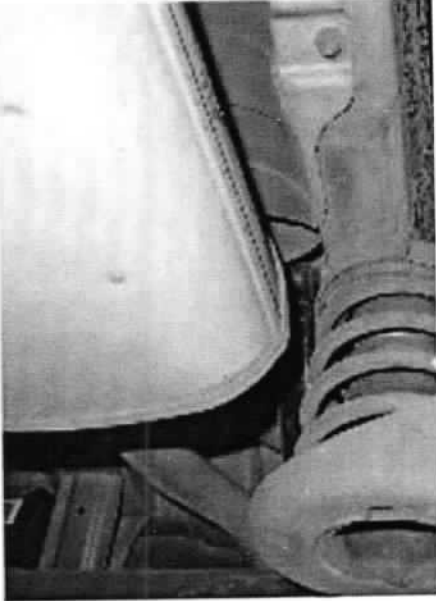
<p>18/19: 1st Inspection view</p>

From the photos, it shows that the damage is minor and its impact is not direct as it's a side swipe case base on the accident report. It is unlikely that the undercarriage will be damage, therefore not necessary to replace, item not allowed.
