Your Ref: Mercedes Benz CLA 250  
(chassis number WDD1173512N428839)  
Our Ref : CI/TP18015177/D

21 August 2018

**INSPECTION REPORT OF AN UNREGISTERD MERCEDES BENZ CLA 250  
MOTOR CAR WITH CHASSIS NUMBER WDD1173512N428839**

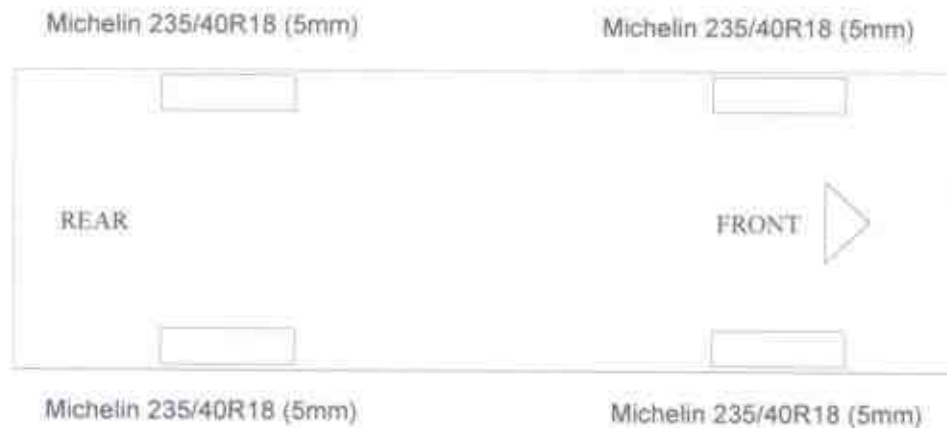
6. It was fitted with 18inch sport wheel rims that were wrapped with tyres that were observed to be of serviceable condition. The tyres were also sufficiently inflated for vehicular operation. The tyre brand, tyre size and approximate remaining tread depth of the 4 tyres of the Motor Car were recorded as follows: -

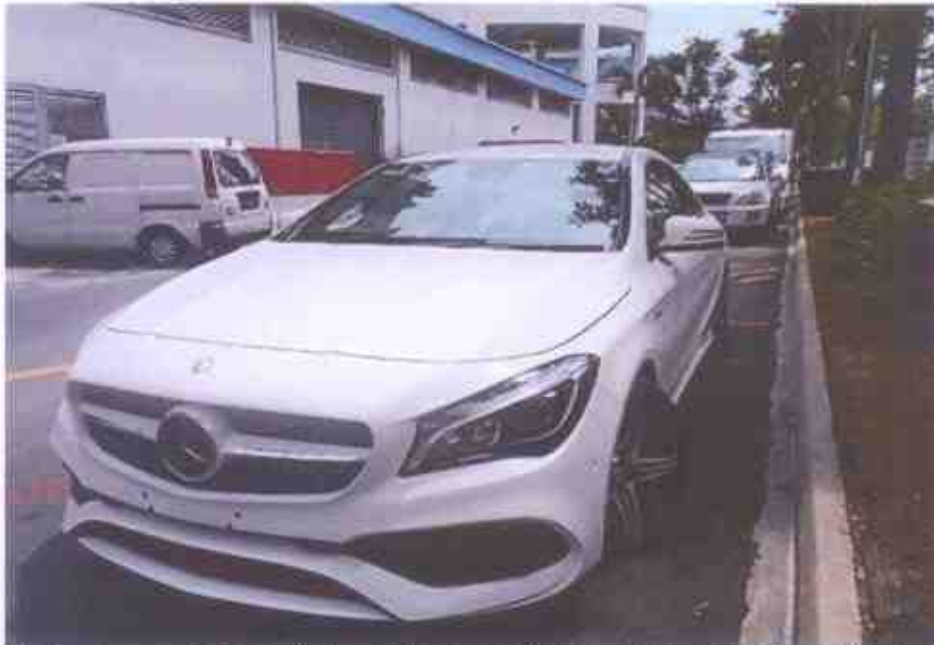
**Photo 1** shows a general view of the front left body of the Motor Car at the time of my inspection. The Motor Car was observed to be in relatively good general condition with no loose exterior fittings observed.

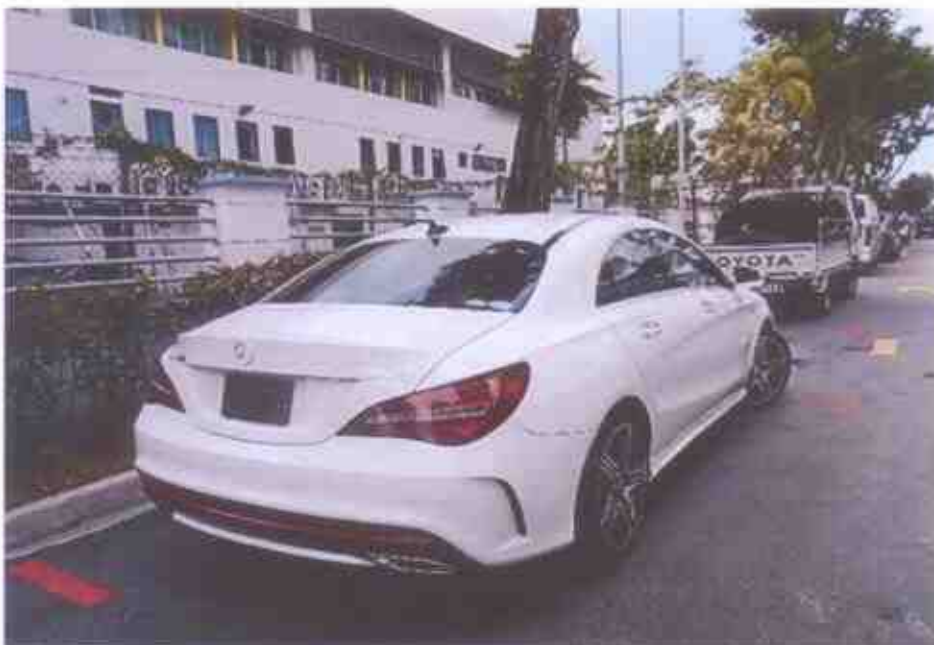
**Photo 2** shows a general view of the rear right body of the Motor Car at the time of my inspection. The Motor Car was observed to be in relatively good general condition with no loose exterior fittings observed.

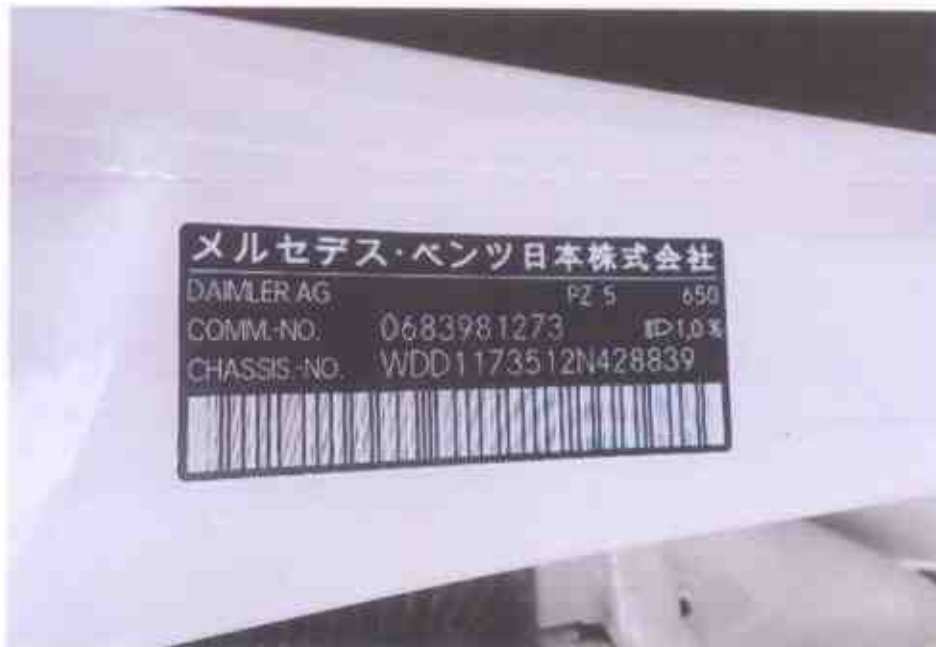
Photo 3 shows the chassis number of the Motor Car. The chassis number recorded was WDD1173512N428839.

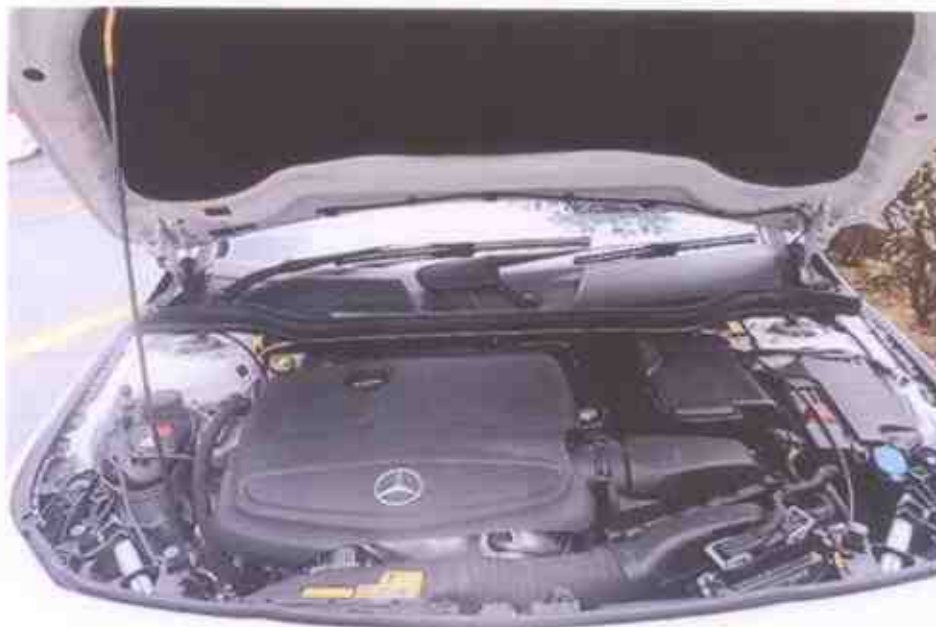
12. My examination of the engine compartment of the Motor Car revealed that the various parts and components inside the engine compartment were all intact and properly fitted. The engine oil, brake fluid and engine coolant were all found to be of sufficient level for operating purposes. Visually, there was also no contamination found to these fluids.
13. My checks on the underside of the Motor Car revealed no sign(s) or indication(s) of fluid leakage and/or fluid stain(s). The engine block and automatic transmission assembly were both secured properly. They were not mounted onto the chassis body or any integral body part of the Motor Car. All undercarriage components of the Motor Car were also observed to be intact and secured in an appropriate manner.

Photo 4 shows a general view of the engine compartment of the Motor Car at the time of my inspection. The various parts and components inside the engine compartment were all observed to be intact and properly fitted. There was also no sign(s) or indication(s) of fluid leak and/or fluid stain found inside the engine compartment. The engine oil, brake fluid and engine coolant were all found to be of sufficient level for operating purposes. Visually, there was also no contamination found to these fluids.

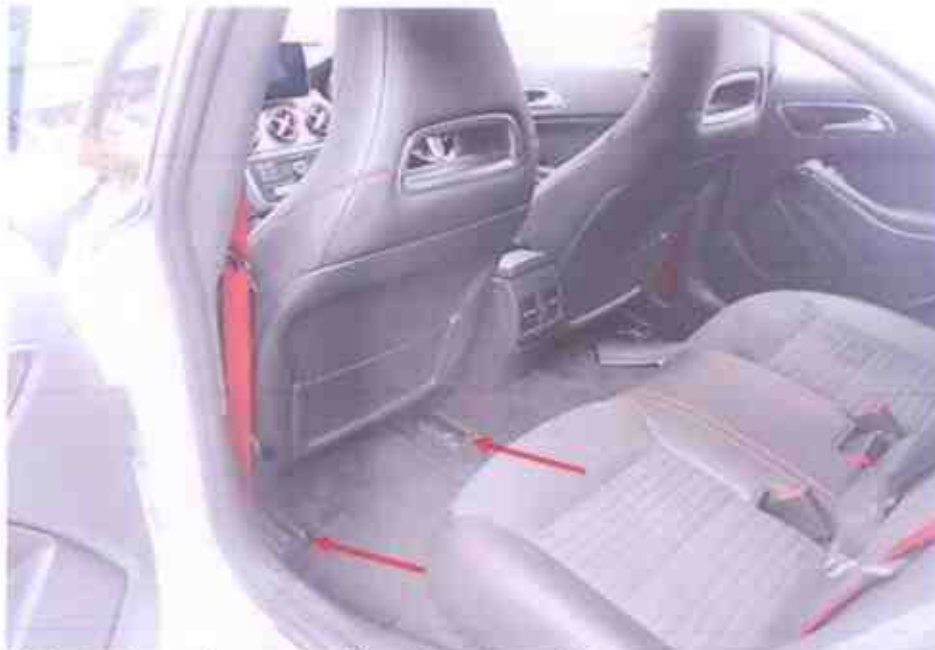
10. The seats of the Motor Car were found to be secured to the floor board of the Motor Car via seat rails bolted onto the floor board. Retractable seat belt reels and pre-tensioners were fitted on all seats of the Motor Car. The seat belt reels were able to be fastened securely to the respective pre-tensioner that is fixed to the side of all the seats.

Photo 5 shows the seats of the Motor Car, which were secured via seat rails (arrowed) to the floor board. All the seats of the Motor Car were fitted with a retractable seat belt reel and pre-tensioner. The seat belts were also able to be fastened to the pretension that were fitted on the side of each individual seat.

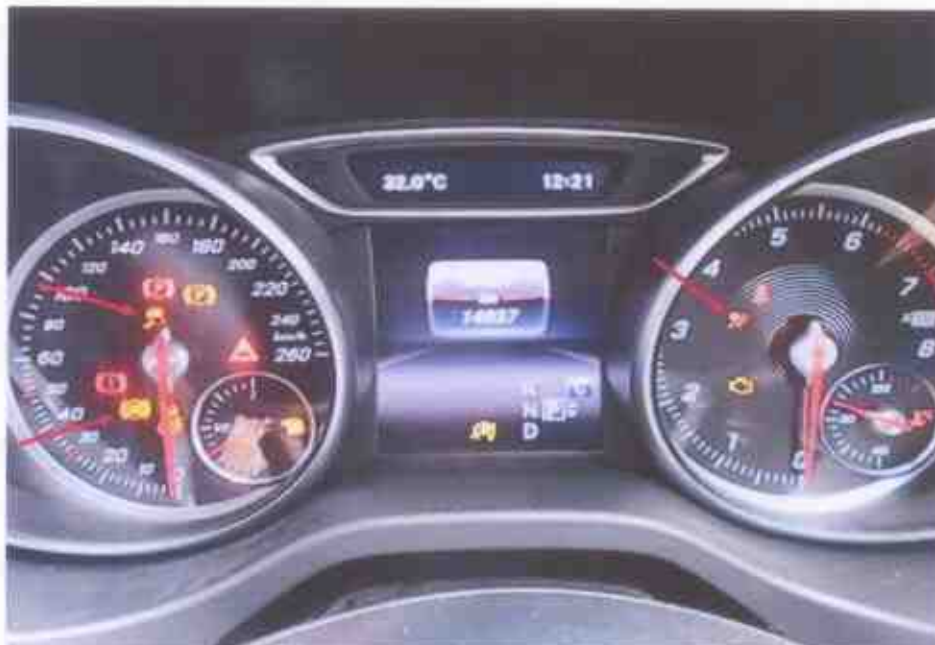
Photo 6 shows the warning lights for the various electronic safety features appearing on the instrument panel of the Motor Car during its self-test when the engine is cranked, in particular the ABS, SRS and TC lights (arrowed).

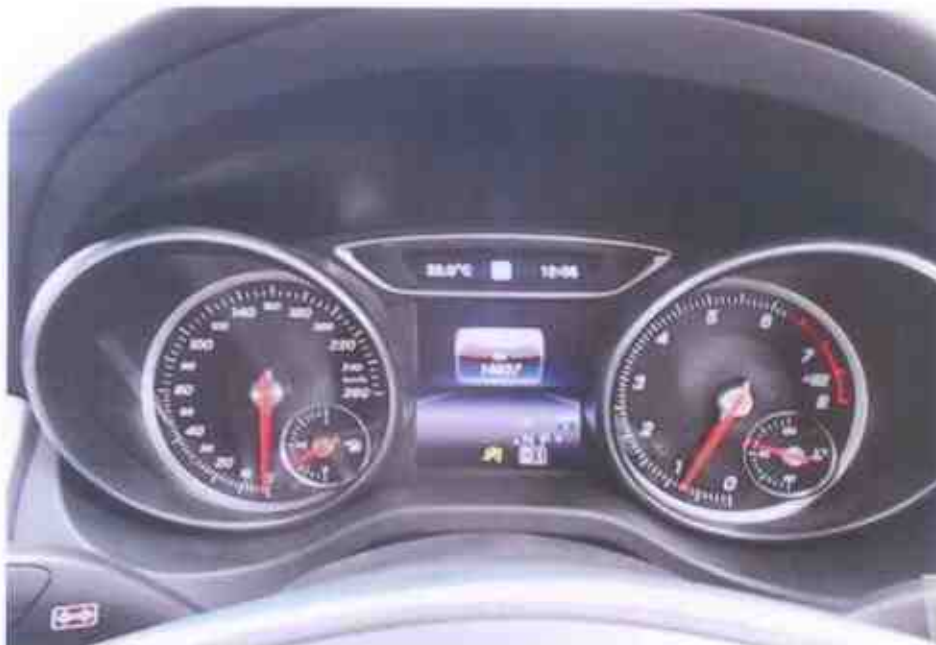
11. The Motor Car's automatic self-test of the functionality of its various electronic safety features like the Anti-Brake Lock System (ABS), Supplemental Restraint System (SRS) and Traction Control (TC) during cranking of the engine had indicated that these electronic systems were in working condition. This was determined from the respective warning lights disappearing from the instrument panel after the self-test.

Photo 7 shows the respective warning lights no longer illuminated, indicating that there is no fault detected to the ABS, SRS and TC systems of the Motor Car during the self-test. These electronic systems were hence in working condition at the time of my inspection.

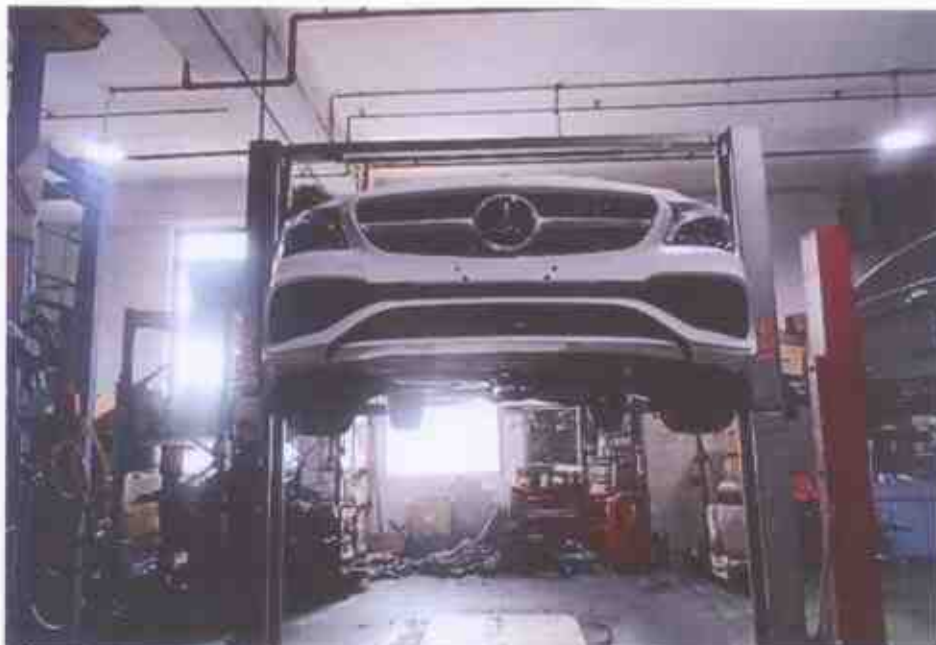
Photo 8 shows the Motor Car hoisted up for checks on its undercarriage. There was no sign(s) or indication(s) of fluid leakage and/or fluid stain(s). The undercarriage components of the Motor Car were also all observed to be intact and secured in an appropriate manner.

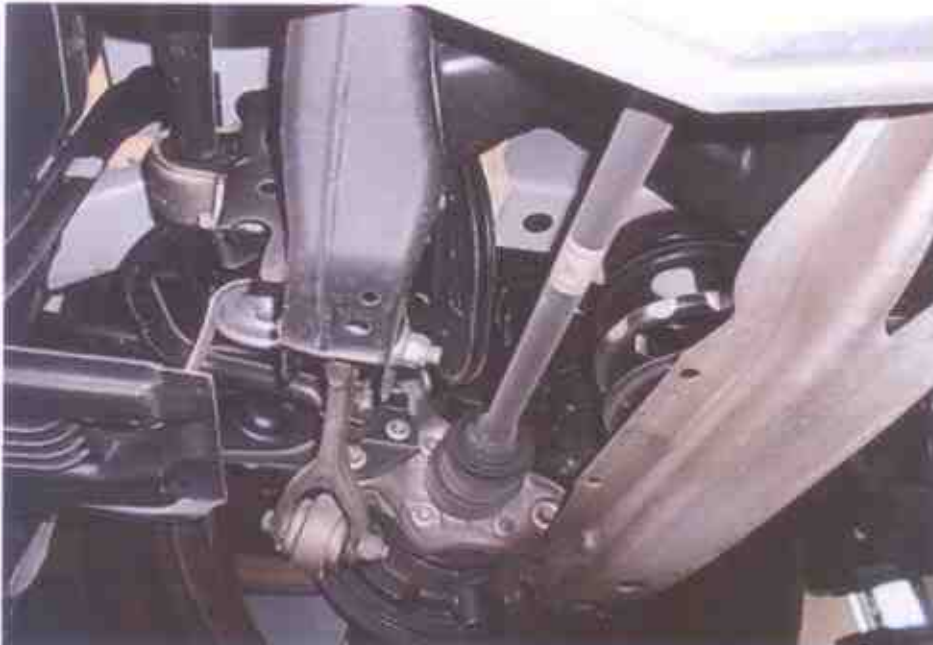
Photo 9 shows a general view of the control arms and linkages at the rear right wheel of the Motor Car. I did not observe any fluid leak and/or fluid stain on the underside of the Motor Car. All of the Motor Car's undercarriage components were observed to be intact and secured in an appropriate manner.

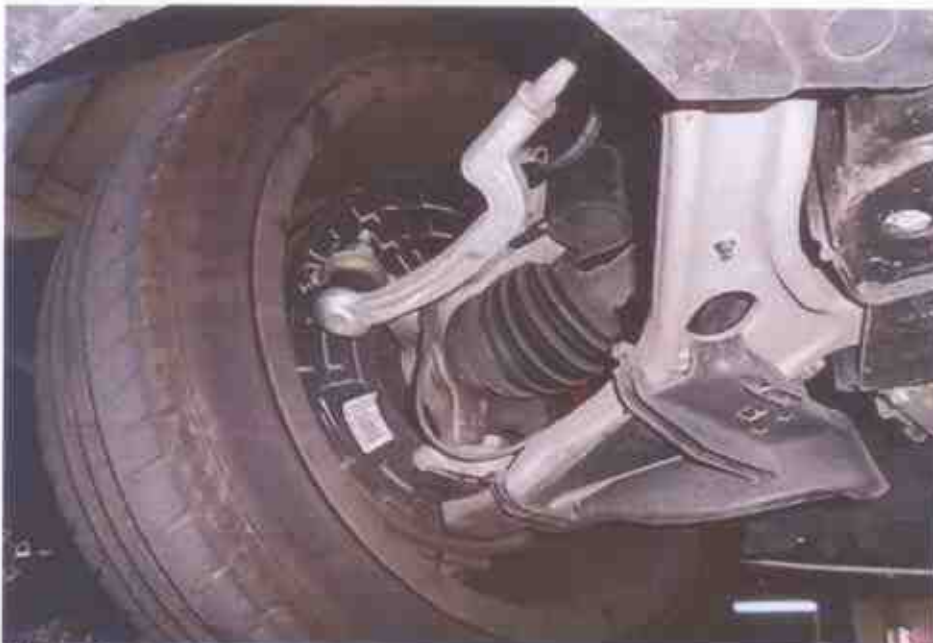
Photo 10 shows the various undercarriage components at the front left wheel of the Motor Car. The mechanical components, control arms and linkages were all found to be intact and secured in an appropriate manner.

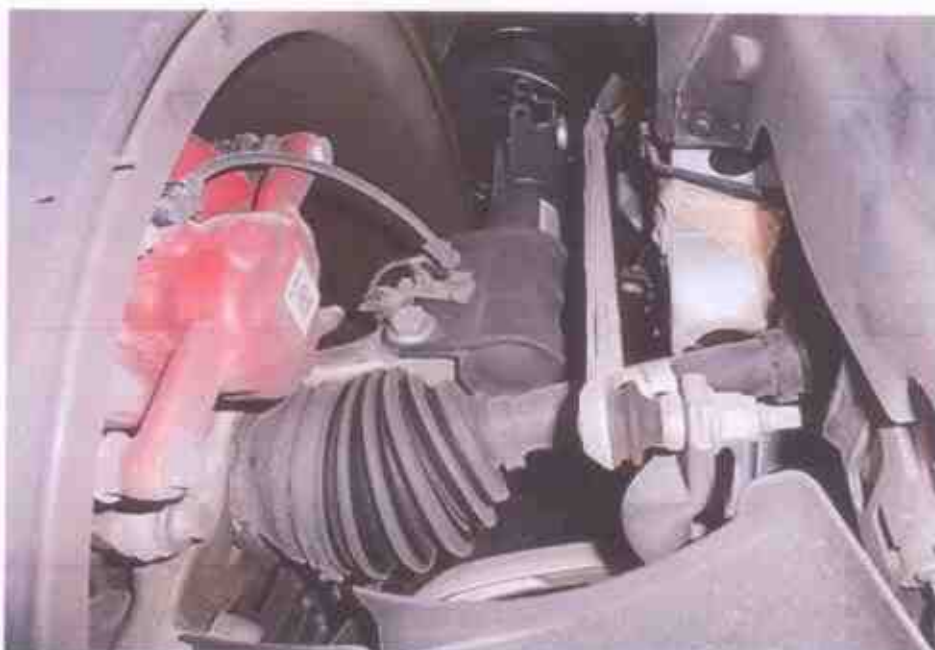
Photo 11 shows the various undercarriage components at the front right wheel of the Motor Car. The mechanical components, control arms and linkages were all found to be intact and secured in an appropriate manner.

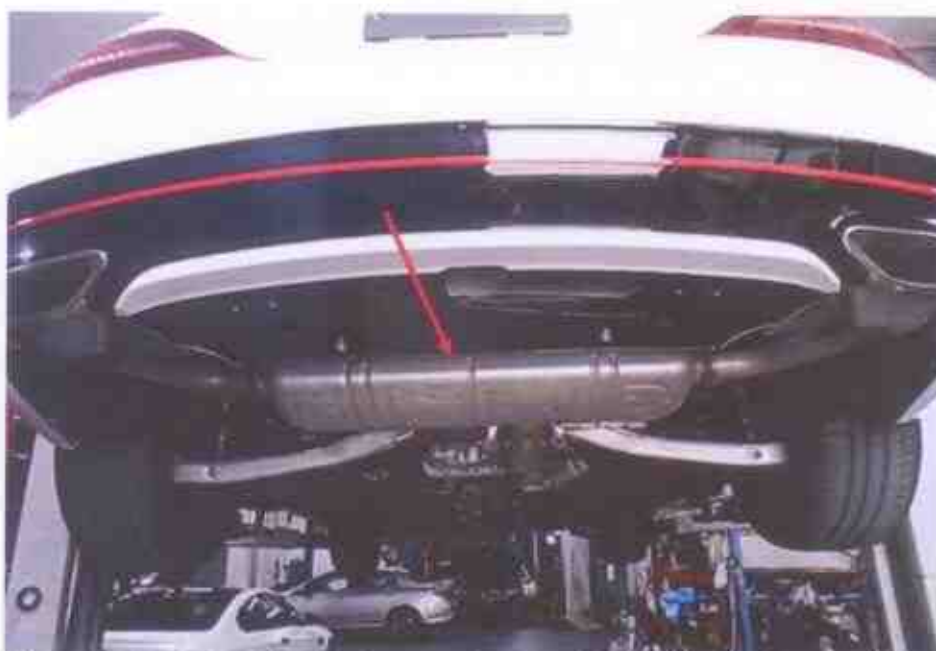
Photo 12 shows the Motor Car's rear exhaust muffler (arrowed). My examination of the Motor Car's exhaust system revealed no sign(s) or indication(s) of any cut or weld marks along its exhaust pipes and on its rear muffler.

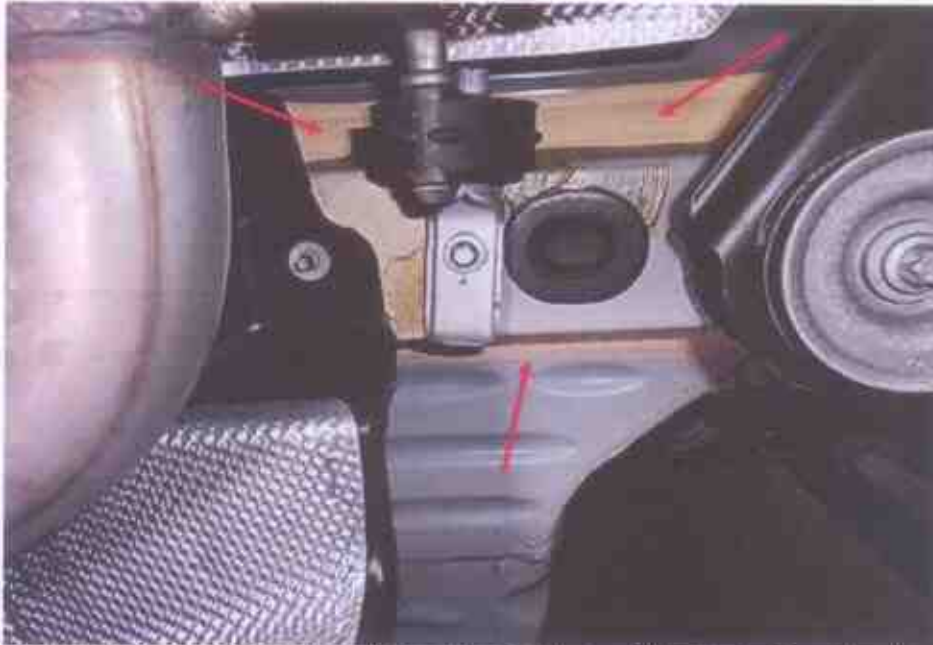
9. Visually, I did not find any weld marks, other than the original spot weld marks, on the chassis body of the Motor Car. The original factory sealant at the joints along the chassis body was also untouched, again indicating that no replacement of the chassis body was carried out; and that the chassis body was originally fitted.

Photo 13 shows the structural body at the right rear of the Motor Car. Visually, I did not find any weld marks other than original spot weld marks on the chassis body of the Motor Car. The joints (arrowed) along the chassis body was also untouched, indicating no work was done on the chassis body of the Motor Car and that the chassis body was originally fitted.

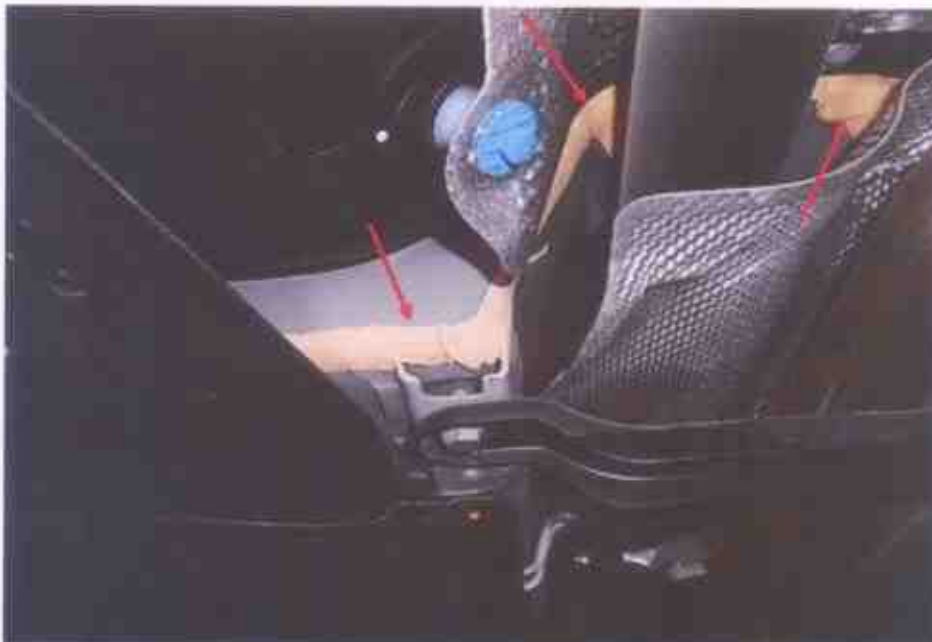
Photo 14 shows the structural body at the centre of the Motor Car. Visually, I did not find any weld marks other than original spot weld marks on the chassis of the Motor Car. The joints (arrowed) along the chassis body was also untouched, indicating no work was done on the chassis body of the Motor Car and that the chassis body was originally fitted.

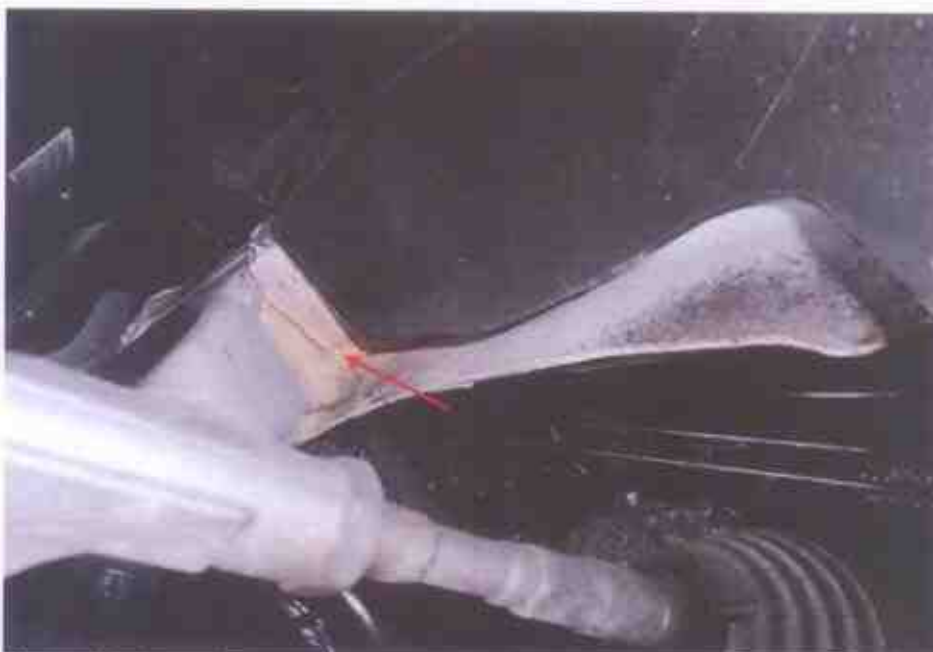
Photo 15 shows the structural body at the front left of the Motor Car. The joints (arrowed) along the chassis body was untouched, indicating no work was done on the chassis body of the Motor Car and that the chassis body was originally fitted.

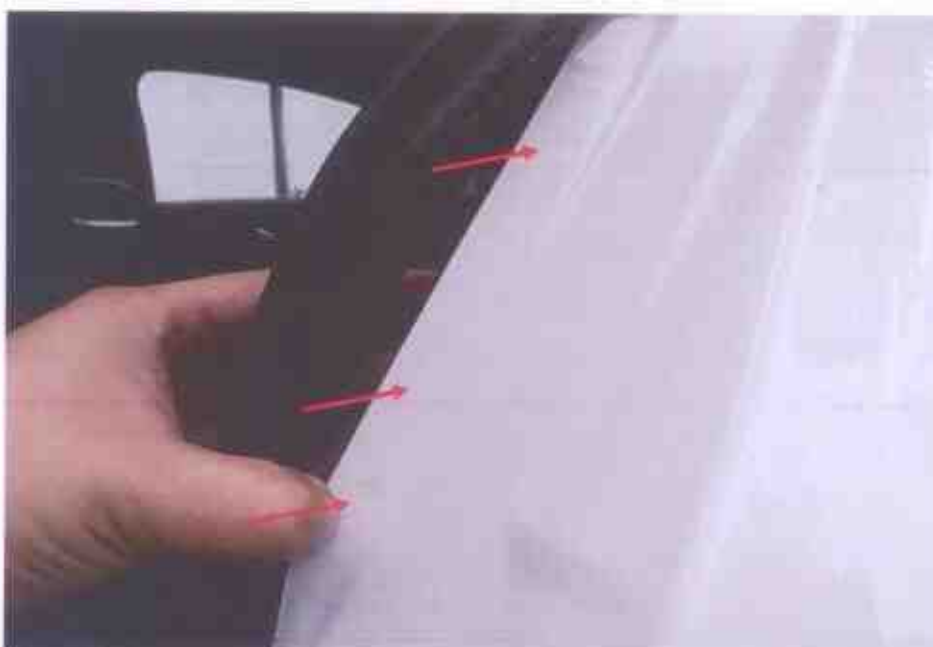
Photo 16 shows the rear left body panel of the Motor Car. I did not find any weld marks other than original spot weld marks (arrowed) on the body panels of the Motor Car, indicating that there was no re-welding works carried out; and that the body panels of the Motor Car were originally fitted.

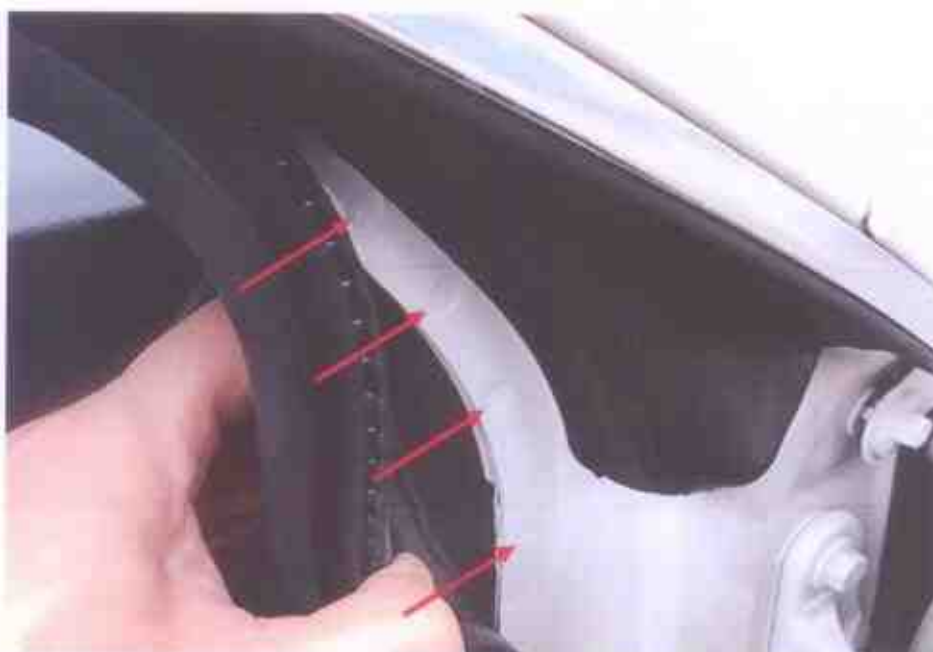
Photo 17 shows the front right "A" pillar of the Motor Car. I did not find any weld marks other than original spot weld marks (arrowed) on the body panels of the Motor Car, indicating that there was no re-welding works carried out; and that the body panels of the Motor Car were originally fitted.
