Your Ref: Mercedes Benz C200
(chassis number WDD2050422R281519)
Our Ref : CI/TP18015254/D

24 August 2018

**INSPECTION REPORT OF AN UNREGISTERED MERCEDES BENZ C200
MOTOR CAR WITH CHASSIS NUMBER WDD2050422R281519**

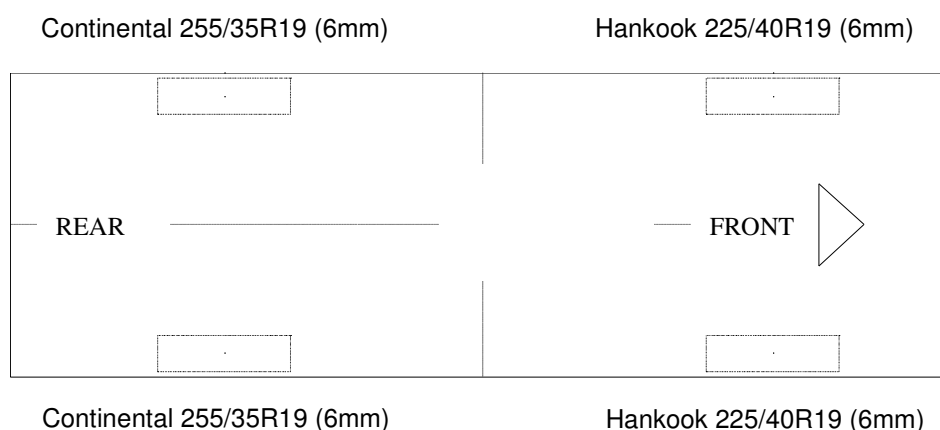
6. It was fitted with 19inch sport wheel rims that were wrapped with tyres that were observed to be of serviceable condition. The tyres were also sufficiently inflated for vehicular operation. The tyre brand, tyre size and approximate remaining tread depth of the 4 tyres of the Motor Car were recorded as follows: -

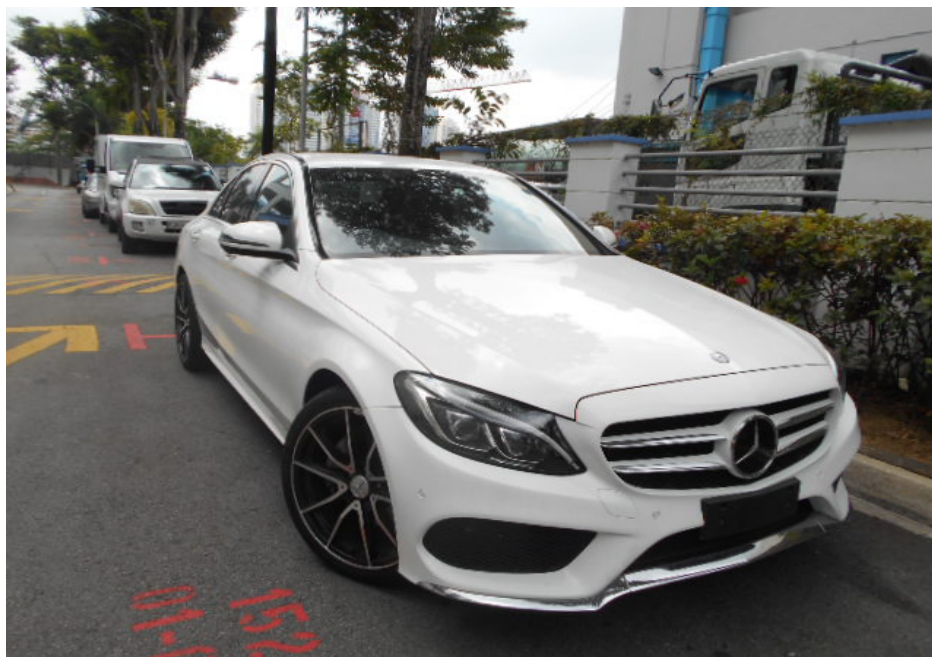
Photo 1 shows a general view of the front right body of the Motor Car at the time of my inspection. The Motor Car was observed to be in relatively good general condition with no loose exterior fittings observed.

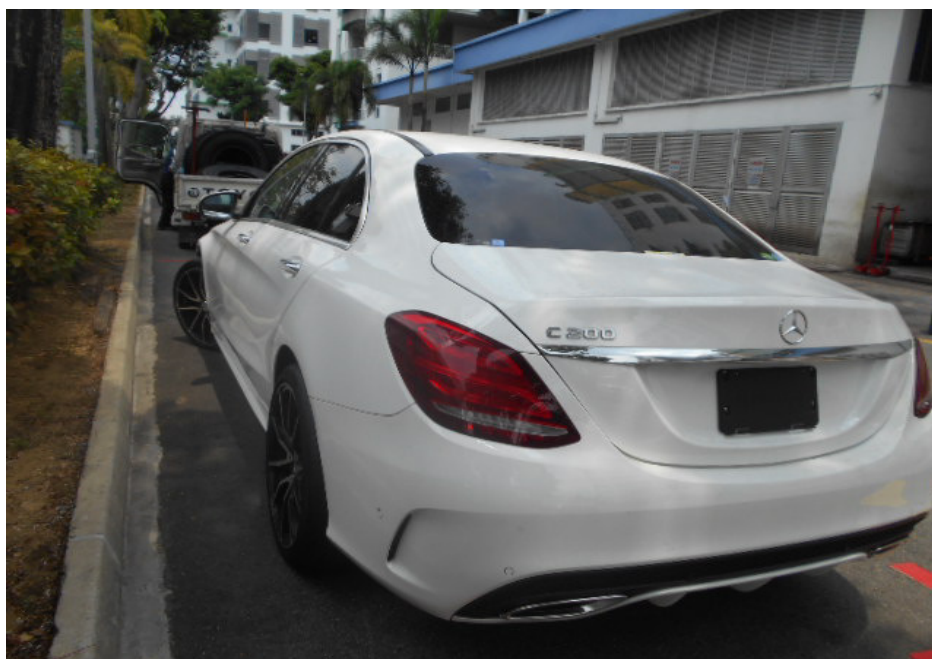
Photo 2 shows a general view of the rear left body of the Motor Car at the time of my inspection. The Motor Car was observed to be in relatively good general condition with no loose exterior fittings observed.

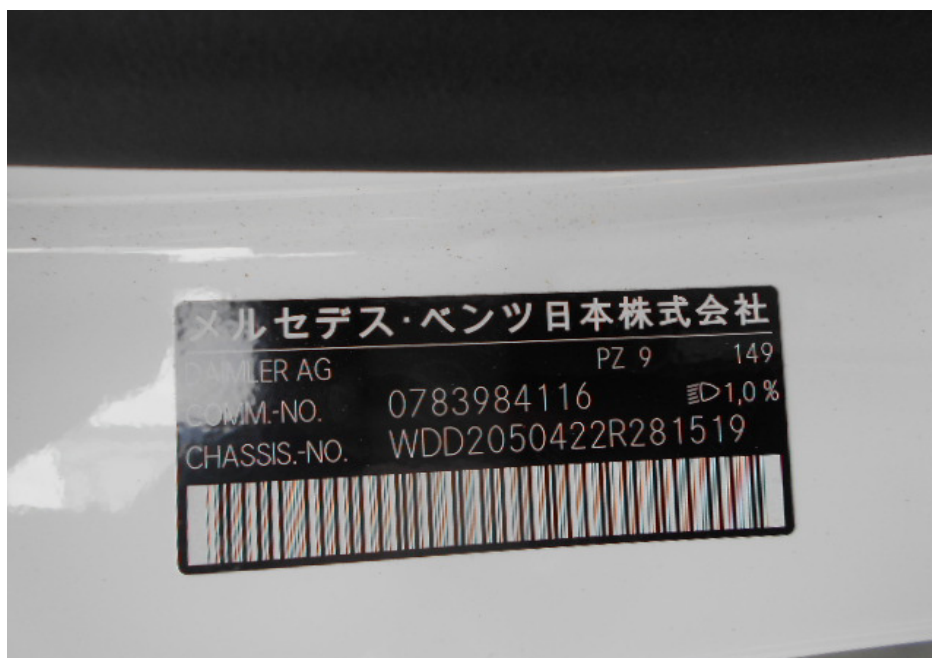
Photo 3 shows the chassis number of the Motor Car. The chassis number recorded was WDD2050422R281519.

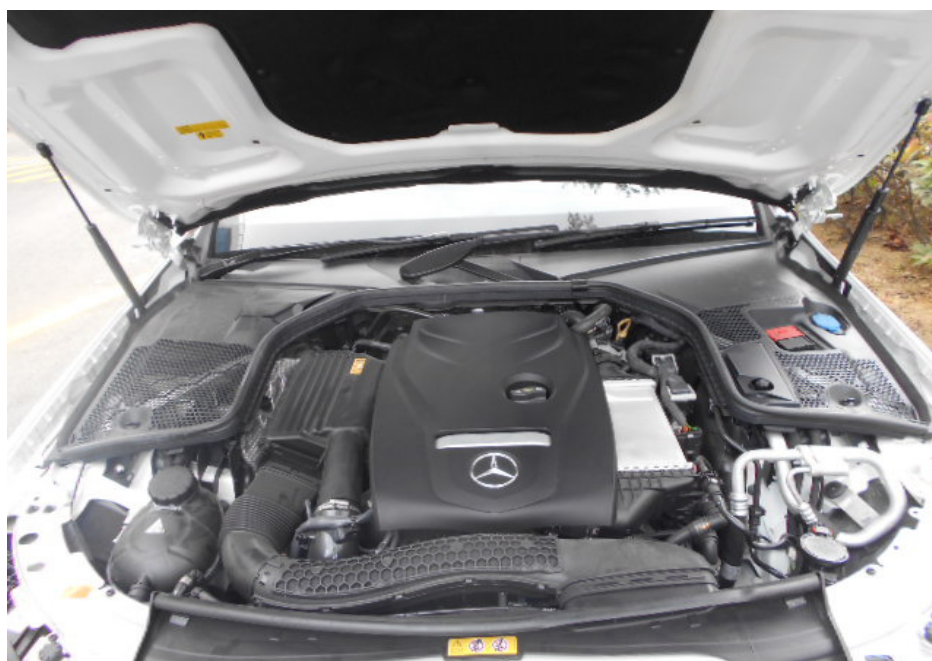
12. My examination of the engine compartment of the Motor Car revealed that the various parts and components inside the engine compartment were all intact and properly fitted. The engine oil, brake fluid and engine coolant were all found to be of sufficient level for operating purposes. Visually, there was also no contamination found to these fluids.
13. My checks on the underside of the Motor Car revealed no sign(s) or indication(s) of fluid leakage and/or fluid stain(s). The engine block and automatic transmission assembly were both secured properly. They were not mounted onto the chassis body or any integral body part of the Motor Car. All undercarriage components of the Motor Car were also observed to be intact and secured in an appropriate manner.

Photo 4 shows a general view of the engine compartment of the Motor Car at the time of my inspection. The various parts and components inside the engine compartment were all observed to be intact and properly fitted. There was also no sign(s) or indication(s) of fluid leak and/or fluid stain found inside the engine compartment. The engine oil, brake fluid and engine coolant were all found to be of sufficient level for operating purposes. Visually, there was also no contamination found to these fluids.

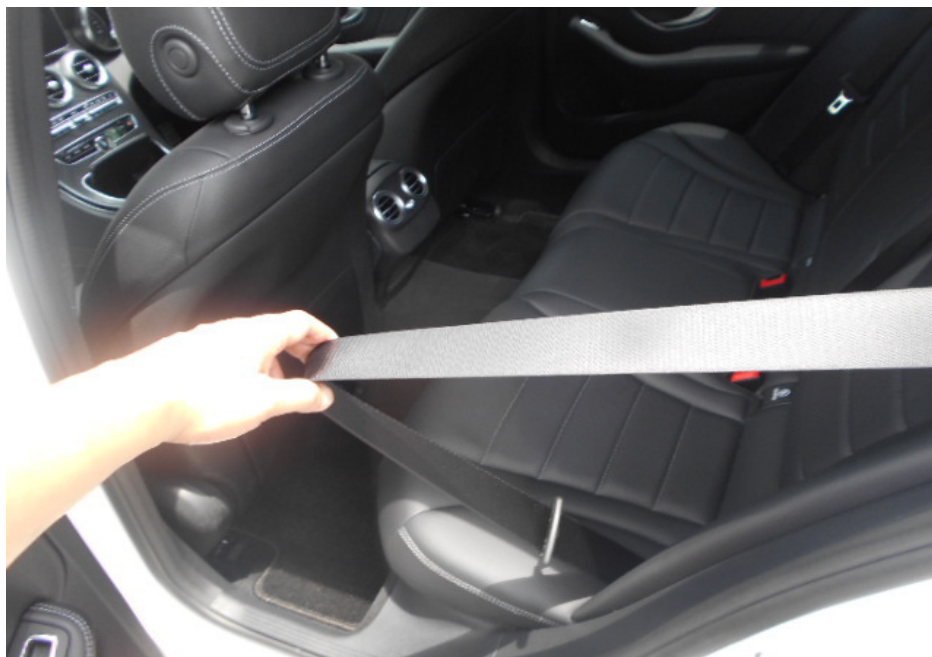
10. The seats of the Motor Car were found to be secured to the floor board of the Motor Car via seat rails bolted onto the floor board. Retractable seat belt reels and pre-tensioners were fitted on all seats of the Motor Car. The seat belt reels were able to be fastened securely to the respective pre-tensioner that is fixed to the side of all the seats.

Photo 5 shows the rear seats of the Motor Car. All the seats were secured via seat rails to the floor board. The seats were also fitted with a retractable seat belt reel and pre-tensioner. The seat belts were tested and able to be fastened to the pretensioners that were fitted on the side of each individual seat.

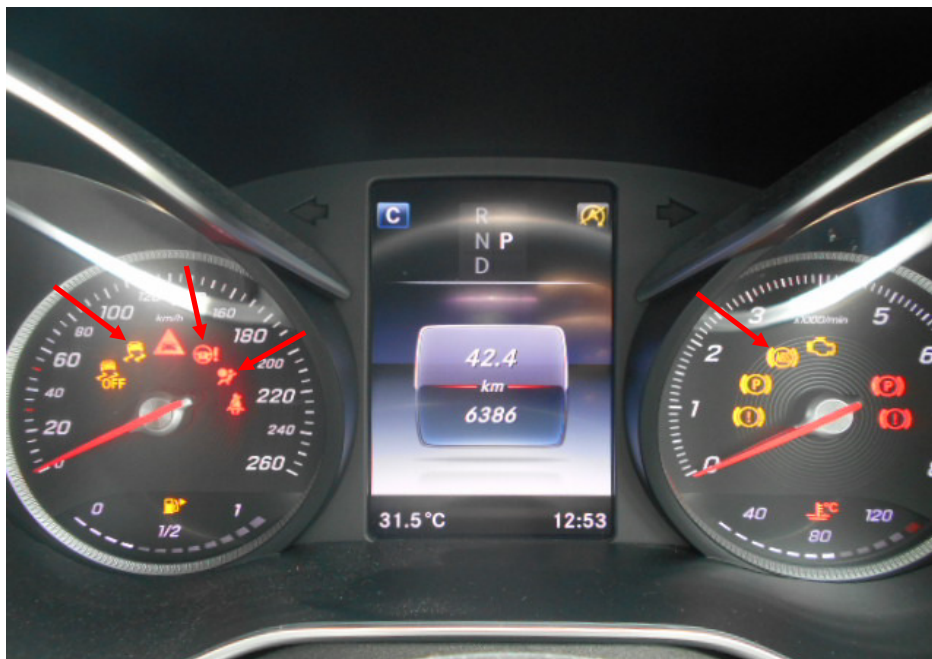
Photo 6 shows the warning lights for the various electronic safety features appearing on the instrument panel of the Motor Car during its self-test when the engine is cranked, in particular the ABS, SRS, PSA and TCS lights (arrowed).

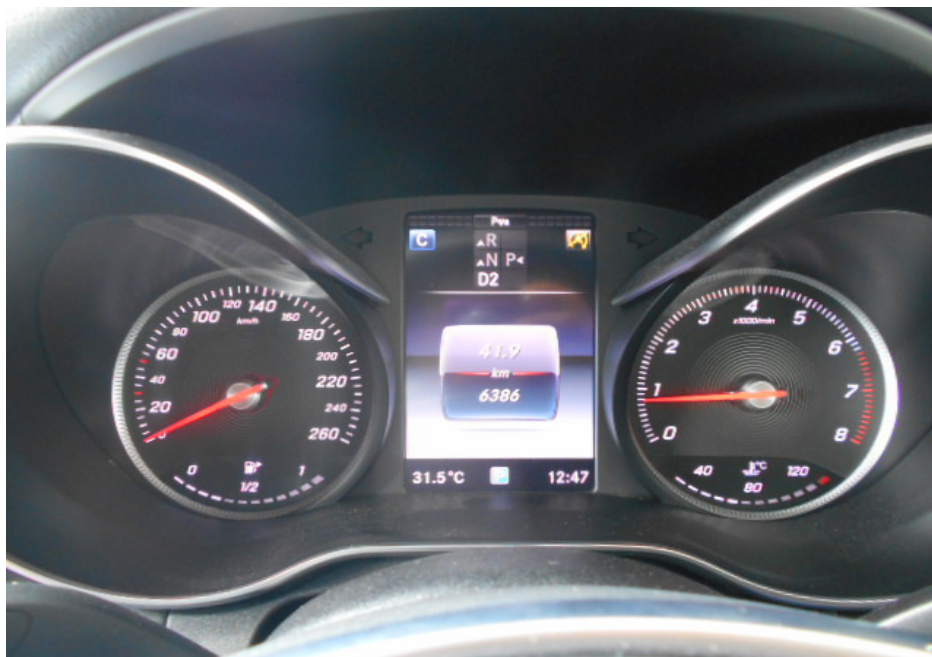
11. The Motor Car's automatic self-test of the functionality of its various electronic safety features like the Anti-Brake Lock System (ABS), Supplemental Restraint System (SRS), Power Steering Assist (PSA) and Traction Control System (TCS) during cranking of the engine had indicated that these electronic systems were in working condition. This was determined from the respective warning lights disappearing from the instrument panel after the self-test.

Photo 7 shows the respective warning lights no longer illuminated, indicating that there is no fault detected to the ABS, SRS, PSA and TCS systems of the Motor Car during the self-test. These electronic systems were hence in working condition at the time of my inspection.

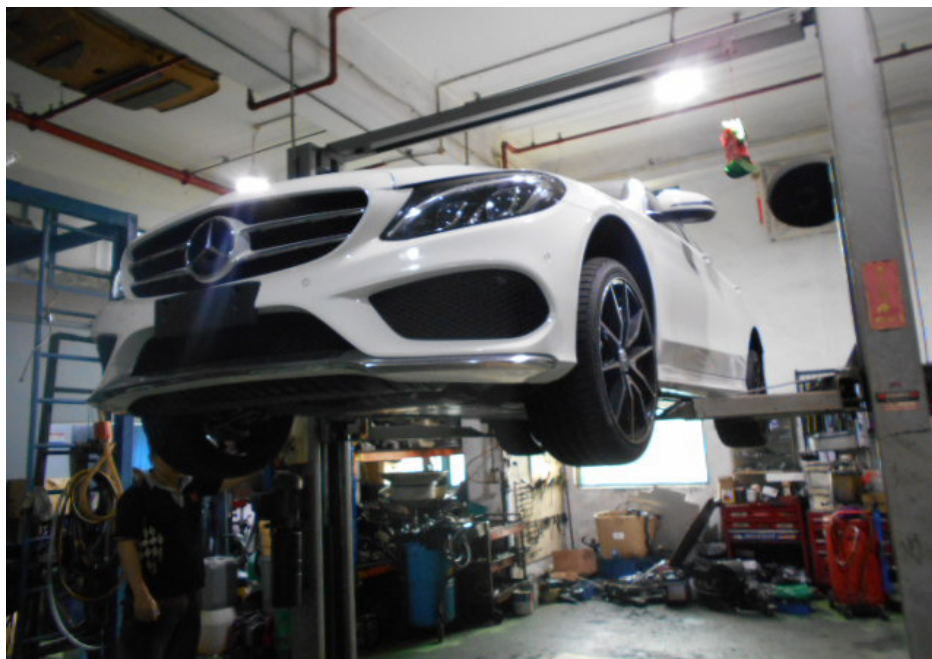
Photo 8 shows the Motor Car hoisted up for checks on its undercarriage. There was no sign(s) or indication(s) of fluid leakage and/or fluid stain(s). The undercarriage components of the Motor Car were also all observed to be intact and secured in an appropriate manner.

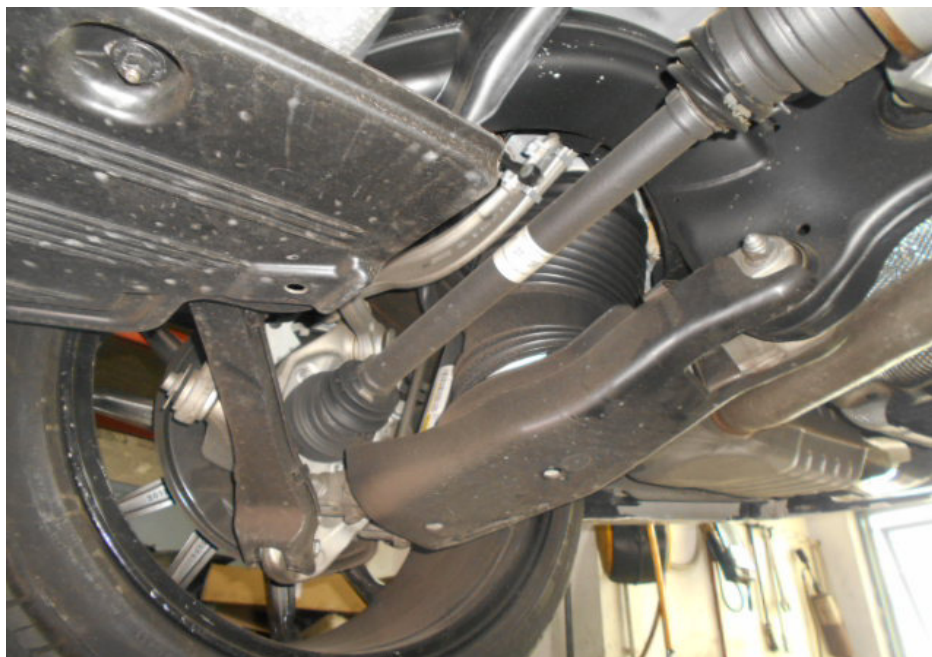
Photo 9 shows a general view of the control arms and linkages at the rear right wheel of the Motor Car. I did not observe any fluid leak and/or fluid stain on the underside of the Motor Car. All of the Motor Car's undercarriage components were observed to be intact and secured in an appropriate manner.

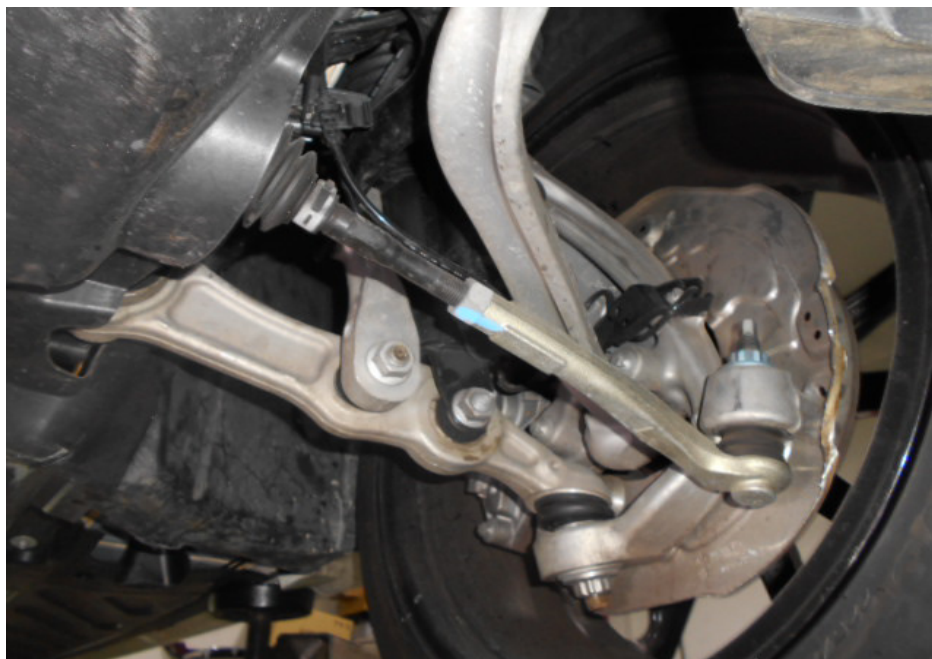
Photo 10 shows the various undercarriage components at the front left wheel of the Motor Car. The mechanical components, control arms and linkages were all found to be intact and secured in an appropriate manner.

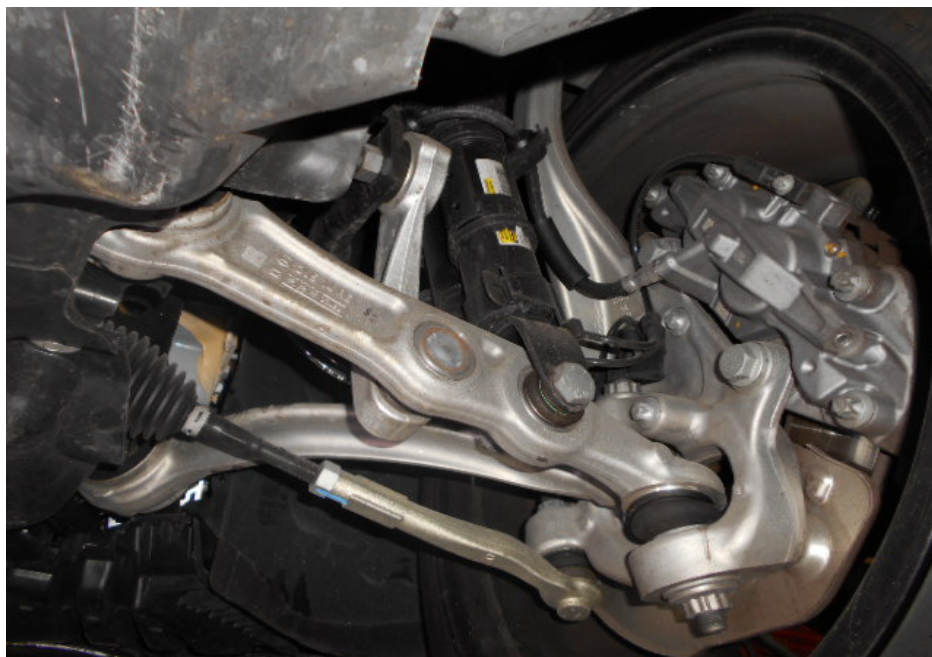
Photo 11 shows the various undercarriage components at the front right wheel of the Motor Car. The mechanical components, control arms and linkages were all found to be intact and secured in an appropriate manner.

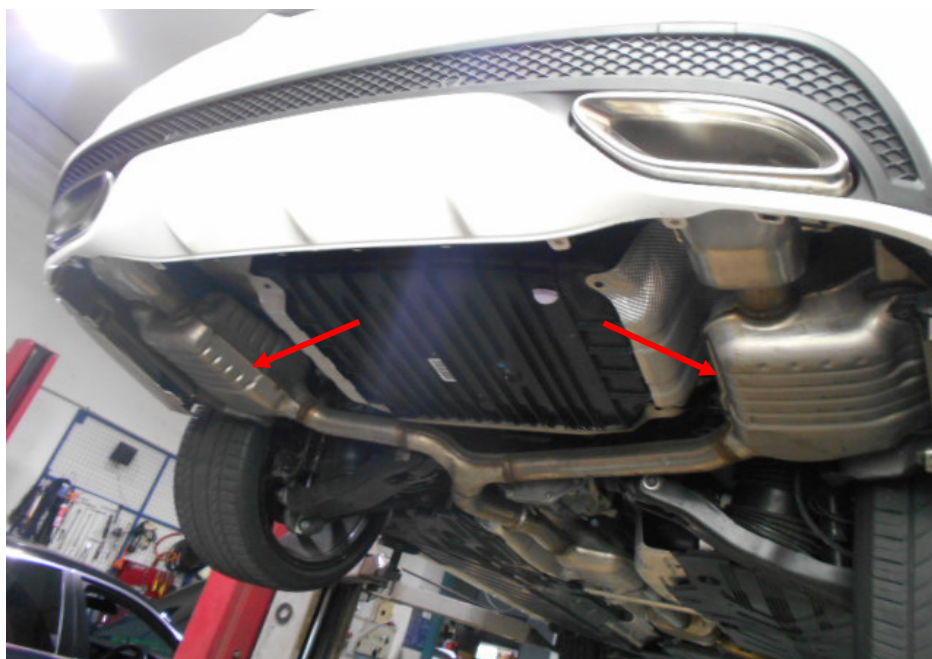
Photo 12 shows the Motor Car's rear exhaust mufflers (arrowed). My examination of the Motor Car's exhaust system revealed no sign(s) or indication(s) of any cut or weld marks along its exhaust pipes and on its rear mufflers.

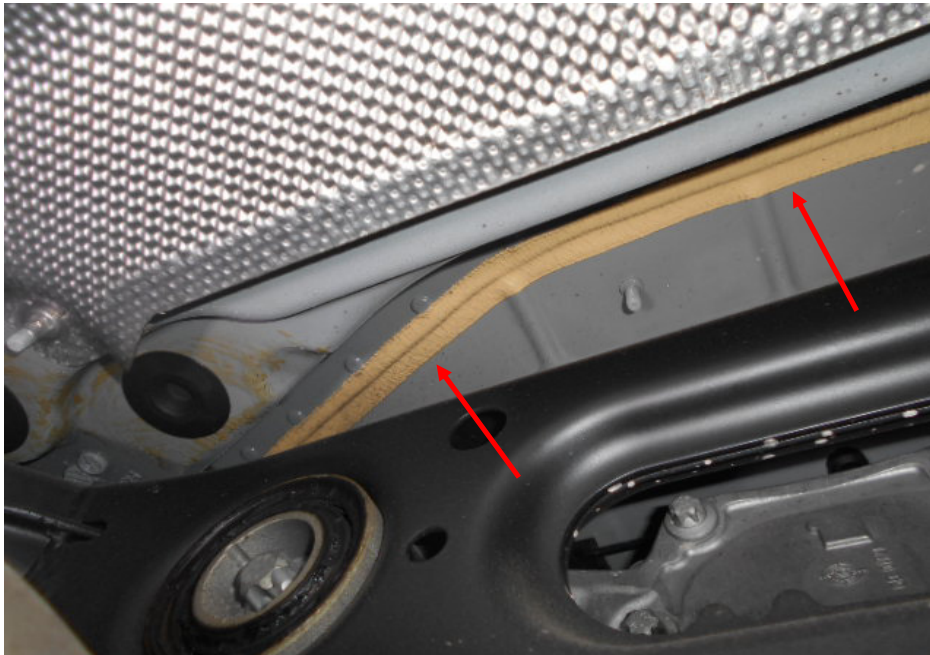
9. Visually, I did not find any weld marks, other than the original spot weld marks, on the chassis body of the Motor Car. The original factory sealant at the joints along the chassis body was also untouched, again indicating that no replacement of the chassis body was carried out; and that the chassis body was originally fitted.

Photo 13 shows the structural body at the rear floorboard of the Motor Car. Visually, I did not find any weld marks other than original spot weld marks on the chassis body of the Motor Car. The joints (arrowed) along the chassis body was also untouched, indicating no work was done on the chassis body of the Motor Car and that the chassis body was originally fitted.

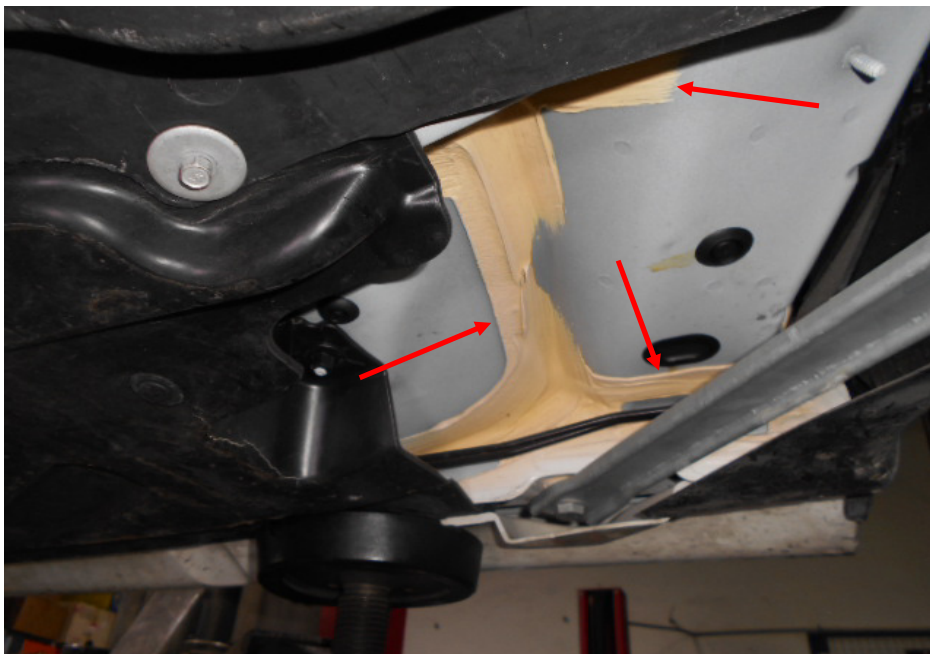
Photo 14 shows the structural body at the centre left of the Motor Car. Visually, I did not find any weld marks other than original spot weld marks on the chassis of the Motor Car. The joints (arrowed) along the chassis body was also untouched, indicating no work was done on the chassis body of the Motor Car and that the chassis body was originally fitted.

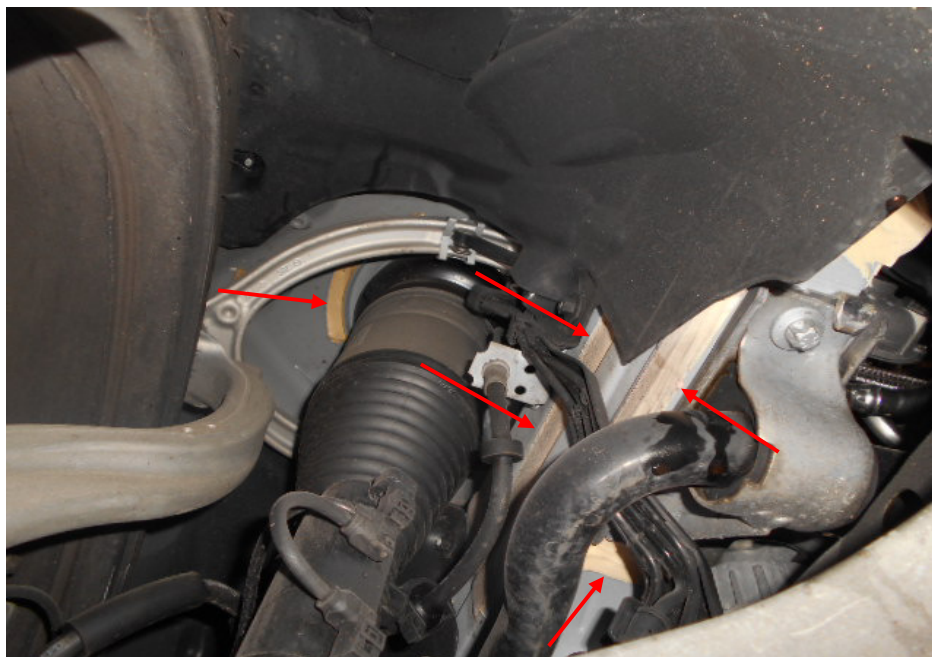
Photo 15 shows the structural body and wheel house panel at the front right of the Motor Car. The joints (arrowed) along the chassis body was untouched, indicating no work was done on the chassis body of the Motor Car and that the chassis body was originally fitted.

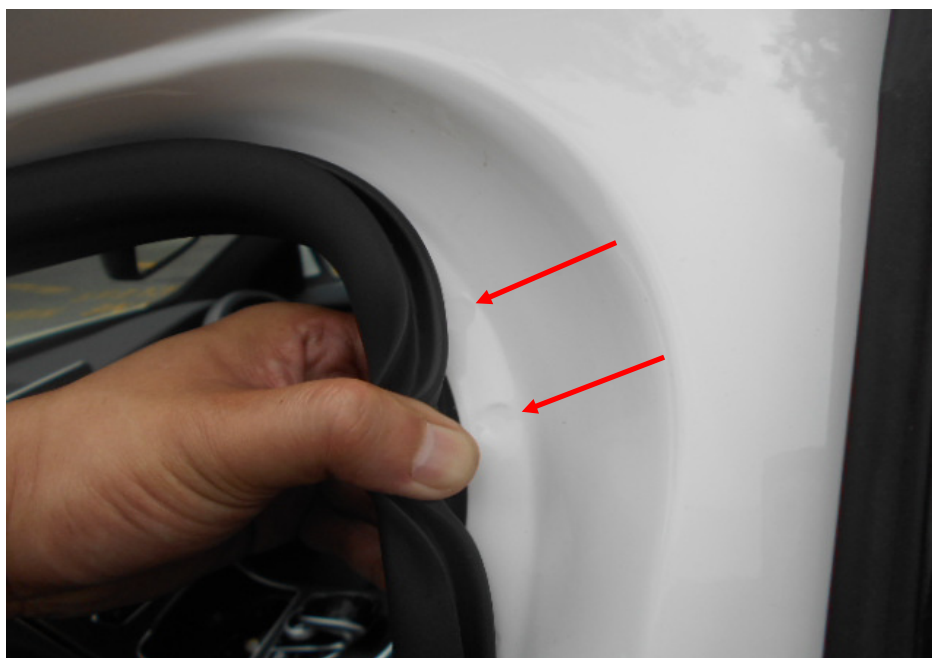
Photo 16 shows the left "B" pillar of the Motor Car. I did not find any weld marks other than original spot weld marks (arrowed) on the body panels of the Motor Car, indicating that there was no re-welding works carried out; and that the body panels of the Motor Car were originally fitted.

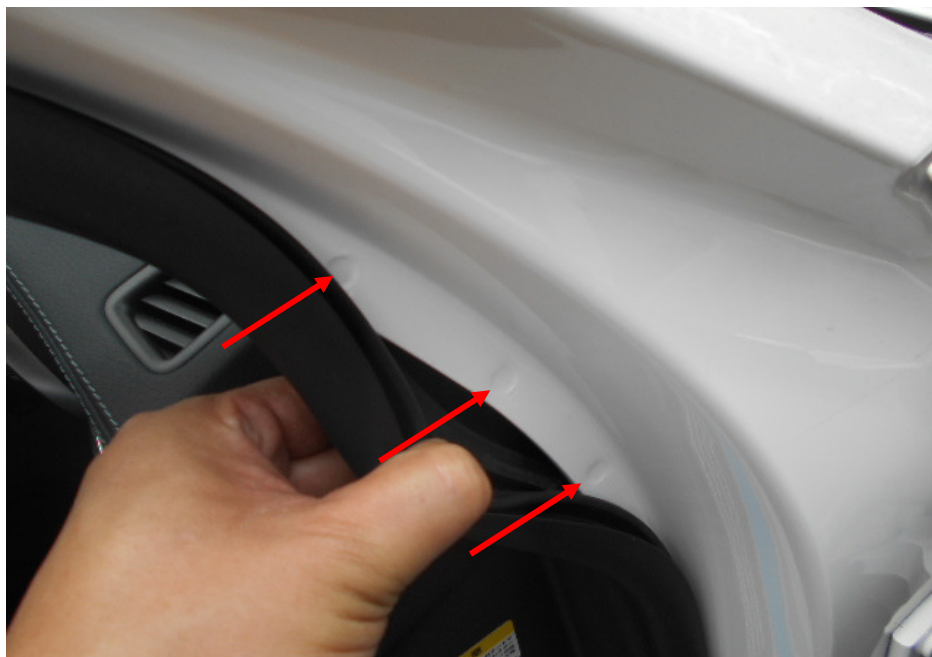
Photo 17 shows the front right “A” pillar of the Motor Car. I did not find any weld marks other than original spot weld marks (arrowed) on the body panels of the Motor Car, indicating that there was no re-welding works carried out; and that the body panels of the Motor Car were originally fitted.
