Your Ref: 1201800010538
Our Ref : CS/FWD18015332/D

07 September 2018

**TECHNICAL INVESTIGATION REPORT OF FIRE INCIDENT INVOLVING THE
INSURED VEHICLE SLF 6990D ON 21 AUGUST 2018**

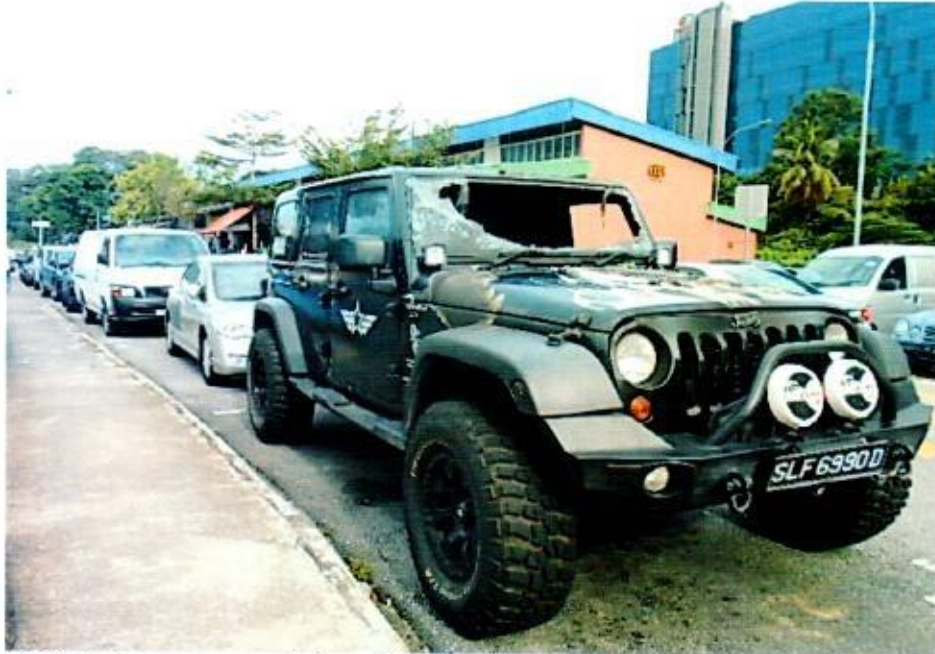
Photo 1 shows a general view of the front right body of the Insured Vehicle at the time of inspection. The Insured Vehicle was observed to have sustained relatively extensive fire damage at its frontal portion. The body panels at the frontal portion like the front right fender, front right wheel arc and front windscreen were found to have been burnt.

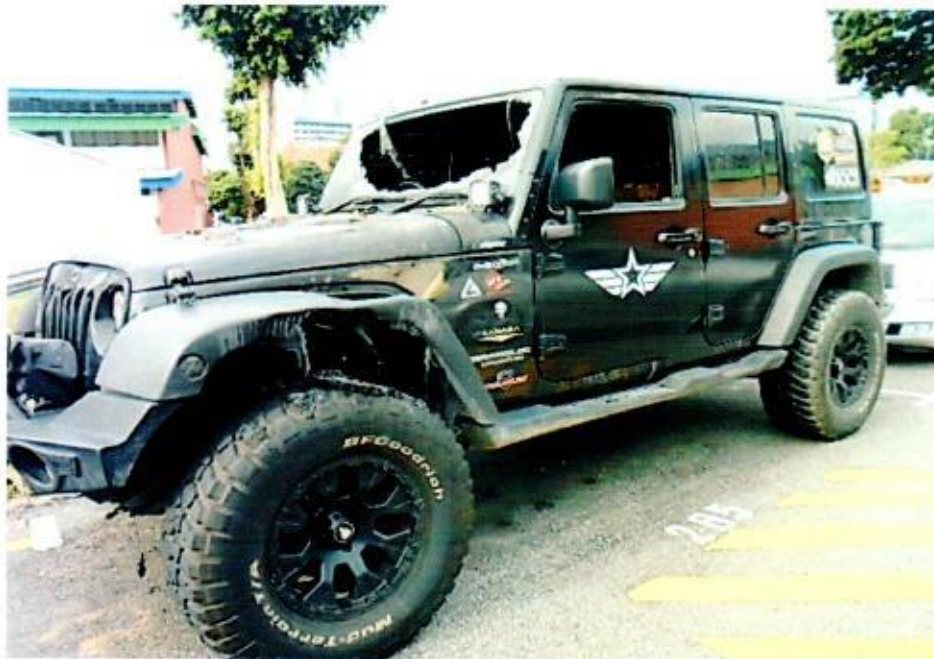
Photo 2 shows a general view of the fire damage at the front left body of the Insured Vehicle. The body panels that were found to have been burnt, include the front left fender and front left wheel arc. The front left door window and front windscreen were also observed to have been broken.

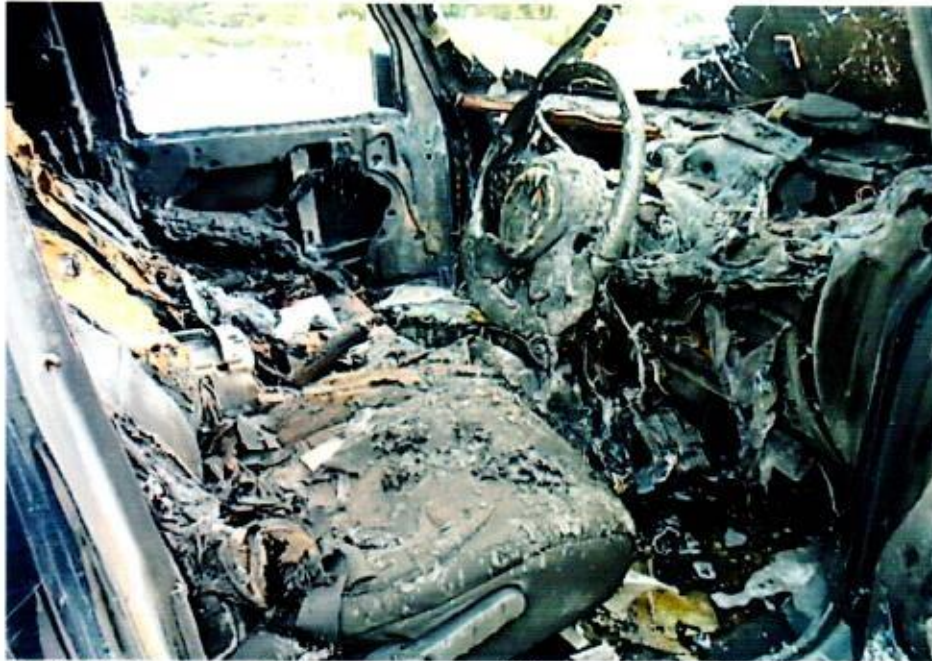
Photo 3 shows the interior compartment of the Insured Vehicle. The seats, roof upholstery, carpet, dashboard and various plastic trims were all burnt and/or melted as a result of the fire.

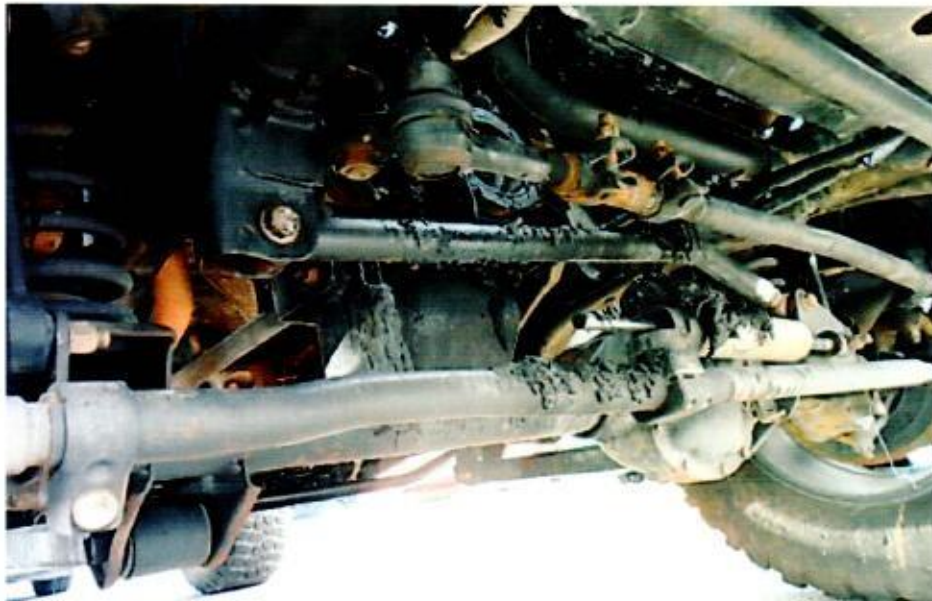
Photo 4 shows the underside of the Insured Vehicle, at its front centre area. Several undercarriage components at the front underside of the Insured Vehicle were observed to have been affected as a result of the fire.

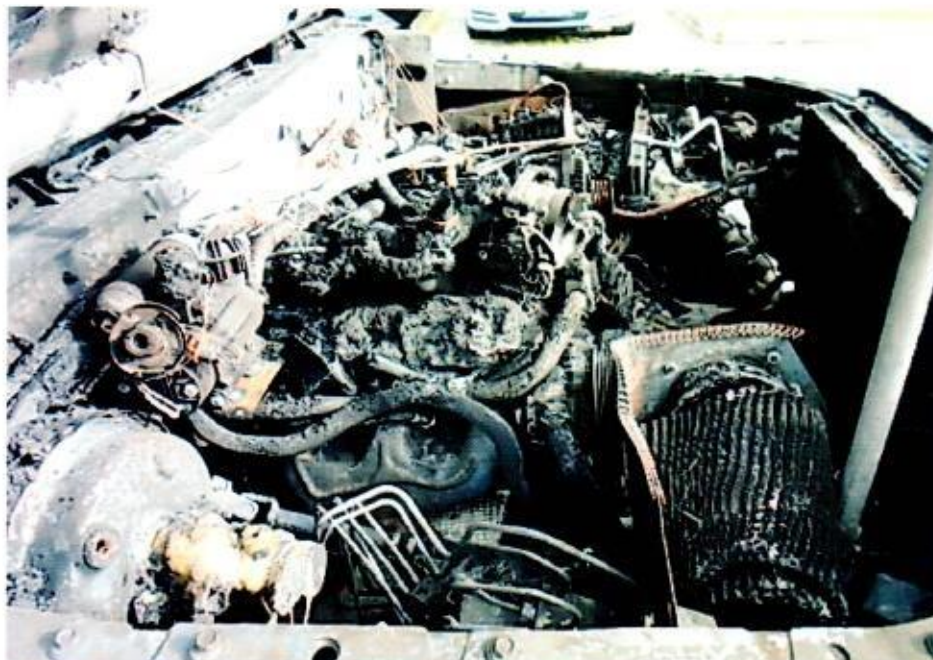
Photo 5 shows the engine compartment of the Insured Vehicle at the time of inspection. Almost all the parts inside the engine compartment were observed to have been burnt and/or melted as a result of the fire. These parts had included its radiator, air condenser, cooling fan, intake manifold, brake pump, battery, air duct, hoses and pipes amongst others.

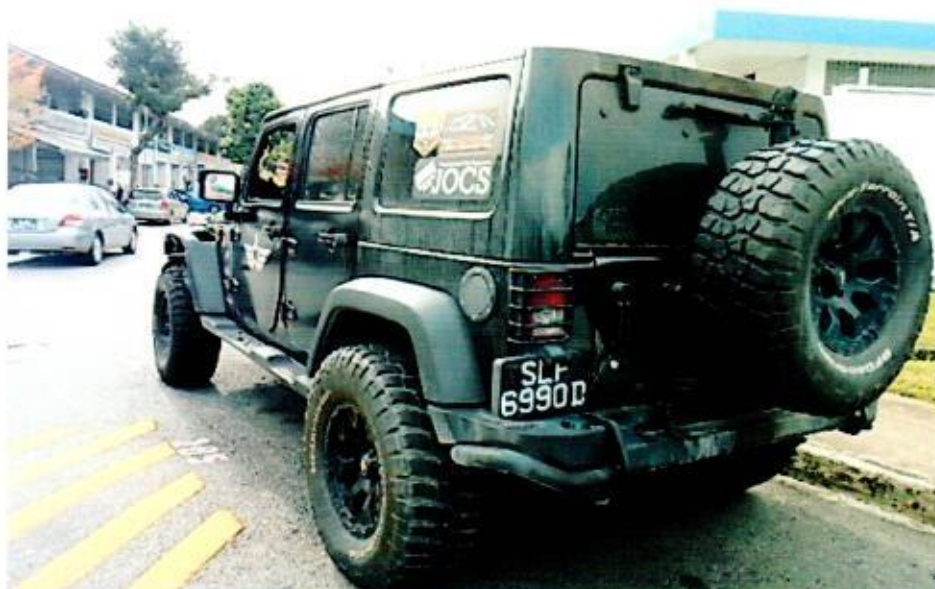
Photo 6 shows a general view of the rear left body of the Insured Vehicle. The rear portion was observed to be unaffected by the fire.

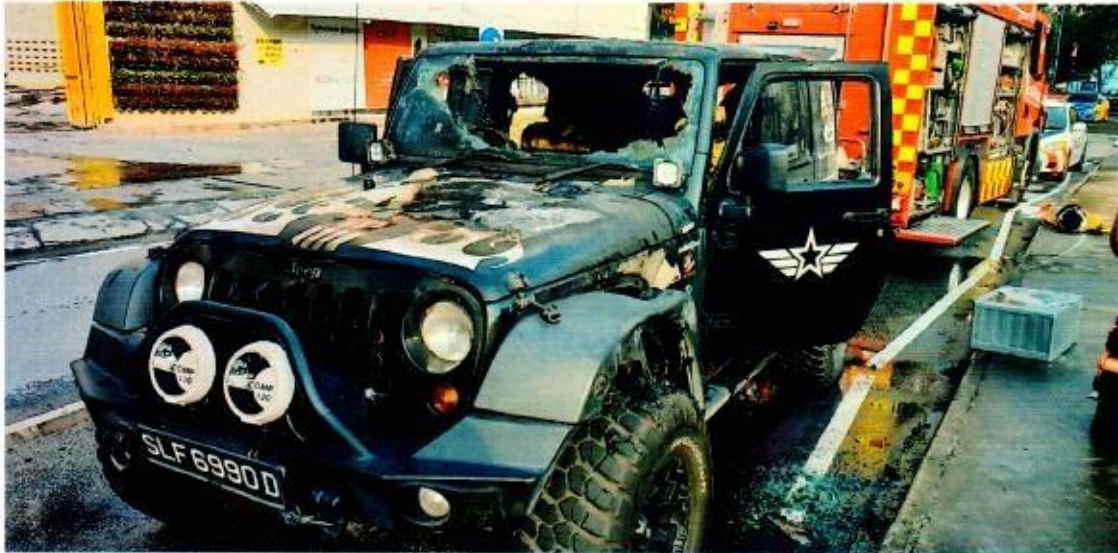
Photo 7 shows a general view of the Insured Vehicle at the incident scene after the fire was extinguished. The Insured vehicle could be seen stopped adjacent to the road kerb with SCDF and police vehicles stopped behind the Insured Vehicle. In general, the observations gathered from my review of the photographs that was taken by Mr Lee at the incident scene had corresponded to the description of events that he had related to me during our conversation on 04 September 2018.

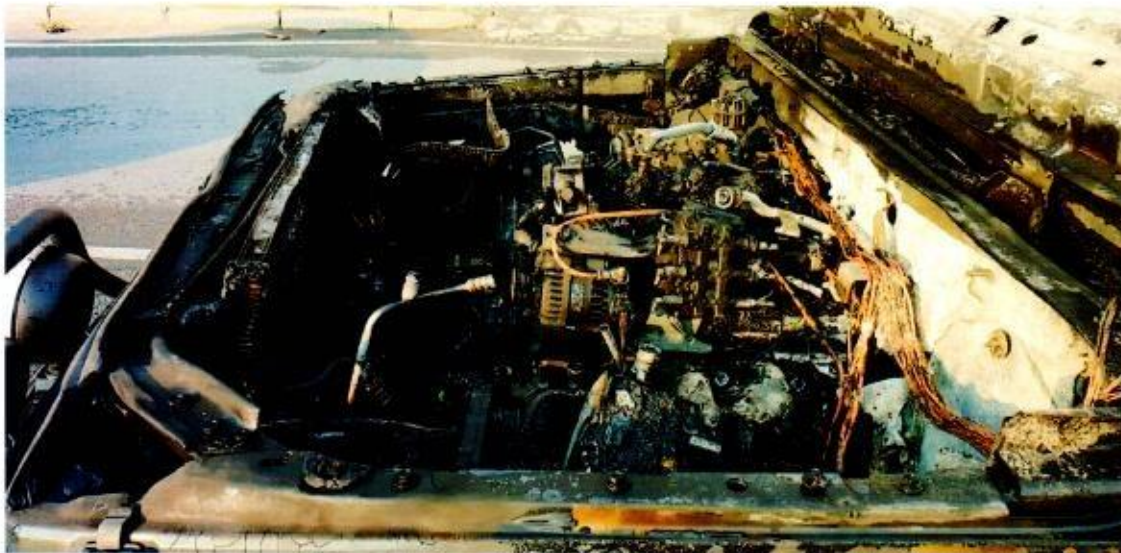
Photo 8 shows a general view of the engine compartment of the Insured Vehicle after the fire was extinguished. The damage of fire nature to the engine compartment, as seen from the photograph provided, was observed to be similar to what I had observed during my inspection of the Insured Vehicle.

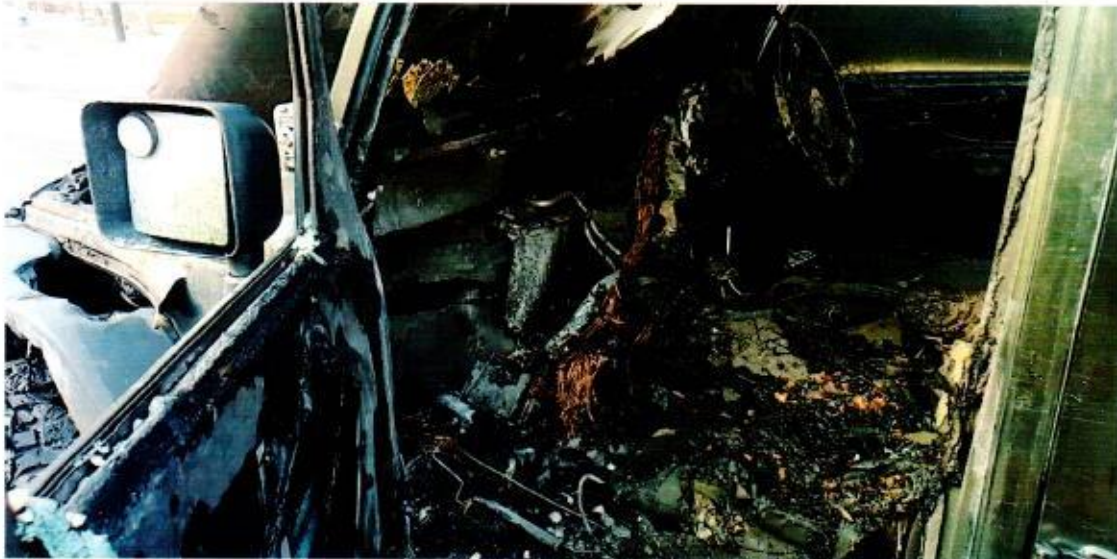
Photo 9 shows the interior compartment of the Insured Vehicle after the fire was extinguished. The damage of fire nature to the interior compartment, as seen from the photograph provided, was observed to be similar to what I had observed during my inspection of the Insured Vehicle.

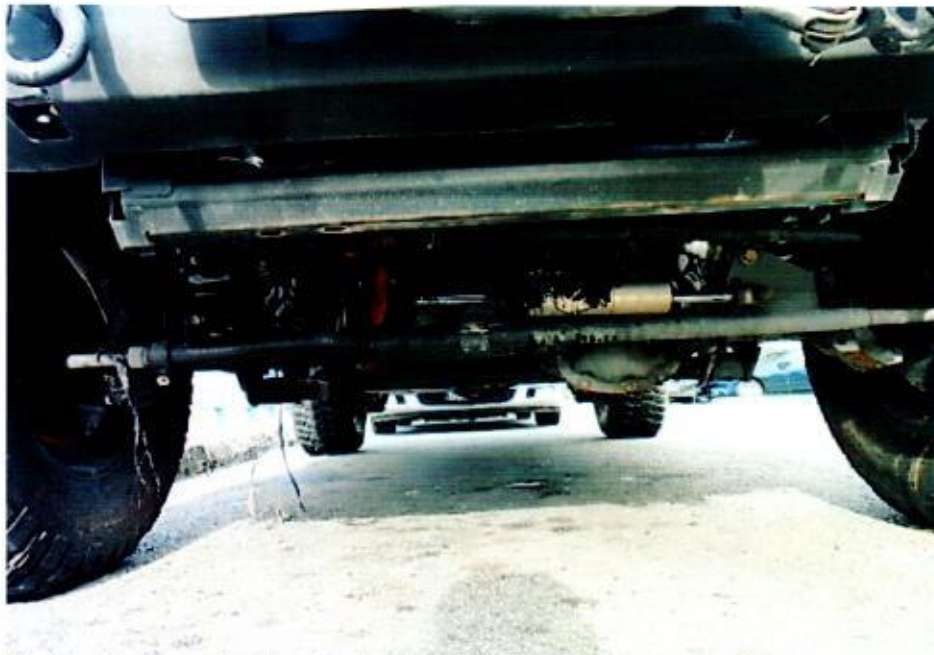
21. Furthermore, the engine of the Insured Vehicle was not located within an enclosed/covered area like in a normal saloon motor car. The engine area was relatively "open" from the underside of the Insured Vehicle, with no engine undercover covering the engine area. Heat generated from engine operation would have been easily dissipated out whilst the Insured Vehicle was moving, hence fire resulting from an engine overheat is unlikely. See photo 11 below.

Photo 11 shows the front underside of the Insured Vehicle. Unlike in a normal saloon motor car, the engine area of the Insured Vehicle was not located within an enclosed/covered area. The engine area was relatively "open" from the underside of the Insured Vehicle, with no engine undercover covering the engine area. Heat generated from engine operation would have been easily dissipated out whilst the Insured Vehicle was moving.

22. Leakage of fluid within the engine compartment may sometimes cause a fire to be ignited when the leaked fluid comes into contact with hot surfaces, like an exhaust pipe. The leaked fluid could possibly reach temperature sufficient for it to self-ignite. However as discussed in paragraph 21 above, the temperature within the engine compartment would have unlikely been able to reach temperature that could result in leaked fluid to self-ignite. Fire due to self-igniting fluid leakage would then seem unlikely for this case.

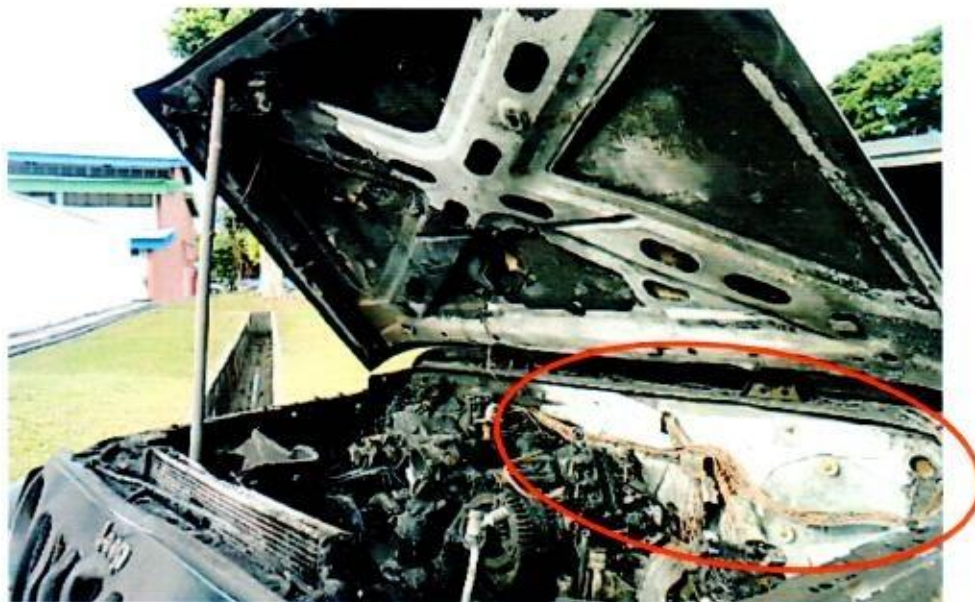
25. The whitish burn marks that were found on the firewall panel of the Insured Vehicle, at the left rear area of the engine compartment directly behind the completely burnt to copper stretch of wirings, are typically known as intense burn marks. These marks are formed when steel/metal material body parts are exposed to prolong high heat intensity. Rust would also start to develop on these steel/metal material body parts soon after a fire. The physical evidence observed on the Insured Vehicle thus indicate that the fire to the Insured Vehicle had originated within its engine compartment, towards the left rear area of the engine compartment. The cause of fire was of electrical nature to the wirings at this area. See photo 12 – 14 below.

Photo 12 shows the intense burn marks (circled) observed on the firewall panel, at the left rear area of the Insured Vehicle's engine compartment.

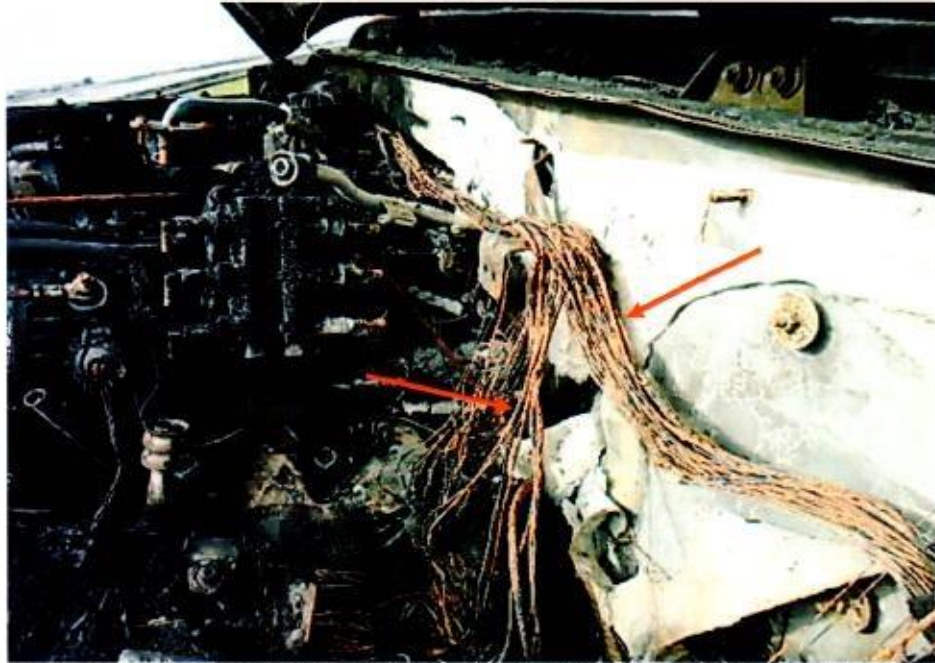
24. The wirings at the left rear area of the engine compartment were observed to be completely burned to its bare copper state. The bright reddish colour of the copper wires suggest that the wirings were exposed to high heat. Such condition normally indicates internal heating of copper wires, which is a sign of an electrical short circuit occurring. The wirings were originally fitted wire harnesses of the Insured Vehicle.

Photo 13 shows the stretch of wirings (arrowed) that were completely burned to its bare copper state, this was directly in front of the firewall wall panel where intense burn marks were found. The bright reddish colour of the copper wires suggest that the wirings were exposed to high heat. Such condition normally indicates internal heating of copper wires, which is a sign of an electrical short circuit occurring.

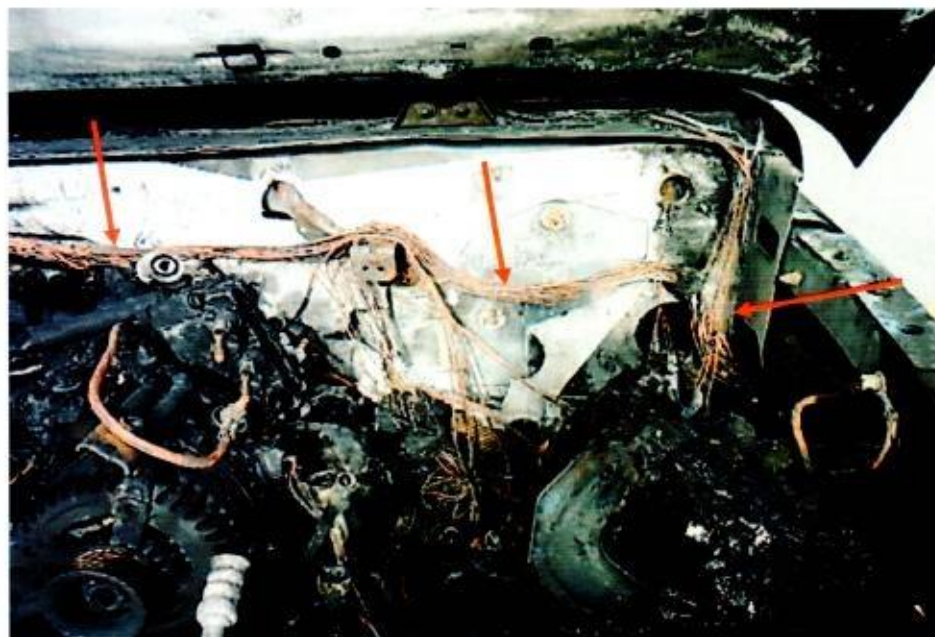
Photo 14 shows the stretch of wirings (arrowed) that were completely burned to its bare copper state. Such condition normally indicates internal heating of copper wires, which is a sign of an electrical short circuit occurring. This then indicates that the cause of fire to the Insured Vehicle was of electrical nature.

27. Having investigated and technically analysed the damages of burnt nature to the Insured Vehicle, I am of the view that the cause of fire to the Insured Vehicle was of electrical in nature. For this particular case, the fire had originated along the wirings inside the engine compartment, at the left rear area of the engine compartment. The wirings were original factory wirings.
