Vehicle No. SHD 9738E  
Insured Veh. GBF 1134K  
Claim No. DM18HO01868-JG  
Policy No. DMCPHQ18-003706  
Accident Date 20/07/2018  
Inspection Date 28/08/2018

# LKK Auto Consultants Pte Ltd

### ADJUSTMENT ON REPAIR COST FOR VEHICLE NO. SHD 9738E

PHOTOGRAPHS FOR VEHICLE NO. SHD 9738E

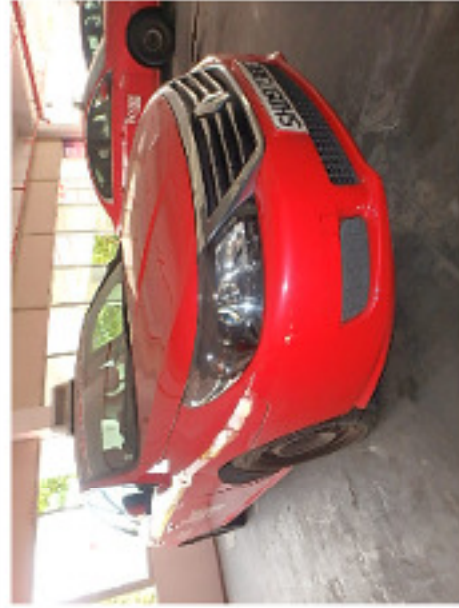
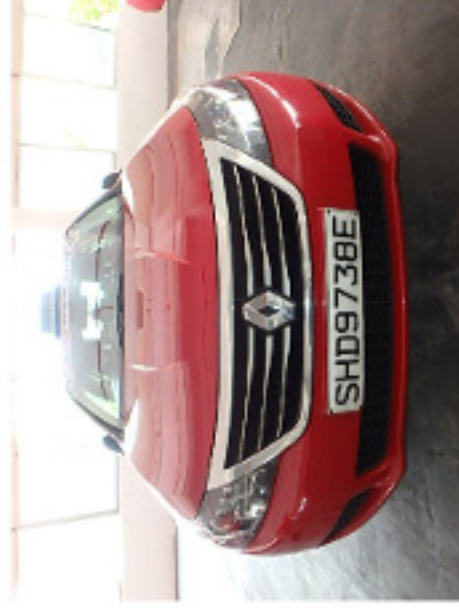
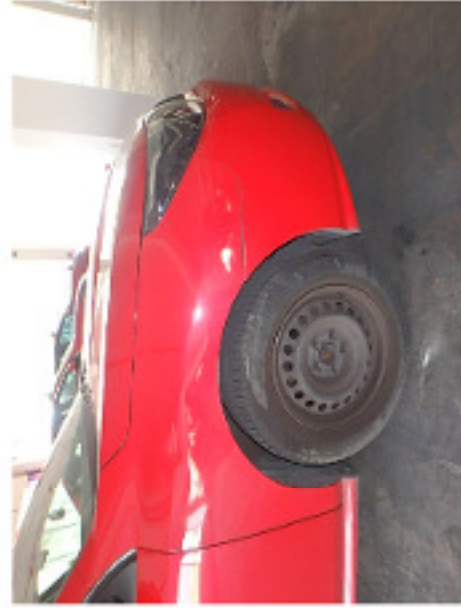
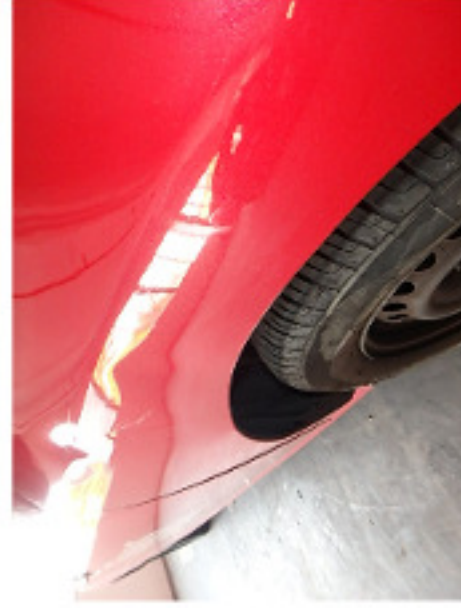
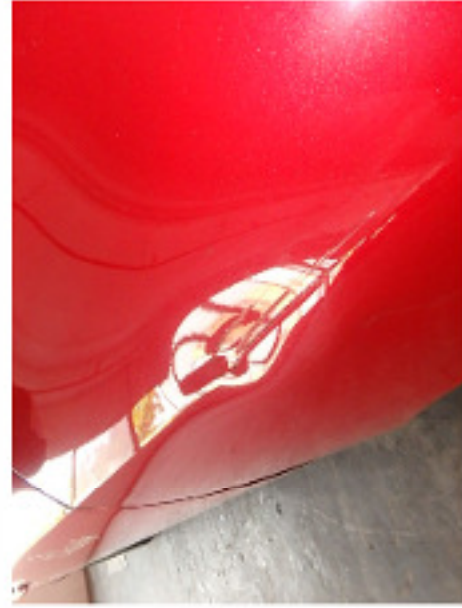
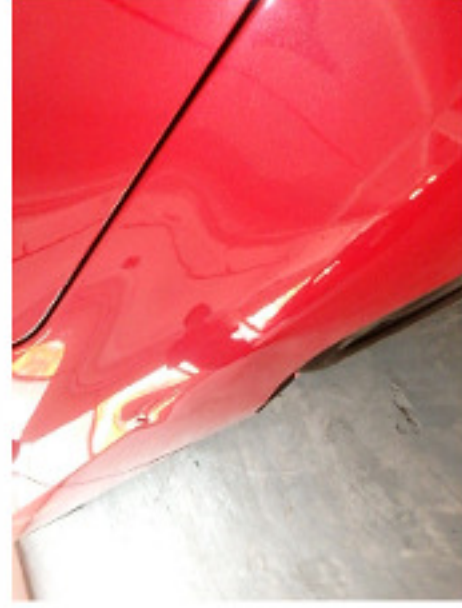
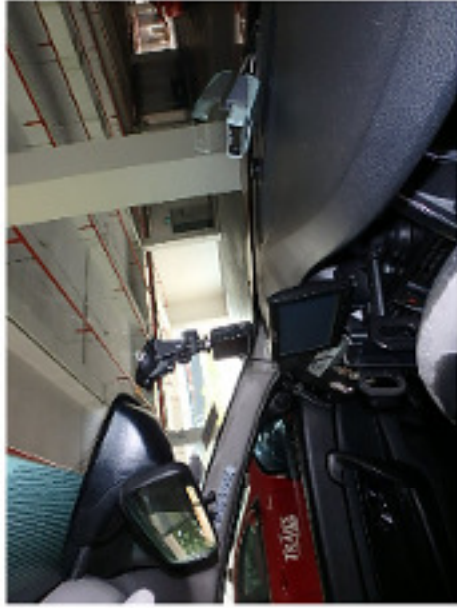
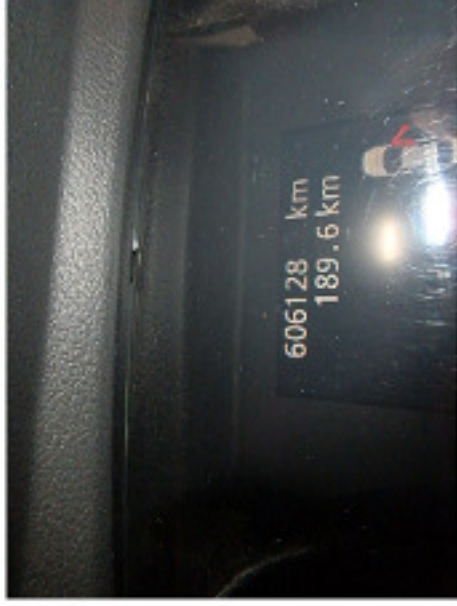
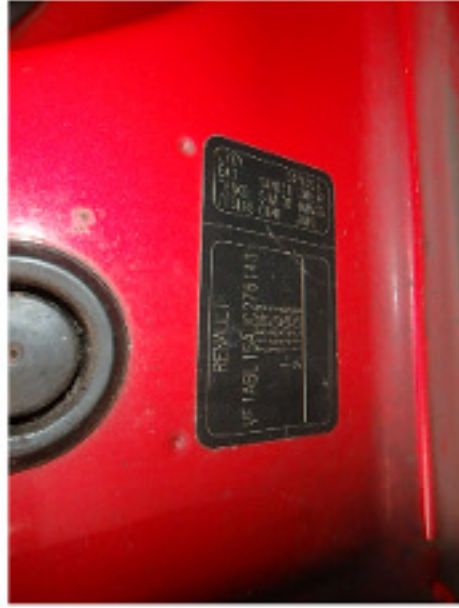
<b>R/H Front Tyre</b>	215/60 R16	GITI	9 mm
	<b>L/H Front Tyre</b>	215/60 R16	GITI	9 mm
	<b>R/H Rear Tyre</b>	215/60 R16	FALKEN	7 mm
	<b>L/H Rear Tyre</b>	215/60 R16	FALKEN	7 mm
<b>4. Description of Damages</b>				
	THE VEHICLE SUSTAINED DAMAGES AT THE O/S FRONT PORTION. DAMAGES SEE DETAILS.			
<b>5. General Information</b>				
	<b>Accident Date</b>	20/07/2018	<b>Inspection Date</b>	28/08/2018
	<b>Survey held at</b>	TRANS-CAB AUTO SERVICES PTE LTD NO.2 ANG MO KIO ST 63 SINGAPORE 569111		
<b>5a. Remarks</b>				
	A)THE INSPECTION WAS CONDUCTED ON A"WITHOUT PREJUDICE" BASIS. B)IN ACCORDANCE TO YOUR INSTRUCTIONS, WE HAVE NOT AUTHORISED REPAIRS.			
<b>5b. Estimate Days of Repair</b>				
	ESTIMATED NORMAL PERIOD FOR REPAIR:		<b>2 Working Days</b>

TO VACUUM ,REPLACE ,REFIX AND RECHARGE AIR CONDENSER .	NOT NECESSARY	380.00	-
	TO REPLACE ,REFIX AND TOP UP COOLANT FOR RADIATOR .	NOT NECESSARY	170.00	-
	TO VACUUM ,REPLACE ,REFIX AND RECHARGE AIR INTERCOOLER.	NOT NECESSARY	170.00	-
	TO TRANSFER OF FRONT WINDSCREEN FITTINGS AND CONDUCT WATER SEEPAGE TEST.	NOT NECESSARY	170.00	-
			8,160.00	450.00
	<b>GRAND TOTAL</b>		<b>18,078.32</b>	<b>1,155.45</b>
	<b>RECOMMENDED COST OF LUMP SUM REPAIRS (TO ITS PRE-ACCIDENT CONDITION)</b>			<b>900.00</b>
