AUTOMOBILE APPRAISAL REPORT

Vehicle Registration No. : GQ 9688 J
Make/Model : Toyota Regius Ace
Year Manufacture/Register : 2017
Colour : Grey
Engine No. : Obscure
Chassis No. : KDH201-0221521
Odometer Reading : 13417km
Date Of Accident : 06 May 2018
Date Of Inspection : 10 May 2018
Name of Workshop : Sheng Li Lai
Place Of Inspection : Kaki Bukit Auto Hub 2
: Kaki Bukit Ave 2 #01-36
: Singapore 417921

VEHICLE DAMAGE INSPECTION REPORT

Our File No: CS3/MSG18008543/LVBS2-1
Date: 05/09/2018

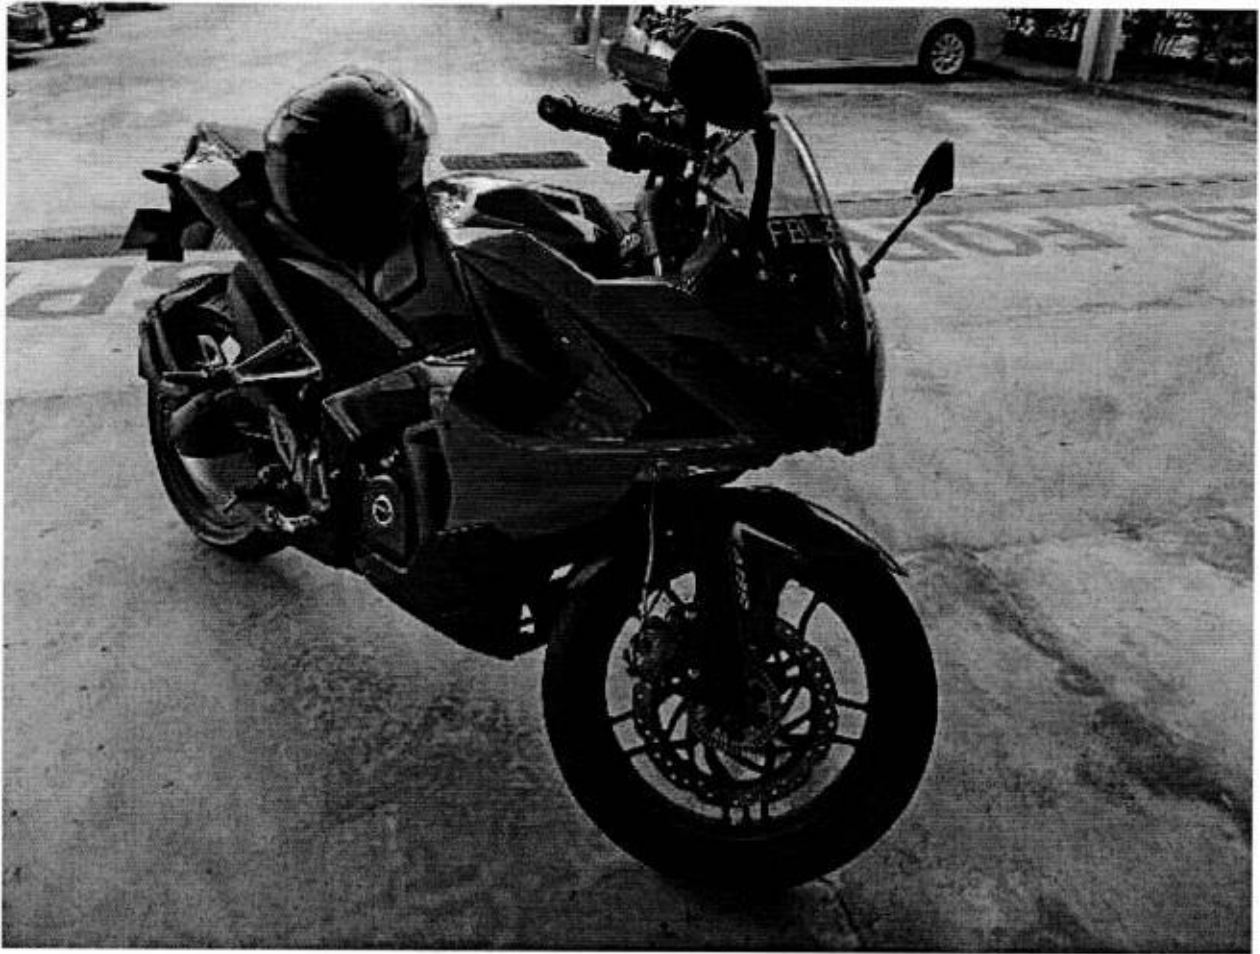
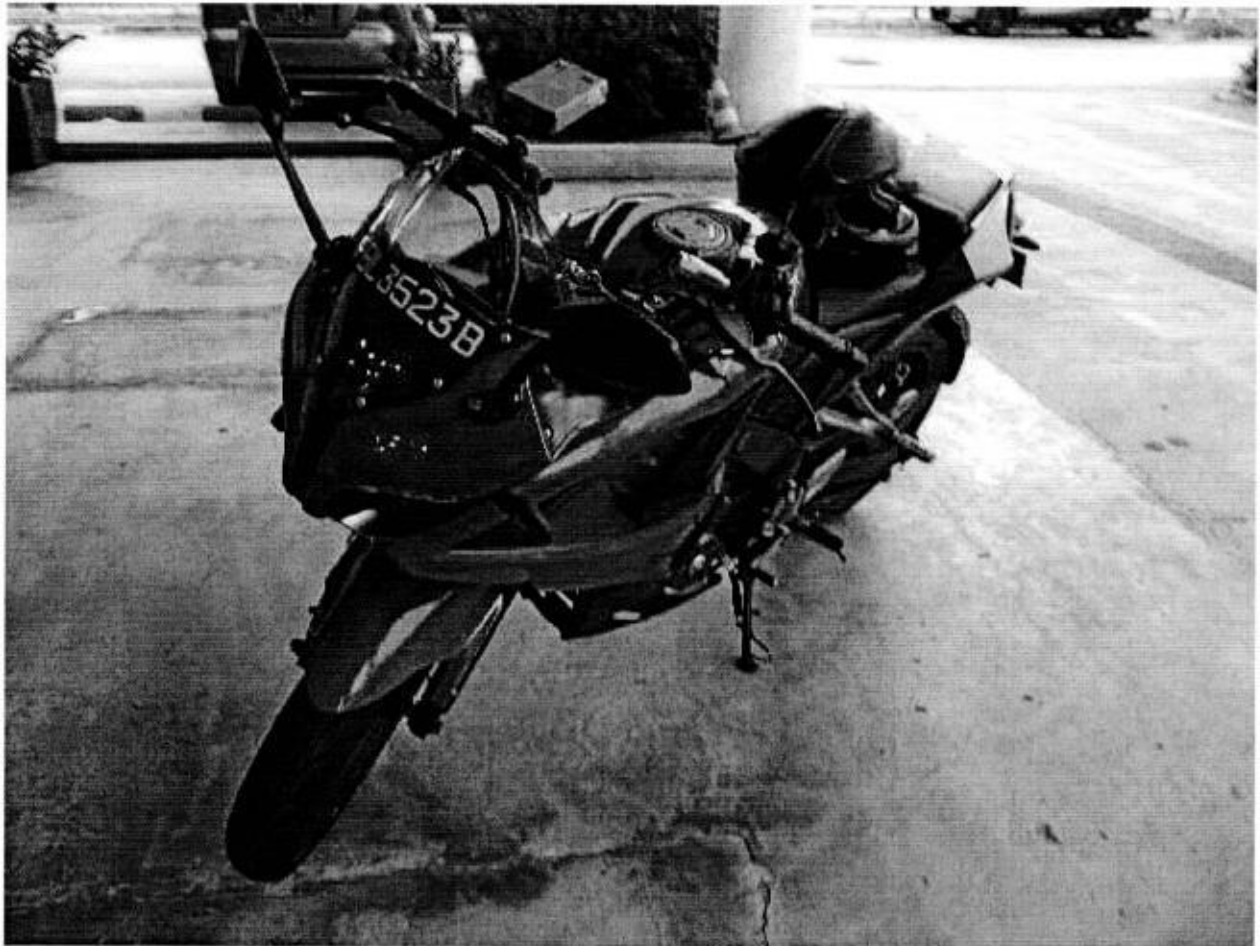
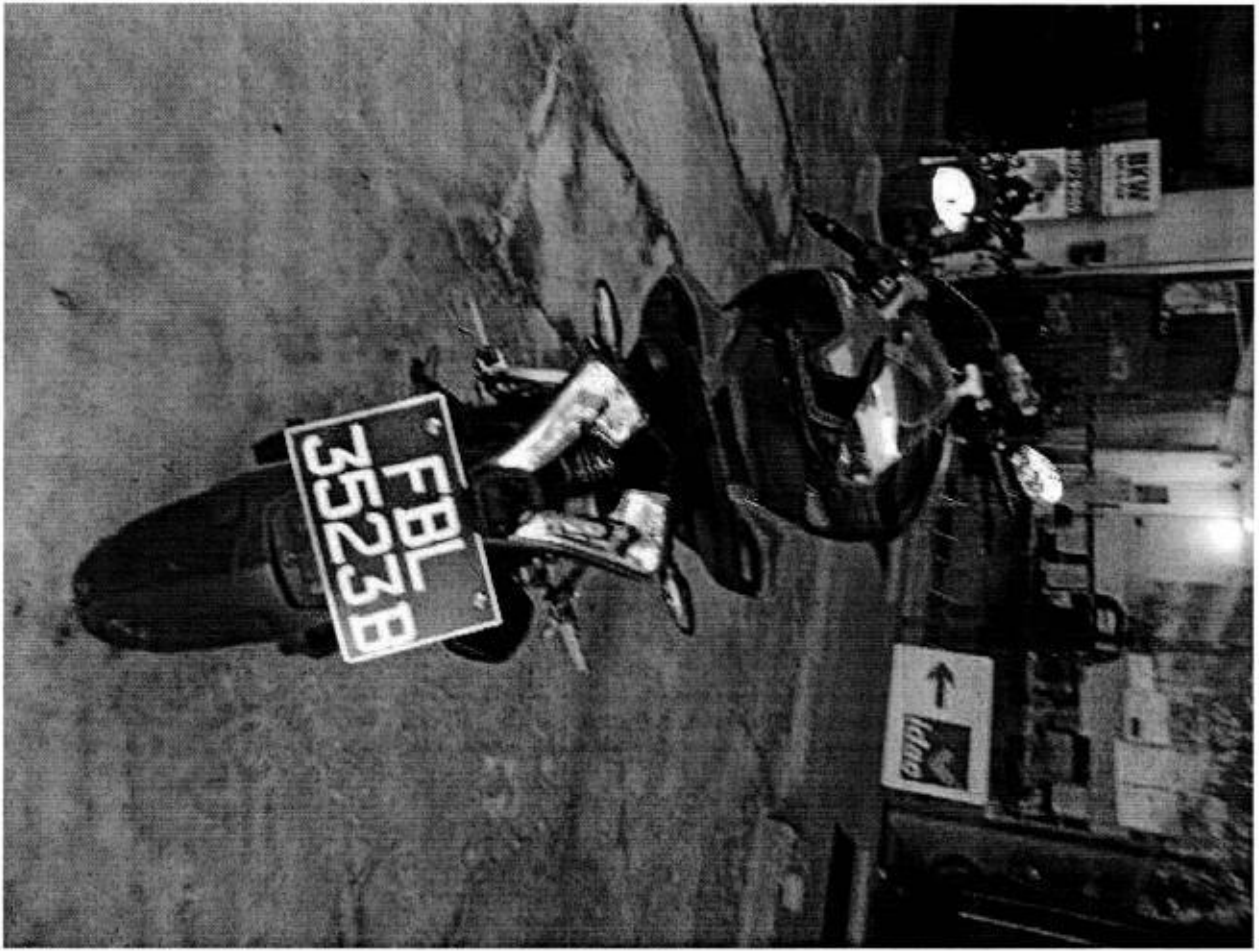
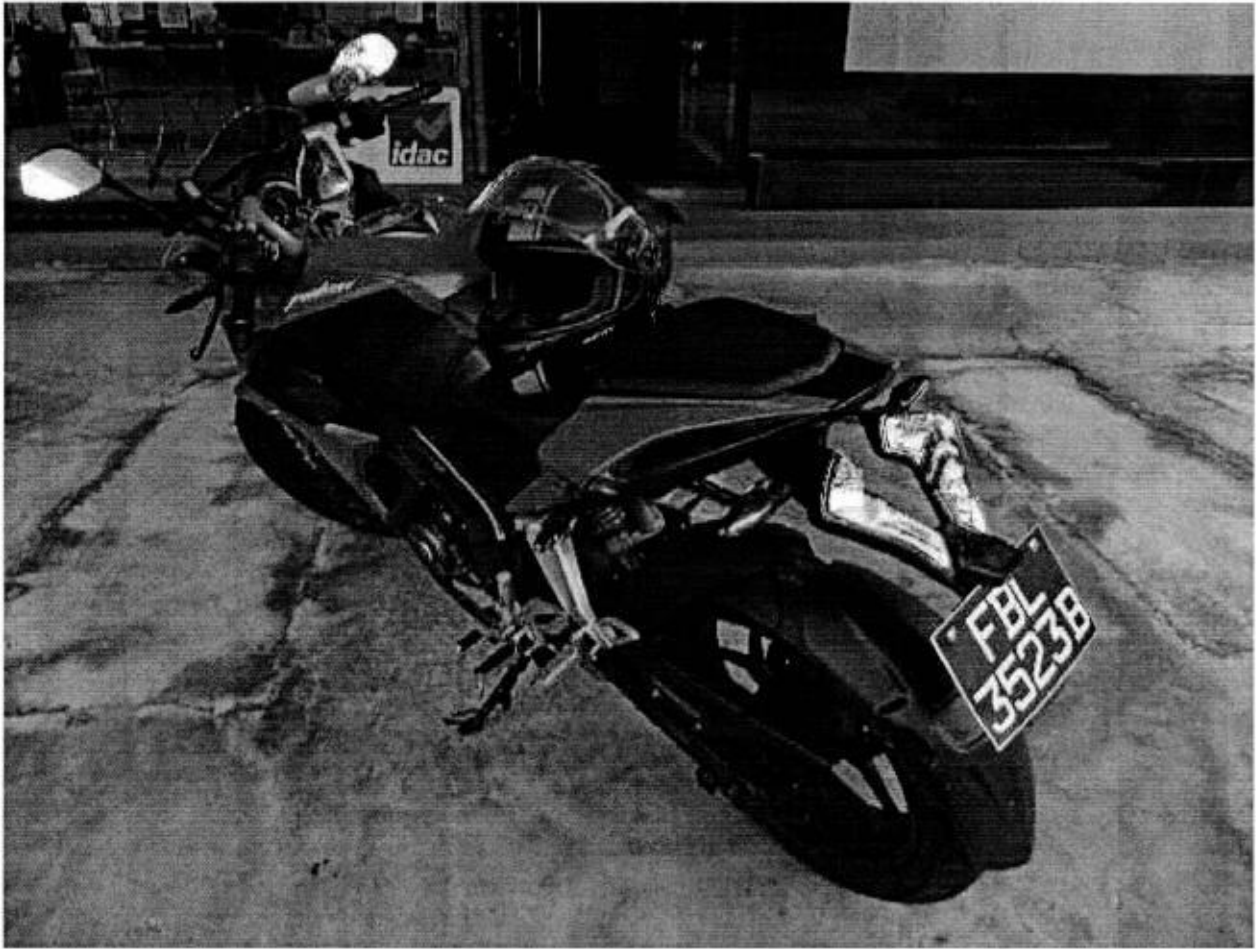
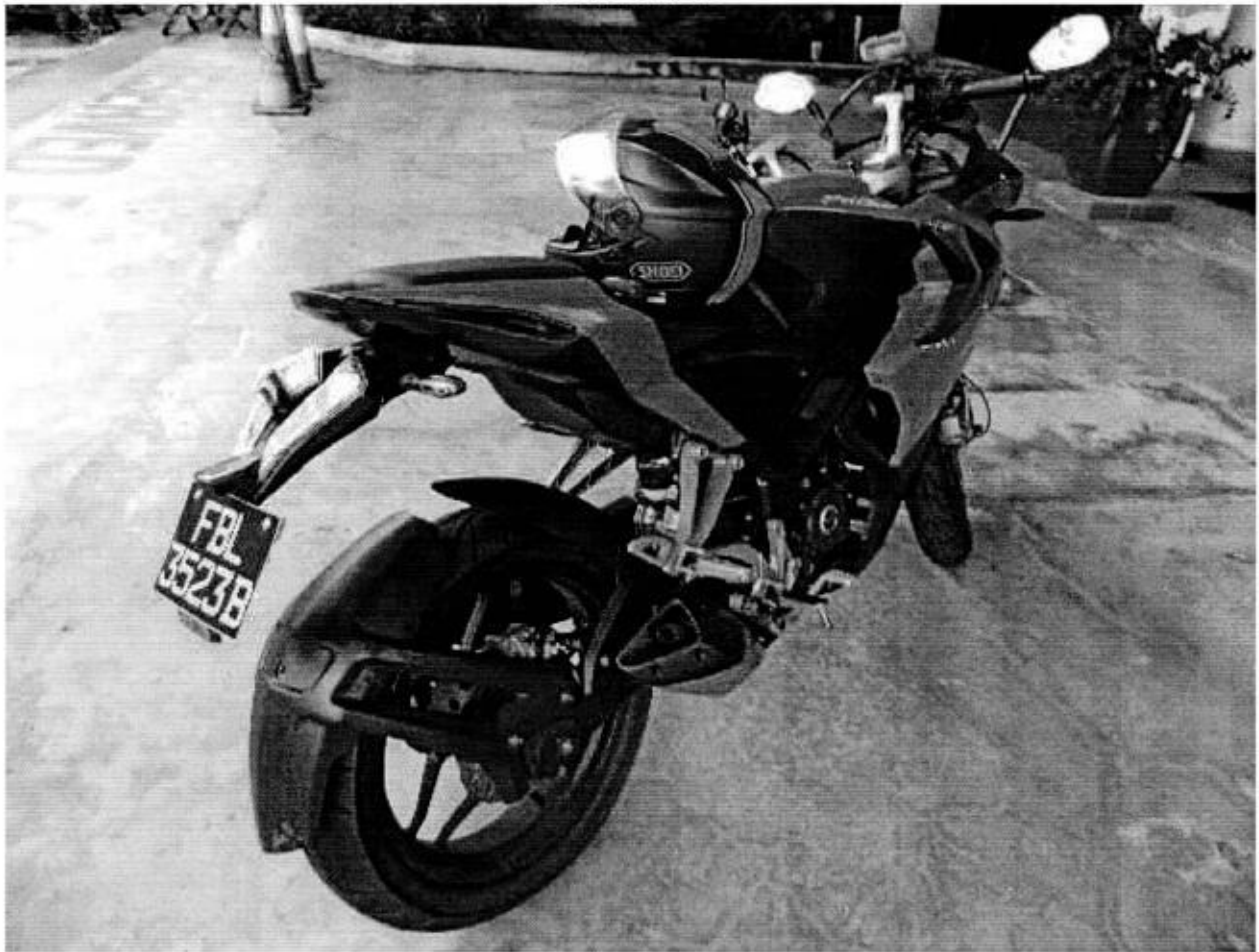
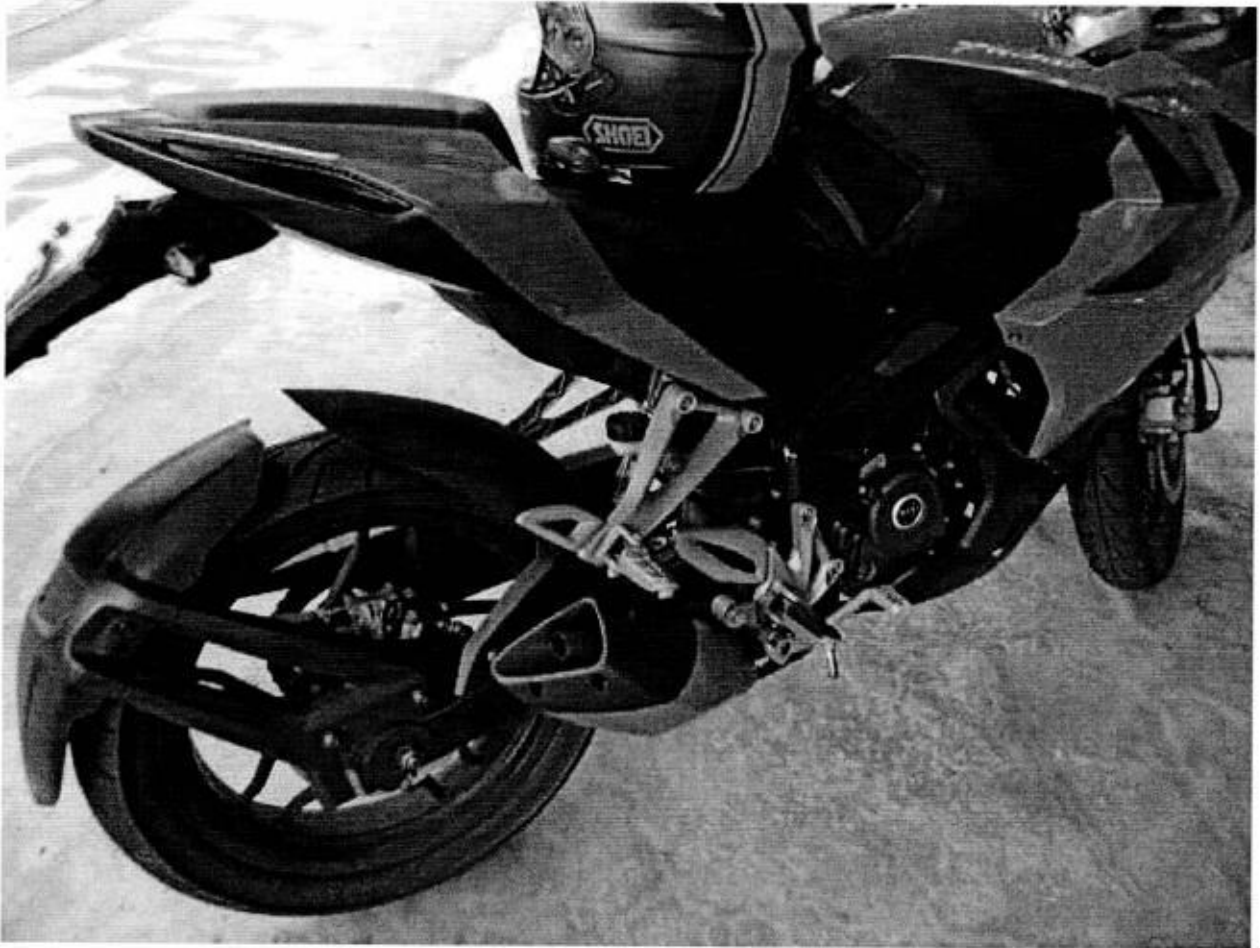
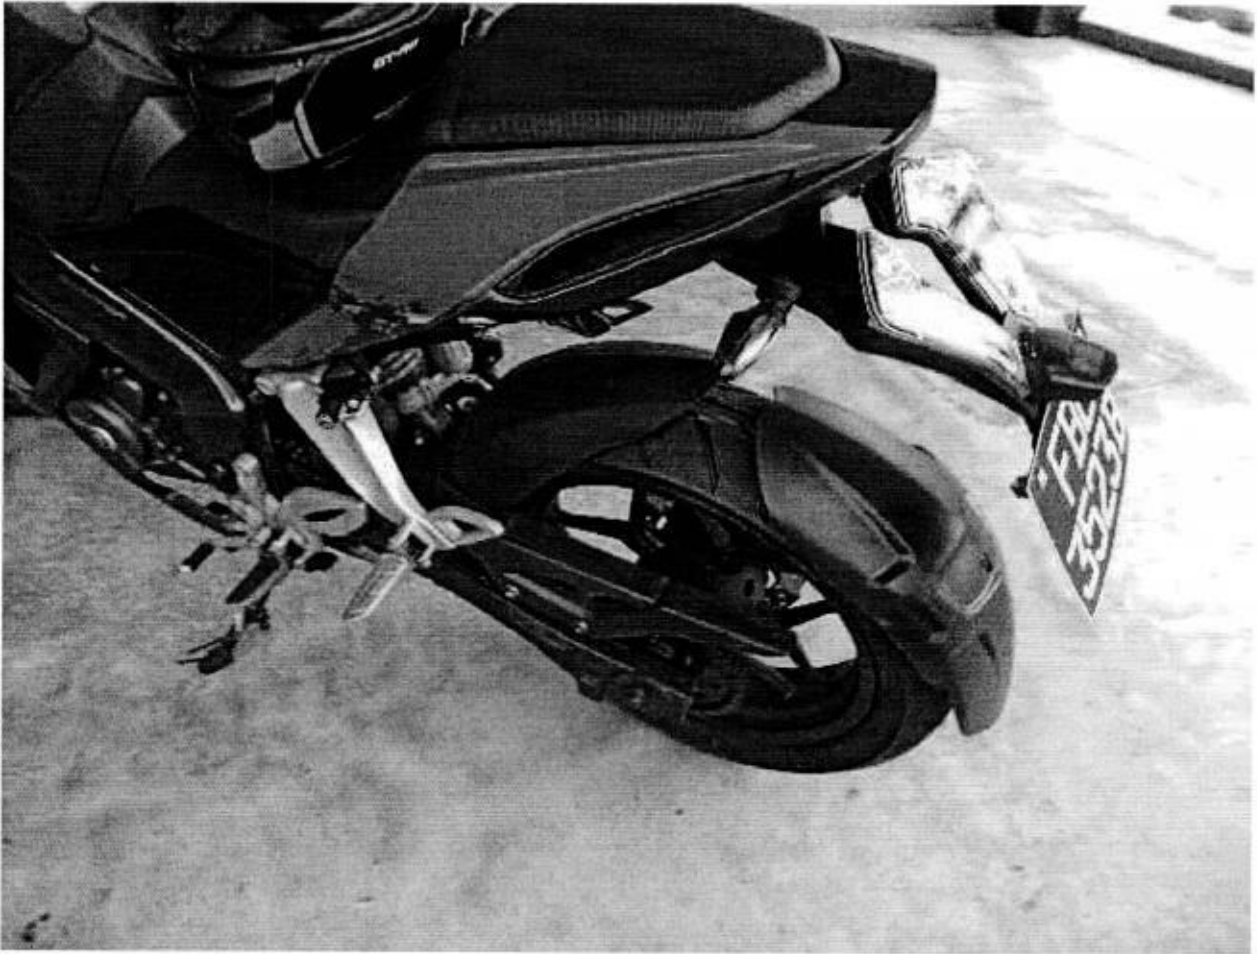
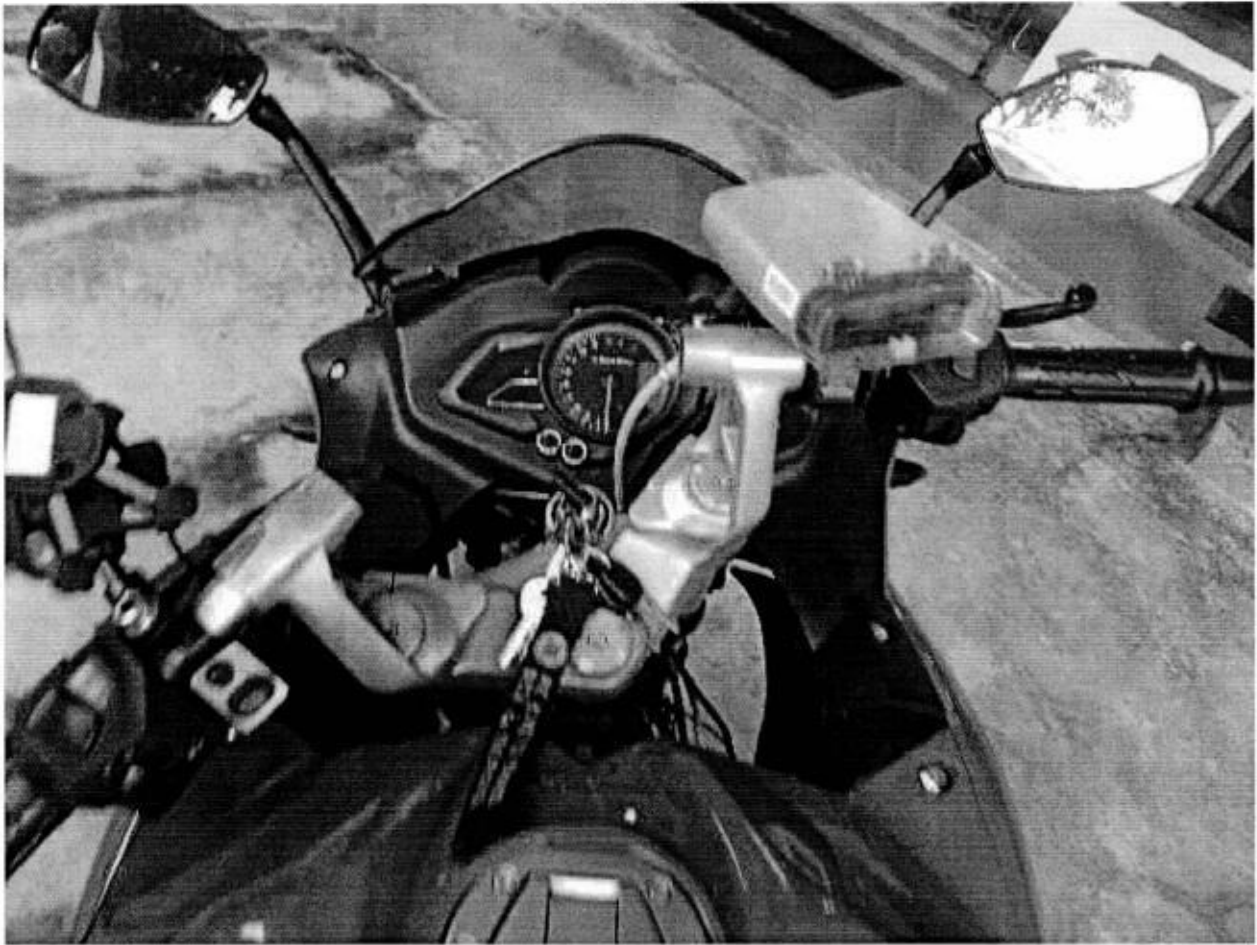
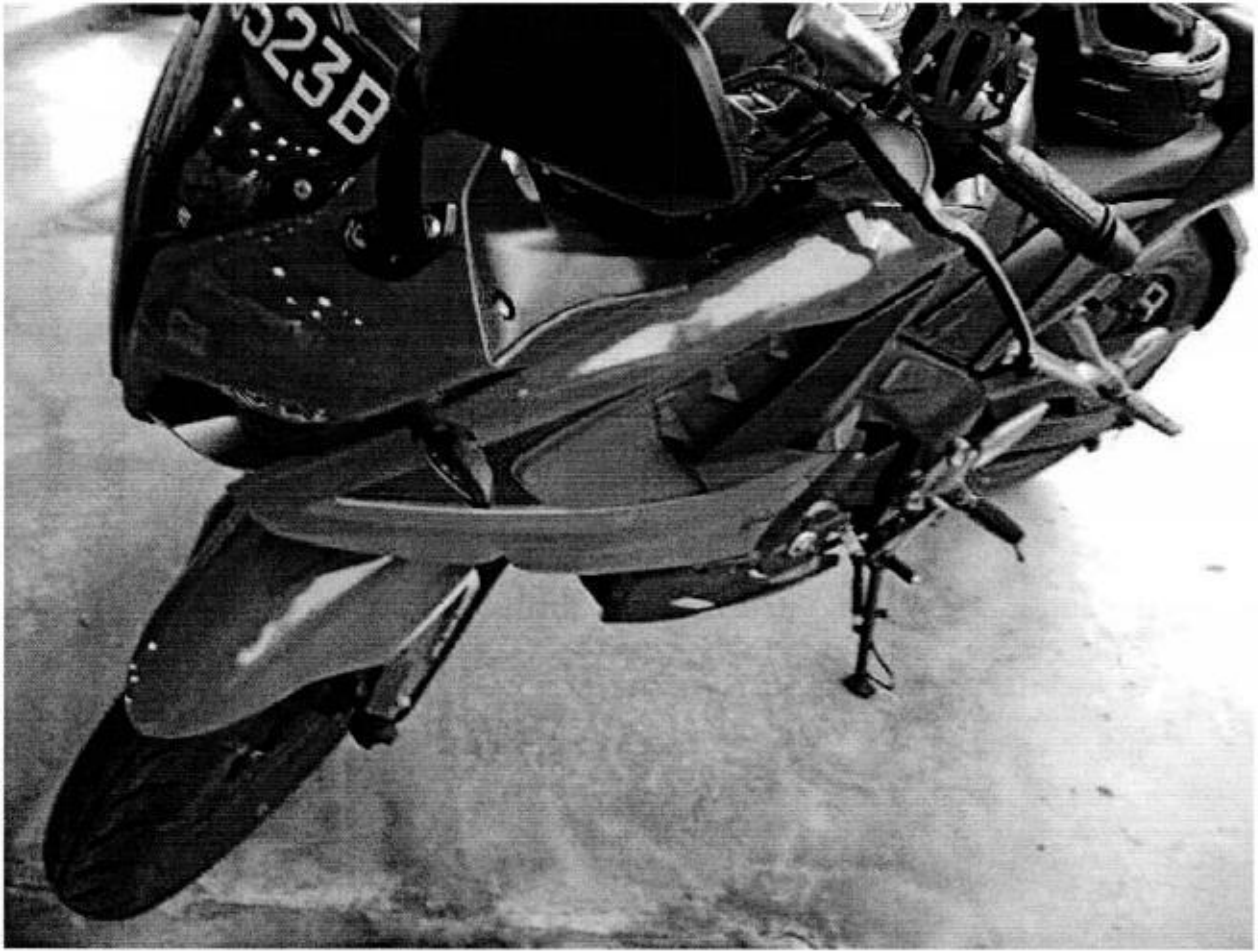
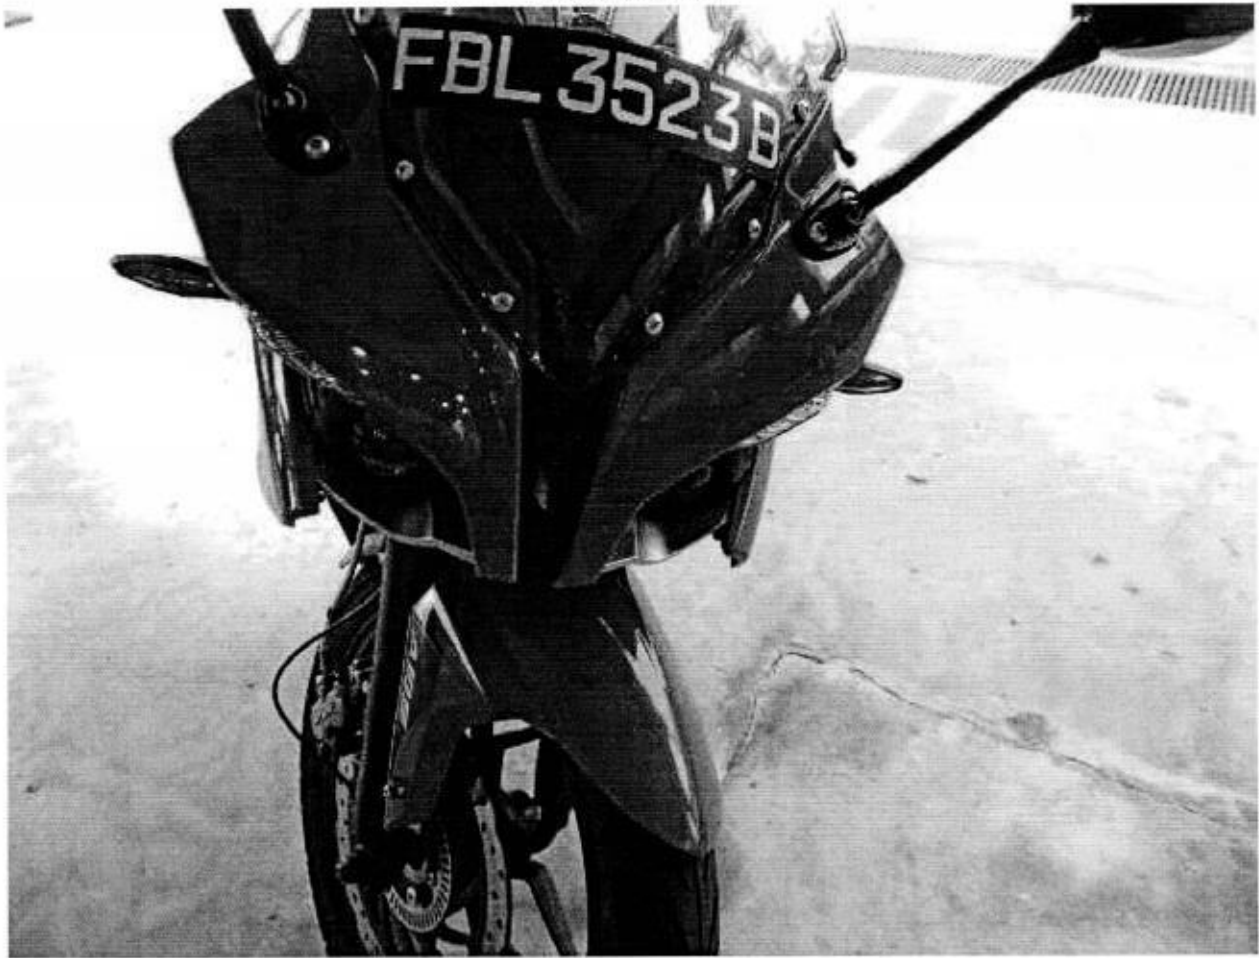
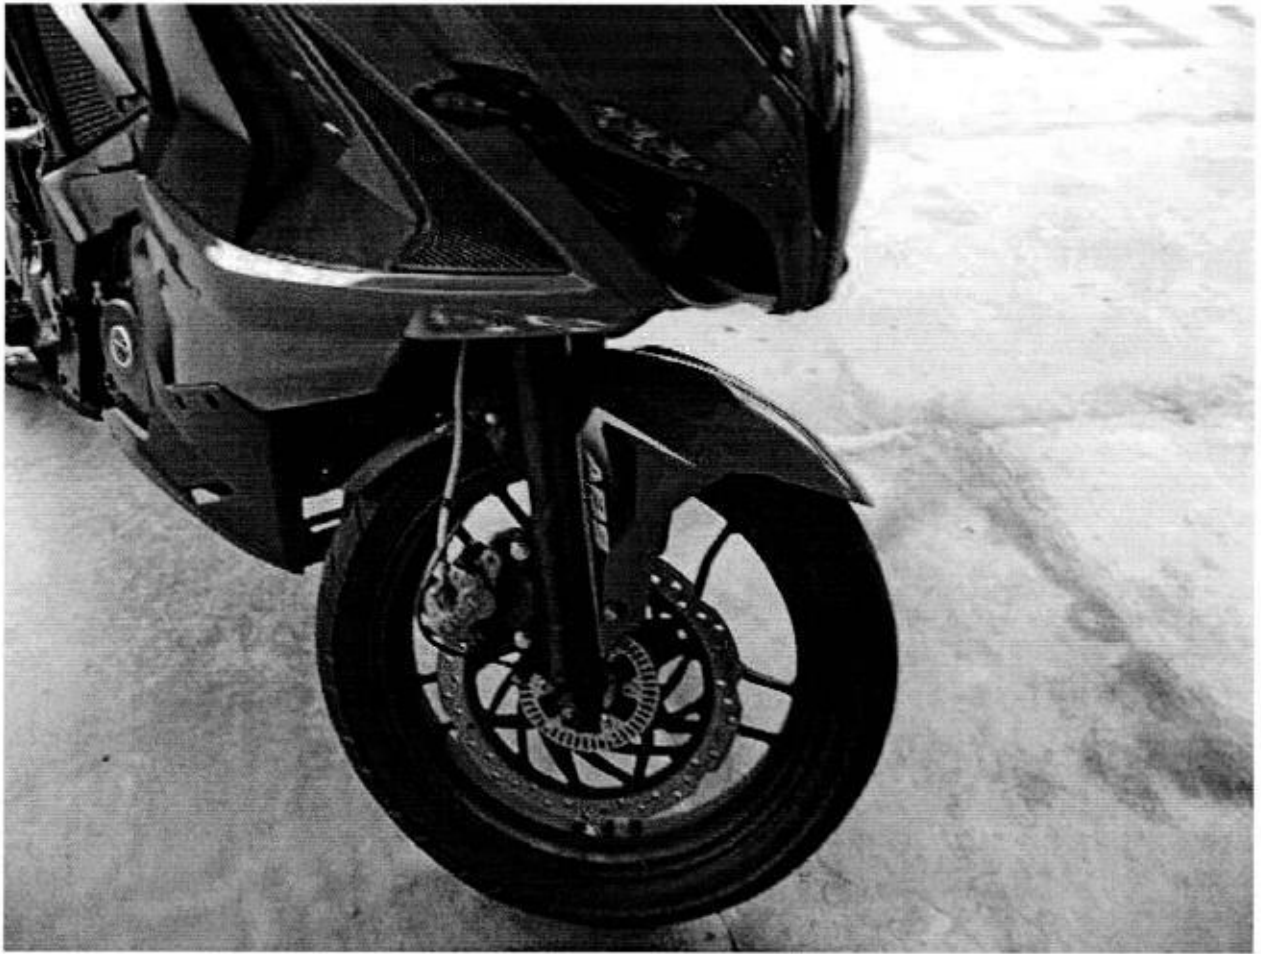
The damages sustained on the vehicle were apparently confined at its n/s portion.
