Your Ref : AWE/NBN/MSIG/0452/ns
Our Ref : CI/LAW18016035/D

01 September 2018

**AUTOMOBILE TECHNICAL INVESTIGATION REPORT OF INCIDENT
INVOLVING SKC 1085C AND SHA 2598D ON 04 JANUARY 2017**

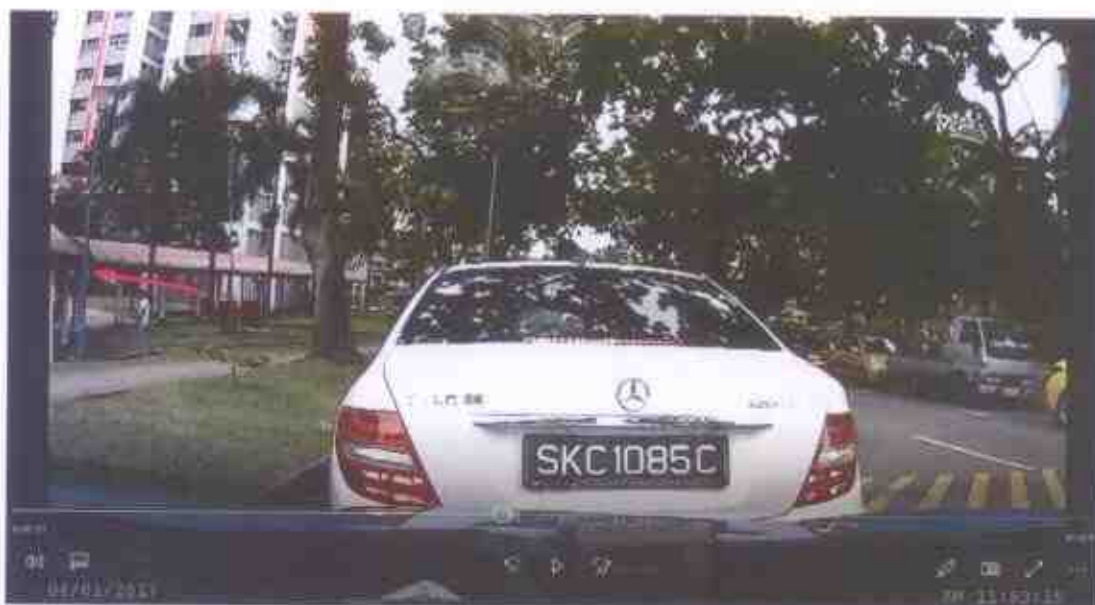
8. At the 11secs to 12secs mark of the video recording, I note that the image captured directly from the recording device was slightly shaky before the image stabilize again almost instantaneously. This was when the rear portion of the Motor Car was very close to the frontal portion of the Motor Taxi. The capturing of such shaky image directly from the video recording device that was mounted on the front windscreen of the Motor Taxi is a sign that there was a slight shaking of the Motor Taxi itself.

9. This shake indicates that there was contact between the rear portion of the Motor Car and the frontal portion of the Motor Taxi. Upon the contact, the Motor Taxi had shook slightly causing the recording device to shake as the recording device was directly mounted onto a body part (front windscreen) of the Motor Taxi. See screenshot below showing the 11secs plus mark of the video recording. One would have to view the video recording to see this slight shaky image.

Screenshot shows the 11secs plus mark of the video recording. The image captured directly from the video recording device became slightly shaky between the 11secs to 12secs mark, indicating that there was contact between the rear portion of the Motor Car and the frontal portion of the Motor Taxi. Focusing on the lamppost (arrowed) that was erected on the pedestrian walkway towards the front left side of the Motor Taxi, one would be able to also detect the slight shaky image.

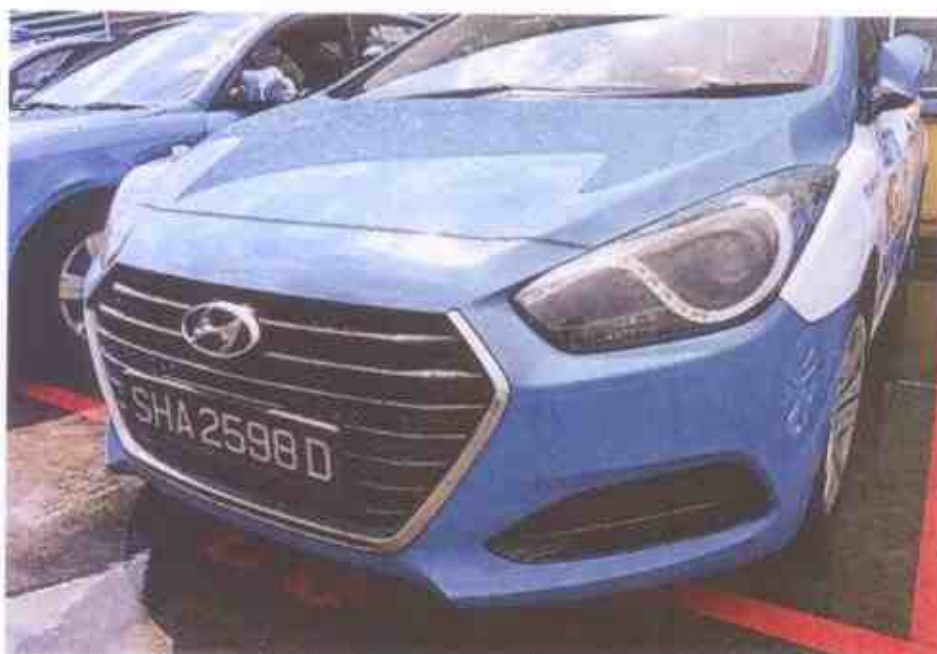
Photo 1 shows a general view of the front left portion of the Motor Taxi at the time of inspection, which was 2 days after the reported incident. No obvious damage could be seen on the frontal portion of the Motor Taxi.

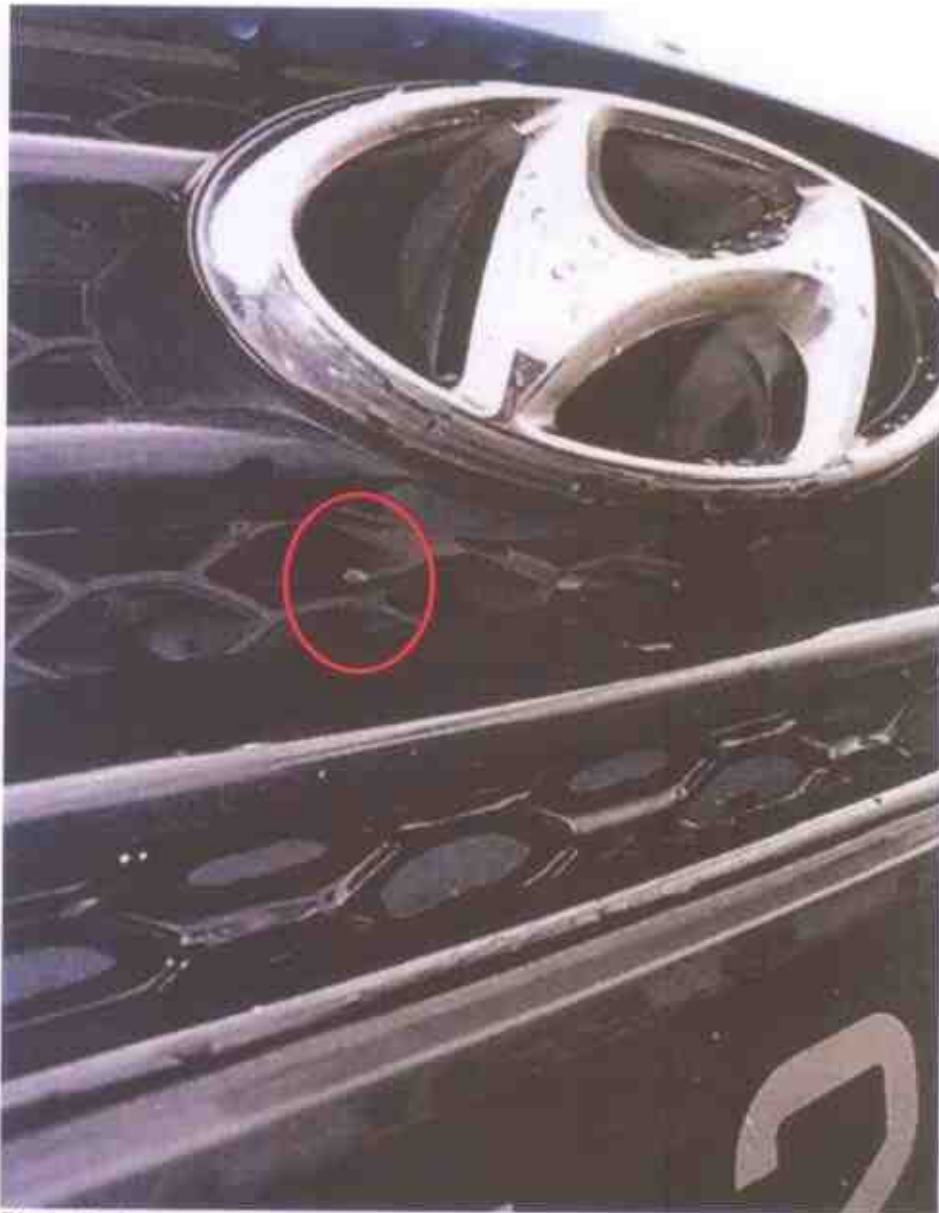
10. Since the video recording had showed that there was contact between the rear portion of the Motor Car and the frontal portion of the Motor Taxi, the following paragraphs discusses the second part of your request ie whether the impact force arising from the contact could have possibly cause bodily injury to the driver of the Motor Taxi.
11. The Vehicle Damage Inspection Report dated 13 January 2017 had indicated that the Motor Taxi was inspected on 06 January 2017, which was 2 days after the incident involving the Motor Car. Body parts that required to be replaced was only the radiator grille, which was indicated as crack.

Photo 2 shows a general view of the cracked (circled) radiator grille of the Motor Taxi. This was directly at the centre of the Motor Taxi's frontal portion, above the front number plate. Apart from this cracked radiator grille, all other body parts at the frontal portion of the Motor Taxi were undamaged and re-usable as indicated in the Vehicle Damage Inspection Report of the Motor Taxi dated 13 January 2017.

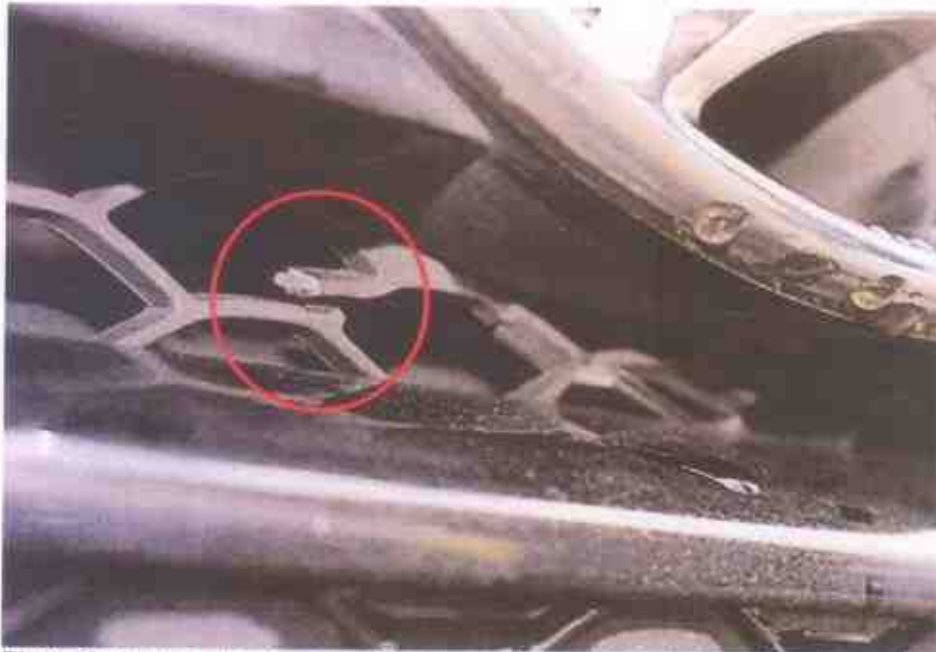
Photo 3 shows a closer view of the cracked (circled) radiator grille of the Motor Taxi. Apart from this cracked radiator grille, all other body parts at the frontal portion of the Motor Taxi were undamaged and re-usable as indicated in the Vehicle Damage Inspection Report of the Motor Taxi dated 13 January 2017.

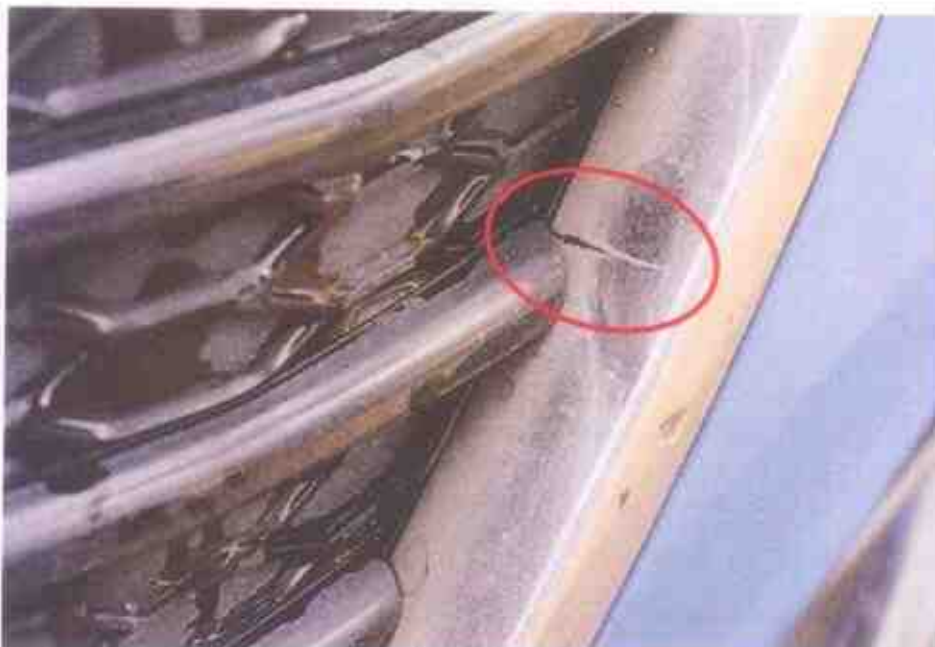
12. The front bumper, front bumper reinforcement, front bumper sponge and front number plate amongst others were indicated as re-fit, which would mean that these body parts were undamaged and re-usable. The radiator grille chrome moulding, although found to be crack, was indicated as old damage.
13. Close examination of the photographs enclosed in the Vehicle Damage Inspection Report produced similar observations regarding the extent of damage to the Motor Taxi. See photo 1 – 4 below.

Photo 4 shows the cracked (circled) radiator grille chrome moulding of the Motor Taxi. This was towards the left of the Motor Taxi's frontal portion. This damage was indicated as old damage in the Vehicle Damage Inspection Report of the Motor Taxi dated 13 January 2017.

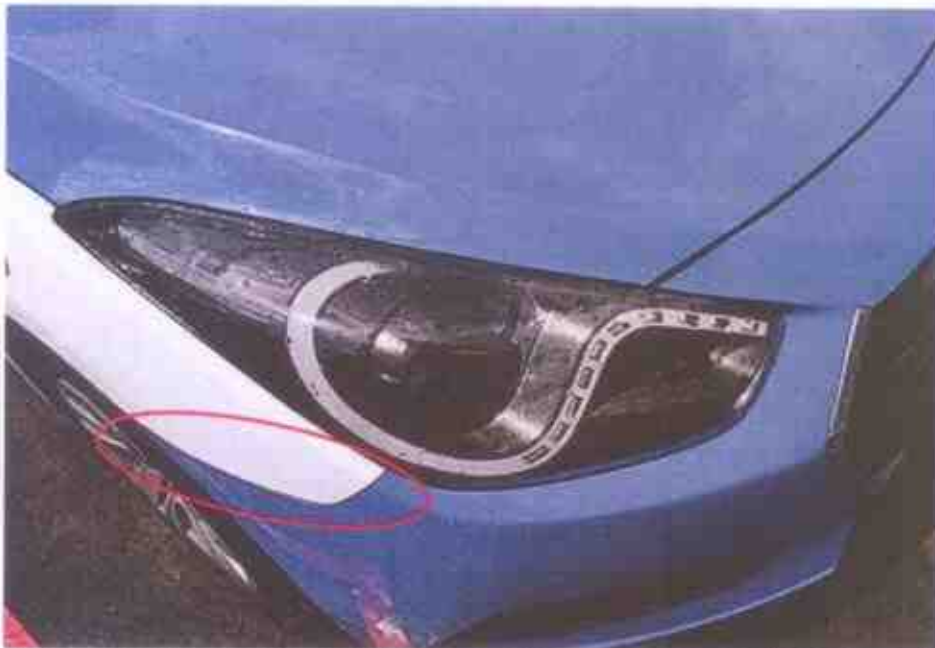
14. In general, the physical damage seen on the Motor Taxi indicates that it had sustained an impact directly onto its frontal portion. This impact was relatively light/minor as there was no obvious misalignment at the corner edges of the front bumper, adjacent to the front fenders. Even the first 2 body parts that would come into contact with the rear portion of the Motor Car, namely the front bumper and front number plate, did not sustain any permanent damage. Given the extent of physical damage seen on the Motor Taxi, it would therefore be reasonable to say that the relatively light/minor impact force from the contact did not dissipate beyond the cracked radiator grille of the Motor Taxi. See photo 5 & 6 below.

Photo 5 shows no obvious misalignment at the corner edges of the Motor Taxi's front bumper, adjacent to its front right fender (circled). This would indicate that the impact onto the frontal portion of the Motor Taxi was relatively light/minor.

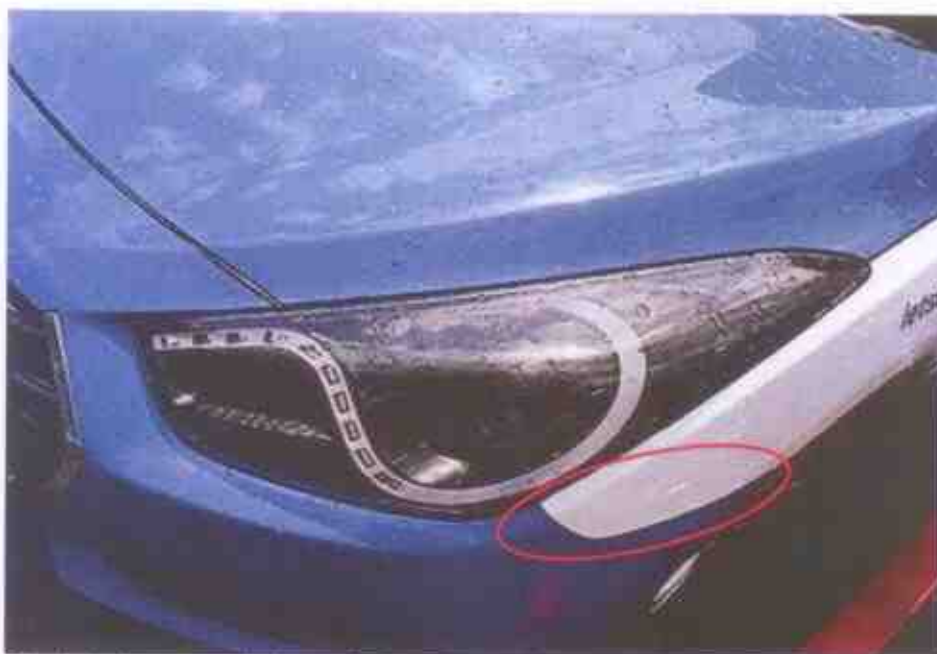
Photo 6 shows no obvious misalignment at the corner edges of the Motor Taxi's front bumper, adjacent to its front right fender (circled). This would indicate that the impact onto the frontal portion of the Motor Taxi was relatively light/minor.
