Your Ref: TP/IP/43085/2018
Our Ref :CI/TPD18013727/Z

16th October 2018

MECHANICAL INSPECTION REPORT OF MOTORCYCLE FS 7646U

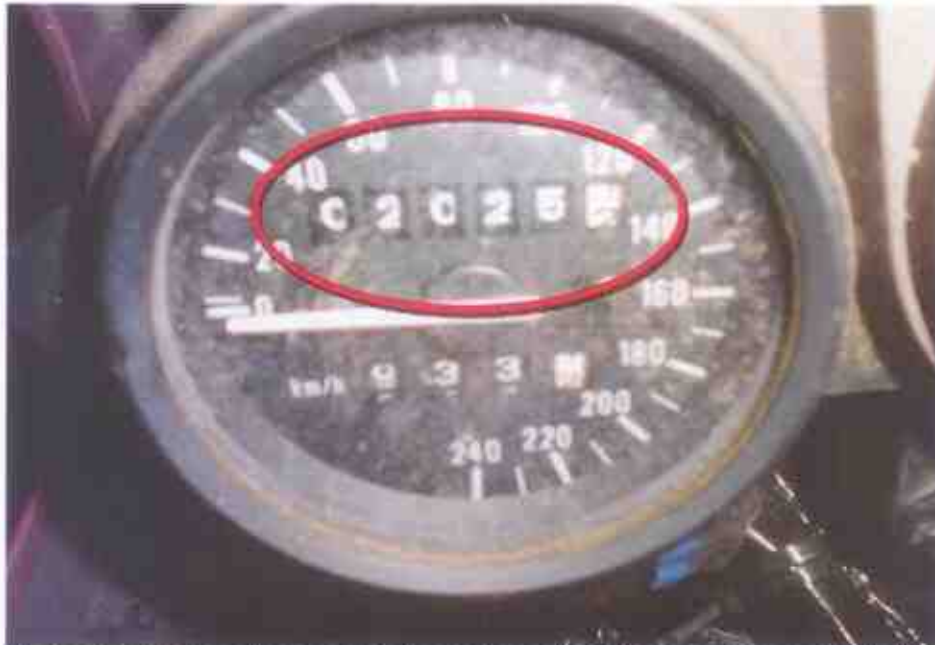
Photo 1 shows the mileage at the time of inspection was recorded at 020252km.

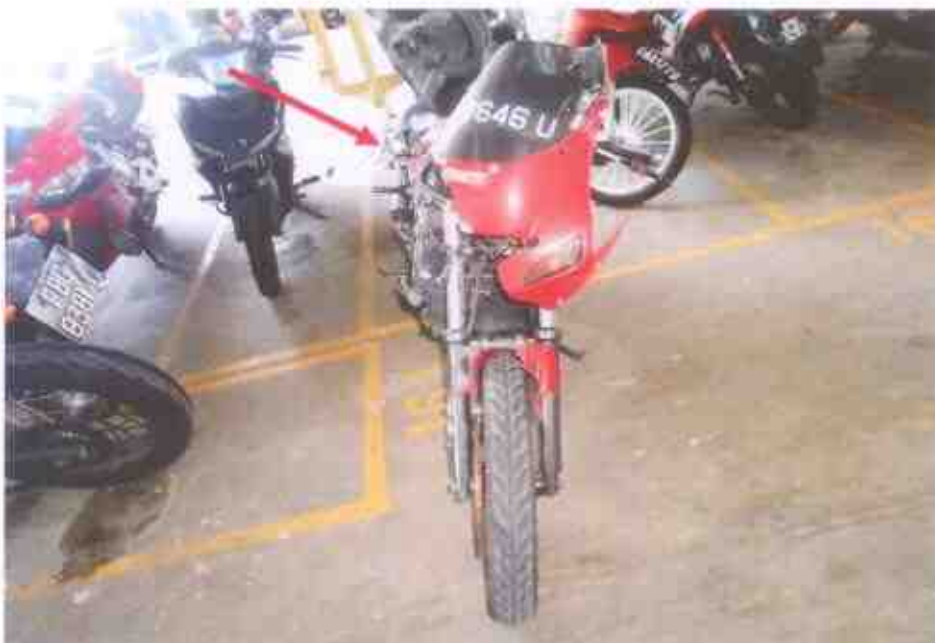
Photo 2 shows a general view of the front body of the Motorcycle at the time of our inspection. The Motorcycle was observed to be sustained with relatively extensive impact due to the accident collision. Amongst the body parts damaged was its handle bar (arrowed), which was observed to be dislocated.

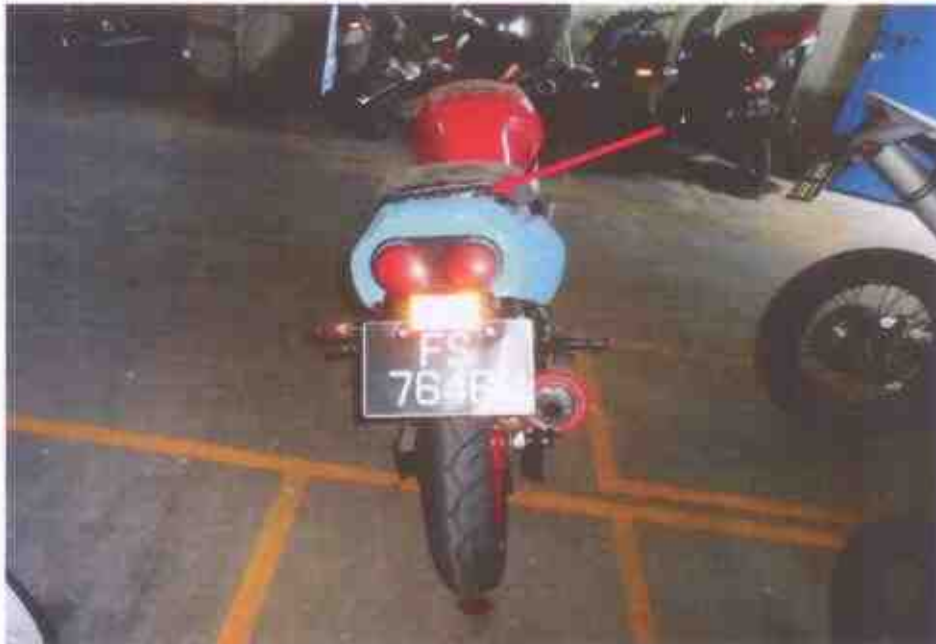
Photo 3 shows a general view of the rear left body of the Motorcycle at the time of our inspection. The Motorcycle was observed to have sustained minor damages at the rear portion.

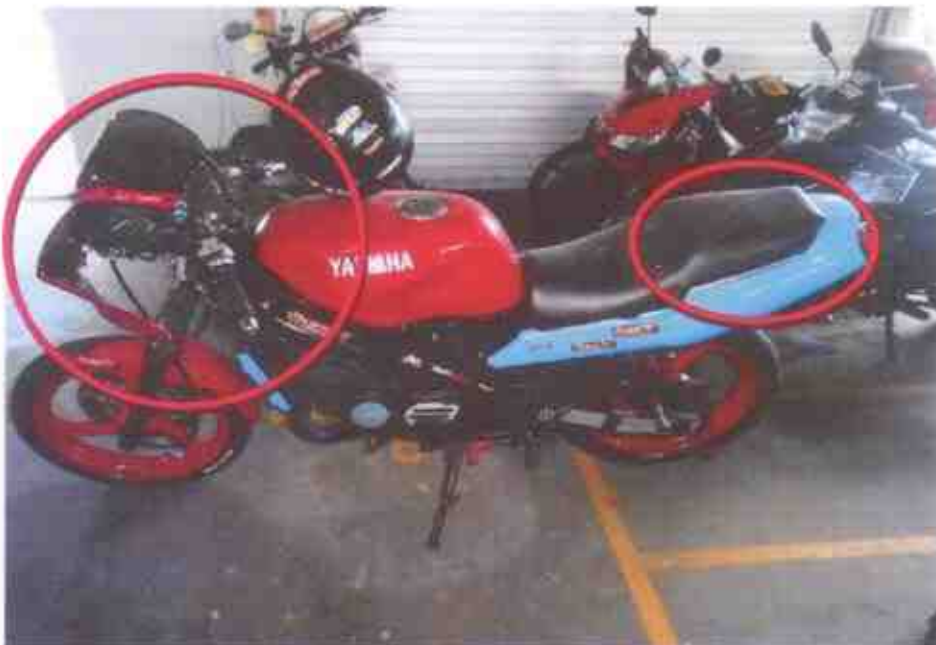
Photo 4 shows a general view of the frontal left portion of the Motorcycle at the time of our inspection. The Motorcycle was observed to be sustained relatively extensive impact due to the accident collision.

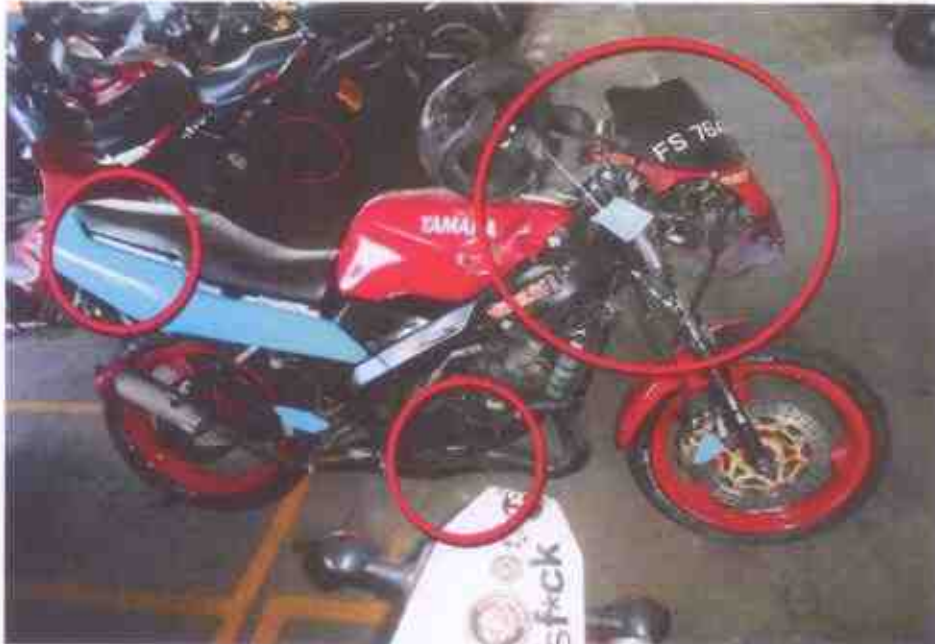
Photo 5 shows a general view of the frontal right portion of the Motorcycle at the time of our inspection. The Motorcycle was observed to be sustained relatively extensive impact due to the accident collision.

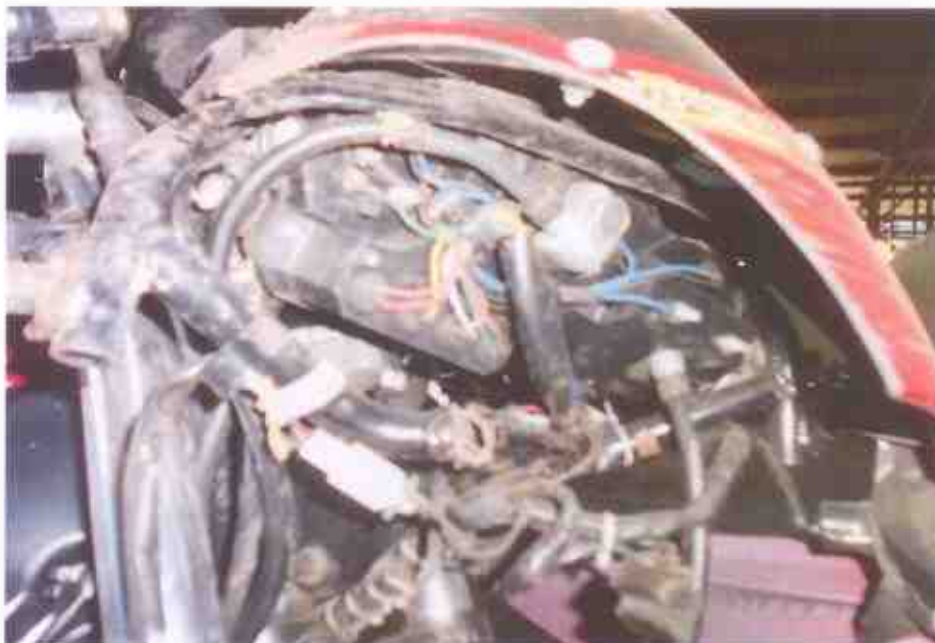
Photo 6 shows a close-up view of the damaged steering system & ignition system of the Motorcycle at the time of our inspection. The Motorcycle was observed to be sustained relatively extensive impact due to the accident collision.

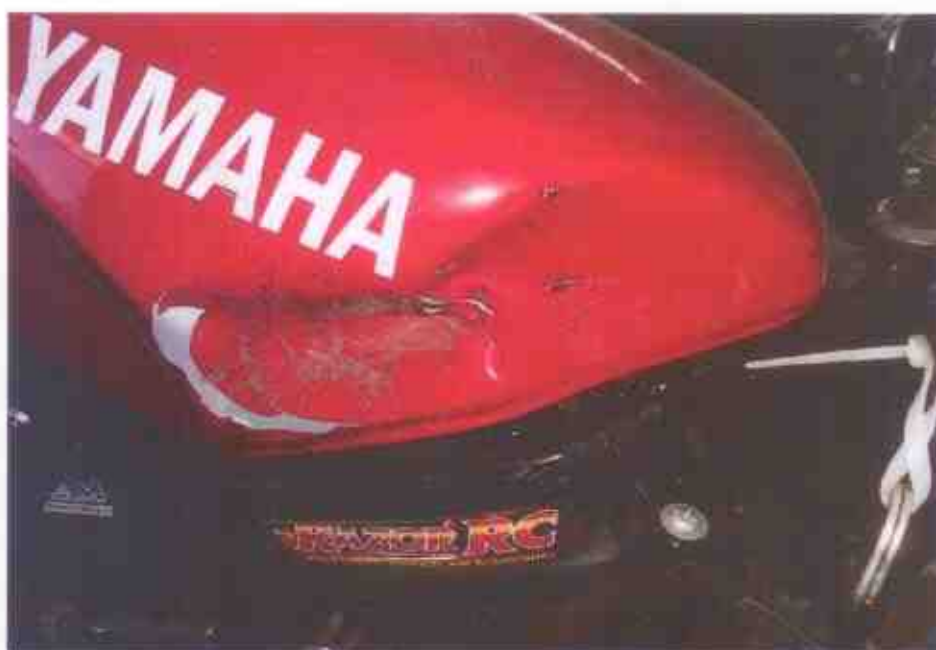
Photo 7 shows a close-up view of the fuel tank of the Motorcycle at the time of our inspection. It was observed to be dented due to the accident collision.

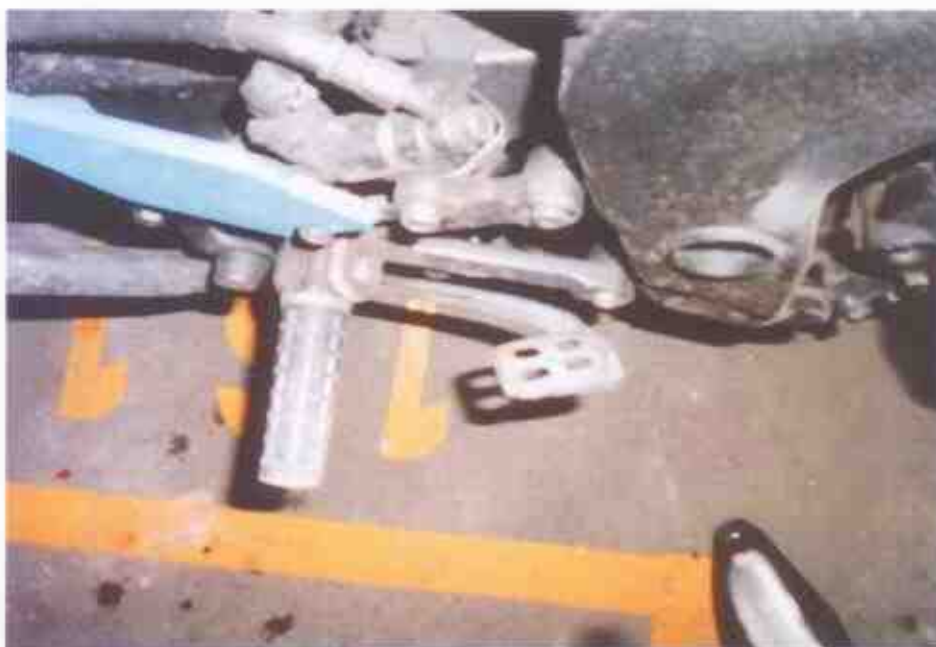
Photo 8 shows a close-up view of the foot brake pedal of the Motorcycle at the time of our inspection. It was observed to be dented inwards due to the accident collision.

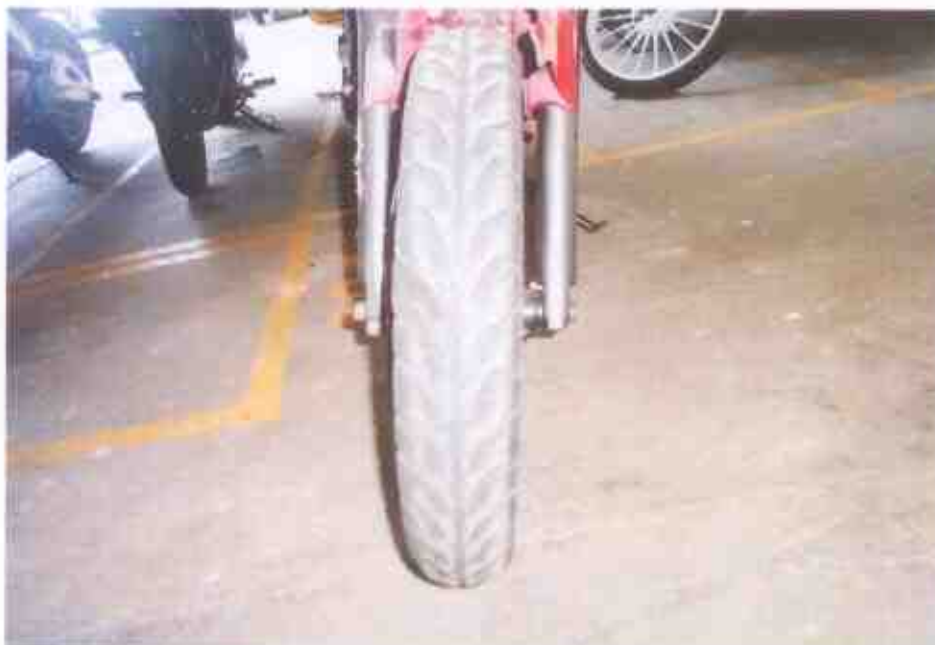
Photo 9 shows the front tyre of the Motorcycle at the time of our inspection. It was found to have sustained torn mark on the outer sidewall likely due to the accident's impact collision. However, the tread pattern was clearly visible.

20. As for the front tyre, it was found to be deflated. Further investigation reveals that it sustained torn mark on the outer sidewall likely due to the accident's impact collision. However, the tread pattern was clearly visible with remaining tread depth of approximately 3mm.

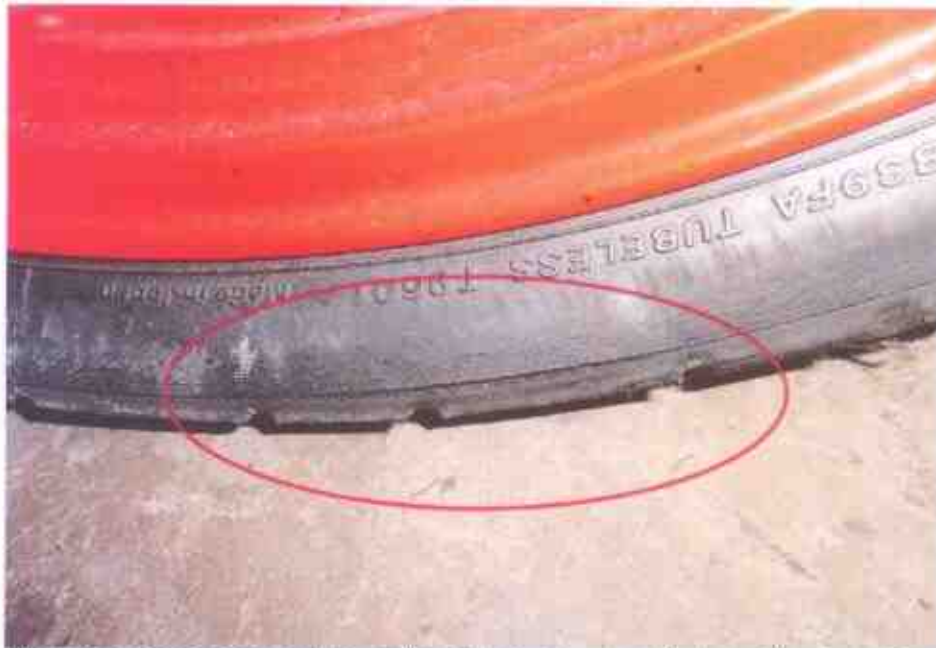
Photo 10 shows the front tyre of the Motorcycle was deflated at the time of our inspection. It was found to have sustained torn mark on the outer sidewall likely due to the accident's impact collision. However, the tread pattern was clearly visible.

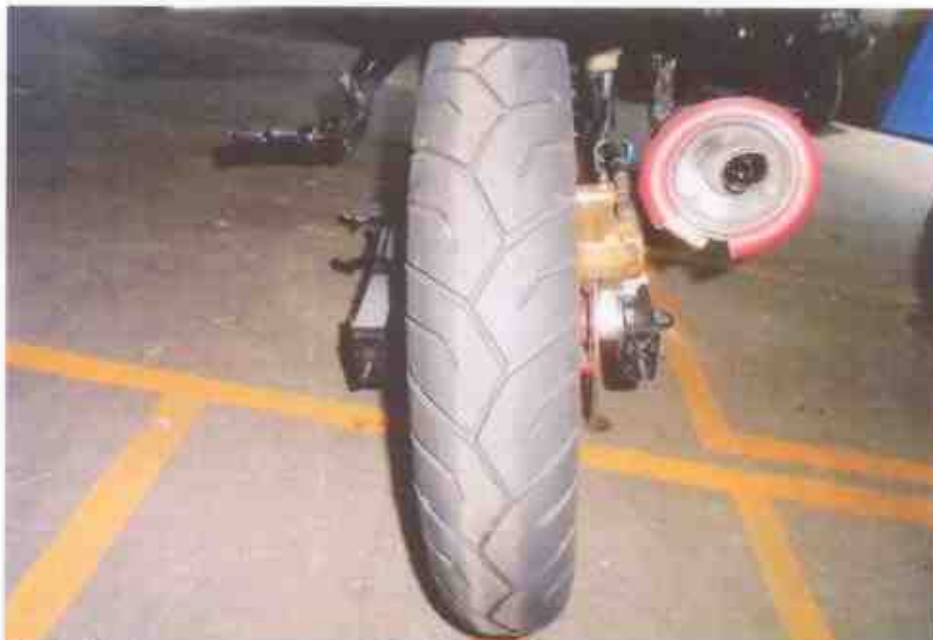
Photo 11 shows the rear tyre of the Motorcycle at the time of our inspection. The rear tyre was observed to be in serviceable condition with remaining tread depth of approximately 4mm. It was also sufficiently inflated for vehicular operation.

19. The rear tyre was observed to be in serviceable condition. The tread pattern of the rear tyre was clearly visible. We did not observe any tear, burst mark(s) and/or punctured hole(s) on the sidewalls as well as across the tread of the rear tyre. It was also observed to be sufficiently inflated for vehicular operation. It was sufficiently inflated for vehicular operation with remaining tread depth of approximately 4mm.

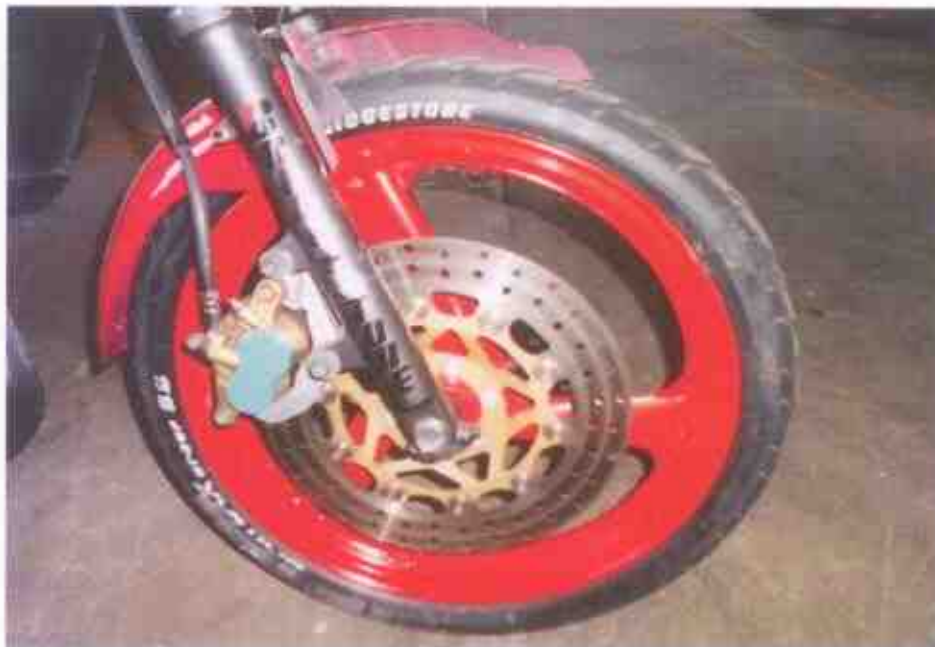
Photo 12 shows the front tyre was wrapped around alloy wheel rim that was found to be without any significant damage.

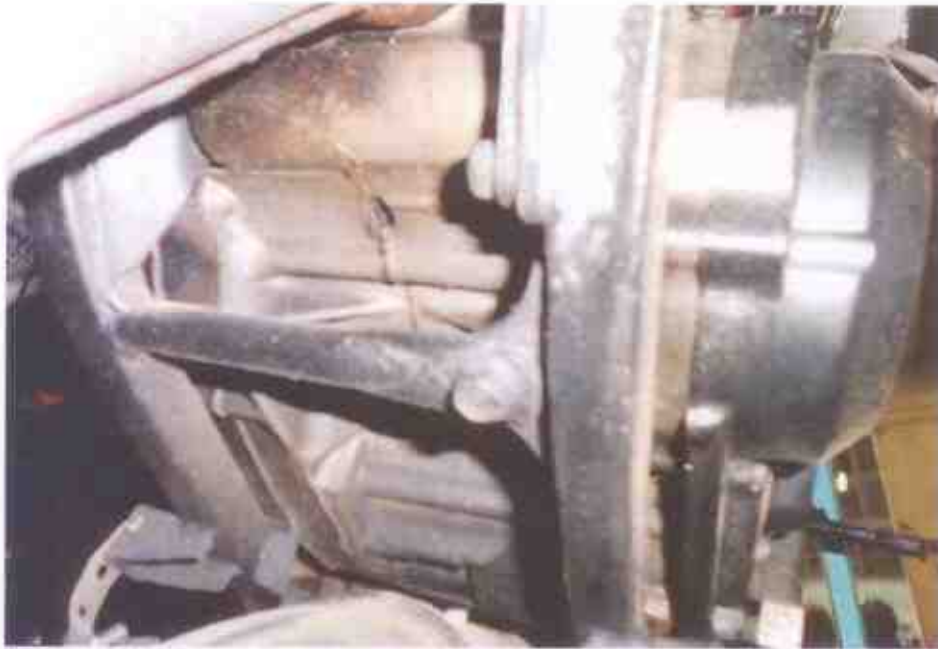
Photo 13 shows no sign(s) or indication(s) of fluid leak observed around the engine area of the Motorcycle.

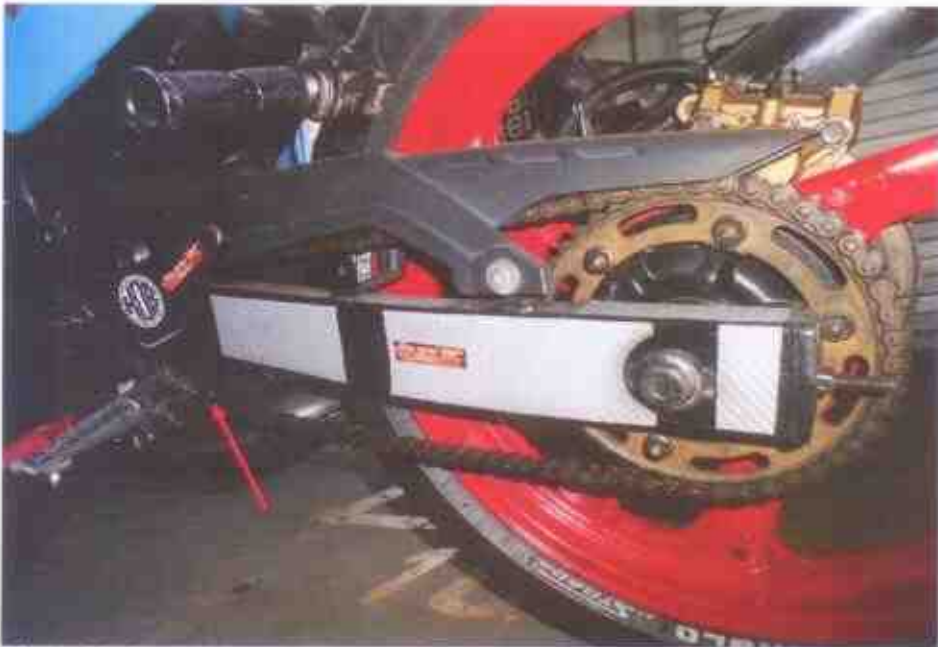
Photo 14 shows the general view of the gear train (arrowed) of the Motorcycle, which was observed to be intact with no misalignment. It was also adequately lubricated for operating purposes.

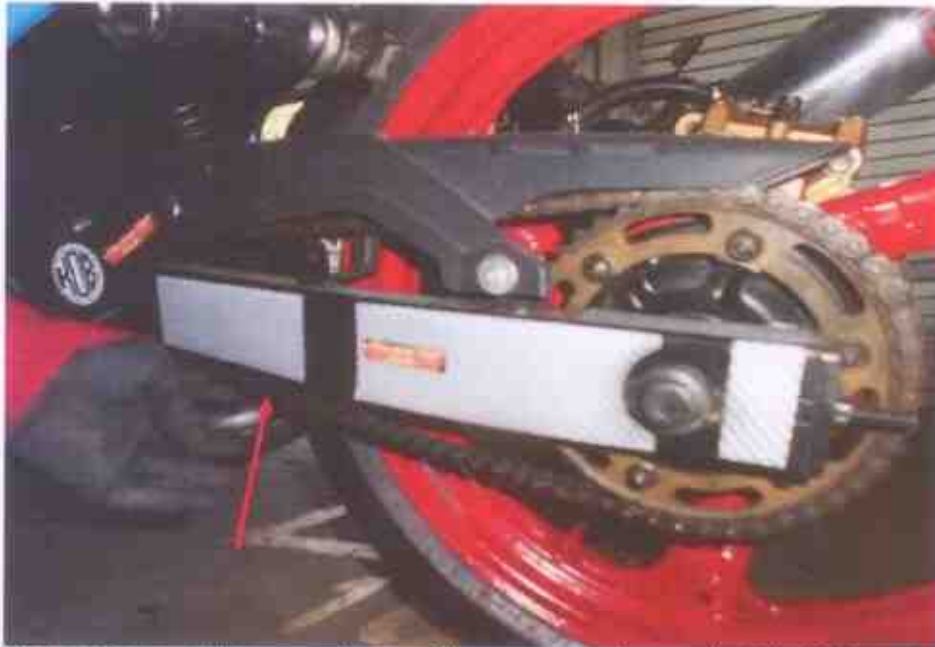
Photo 15 shows the general view of the gear train (arrowed) of the Motorcycle, which was observed to be intact with no misalignment. It was also adequately lubricated for operating purposes. Free play tension was also observed & found adequately acceptable.

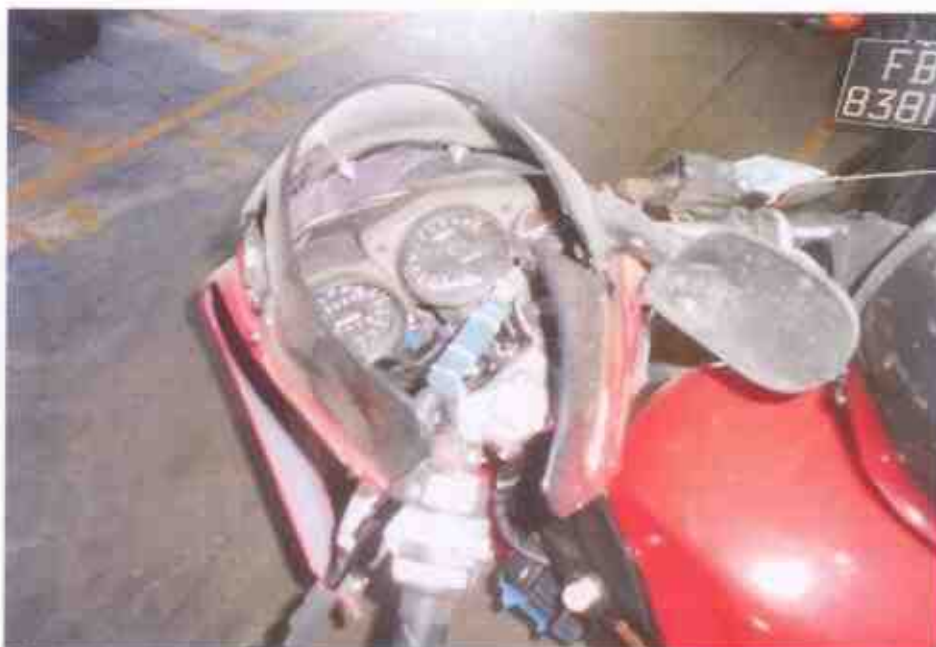
12. For this case, we were not able to conduct any test(s) on the steering system of the Motorcycle due to the damage on its steering system. It was found to be dislocated as a result of the accident, hence causing the whole steering system not to be in a serviceable condition.
13. The braking system of the Motorcycle was observed to be of a full hydraulic type, where hydraulic (brake fluid) pressure controls the brake for the front wheel and rear wheel. The brake for the front wheel is engaged by pulling the brake lever at the right side of the Motorcycle's handle bar while the brake for the rear wheel is engaged by stepping on the brake pedal at the right side foot rest of the Motorcycle.

Photo 16 shows the front handle bar was observed to be dislocated as a result of the accident. Hence, we are not able to conduct any tests on the steering system of the Motorcycle.

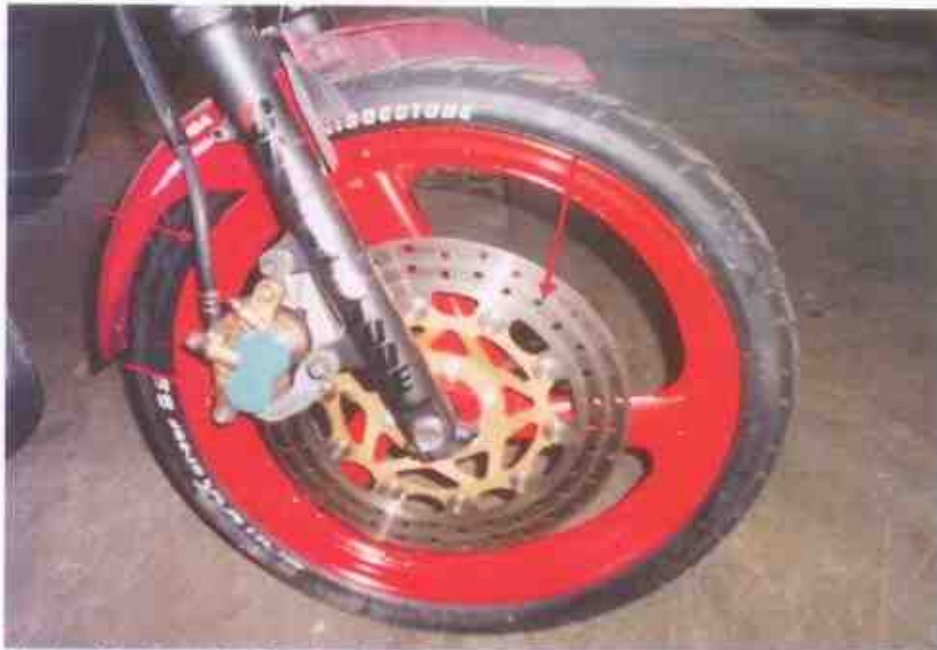
Photo 17 shows the front brake calliper, front brake disc and brake pad of the Motorcycle (arrowed), which are all part of the components in the front brake system of the Motorcycle. Our visual checks of these various components had revealed all to be intact with no visible damage.

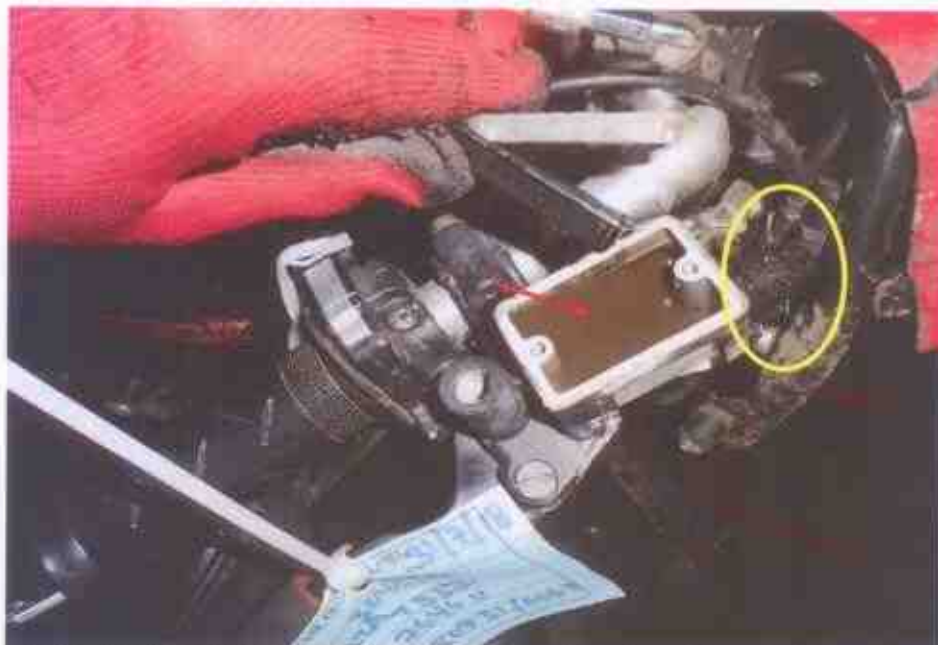
14. Static brake test conducted on the front brake reveals that it was not in serviceable condition. There was no resistance felt upon gripping the brake lever. Further investigation on the front brake reservoir found that brake fluid leakage from the connection to the brake hose right after the brake fluid reservoir. We could visually see the brake fluid leakage upon gripping the brake lever each time.

Photo 18 shows the front brake fluid observed to be sufficient at time of our inspection. However, fluid leakage was observed came from the connecting hoses right after the brake fluid reservoir. (Circled)

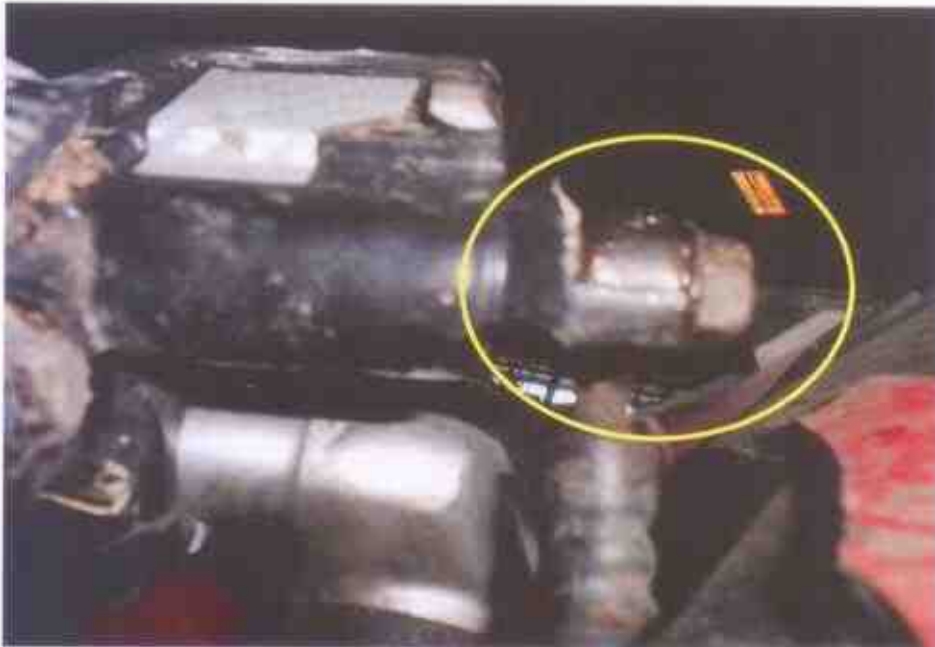
Photo 19 shows the front brake fluid observed to be sufficient at time of our inspection. However, fluid leakage was observed came from the connecting hoses right after the brake fluid reservoir. (Circled)

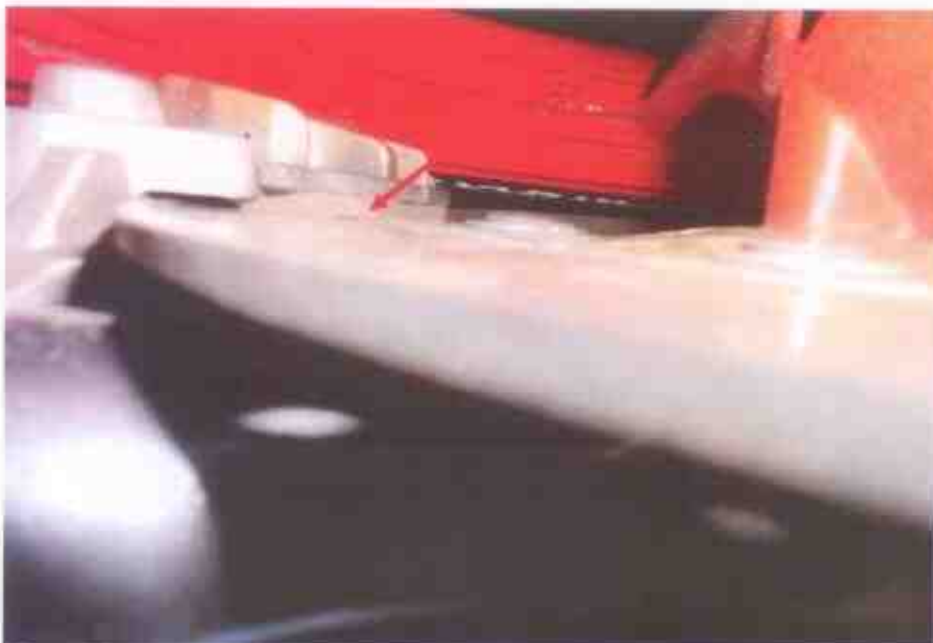
Photo 20 shows the front brake pad of the Motorcycle (arrowed), which are still with sufficient frictional material for operational purposes.

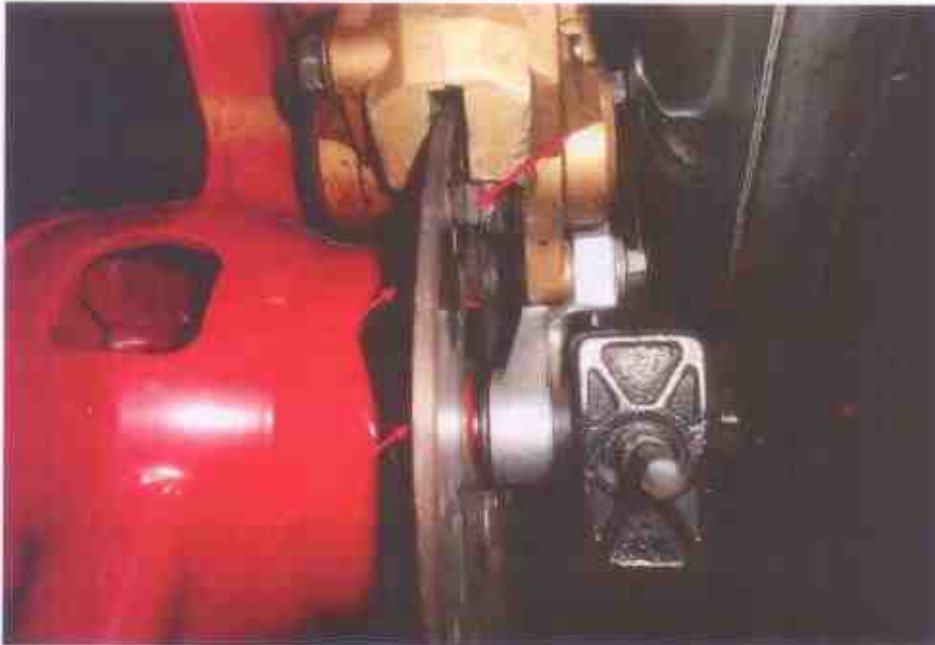
Photo 21 shows the rear brake pad of the Motorcycle (arrowed), which are still with sufficient frictional material for operational purposes.

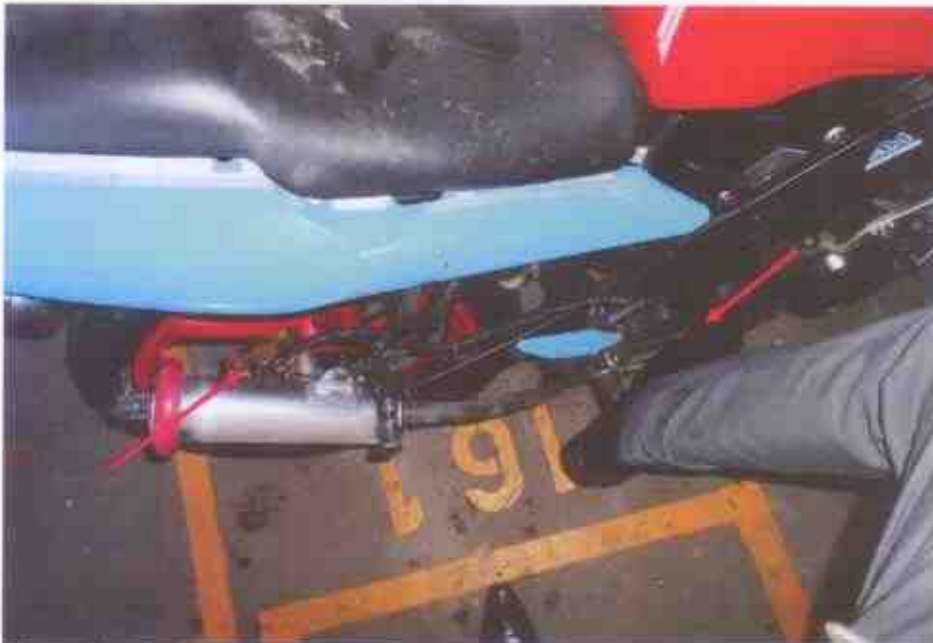
15. As for the rear brake a static brake tests conducted on the Motorcycle had appeared to indicate that the rear brake system of the Motorcycle was in serviceable condition. There was some resistance felt (spongy like feel) upon stepping on the rear brake foot padle. This would indicate that there was no leakage of pressure/vacuum in the rear brake mechanical parts. Our checks on the rear brake fluid had also indicated that the brake fluid was of sufficient level for operational purposes, and without contamination.

Photo 22 shows a static brake test performed on the rear brake. It was found to be in a serviceable condition.
