Your Ref: TP/IP/43847/2018
Our Ref : CI/TPD18016115/Z

28th November 2018

MECHANICAL INSPECTION REPORT OF MOTOR CAR SLM 7686P

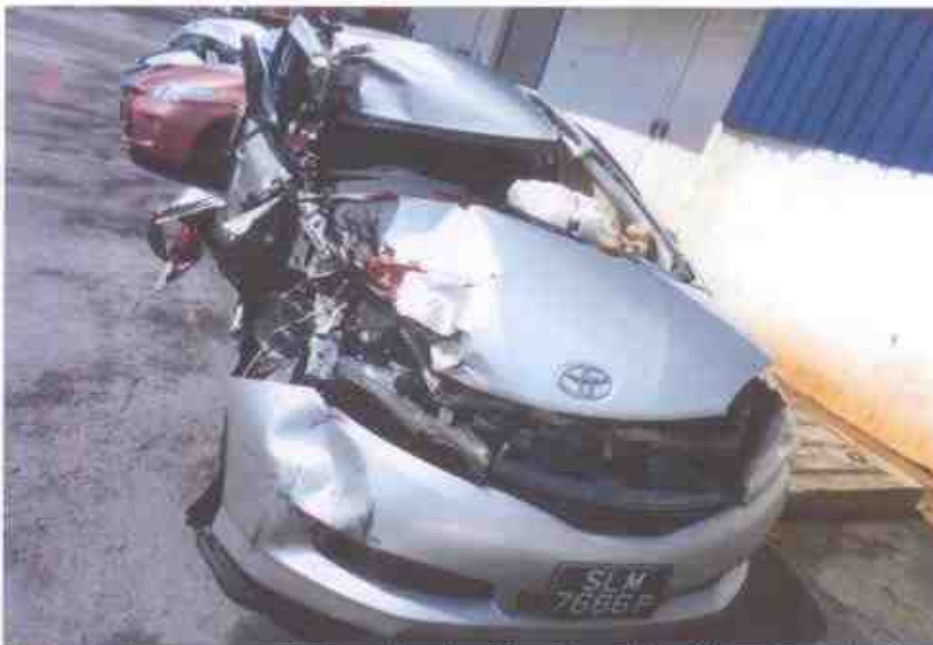
Photo 1 shows a general view of the frontal portion of the Motor Car at the time of our inspection. The Motor Car was observed to have sustained extensive impact damage at its frontal portion. The impact force was significant, causing the various parts and components inside the engine compartment to be damaged.

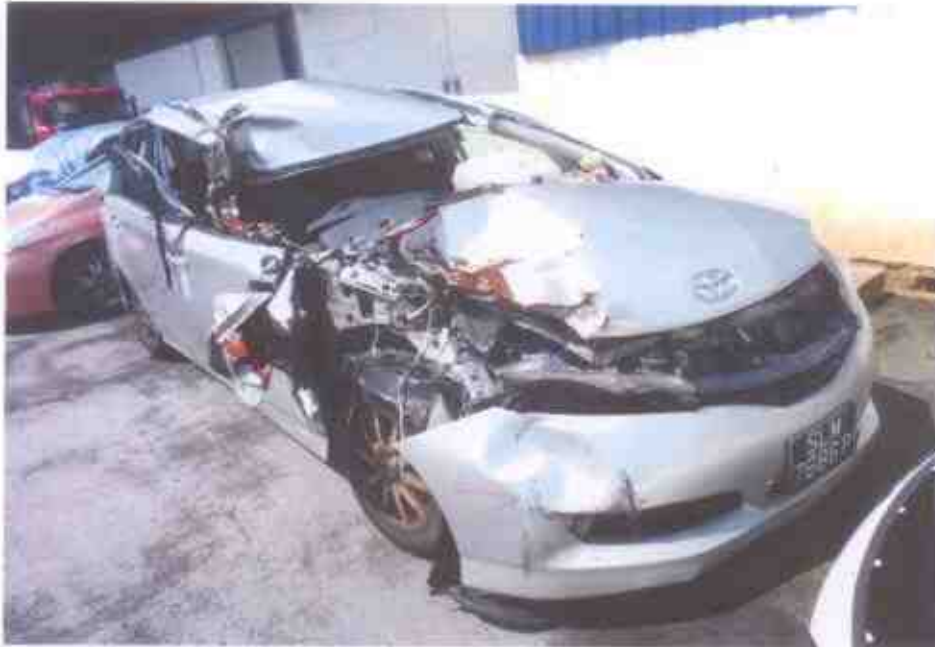
Photo 2 shows a general view of the front right portion of the Motor Car at the time of our inspection. The Motor Car was observed to have sustained extensive impact damage at its frontal portion.

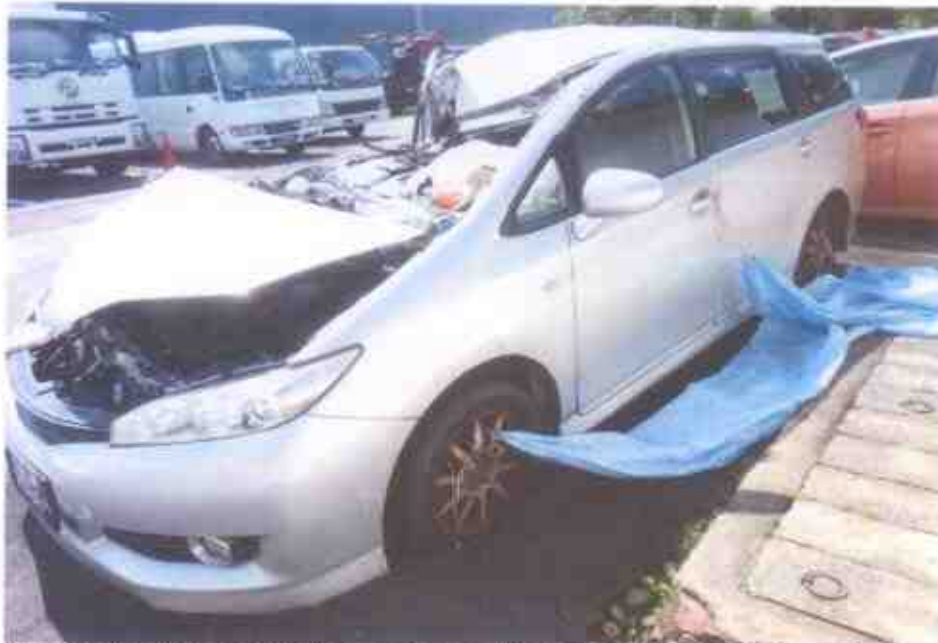
Photo 3 shows a general view of the front left portion of the Motor Car at the time of our inspection. The Motor Car was observed to have sustained with extensive impact damage at its frontal portion.

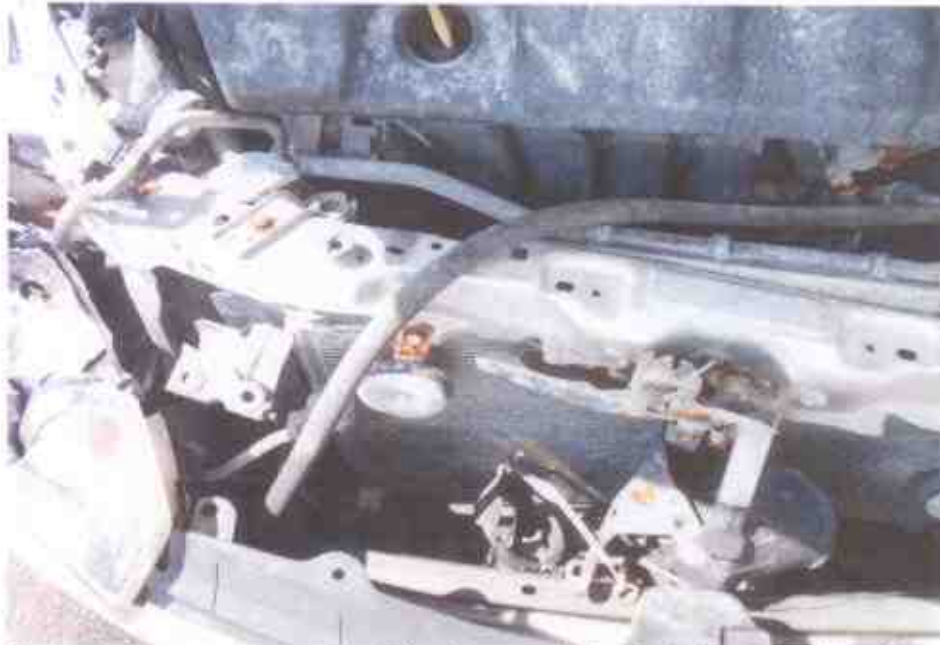
Photo 4 shows a closer view of the damage at the frontal portion of the Motor Car's engine. The impact force was significant, causing the various parts and components inside the engine compartment to be pushed inwards, towards the rear of the Motor Car.

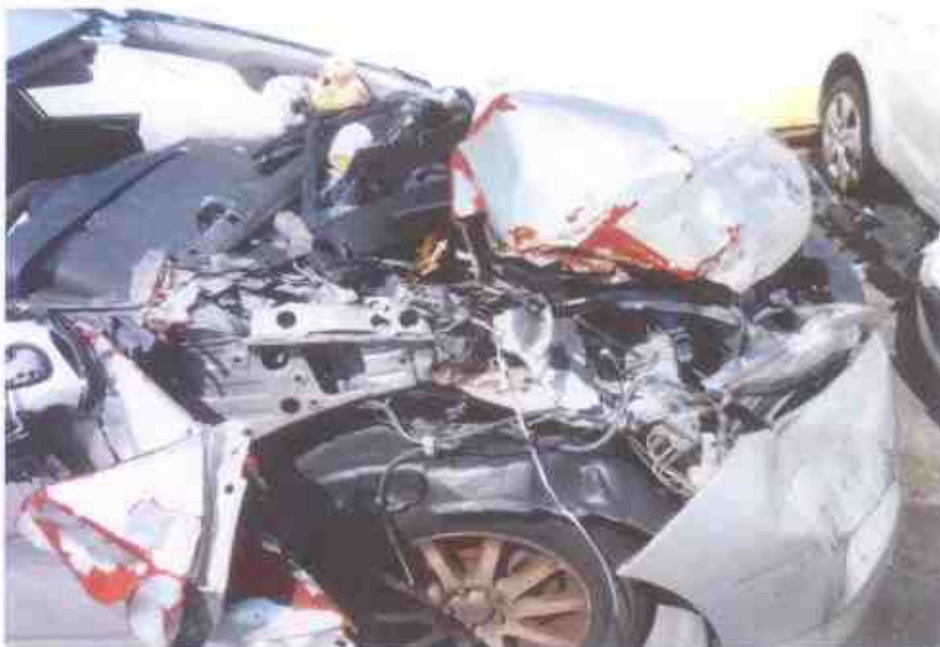
Photo 5 shows a closer view of the damage at the frontal right portion of the Motor Car. The impact force was significant, causing the various parts and components inside the engine compartment to be pushed inwards, towards the rear of the Motor Car.

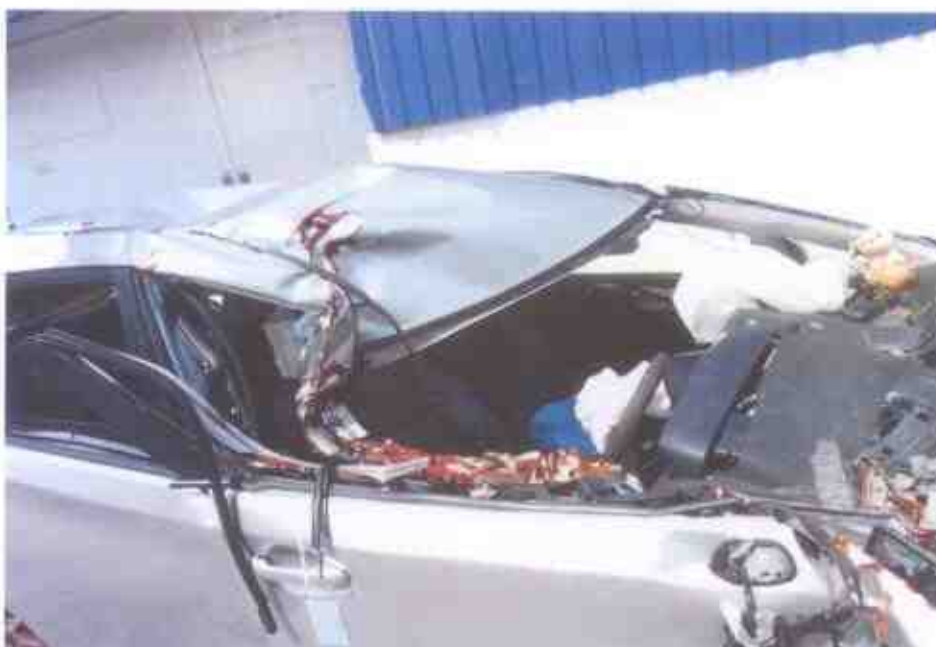
Photo 6 shows a closer view of the damage at the frontal portion of the Motor Car. The impact force was significant, causing extensive damage to the windshield & rooftop amongst others due to the accident.

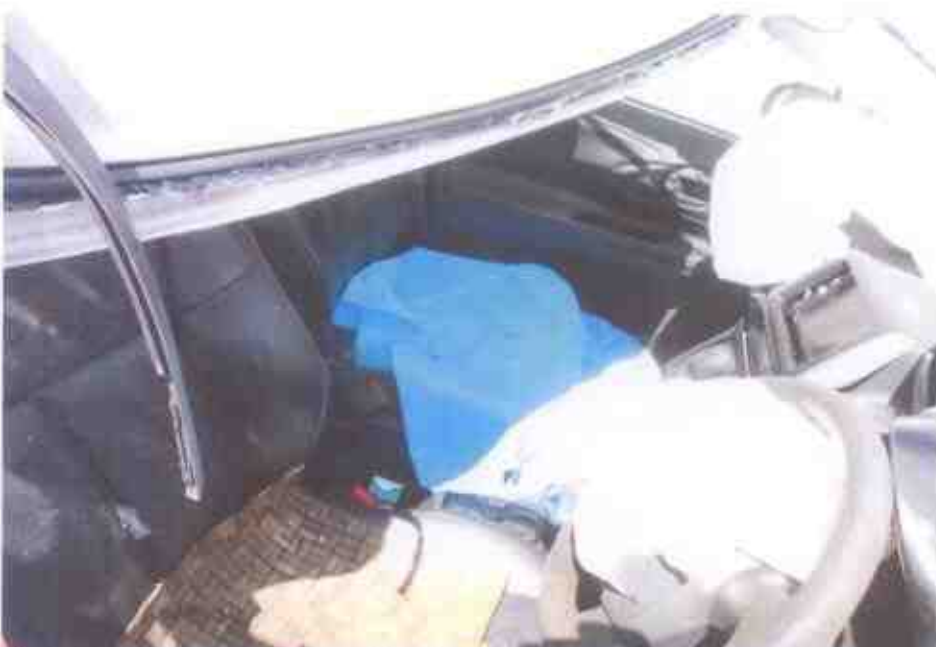
Photo 7 shows a closer view of the interior cabin of the Motor Car. The impact force caused damages to the interior cabin and also activated both driver's & passenger's airbag at time of impact.

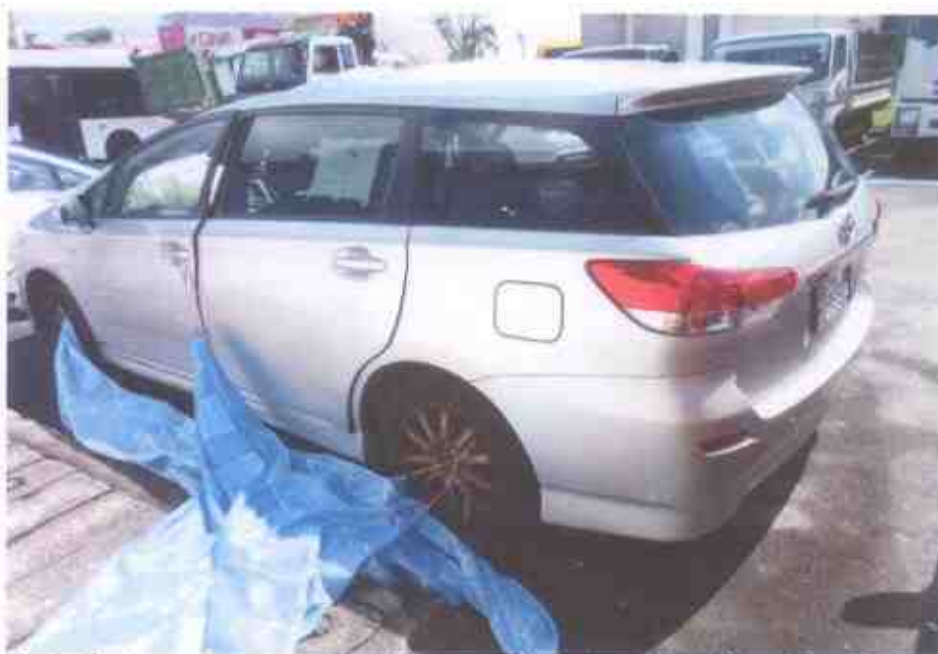
Photo 8 shows a general view of the rear left portion of the Motor Car. The rear portion was observed to be in good condition, no damages found at time of our inspection.

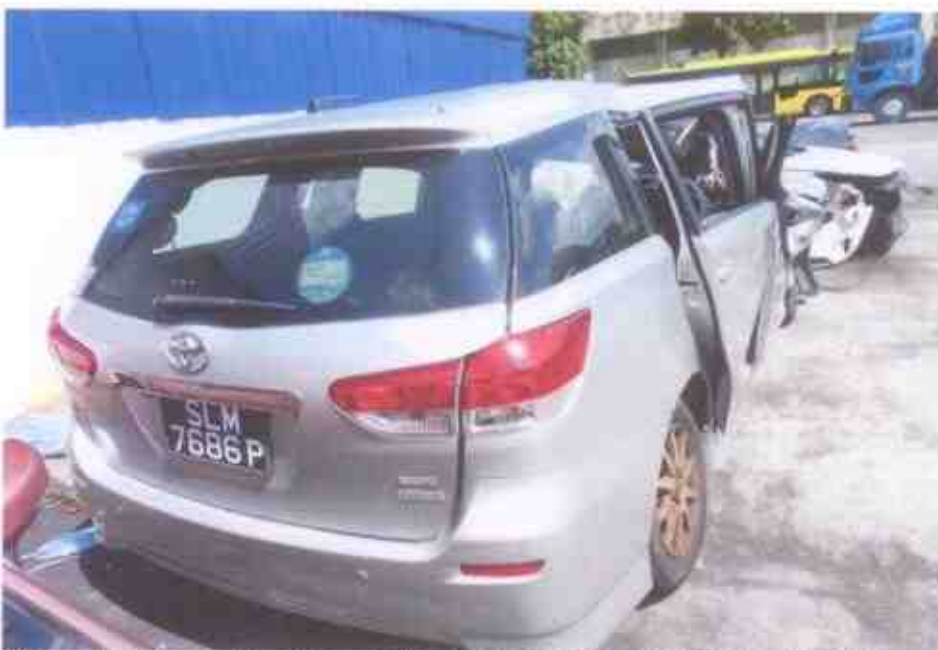
Photo 9 shows a general view of the rear right portion of the Motor Car. The rear portion was observed to be in good condition, no damages found on the Motor Car's body at time of our inspection. However, we found that the rear boot lid sustained minor misalignment due to the accident.

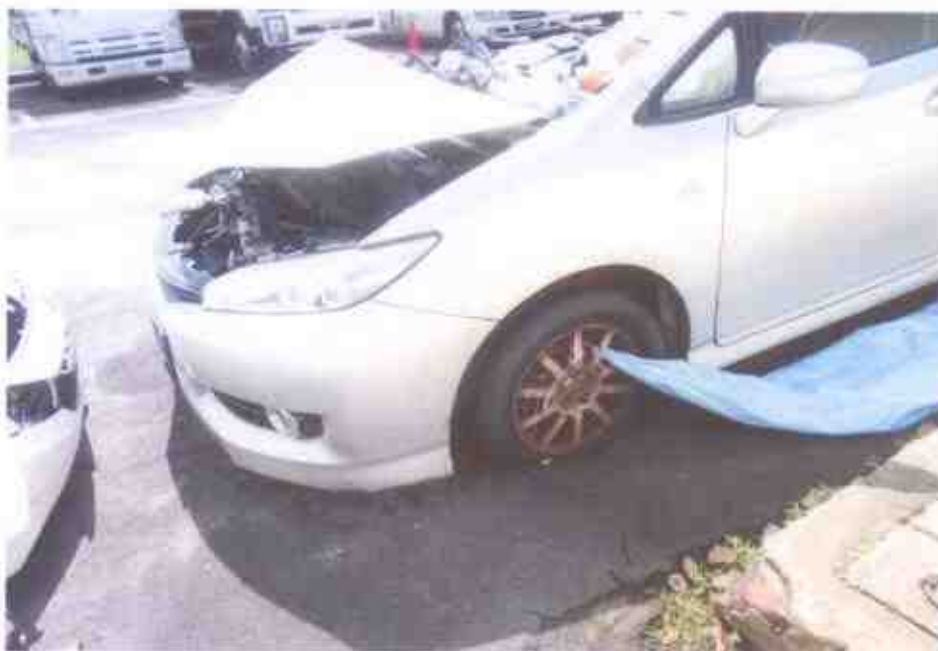
Photo 10 shows the general view condition of the front left tyre of the Motor Car. It was observed to be deflated as a result of the accident.

19. The front left tyre was observed to be damaged (deflated & torn) due to the accident's impact. The remaining tread depth of the front left tyre was approximately 5mm.

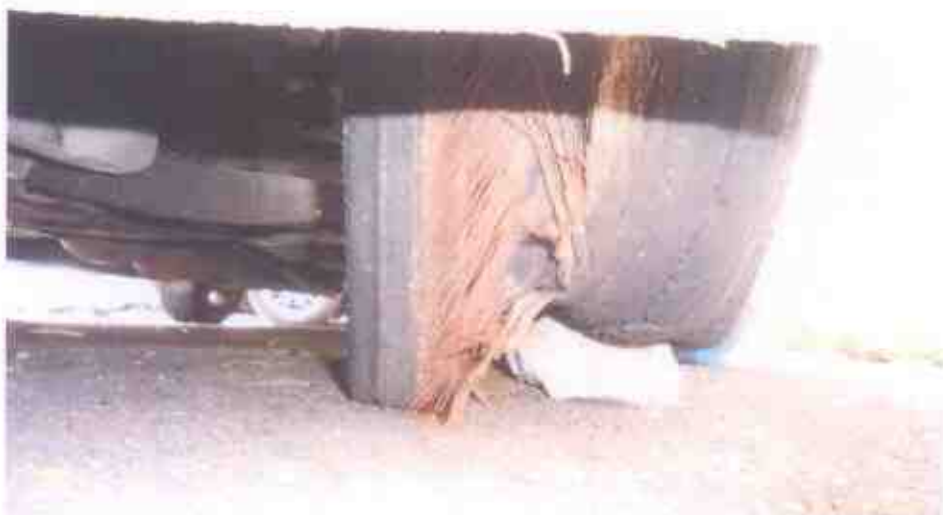
Photo 11 shows the condition of the front left tyre of the Motor Car, which was observed to be torn due to the accident's impact.

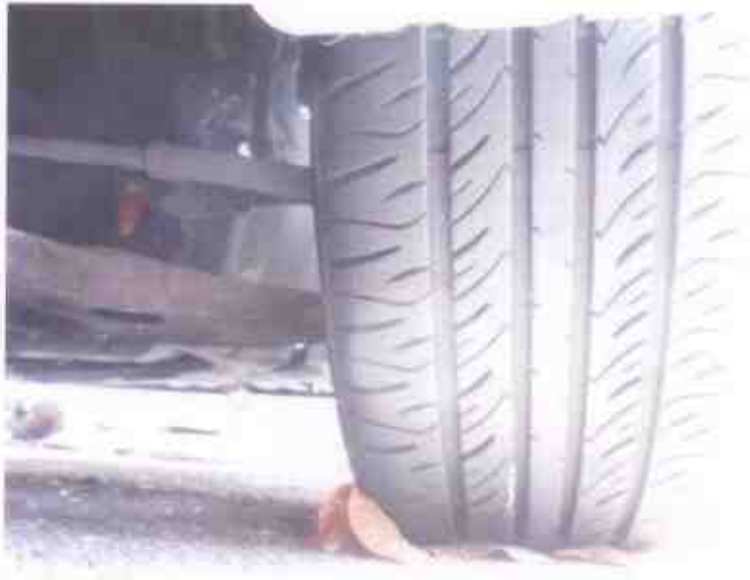
Photo 12 shows the condition of the front right tyre of the Motor Car, which was observed to be in serviceable condition. The tyre was also observed to be sufficiently inflated for vehicular operation. The remaining tread depth of the front left tyre was approximately 6mm.

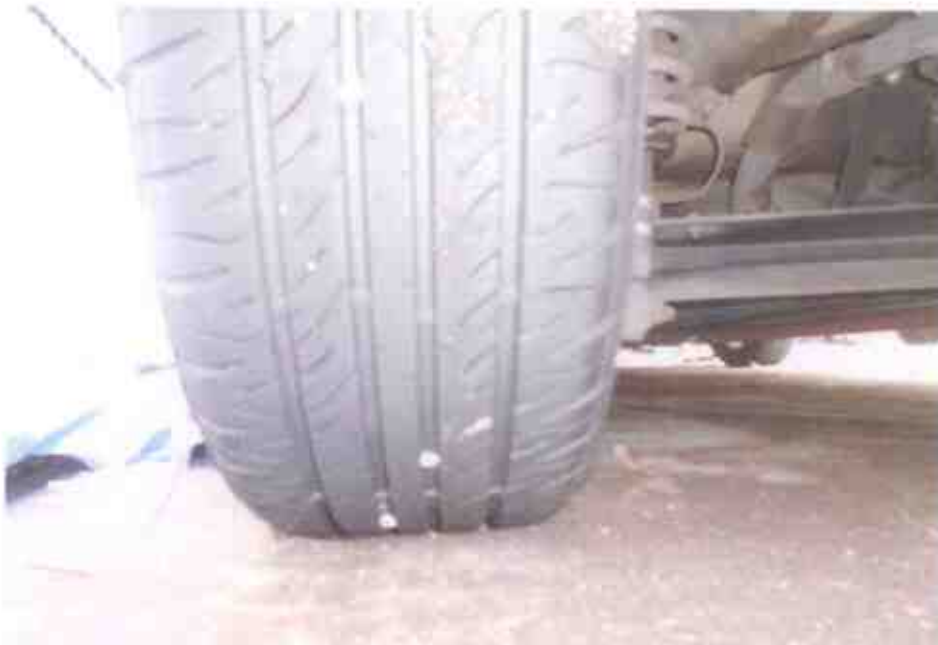
Photo 13 shows the condition of the rear left tyre of the Motor Car, which was observed to be in serviceable condition. The tyre was also observed to be sufficiently inflated for vehicular operation. The remaining tread depth of the front left tyre was approximately 5mm.

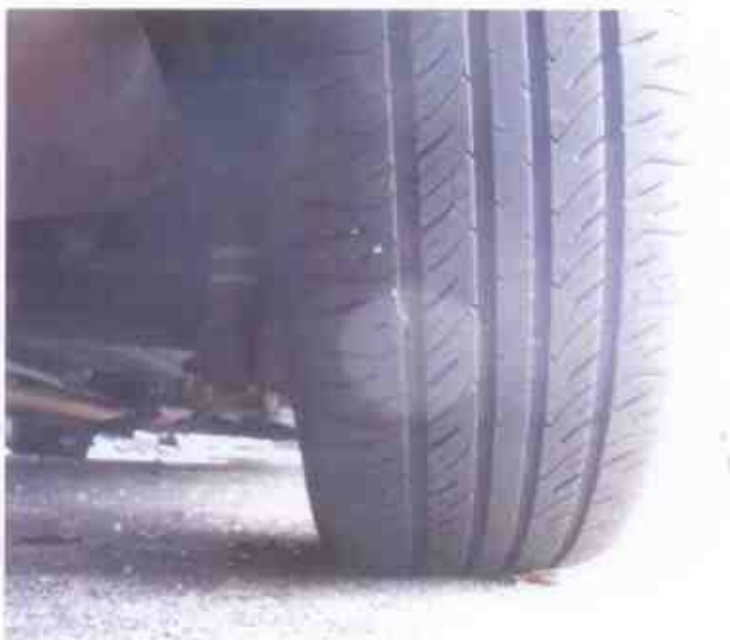
Photo 14 shows the condition of the rear right tyre of the Motor Car, which was observed to be in serviceable condition. The tyre was also observed to be sufficiently inflated for vehicular operation. The remaining tread depth of the front left tyre was approximately 5mm.

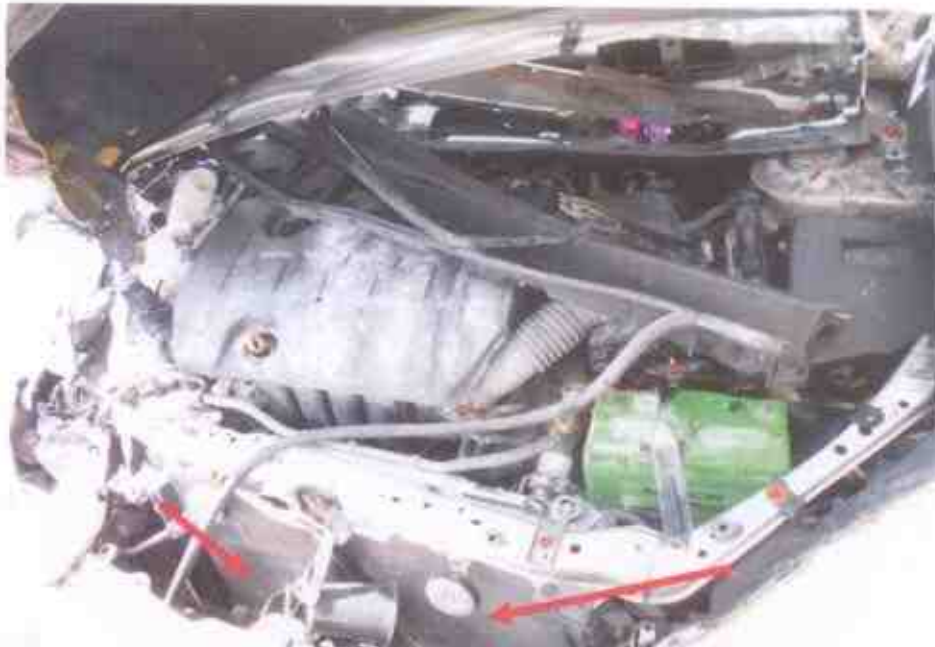
Photo 15 shows the close up view of the radiator's tank that was observed to be damaged likely due to the accident impact.

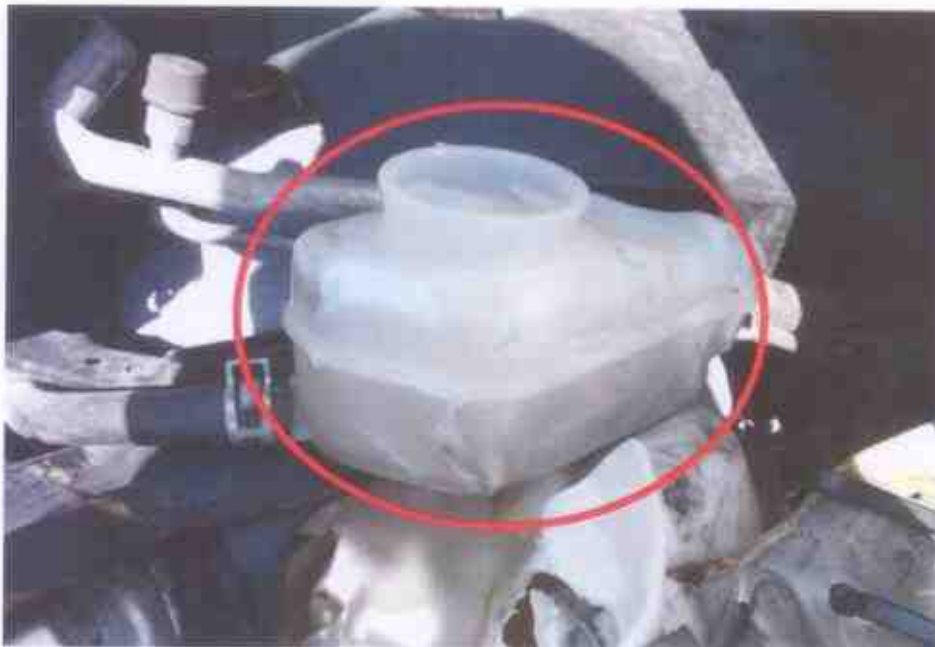
Photo 16 shows the close up view of the brake fluid reservoir that was broken likely due to the accident impact.

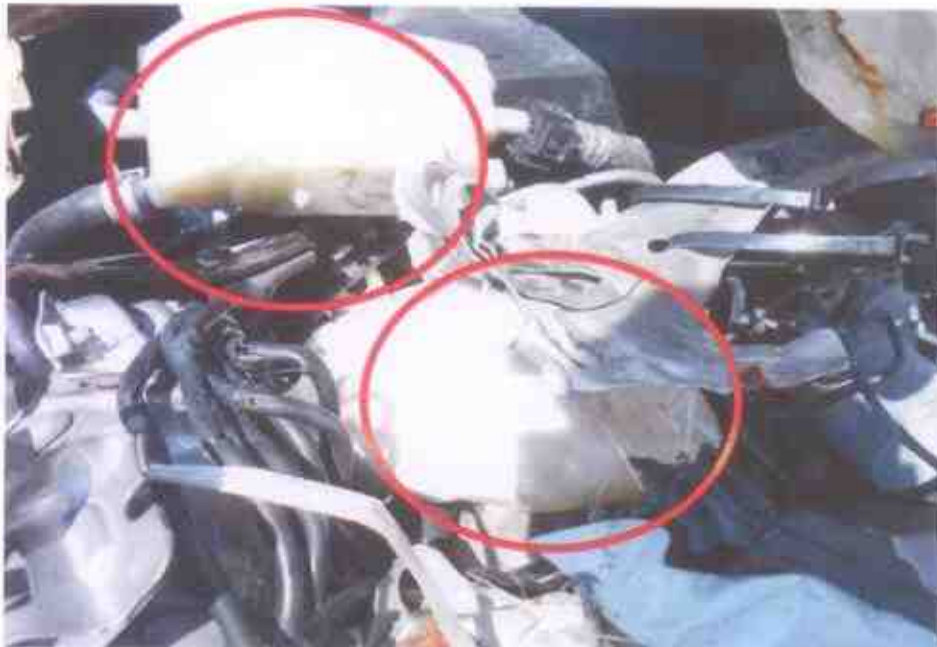
Photo 17 shows the close up view of the engine coolant fluid reservoir & brake fluid reservoir damages due to the accident impact.

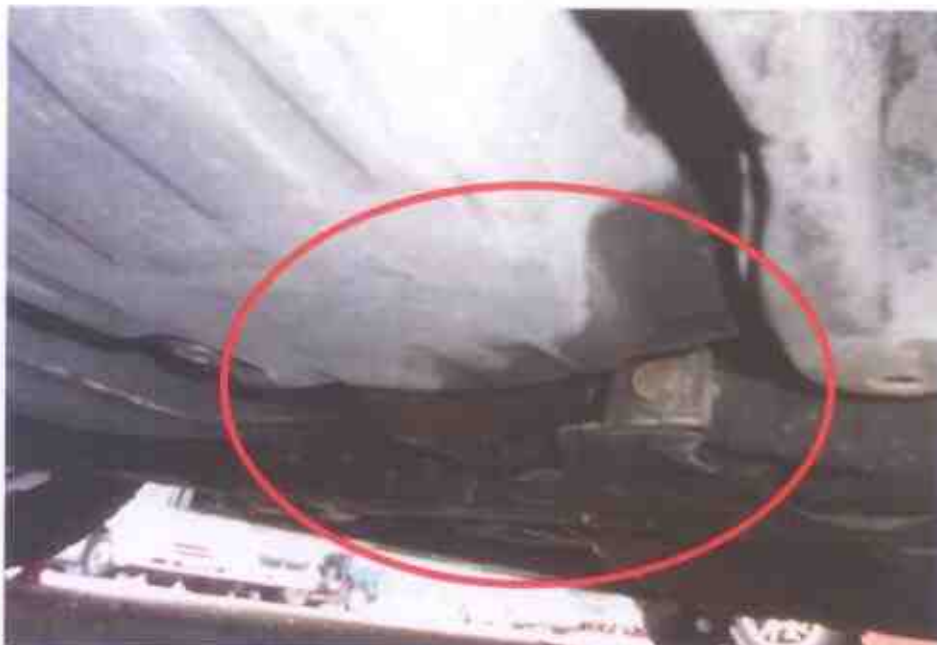
Photo 18 shows the close up view of the fluid leakage at the undercarriage area likely due to the accident impact.

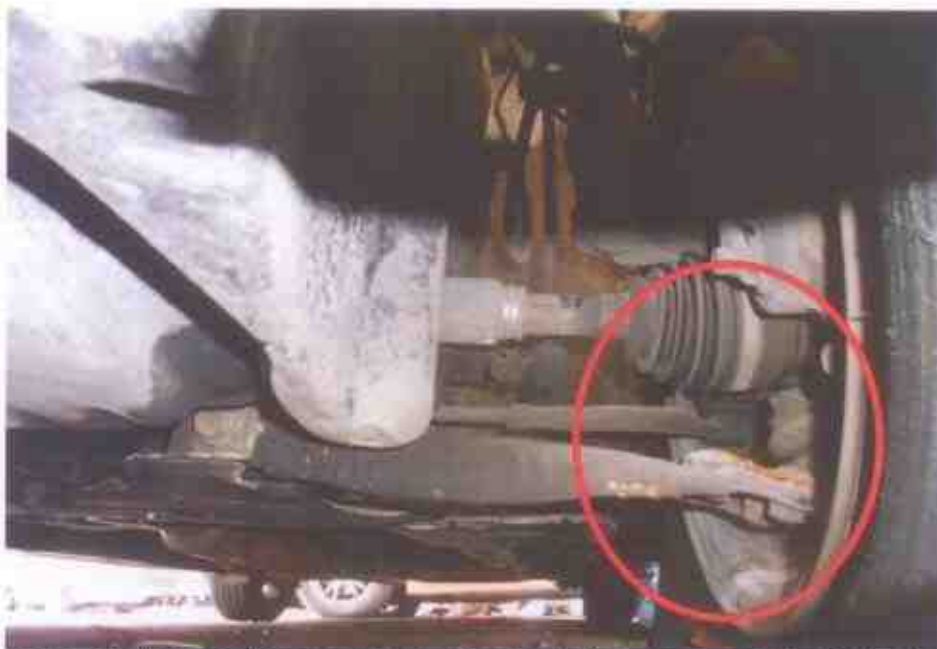
Photo 19 shows a close up view on the front left lower arm of the Motor Car steering system. We were not able to conduct any tests on the steering system of the Motor Car due to the damage to these components as a result of the accident.

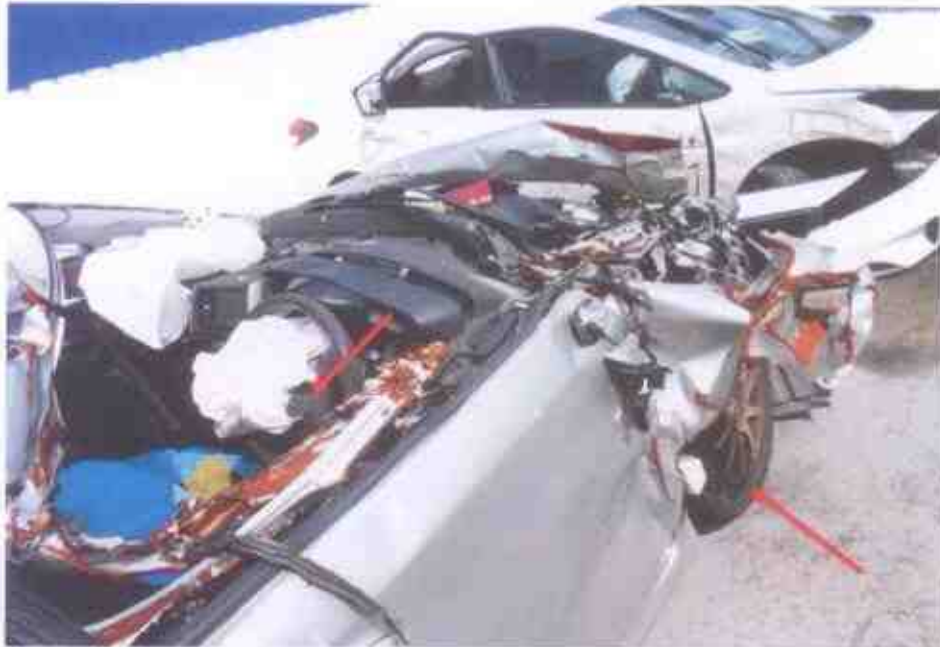
Photo 20 shows the damaged on the steering system of the Motor Car. We were not able to conduct any tests on the steering system of the Motor Car due to the damage to these components. It was observed to be misaligned from its original alignment as a result of the accident.

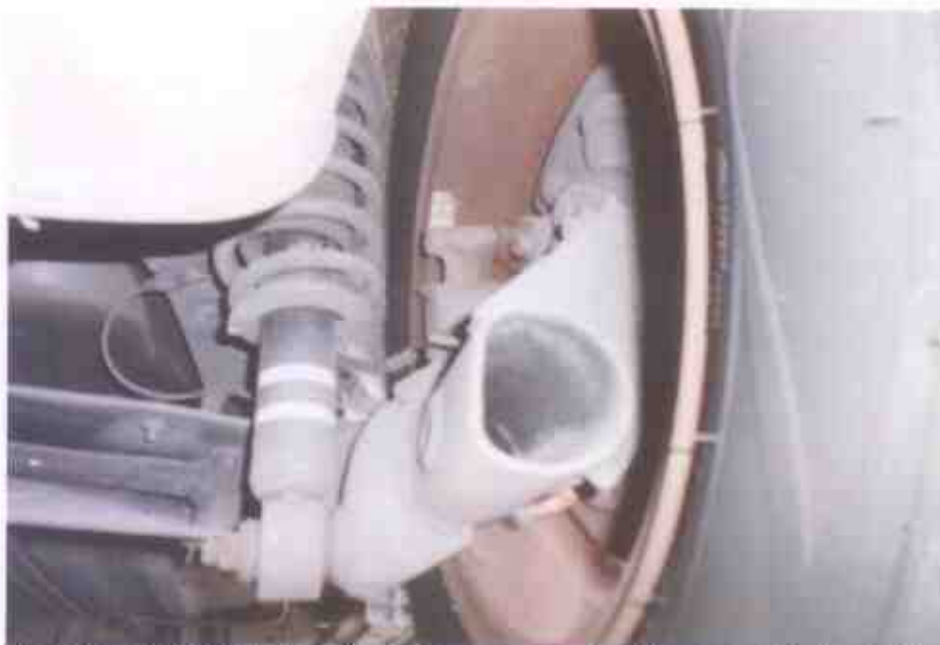
Photo 21 shows the braking & steering components at the rear right wheel of the Motor Car. We did not observe any leakage of brake fluid at the time of our inspection of the Motor Car.

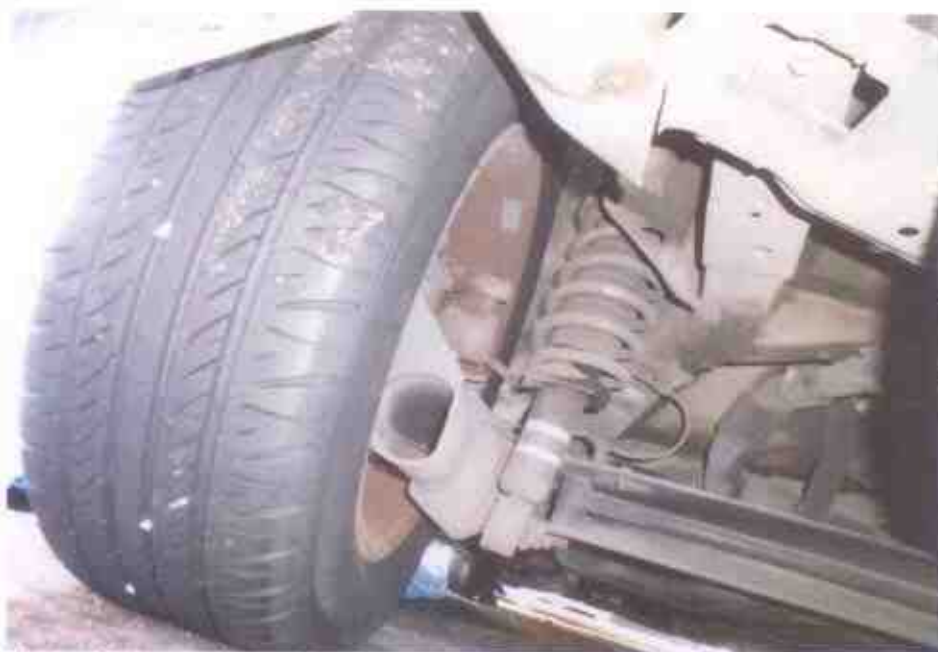
Photo 22 shows the braking & steering components at the left right wheel of the Motor Car. We did not observe any leakage of brake fluid at the time of our inspection of the Motor Car.

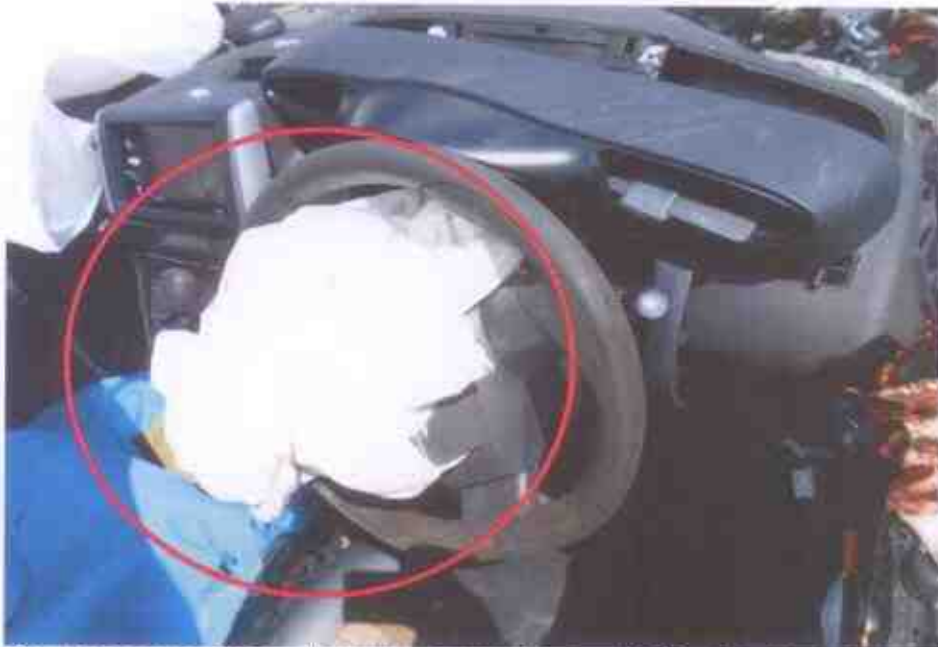
Photo 23 shows the Supplemental Restraint System (SRS) of the Motor Car was however likely to be in normal operating condition at the material time of the accident. The evidence of the deployed driver's airbag indicates that the impact sensors and control module of the Motor Car's SRS were all in serviceable condition at the material time of accident.

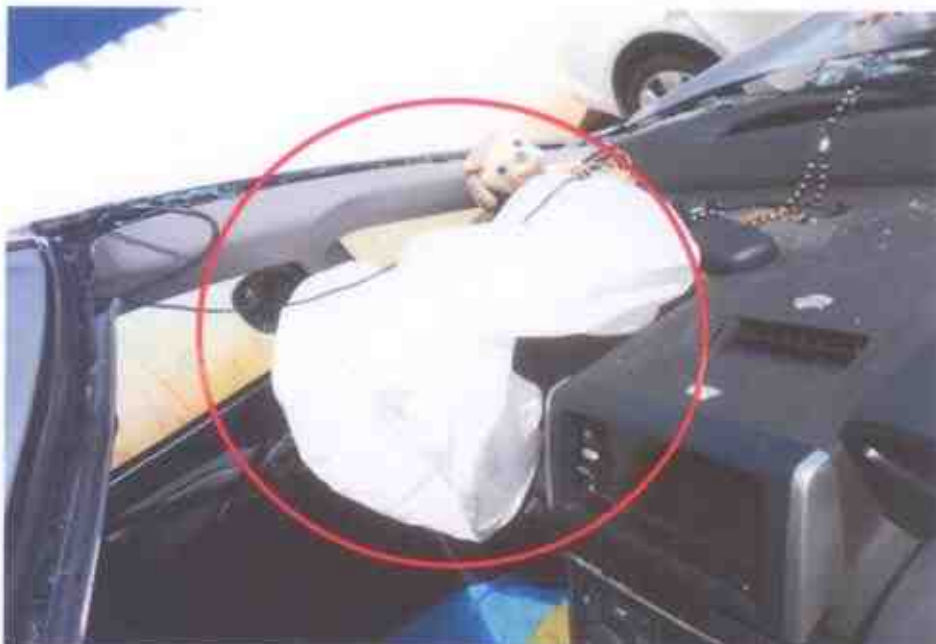
Photo 24 shows the Supplemental Restraint System (SRS) of the Motor Car was however likely to be in normal operating condition at the material time of the accident. The evidence of the deployed passenger's airbag indicates that the impact sensors and control module of the Motor Car's SRS were all in serviceable condition at the material time of accident.
