Your Ref : TP/IP/43461/2018  
Our Ref : CI/TPD18016119/Z

**Fatal Accident Investigation Team**  
Traffic Police Department  
Singapore Police Force  
10 Ubi Avenue 3  
Singapore 408865

### **MECHANICAL INSPECTION REPORT OF MOTORCYCLE JQV 5714**

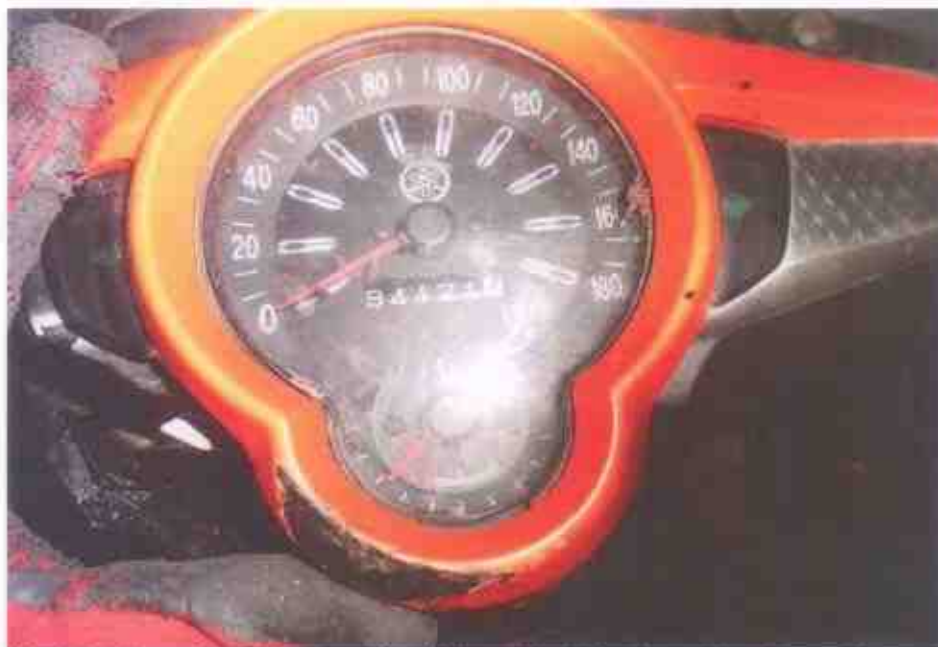
Photo 1 shows the mileage of the Motorcycle at the time of our inspection was recorded at 941217km.

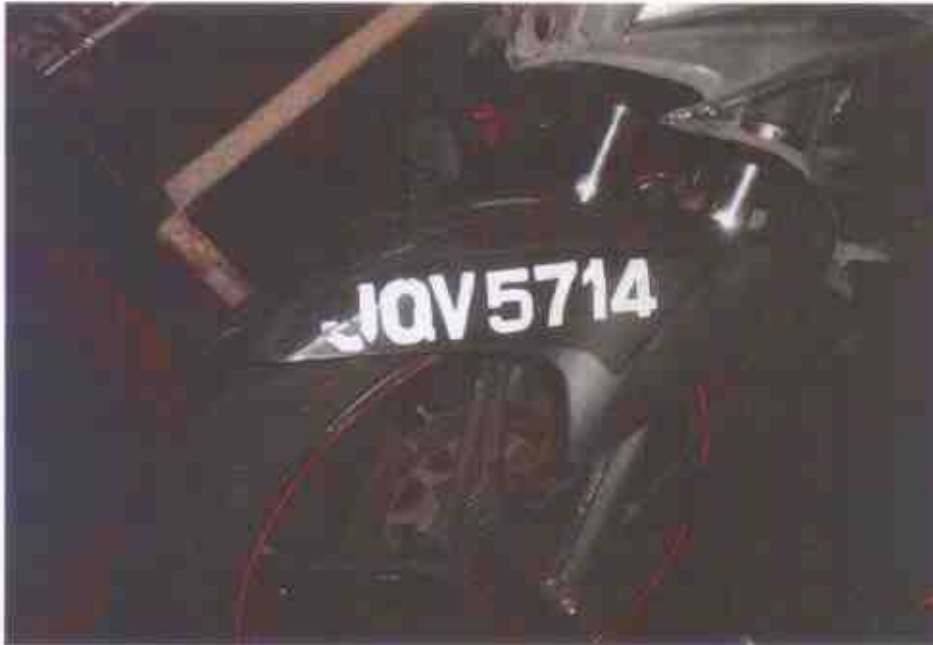
Photo 2 shows the Motorcycle number plate for identification.

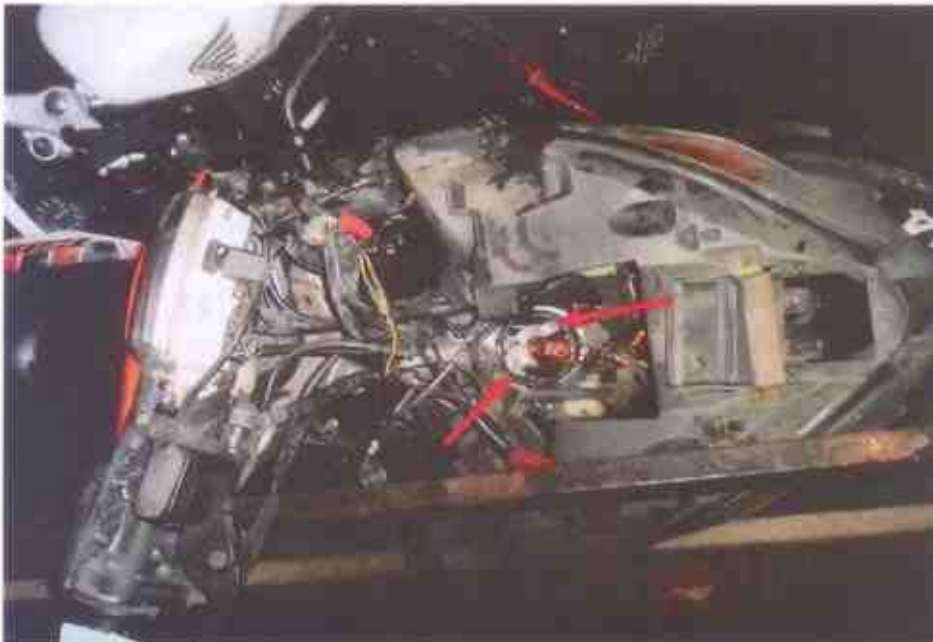
Photo 3 shows a semi close-up view of the front portion of the Motorcycle at the time of our inspection. The Motorcycle was observed to have sustained with relatively extensive impact due to the accident collision. Amongst the body parts damaged was its front steering system (arrowed), which was observed to be broken.

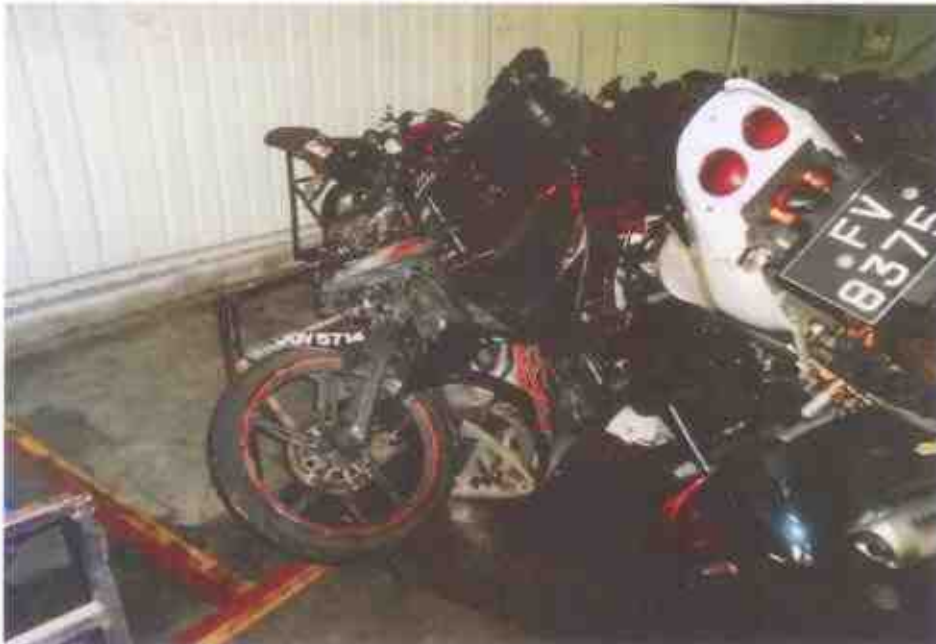
4. The mileage of the Motorcycle at the time of our inspection was recorded at 941217km.
5. The Motorcycle was observed to have sustained severe damages at the frontal portion, along both its left side and right side. The body parts that were found to have been damaged includes its dislodged handle bar, missing wing mirrors, damaged radiator, bent rear brake pedal, left & right fairing and stand amongst others. Its front forks assemblies were also observed to be bent as a result of the accident.

Photo 4 shows a general view of the front portion of the Motorcycle at the time of our inspection. The Motorcycle was observed to have sustained extensive damages at the frontal portion, along both its left side and right side.

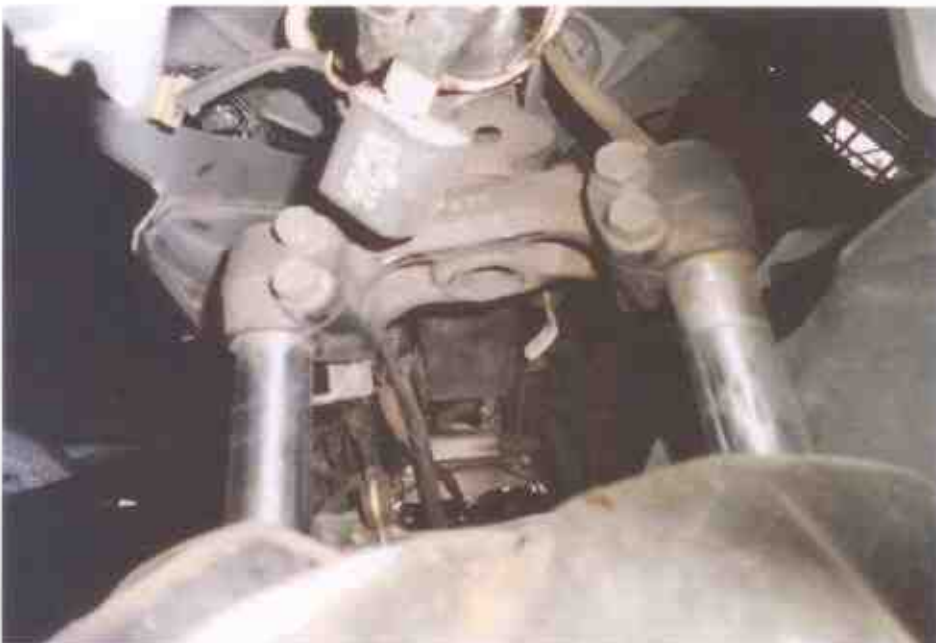
Photo 5 shows a close-up view of the front fork of the Motorcycle at the time of our inspection. It was observed to be bent due to the accident collision.

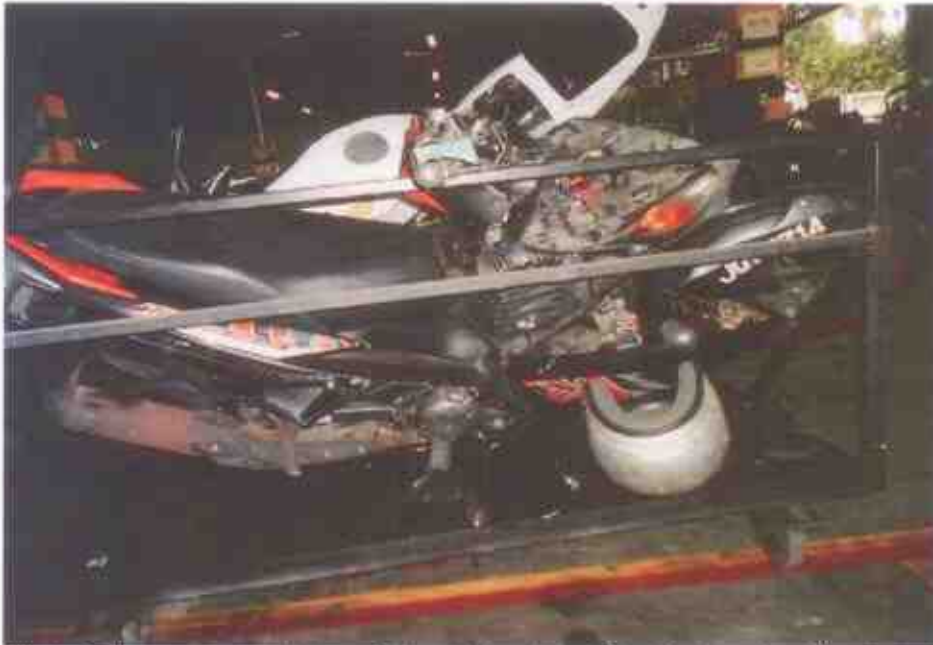
Photo 6 shows a general view of the right portion of the Motorcycle at the time of our inspection. The Motorcycle was observed to have sustained relatively extensive impact including damages to the steering system as a result of the accident collision.

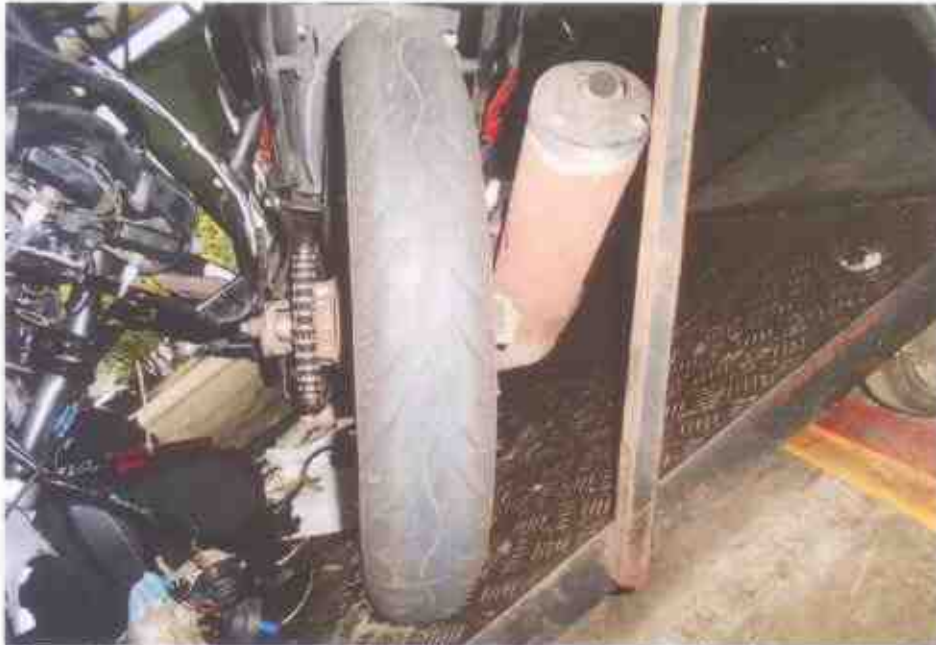
7. The condition of the Motorcycle's rear tyre was observed to be in serviceable condition. The tread pattern of the rear tyre was clearly visible. We did not observe any tear, burst mark(s) and/or punctured hole(s) on the sidewalls as well as across the tread of the rear tyre. The tyre brand, tyre size and remaining tread depth of the 2 tyres were recorded as follows:-

Photo 7 shows the rear tyre of the Motorcycle at the time of our inspection. The rear tyre was observed to be in serviceable condition with remaining tread depth of approximately 3mm. The tyre was also observed to be sufficiently inflated for vehicular operation. There was no significant damage observed on the rear wheel rim & tyre.

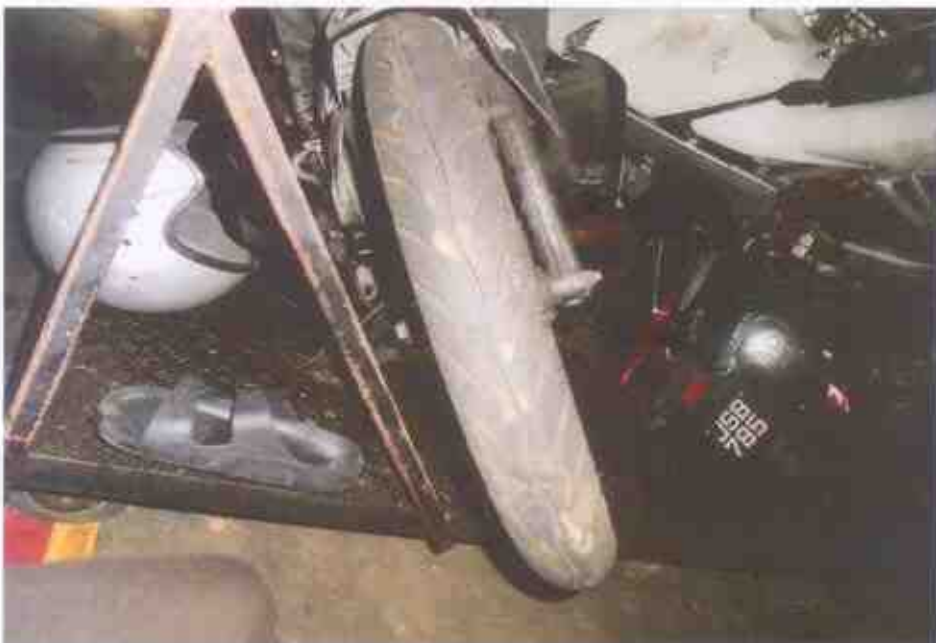
Photo 8 shows the front tyre of the Motorcycle at the time of our inspection. The pattern of the tread was clearly visible with remaining tread depth of approximately 3mm. There was no tear, burst mark(s) and/or punctured hole(s) on the sidewalls as well as across the tread of the front tyre.

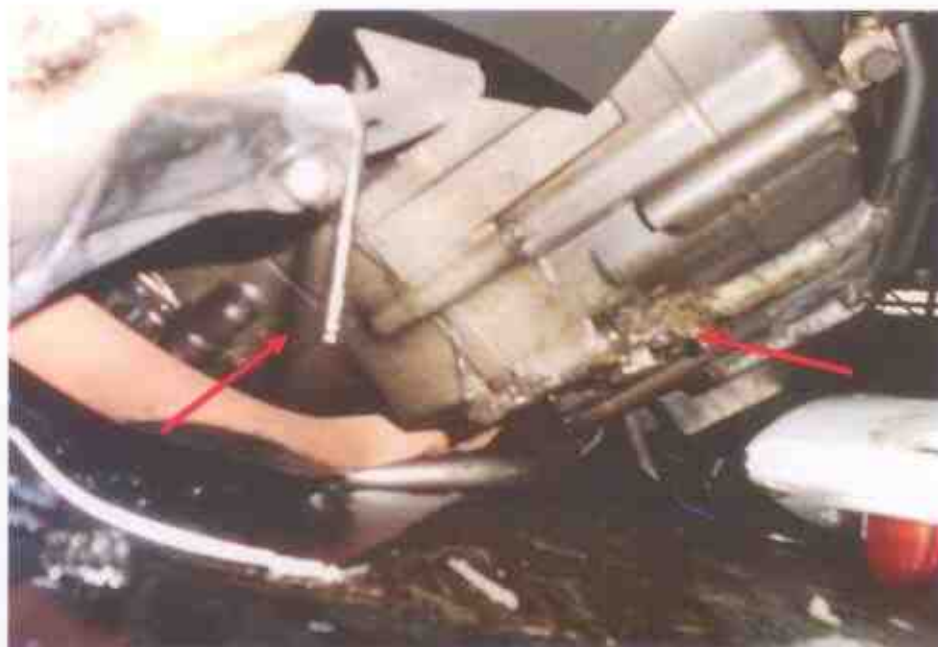
9. Upon examination of the engine area of the Motorcycle, we had observed that the various engine related parts and components were intact with no visible damage except for radiator was observed to be damaged as a result of the accident. The engine underside was however observed to be covered with brownish fluid, suggesting leakage of fluid as a result of the accident.
10. The gear chain of the Motorcycle was found to be intact without any misalignment. It was also adequately lubricated for operating purposes. See photo 9 – 13 below.

Photo 9 shows sign(s) or indication(s) of fluid leakage observed around the engine's underside area of the Motorcycle.

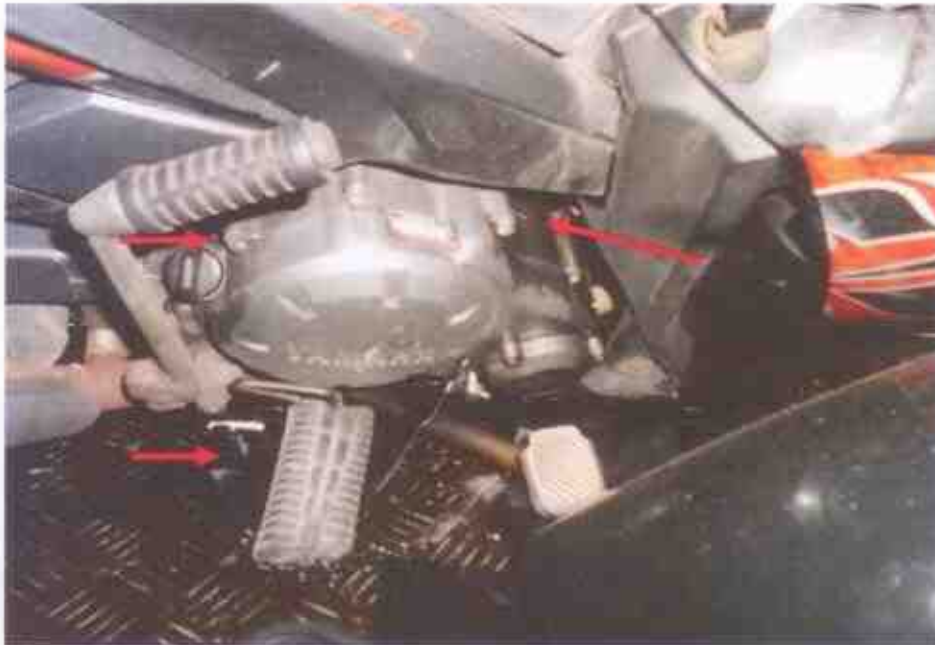
Photo 10 shows sign(s) or indication(s) of fluid leakage observed around the engine's area & fluid stain on the floor right under the engine pan of the Motorcycle.

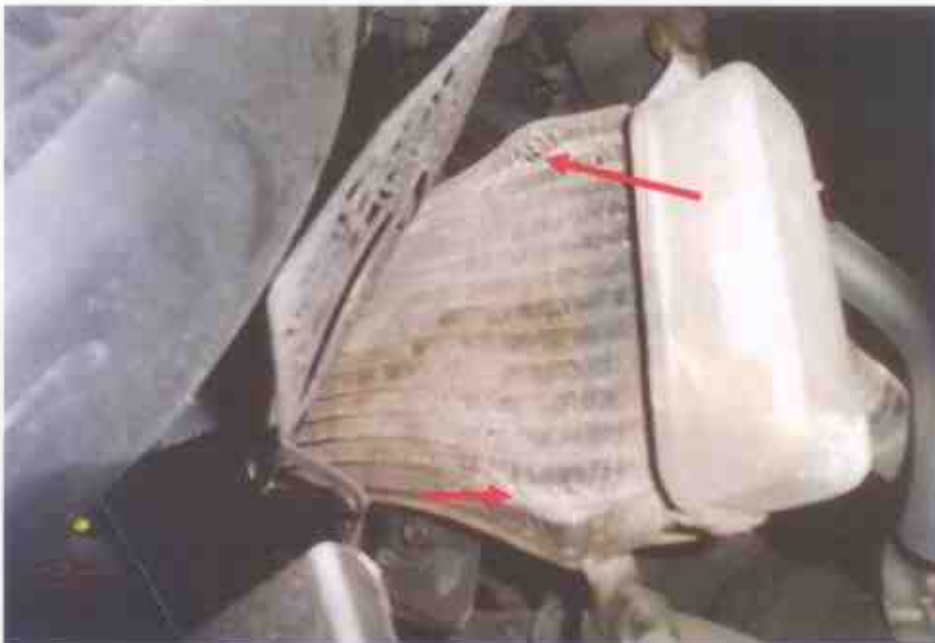
Photo 11 shows the close-up view of the corrugated radiator as a result of the accident's impact collision.

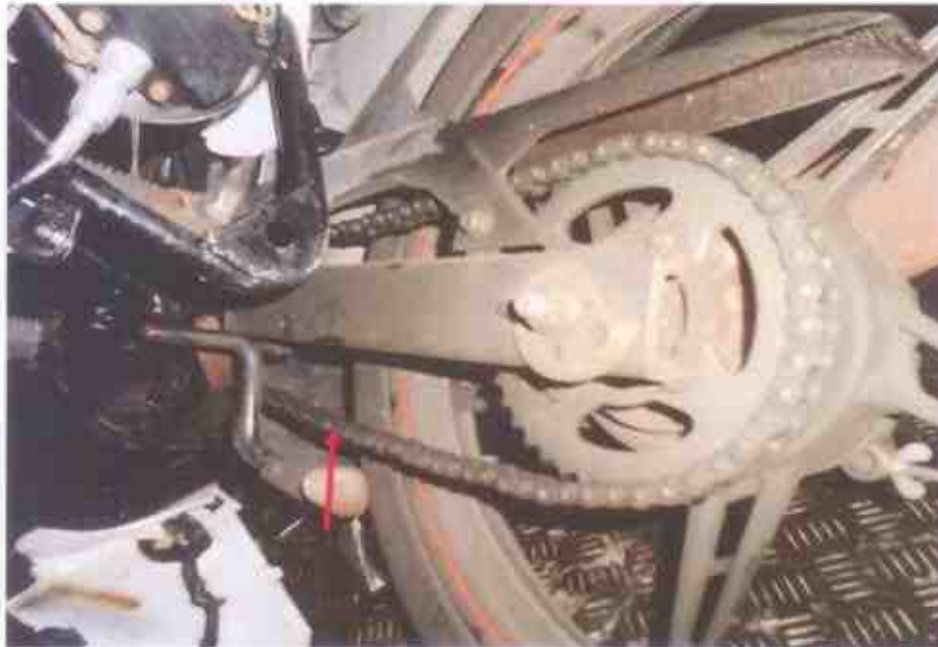
Photo 12 shows the general view of the gear train (arrowed) of the Motorcycle, which was observed to be intact with no misalignment. It was also adequately lubricated for operating purposes.

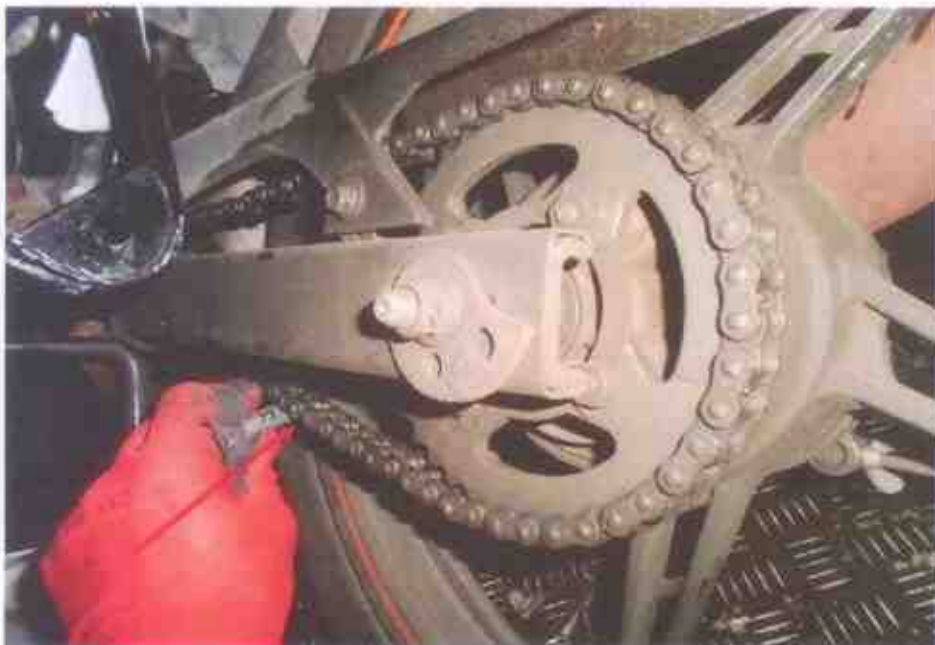
Photo 13 shows the general view of the gear train (arrowed) of the Motorcycle, which was observed to be intact with no misalignment. It was also adequately lubricated for operating purposes.

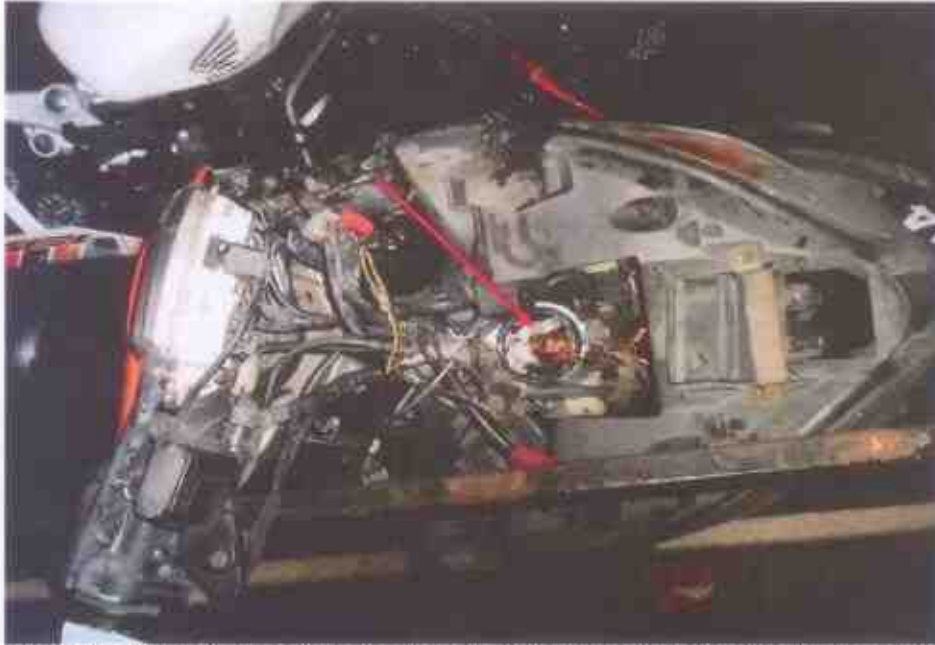
Photo 14 shows the handle bar (arrowed) was observed to be dislodged from the original installation as a result of the accident.

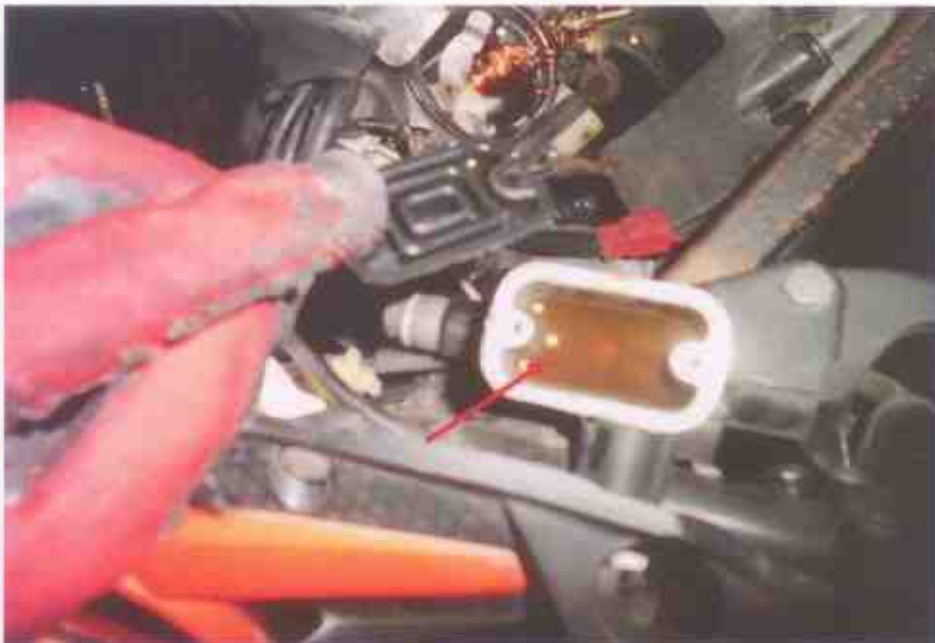
Photo 15 shows the front brake fluid reservoir (arrowed) was observed to be unaffected by the accident. It was observed to be of sufficient level & not contaminated at the time of our inspection.

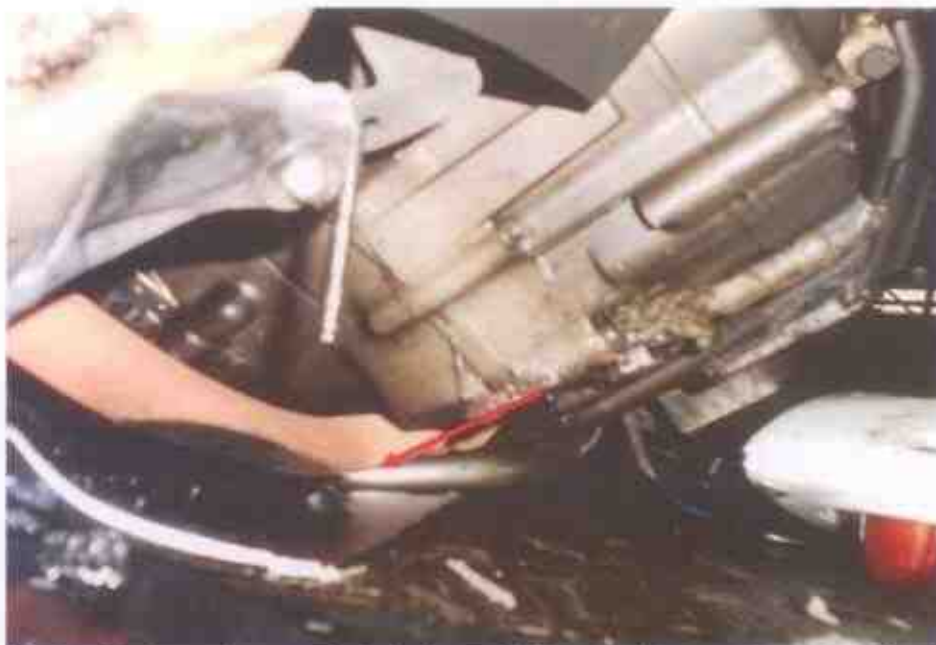
13. A static brake test for the rear brake was unable to be conducted due to damage on some supporting components & damaged foot brake pedal due to the accident's impact collision.

Photo 16 shows the rear foot brake pedal (arrowed) was observed to be in damaged due to the accident's impact collision.

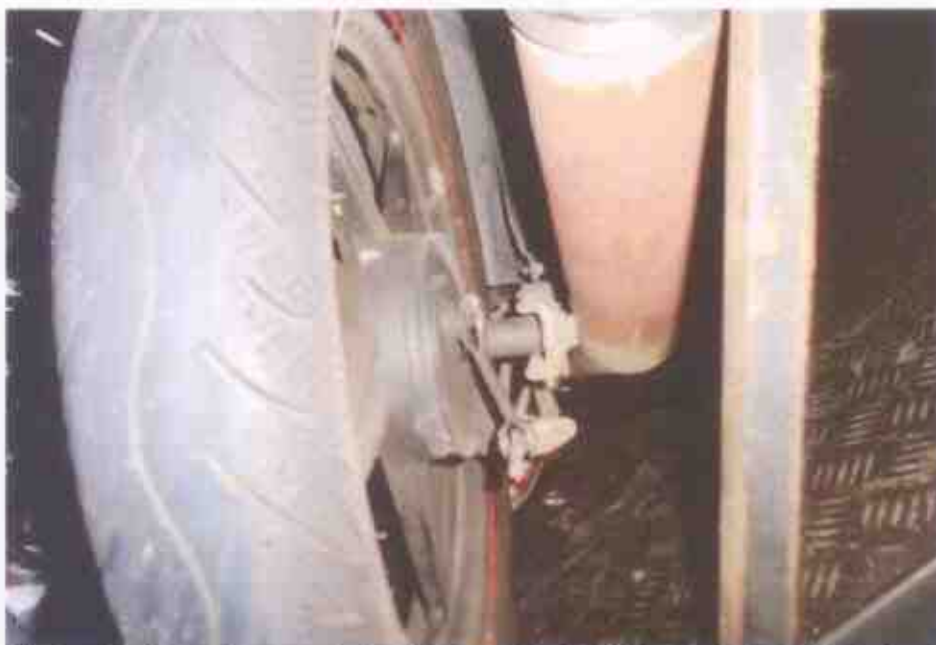
Photo 17 shows the rear brake drum spring & cable was observed to be in serviceable condition unaffected by the accident despite the damage sustained on the foot brake pedal.

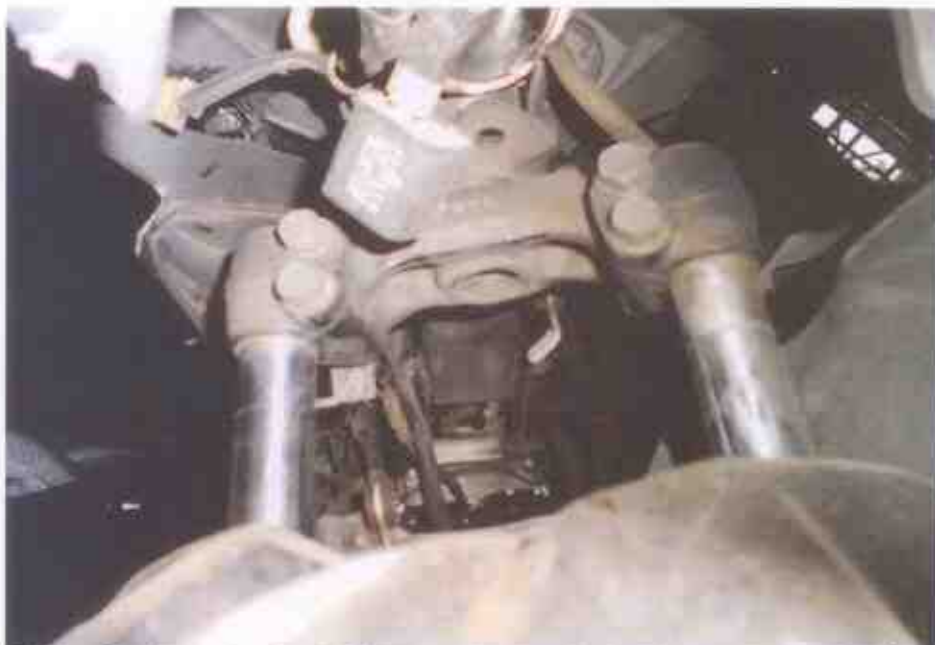
11. For this case, we were not able to conduct any test(s) on the steering system of the Motorcycle due to the damages on its handle bar and front fork. It was found to be damaged as a result of the accident, hence causing the whole steering system to be in a state of immobility.

Photo 18 shows the front fork was observed to be bent as a result of the accident. Hence, we are unable to conduct any tests on the steering system of the Motorcycle.
