Your Ref: TP/IP/45327/2018
Our Ref : CI/TPD18016120/Z

03rd January 2019

MECHANICAL INSPECTION REPORT OF MOTOR LORRY GBF 3128R

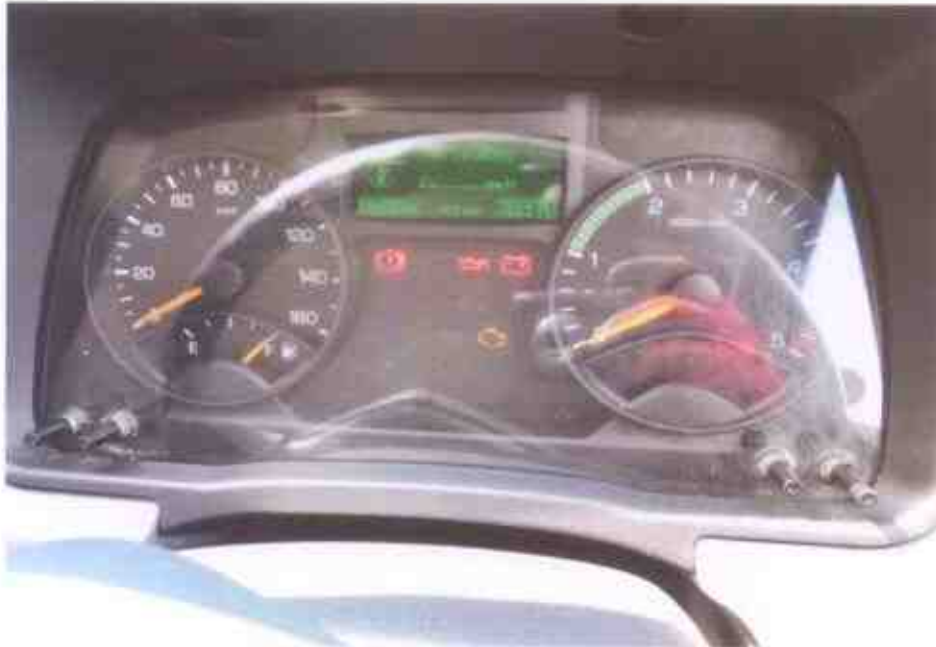
Photo 1 shows the mileage of the Motor Lorry at the time of our inspection was recorded as 36370km.

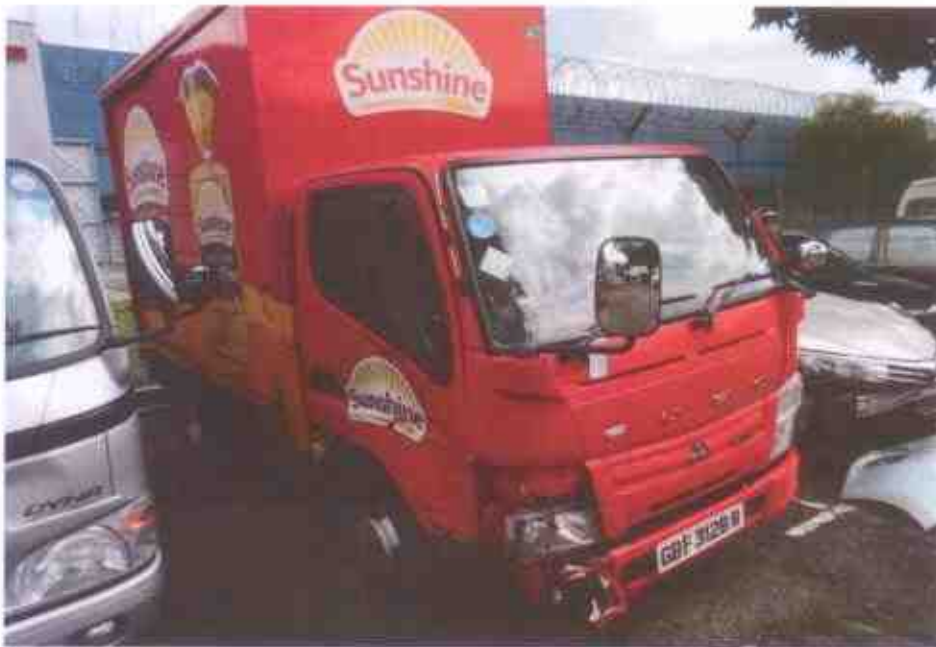
Photo 2 shows a general view of the front portion of the Motor Lorry at the time of our inspection. The Motor Lorry was observed to have sustained minor damages at its front right headlamp, front right lower bumper and its right driver door were amongst the body parts that were damaged as a result of the accident.

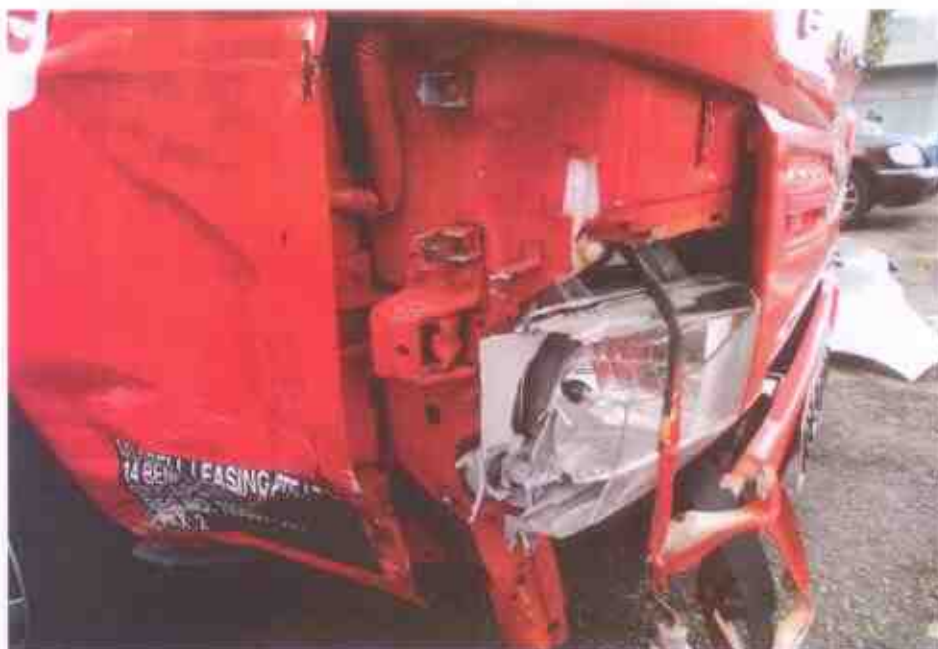
Photo 3 shows a damaged headlamp, lower bumper and right door likely due to the accident's impact.

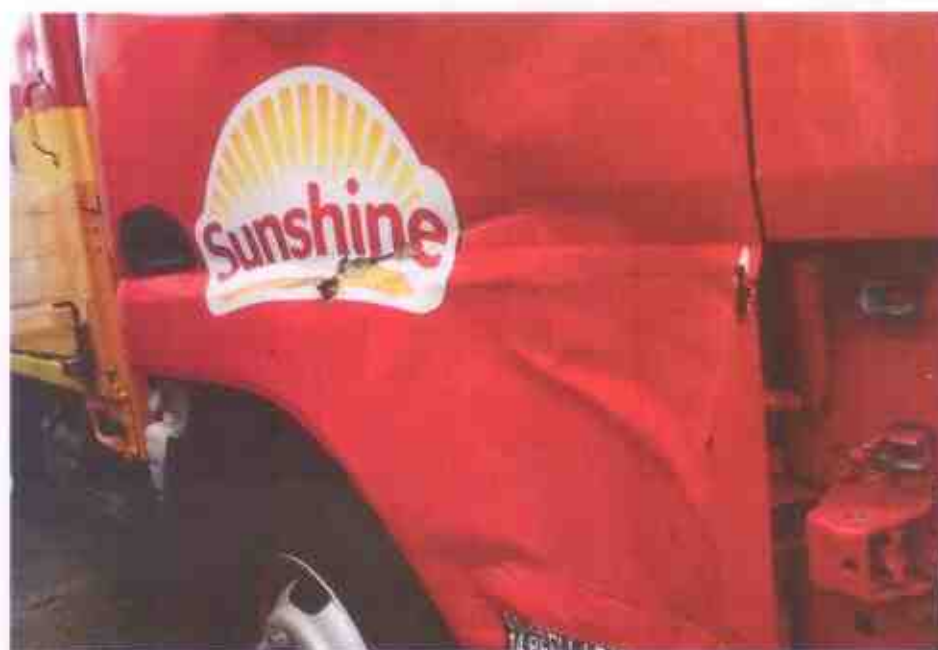
Photo 4 shows the close-up view of the damaged right door of the Motor Lorry. It was observed to have sustained damages as a result of the accidents.

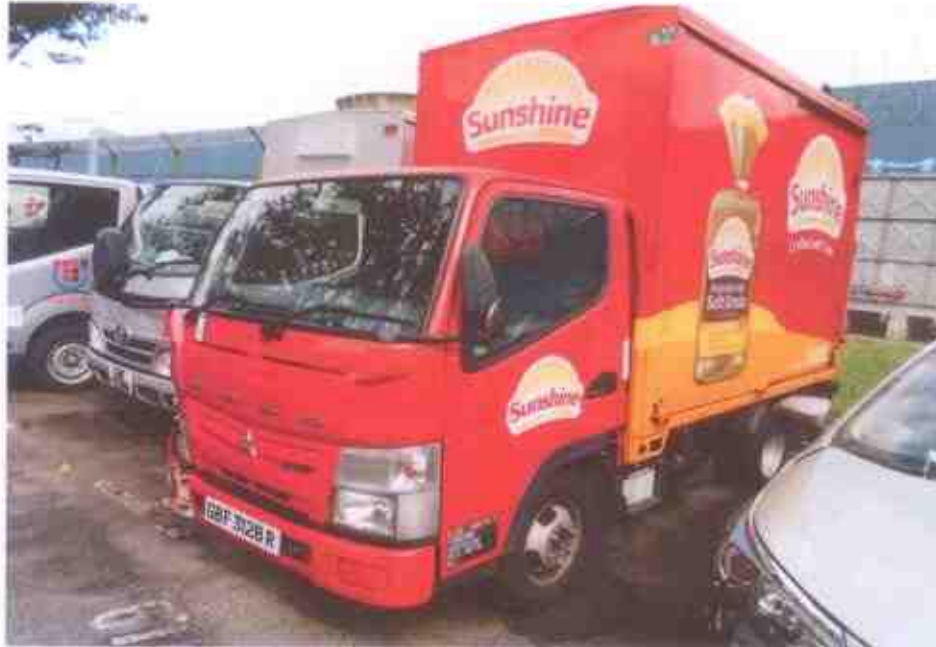
Photo 5 shows a general view of the front left portion of the Motor Lorry at the time of our inspection. The Motor Lorry was observed to be in good condition unaffected by the accident's impact.

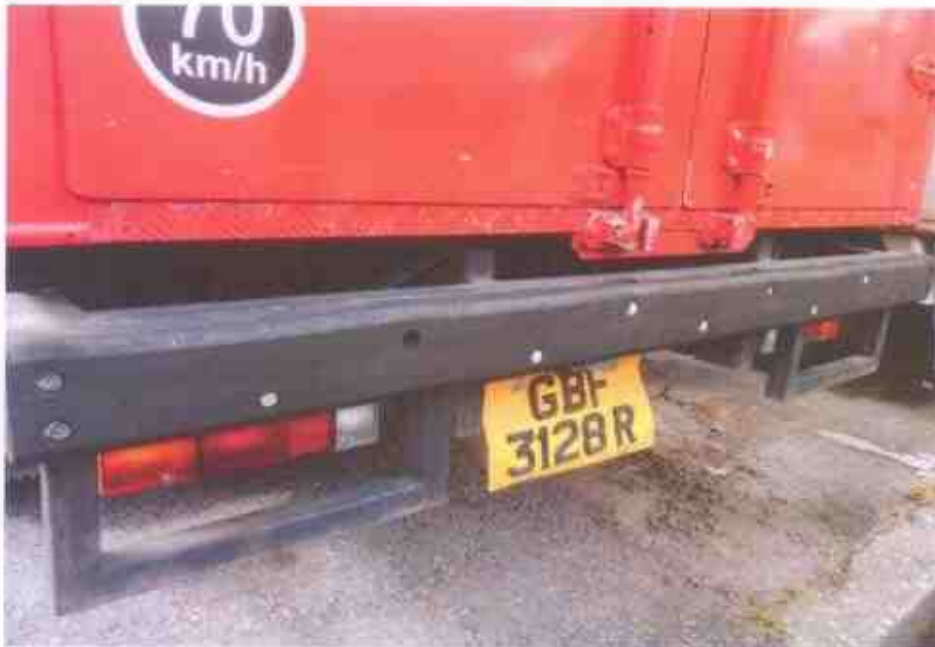
Photo 6 shows a general view of the Motor Lorry's rear body at the time of our inspection. There was no damage found to the rear portion of the Motor Lorry.

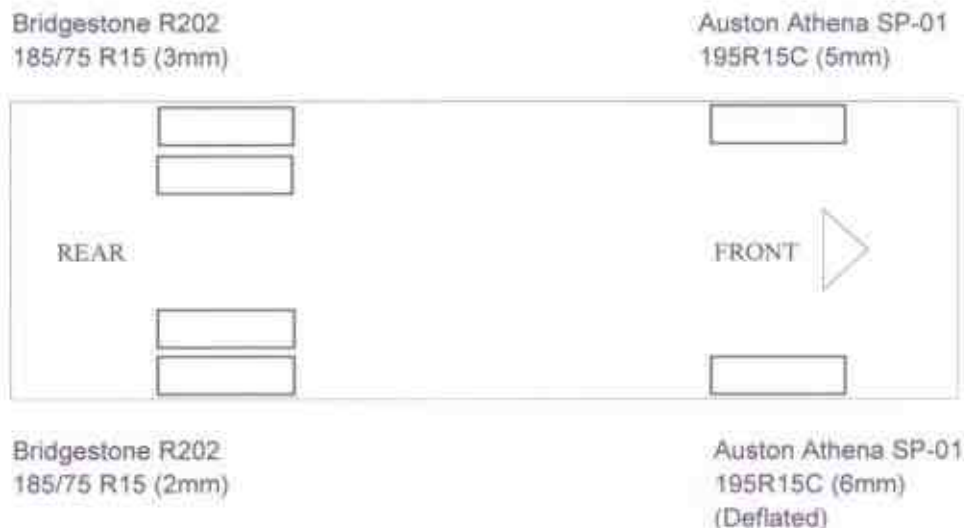
6. The front left tyre and 4 rear tyres of the Motor Lorry were observed to be in serviceable condition and sufficiently inflated for vehicular operation. We did not find any tear, cut or burst mark(s) on the outer and the inner sidewalls as well as across the tread of the 5 tyres.
7. As for the front right tyre it was observed to be torn at the outer sidewall as a result of the accident's impact collision. It was also found to be deflated at time of our examination.
8. The tyre brand, tyre size and remaining tread depth of the 6 tyres of the Motor Lorry were recorded as follows:-

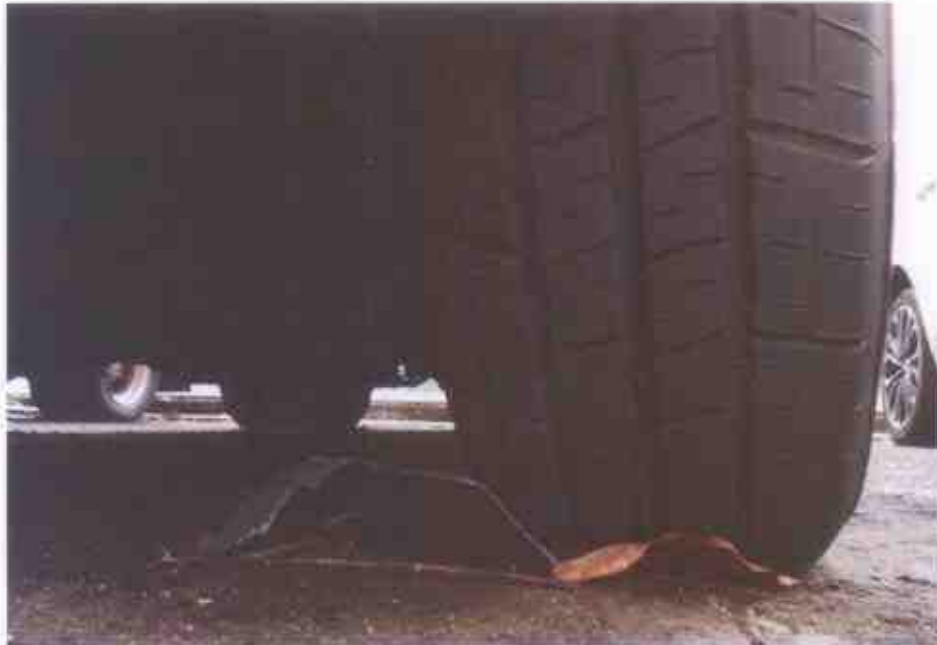
Photo 7 shows the condition of the front left tyre of the Motor Lorry, which was observed to be in serviceable condition with remaining tread depth of approximately 5mm. The tyre, which was wrapped around standard alloy wheel rim, was also observed to be sufficiently inflated for vehicular operation.

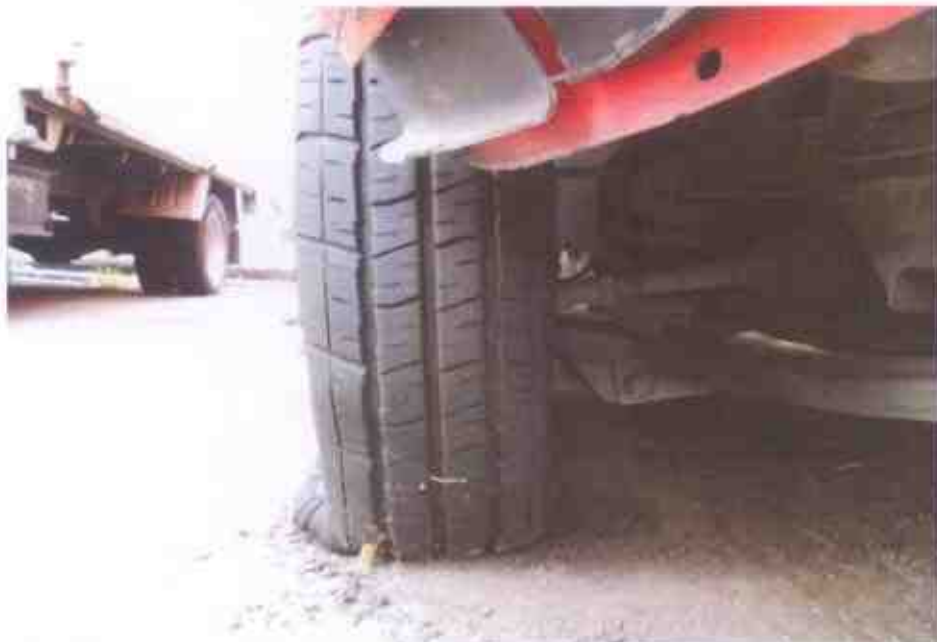
Photo 8 shows the condition of the front right tyre of the Motor Lorry, which was observed to be deflated & torn at the outer sidewall as a result of the accident. The remaining tread depth was measured at approximately 6mm.

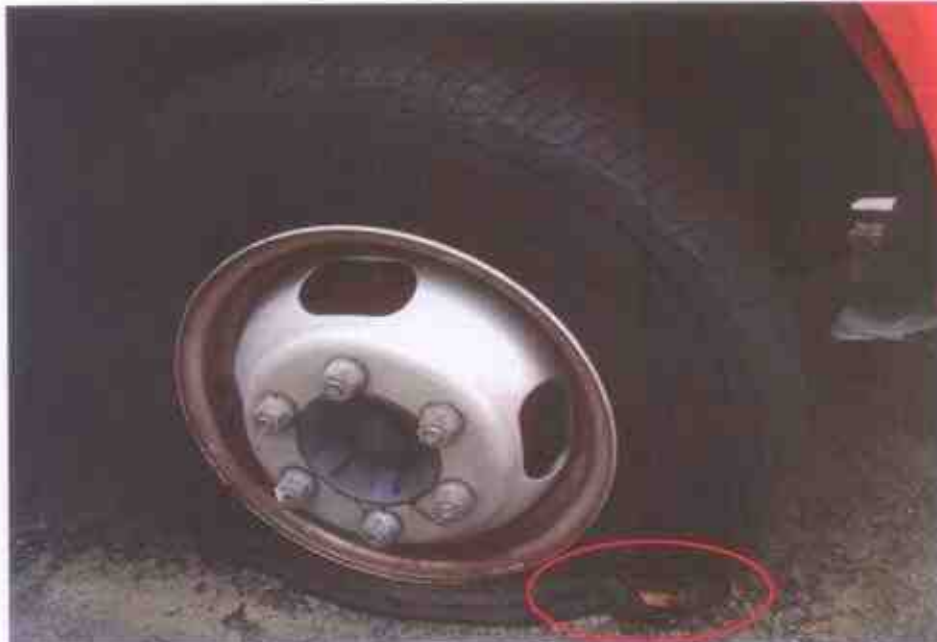
Photo 9 shows the condition of the front right tyre of the Motor Lorry, which was observed to be deflated & torn at the outer sidewall as a result of the accident. The remaining tread depth was measured at approximately 6mm.

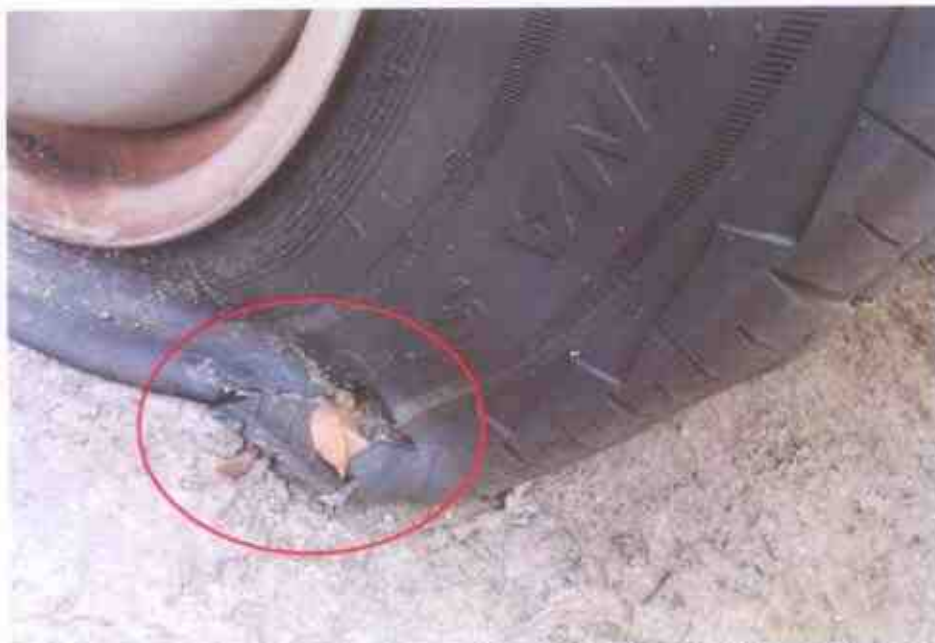
Photo 10 shows the close-up view condition of the front right tyre of the Motor Lorry, which was observed to be deflated & torn at the outer sidewall as a result of the accident. The remaining tread depth was measured at approximately 6mm.

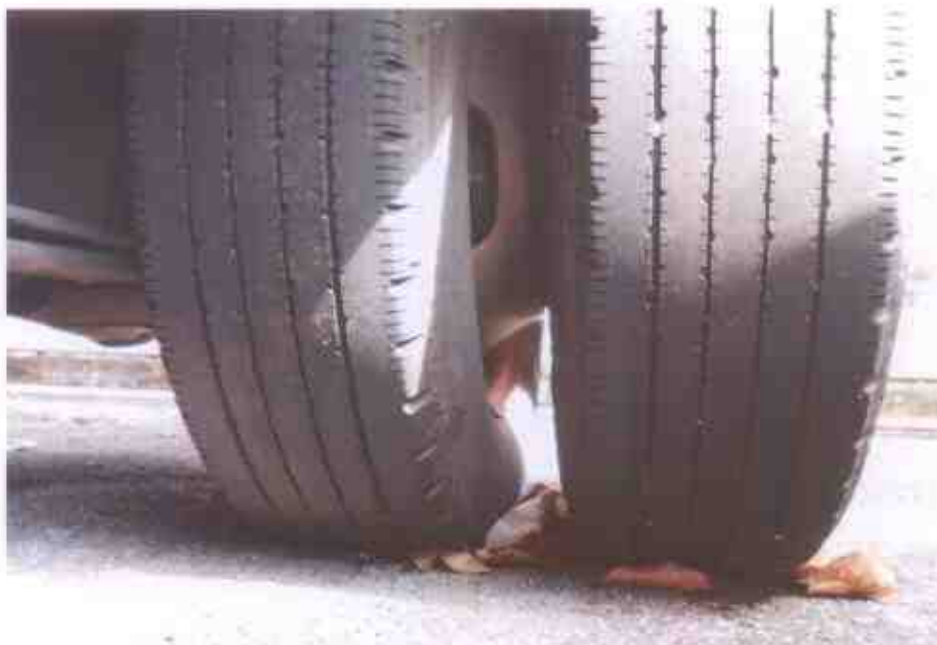
Photo 11 shows the condition of the rear left tyres of the Motor Lorry, which was observed to be in serviceable condition with remaining tread depth of approximately 3mm. The tyres, which were wrapped around standard alloy wheel rim, were also observed to be sufficiently inflated for vehicular operation.

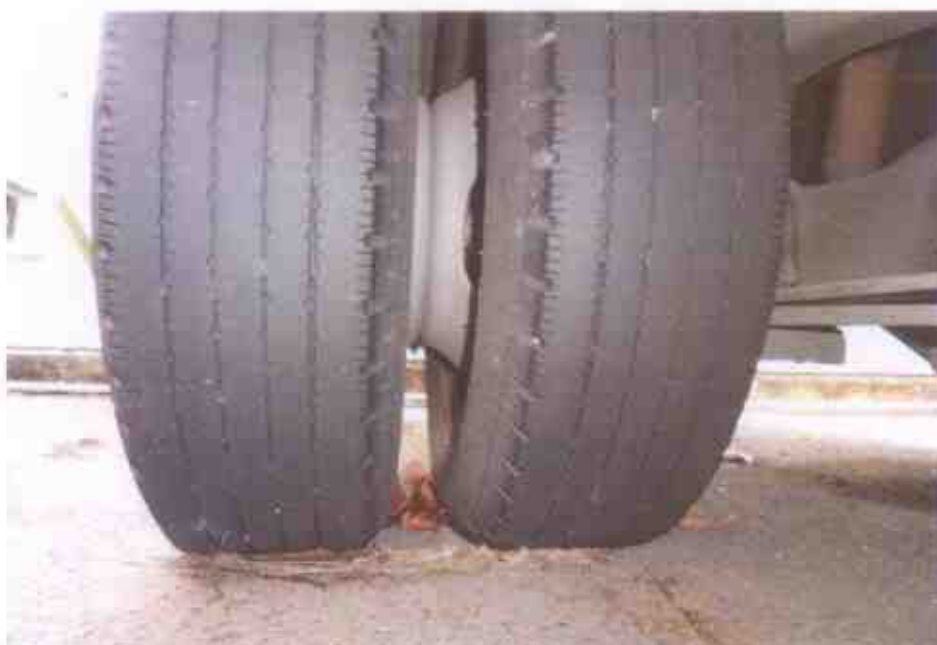
Photo 12 shows the condition of the rear right tyres of the Motor Lorry, which were observed to be in serviceable condition with remaining tread depth of approximately 2mm.

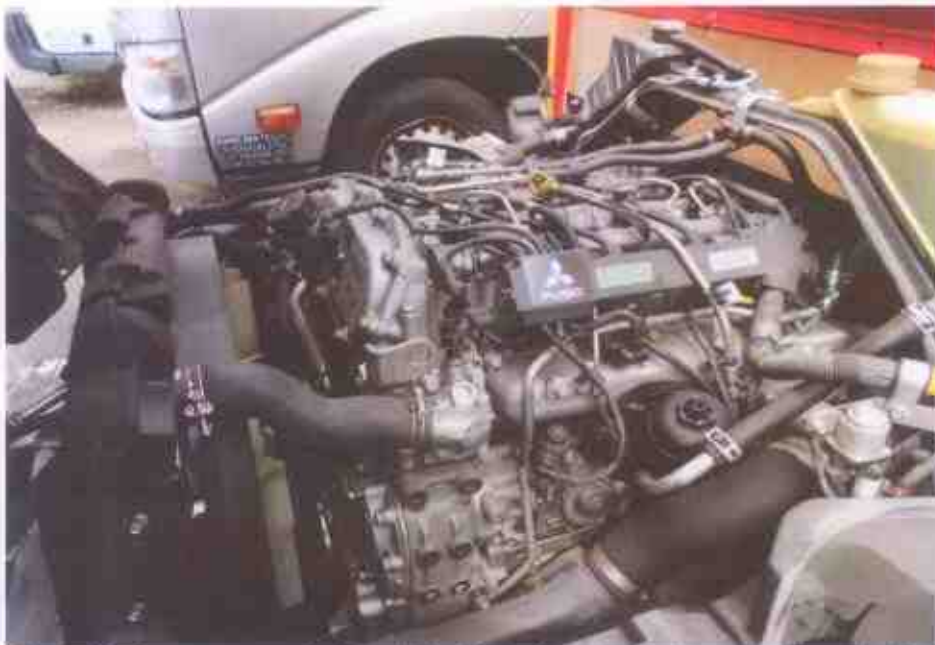
Photo 13 shows a general view of the Motor Lorry's engine compartment, which was accessed by lifting the front cabin of the Motor Lorry. The various parts and components inside the engine compartment were unaffected by the accident. There was also no sign(s) or indication(s) of fresh fluid leakage and/or fluid stain within the engine.

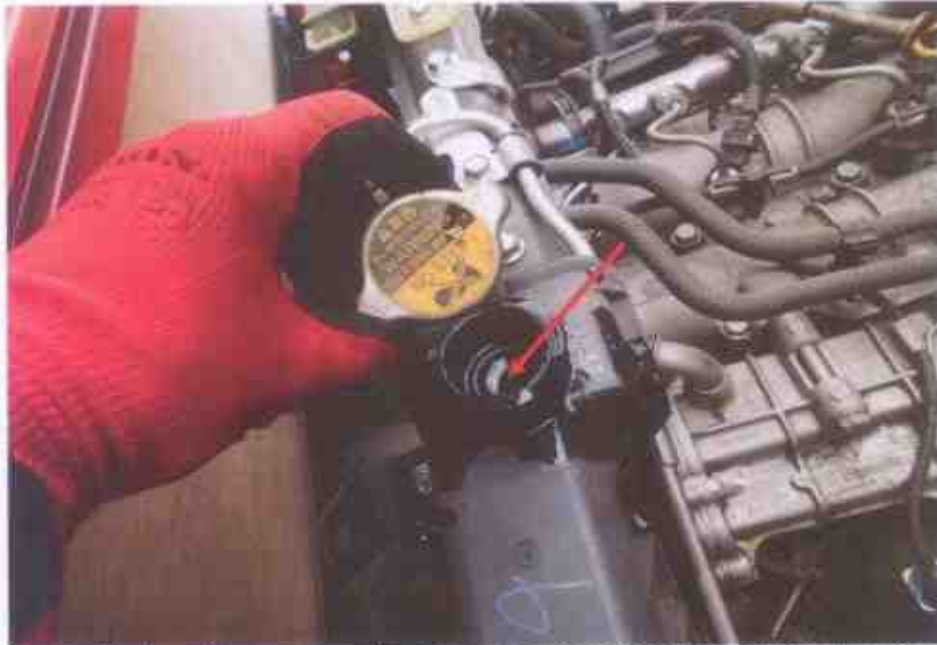
Photo 14 shows the engine coolant reservoir of the Motor Lorry at the time of our inspection. The engine coolant was observed to be of sufficient level and without any visible contamination (arrowed).

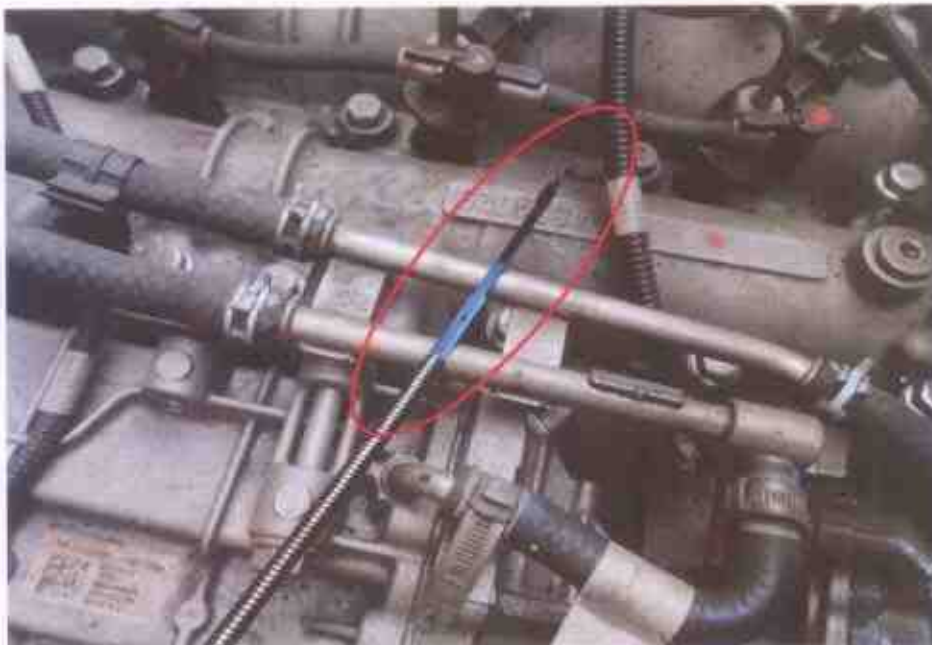
Photo 15 shows the engine dip stick of the Motor Lorry at the time of our inspection. The engine oil was observed to be of sufficient level and without any visible contamination (circled).

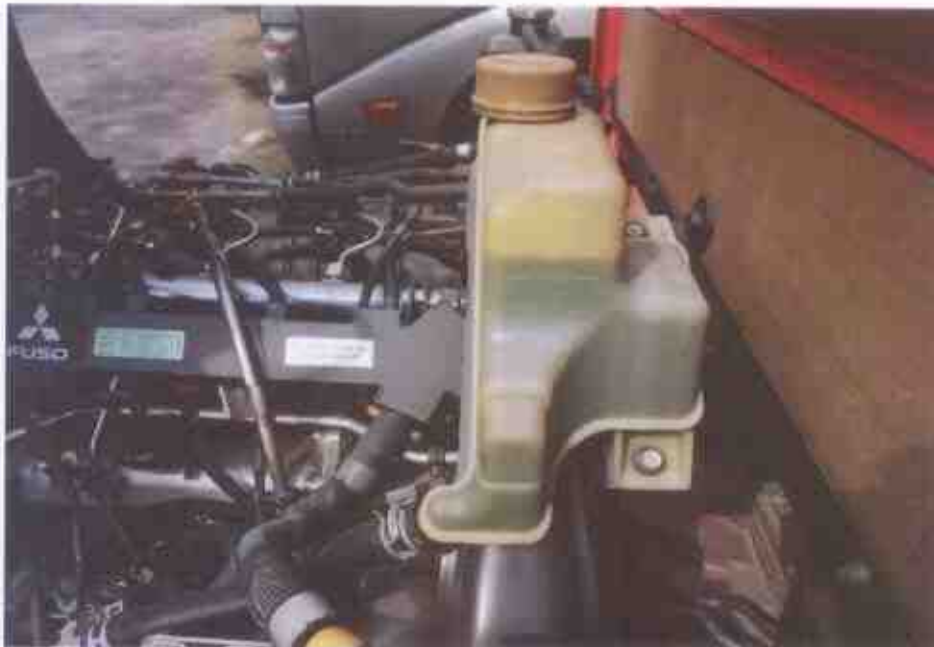
Photo 16 shows the power steering fluid of the Motor Lorry at the time of our inspection. The fluid was observed to be of sufficient level and without any visible contamination.

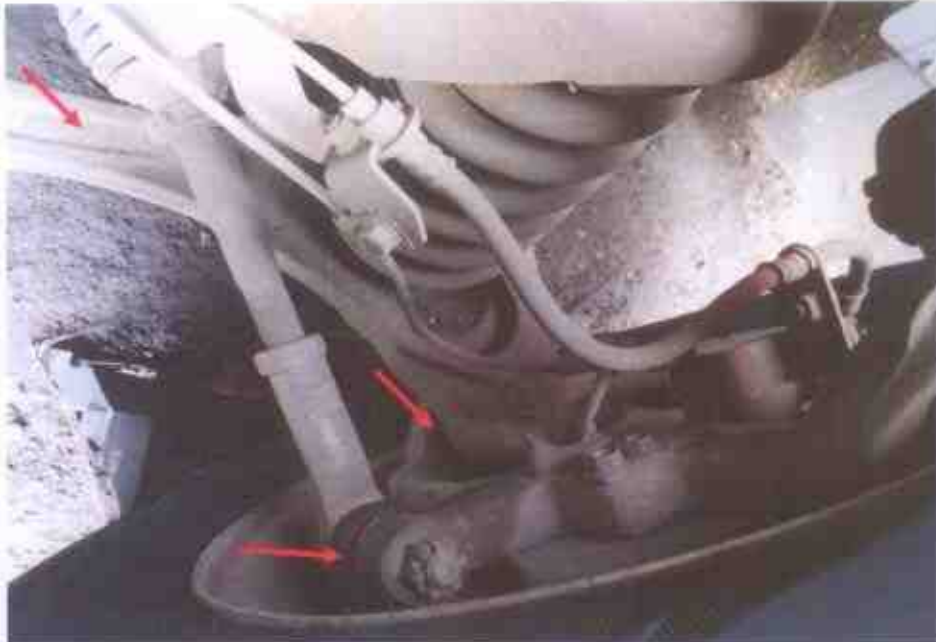
Photo 17 shows the various undercarriage components at the front left wheel of the Motor Lorry, in particular the steering tie rod end (arrowed). The various undercarriage components of the Motor Lorry were all found to be intact without any visible damage. There was also no sign of fluid stain(s) observed on the various undercarriage components.

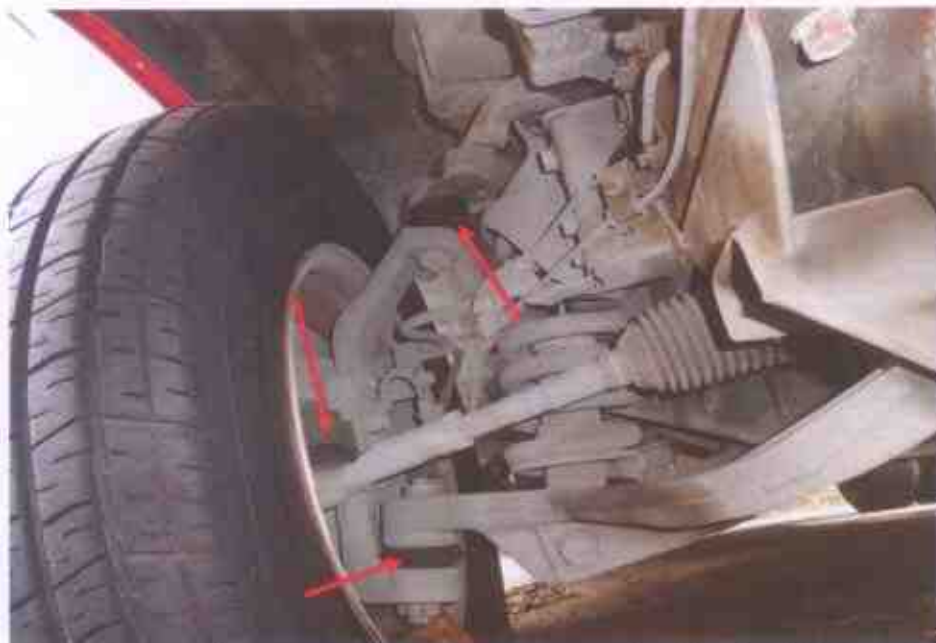
Photo 18 shows the various undercarriage components at the front right wheel of the Motor Lorry, in particular the steering tie rod end (arrowed). The various undercarriage components of the Motor Lorry were all found to be intact without any visible damage. There was also no sign of fluid stain(s) observed on the various undercarriage components.

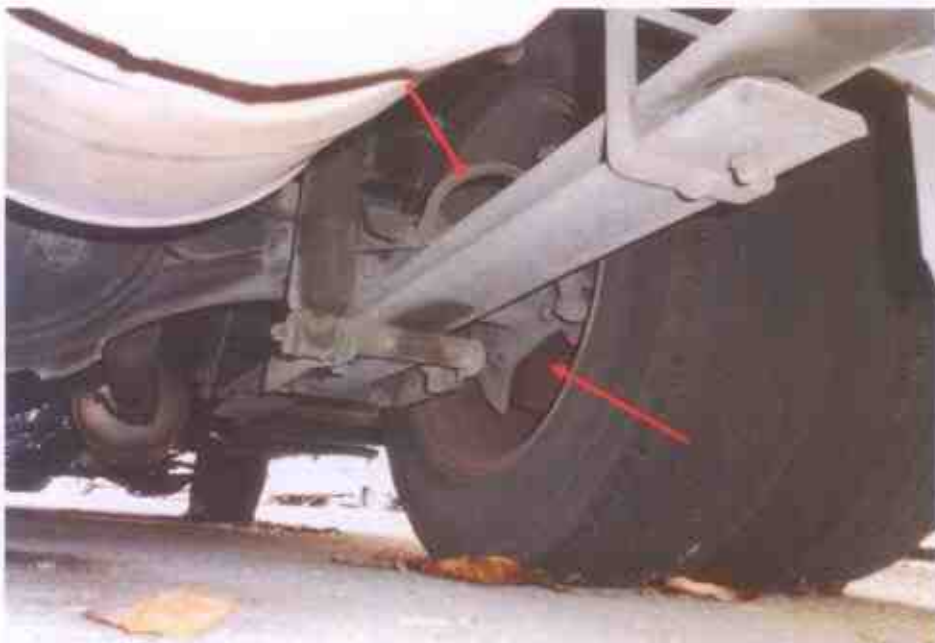
Photo 19 shows the various undercarriage components at the rear right wheels of the Motor Lorry. There was no sign(s) of brake fluid leakage along the brake hoses and brake pipes.

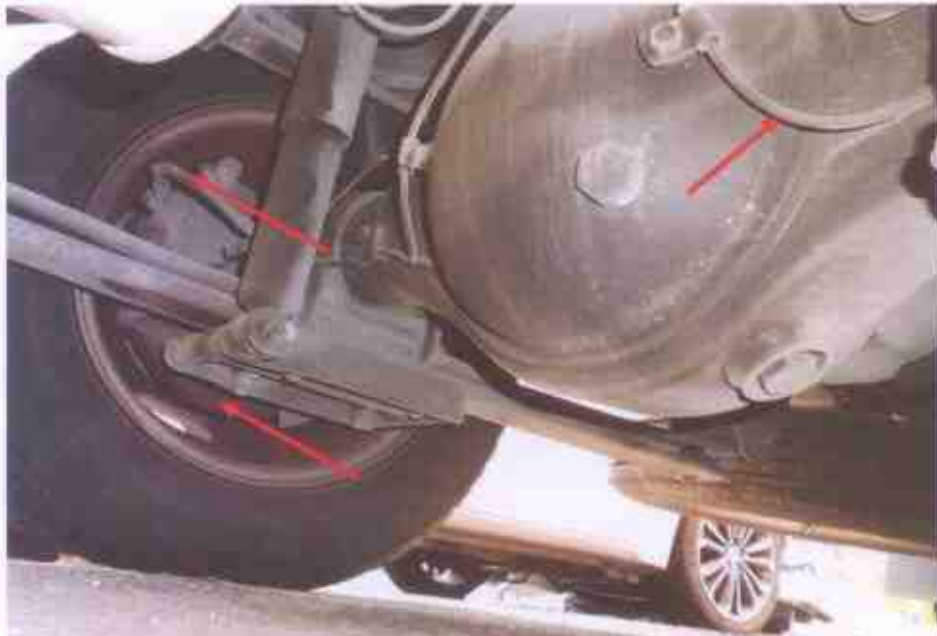
Photo 20 shows the various undercarriage components at the rear left wheels of the Motor Lorry. There was no sign(s) of brake fluid leakage along the brake hoses and brake pipes.

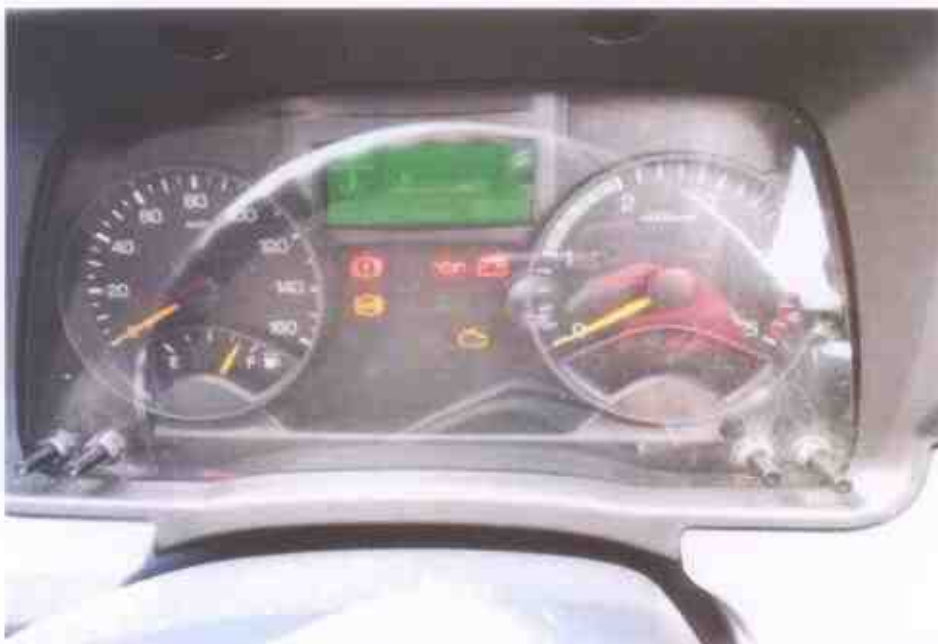
Photo 21 shows the warning lights for the various electronic operating systems of the Motor Car appearing on its instrument panel during the self-test when the engine was cranked.

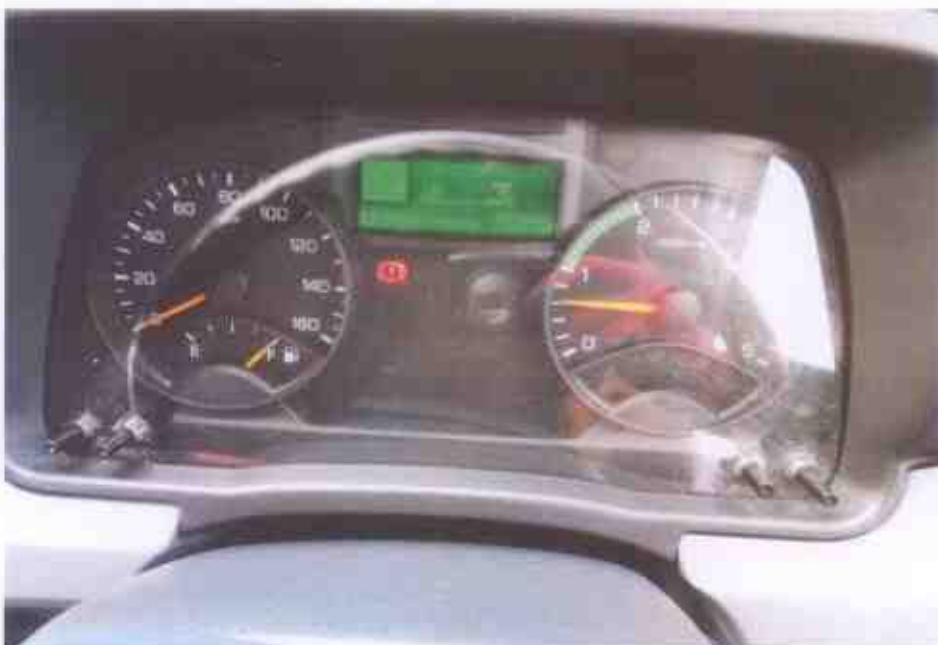
Photo 22 shows no warning lights illuminated on the instrument panel of the Motor Van after the engine was cranked. This would suggest that there was no abnormality to the various electronic operating systems of the Motor Car.

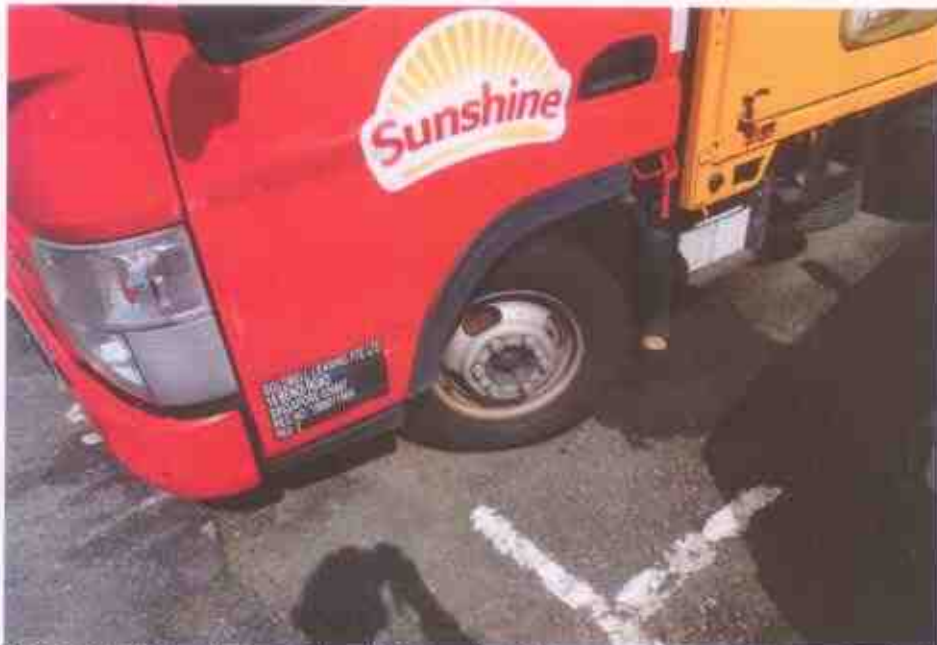
Photo 23 shows the operational test on the Motor Lorry. It was observed to be in serviceable condition. Operational test such as moving forward, turn left & right and also braking test on the Motor Lorry was conducted successfully.

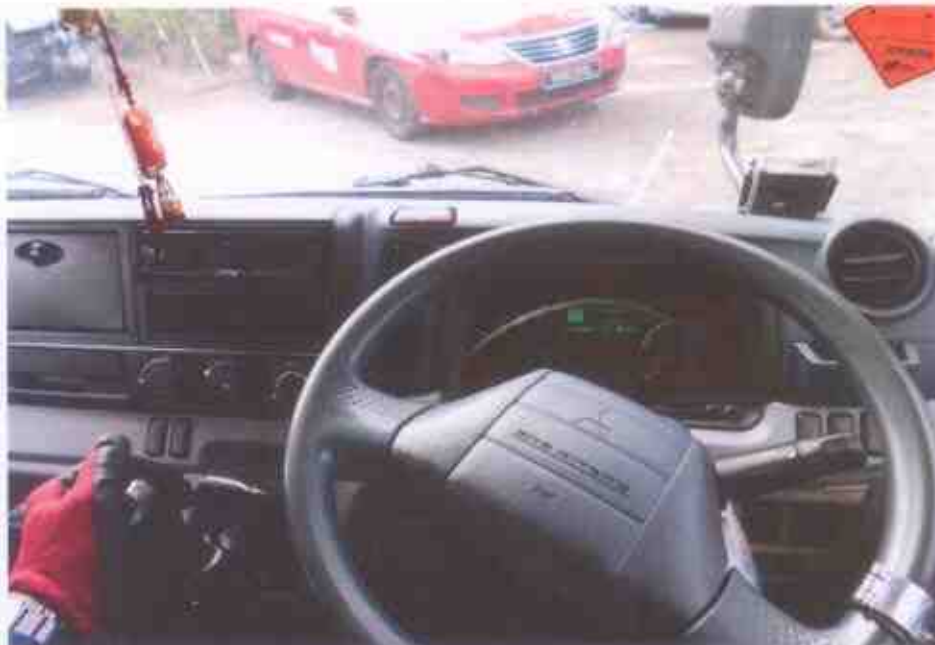
Photo 24 shows the operational test on the Motor Lorry. It was observed to be in serviceable condition. Operational test such as moving forward, reverse, turn left & right and also braking test on the Motor Lorry was conducted successfully.
