Your Ref: TP/IP/45327/2018
Our Ref :CI/TPD18016121/Z

10th October 2018

MECHANICAL INSPECTION REPORT OF MOTORCYCLE JSU 8134

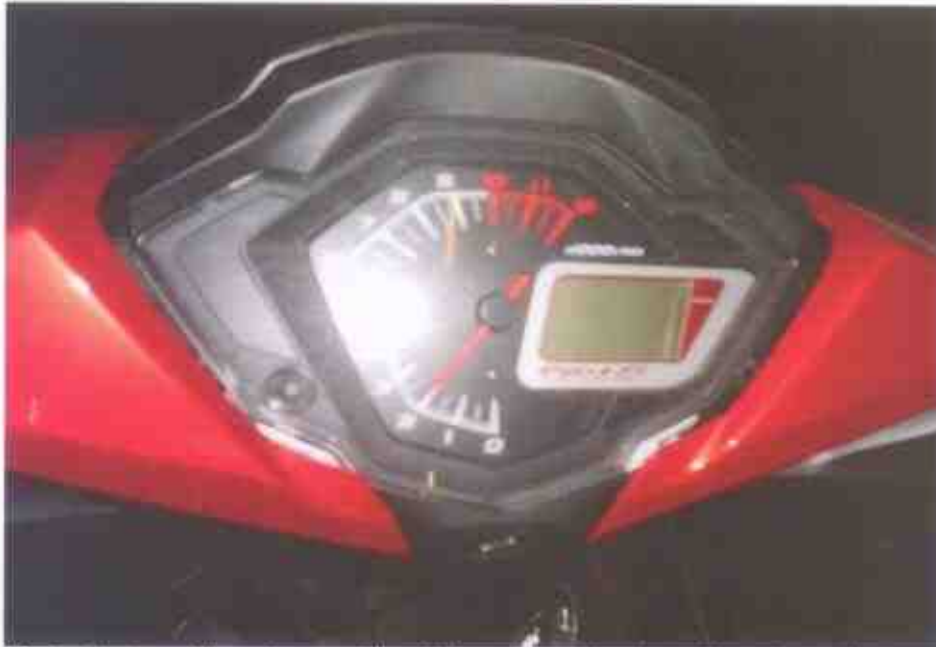
Photo 1 shows the mileage of the Motorcycle at the time of our inspection was not recorded due to damages sustained on the ignition system of the Motorcycle.

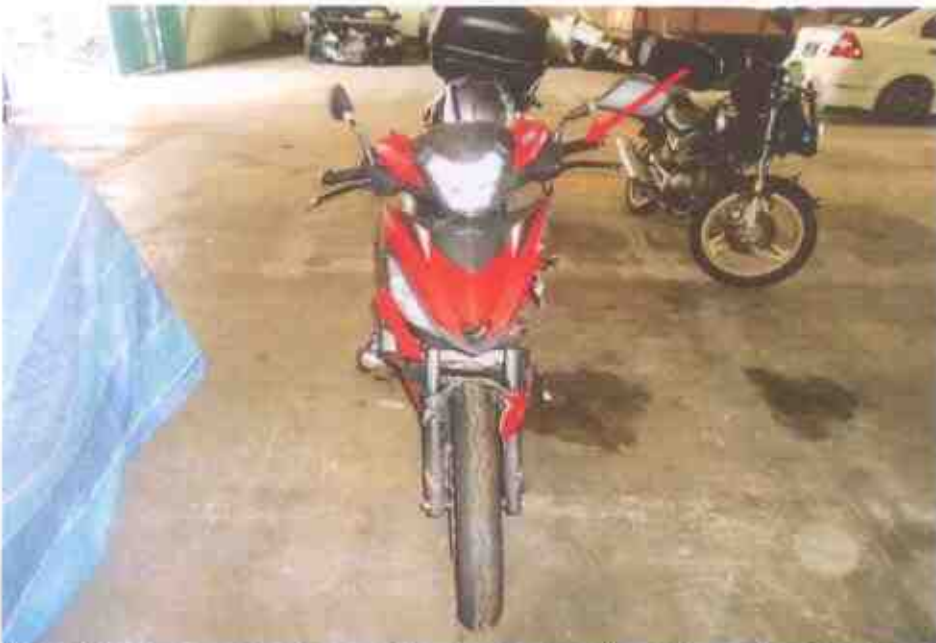
Photo 2 shows a general view of the front body of the Motorcycle at the time of our inspection. The Motorcycle was observed to be sustained with relatively extensive impact due to the accident collision. Amongst the body parts damaged was its handle bar (arrowed), which was observed to be misaligned.

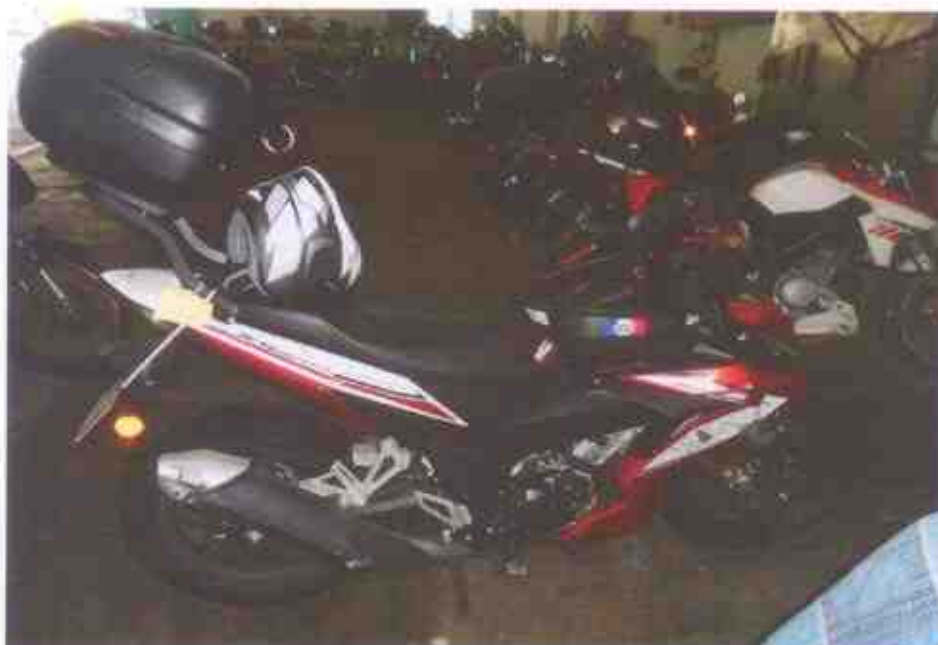
Photo 4 shows a general view of the right side portion of the Motorcycle at the time of our inspection. The Motorcycle was observed to be sustained relatively minor impact on the right side portion likely due to the accident collision.

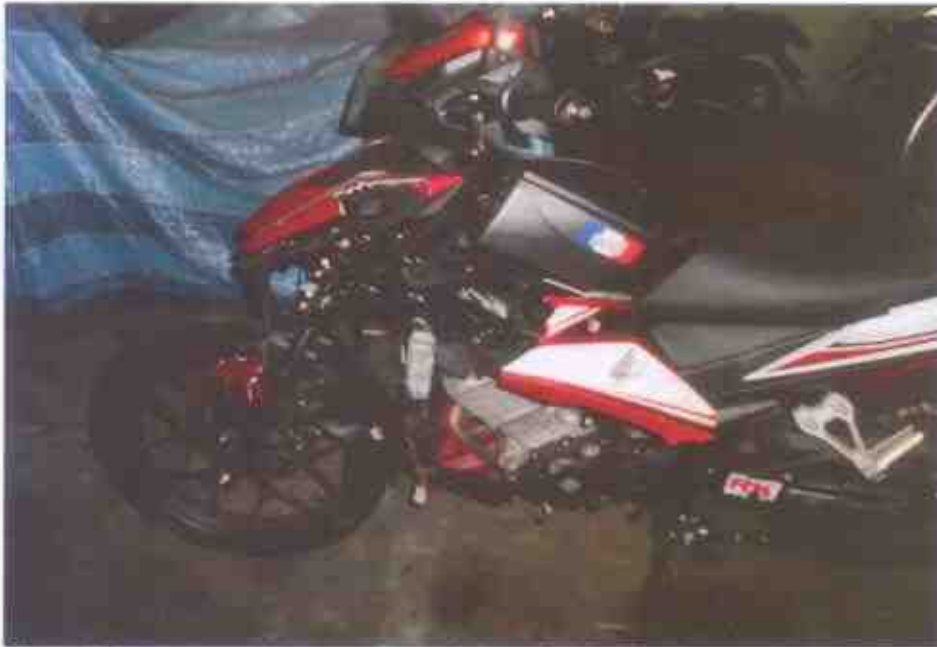
Photo 5 shows a semi close-up view of the left side of the Motorcycle at the time of our inspection. It was observed to have sustained with extensive damages on the ignition system, left-side fairing, left signal lamp & shift gear pedal/ foot rest due to the accident collision.

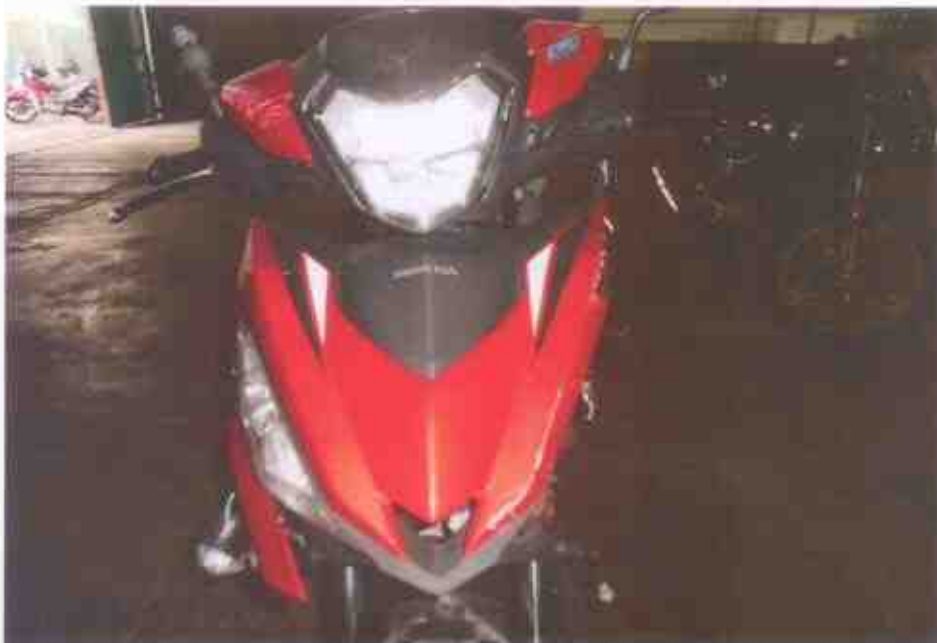
Photo 6 shows a close-up view of the handle bar of the Motorcycle at the time of our inspection. It was observed to have sustained with misalignment due to the accident collision.

10. For this case, we were not able to conduct any test(s) on the steering system of the Motorcycle due to the damage on its handle bar. The handle bar was found to be misaligned as a result of the accident, hence causing the whole steering system to be in a state of immobility.

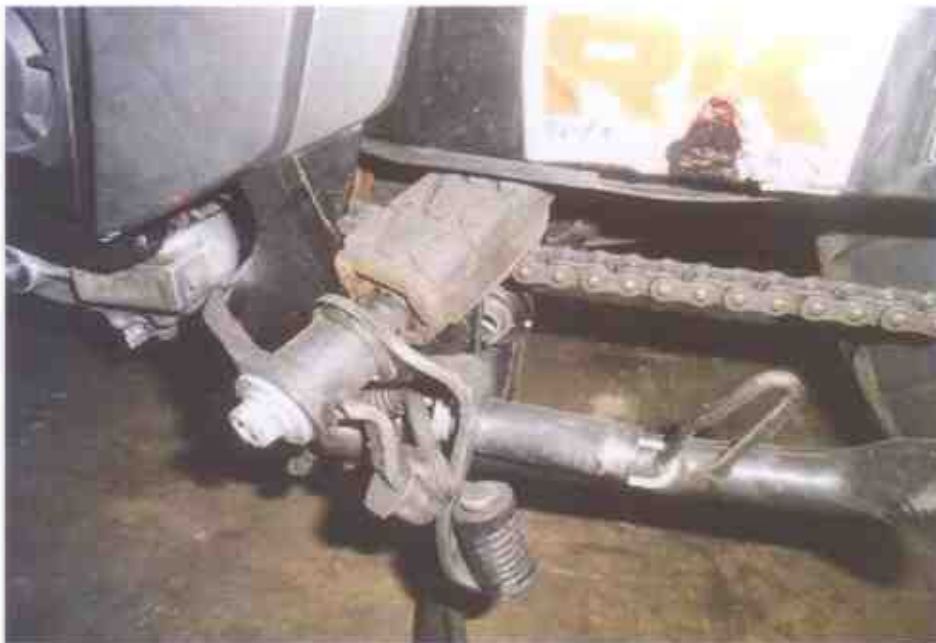
Photo 8 shows a close-up view of the stuck foot pedal in between the gear chain of the Motorcycle at the time of our inspection. It was likely due to the accident collision.

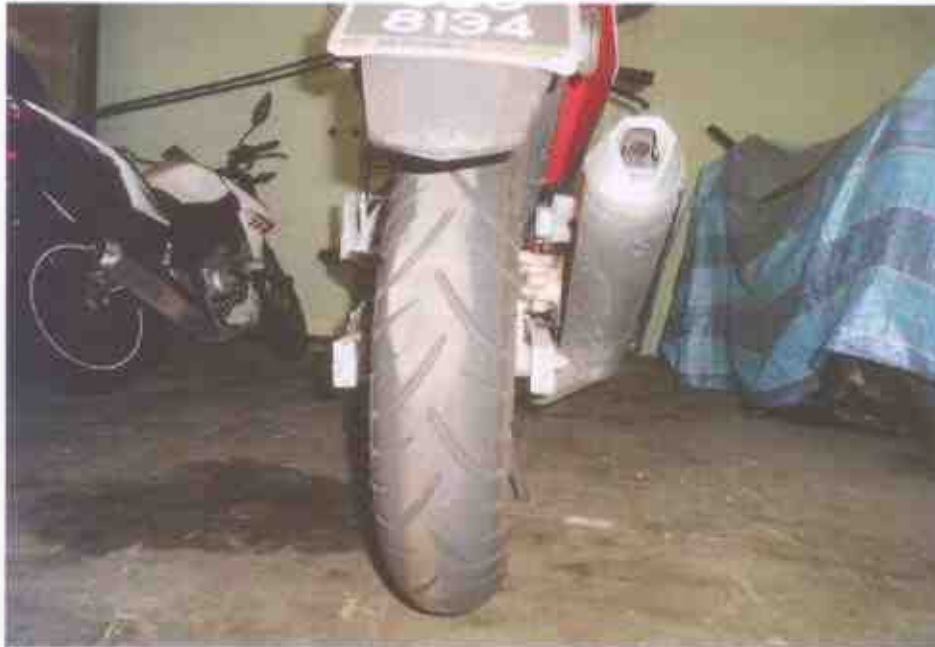
Photo 9 shows the rear tyre of the Motorcycle at the time of our inspection. The rear tyre was observed to be in serviceable condition with remaining tread depth of approximately 4mm. The tyre was also observed to be sufficiently inflated for vehicular operation. There was no significant damage observed on the rear wheel rim & tyre.

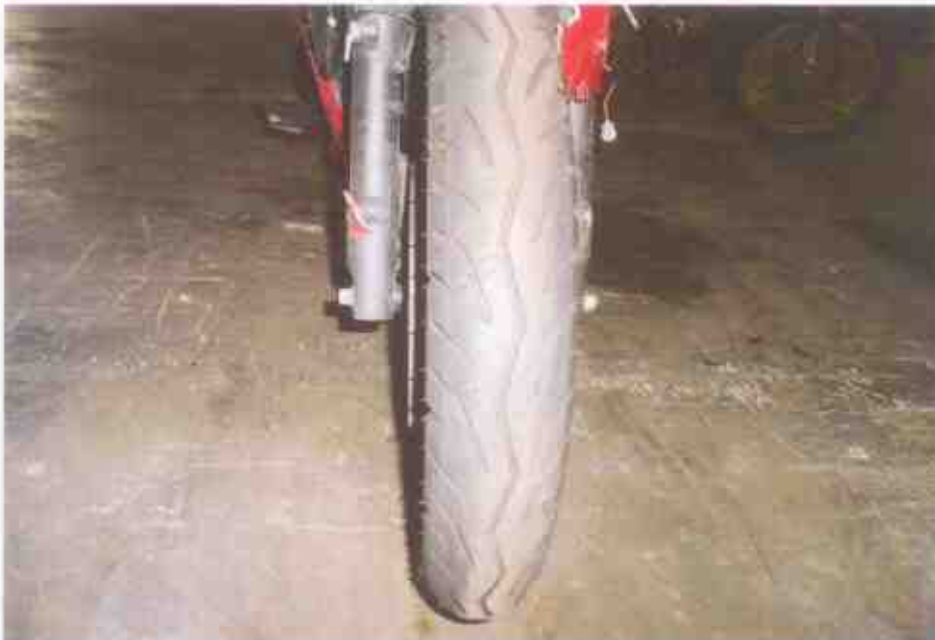
Photo 10 shows the front tyre of the Motorcycle. The pattern of the tread was clearly visible. There was no tear, burst mark(s) and/or punctured hole(s) on the sidewalls as well as across the tread of the front tyre.

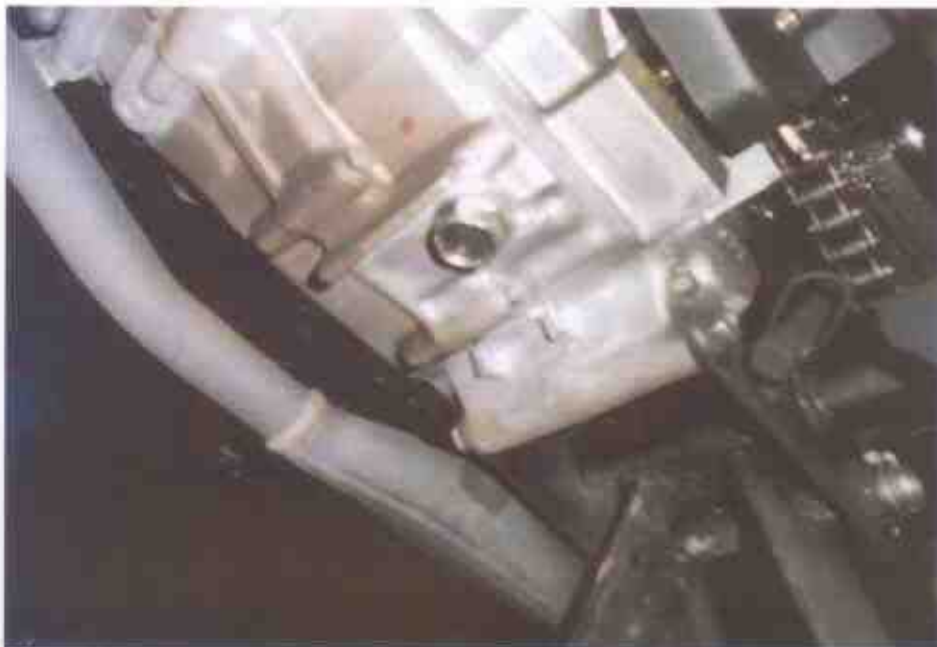
Photo 11 shows no sign(s) or indication(s) of fluid leakage stain observed around the engine undercarriage area of the Motorcycle.

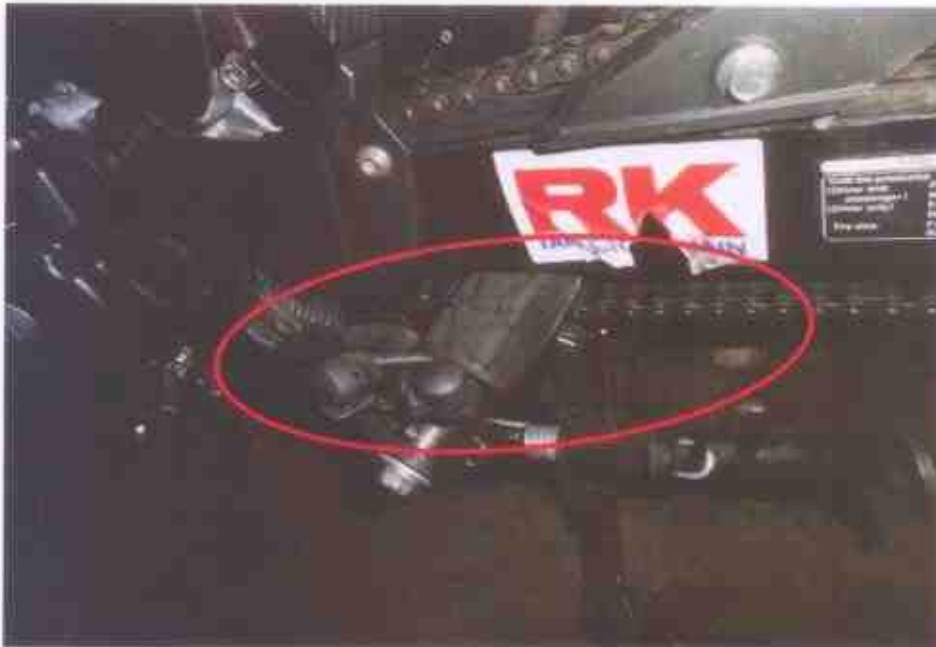
Photo 12 shows the free play tension test was unable to be conducted due to the stuck foot rest in between the gear chain likely due to the accident's collision impact.

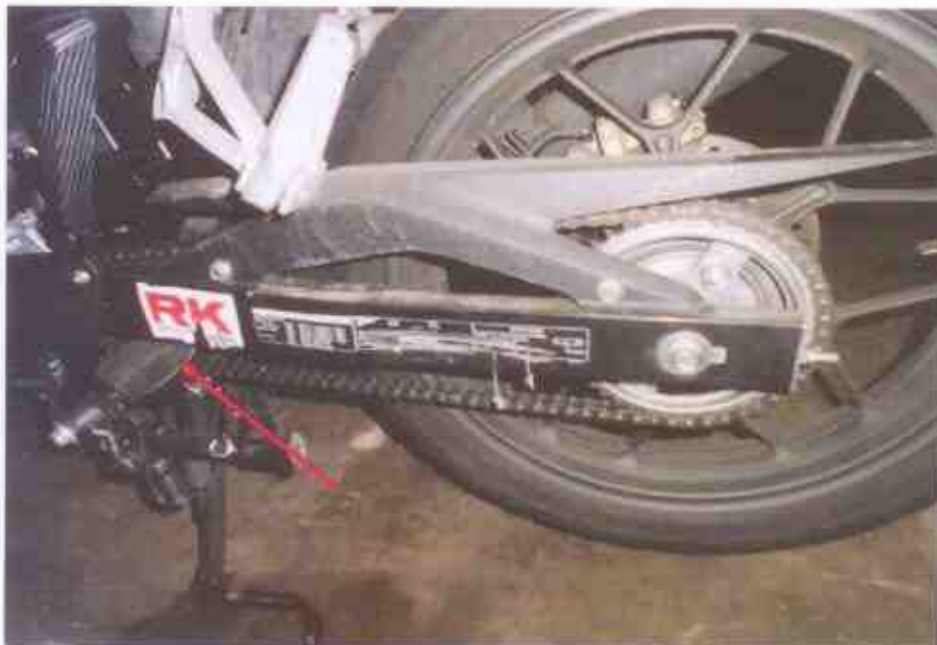
Photo 13 shows the general view of the gear train (arrowed) of the Motorcycle, which was observed to be intact with no misalignment. However, free play tension test was unable to be conducted due to the stuck foot rest in between the gear chain.

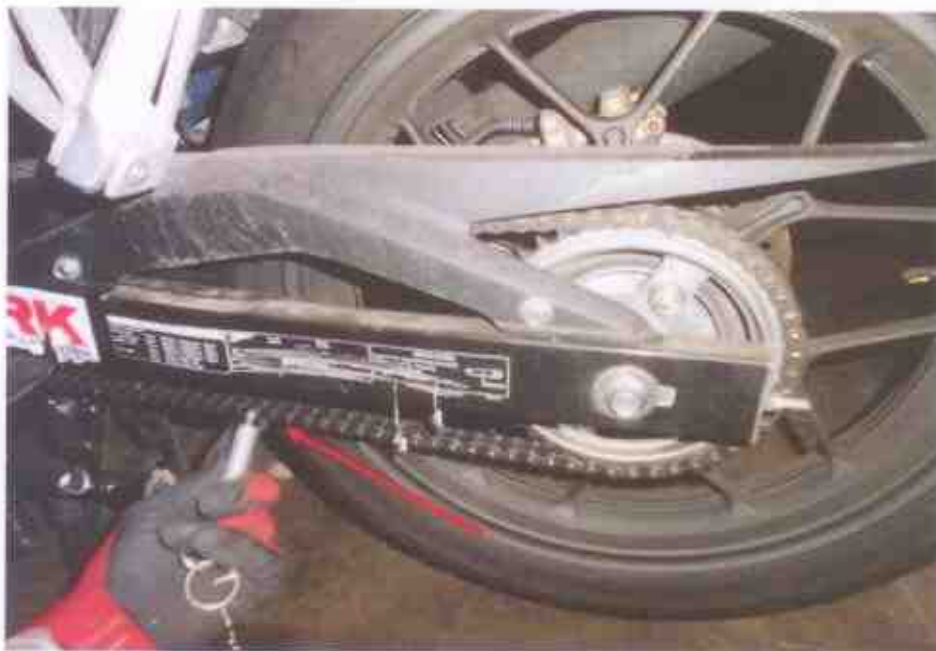
Photo 14 shows the general view of the gear train (arrowed) of the Motorcycle, which was observed to be intact with no misalignment. It was also adequately lubricated for operating purposes. However, free play tension test was unable to be conducted due to the stuck foot rest in between the gear chain due to the accident.

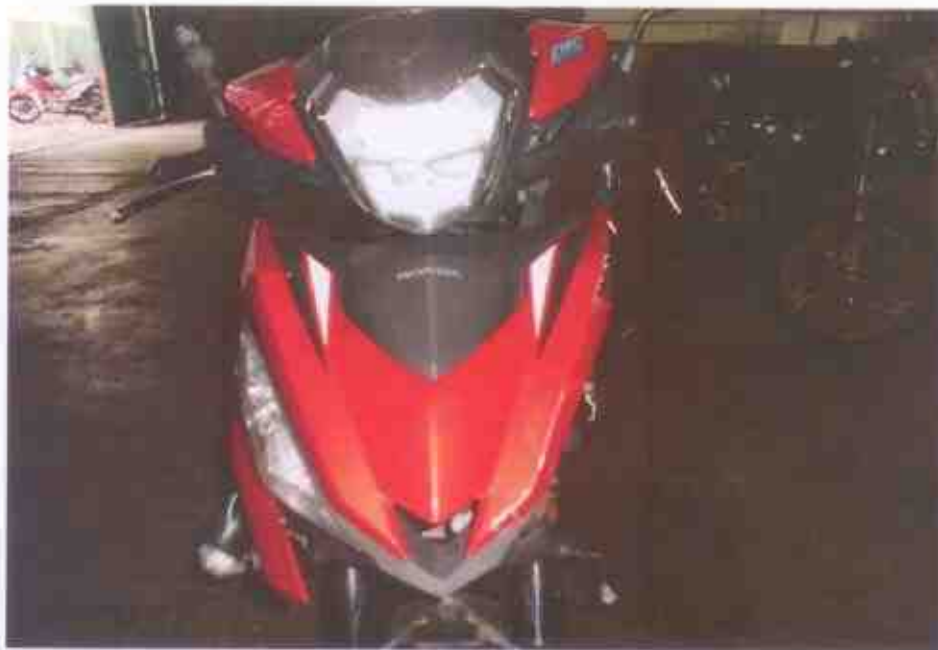
Photo 15 shows the handle bar was observed to be misaligned as a result of the accident. Hence, we are not able to conduct any tests on the steering system of the Motorcycle.

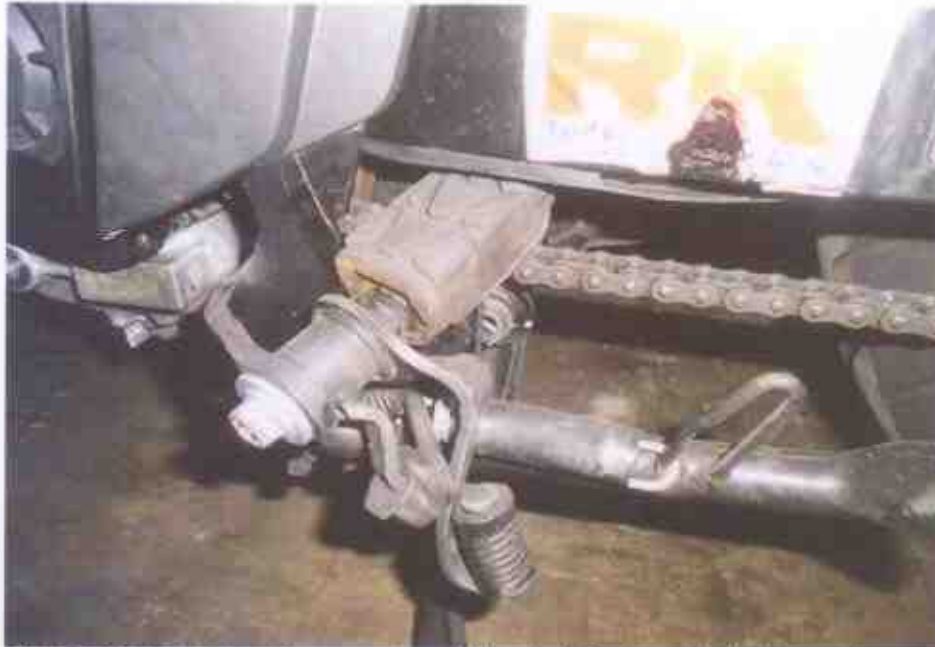
Photo 16 shows the close-up view of the stuck foot rest in between the gear chain as a result of the accident.

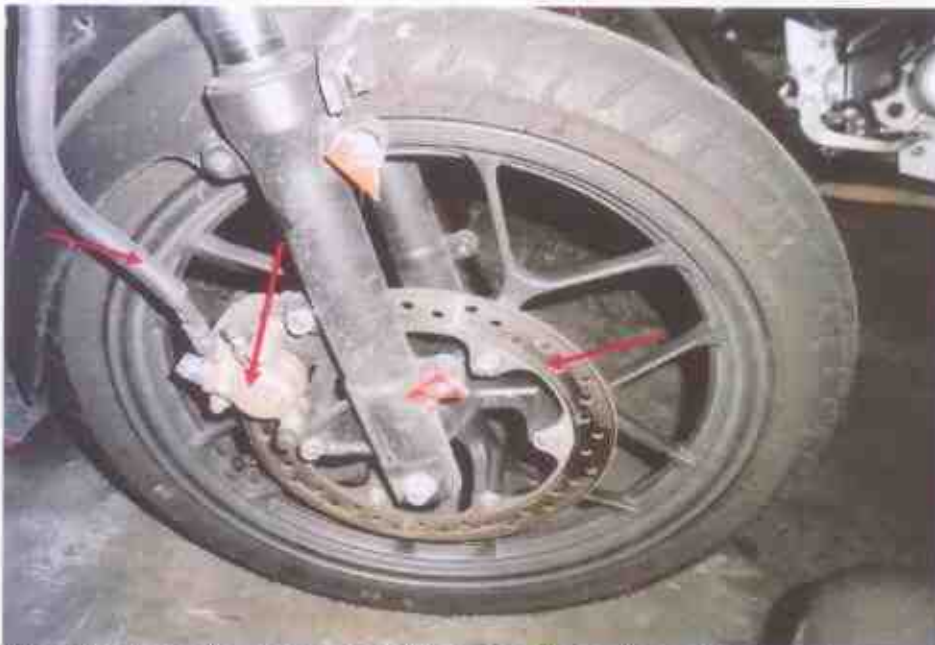
Photo 17 shows the front brake calliper, front brake disc and front brake hose of the Motorcycle (arrowed), which are all part of the components in the front brake system of the Motorcycle. Our visual checks of these various components had revealed all to be intact with no visible damage. No leakage of brake fluid was also observed.

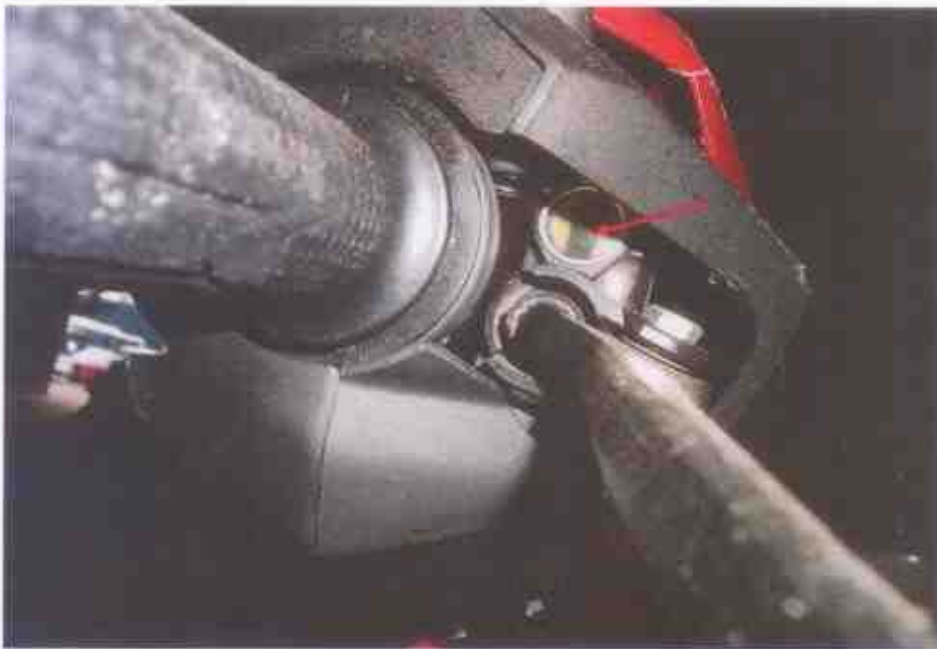
Photo 18 shows the front brake fluid reservoir at time of our inspection. It was observed to be at a sufficient level without any contamination.

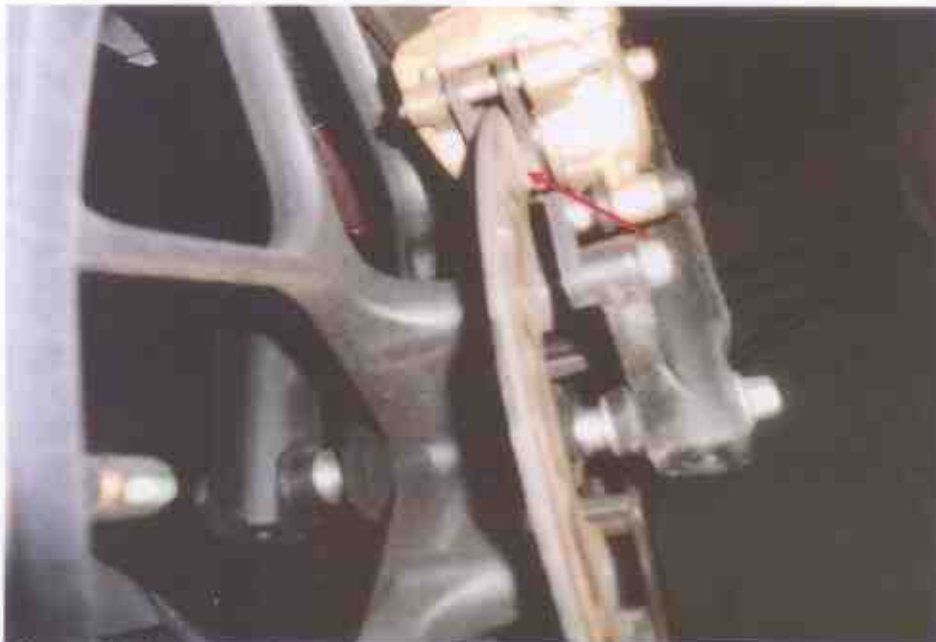
Photo 19 shows the front brake pad at time of our inspection. The frictional material was observed to be at a sufficient level for operational purposes.

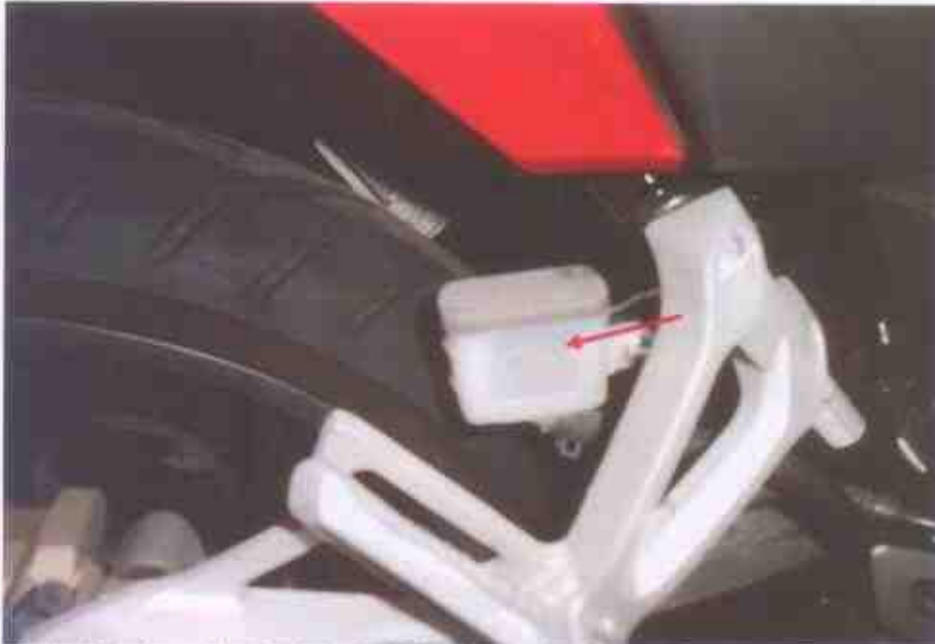
Photo 20 shows the front brake fluid reservoir at time of our inspection. It was observed to be at a sufficient level without any contamination.

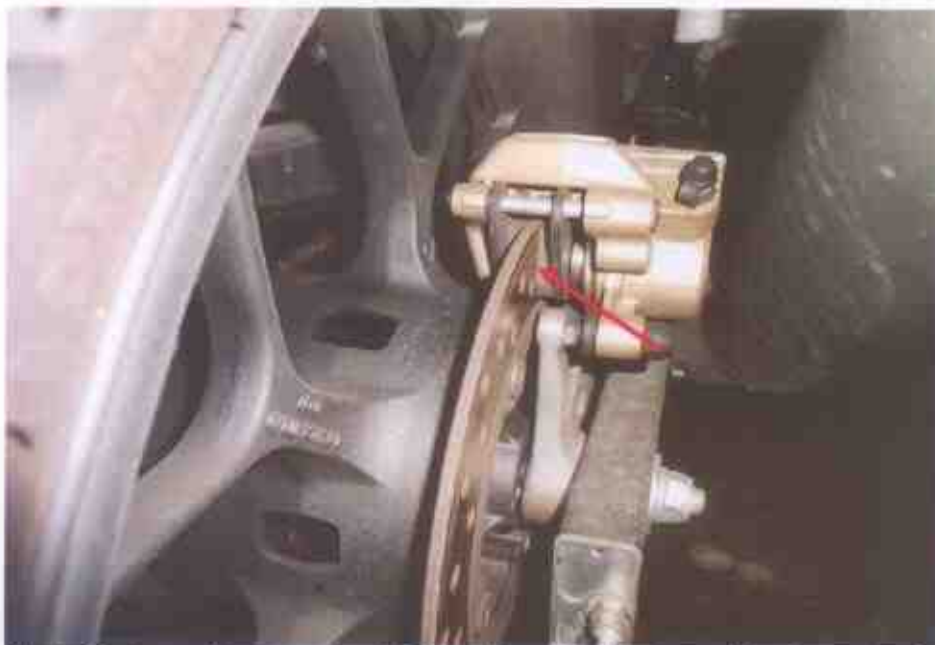
Photo 21 shows the rear wheel of the Motorcycle. The type of brake system for the rear wheel was of hydraulic type, controlled by the brake foot pedal of the Motorcycle. Our checks of the calliper (arrowed) & brake pad which are all part of the components in the rear brake system of the Motorcycle reveal all to be intact and without damage.
