Your Ref: TP/IP/47547/2018  
Our Ref :CI/TPD18016123/Z

**Fatal Accident Investigation Team**

**MECHANICAL INSPECTION REPORT OF MOTORCYCLE FBE 785T**

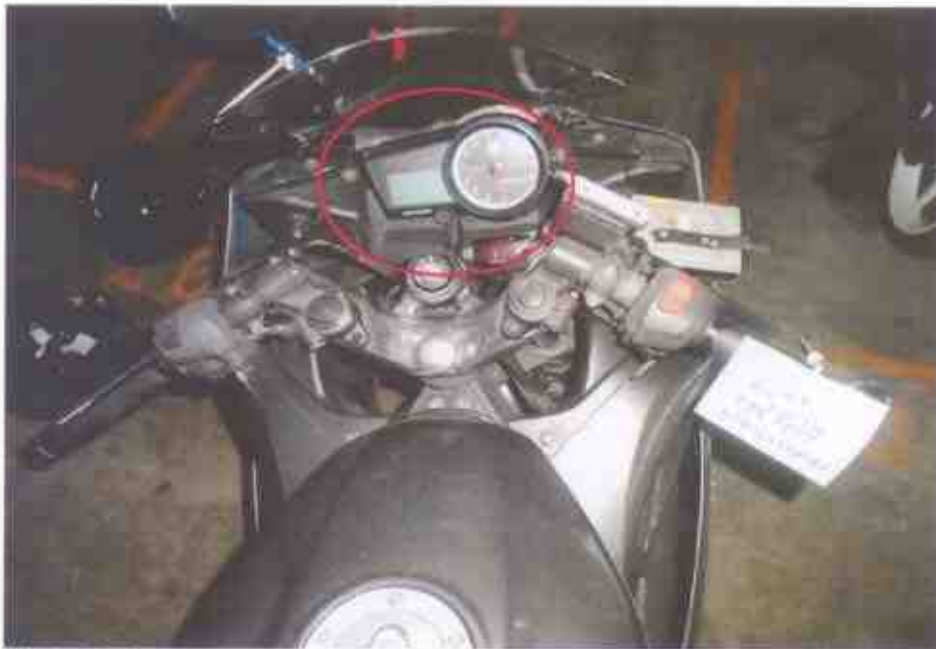
Photo 1 shows a general view of the mileage meter at time of our inspection. The mileage was not recorded due to the inability to start the motorcycle.

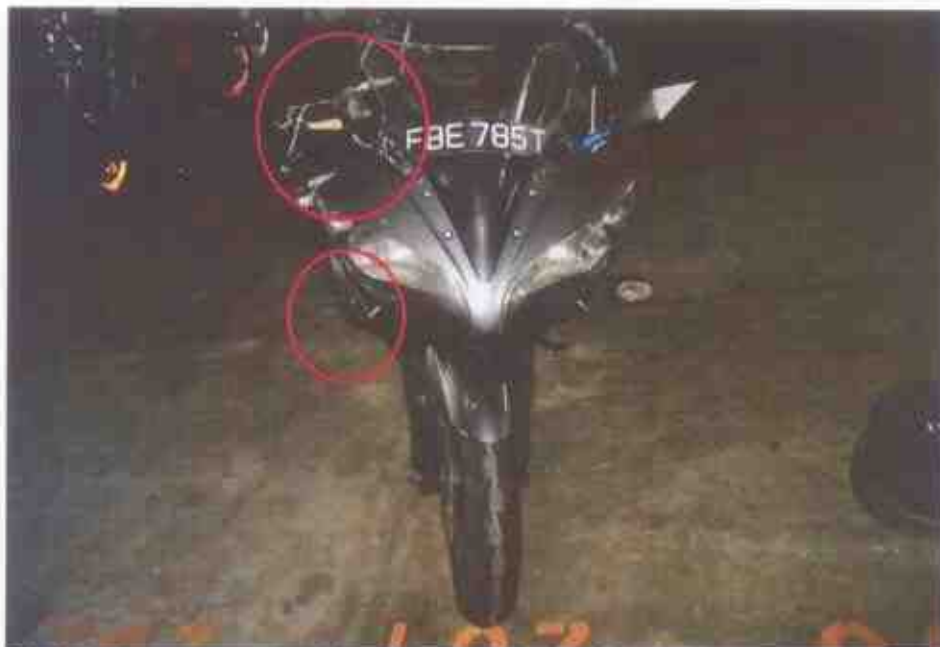
Photo 2 shows a general view of the front body of the Motorcycle at the time of our inspection. The Motorcycle was observed to have sustained relatively minor damages at time of inspection. The damages were observed to be confined to its right side of the Motorcycle.

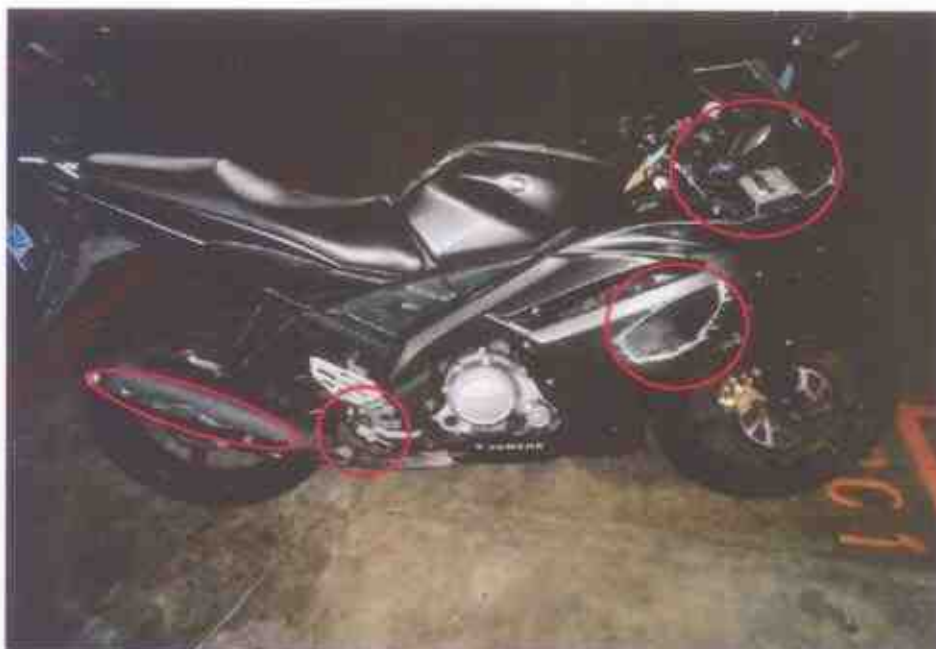
**Photo 3** shows a general view of the right body of the Motorcycle at the time of our inspection. The Motorcycle was observed to have sustained relatively minor damages at time of inspection. The damages were observed to be confined to its right side of the Motorcycle

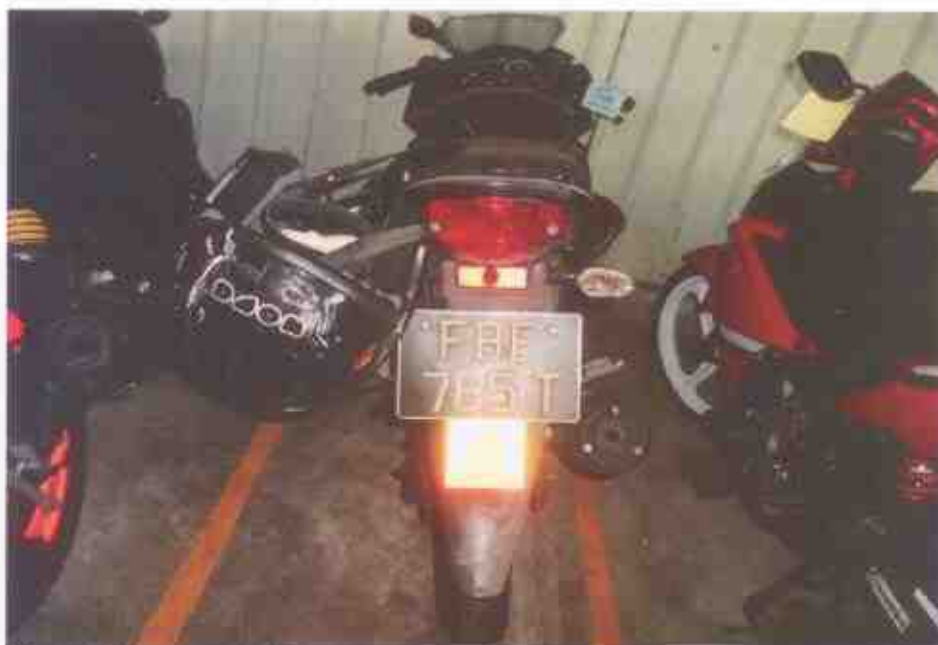
**Photo 4** shows a general view of the rear body of the Motorcycle at the time of our inspection. The Motorcycle was observed to be in good condition unaffected by the accident's impact.

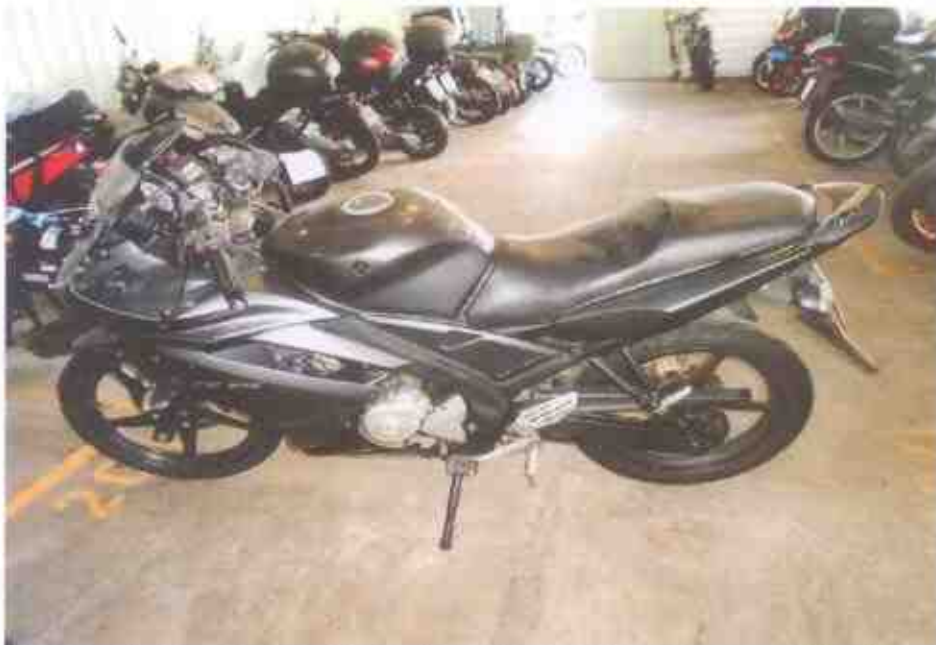
Photo 5 shows a general view of the left body of the Motorcycle at the time of our inspection. The Motorcycle was observed to be in good condition unaffected by the accident's impact collision.

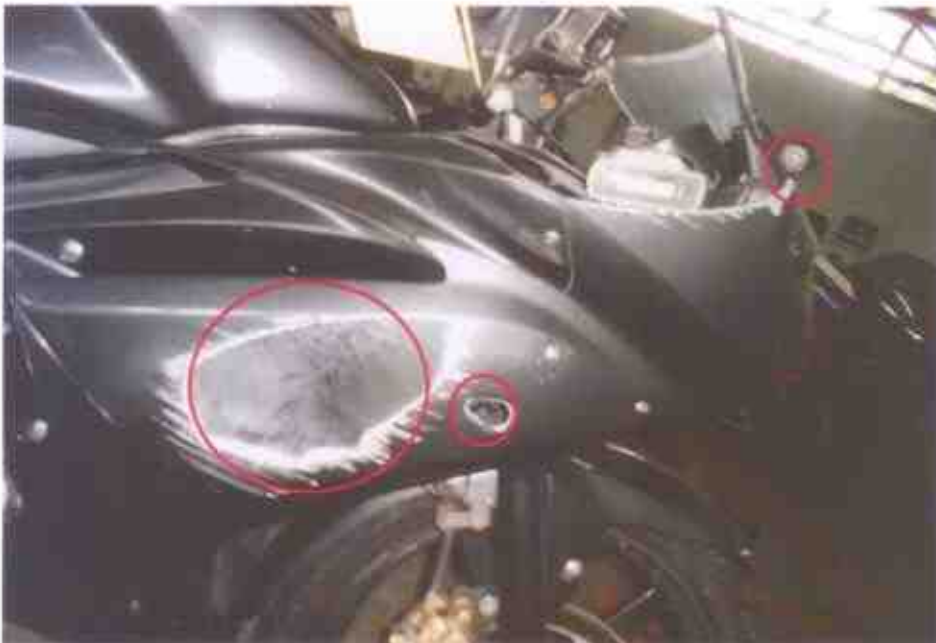
Photo 6 shows a closer view of the missing front right signal lamp, scratched portion of the side fairing & missing wing mirror of the Motorcycle at the time of our inspection. The Motorcycle was observed to have sustained with relatively minor damages due to the accident collision. (Circled)

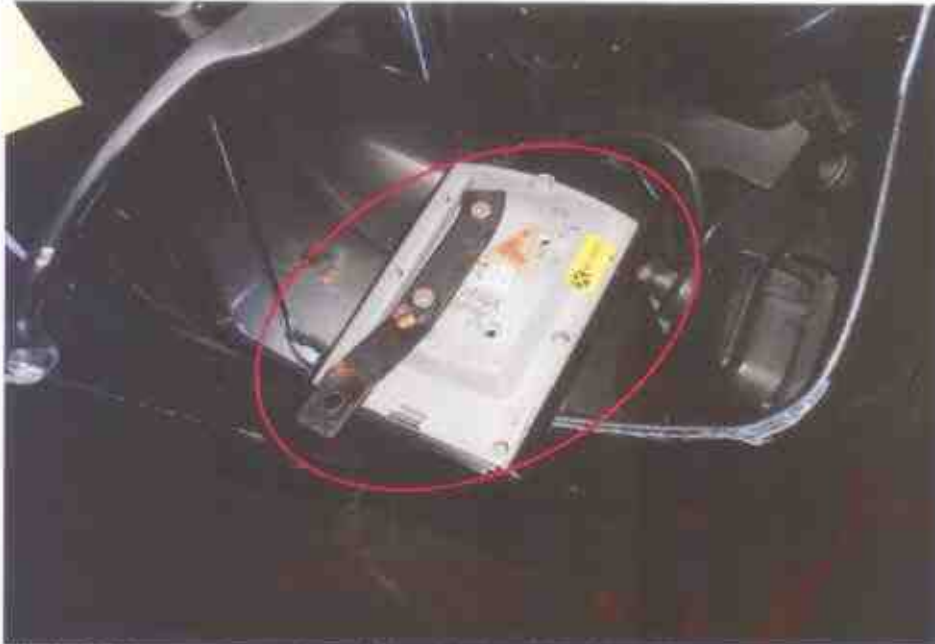
Photo 7 shows a closer view of the dislodged UI of the Motorcycle at the time of our inspection. It was observed to be dislodged due to the accident collision. (Circled)

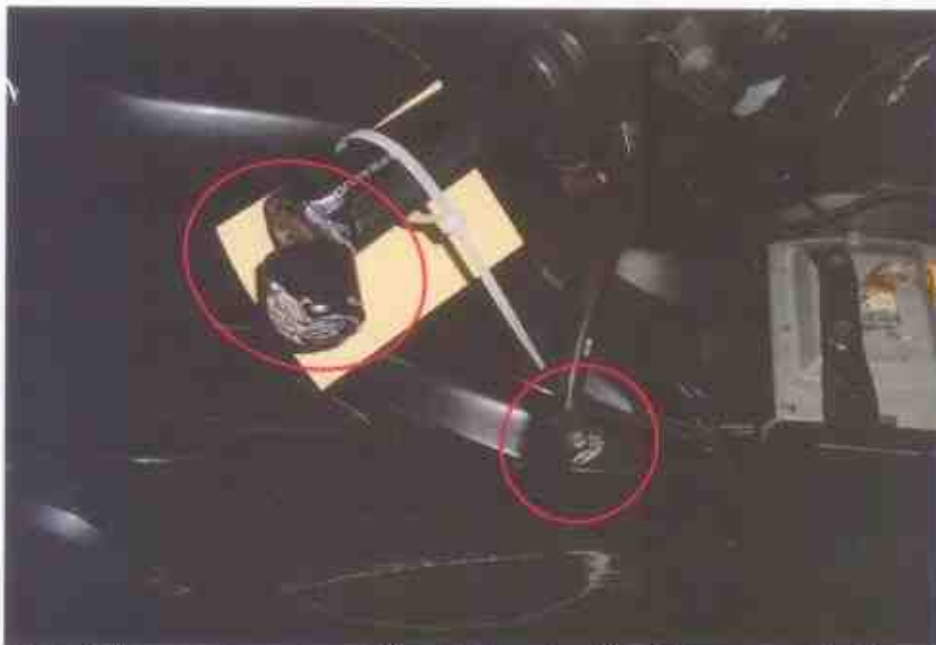
Photo 8 shows a closer view of the right handle of the Motorcycle at the time of our inspection. The Motorcycle was observed to have sustained with relatively minor damages due to the accident collision. (Circled)

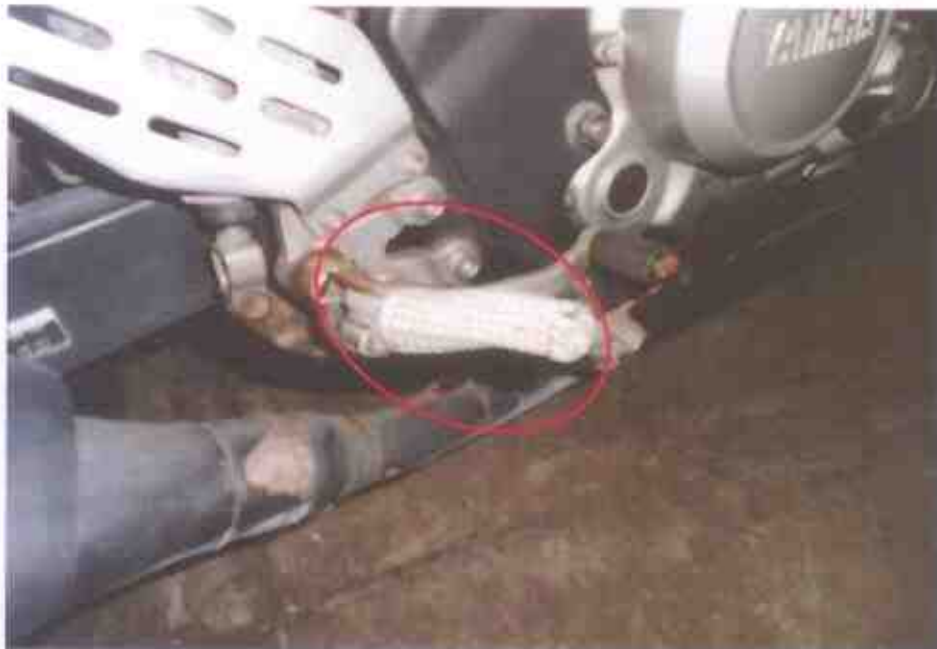
Photo 9 shows a closer view of the right foot rest of the Motorcycle at the time of our inspection. The Motorcycle was observed to have sustained with relatively minor damages due to the accident collision. (Circled)

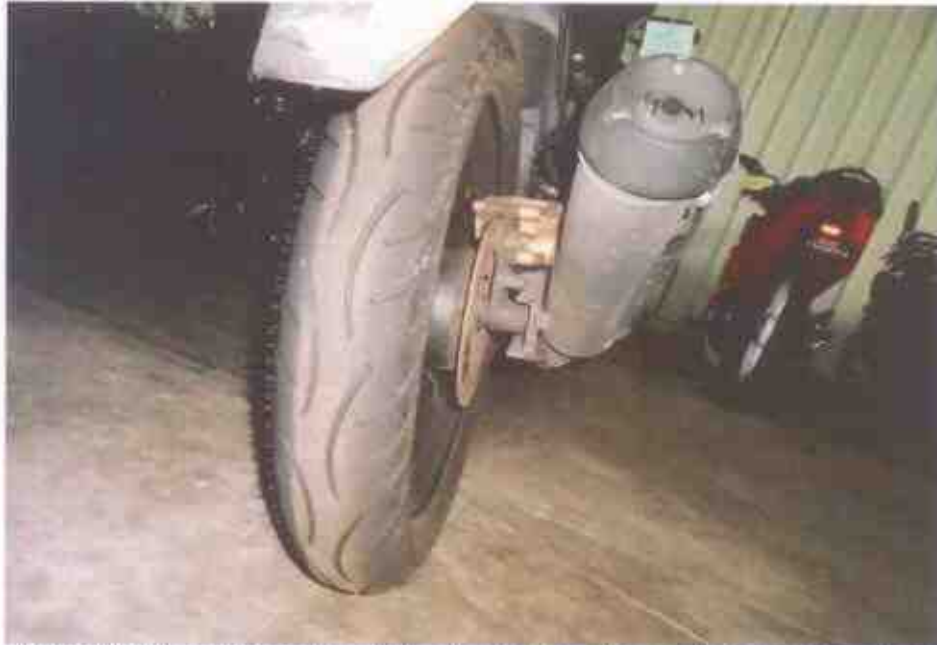
Photo 10 shows the rear tyre of the Motorcycle. The rear tyre was observed to be in serviceable condition with remaining tread depth of approximately 5mm. The tyre was also observed to be sufficiently inflated for vehicular operation.

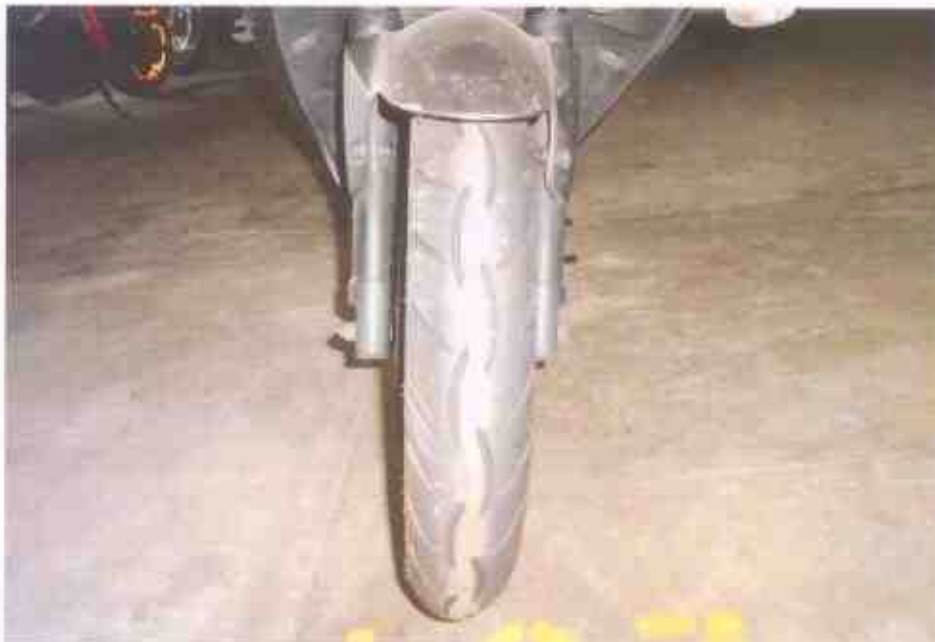
Photo 11 shows the front tyre of the Motorcycle. The front tyre was observed to be in serviceable condition with remaining tread depth of approximately 5mm. The tyre was also observed to be sufficiently inflated for vehicular operation.

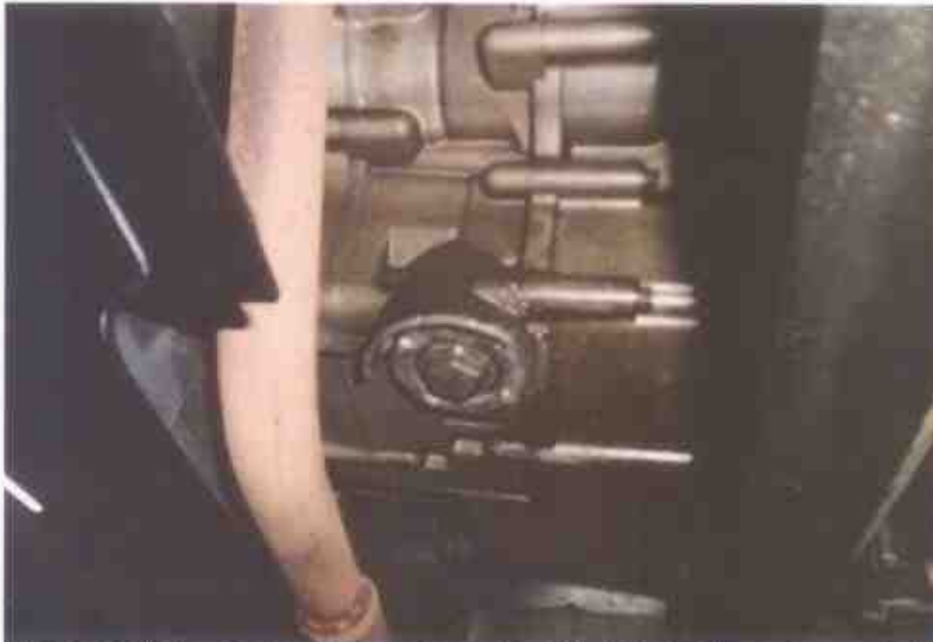
Photo 12 shows no sign(s) or indication(s) of fluid leak observed around the underside of the engine area of the Motorcycle.

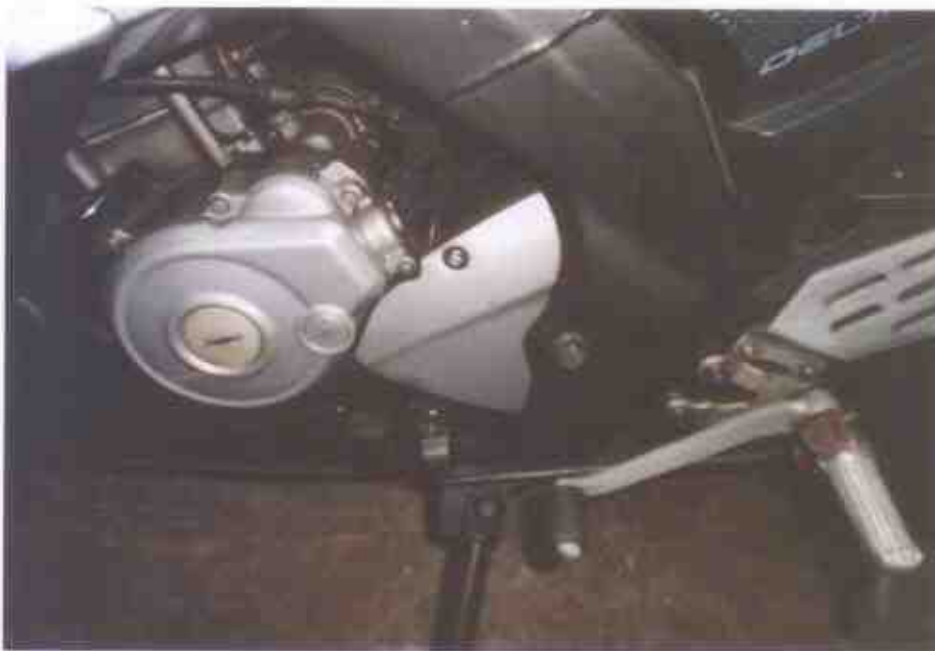
Photo 13 shows no sign(s) or indication(s) of fluid leakage stain observed around the engine area of the Motorcycle.

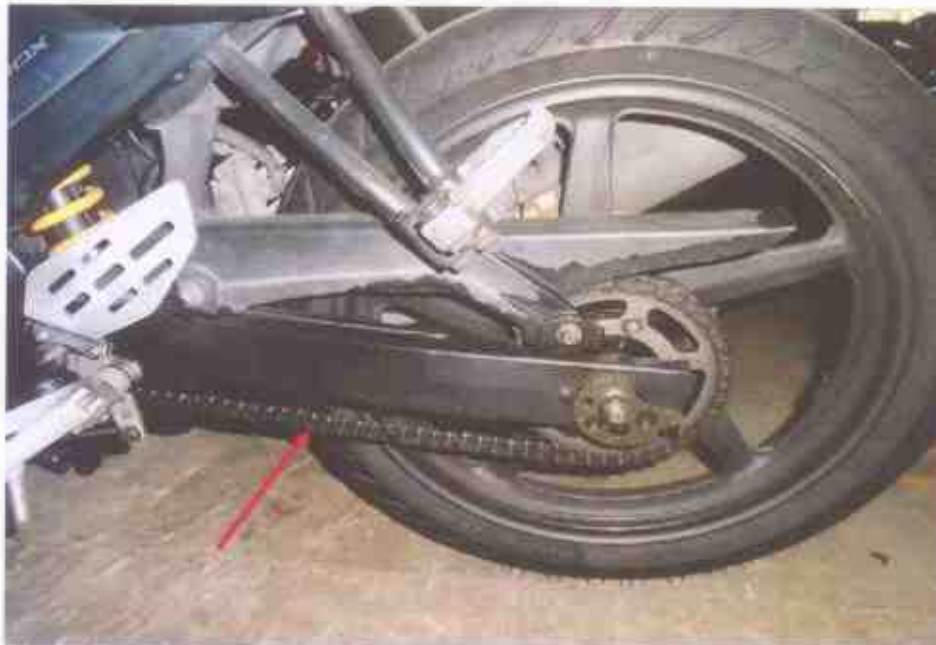
Photo 14 shows the general view of the gear train (arrowed) of the Motorcycle, which was observed to be intact with no misalignment. It was also adequately lubricated for operating purposes.

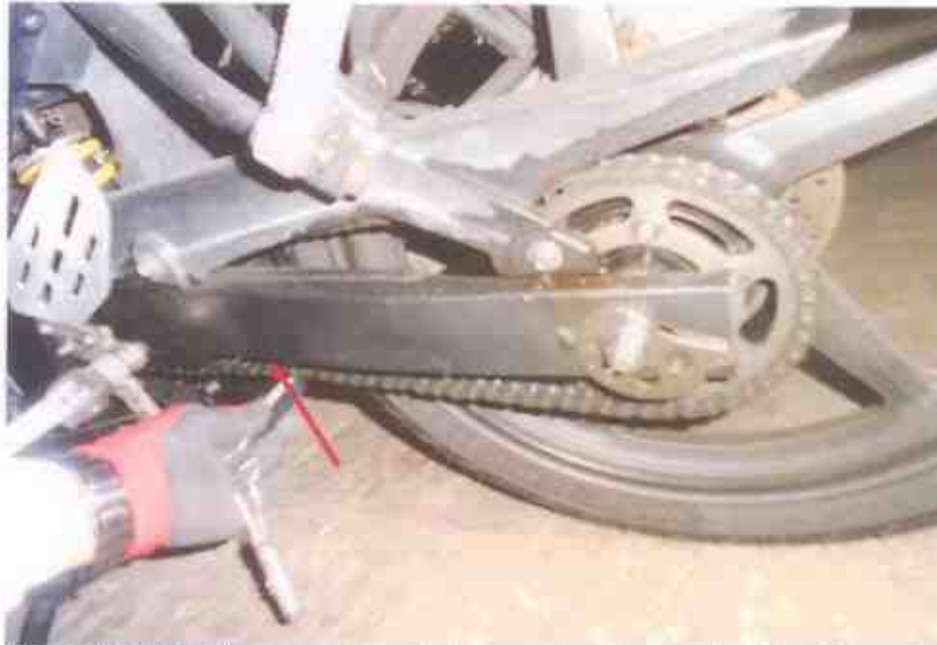
Photo 15 shows the general view of the gear train (arrowed) of the Motorcycle, which was observed to be intact with no misalignment. It was also adequately lubricated for operating purposes. Free play tension was also observed & found adequately acceptable.

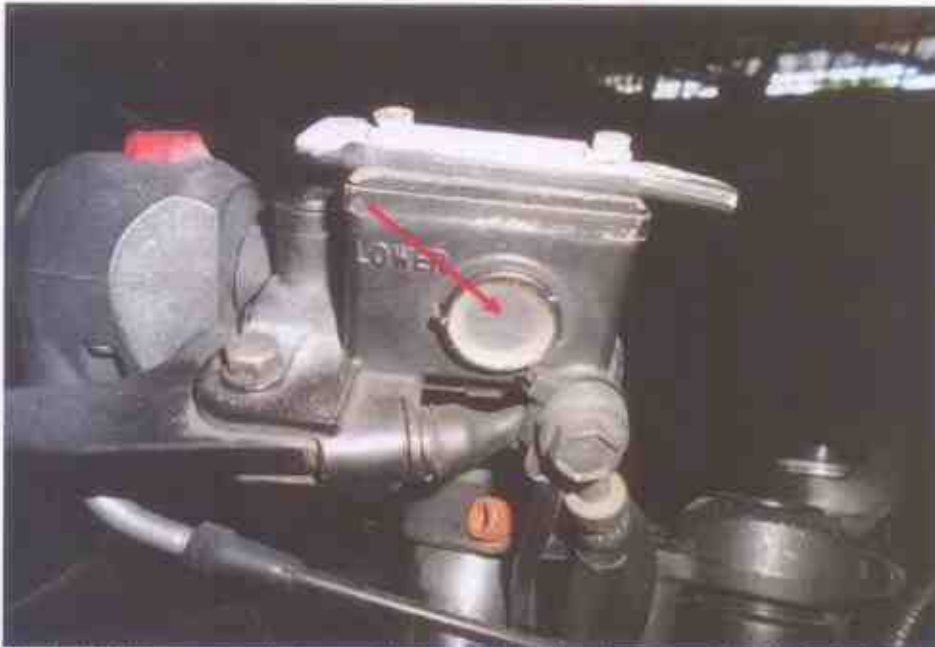
Photo 16 shows our checks on the brake fluid (front) reservoir had also indicated that the brake fluid was of sufficient level for operational purposes, and without contamination.

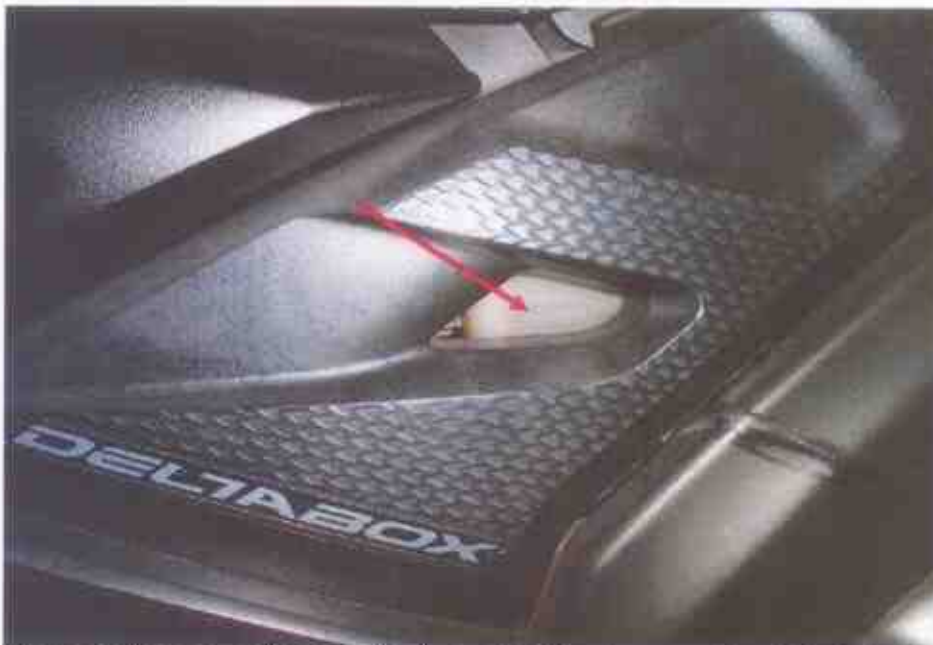
Photo 17 shows our checks on the brake fluid (rear) reservoir had also indicated that the brake fluid was of sufficient level for operational purposes, and without contamination.

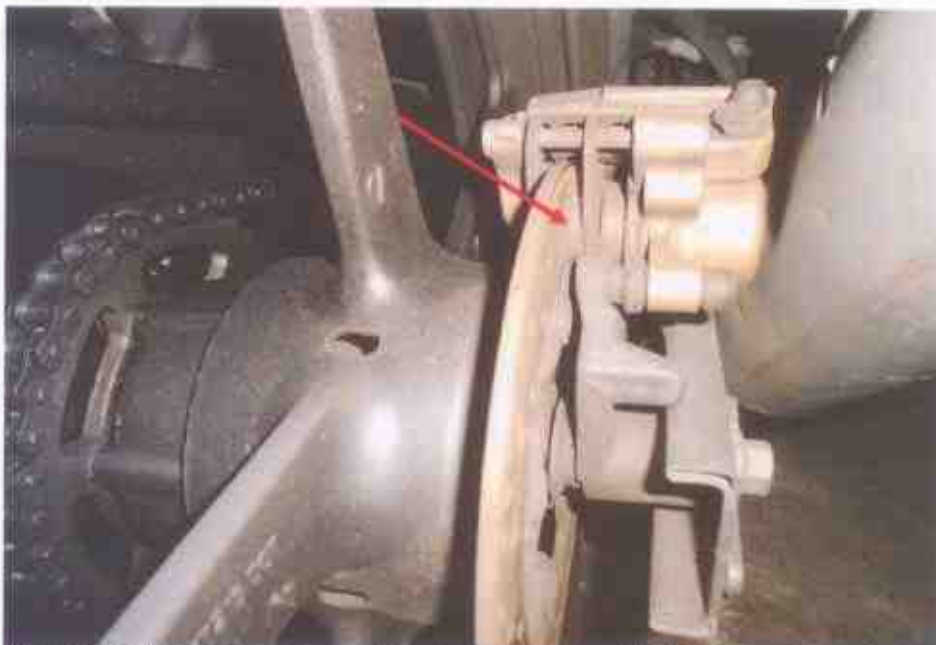
Photo 19 shows a close-up view our checks on the brake pad (rear). The frictional material was observed to be in a sufficient level for operational purposes.

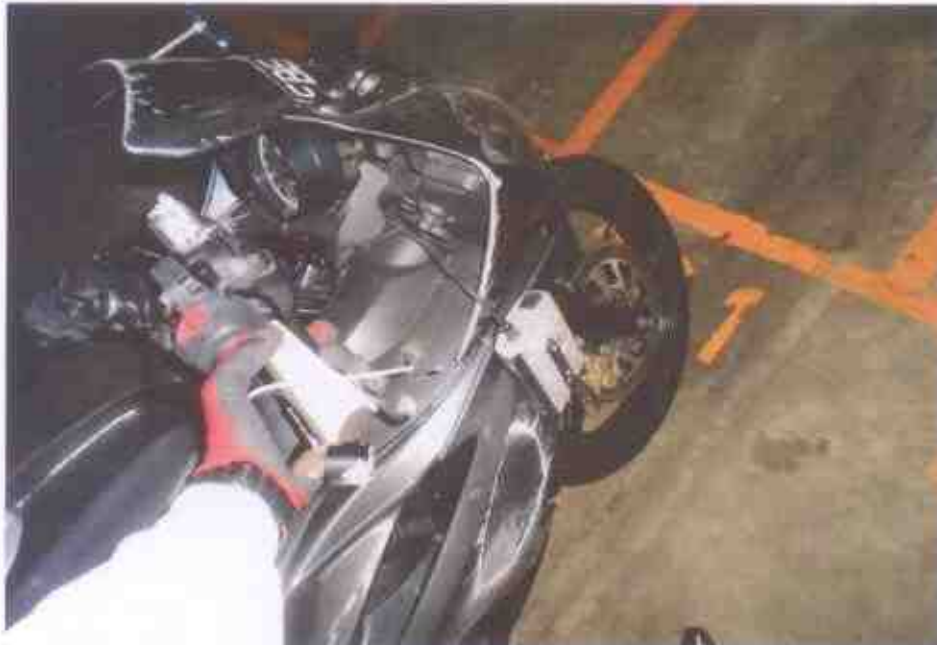
Photo 20 shows testing of the braking of the front brake in progress. There was some resistance felt (spongy like feel) upon pressing the brake lever.

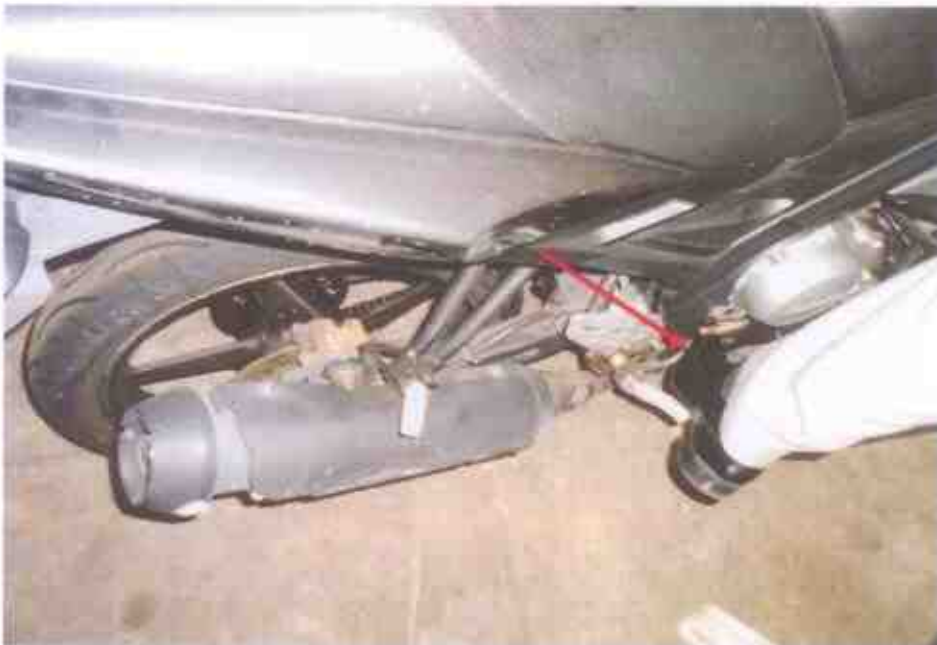
Photo 21 shows testing of the braking of the rear brake in progress. There was some resistance felt (spongy like feel) upon stepping on the brake pedal.
