Your Ref: TP/IP/44465/2018
Our Ref : CI/TPD18016124/Z

Fatal Accident Investigation Team
Traffic Police Department
Singapore Police Force
10 Ubi Avenue 3
Singapore 408865

MECHANICAL INSPECTION REPORT OF MOTOR CAR SLN 9906L

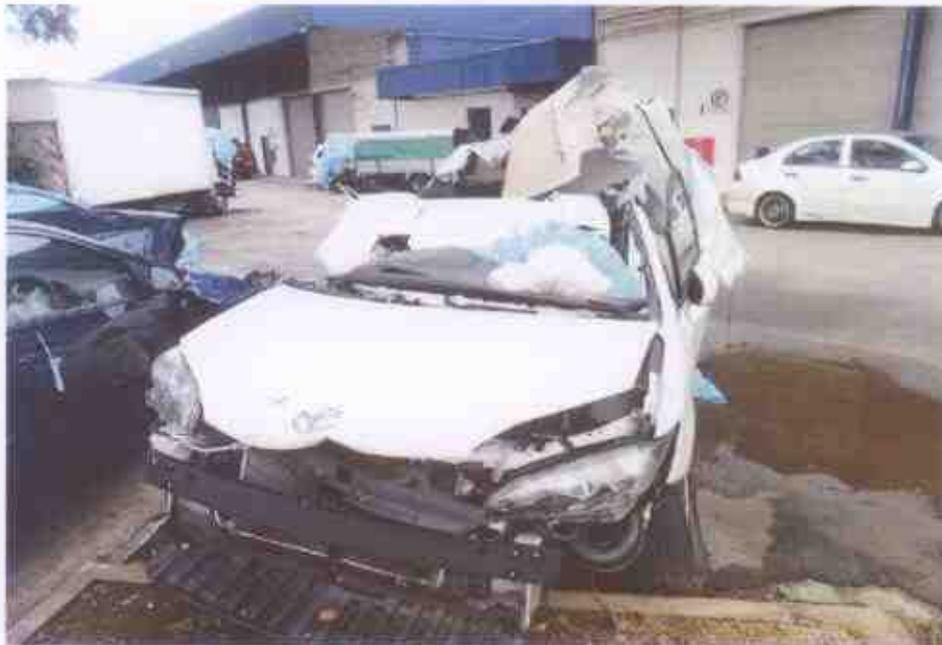
Photo 1 shows a general view of the frontal portion of the Motor Car at the time of our inspection. The Motor Car was observed to have sustained extensive impact damage at its frontal portion. The impact force was significant, causing the various parts and components inside the engine compartment to be damaged.

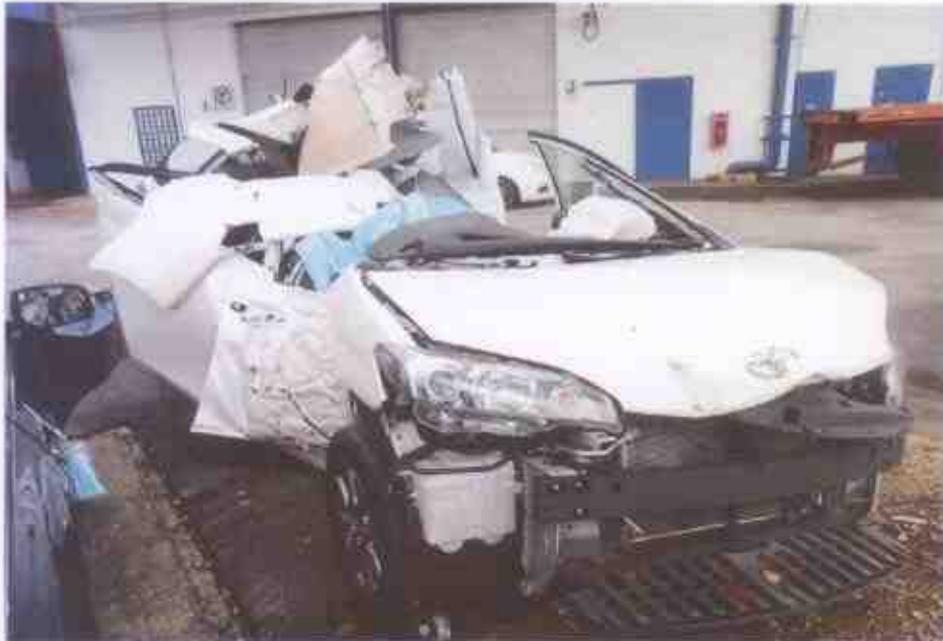
Photo 2 shows a general view of the front right portion of the Motor Car at the time of our inspection. The Motor Car was observed to have sustained extensive impact damage at its frontal portion.

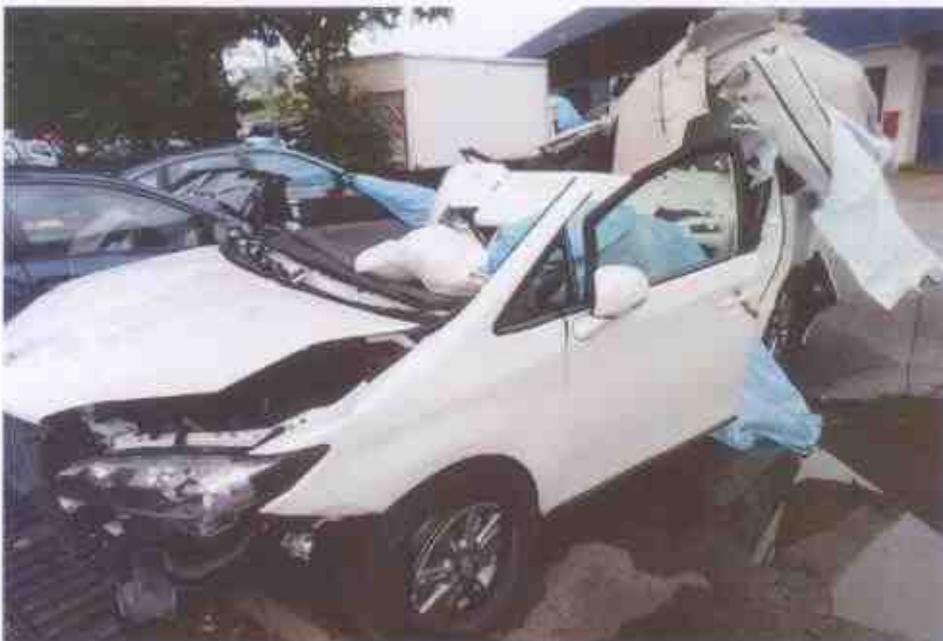
Photo 3 shows a general view of the front left portion of the Motor Car at the time of our inspection. The Motor Car was observed to have sustained with extensive impact damage at its frontal portion.

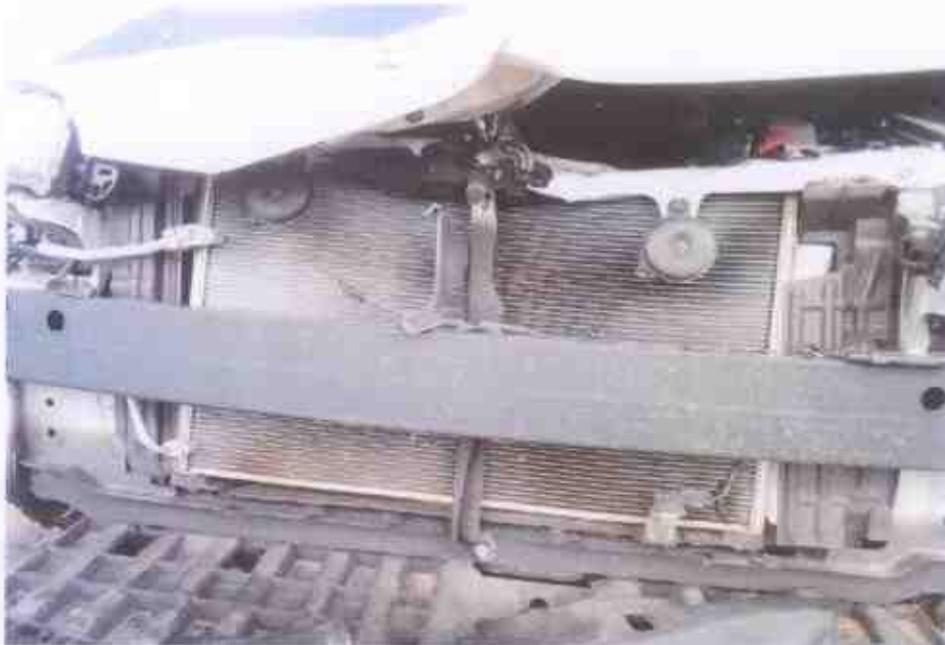
Photo 4 shows a closer view of the damage at the frontal portion of the Motor Car's engine. The impact force was significant, causing the various parts and components inside the engine compartment to be pushed inwards, towards the rear of the Motor Car.

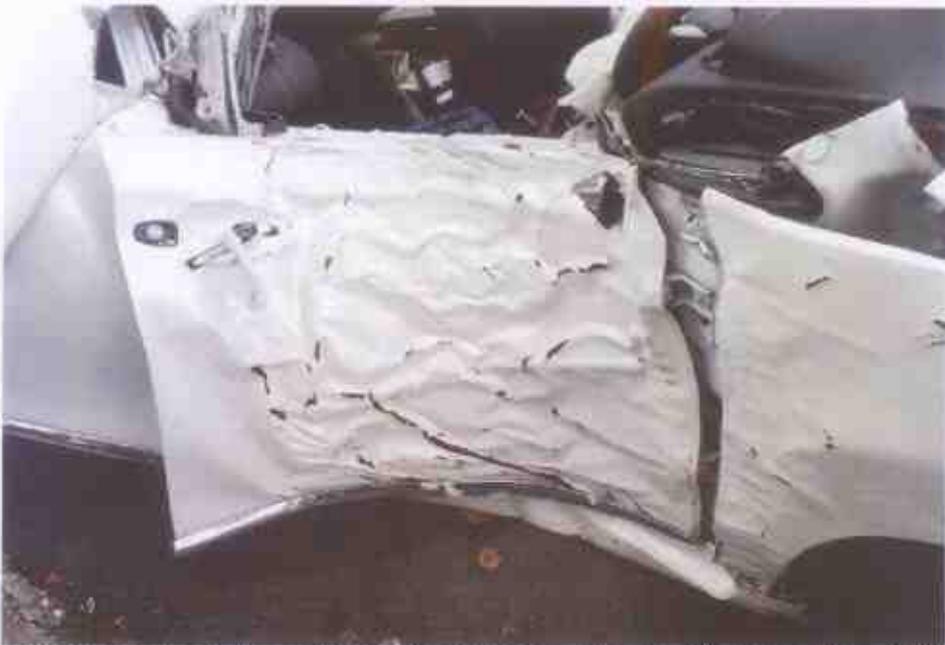
Photo 5 shows a closer view of the damage at the frontal right portion of the Motor Car. The impact force was significant, causing the various parts and components inside the engine compartment to be corrugated due to the accident's collision impact.

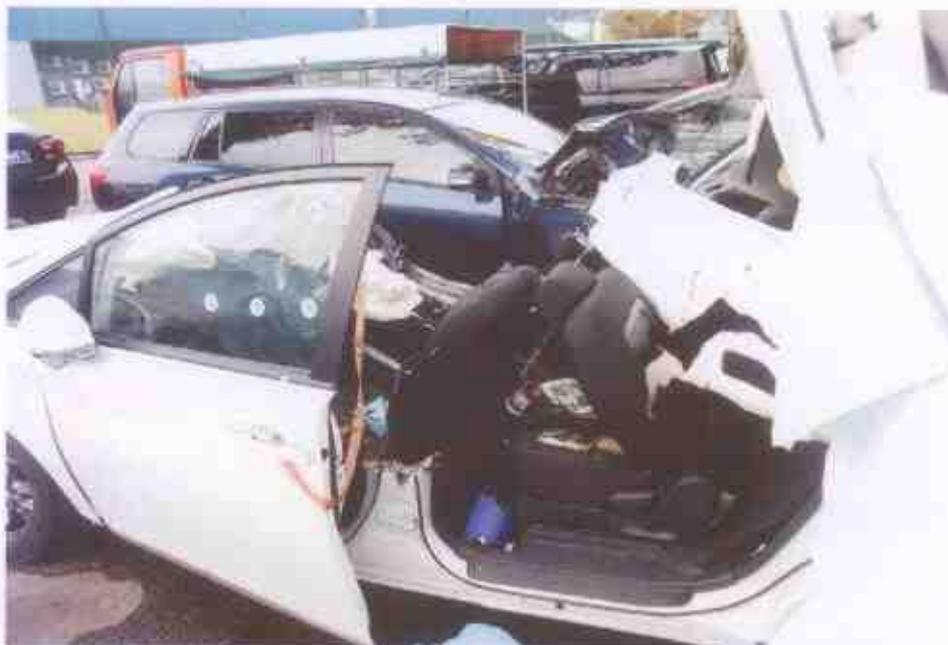
Photo 6 shows a closer view of the damage at the left portion of the Motor Car. The impact force was significant, causing the various parts and components inside the engine compartment to be crushed due to the accident's impact collision.

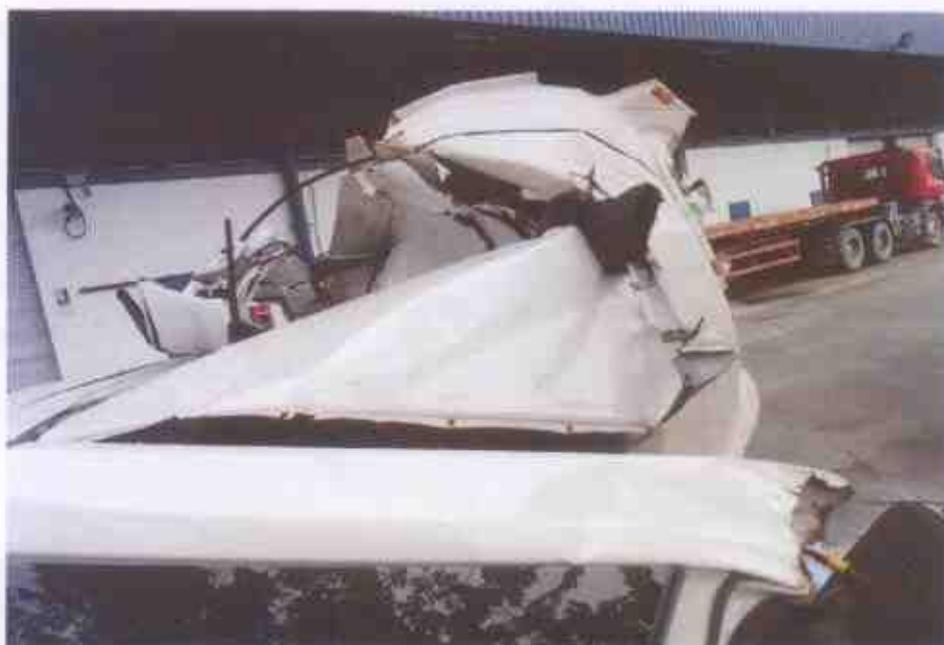
Photo 7 shows a closer view of the damage at the roof panel of the Motor Car. The impact force was significant, causing the roof panel to be buckled due to the accident's impact collision.

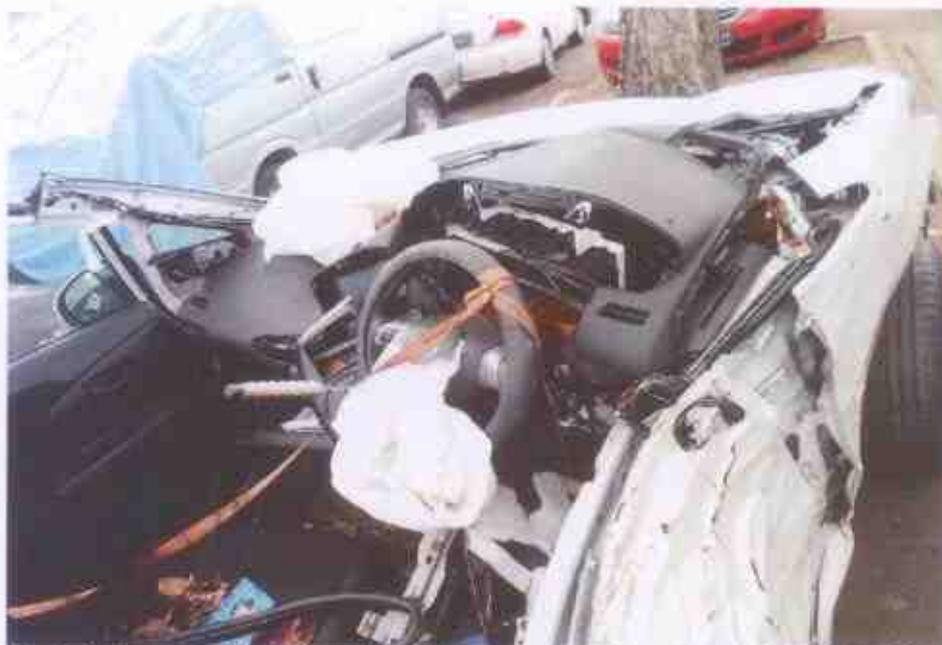
Photo 8 shows a closer view of the damage at the driver's seat of the Motor Car. The impact force was significant, causing the various parts and components inside the interior compartment to be pushed inwards, including its ignition system.

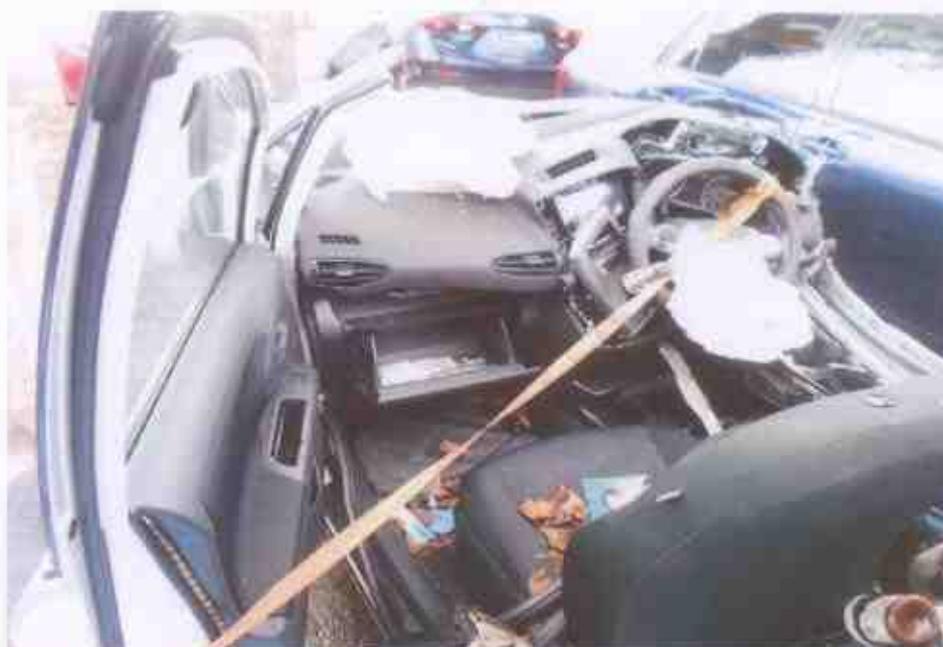
Photo 9 shows a closer view of the left front passenger seat of the Motor Car. The impact force was significant, causing the various parts and components inside the engine compartment to be pushed inwards, towards the rear of the Motor Car.

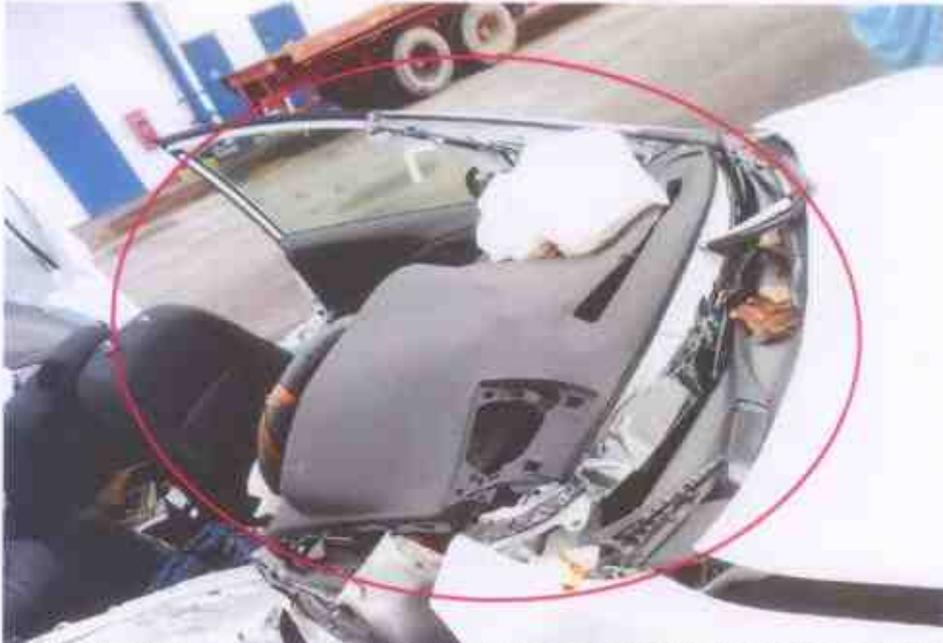
Photo 10 shows a closer view of the damage at the windscreen area of the Motor Car. The impact force was significant, causing the windscreen to sustain a shattering cracked.

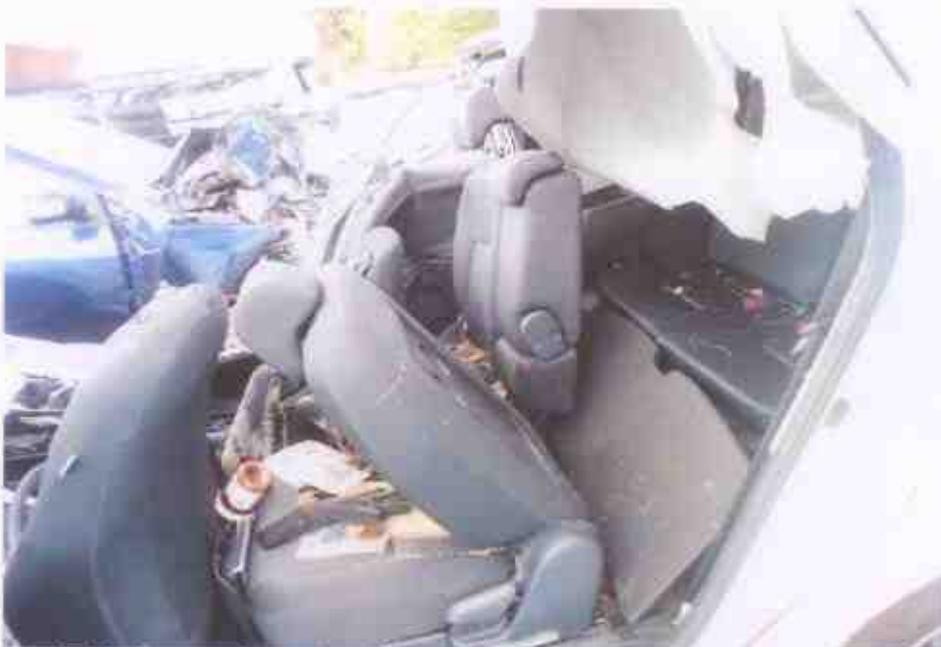
Photo 11 shows a closer view of the damages at the interior portion of the Motor Car due to the extensive impact collision at time of the accident.

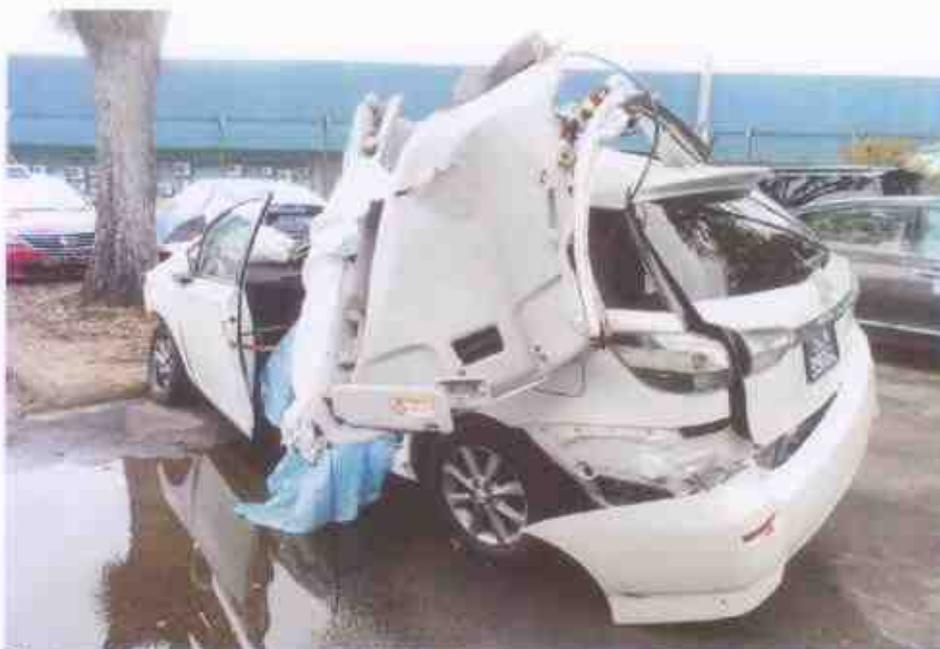
Photo 12 shows a general view of the rear left portion of the Motor Car at the time of our inspection. The rear portion was observed to be relatively sustained with extensive impact by the accident impact collision.

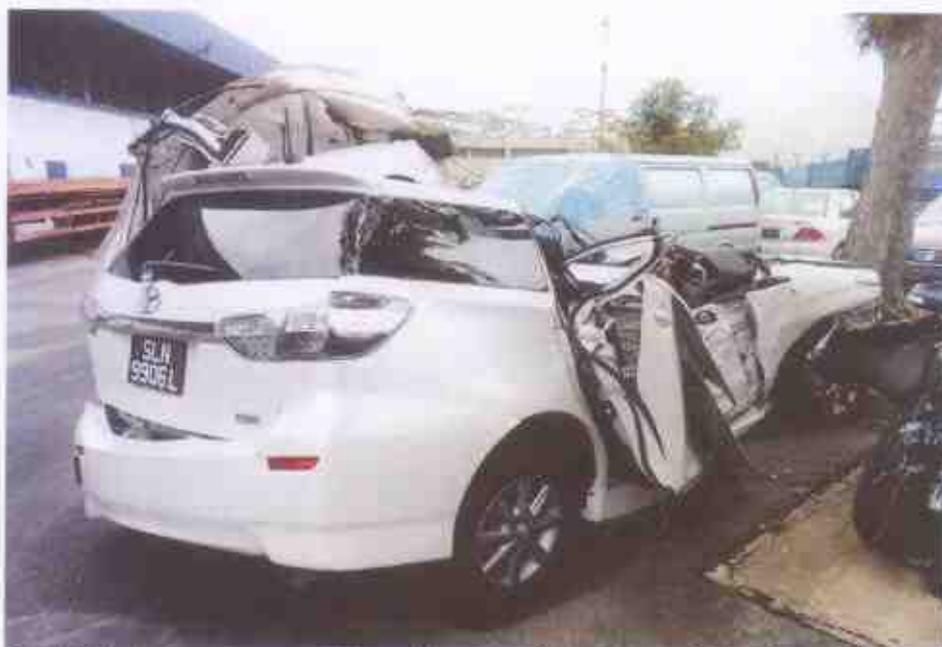
Photo 13 shows a general view of the rear right portion of the Motor Car at the time of our inspection. The rear portion was observed to be relatively sustained with extensive damages due to the accident's impact collision.

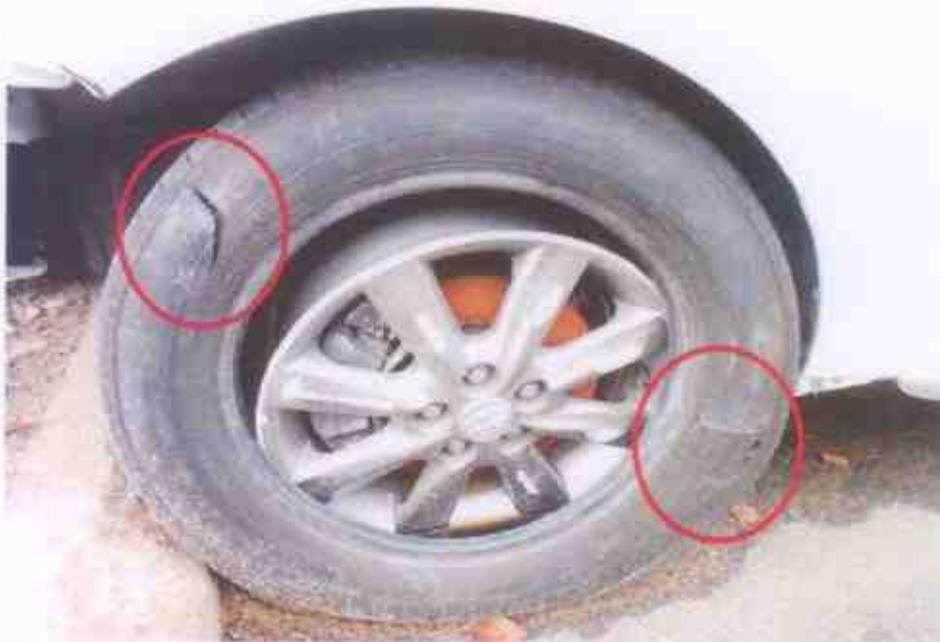
7. The Motor Car's front left tyre was observed to sustain with torn marks on the outer sidewall & deflated due to the accident's impact collision. However, the tread pattern was clearly visible with remaining tread depth of approximately 6mm.
8. As for the condition of the other 3 Motor Car's tyres, it was observed to be in serviceable condition. We did not find any tear, cut or burst mark(s) on the outer and the inner sidewalls as well as across the tread of the 3 tyres. The 3 tyres were also observed to be sufficiently inflated for vehicular operation. The tyre brand, tyre size and remaining tread depth of the 3 tyres were recorded as follows:-

Photo 14 shows the condition of the front left portion of the Motor Car, which was observed to be deflated. Torn marks were also found on the outer sidewall of the tyre due to the accident's impact.

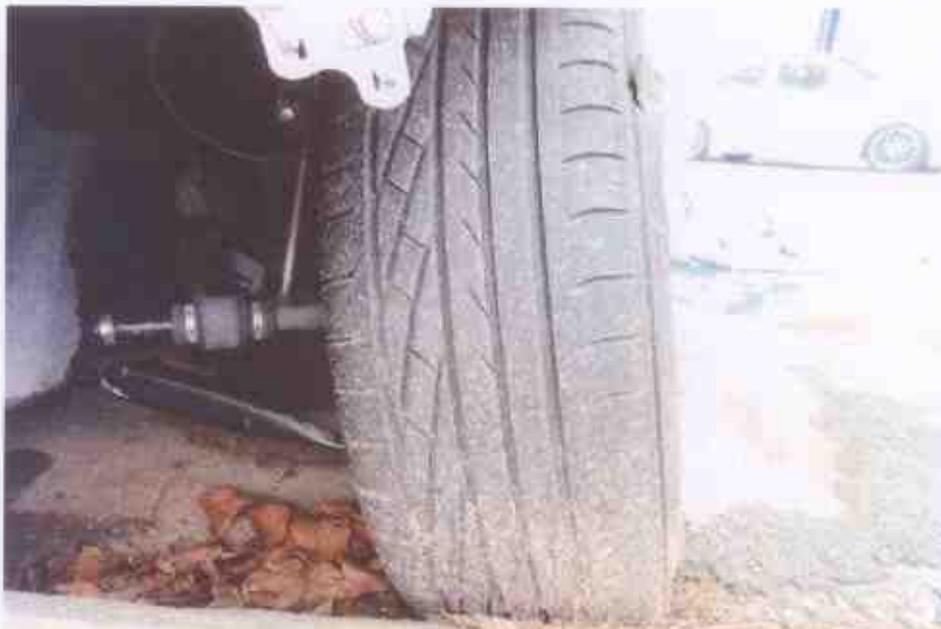
Photo 15 shows the condition of the front left portion of the Motor Car, which was observed to be deflated. Torn marks were also found on the outer sidewall of the tyre due to the accident's impact. However, the tread pattern was visually clear with tread depth measurement of 6mm.

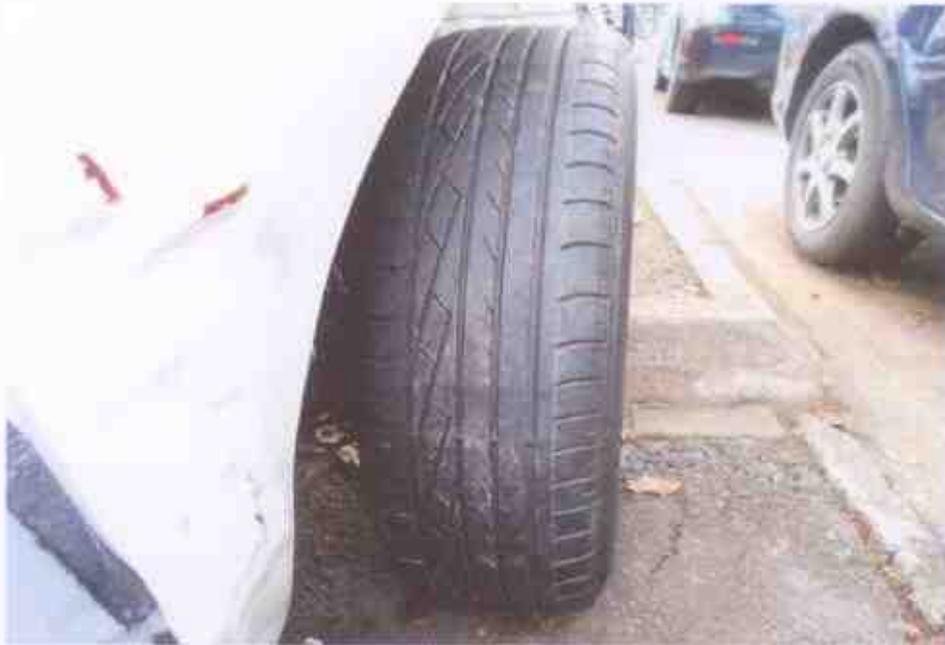
Photo 16 shows the condition of the front right tyre of the Motor Car, which was observed to be in serviceable condition. It was also observed to be sufficiently inflated for vehicular operation.

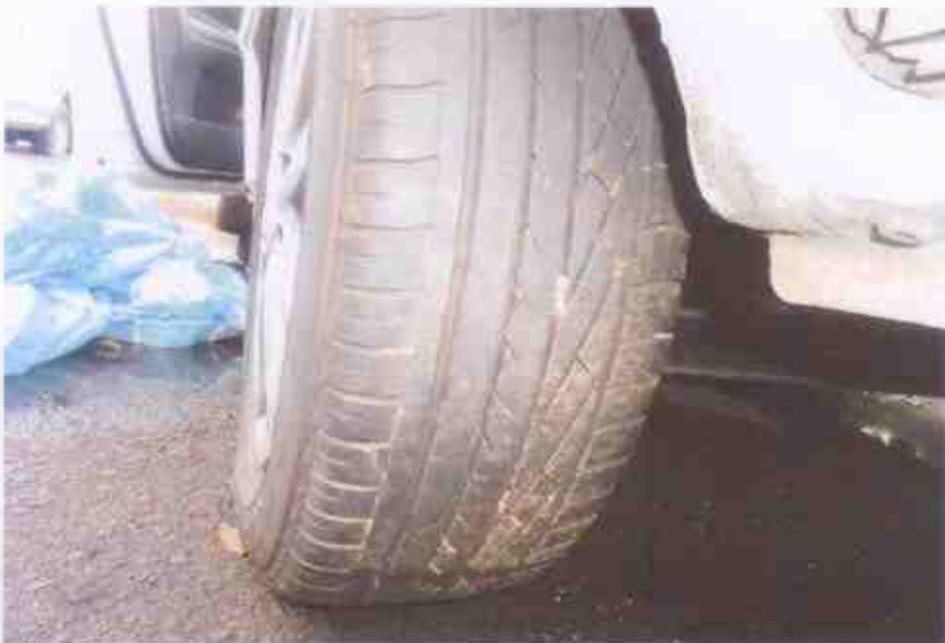
Photo 17 shows the condition of the rear left tyre of the Motor Car, which was observed to be in serviceable condition. It was also observed to be sufficiently inflated for vehicular operation.

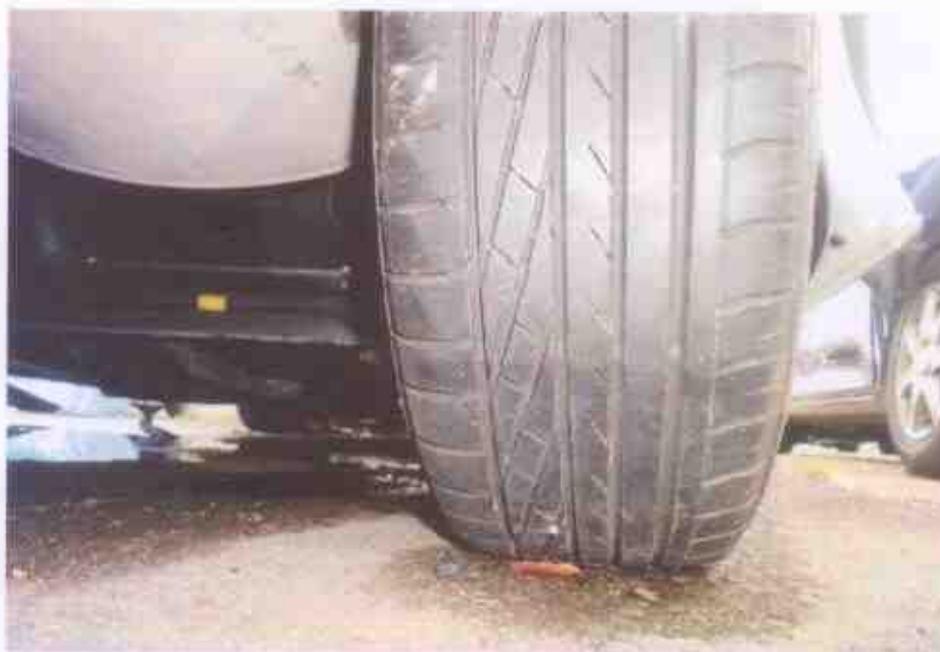
Photo 18 shows the condition of the rear right tyre of the Motor Car, which was observed to be in serviceable condition. The 4 tyres were also observed to be sufficiently inflated for vehicular operation.

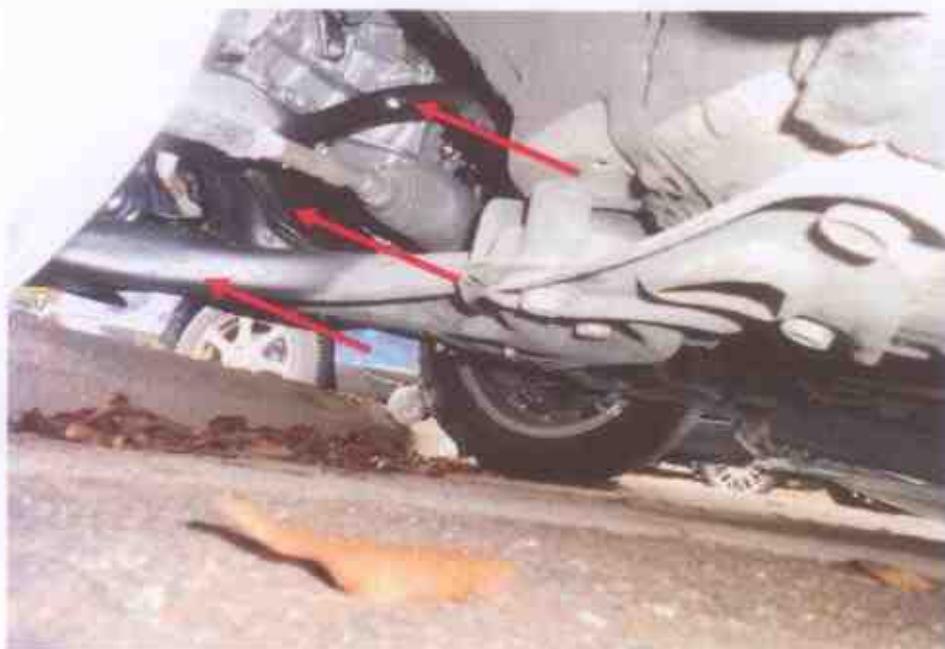
11. Leakage of the various operating fluids like the engine oil, engine coolant, power steering fluid and brake fluid was also noted. Given the extent of damages to the engine compartment, the leakages were likely due to the accident. The engine undercarriage was however observed to be covered with fluid, suggesting leakage of fluid. There was no accumulation of dust and/or dirt particles on the engine housing where the fluid stains had formed. This would indicate that the fluid leakage was a fresh leak and likely to be a result of the accident. We were therefore unable to comment whether these operating fluids were of sufficient level and without contamination for vehicular operation prior to the accident. See photo 19 to 20 below.

Photo 19 shows the close up view of the undercarriage of the Motor Car. Signs of fluid leakage were observed due to the accident's impact.

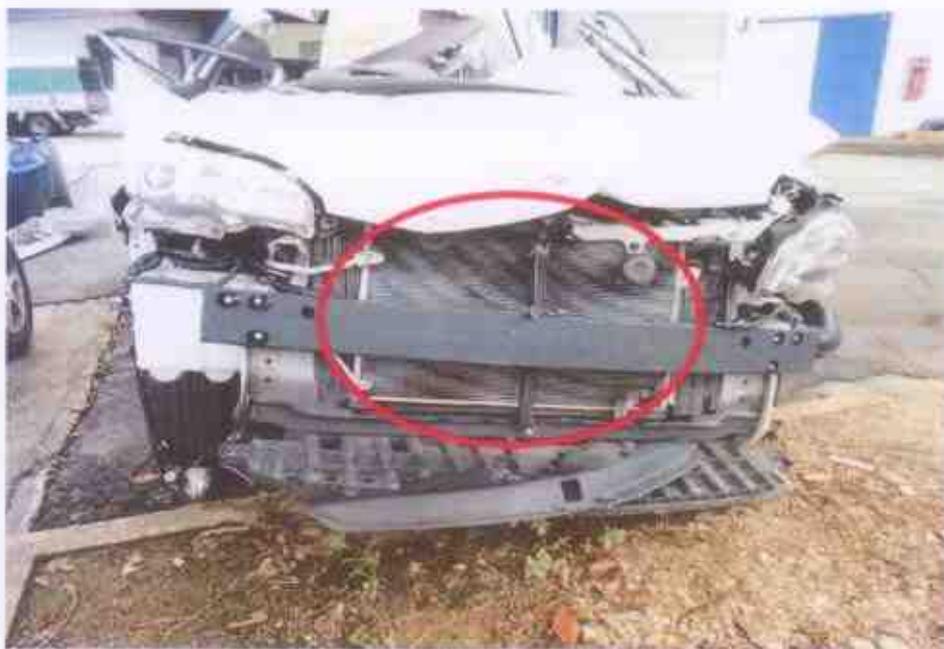
Photo 20 shows the close up view of the radiator's tank that was observed to be damaged likely due to the accident impact.

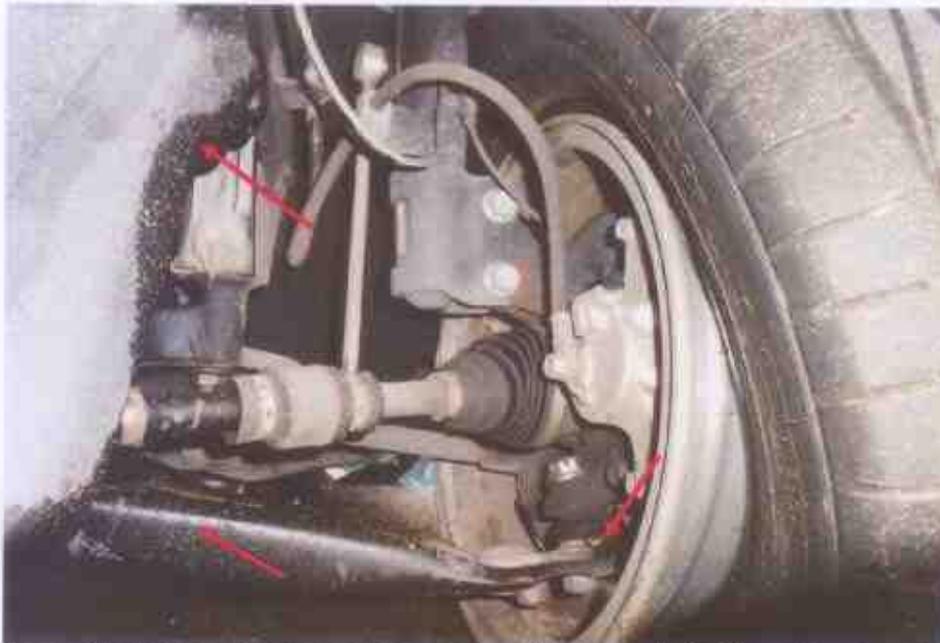
Photo 21 shows a close up view on the front left drive shaft of the Motor Car. We were not able to conduct any tests on the steering system of the Motor Car due to the damage to these components as a result of the accident.

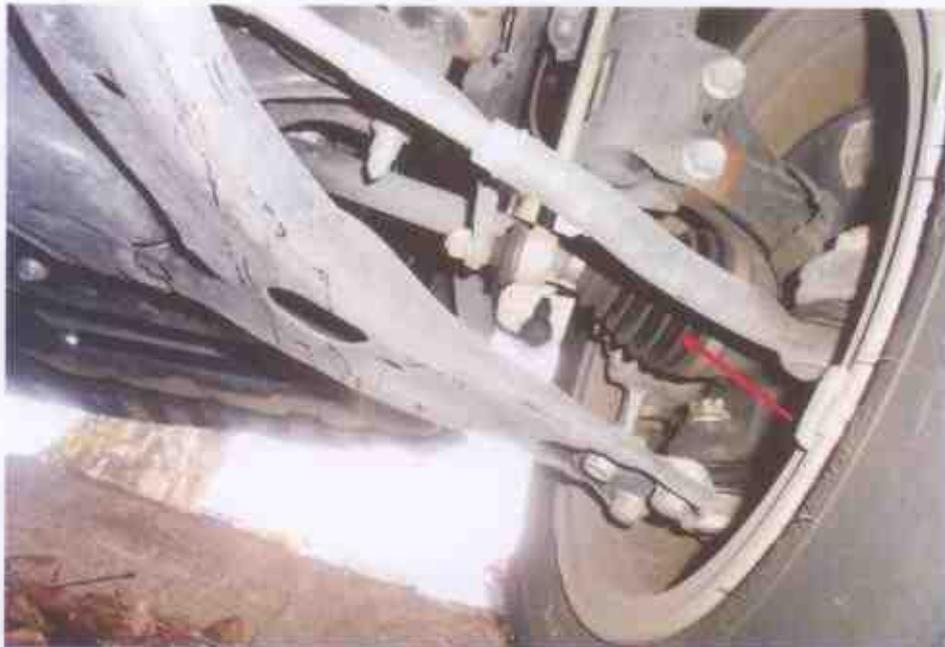
Photo 22 shows the general view on the front right drive shaft of the Motor Car. We were not able to conduct any tests on the steering system of the Motor Car due to the damages to this components, as well as leakage of fluids.

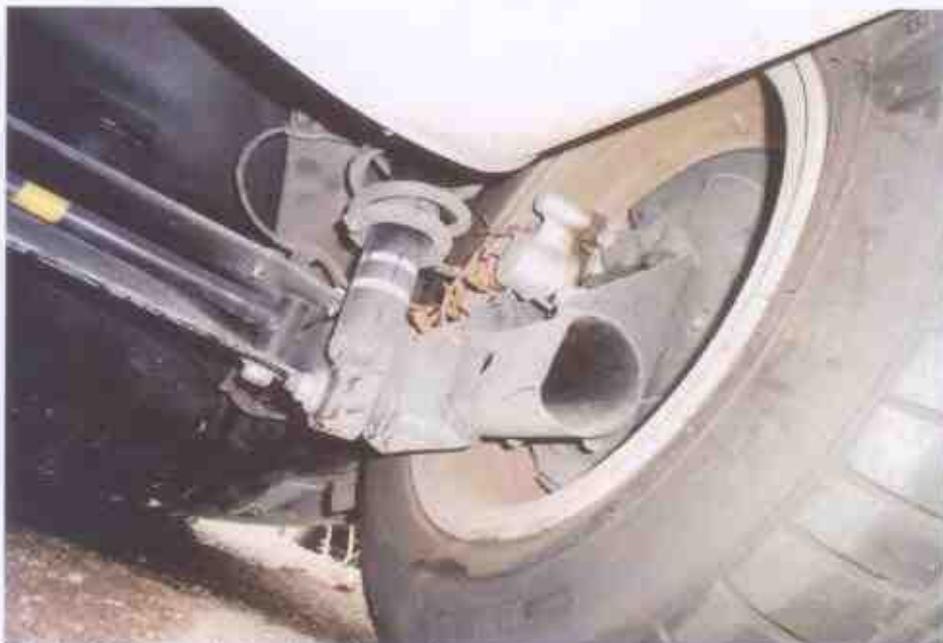
Photo 23 shows the braking & steering components at the rear right wheel of the Motor Car. We did not observe any leakage of brake fluid at the time of our inspection of the Motor Car.

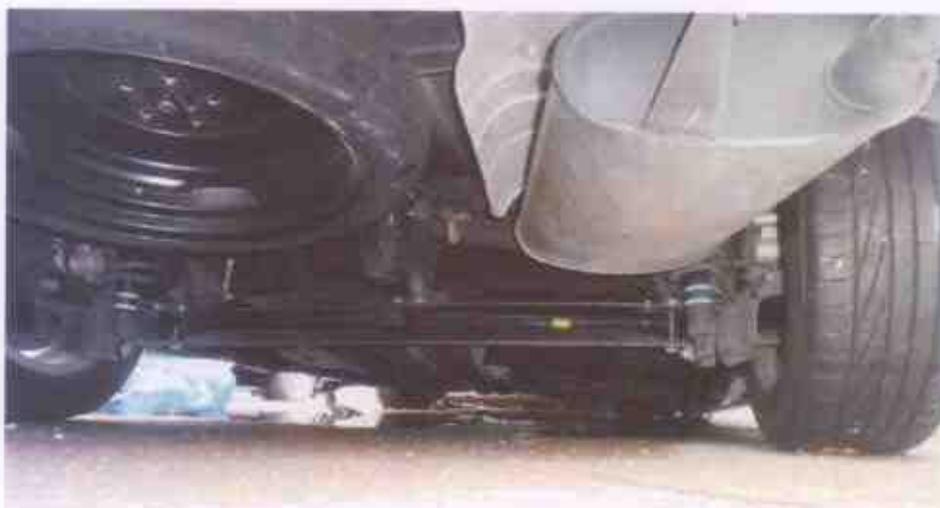
Photo 24 shows the undercarriage components of the Motor Car. It was observe to sustain an extensive damage at the time of our inspection. The body structure was observed to be affected by the accident's impact collision.

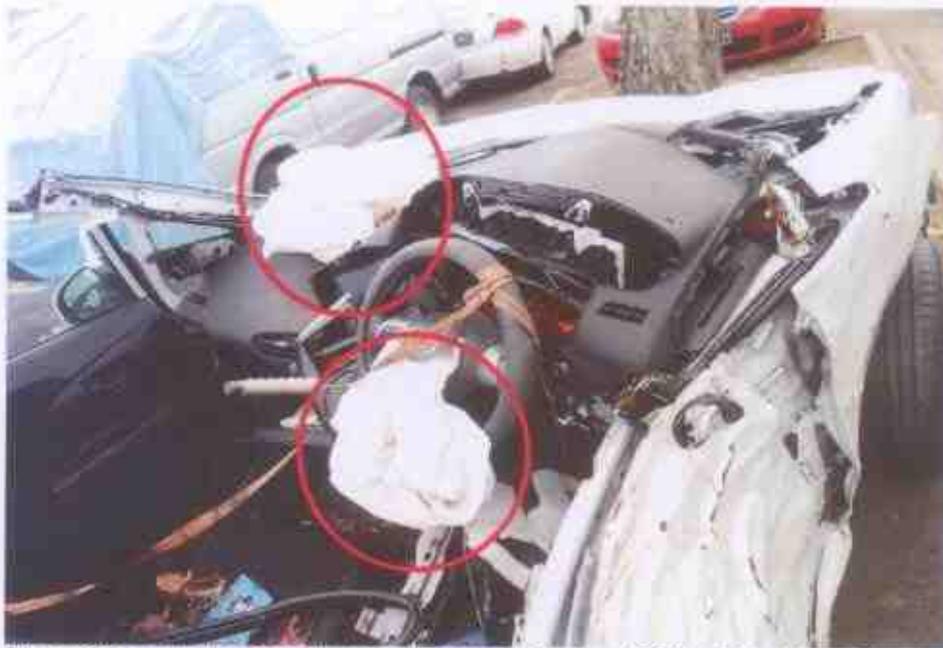
13. The Motor Car's automatic self-test of the functionality of its various operating systems like the Anti-Brake Lock System (ABS) and Supplemental Restraint System (SRS) was not able to be initiated due to major mechanical damages which includes its ignition system and engine system of the Motor Car.
14. The Supplemental Restraint System (SRS) of the Motor Car was however likely to be in normal operating condition at the material time of the accident. The evidence of the deployed the driver's & front passenger's airbag indicates that the impact sensors and control module of the Motor Car's SRS were all in serviceable condition at the material time of accident. See photo 25 below.

Photo 25 shows the Supplemental Restraint System (SRS) of the Motor Car was however likely to be in normal operating condition at the material time of the accident. The evidence of the deployed front driver & passenger's airbag indicates that the impact sensors and control module of the Motor Car's SRS were all in serviceable condition at the material time of accident.
