Your Ref: TP/IP/43683/2018  
Our Ref : CI/TPD18016125/Z

19<sup>th</sup> December 2018

### **MECHANICAL INSPECTION REPORT OF MOTOR TAXI SHD 7126J**

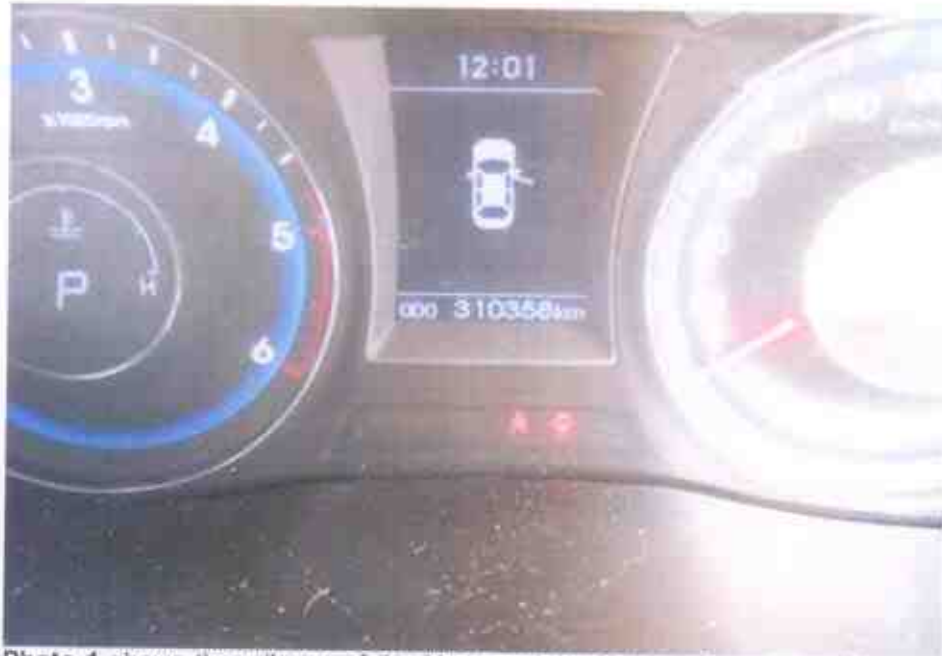
**Photo 1** shows the mileage of the Motor taxi at the time of our inspection was recorded at 310358km.

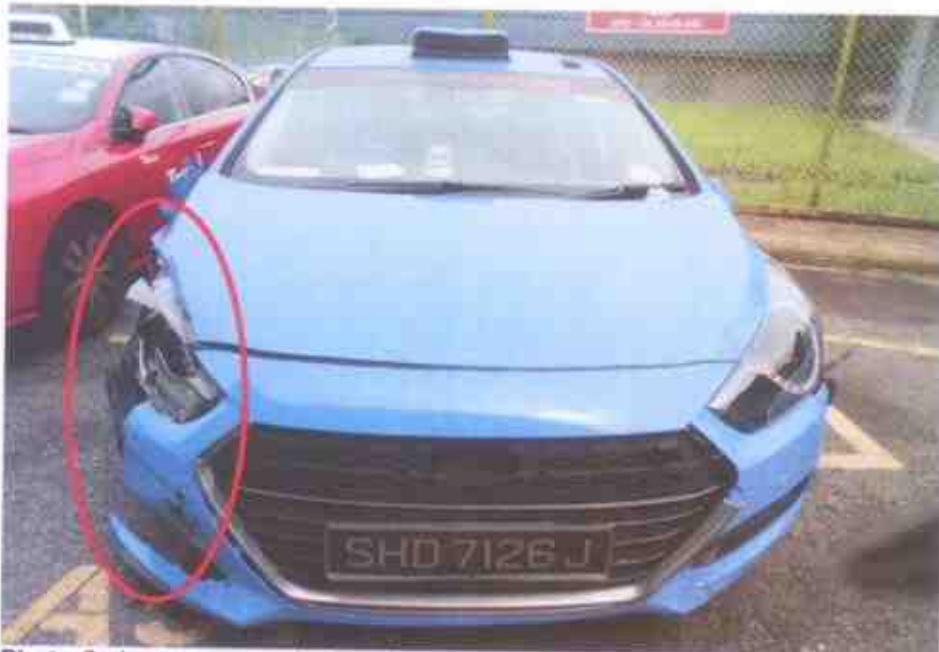
4. The mileage of the Motor taxi at the time of our inspection was recorded at 310358km.
5. The Motor taxi had sustained impact damages to its frontal left & right portion. Its front right lower bumper was observed to be damaged; it's both side headlamp, both left & right side fender, front bonnet, left & right front door & left & right side mirror was damaged likely due to the accident's collision impact.

**Photo 2** shows a general view of the front body of the Motor Taxi at the time of our inspection. The Motor Taxi was observed to have sustained impact damages that were confined to its frontal left & right portion. Its front right lower bumper was observed to be damaged likely due to the accident's collision impact.

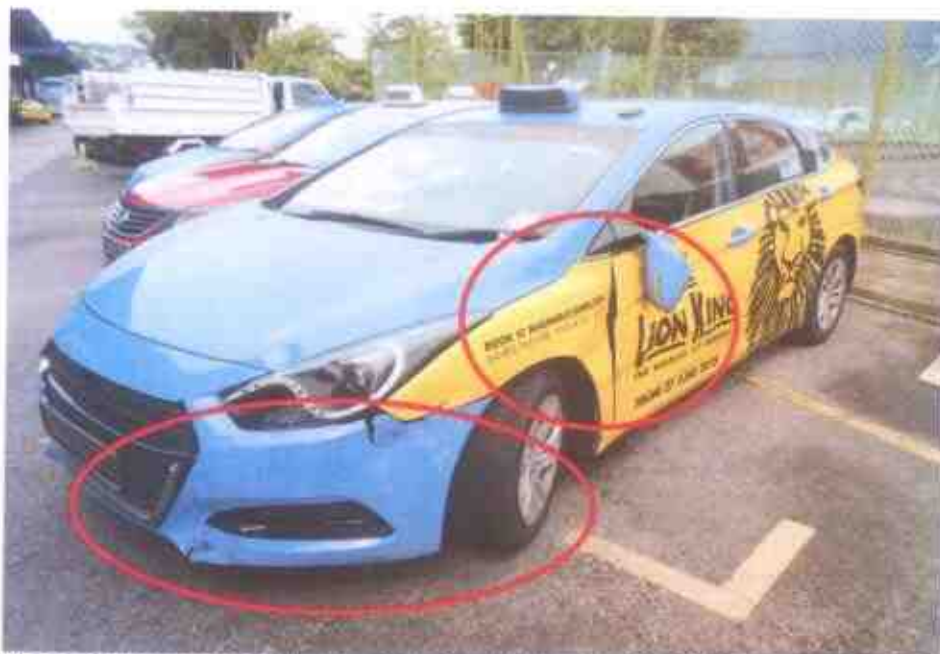
Photo 3 shows a general view of the front left body of the Motor Taxi at the time of our inspection. The Motor Taxi was observed to have sustained minor impact damages that were confined to its frontal left & right portion.

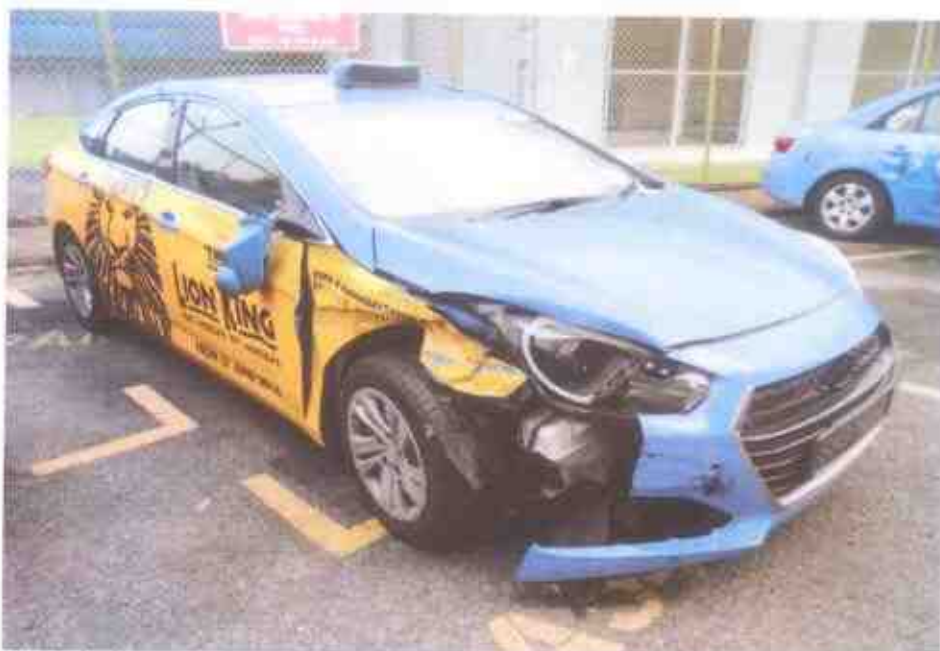
Photo 4 shows a general view of the front right body of the Motor Taxi at the time of our inspection. The Motor Taxi was observed to have sustained impact damages that were confined to its frontal left & right portion.

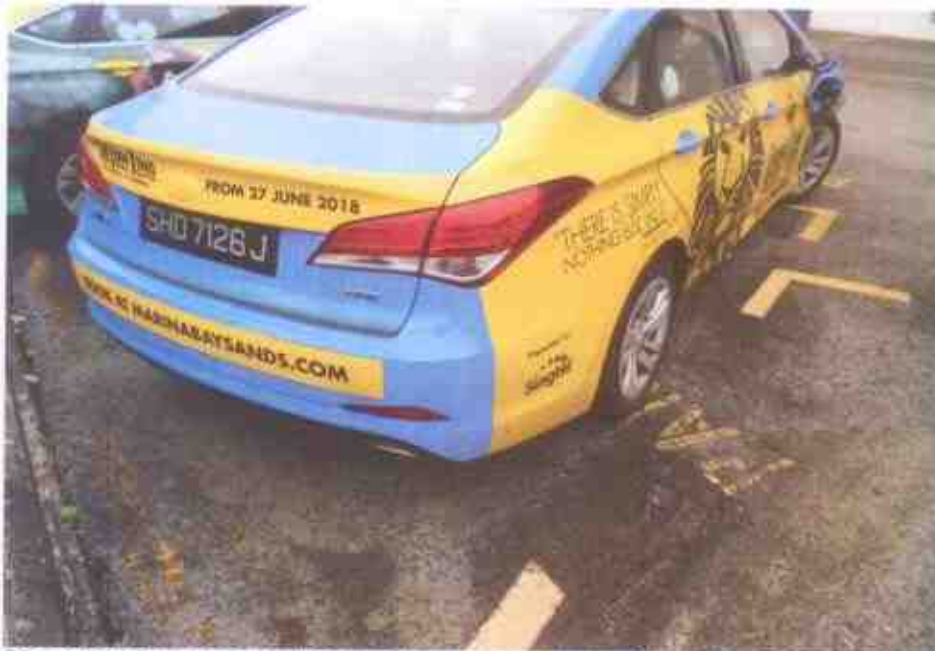
**Photo 5** shows a general view of the rear right body of the Motor Taxi at the time of our inspection. The Motor Taxi was observed to be in good general condition.

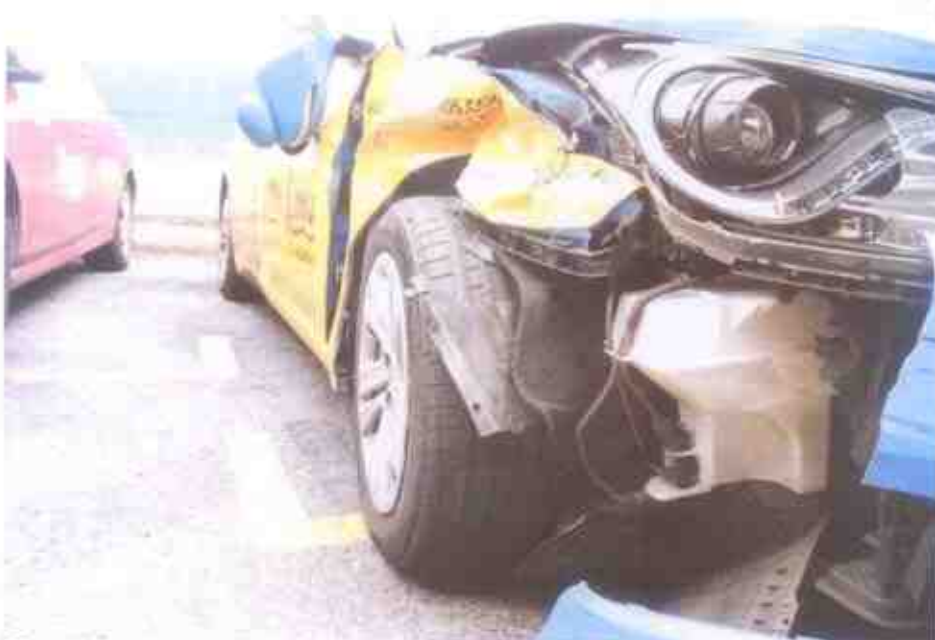
**Photo 6** shows a semi close up view of the front right portion of the Motor Taxi at the time of our inspection. The Motor Taxi had sustained damages at the front right lower bumper, headlamp, side fender, driver door & right side mirror likely due to the accident.

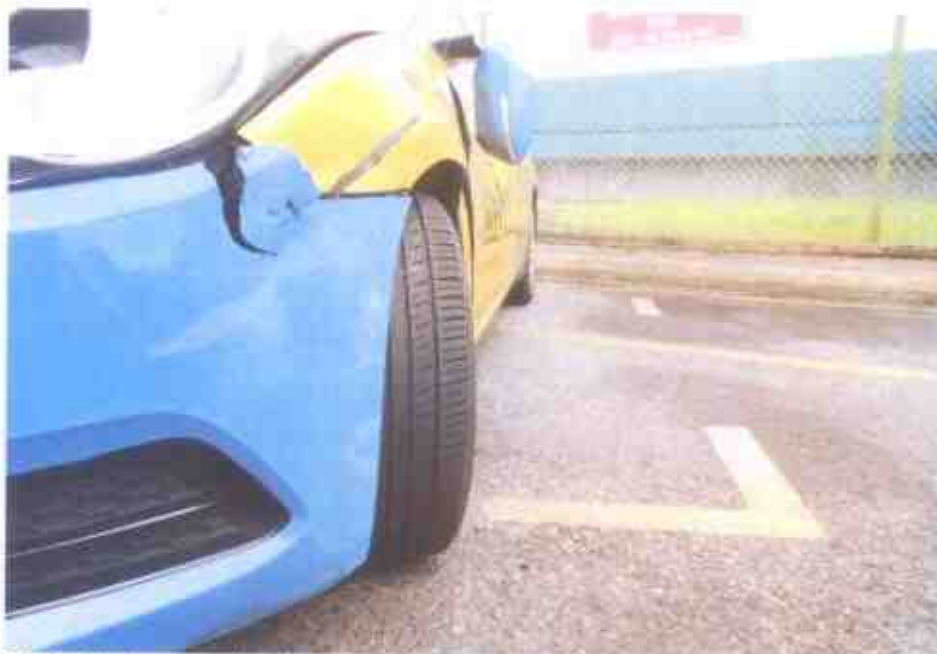
Photo 7 shows a close up view of the front left portion of the Motor Taxi at the time of our inspection. The Motor Taxi had sustained damages at the front right lower bumper, headlamp, side fender, passenger's door & left side mirror likely due to the accident.

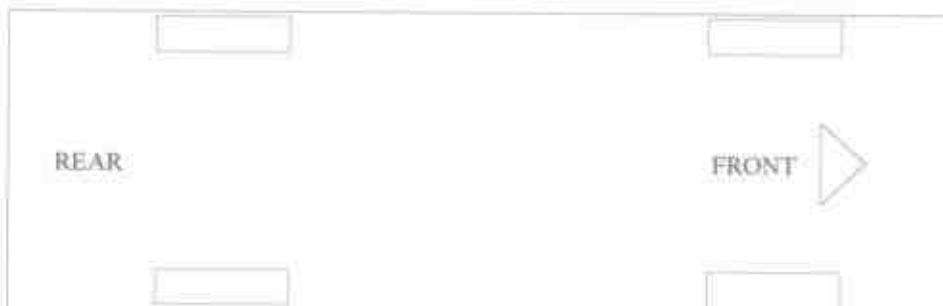
7. The condition of the Motor Taxi's 4 tyres was observed to be in serviceable condition. We did not find any tear, cut or burst mark(s) on the outer and the inner sidewalls as well as across the tread of the 4 tyres. The 4 tyres were also observed to be sufficiently inflated for vehicular operation. The tyre brand, tyre size and remaining tread depth of the 4 tyres were recorded as follows:-

Westlake Radial RP26  
205/60R16 (5mm)

Westlake Radial RP26  
205/60R16 (3mm)

Hankook Optimo H724  
205/60R16 (5mm)

Westlake Radial RP26  
205/60R16 (4mm)

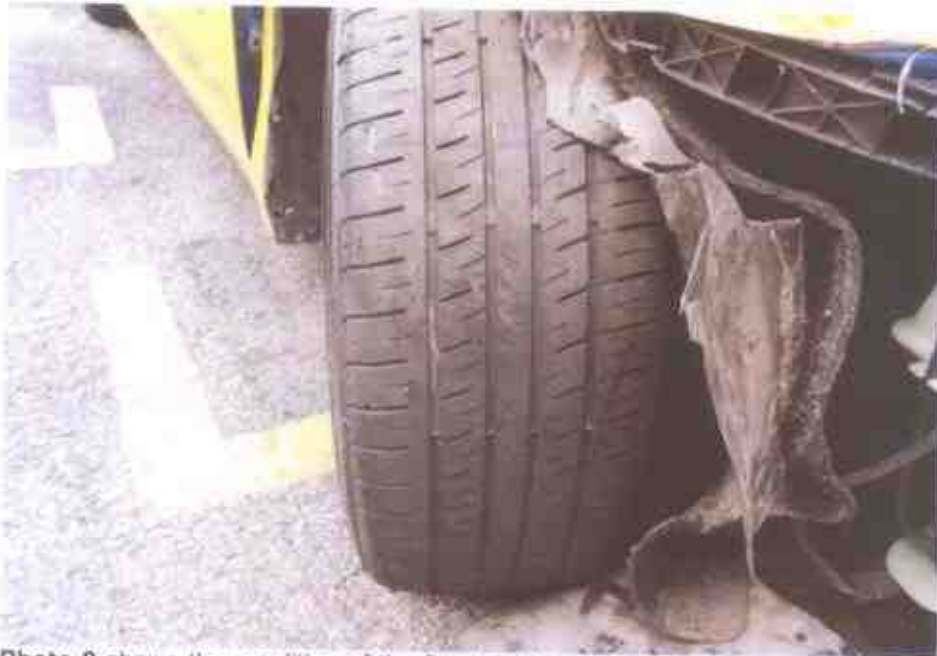
Photo 8 shows the condition of the front right tyre of the Motor Taxi, which was observed to be in serviceable condition with remaining tread depth of approximately 4mm.

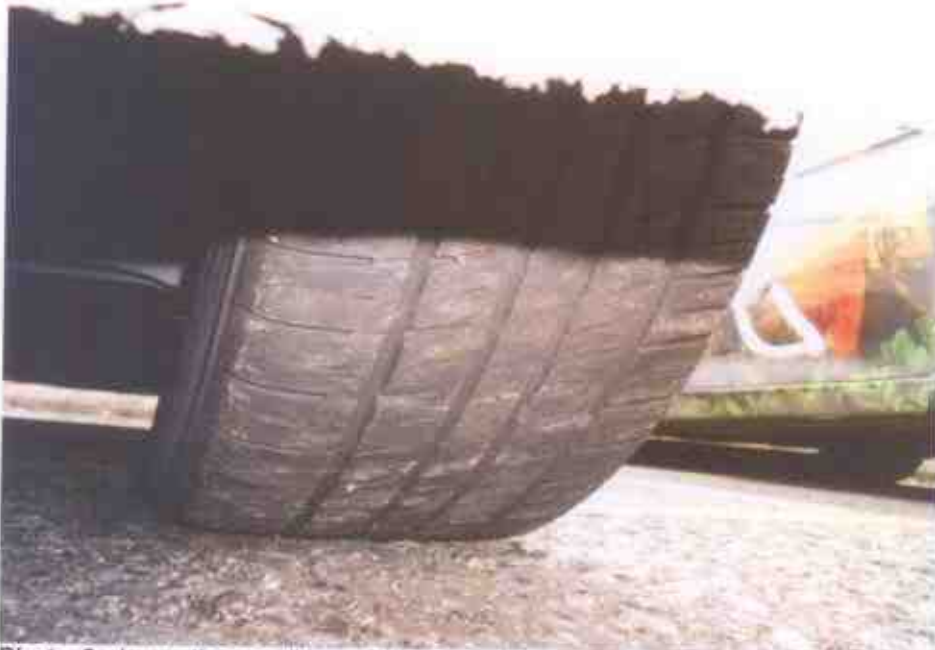
Photo 9 shows the condition of the front left tyre of the Motor Taxi, which was observed to be in serviceable condition with remaining tread depth of approximately 3mm.

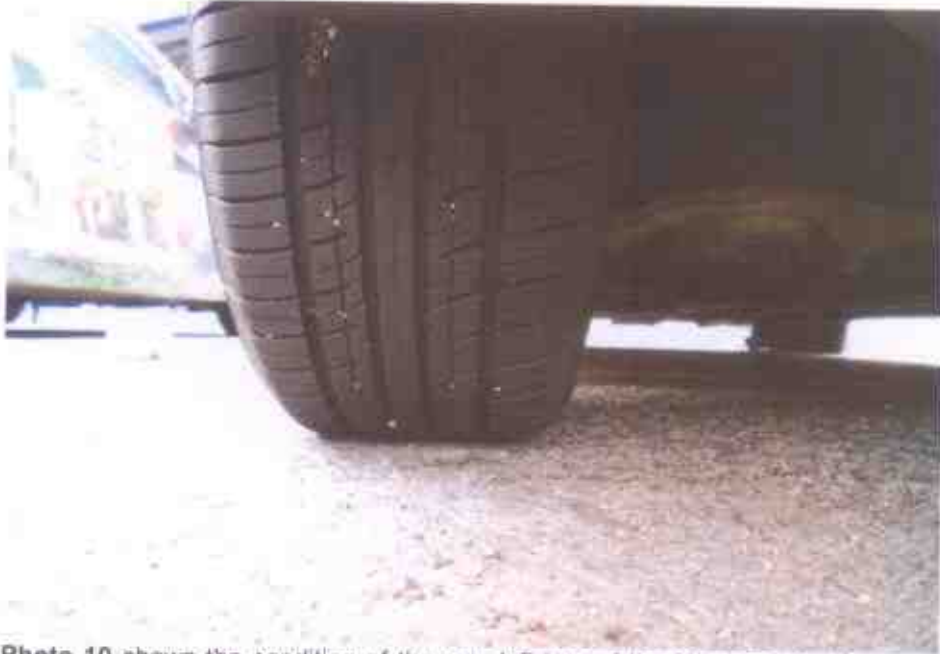
**Photo 10** shows the condition of the rear left tyre of the Motor Taxi, which was observed to be in serviceable condition with remaining tread depth of approximately 5mm.

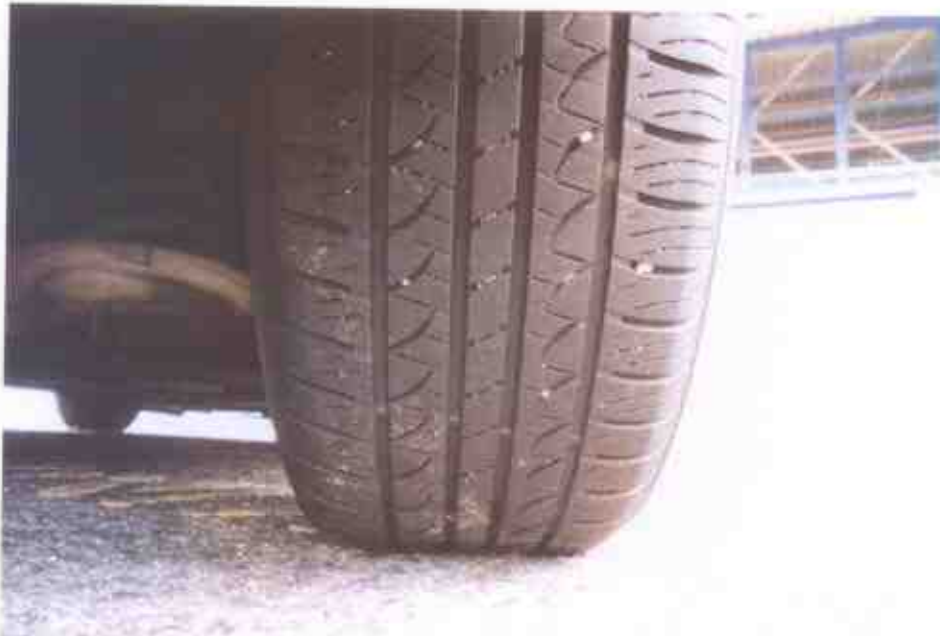
**Photo 11** shows the condition of the rear right tyre of the Motor Taxi, which was observed to be in serviceable condition with remaining tread depth of approximately 5mm.

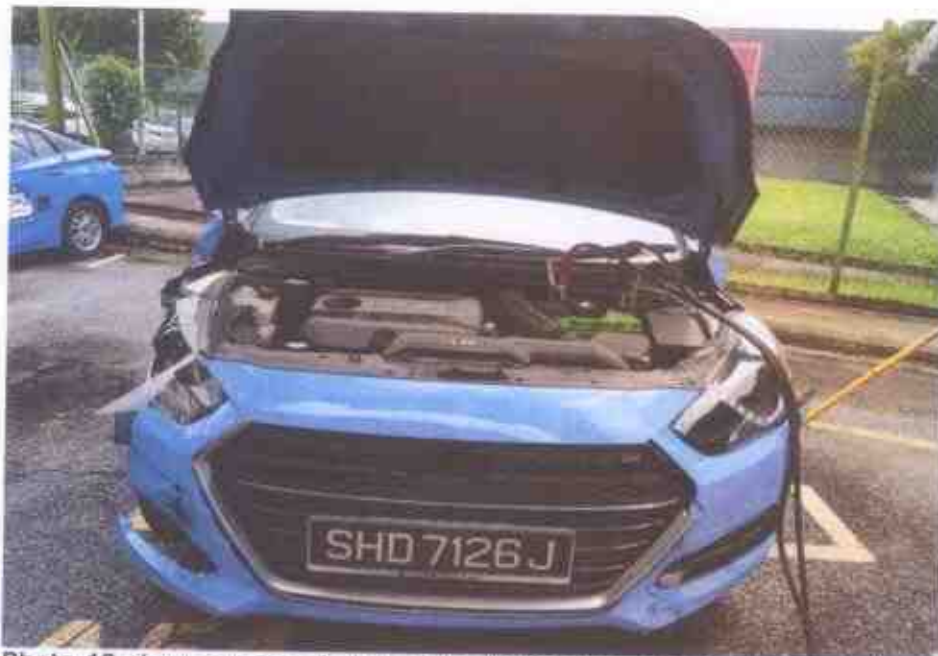
Photo 12 shows a general view of the Motor Car's engine compartment. The various parts and components inside the engine compartment were unaffected by the accident. There was also no sign(s) or indication(s) of fluid leakage and/or fluid stain within the engine compartment.

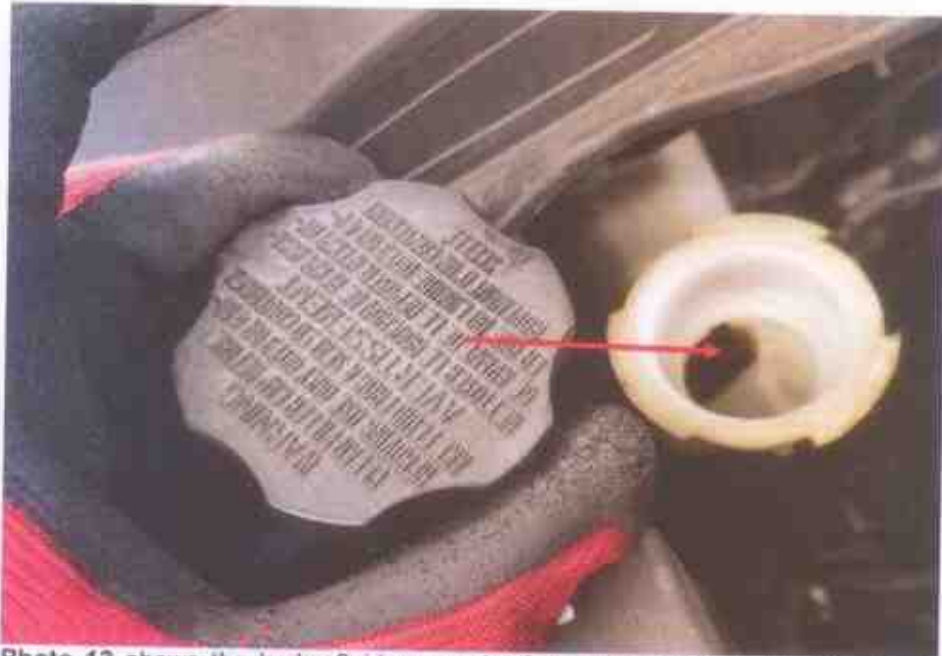
**Photo 13** shows the brake fluid reservoir of the Motor Taxi at the time of our inspection. The brake fluid was observed to be of sufficient level (arrowed) and without any visible contamination.

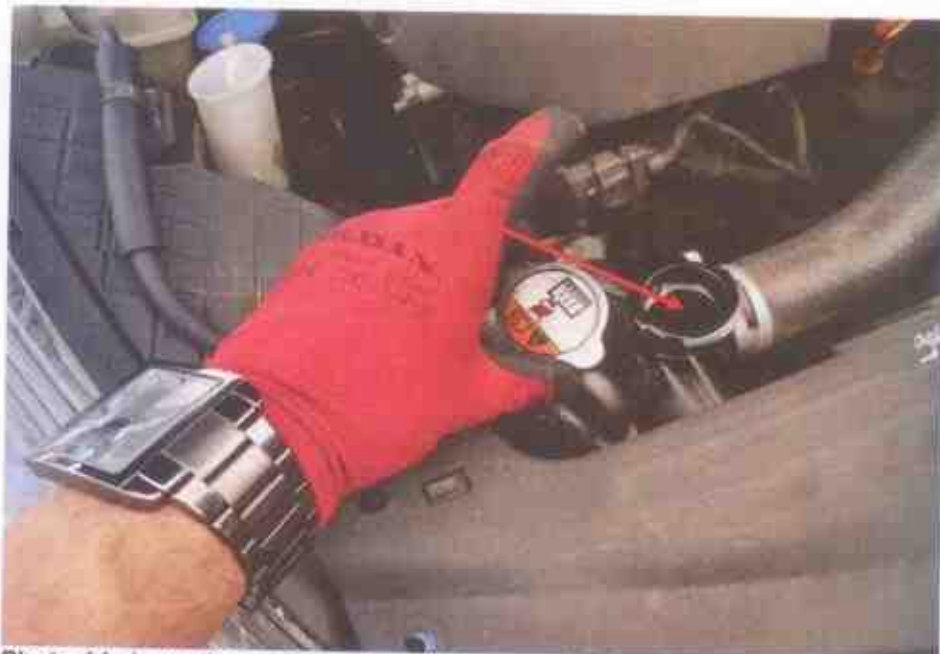
**Photo 14** shows the engine coolant fluid reservoir of the Motor Taxi at the time of our inspection. The engine coolant fluid was observed to be of sufficient level and without any visible contamination.

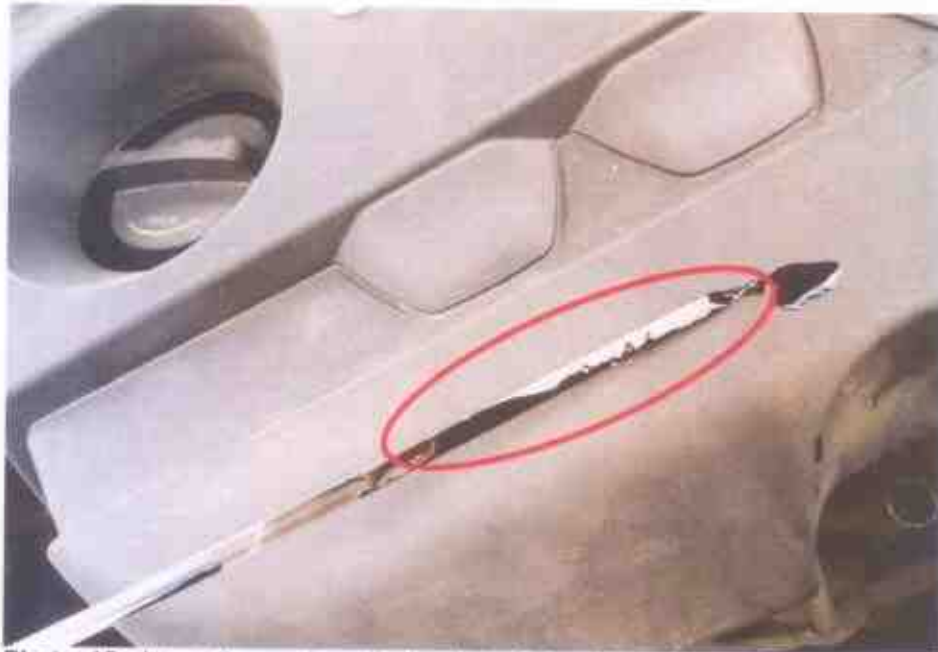
Photo 15 shows the engine oil dip stick of the Motor Taxi at the time of our inspection. The engine oil was observed to be of sufficient level and without any visible contamination.

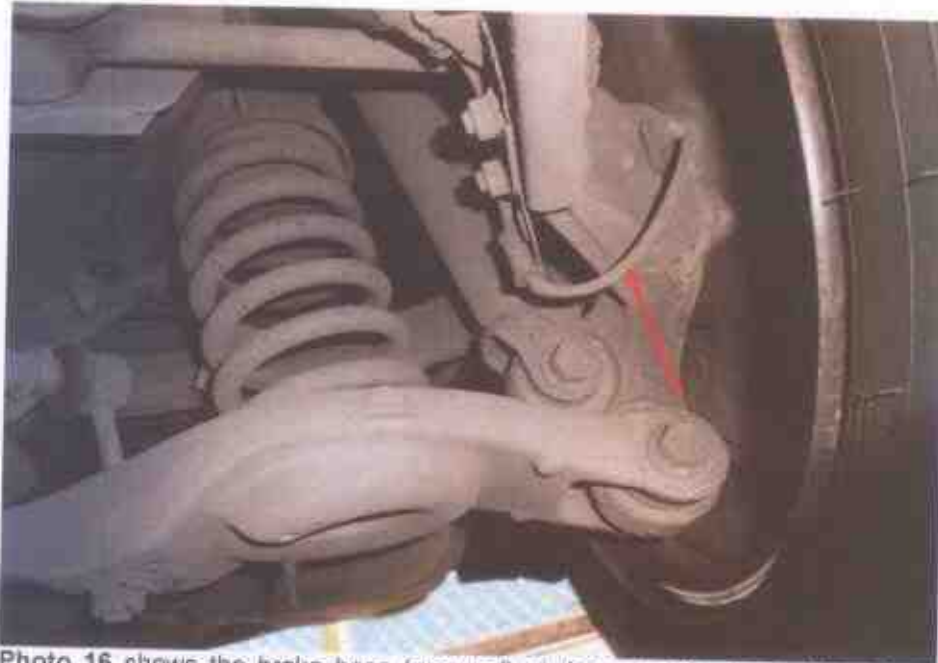
Photo 16 shows the brake hose (arrowed) at the rear left wheel of the Motor Taxi. We did not observe any leakage of brake fluid at the time of our inspection of the Motor Taxi. Our visual inspection of the various mechanical components of the Motor Taxi's braking system revealed all to be intact without visible damage.

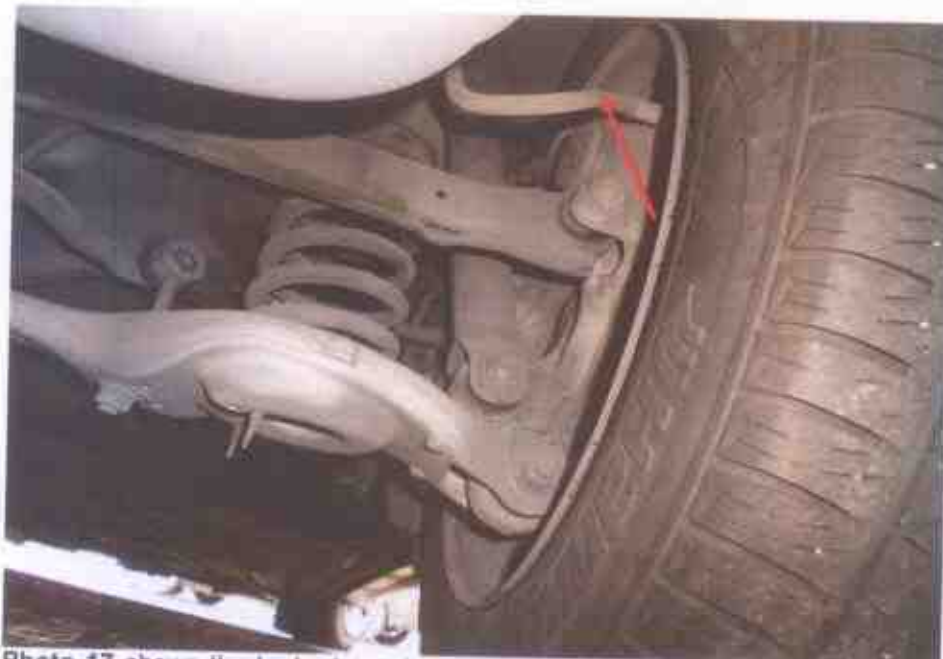
Photo 17 shows the brake hose (arrowed) at the rear right wheel of the Motor Taxi. We did not observe any leakage of brake fluid at the time of our inspection of the Motor Taxi. Our visual inspection of the various mechanical components of the Motor Taxi's braking system revealed all to be intact without visible damage.

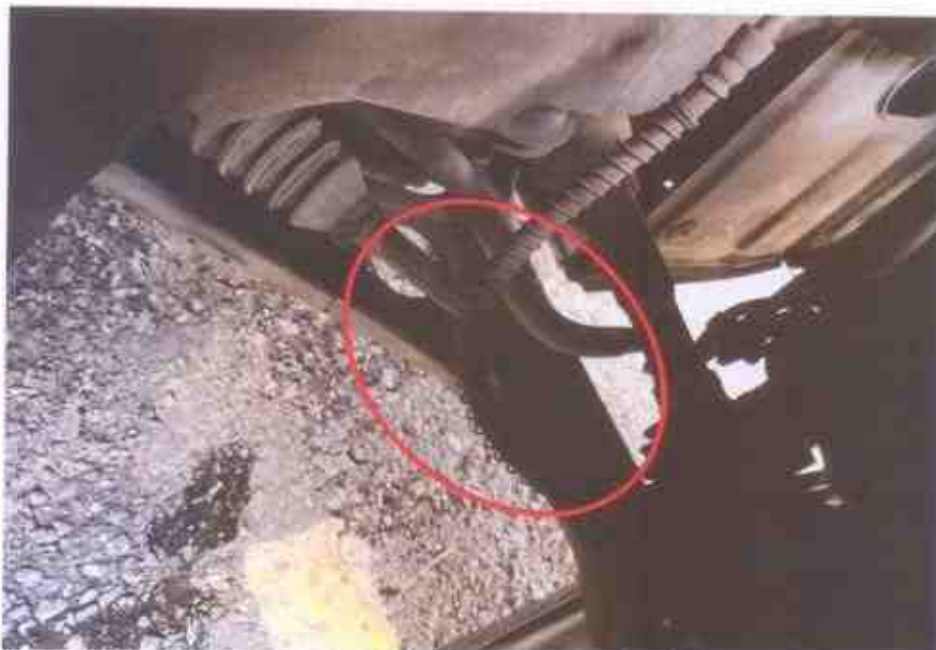
12. The mechanical components of the Motor Taxi's steering system in particular the steering rod was found to be damaged as a result of the accident. However, our visual examination of the other various steering components, which had included the rack and pinion, tie rod ends and ball joints, revealed that these components were all generally in good condition.
13. The mechanical components of the Motor Taxi's braking system were all found to be visually intact and undamaged. Our visual examination of the various braking components like the brake master pump, brake booster, brake callipers and brake hoses amongst others were found to be in serviceable condition without any damage.
14. Static test on the steering system of the Motor Taxi was unable to be conducted due to the damage on the steering rod as a result of the accident. See photo 16 - 20 below.

Photo 18 shows the various undercarriage components at the front right wheel of the Motor Taxi, in particular the steering rod (circled). It was observed to be bent as a result of the accident.

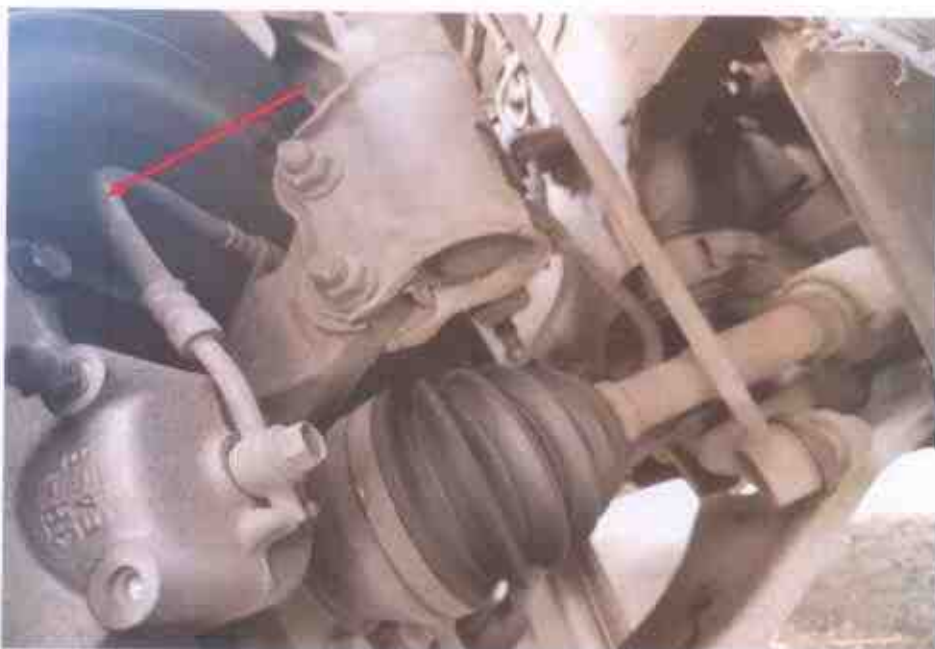
Photo 19 shows the various undercarriage components at the front right wheel of the Motor Taxi. We did not observe any leakage of brake fluid (arrowed) at the time of our inspection of the Motor Taxi. Our visual inspection of the various mechanical components of the Motor Taxi's braking system revealed all to be intact and without visible damage, indicating that the braking system was likely to be in serviceable condition at the material time of accident.

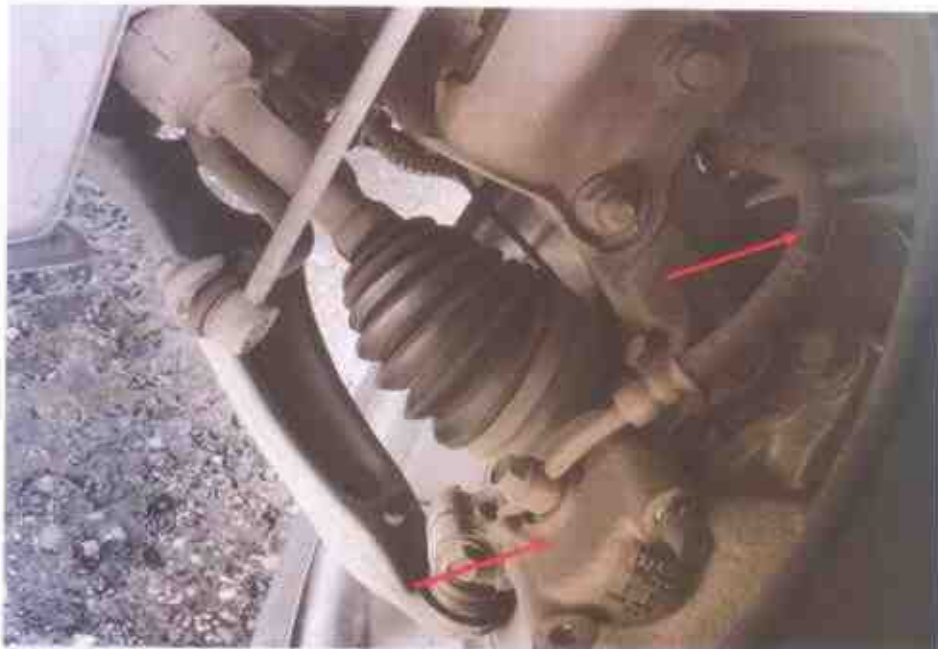
Photo 20 shows the various undercarriage components at the front left wheel of the Motor Taxi. We did not observe any leakage of brake fluid (arrowed) at the time of our inspection of the Motor Taxi. Our visual inspection of the various mechanical components of the Motor Taxi's braking system revealed all to be intact and without visible damage, indicating that the braking system was likely to be in serviceable condition at the material time of accident.

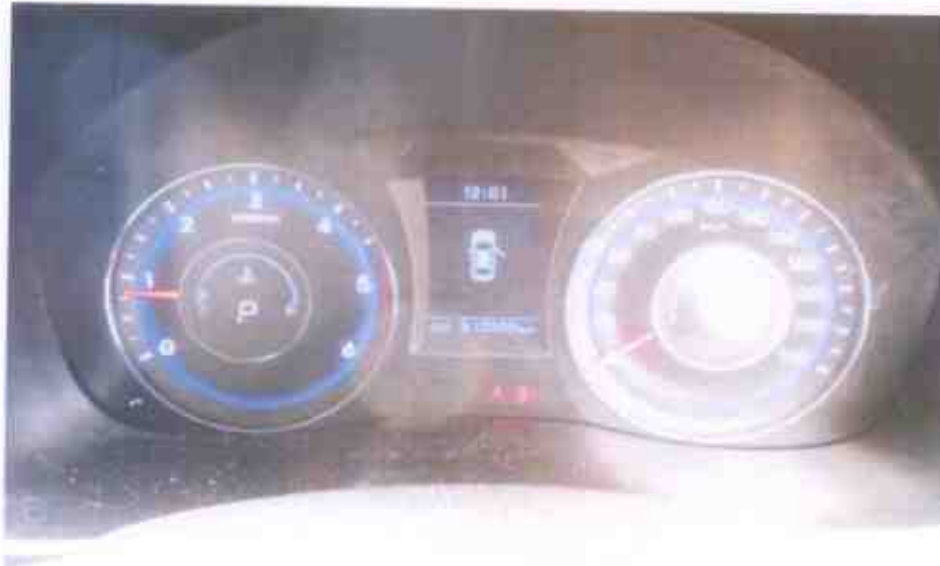
15. The Motor Taxi's automatic self-test of the functionality of its various electronic operating systems like the Anti-Brake Lock System (ABS), SRS, engine check light, battery light and diesel glow plug during cranking of the engine had indicated that these systems were in working condition and without abnormality. This can be established from the warning lights disappearing from the instrument panel after the self-test. See photo 21 below.

**Photo 21** shows no warning lights illuminated on the instrument panel of the Motor Taxi after the engine was cranked. This would suggest that there was no abnormality to the various electronic operating systems of the Motor Taxi, like the ABS light engine check light, battery light and diesel glow plug.

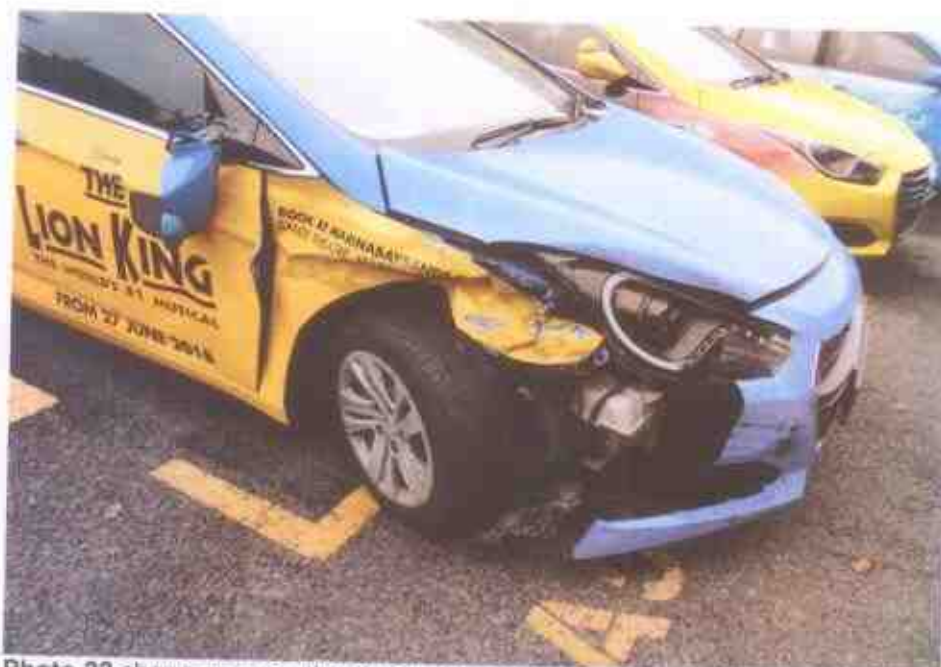
16. A short operational test of the Motor Taxi, to primarily determine whether there was any abnormality to its engine system, its transmission system and braking system was subsequently carried out.
17. During the operational test, the transmission system of the Motor Taxi was able to be shifted to drive mode and reverse mode without any difficulty. There were no abnormal sounds heard and/or abnormal behaviour of the Motor Taxi's engine system. It was able to move forward and backward normally. The braking system was also found to be in working condition as the Motor Taxi was able to slow down and come to a complete stop upon depressing of the brake pedal. See photo 22 below.

Photo 22 shows an operational test of the Motor Taxi. We were able to move the vehicle reverse, forward and backward normally.
