SPECIALIST INSPECTION REPORT:

YM8972C - Havi Logistics (S) Pte Ltd - Insured vehicle hit 3 pedestrians on 6/11/2012

SPECIALIST INSPECTION REPORT

Specialist inspection/ investigation of the Insured vehicle YM8972C on 23 November 2012; determines if there were any defects or deficiencies at the material time that could have caused or contributed to the accident.

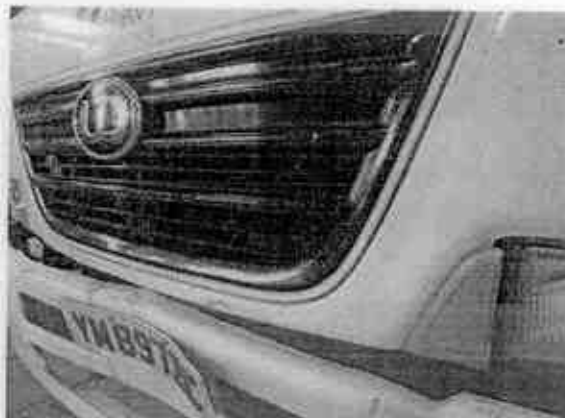
Photo2: Front bumper, front number plate and front grille dented.

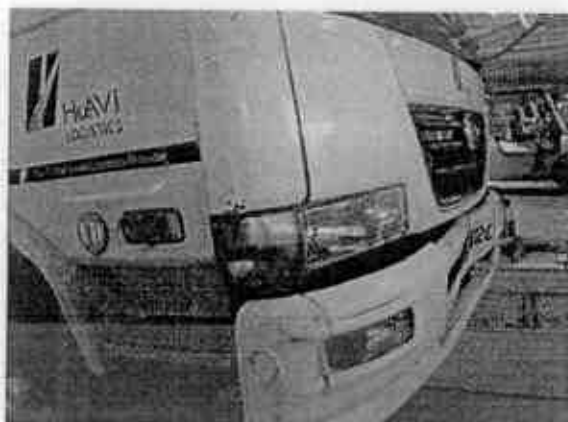
Photo 3: Front bumper corner rhs, corner panel rhs, and right signal light damaged.

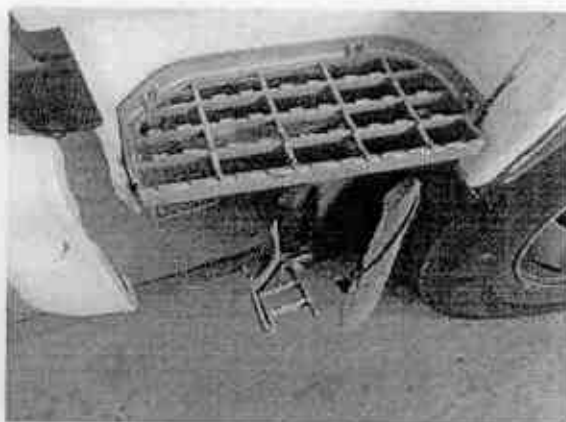
Photo 4: Lower step plate, garnish lhs broken, torn.

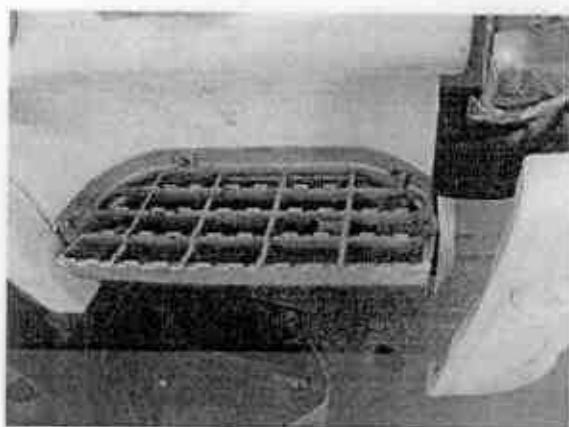
Photo 5 Lower step plate, garnish rhs broken, torn.

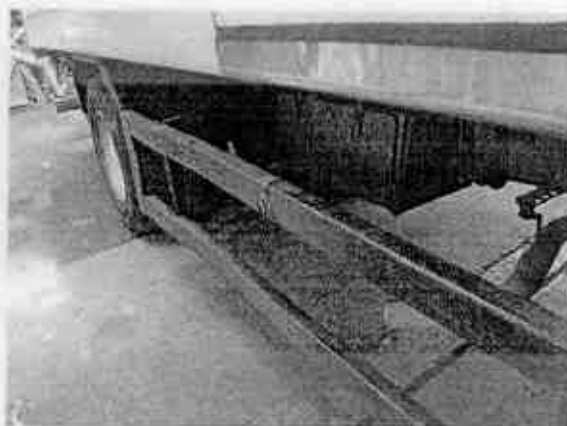
- 3.6 Certain body parts were corroded, bent and distorted, e.g. under-ride side protection guard-rails, rear bumper, driver-side floor panel, etc. See Photos 1 to 25, and 28.

Photo 6: Side guide rail rhs bent.

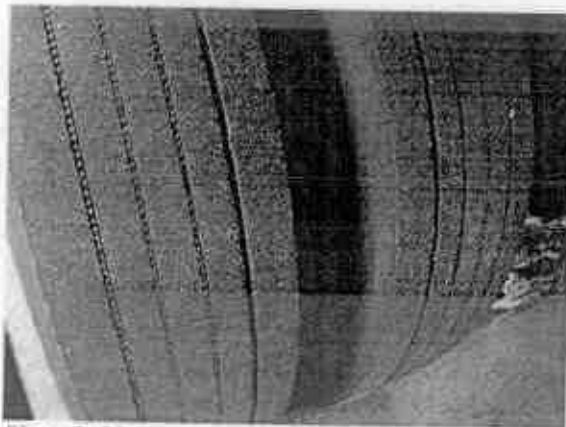
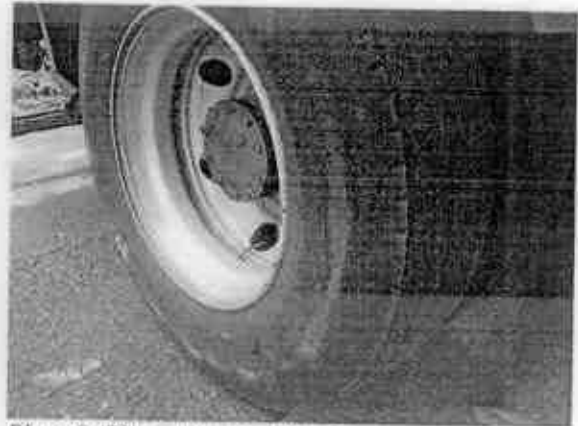
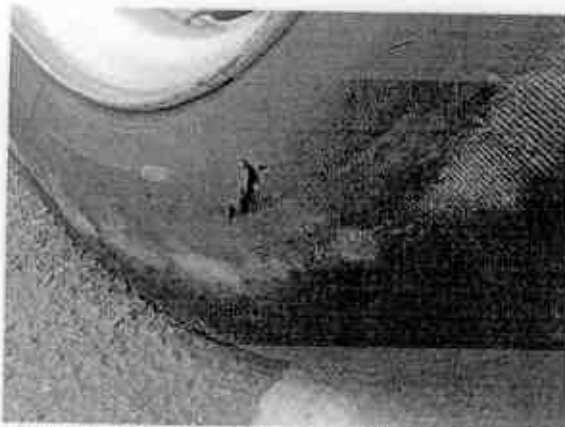
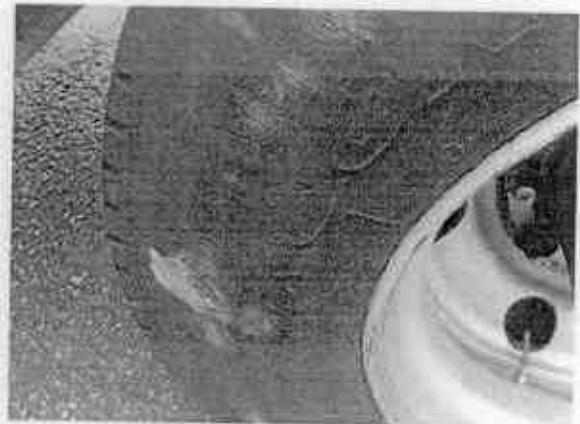
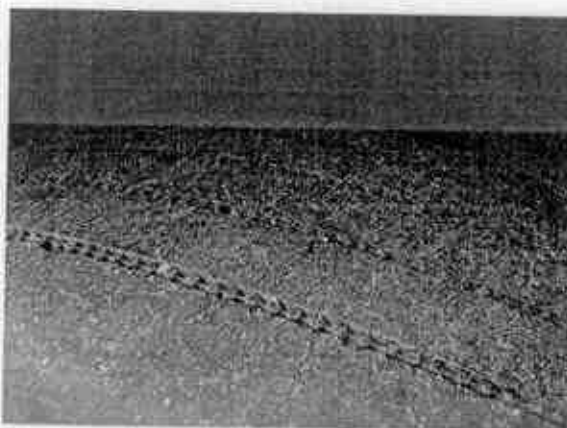
- 3.7 The rear tyres were worn down to the legal minimum limit of 1 mm tread depth, and their outer side-wall canvass exposed. See Photos 7 to 11, 13 to 15, and 20 to 25.

Photo 7: Rhs rear tyres.

Photo 8: Rhs rear tyres side wall.

Photo 9: Closer view of the tyre wall.

Photo 10: Another view of the side wall rear tyre.

Photo 11: Another closer view of the rear tyre.

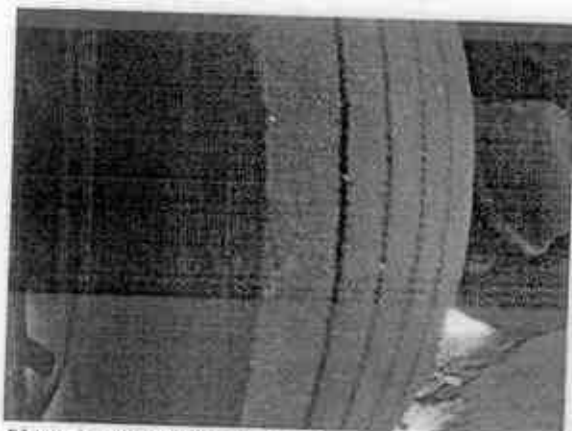
Photo 13: Unevenly worn tyre is seen.

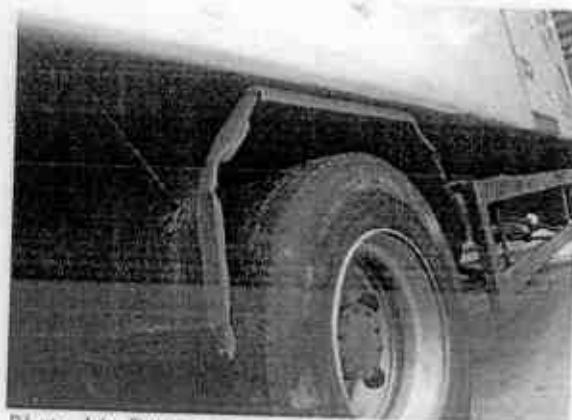
Photo 14: Damaged rear mudguard and rear tyre rhs can be seen.

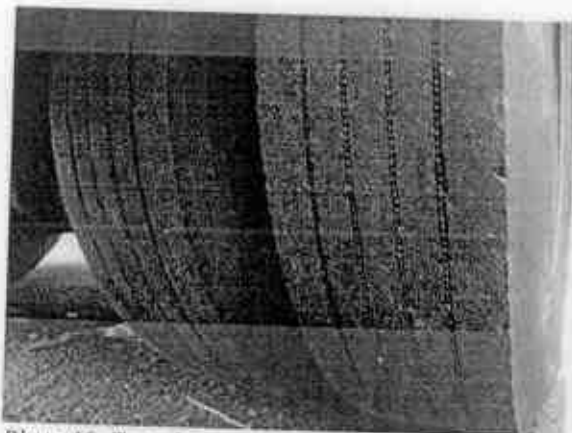
Photo 15: Tyre rhs rear can be seen.

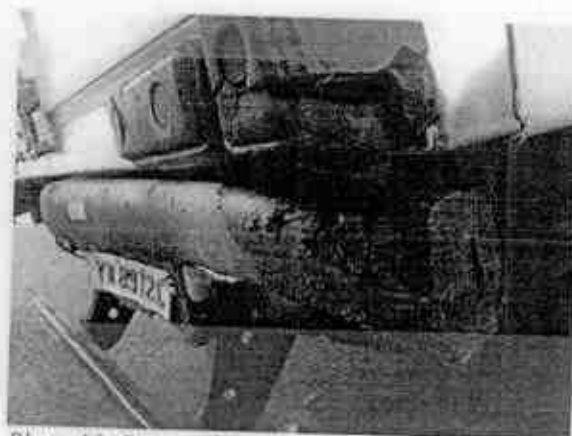
Photo 16: Rear cushion rhs worn and torn and rear number plate distorted.

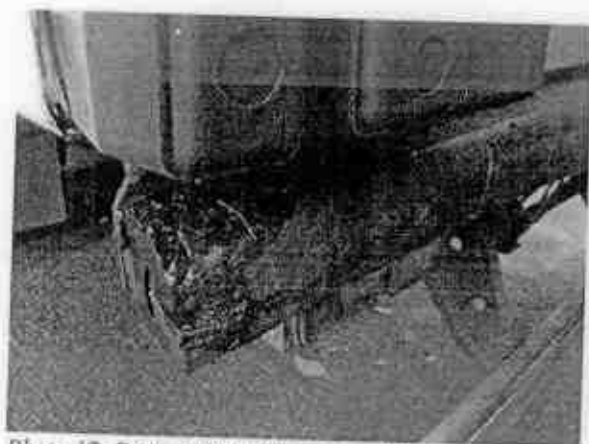
Photo 17: Rear cushion lhs worn and torn.

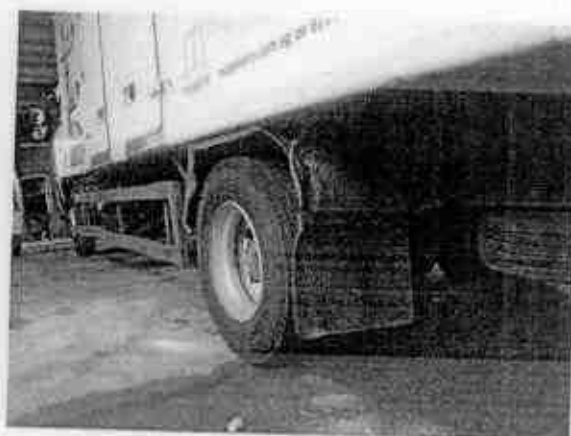
Photo 18: Lhs rear mudguard distorted is seen.

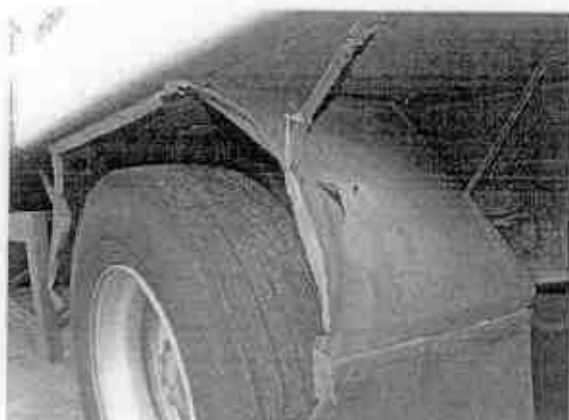
Photo 19: Closer view of the torn and distorted lhs rear mudguard.

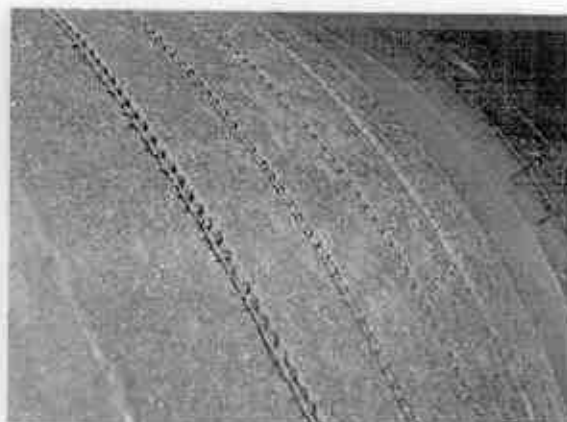
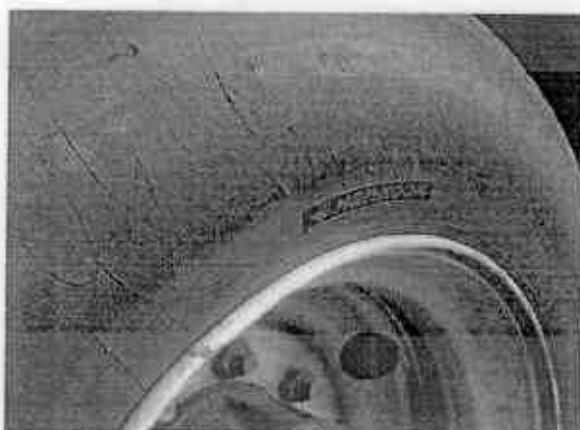
Photo 20: Rear tyre.

Photo 21: The side wall of lhs rear tyre can also be seen.

Photo 23: Side wall of lhs rear tyre.

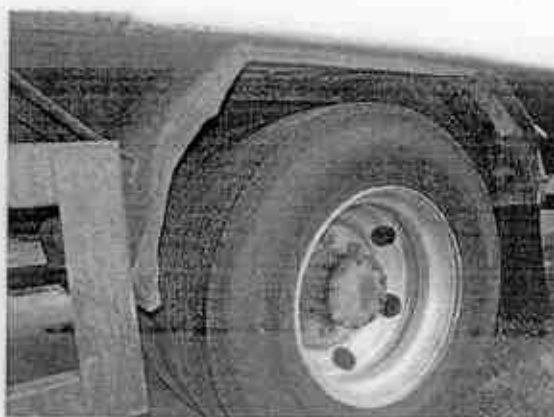
Photo 24: Another view of the distorted rear lhs mudguard.

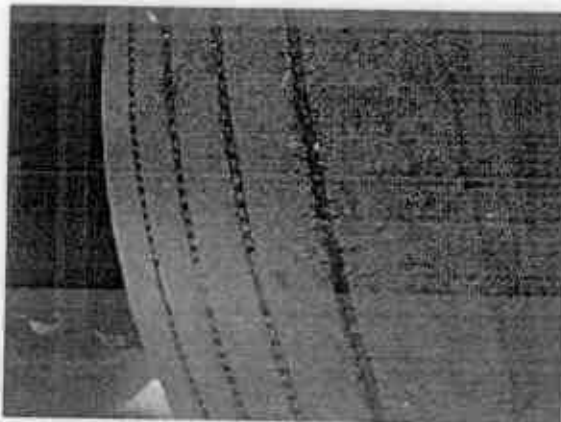
Photo 25: View of another tyre.

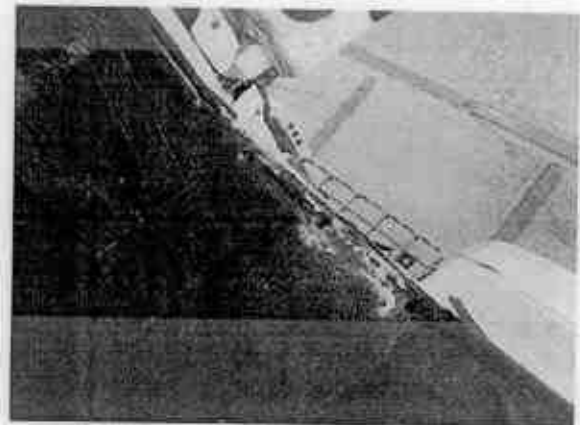
Photo 28: Corroded floor board on the driver side.

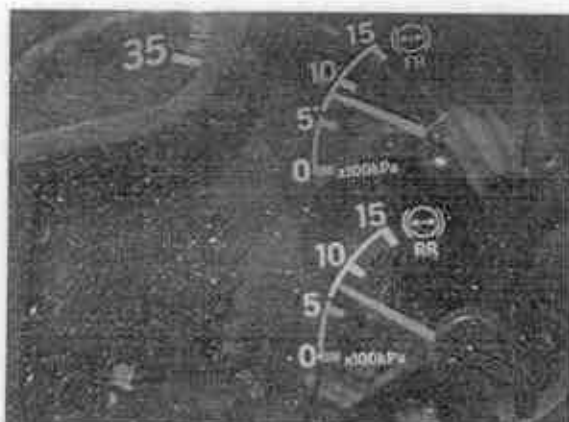
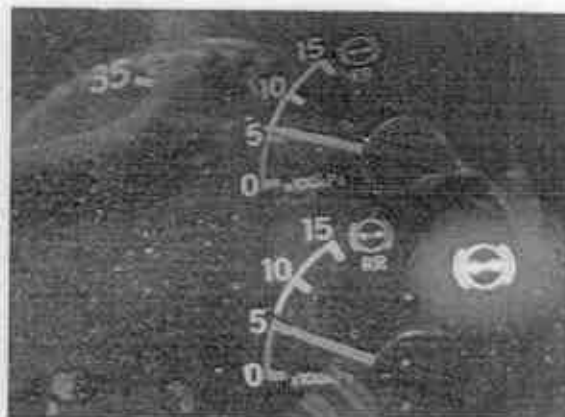
- 3.12 According to TCiM's Workshop Supervisor, Tan Kim Tow, brake tests were conducted on the road by mechanics without any instrumentation.
- 3.13 In other words, the effectiveness of the brakes was not measured and no readings printed or recorded to show its actual efficiency, but instead they were only judged by the individual mechanic's feeling and experience.
- 3.14 The recommended standard or methodology to gauge and measure a vehicle's brake efficiency is to test it on a roller-brake tester, similar to those used in the Vehicle Inspection Test Centres, accepted by the LTA.
- 3.15 This manner of brake testing eliminates human error or judgment that may vary from one individual to another.
- 3.16 Further, it provides tangible and objective results of the braking efficiency for both the front and the rear brakes.

- 3.17 The subject vehicle uses air-brakes.
- 3.18 Checks and tests carried out showed that the air build-up was slow.
- 3.19 It was also found that its air-pressure dip was more rapid than normal, suggesting either some leakage or a related deficiency in the system.
See Photos 29 to 30.

Photo 29: Air-pressure build-up for the braking system.

Photo 30: Air-pressure down to danger warning with 3 step applications.

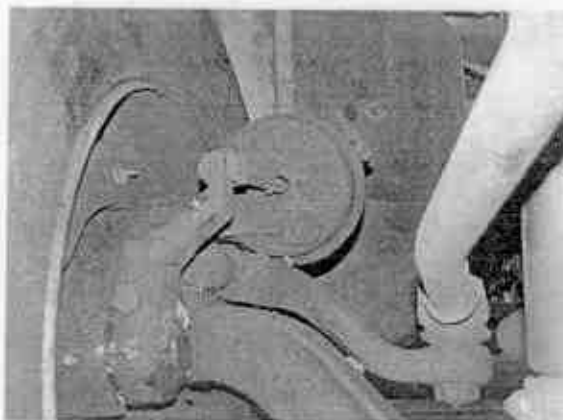
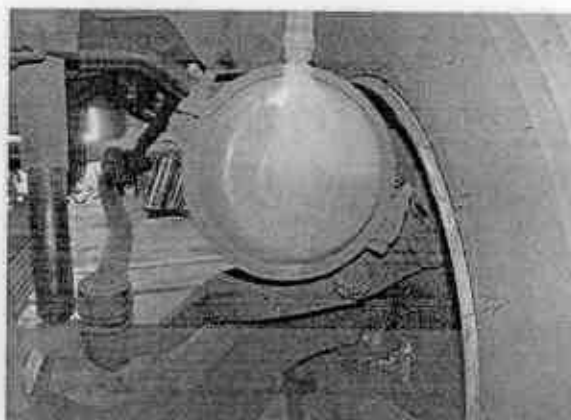
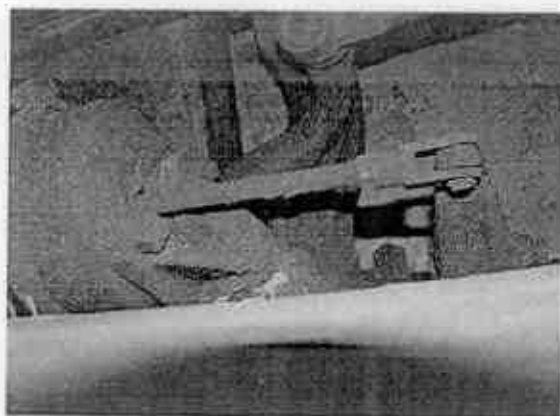
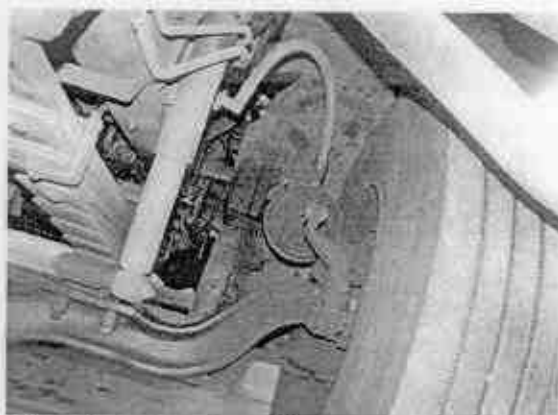
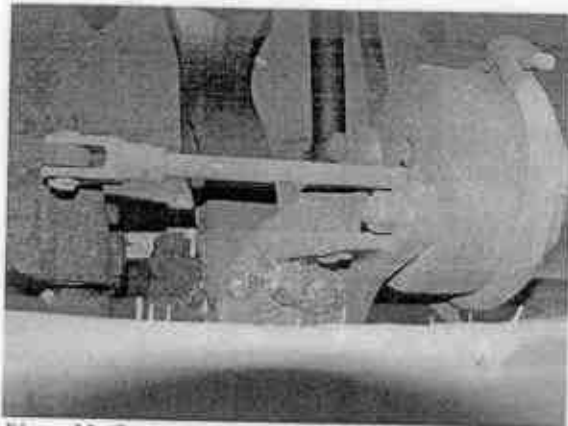
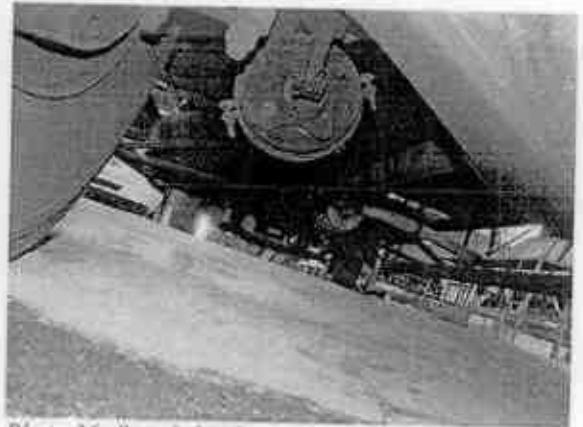
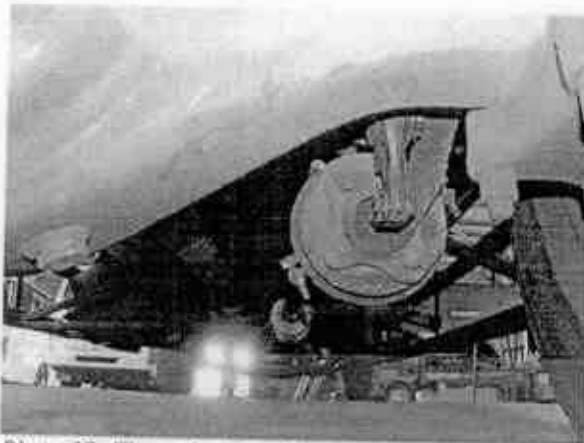
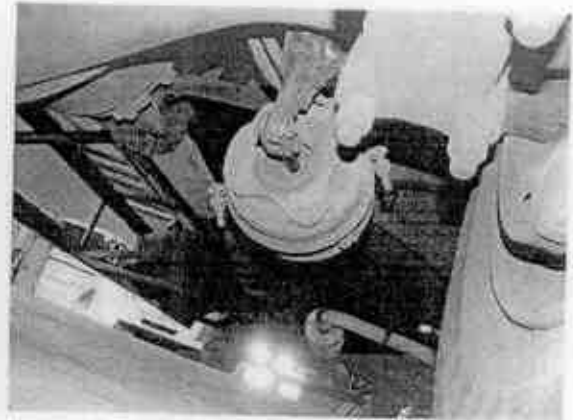
- 3.20 However, no further tests were carried out in this regard because of lack of test facility and tools.
- 3.21 Inspection of the front and rear brake air-chambers, push-rods and brake lever adjusters showed that they were cluttered with thick mud and dirt.

- 3.22 This would likely suggest that little or no attention had been given to this area for a lengthy period of time.
See Photos 31 to 38 and 41 to 42.

Photo 31: Front air chamber (push-rod) appears muddy and dirty.

Photo 32: Other side of front air chamber and undercarriage with thick grease.

Photo 33: Air chamber push-rod and adjuster covered with thick dirt.

Photo 34: Another view of the front undercarriage.

Photo 35: Front air-chamber push rod.

Photo 36: Rear left side of the air chamber.

Photo 37: The right side of the air chamber push rod lever.

Photo 38: Another view of the right side air chamber.

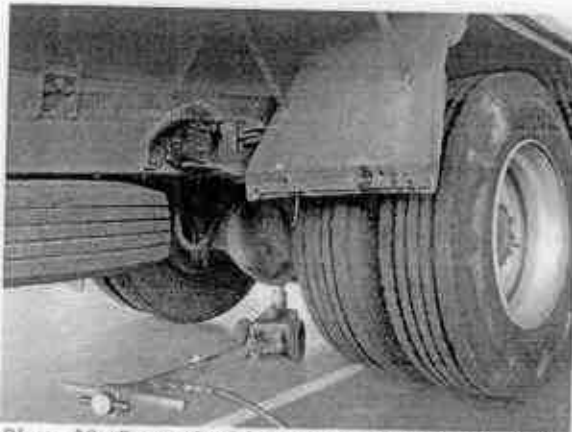
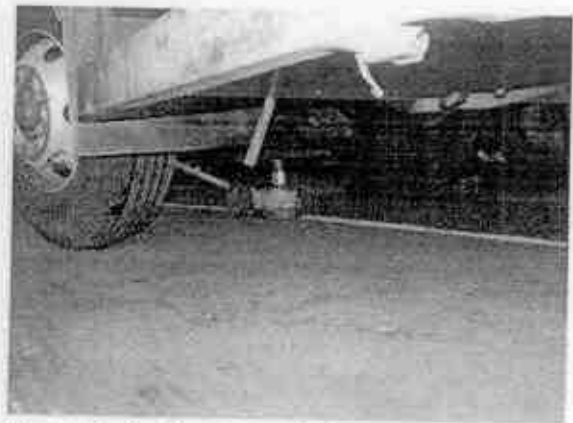
- 3.24 Unless the wheels are jacked up or suspended to check for binding, one cannot tell the integrity of the adjustment. See Photos 39 to 40.
- 3.25 Alternatively, measurement of the push-rod stroke helps ensure the proper level of the adjustment.

Photo 39: Rear wheel being jacked up for the brake test.

Photo 40: Another view of the brake test.

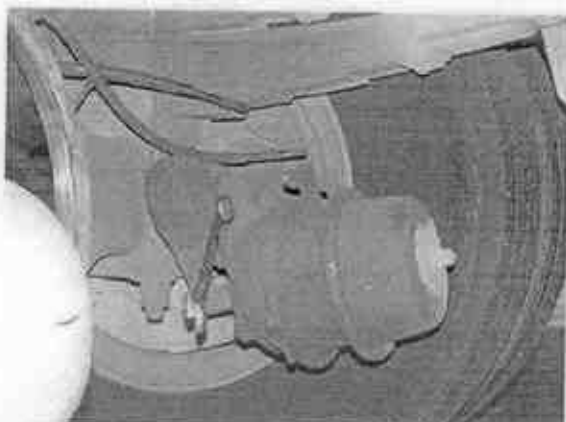
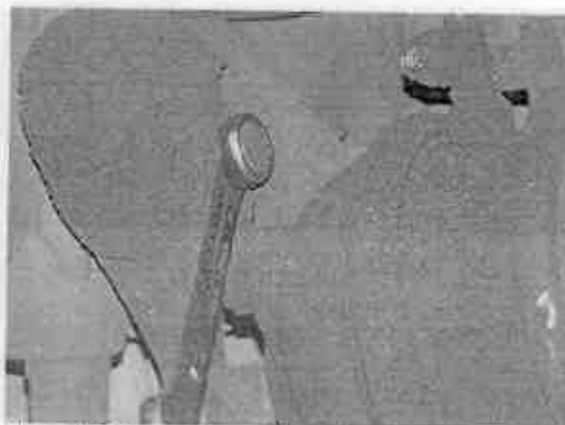
- 3.23 The Workshop Supervisor explained that the brake adjustments were carried out according to the recommended procedure as set out in the manual - first tightening the push-rod lever and then releasing it by three clicks. See Photos 41 to 42.

Photo 41: The rear brake adjustment shown by a mechanic.

Photo 42: Closer view of the brake adjustment.

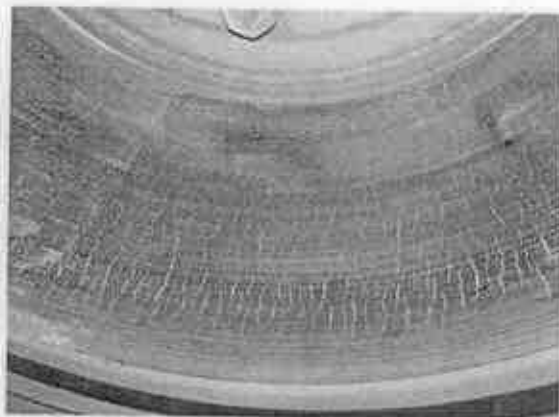
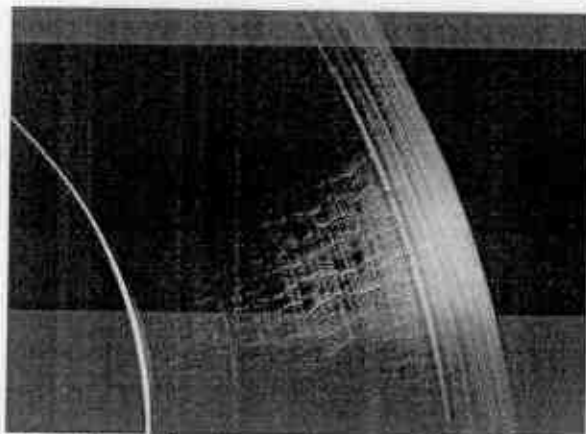
3.32 The inspection of both the rear brake drums with failed brake efficiency of 19% tested at the STA, found that there were evidence of overheating – the drums exhibit multiple crack, a phenomenon caused by overheating, normally attributed by incorrect brakes adjustment. See Photos 46 to 47, and 53 to 58.

Photo 46: View showing cracks to the rear brake drum - evidence of overheating.

Photo 47: Another view of the cracked brake drum is seen.

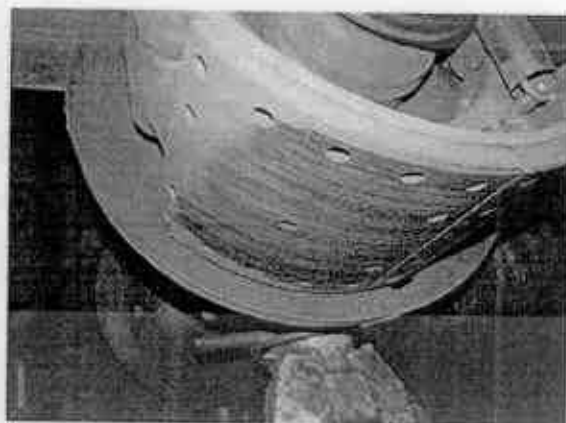
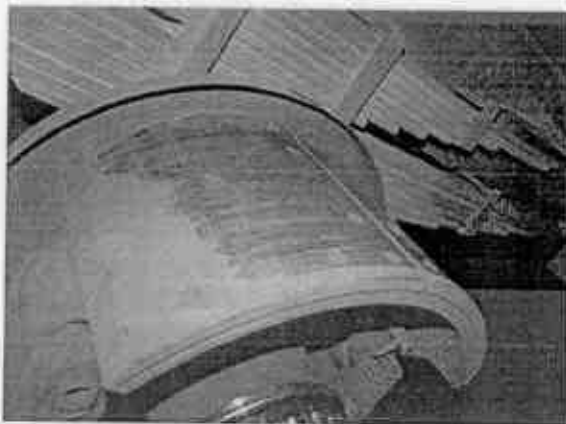
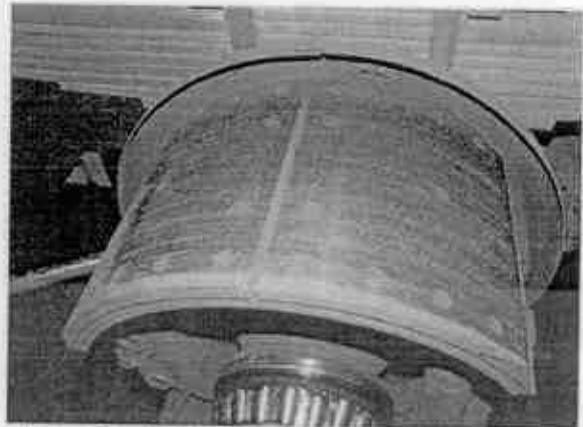
3.33 The brake linings also appear to exhibit signs of fading attributed by overheating. See Photos 48 to 50.

3.34 Brake fade would cause loss or inefficient braking.

Photo 48: The rear brake lining is worn out unevenly.

Photo 49: Uneven wear of the rear brake lining.

Photo 50: Brake linings appear faded due to overheating and need replacement.

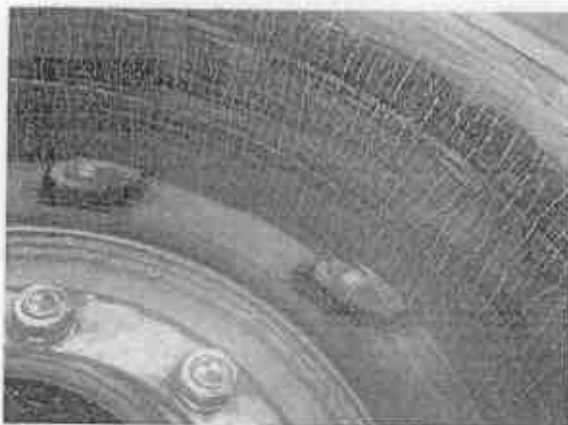
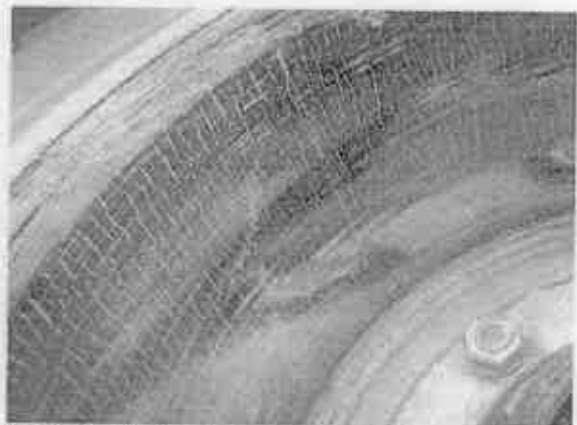
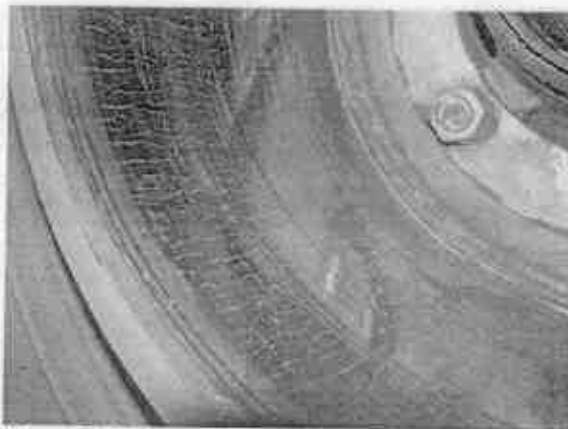
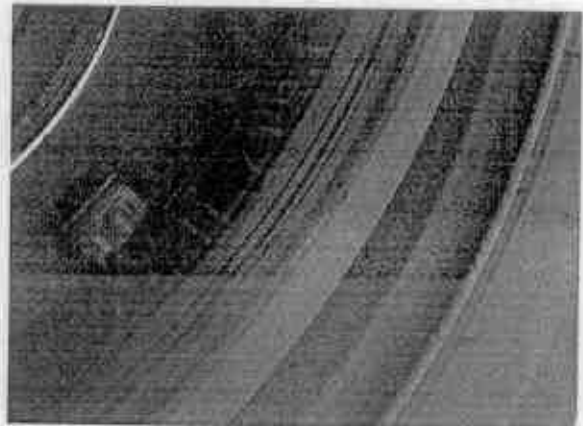
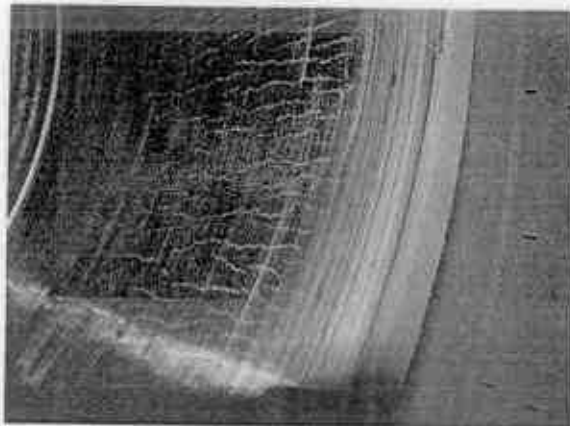
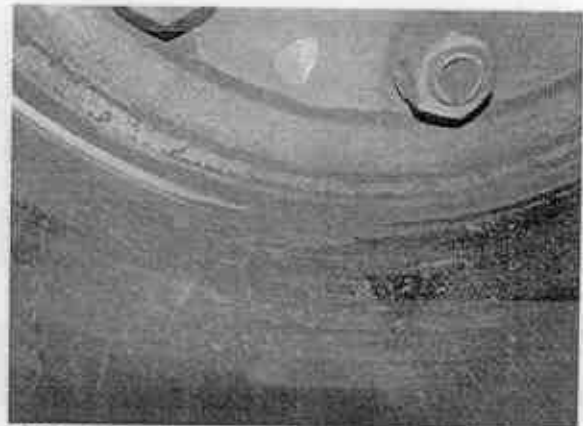
3.35 The rear brake drums were also worn.

Photo 53: Right rear brake drum show cracks, evidence of overheating brakes.

Photo 54: Another view of the brake drum cracks.

Photo 55: Close-up view of the cracks can be seen.

Photo 56: There is also evidence of excessive wear to the brake drum.

Photo 57: Cracks and excessive wear evident on the rear brake drum.

Photo 58: Another view of the right rear brake drum.
