Your Ref: YM 8972C  
Our Ref : CI/TP18016255/D

20 September 2018

**Mechanical Condition Report Of Motor Lorry YM 8972C,  
Involved In An Accident On 06 November 2012**

**Requested By  
Tan Chong Industrial Machinery (Pte) Ltd  
23 Jalan Buroh  
Singapore 619479**

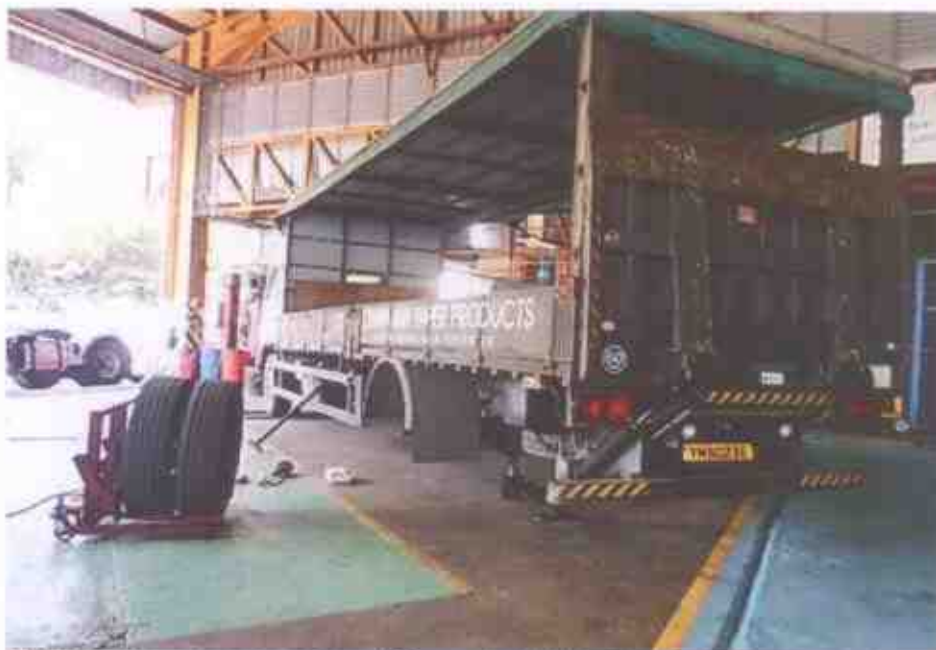
**Photo 1** shows a general view of Exemplar Vehicle 1, which was an exact same model as the Motor Lorry. The rear left brake drums were removed for my checks on the condition of the brake drums.

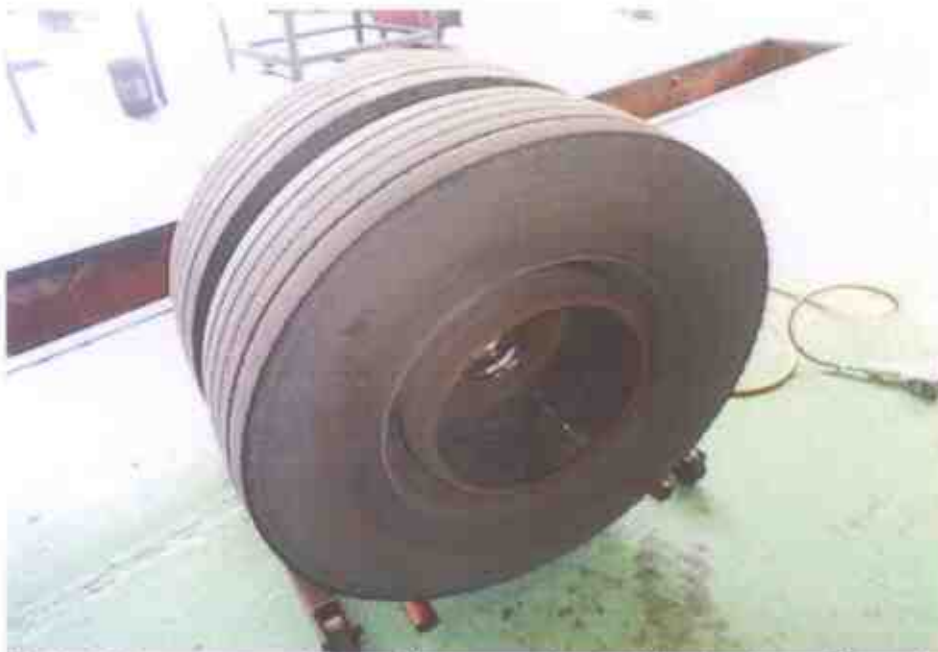
**Photo 2** shows a general view of the removed rear left brake drum of Exemplar Vehicle 1. I had found the same type of marks, which were referred to as "cracks" in Koays Report. These marks were observed to be around the entire circumference of the brake drum.

43. Having checked the front and rear brake drums of several heavy commercial vehicles similar to that of the Motor Lorry, it would appear to me that the marks referred to as "cracks", and seen in the photographs shown in page 14, page 15 and page 16 of Koays Report, are marks that can commonly be found on the brake drums of heavy commercial vehicles. Basing on the results of the roller brake tests at STA Inspection Centre, heavy commercial vehicles with such marks on their brake drums would still have an efficient braking system.

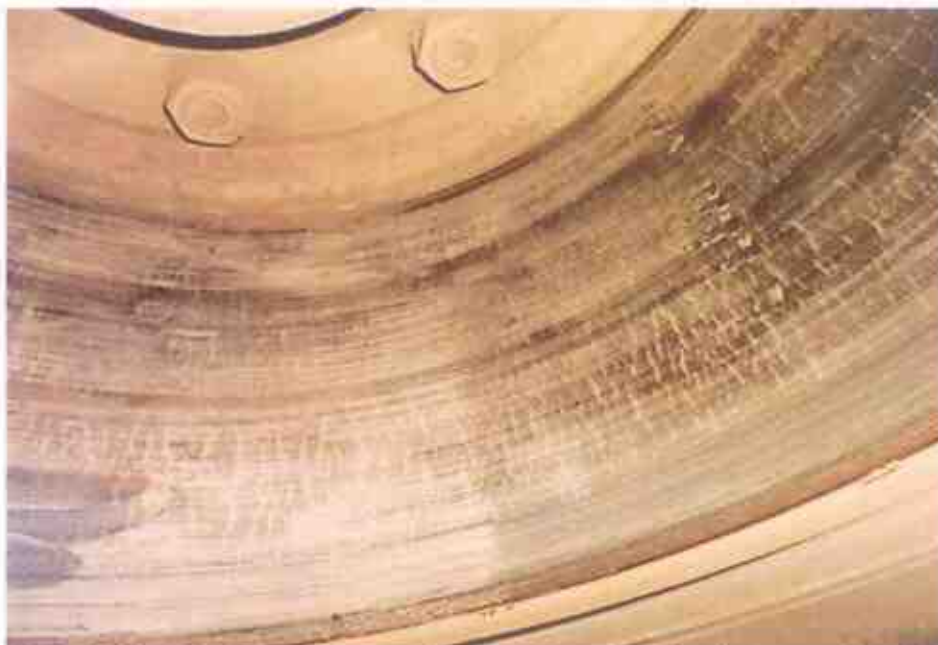
**Photo 3** shows a close-up view of the same type of marks that were referred to as "cracks" in Koays Report (refer to the photographs seen in page 14 to page 16 of Koays Report). These marks were found on the rear left brake drum of Exemplar Vehicle 1.

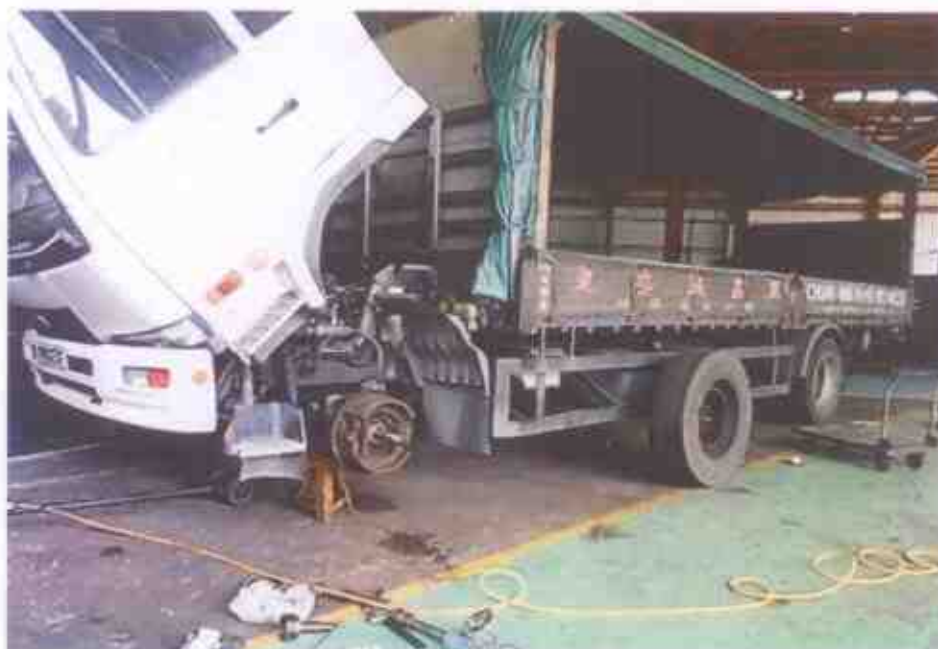
Photo 4 shows the front left brake drum of Exemplar Vehicle 1, removed for checks on the condition of the front left brake drum. Exemplar Vehicle 1 was an exact same model as the Motor Lorry.

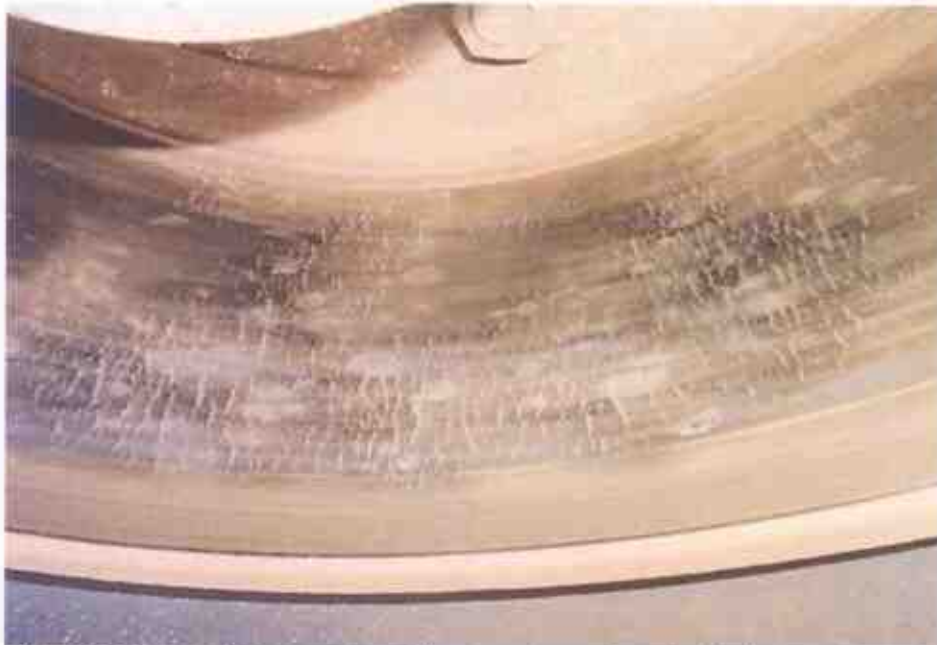
Photo 6 shows a close-up view of the same type of marks that were referred to as "cracks" in Koays Report (refer to the photographs seen in page 14 to page 16 of Koays Report). These marks were found on the front left brake drum of Exemplar Vehicle 1.

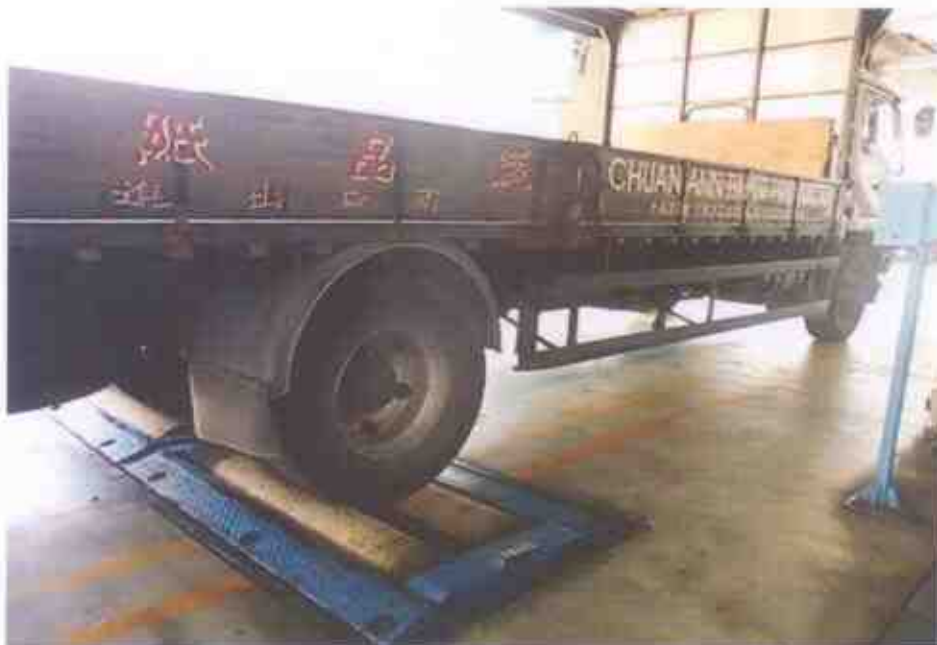
Photo 7 shows Exemplar Vehicle 1 going through the roller brake test at STA Inspection Centre with the brake drums condition as seen in photograph 3 and photograph 6 above. There were 2 tests carried out to ensure the accuracy of the result.

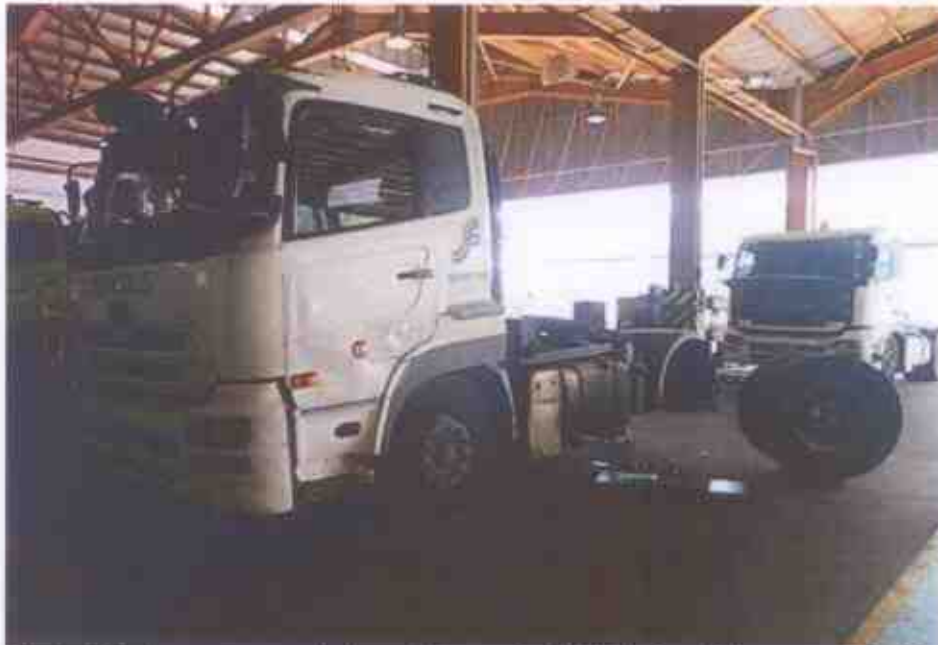
Photo 10 shows a general view of Exemplar Vehicle 2, a Nissan model prime mover that was fitted with a full air-brake system, the same type that was fitted on the Motor Lorry. The rear left brake drums were removed for my checks on the condition of the brake drums.

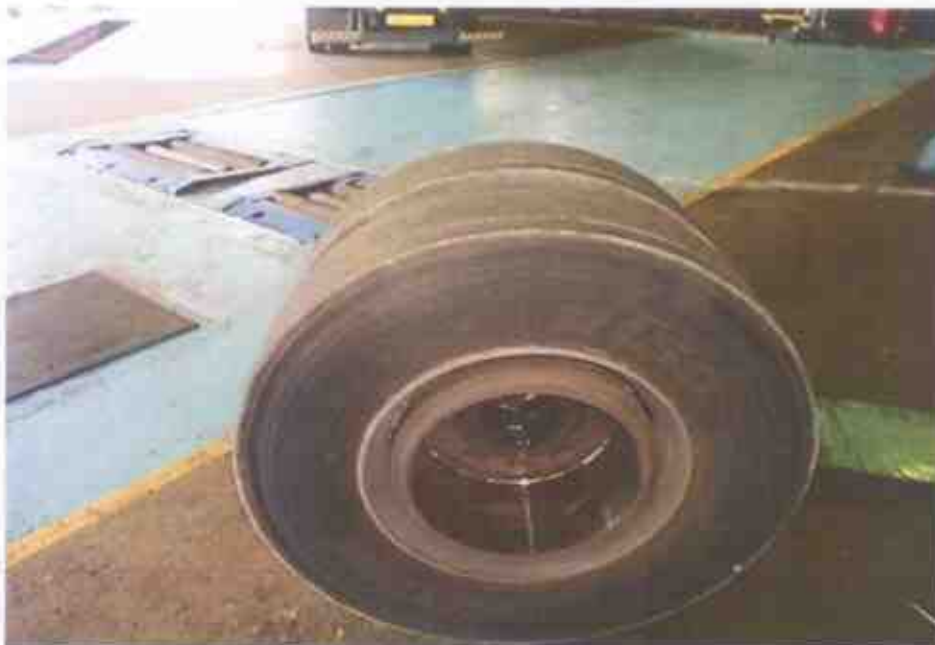
Photo 11 shows a general view of the removed rear left brake drum of Exemplar Vehicle 2. I had found the same type of marks, which were referred to as "cracks" in Koays Report. These marks were observed to be around the entire circumference of the rear left brake drum.

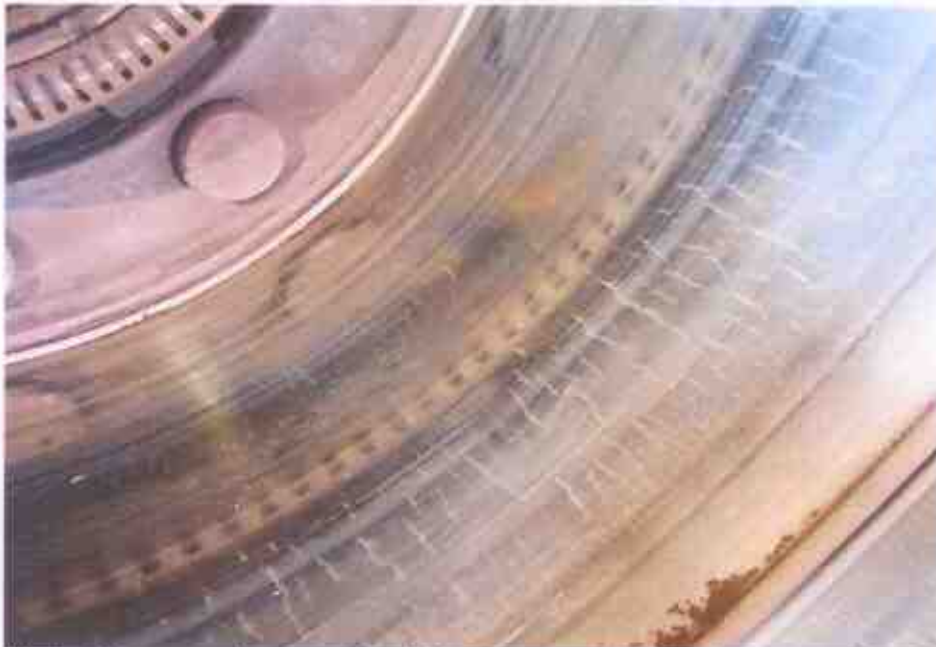
Photo 12 shows a close-up view of the same type of marks that were referred to as "cracks" in Koays Report (refer to the photographs seen in page 14 to page 16 of Koays Report). These marks were found on the rear left brake drum of Exemplar Vehicle 2.

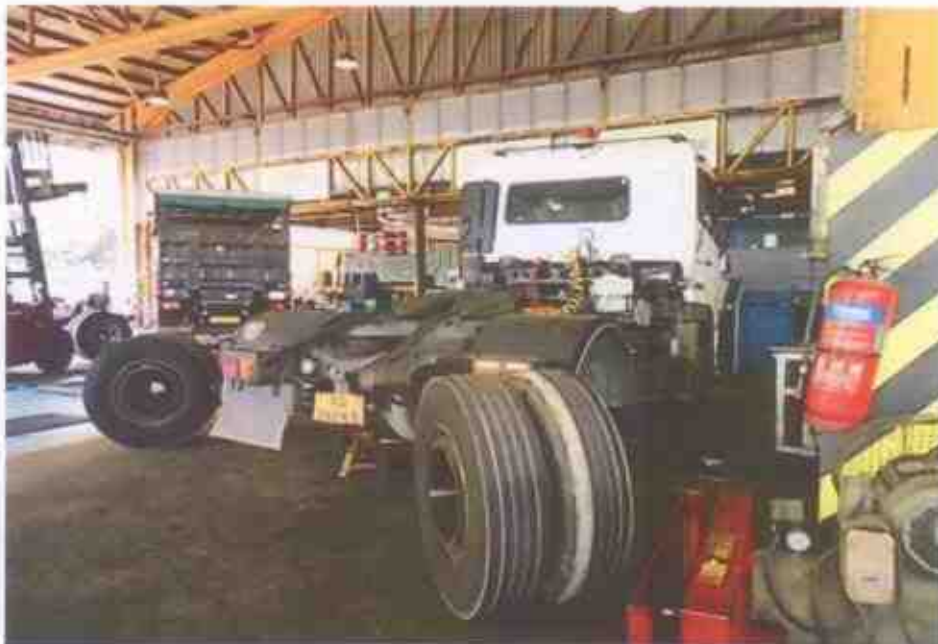
Photo 13 shows a general view of Exemplar Vehicle 2 with its rear right brake drums removed for my checks on the condition of the brake drums.

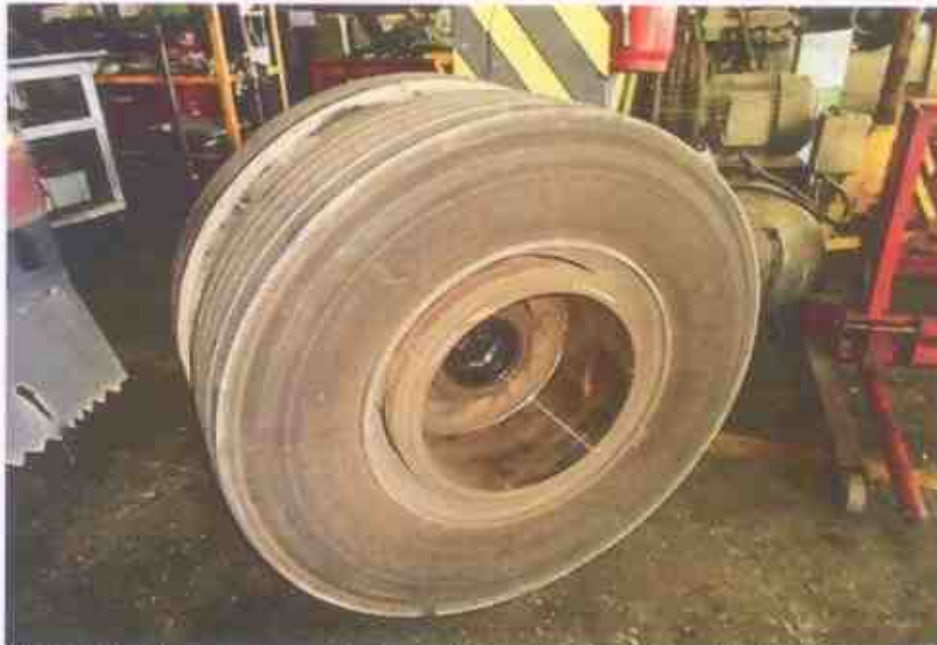
Photo 14 shows a general view of the removed rear right brake drum of Exemplar Vehicle 2. I had found the same type of marks, which were referred to as "cracks" in Koays Report. These marks were observed to be around the entire circumference of the brake drum.

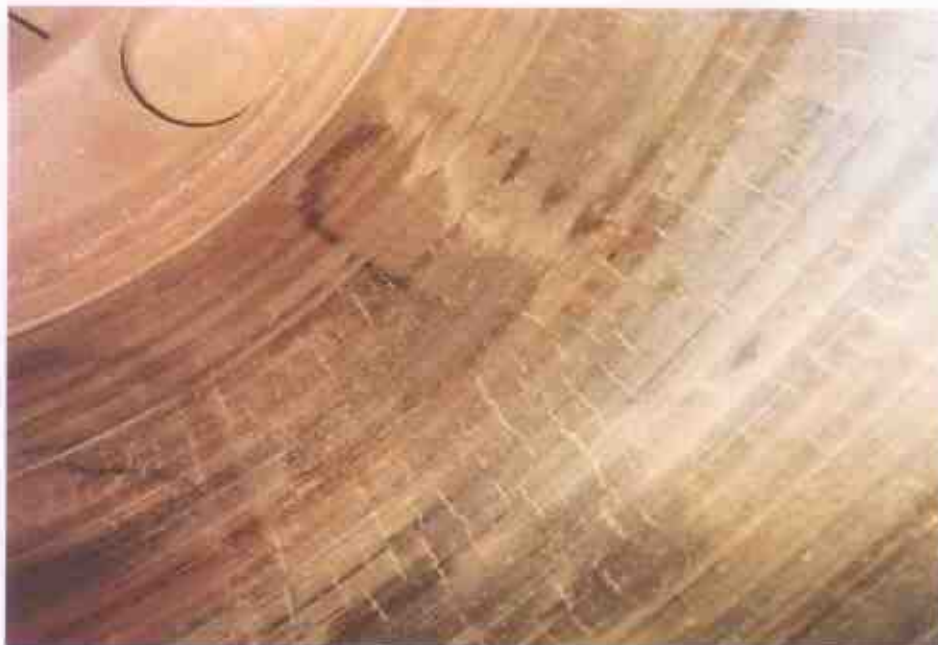
Photo 15 shows a close-up view of the same type of marks that were referred to as "cracks" in Koays Report (refer to the photographs seen in page 14 to page 16 of Koays Report). These marks were found on the rear right brake drum of Exemplar Vehicle 2.

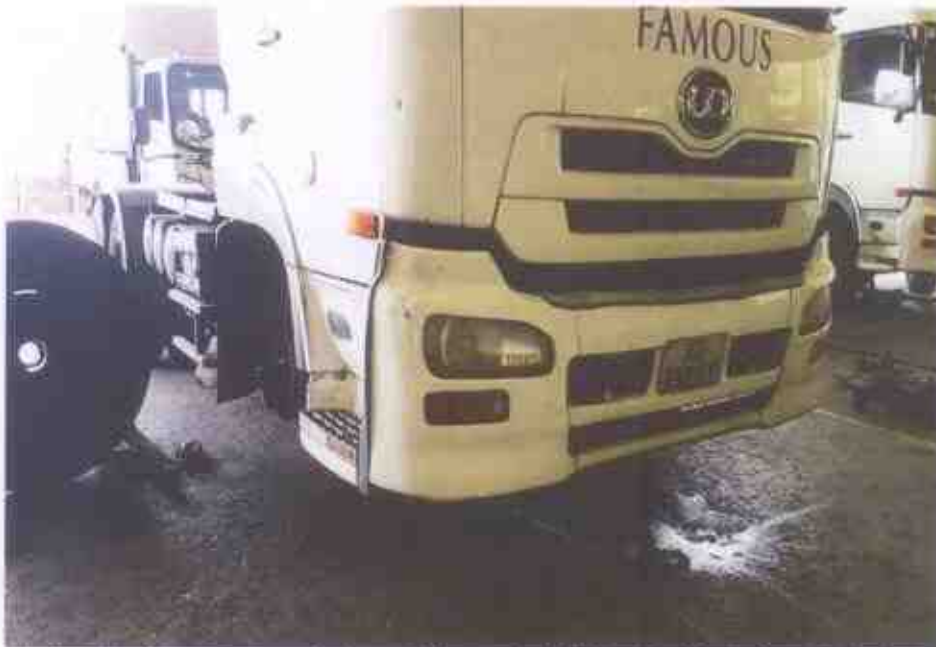
**Photo 16** shows a general view of Exemplar Vehicle 2 with its front right brake drums removed for my checks on the condition of the brake drums.

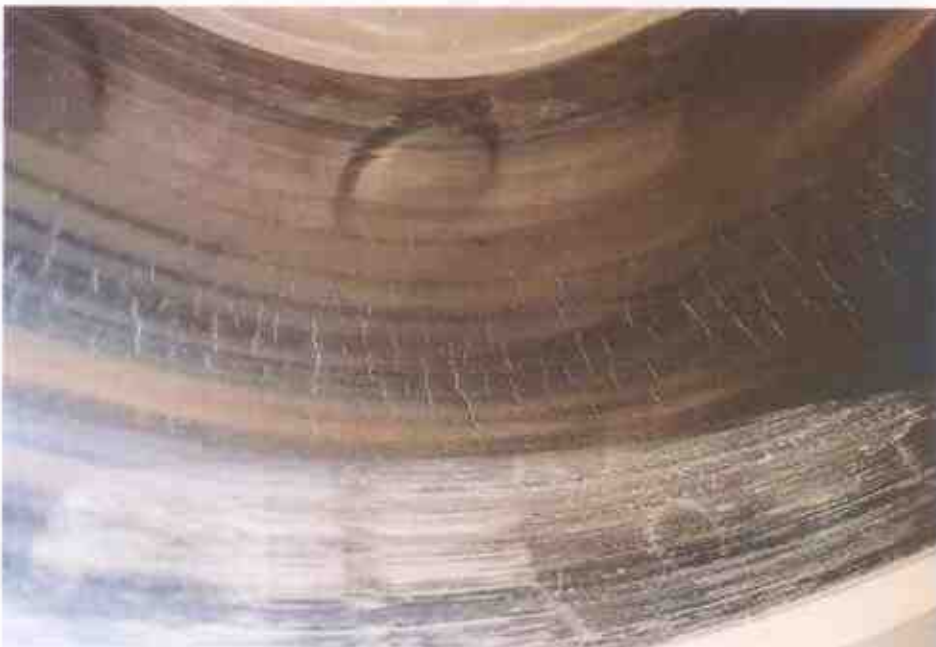
**Photo 17** shows a close-up view of the same type of marks that were referred to as "cracks" in Koays Report (refer to the photographs seen in page 14 to page 16 of Koays Report). These marks were found on the front right brake drum of Exemplar Vehicle 2.

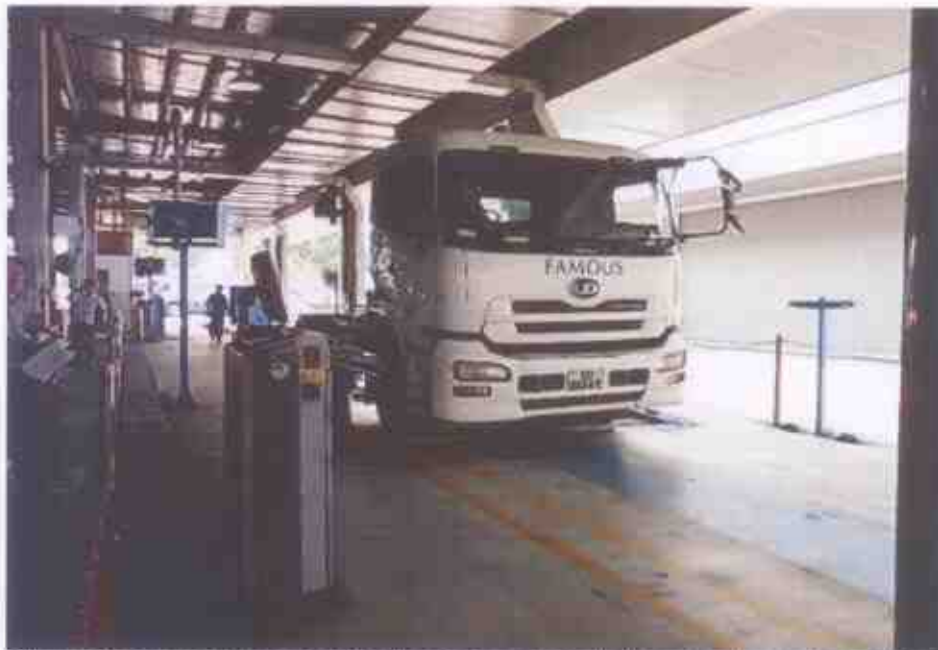
Photo 18 shows Exemplar Vehicle 2 going through the roller brake test at STA Inspection Centre with the brake drums condition as seen in photograph 12, photograph 15 and photograph 17 above.
