Your Ref: 3654030455SG
Our Ref : CI/AIG18016257/N

10 September 2018

**TECHNICAL INVESTIGATION REPORT OF FIRE INCIDENT INVOLVING THE
INSURED VEHICLE SJV 1154Z ON 27 AUGUST 2018**

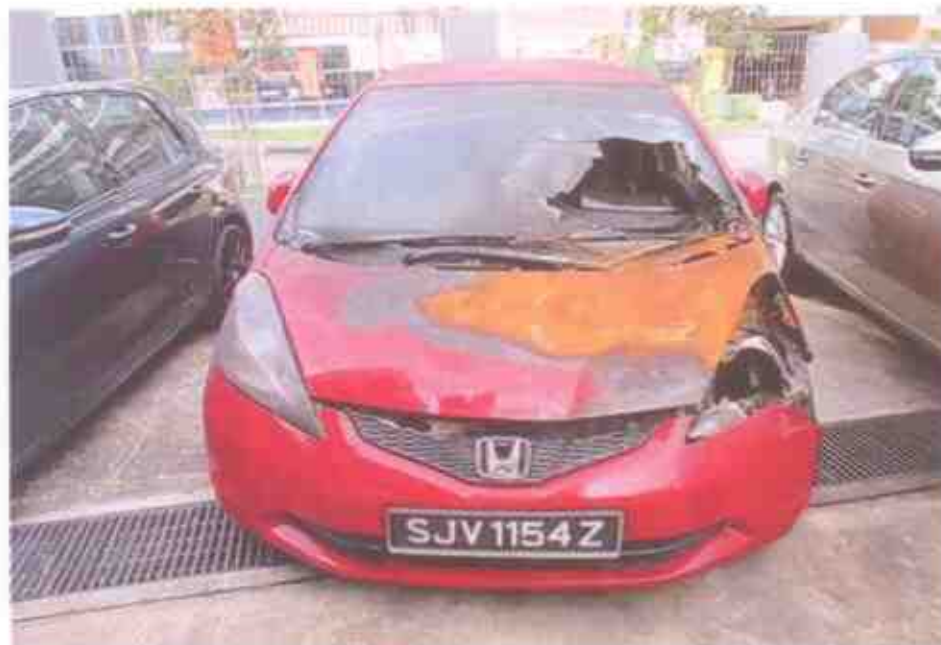
Photo 1 shows the general view of the front portion of the Insured Vehicle at the time of our inspection. The exterior body of the Insured Vehicle had sustained visible fire damage. This included its windscreen, front bonnet, headlights, front bumper, side panels, front rims and front tyres.

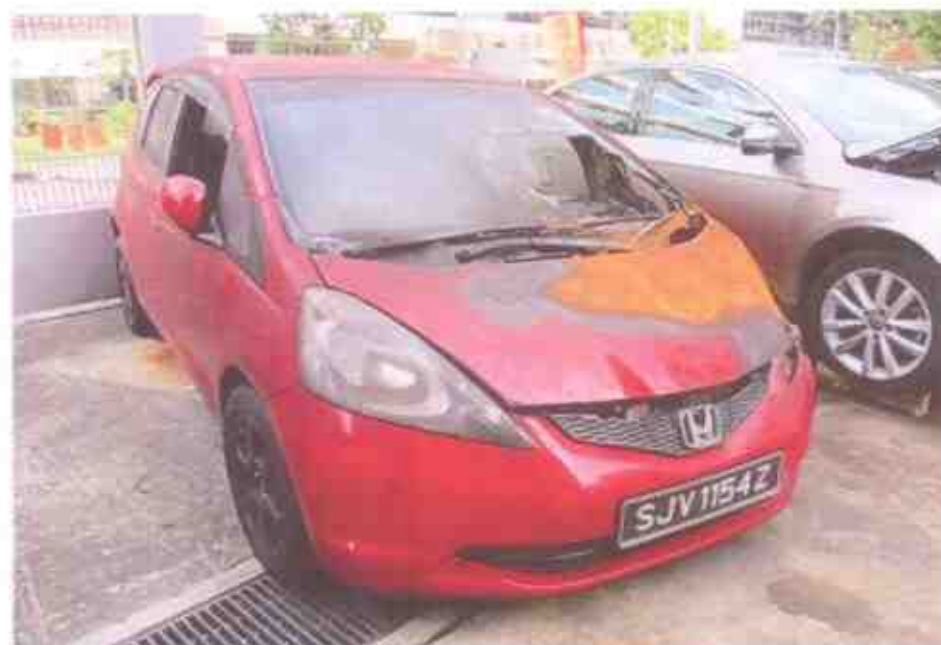
Photo 2 shows the general view of the right portion of the Insured Vehicle at the time of our inspection. The exterior body of the Insured Vehicle had sustained visible fire damage. This included its windscreen, front bonnet, front bumper and right headlight.

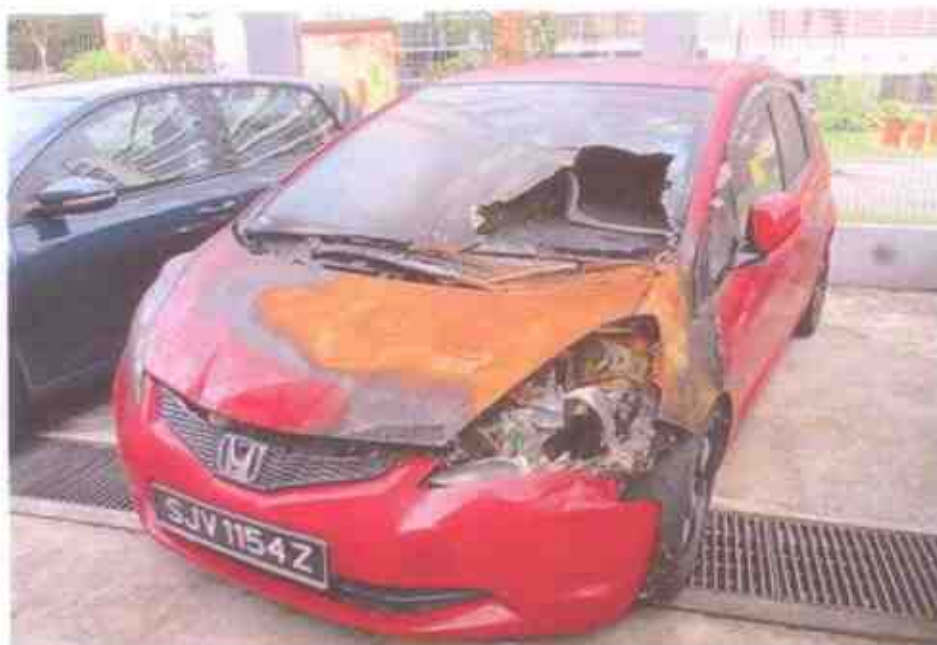
Photo 3 shows the general view of the left portion of the Insured Vehicle at the time of our inspection. The exterior body of the Insured Vehicle had sustained visible fire damage. This included its windscreen, front bonnet, left headlight, front bumper, left side panel, left front rim and left front tyre.

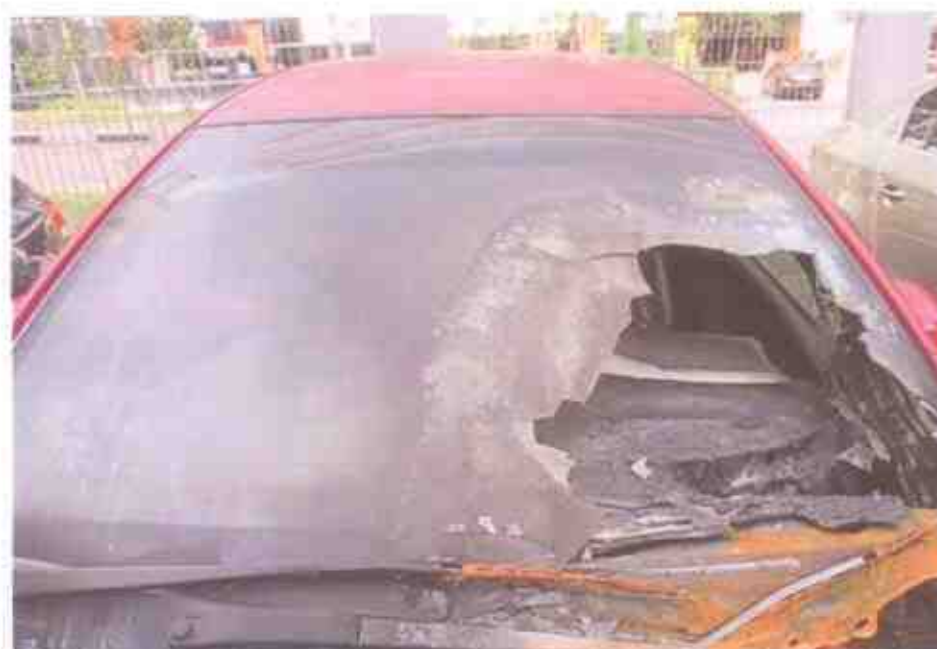
Photo 4 shows a closer view of the windscreen of the Insured Vehicle at the time of our inspection. The windscreen had sustained extensive fire damage.

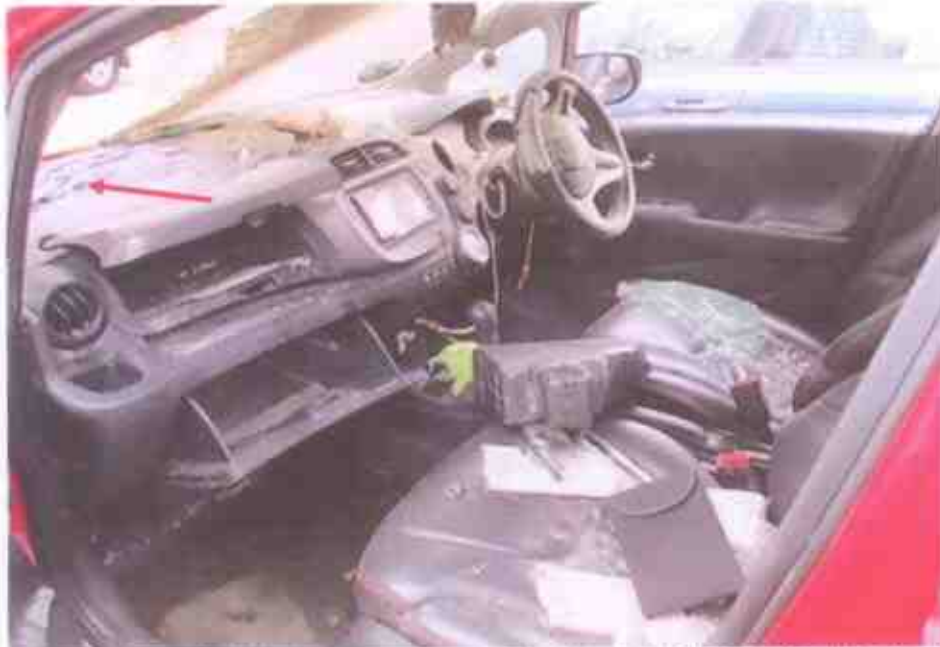
Photo 5 shows the interior compartment of the Insured Vehicle at the time of our inspection. The interior compartment of the Insured Vehicle was observed to be severely affected by the fire, in particular the left portion of the dashboard (arrowed).

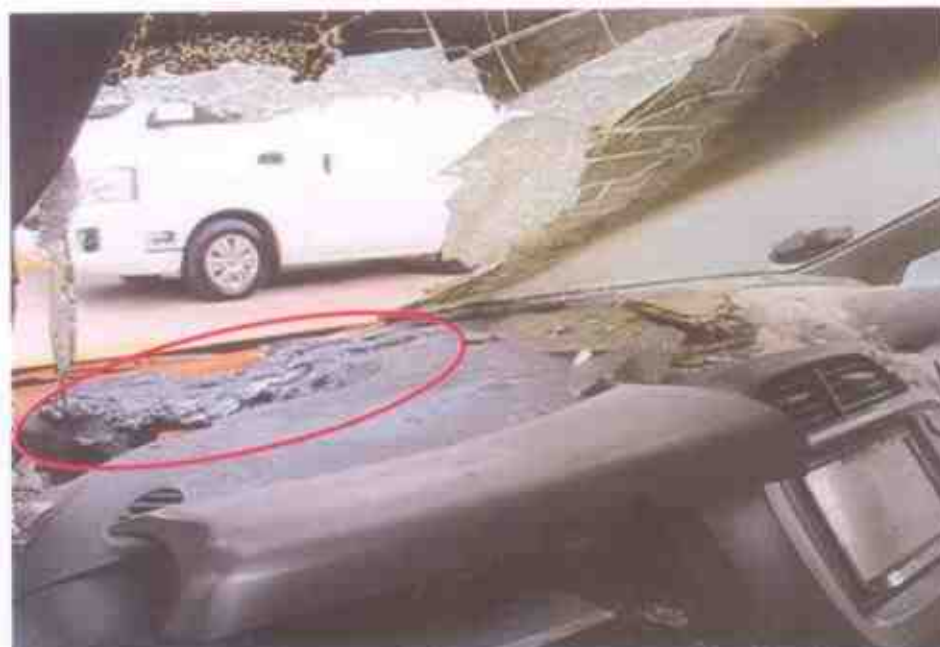
Photo 6 shows a closer view of the the interior compartment of the Insured Vehicle which was observed to be severely affected by the fire, in particular the left portion of the dashboard (circled).

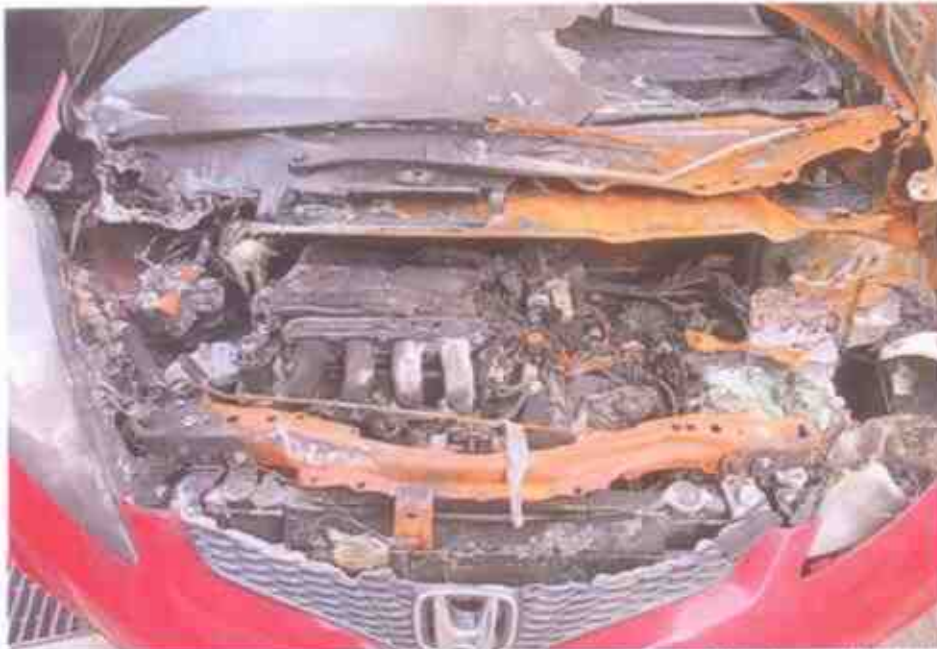
Photo 7 shows a general view of the engine compartment of the Insured Vehicle at the time of our inspection. Most of the components inside the engine compartment were found to be severely burnt and/or melted as a result of the fire.

8. For this particular case, the fire appears to have originated within the engine compartment of the Insured Vehicle, somewhere around the left rear portion of the engine compartment. This can be determined based on the circumstances of the case as well as given that the fire damage around the rear left portion of the engine compartment was most extensive.

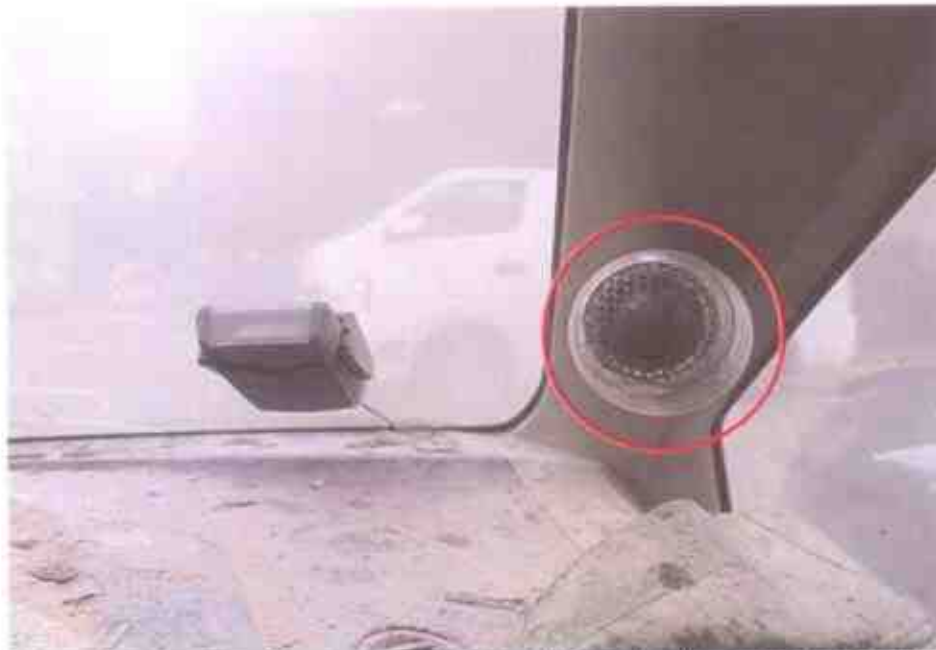
Photo 8 shows the 1st aftermarket twitter fitted onto the right corner of the dashboard of the Insured Vehicle upon our inspection which had sustained minor fire damage (circled).

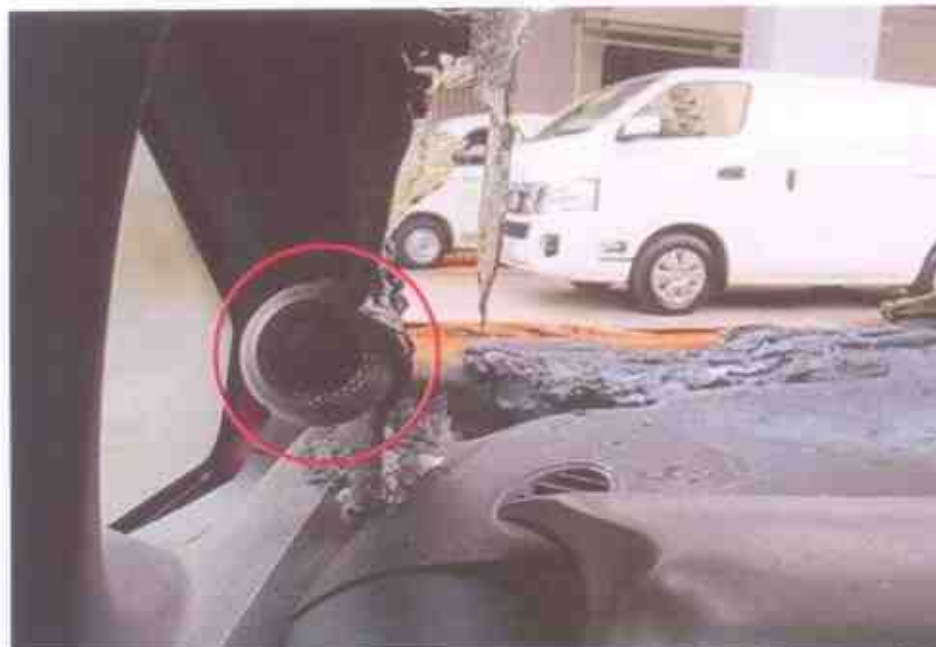
Photo 9 shows the 2nd aftermarket twitter fitted onto the left corner of the dashboard of the Insured Vehicle upon our inspection which had sustained serious fire damage (circled).

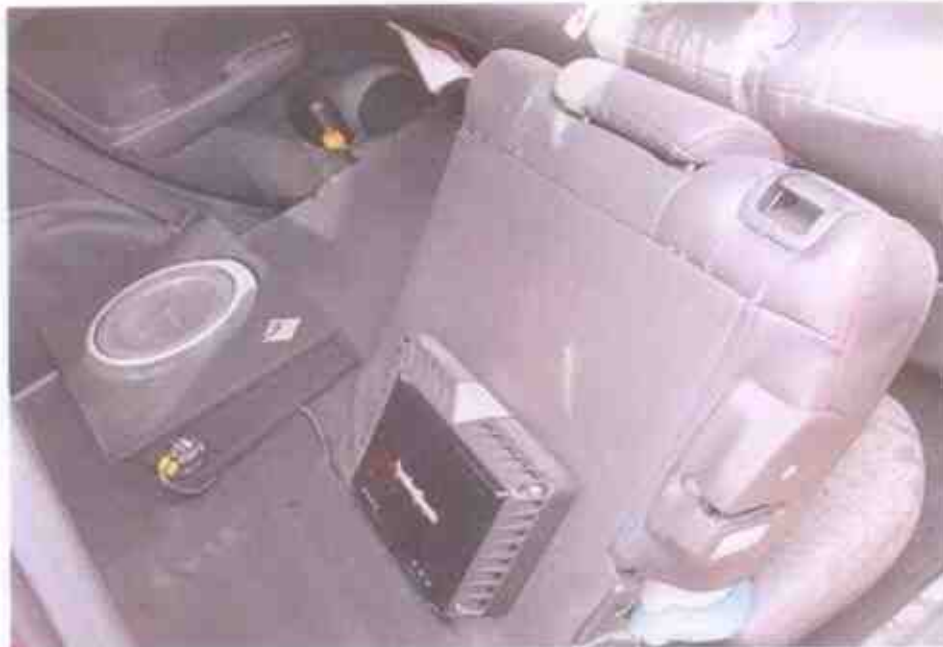
Photo 10 shows the aftermarket amplifier and subwoofer fitted behind the rear passenger seats of the Insured Vehicle upon our inspection.

31. We are further of the opinion that the additionally fitted electrical/electronic components found on the Insured Vehicle could have possibly caused overloading to the electrical system of the Insured Vehicle. However considering that the installation was carried out shortly after the Insured Vehicle was purchased which was approximately more than 8 years prior to the fire incident, the overloading was likely to be minimal.

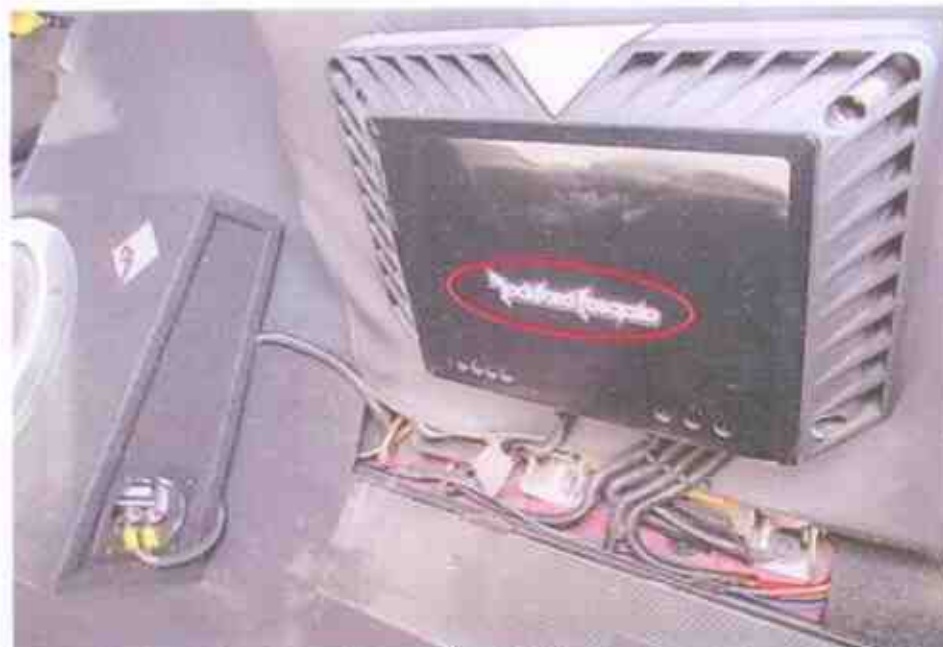
Photo 11 shows the aftermarket amplifier fitted behind the rear passenger seat of the Insured Vehicle upon our inspection. The brand of the amplifier was 'ROCKFORD FOSGATE' (circled).

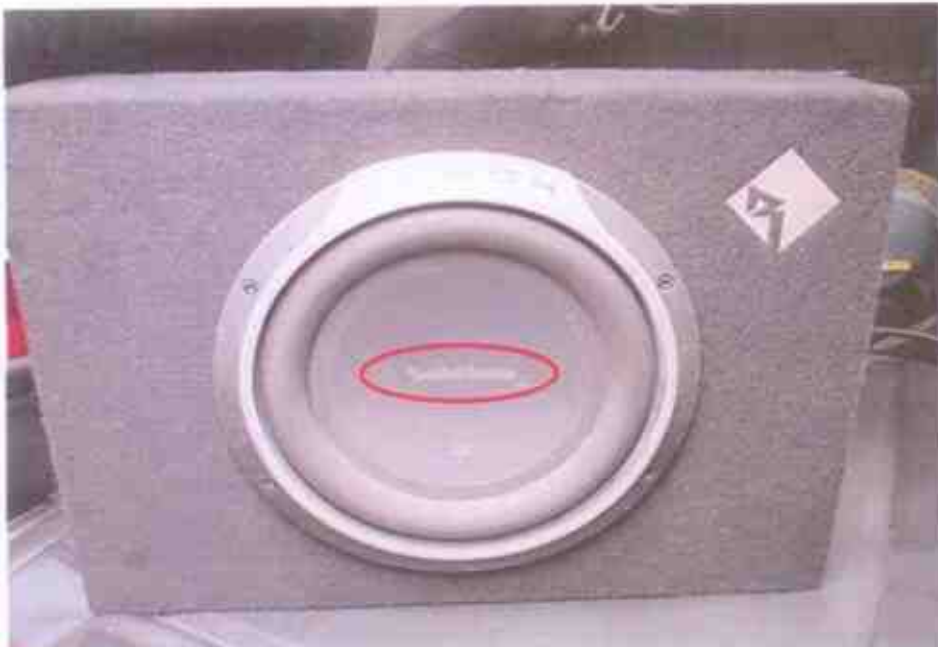
Photo 12 shows the aftermarket subwoofer fitted behind the rear passenger seat of the Insured Vehicle upon our inspection. The brand of the subwoofer was 'ROCKFORD FOSGATE' (circled).

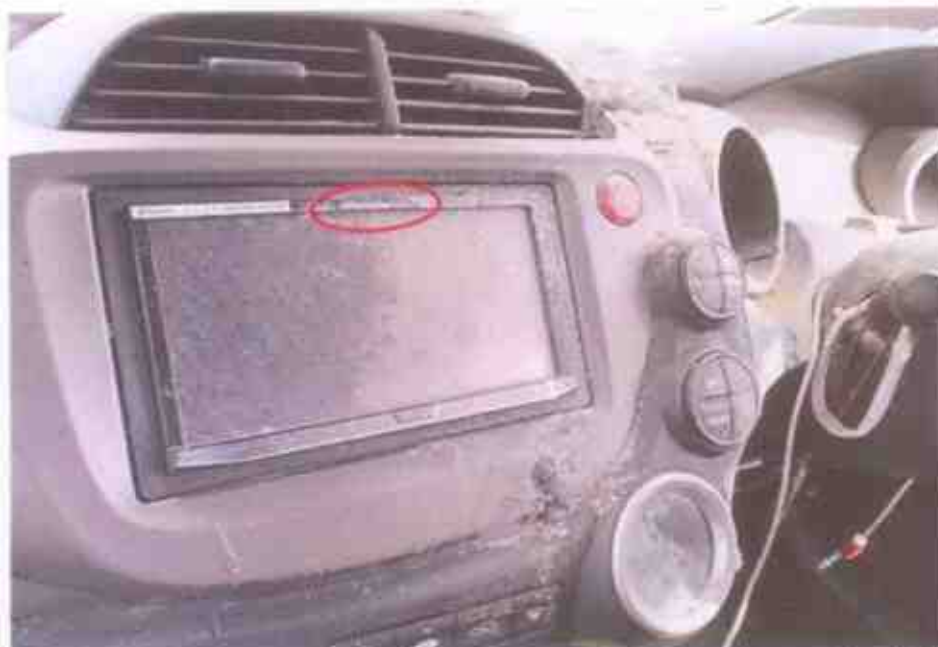
Photo 13 shows the in-car DVD player that was fitted at the centre portion of the front dashboard of the Insured Vehicle which had sustained serious fire damage. The brand of the in-car DVD player was 'PIONEER' (circled).

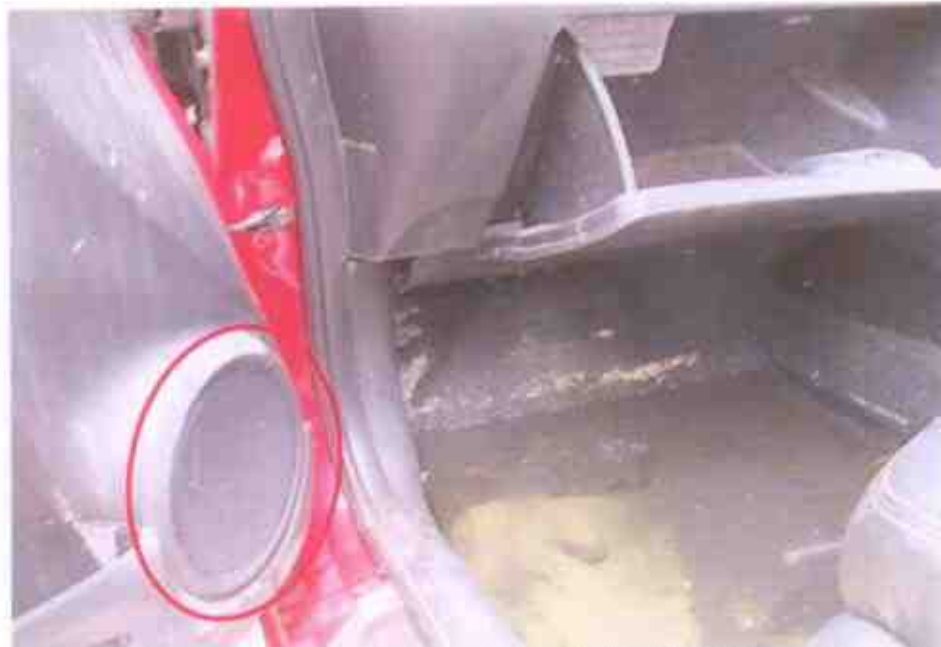
Photo 14 shows the 1st aftermarket speaker fitted at the front passenger door panel (circled).

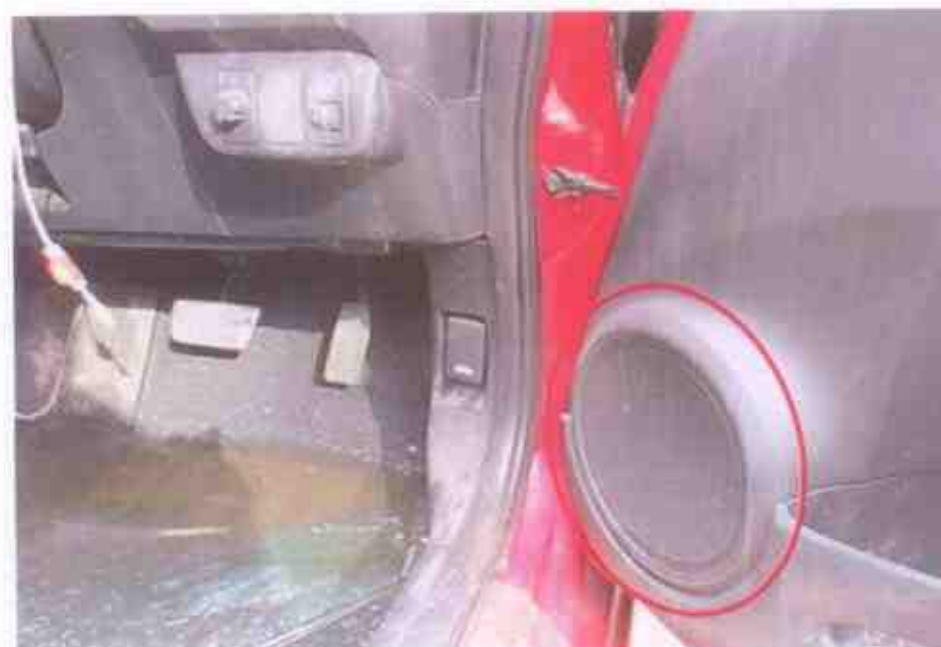
Photo 15 shows the 2nd aftermarket speaker fitted at the driver door panel (circled).

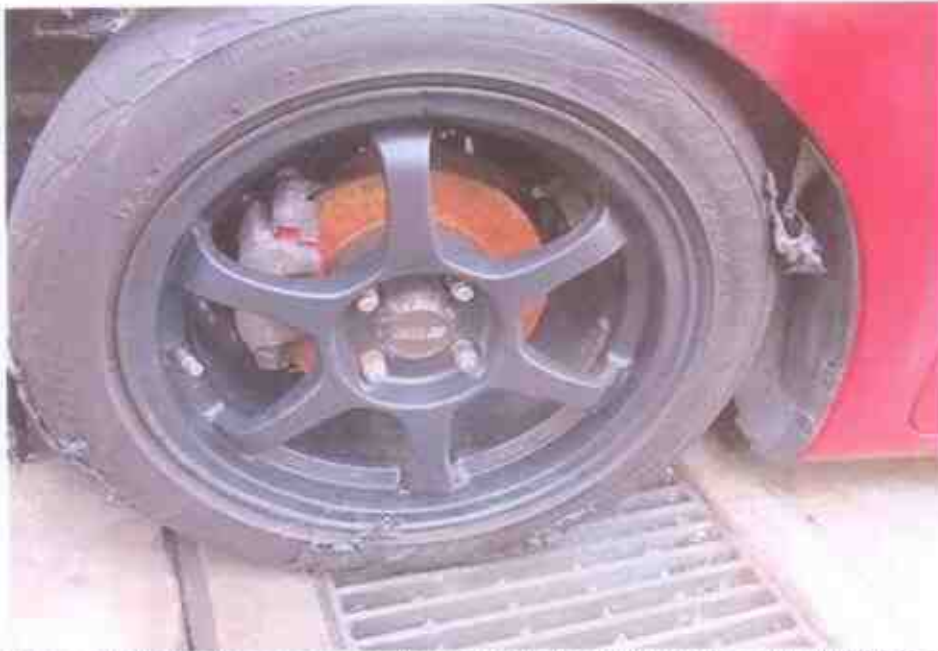
Photo 16 shows the non-standard rim found to be fitted on the Insured Vehicle at the time of our inspection. The 15- inch alloy rims fitted on the Insured Vehicle were not the standard type for the Insured Vehicle.

32. Although the aftermarket alloy rims and fitted on the Insured Vehicle were not the standard type for the Insured Vehicle, we are of the view that these parts did not cause and/or contribute to the fire incident.

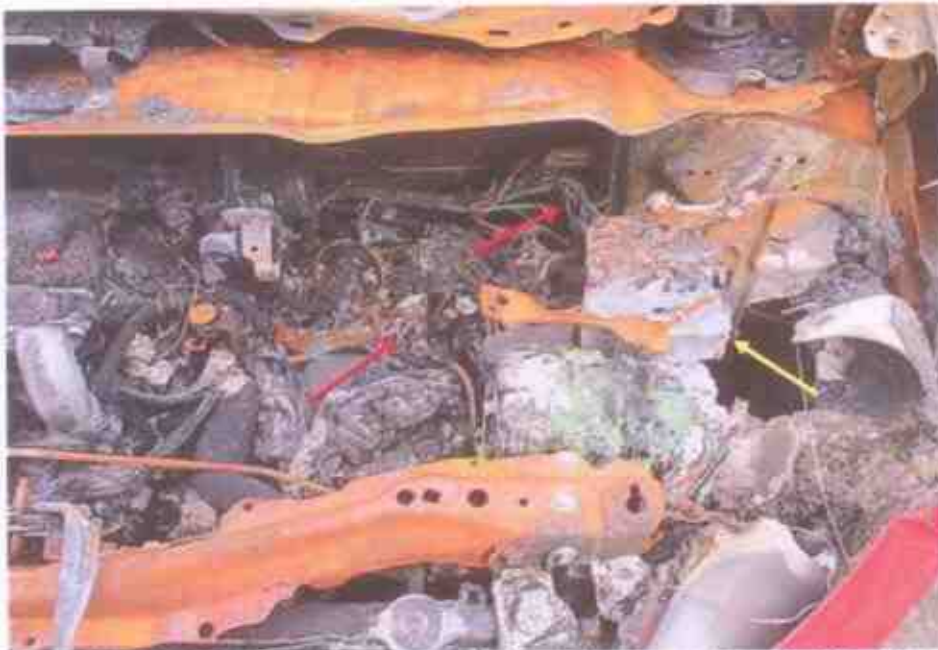
9. Upon closer examination of the area where the fire to the Insured Vehicle had likely started, we had found greenish residue on several stretches of original factory fitted wirings leading towards the Engine Control Module (ECM) of the Insured Vehicle. The presence of greenish residue indicates internal heating of copper wires, a sign of an electrical short circuit occurring. The greenish residue is normally left behind from oxidation as a result of chemical reaction involving the copper wires. This physical evidence would then appear to suggest that the cause of fire to the Insured Vehicle could have possibly been due to electrical in nature. See photos 17 – 20 below.

Photo 17 shows the wirings around the left rear portion of the engine compartment, which is in the immediate vicinity where the fire to the Insured Vehicle had likely started. Greenish residue was found on the wirings (red arrows) leading to the Engine Control Module (ECM) (yellow arrow). The presence of such greenish residue suggests occurrence of an electrical short circuit.

28. Having investigated and technically analysed the damages of burnt nature to the Insured Vehicle, we are of the view that the cause of fire to the Insured Vehicle was of electrical in nature. For this particular case, the fire had originated along the wiring inside the engine compartment, somewhere around the rear left portion of the engine compartment. The wirings were original factory wirings leading to the Engine Control Module (ECM) of the Insured Vehicle.

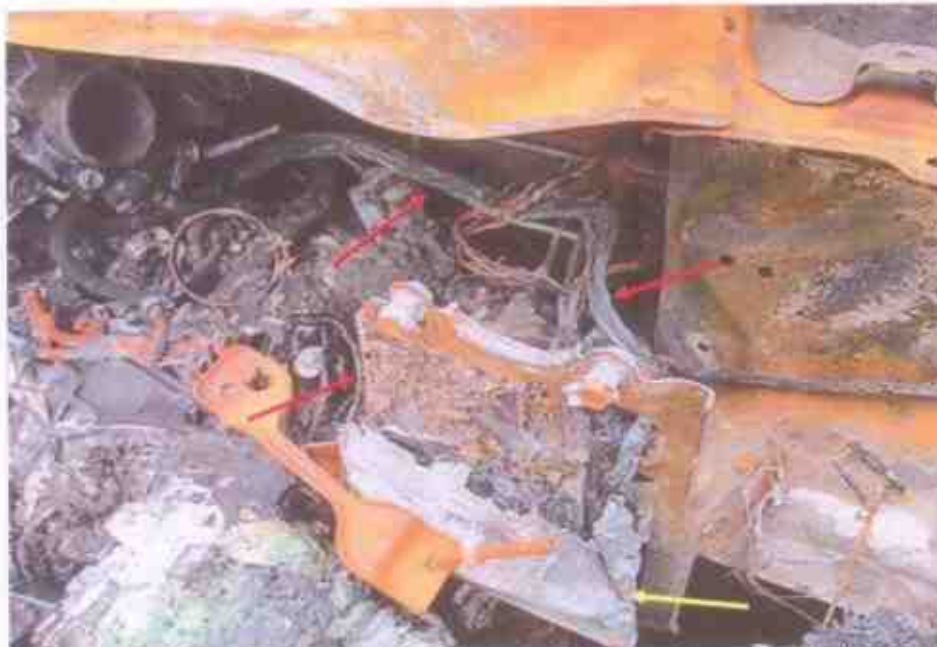
Photo 18 shows a closer view of the wirings with greenish residue (red arrows) leading to the Engine Control Module (ECM) (yellow arrow). The presence of such greenish residue suggest occurrence of an electrical short circuit.

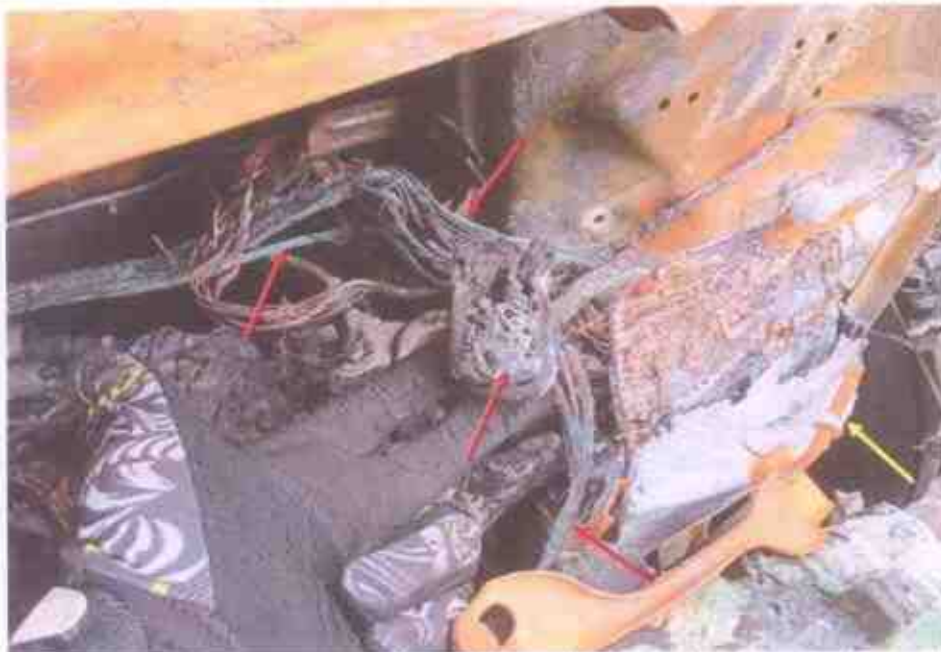
Photo 19 shows a closer view of the wirings with greenish residue (red arrows) leading to the Engine Control Module (ECM) (yellow arrow). The presence of such greenish residue suggest occurrence of an electrical short circuit.

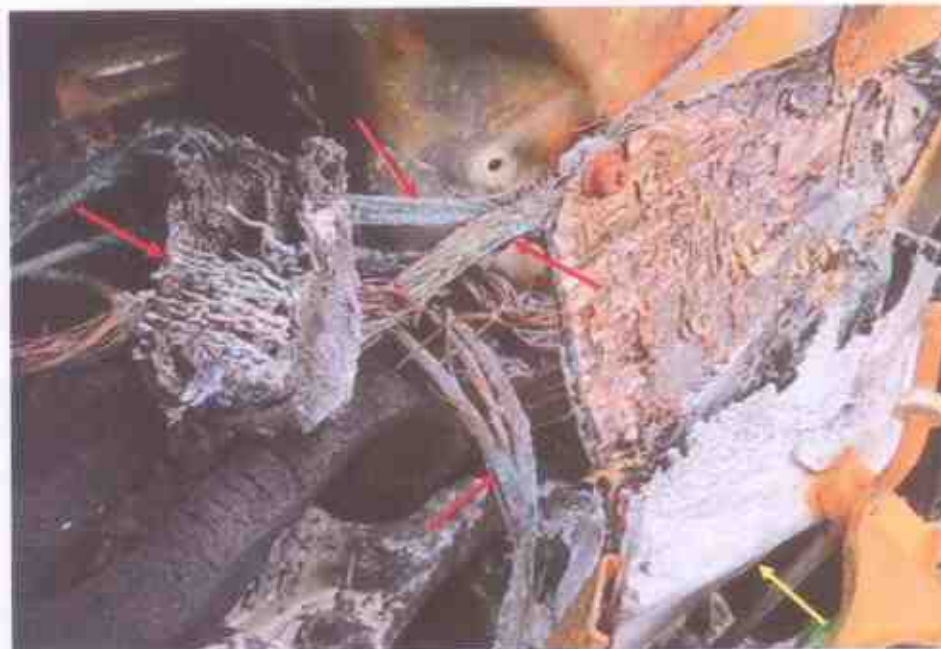
Photo 20 shows a close up view of the wirings with greenish residue (red arrows) leading to the Engine Control Module (ECM) (yellow arrow). The presence of such greenish residue suggest occurrence of an electrical short circuit.

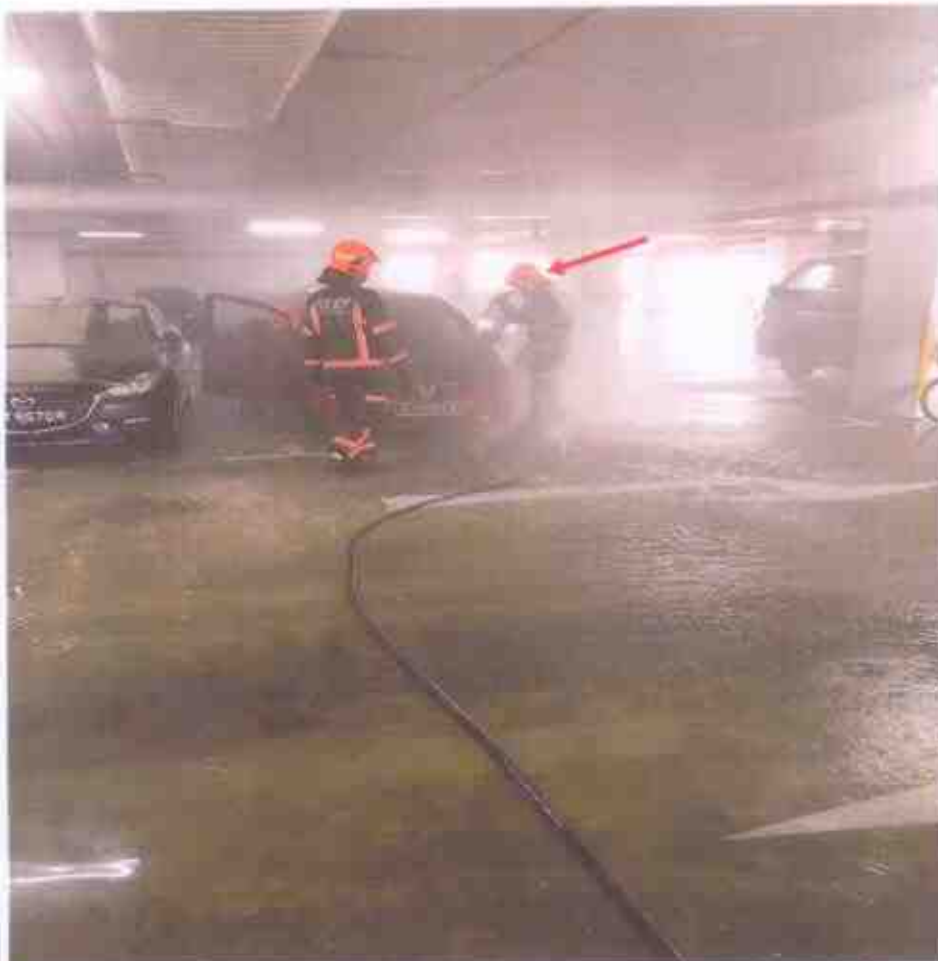
Photo 21 shows firefighters putting out the last remnants of the fire to the Insured Vehicle (arrowed). In general, the information that could be gathered from this photograph had corresponded to the events that were related to us by Mr Tan, which is the SCDF were already at the incident location and putting out the fire by the time Mr Tan had arrived.

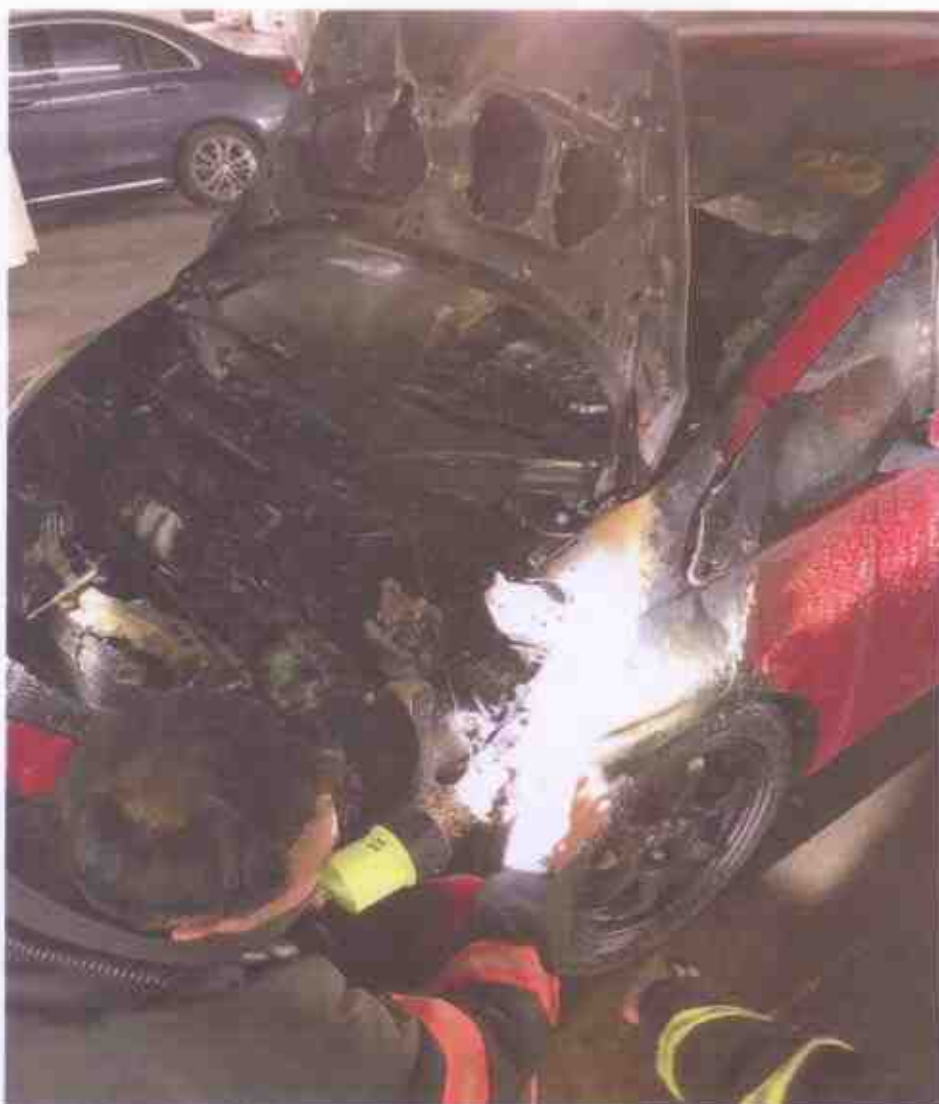
Photo 22 shows SCDF personnel conducting preliminary investigations as to how the fire to the Insured vehicle had likely started.

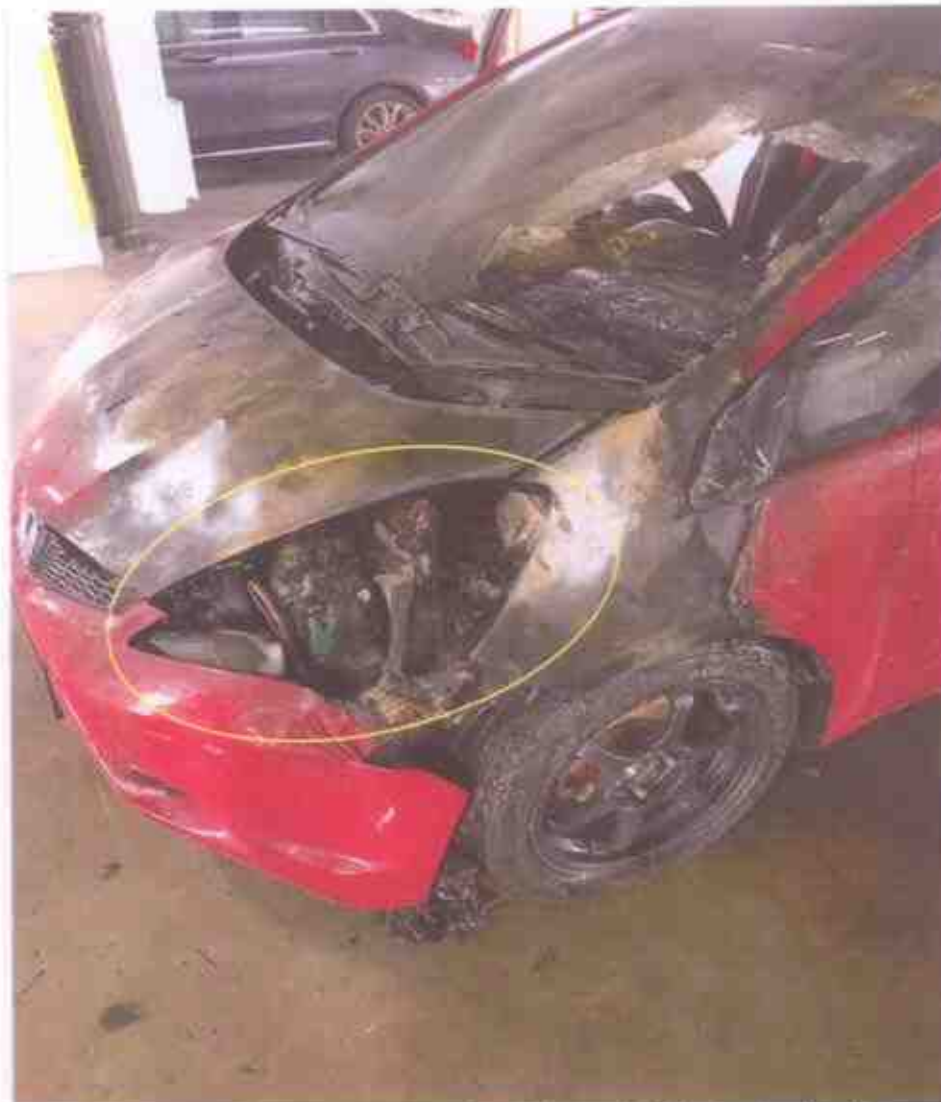
Photo 23 shows the left side view of the Insured Vehicle after the fire was extinguished. The extensive damages sustained to the left front portion of the Insured Vehicle indicate that the fire had started from the left portion of the engine compartment (circled).
