**SURVEY OF VEHICLE NO. SJT 4592H** ✓

## AUTOMOBILE ASSESSMENT REPORT

## THIRD PARTY SURVEY ACCIDENT HAPPENED ON 4 Oct 2017

**EVALUATION REPORT (PAPER SURVEY) OF ACCIDENT VEHICLE NO:  
SJT 4592H INSURED VEHICLE: YP 5879T ACCIDENT DATE: 04/10/2017**

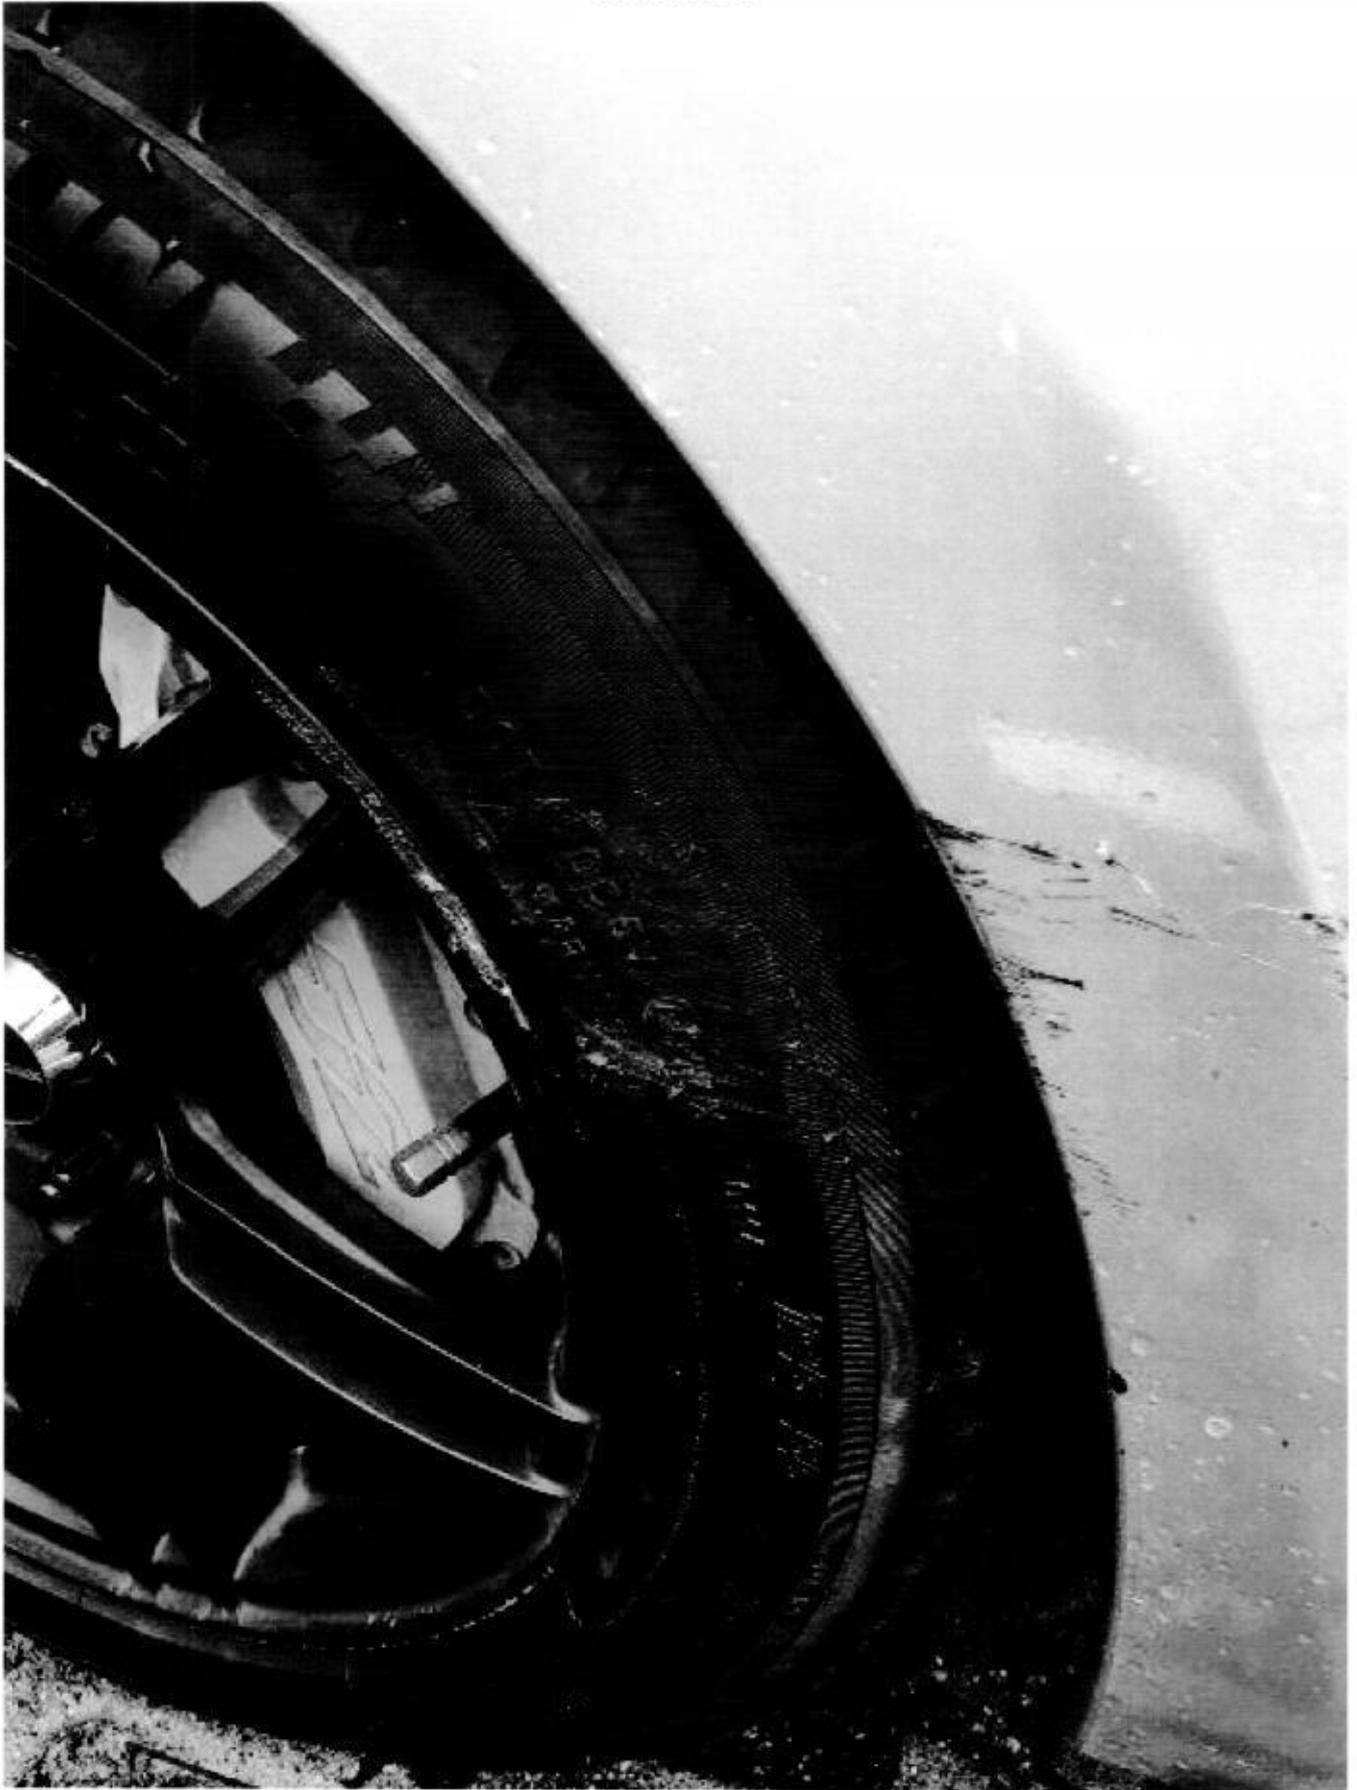
Accident Photo

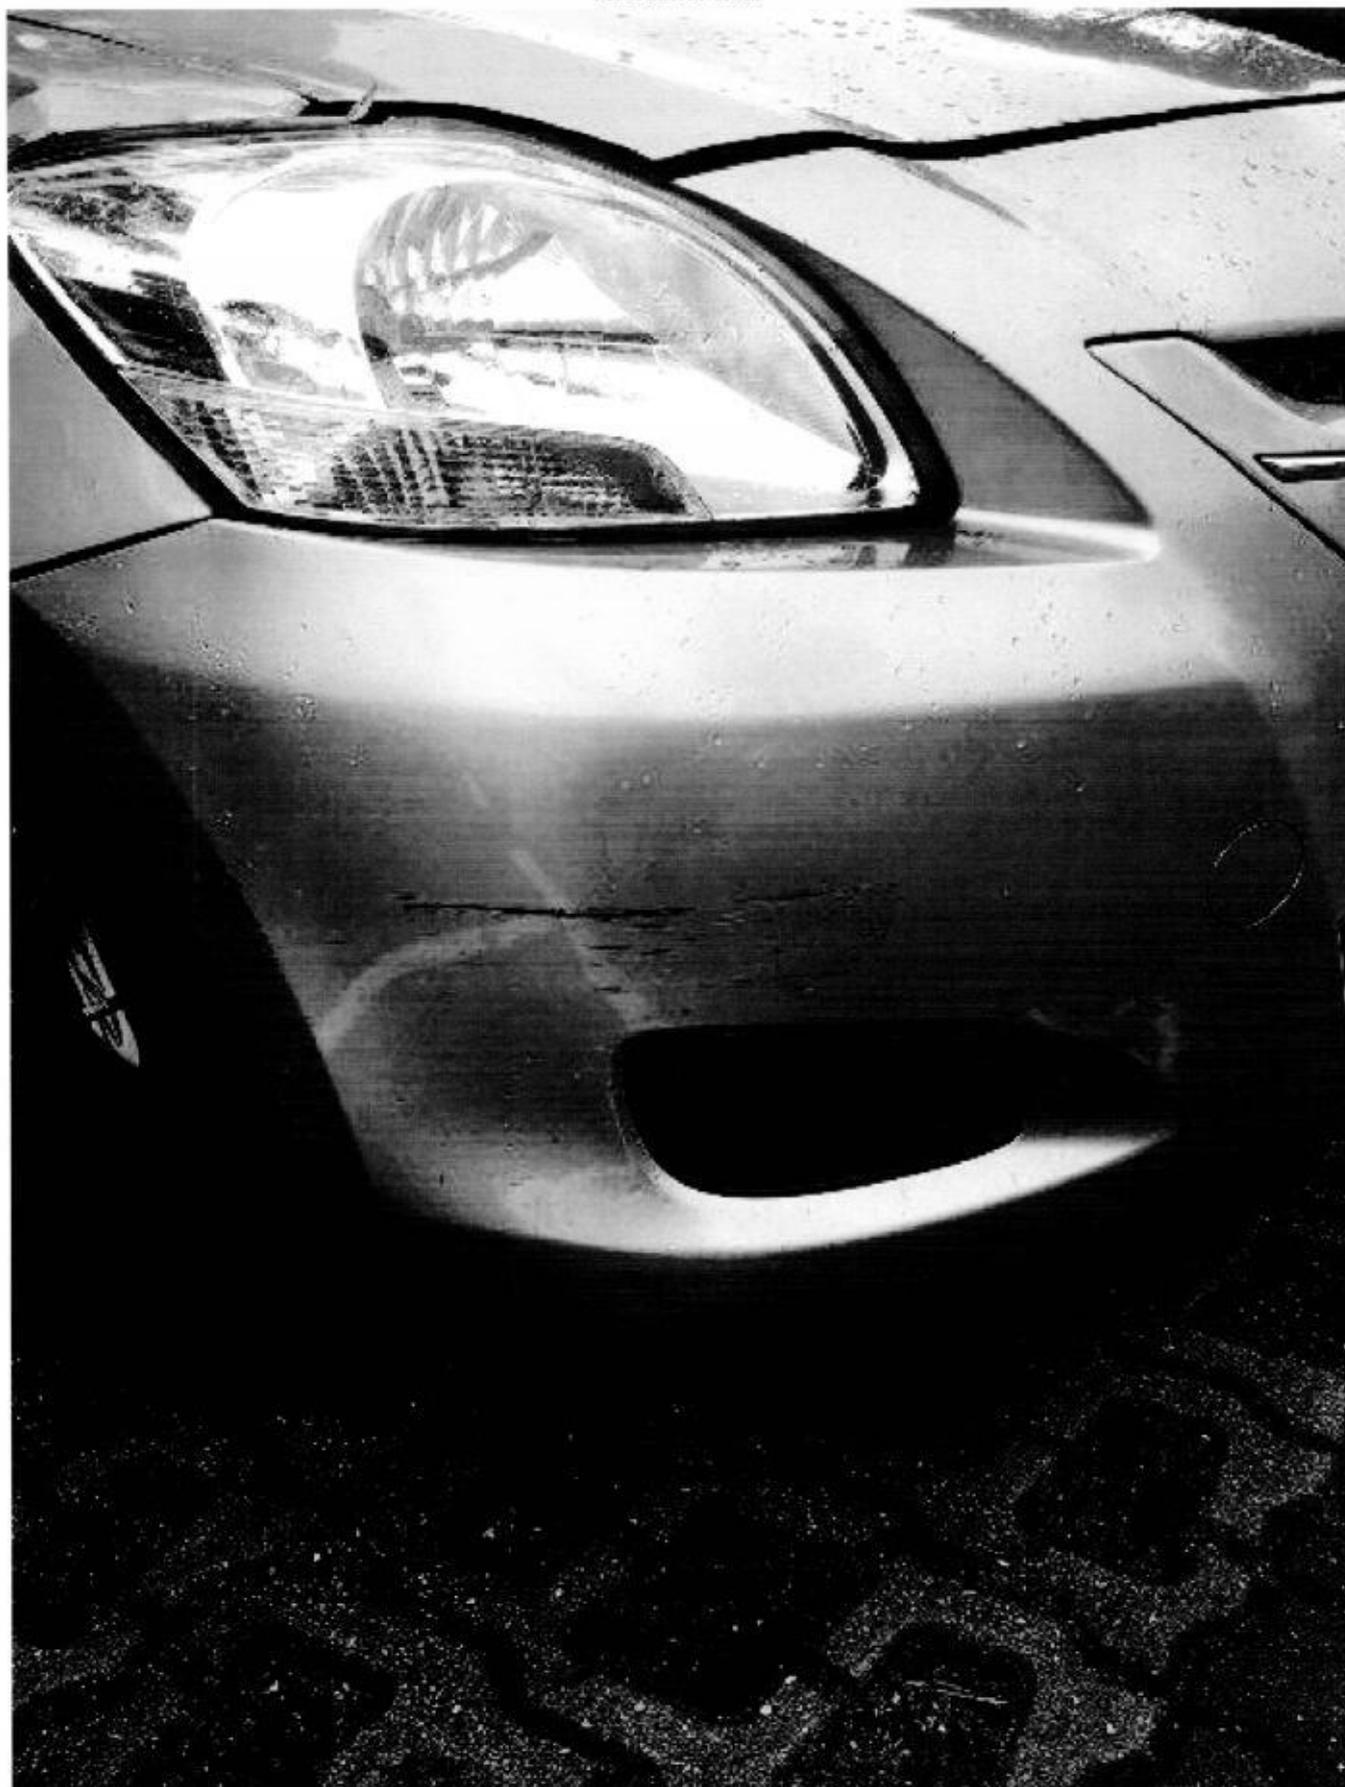
Accident Photo

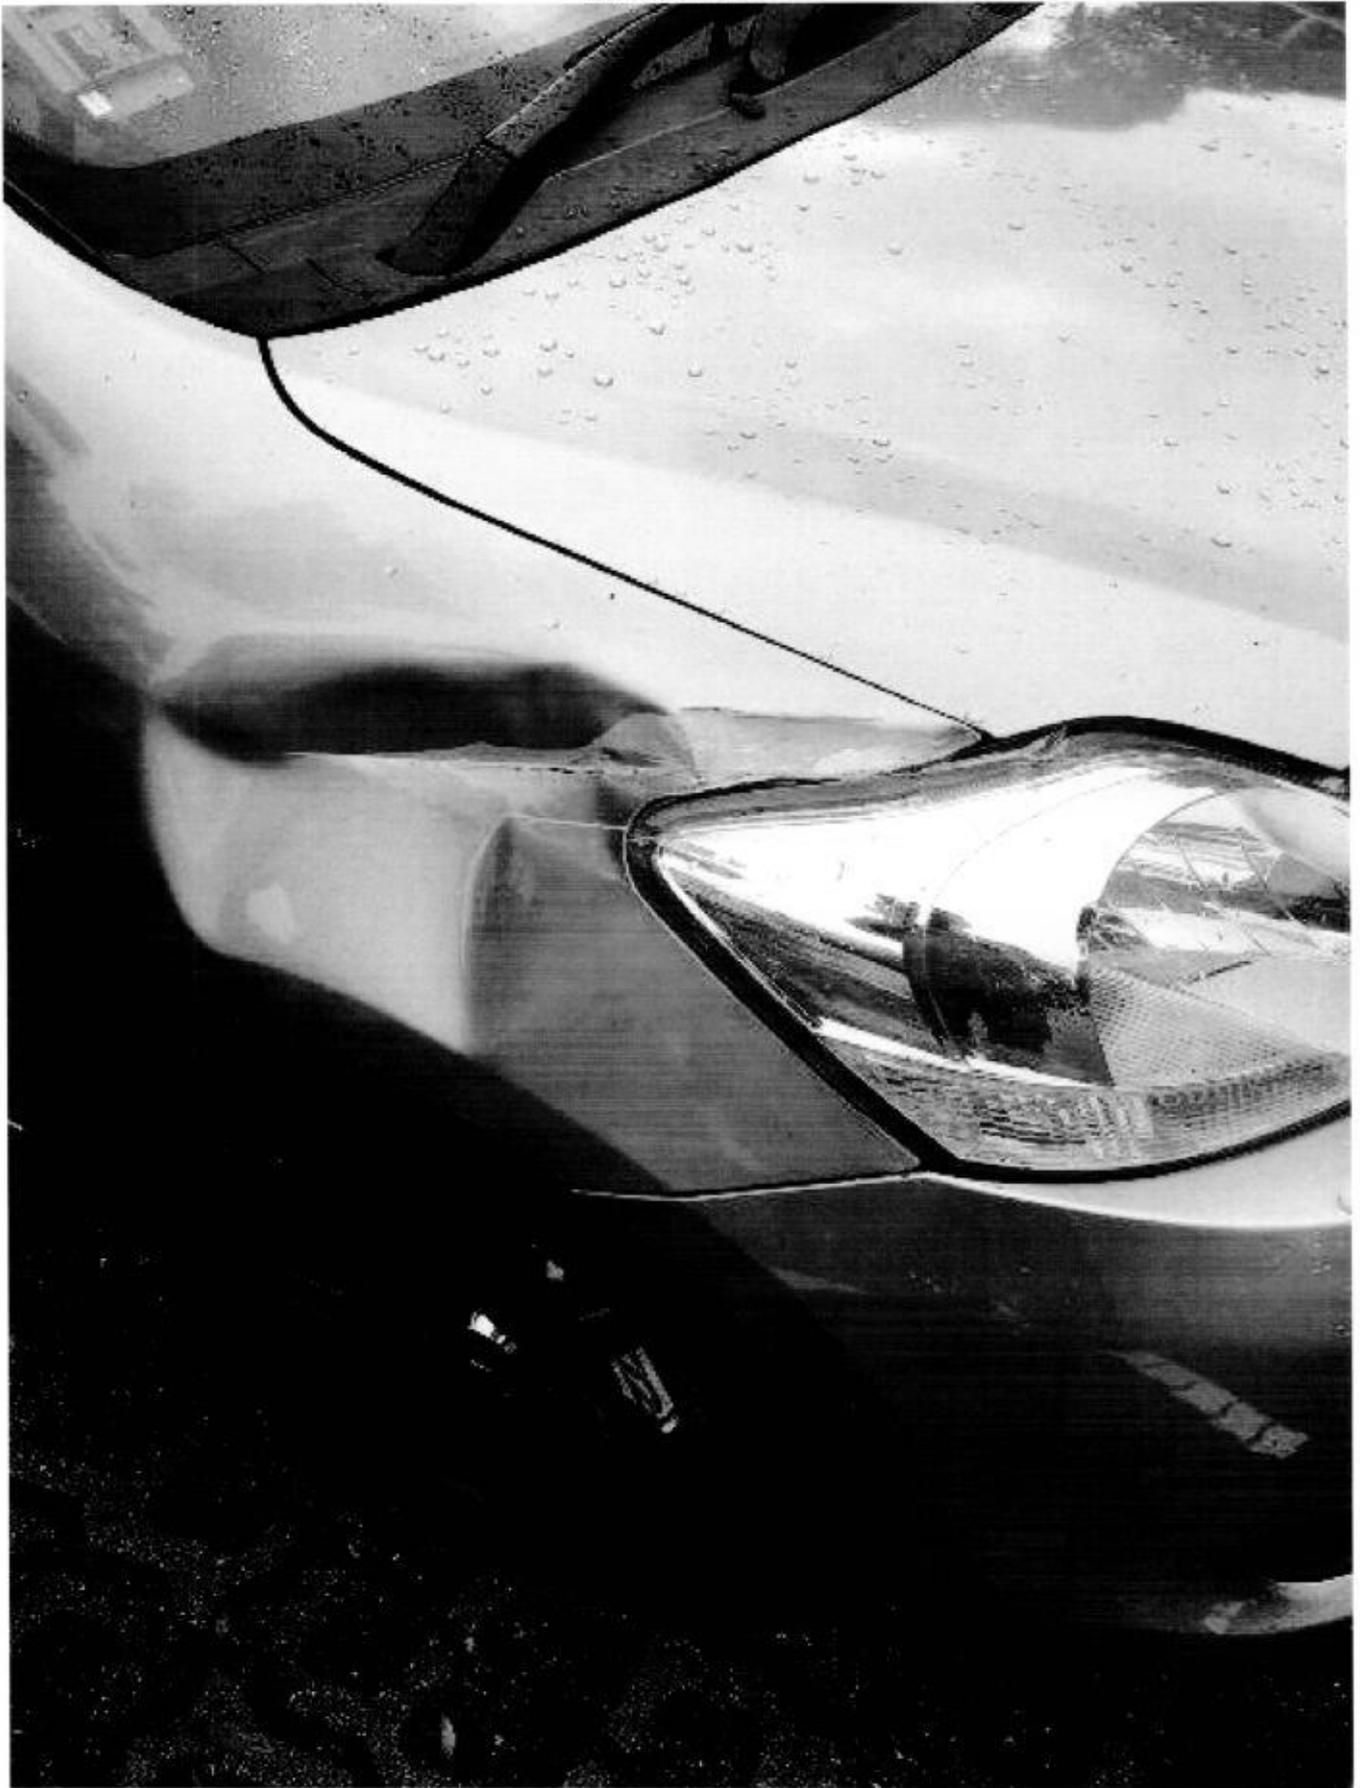
Accident Photo

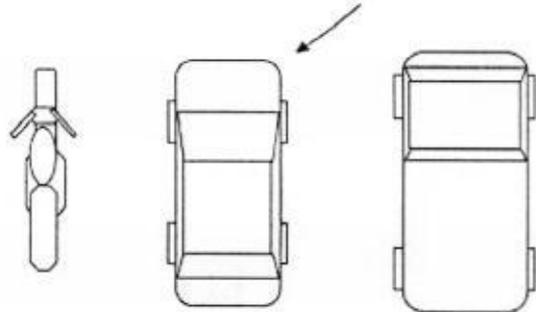
At the time of inspection, this vehicle sustained damages to the **O/S Front** portion. Please see attached scheduled for details.
