**SURVEY OF VEHICLE NO. SJT 4592H** ✓

**THIRD PARTY SURVEY**  
**ACCIDENT HAPPENED ON 4 Oct 2017**

**EVALUATION REPORT (PAPER SURVEY) OF ACCIDENT VEHICLE NO:  
SJT 4592H INSURED VEHICLE: YP 5879T ACCIDENT DATE: 04/10/2017**

## ADJUSTMENT ON REPAIR COST FOR VEHICLE NO. SJT 4592H

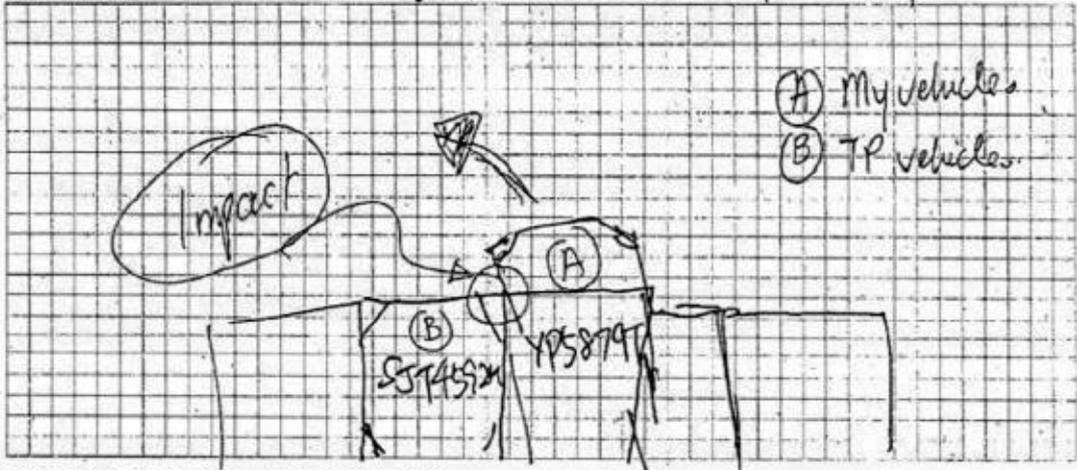
Sketch Plan #2 Pg. 1

As I coming out of carpark <sup>but</sup> did not notice a car was parked on my left. I scratched SJT 4592H.

DAMAGED TO SJT 4592H  
 left fender dent  
 left bumper slight dent  
 front right rim damaged.
