Your Ref: TP/IP/49129/2018
Our Ref : CI/TPD18016724/Z

31st October 2018

MECHANICAL INSPECTION REPORT OF MOTORCYCLE JRY 6722

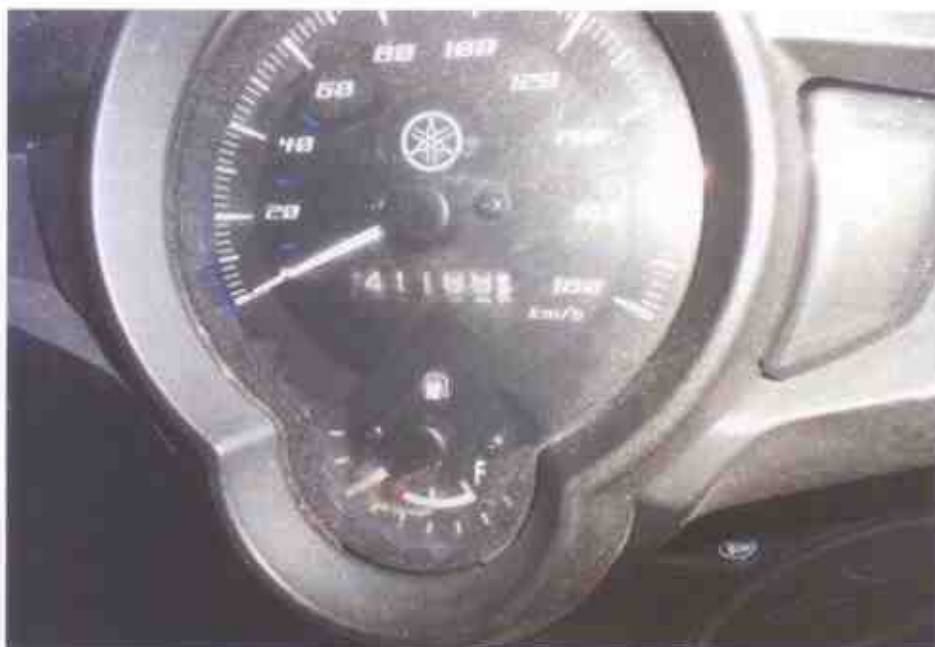
Photo 1 shows a close-up view of the mileage meter at time of our inspection. The mileage was recorded at 41188.8km.

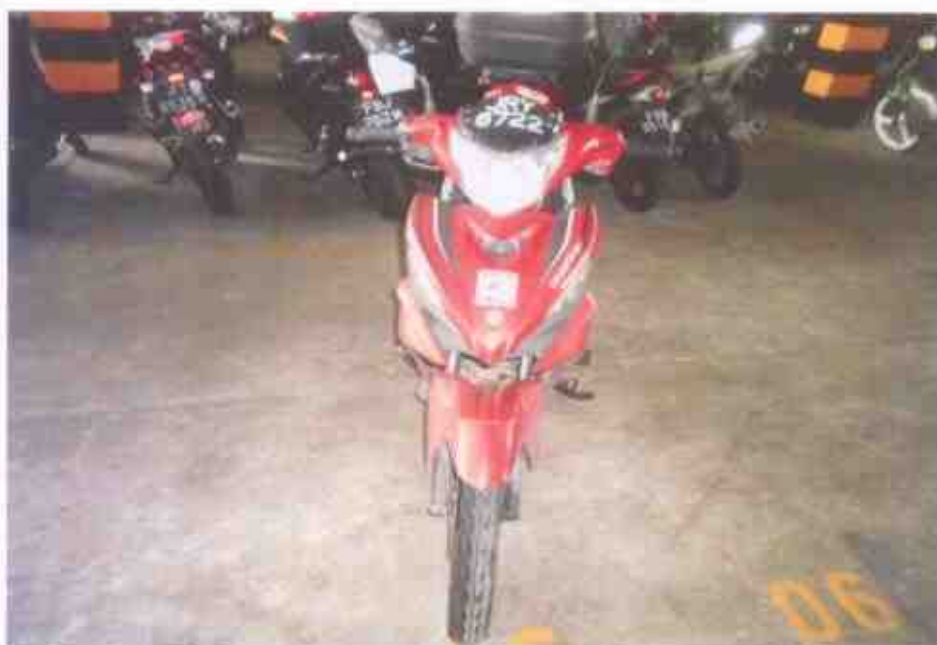
Photo 2 shows a general view of the front body of the Motorcycle at the time of our inspection. The Motorcycle was observed to have sustained relatively minor damages at time of inspection. The damages were observed to be confined to its front & right portion of the Motorcycle.

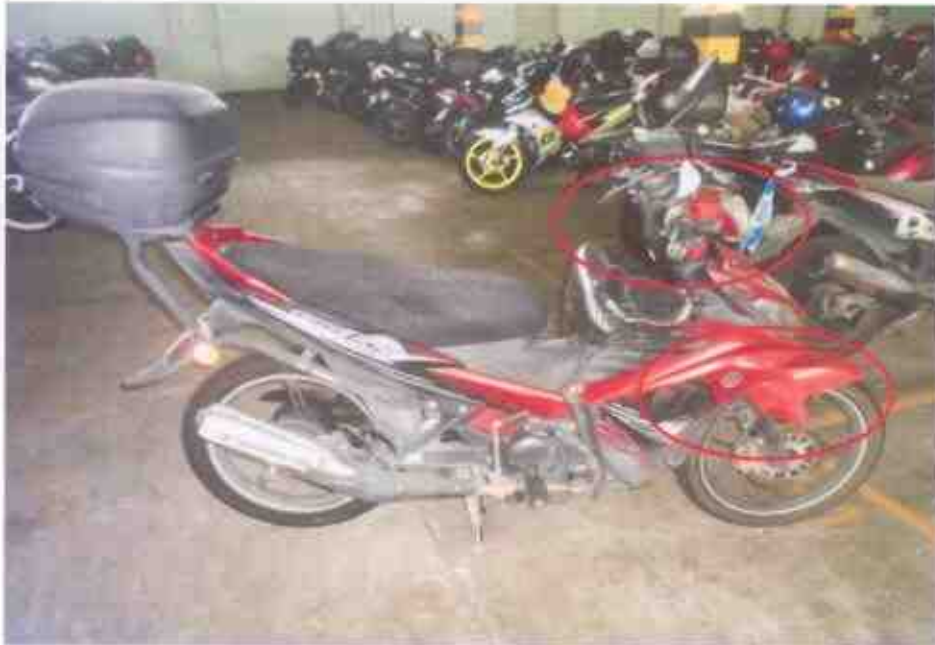
Photo 3 shows a general view of the right body of the Motorcycle at the time of our inspection. The Motorcycle was observed to have sustained relatively minor damages on the right side fairing, handle, mud guard & brake lever at time of our inspection.

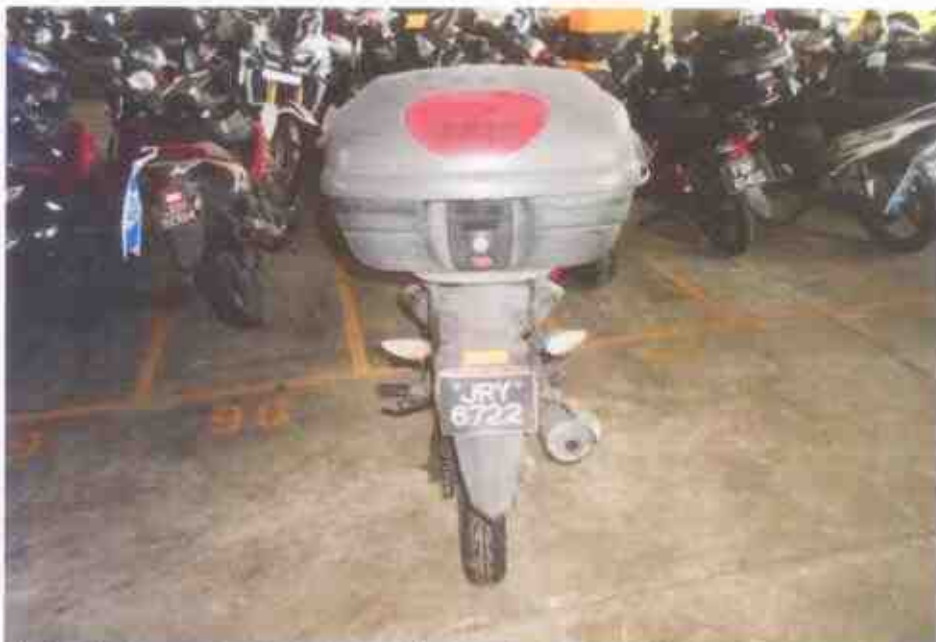
Photo 4 shows a general view of the rear body of the Motorcycle at the time of our inspection. The Motorcycle was observed to be in good condition unaffected by the accident.

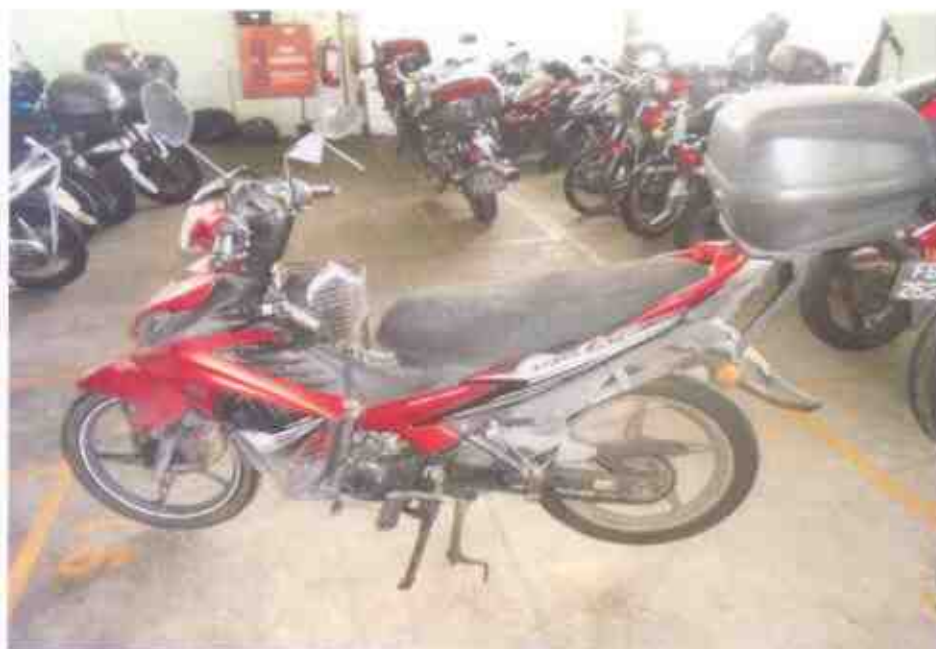
Photo 5 shows a general view of the left body of the Motorcycle at the time of our inspection. The Motorcycle was observed to have sustained relatively minor damages on the left side fairing at time of our inspection.

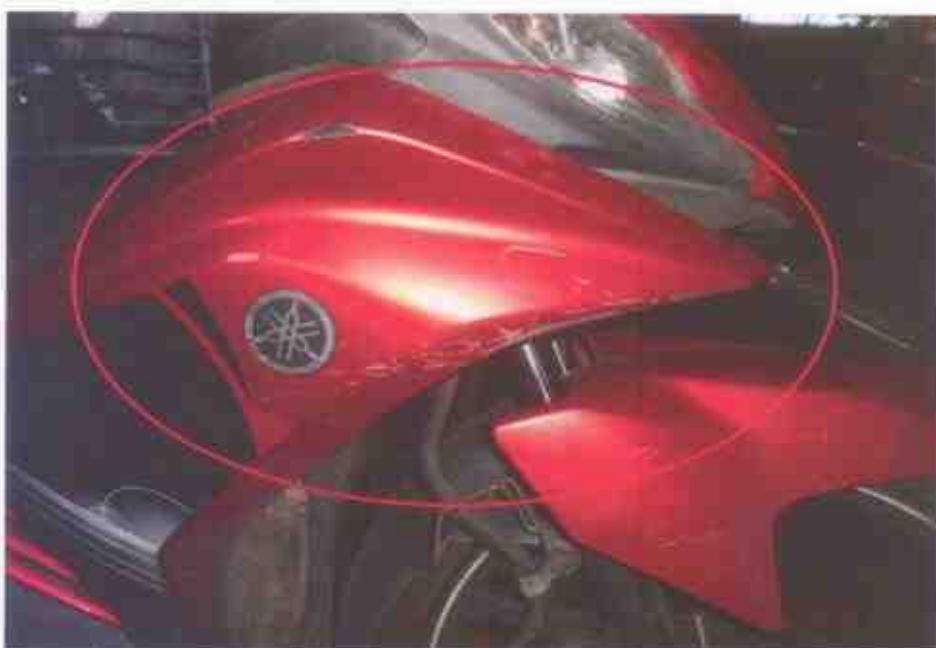
Photo 6 shows a closer view of the right fairing of the Motorcycle at the time of our inspection. The Motorcycle was observed to have sustained with relatively minor damages due to the accident collision. (Circled)

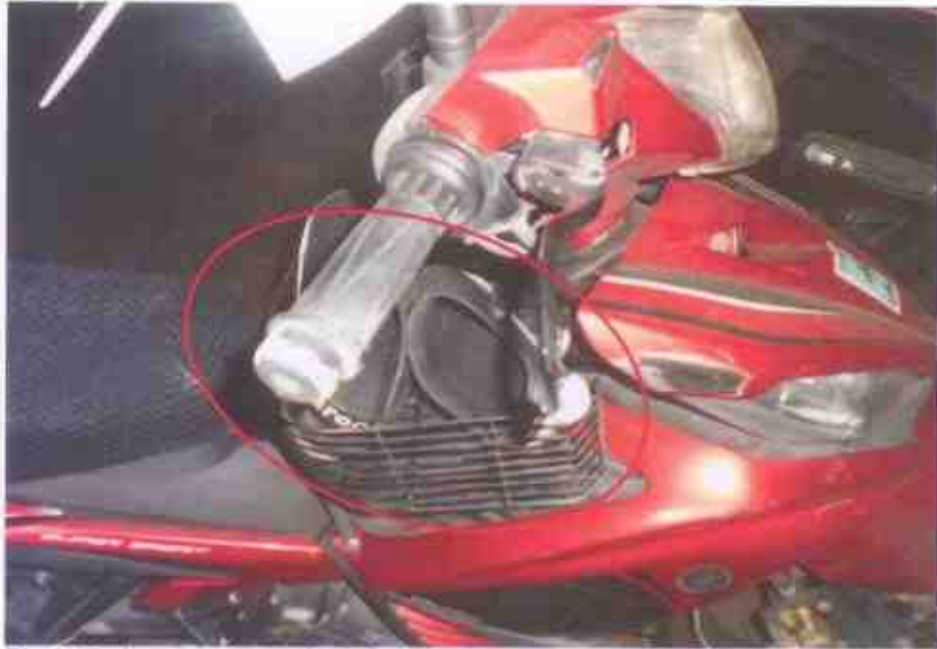
Photo 7 shows a closer view of the right handle & brake lever of the Motorcycle at the time of our inspection. The Motorcycle was observed to have sustained with relatively minor damages due to the accident collision. (Circled)

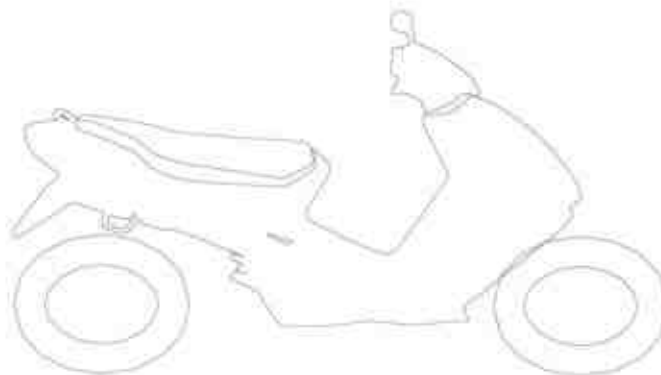
IRC Wing NR77
80/90 - R17 (3mm)

IRC Wing NR77
70/90 - R17 (3mm)

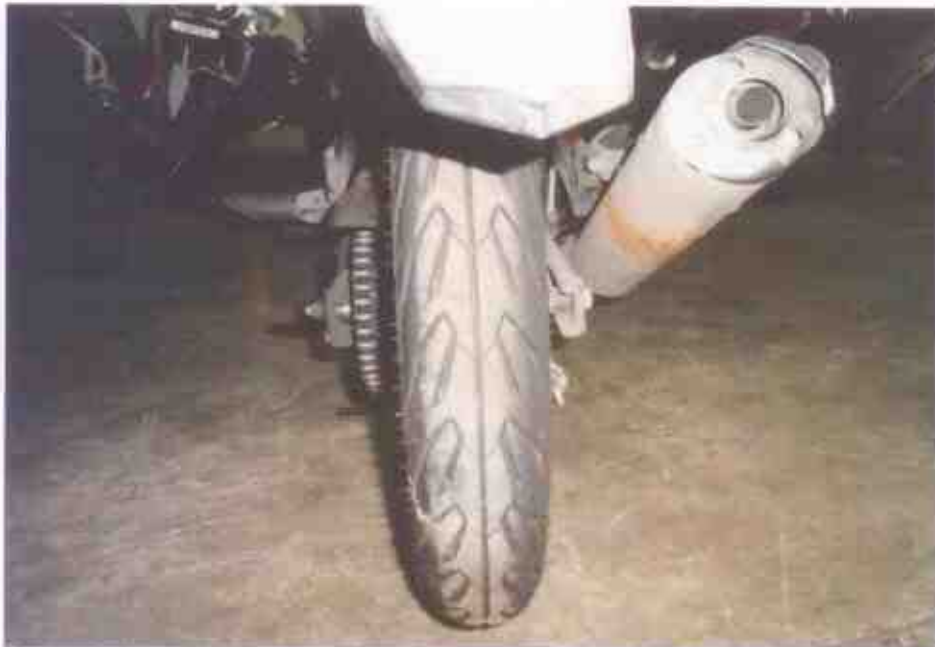
Photo 8 shows the rear tyre of the Motorcycle. The rear tyre was observed to be in serviceable condition with remaining tread depth of approximately 3mm. The tyre was also observed to be sufficiently inflated for vehicular operation.

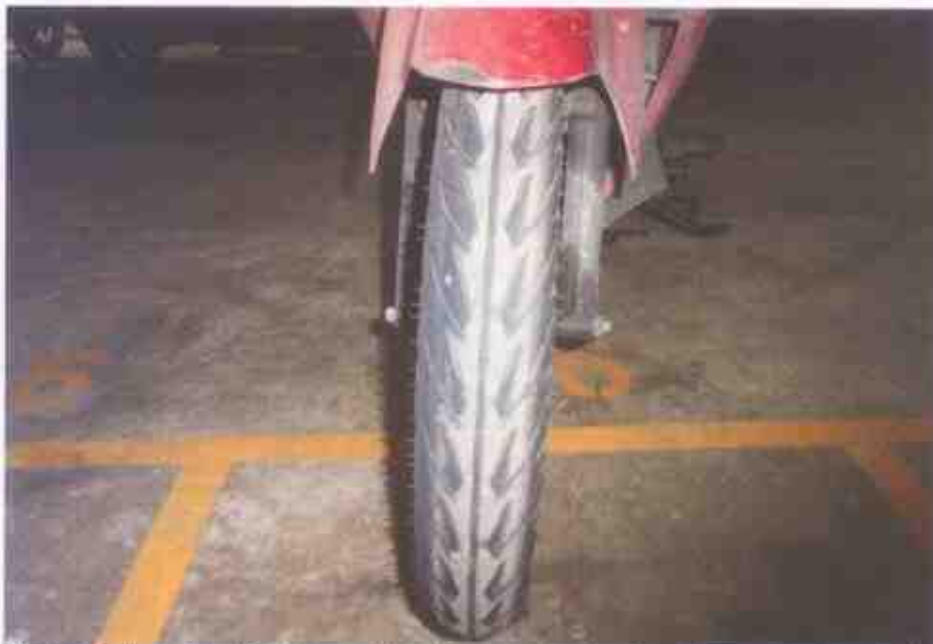
Photo 9 shows the front tyre of the Motorcycle. The front tyre was observed to be in serviceable condition with remaining tread depth of approximately 3mm. The tyre was also observed to be sufficiently inflated for vehicular operation.

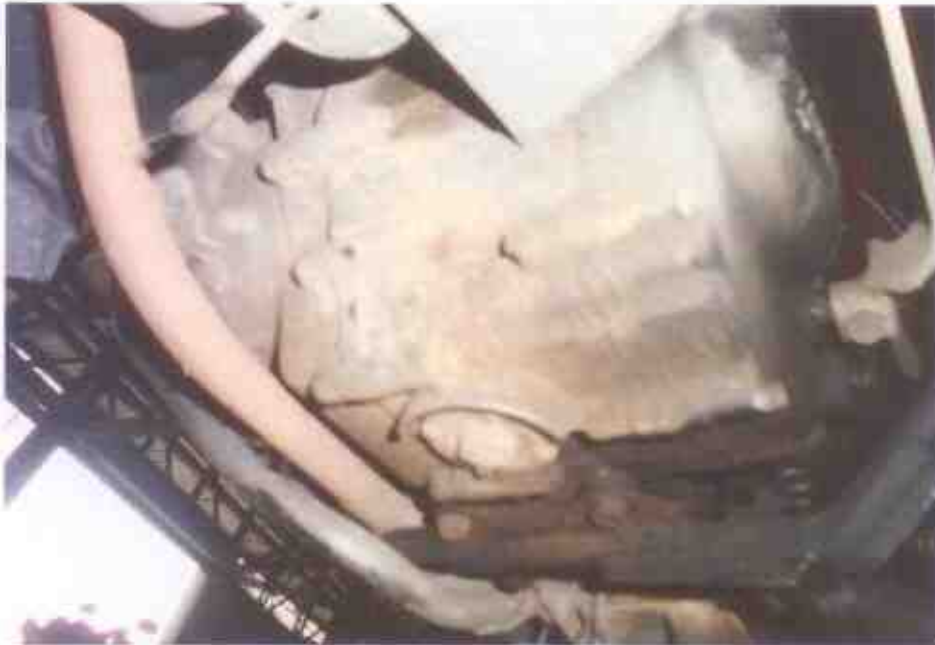
Photo 10 shows no sign(s) or indication(s) of fluid leak observed around the underside of the engine area of the Motorcycle.

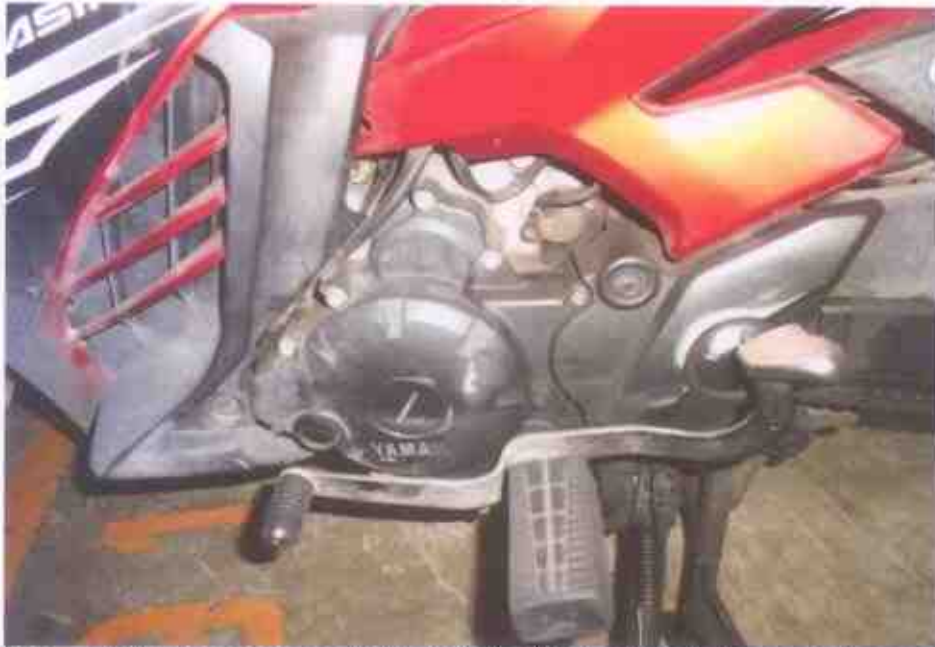
Photo 11 shows no sign(s) or indication(s) of fluid leakage stain observed around the engine area of the Motorcycle.

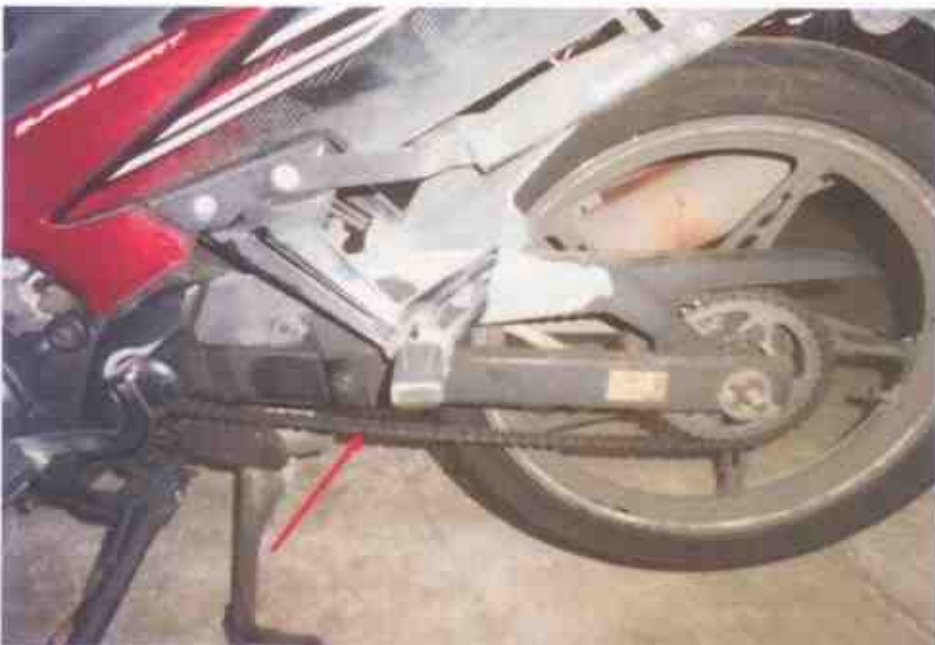
Photo 12 shows the general view of the gear train (arrowed) of the Motorcycle, which was observed to be intact with no misalignment. It was also adequately lubricated for operating purposes.

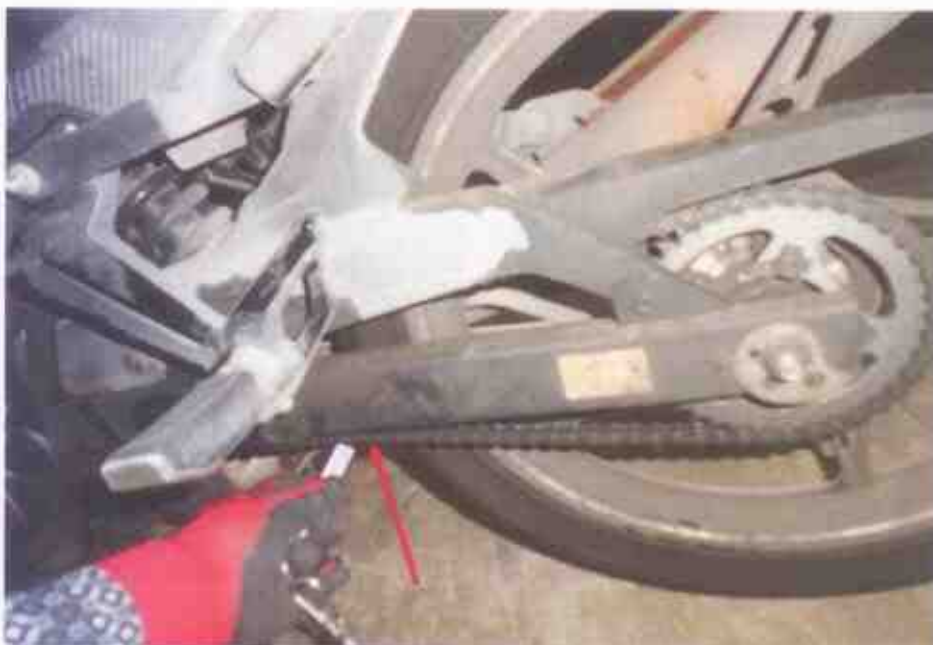
Photo 13 shows the general view of the gear train (arrowed) of the Motorcycle, which was observed to be intact with no misalignment. It was also adequately lubricated for operating purposes. Free play tension was also observed & found adequately acceptable.

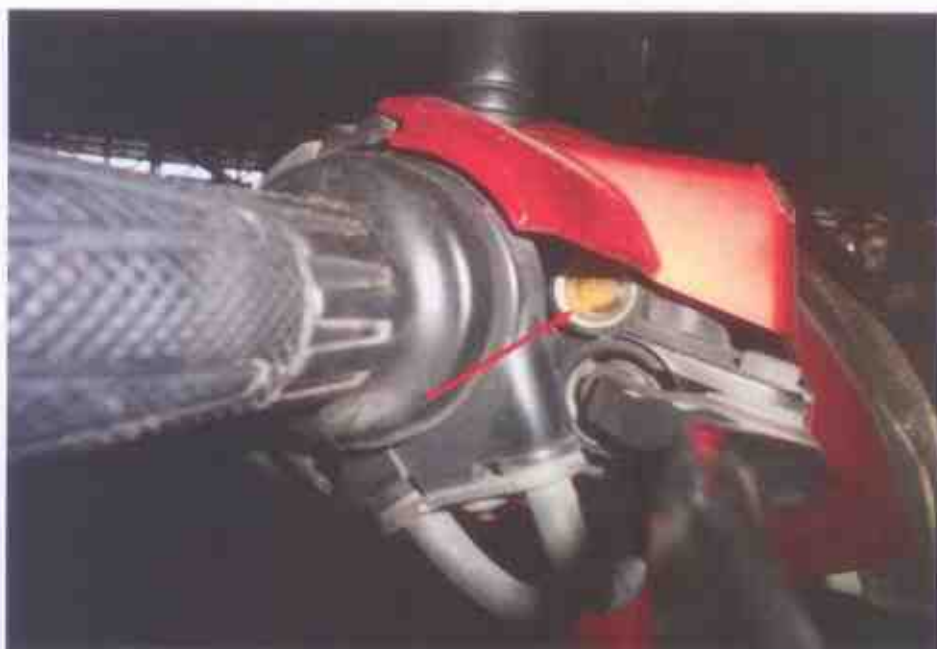
Photo 14 shows our checks on the brake fluid (front) reservoir had also indicated that the brake fluid was of sufficient level for operational purposes, and without contamination.

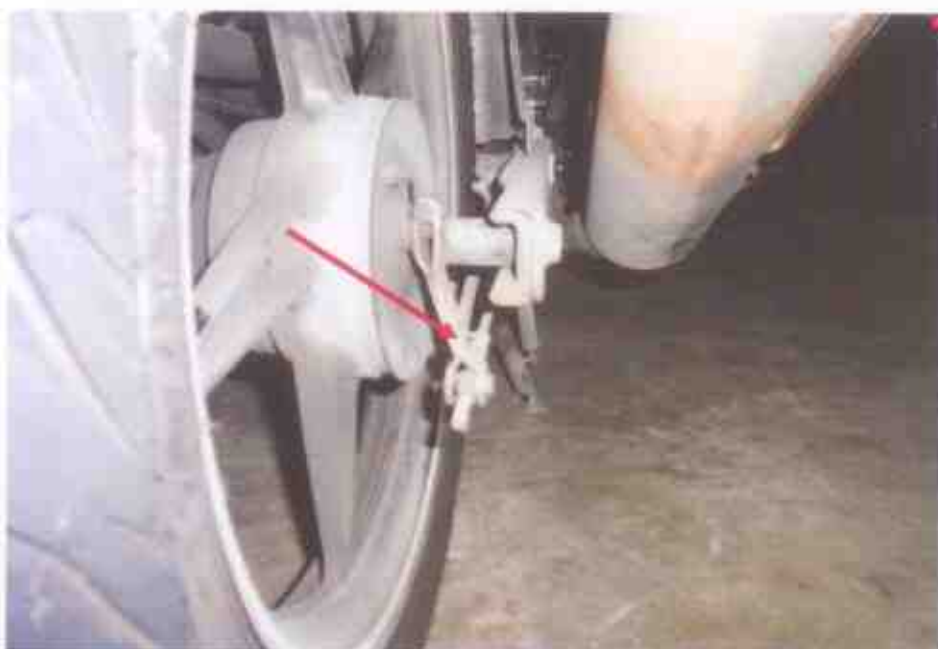
Photo 15 shows our checks on the rear brake mechanical components had also indicated that the rear brake was fit for operational purposes, without abnormalities unaffected by the accident.

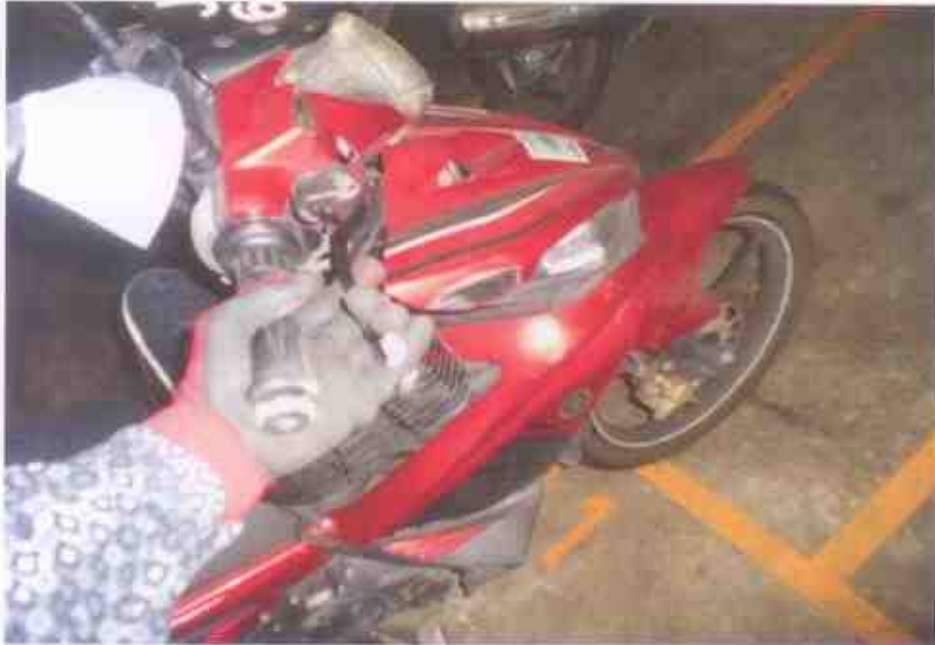
Photo 16 shows testing of the braking of the front brake in progress. There was some resistance felt (spongy like feel) upon pressing the brake lever.

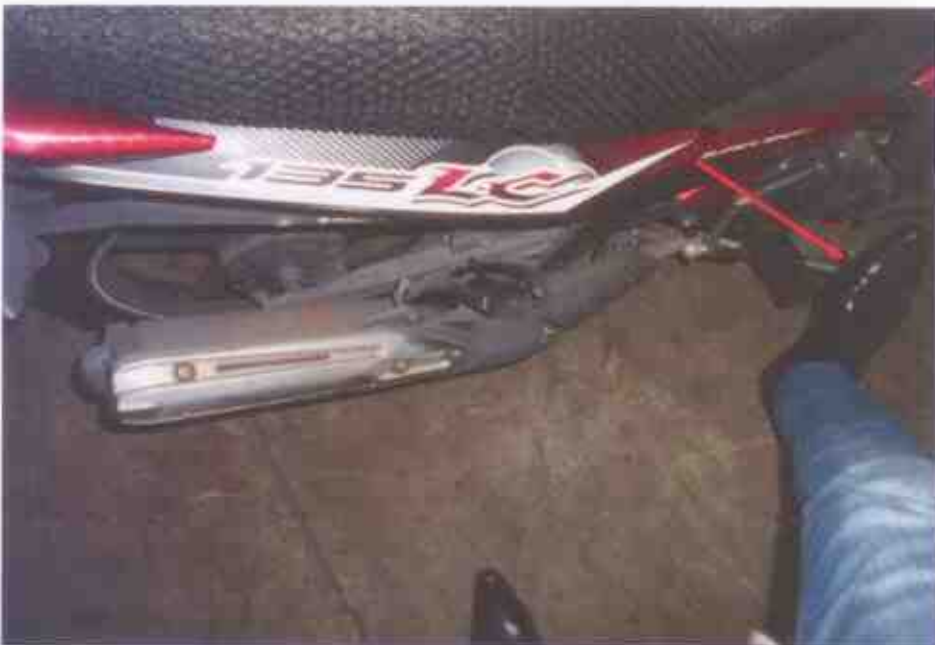
Photo 17 shows testing of the braking of the rear brake in progress. There was some resistance felt (spongy like feel) upon stepping on the brake pedal.

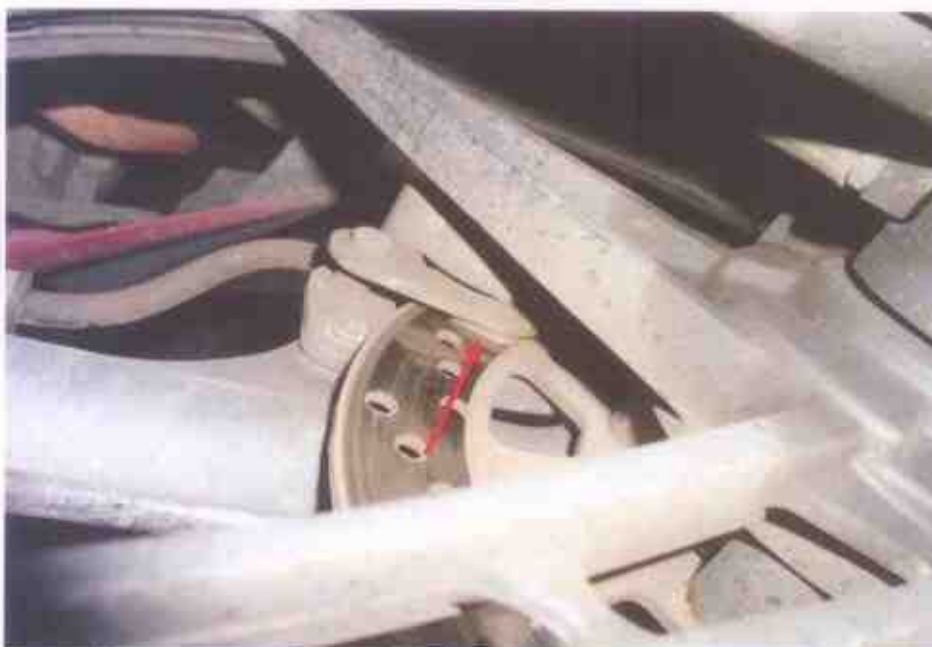
Photo 18 shows the front brake pad at time of our inspection. The frictional material was observed to be sufficient for operational purposes.
