Your Ref: TP/IP/48921/2018
Our Ref : CI/TPD18016725/Z

10th January 2019

MECHANICAL INSPECTION REPORT OF MOTOR BUS PC 3156J

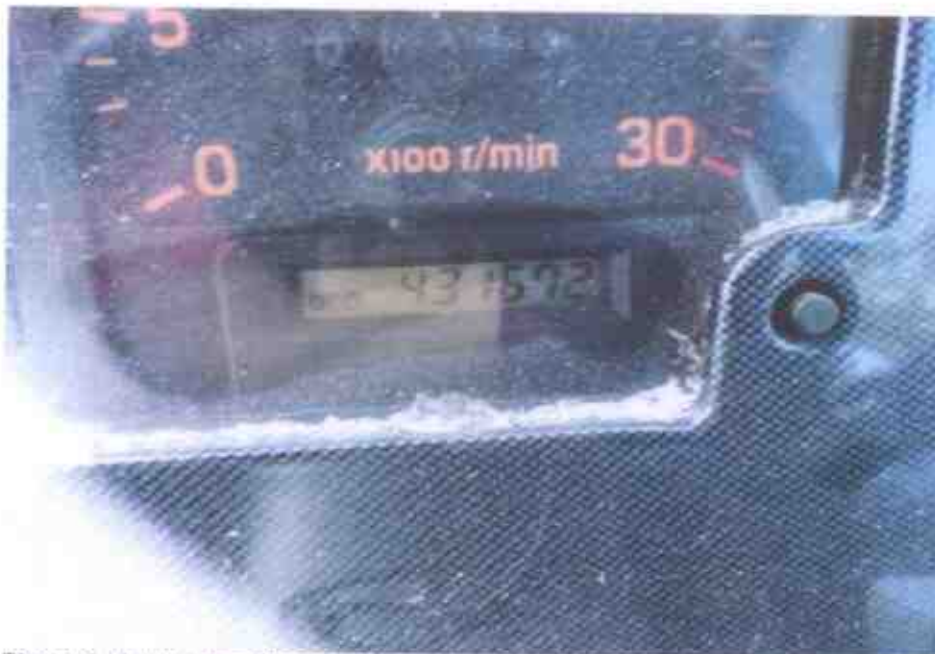
4. The mileage of the Motor Bus at the time of our inspection was recorded as 431672km.
5. The Motor Bus was observed to have sustained damages at its frontal portion. Its front lower bumper was observed to be damaged; its front panel was observed to be damaged and its entire windshield was observed to be shattered pushed inwards towards the rear of the Motor Bus at time of our inspection.
6. The damages were consistent with the accidents case fact that on 29th August 2018, sometime before 1805hrs, a motorcycle was travelling along Pasir Panjang Road towards West Coast Highway while the Motor Bus was travelling on the opposite direction towards Telok Blangah Road. The Motor Bus had made a right turn at the junction of Harbour Drive, resulting in a collision (head to side) with the motorcyclist who was travelling straight. See photo 1 – 6 below.

Photo 1 shows the mileage of the Motor Bus at the time of our inspection was recorded as 431672km.

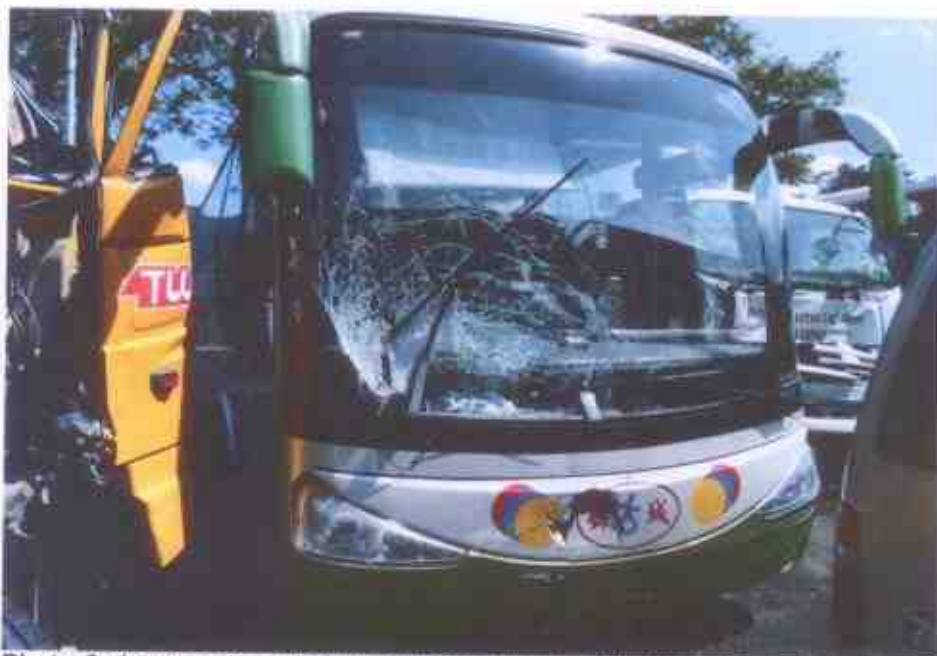
Photo 2 shows a general view of the front body of the Motor Bus at the time of our inspection. The Motor Bus was observed to have sustained damages at its front portion as a result of the accident's collision.

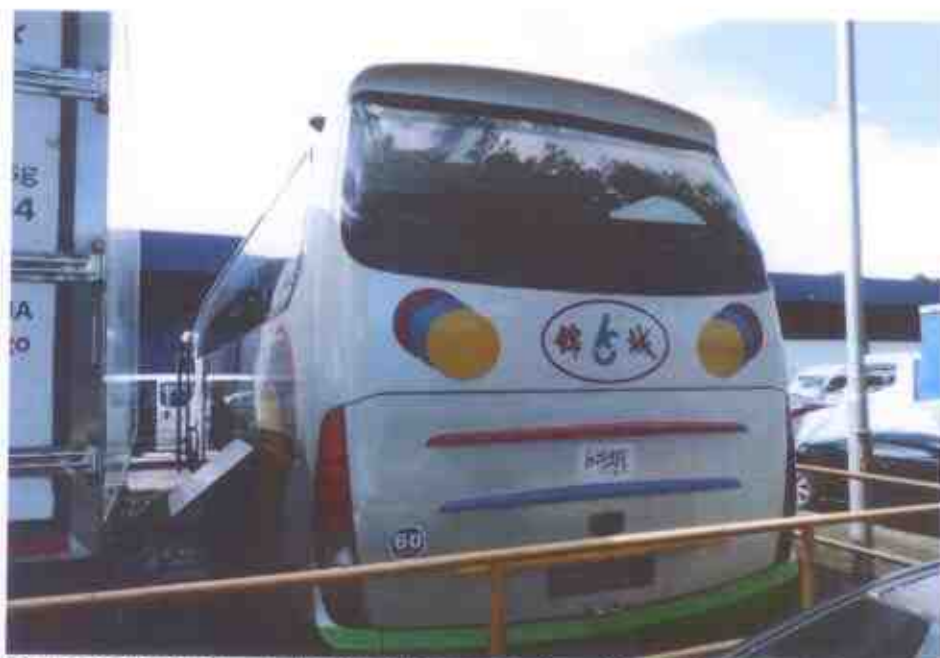
Photo 3 shows a general view of the rear portion of the Motor Bus at the time of our inspection. The Motor Bus was observed to be in good condition unaffected by the accident.

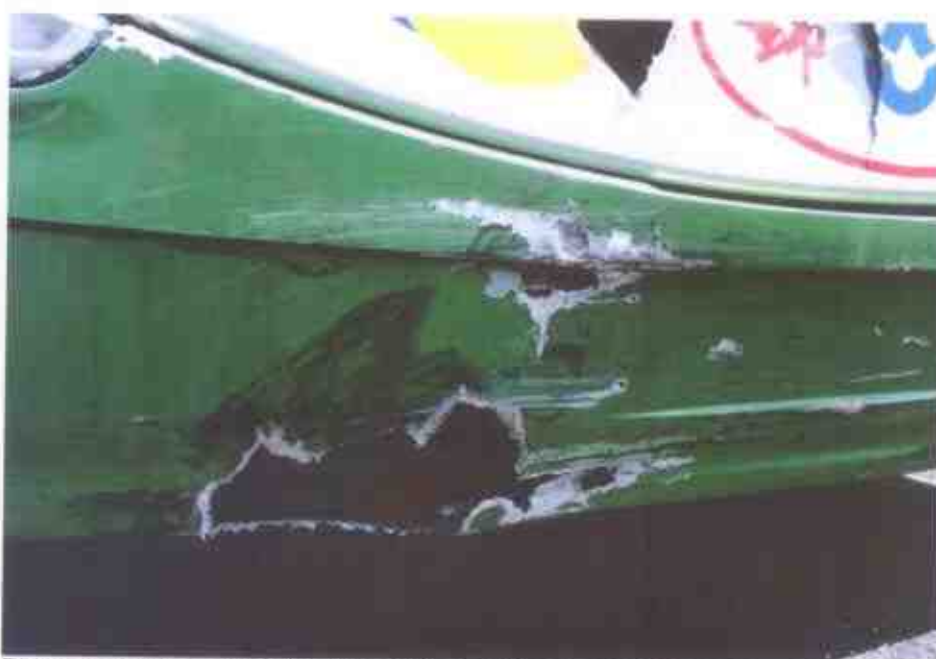
Photo 4 shows a close-up view of the front body of the Motor Bus at the time of our inspection. The Motor Bus front lower bumper was observed to sustained damages due to the accident's impact.

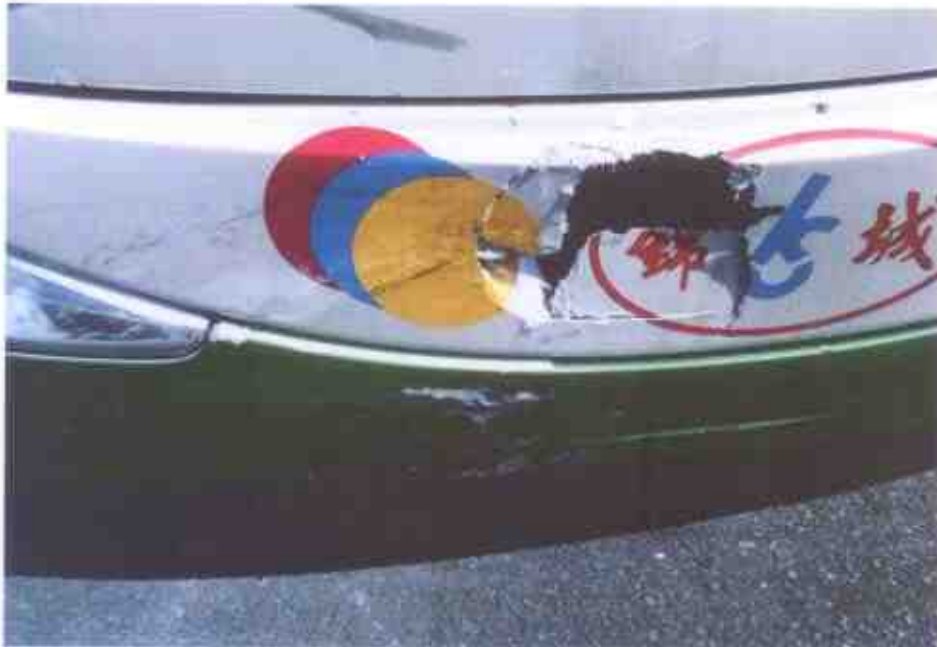
Photo 5 shows a close-up view of the front right body of the Motor Bus at the time of our inspection. The Motor Bus front panel was observed to sustained damages due to the accident's impact.

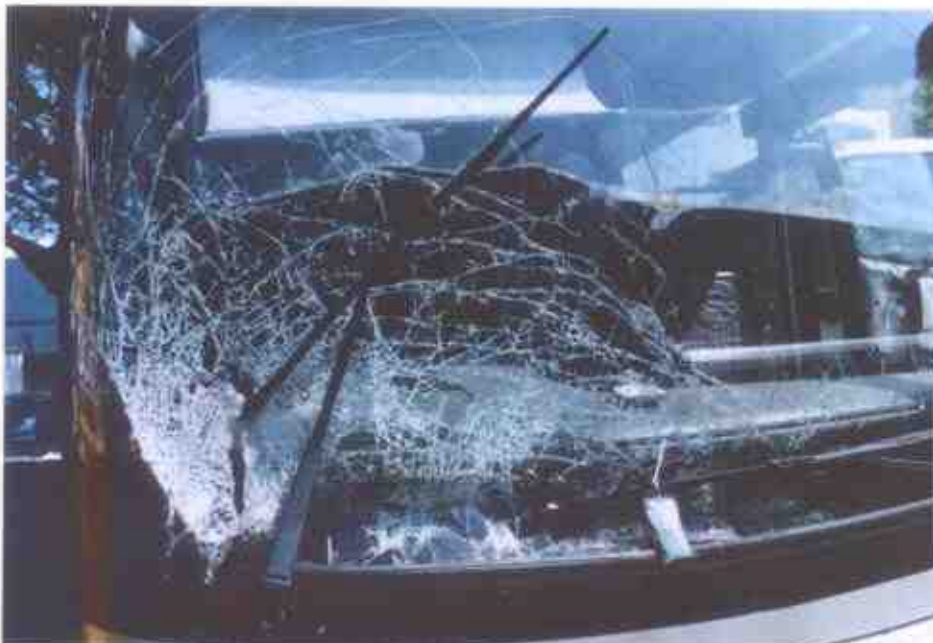
Photo 6 shows a close-up view of the cracked front windshield of the Motor Bus.

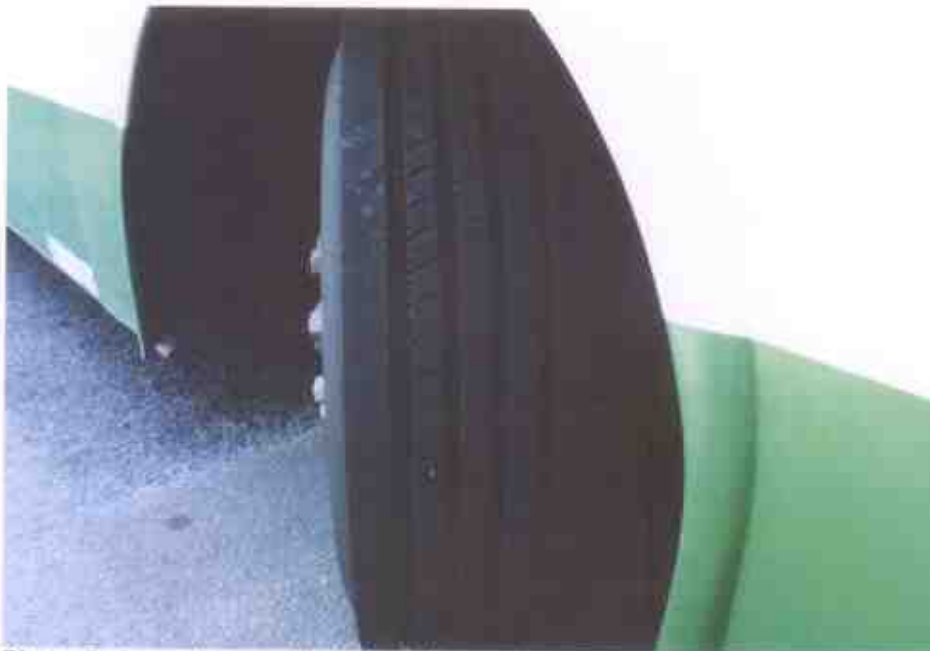
Photo 7 shows the condition of the front right tyre of the Motor Bus, which was observed to be in serviceable condition with remaining tread depth of approximately 8mm. The tyre was also observed to be sufficiently inflated for vehicular operation.

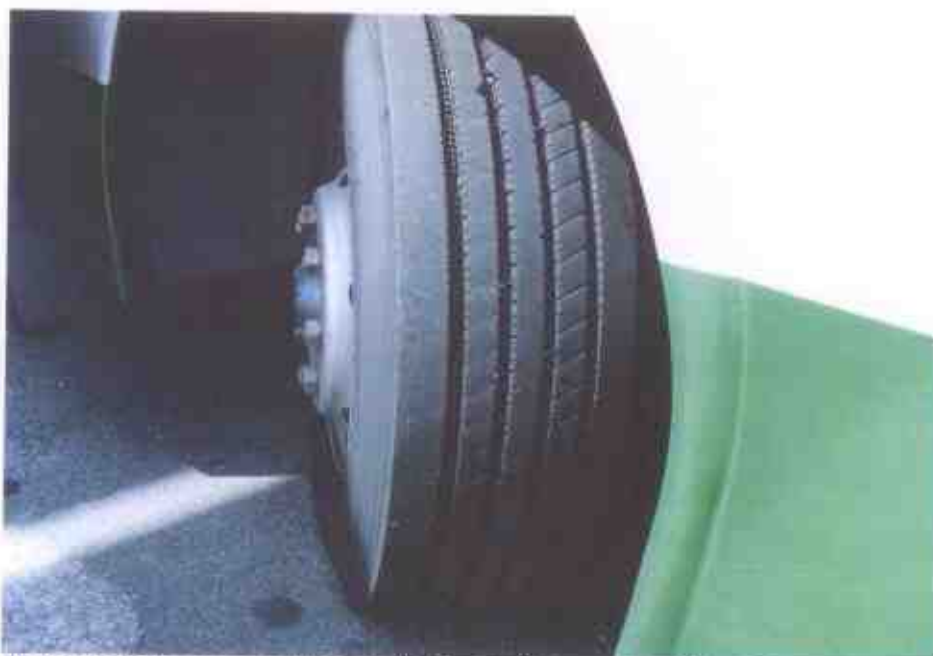
Photo 8 shows the condition of the front left tyre of the Motor Bus, which was observed to be in serviceable condition with remaining tread depth of approximately 8mm. The tyre was also observed to be sufficiently inflated for vehicular operation.

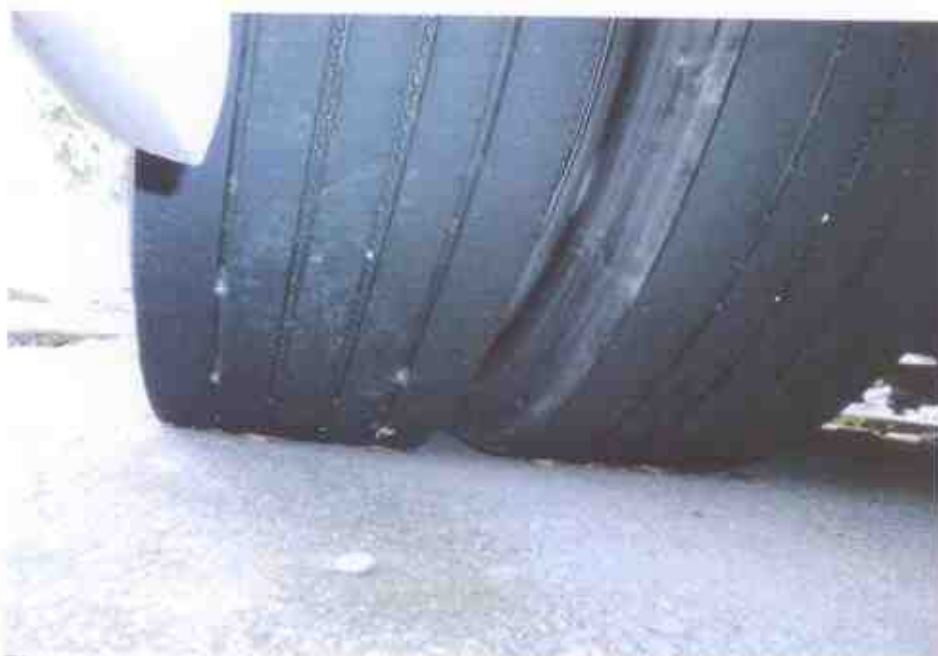
Photo 9 shows the condition of the rear right tyres of the Motor Bus, which were observed to be in serviceable condition with remaining tread depth of approximately 5mm. The tyres, which were wrapped around standard alloy wheels rims, were also observed to be sufficiently inflated for vehicular operation.

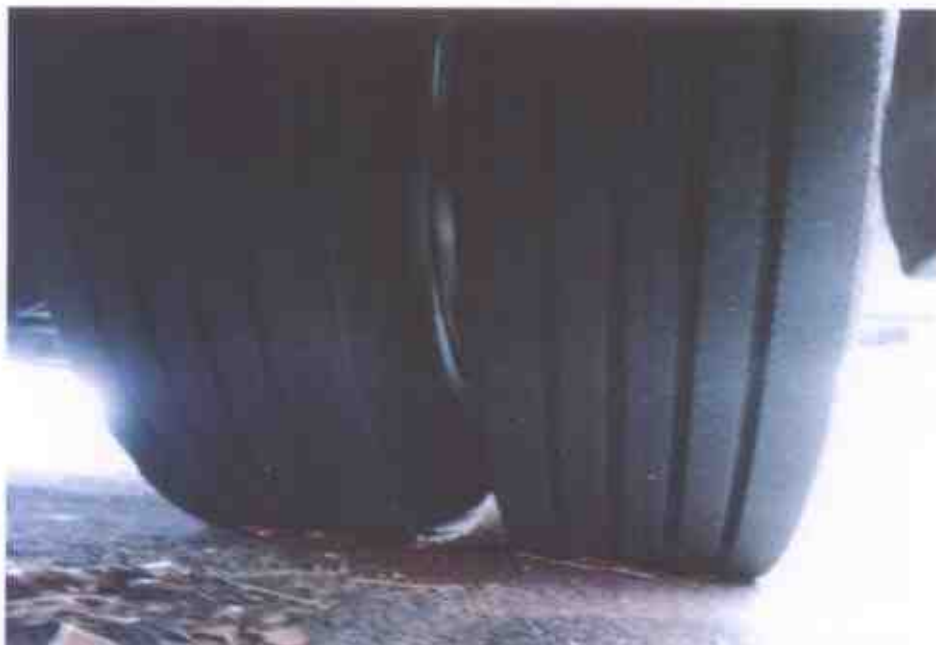
Photo 10 shows the condition of the rear left tyres of the Motor Bus, which were observed to be in serviceable condition with remaining tread depth of approximately 7mm. The tyres, which were wrapped around standard alloy wheel rims, were also observed to be sufficiently inflated for vehicular operation.

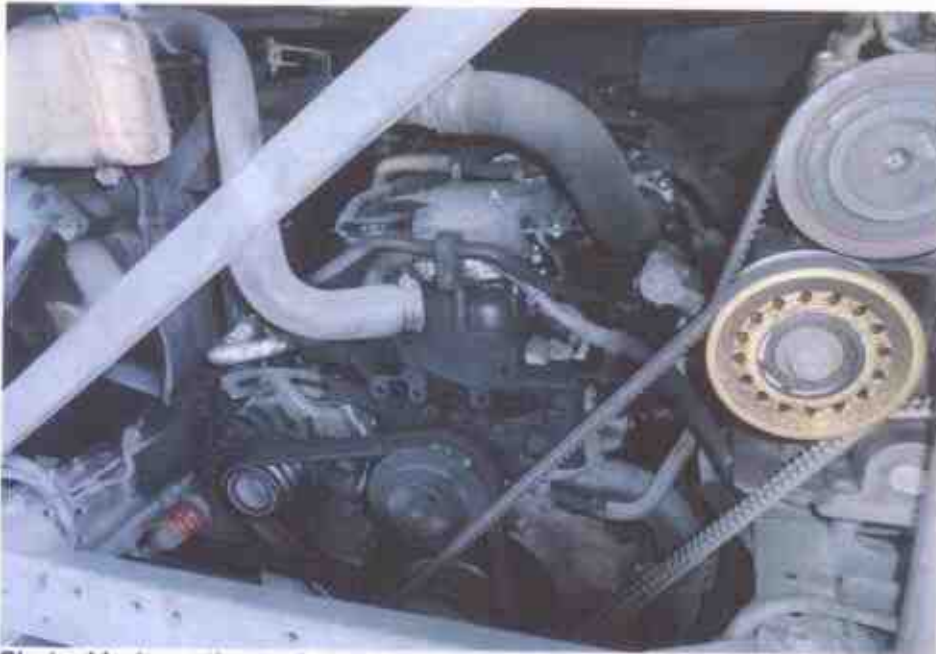
Photo 11 shows the engine compartment of the Motor Bus was located at the rear of the Motor Bus.

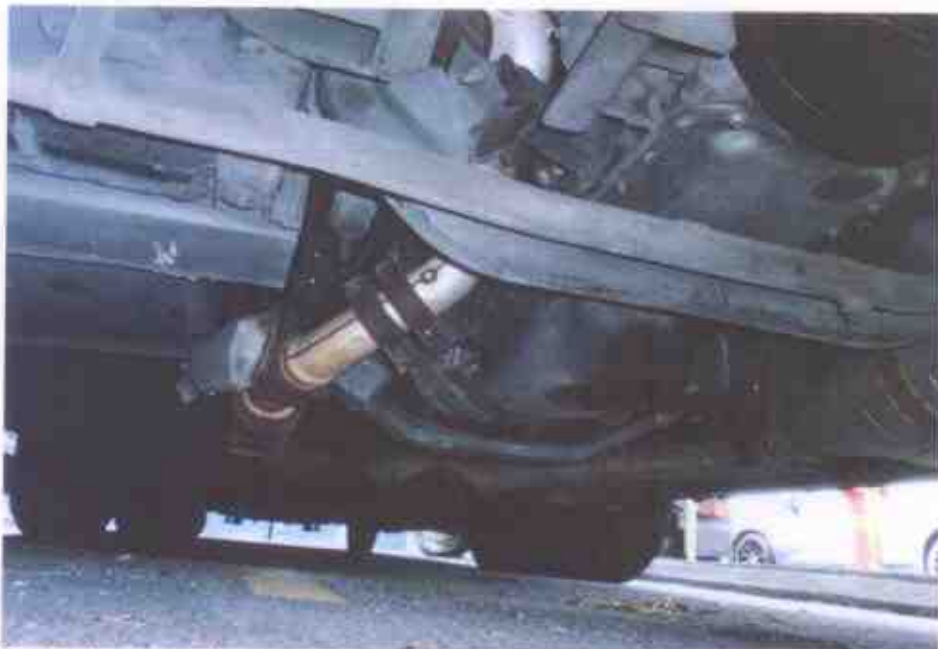
11. Our subsequent checks on the underside of the Motor Bus reveals some fluid stain sighted under the engine compartment. Further investigation found that the fluid stain was a pre-existed prior the accident & not a fresh fluid. This was due to some dirt observed on the fluid stain. Conclusively, it is not likely to be related to the accident. Visually, the various undercarriage components of the Motor Bus were observed to be intact and without any visible damage except for the damages caused by the accident. See photo 11 – 15 below.

Photo 12 shows the engine undercarriage of the Motor Bus. Some pre-existed fluid was observed at time of our inspection.

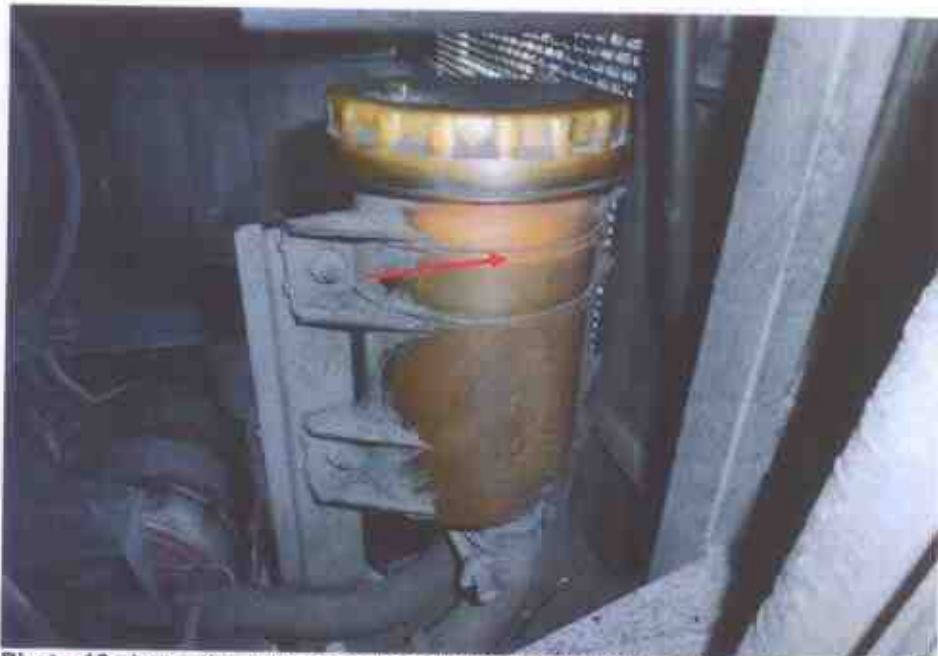
Photo 13 shows the power steering fluid of the Motor Bus. It was observed to be of sufficient level without any contamination at time of our inspection.

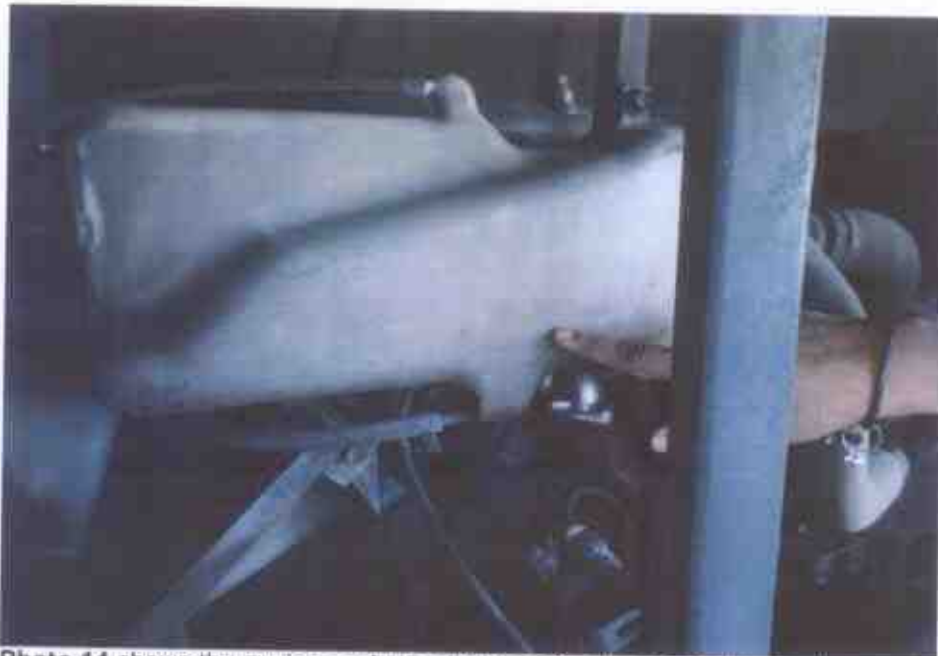
Photo 14 shows the engine coolant cylinder of the Motor Bus. It was observed to be of sufficient level without any contamination at time of our inspection.

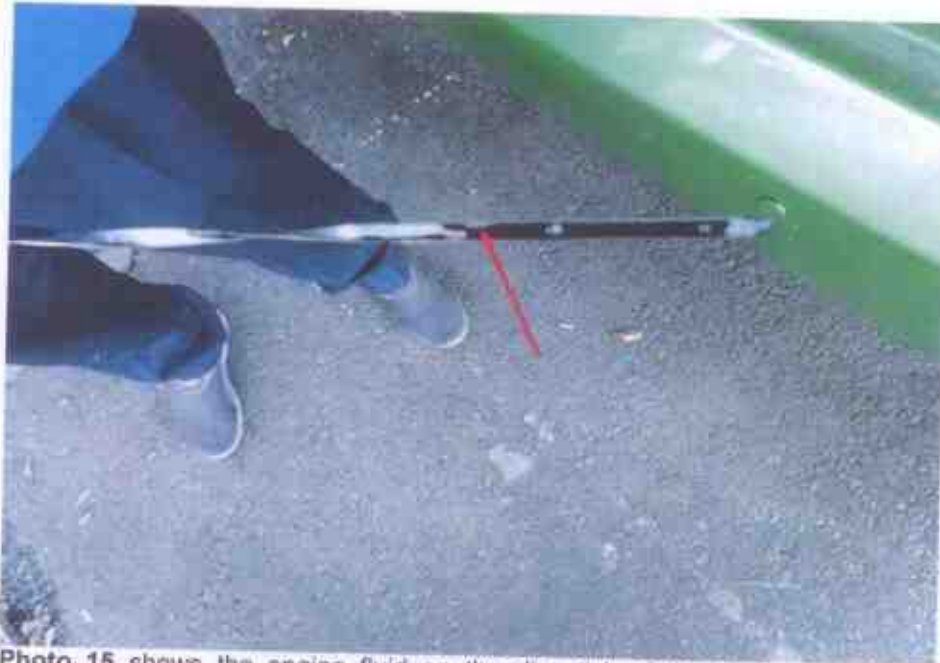
Photo 16 shows the engine fluid on the dip stick of the Motor Bus. It was observed to be of sufficient level without any contamination at time of our inspection.

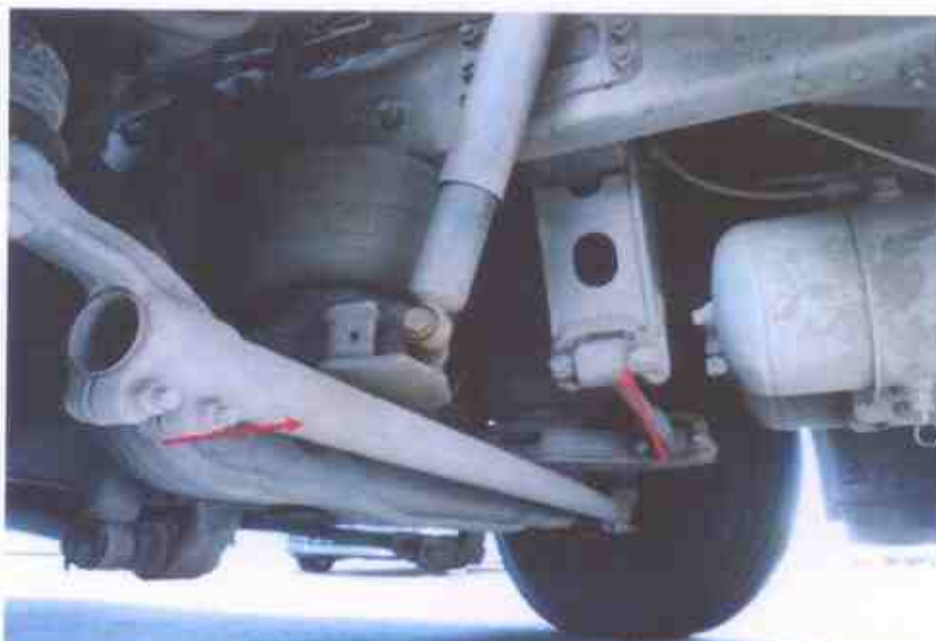
Photo 16 shows some of the mechanical components (arrowed) of the Motor Bus's steering system. Our visual check on the various mechanical components of the steering system revealed all to be intact and in good condition. The steering system of the Motor Bus likely to be in serviceable condition at the time of accident.

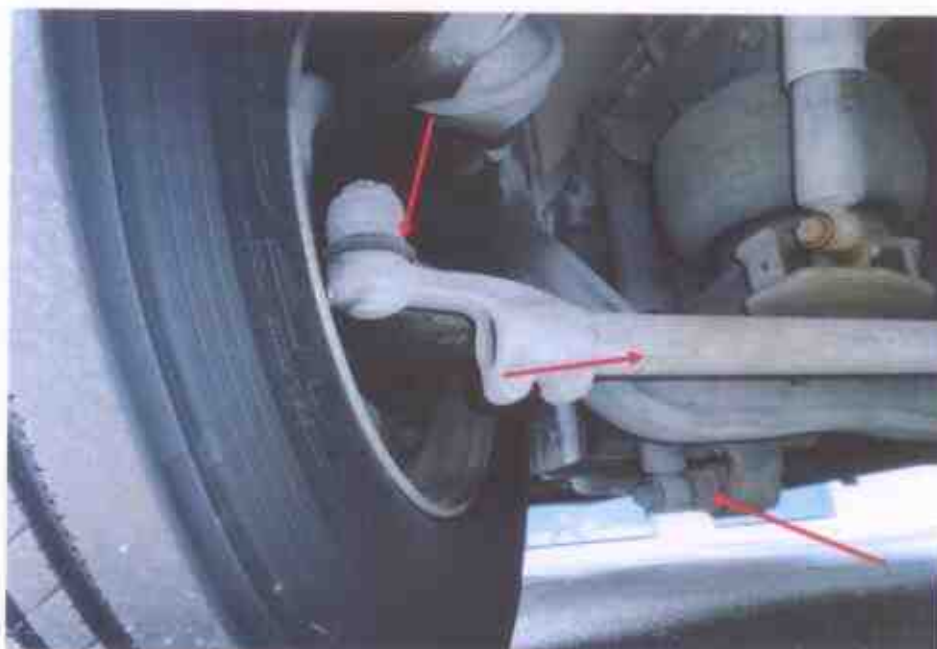
Photo 17 shows the front left wheel components of the front steering system of the Motor Bus. The various undercarriage components of the Motor Bus were all observed to be intact and without any visible damage. This had included the steering rack and steering ball joints (arrowed) of the Motor Bus, which were observed to be securely attached to the front left wheel and front right wheel.

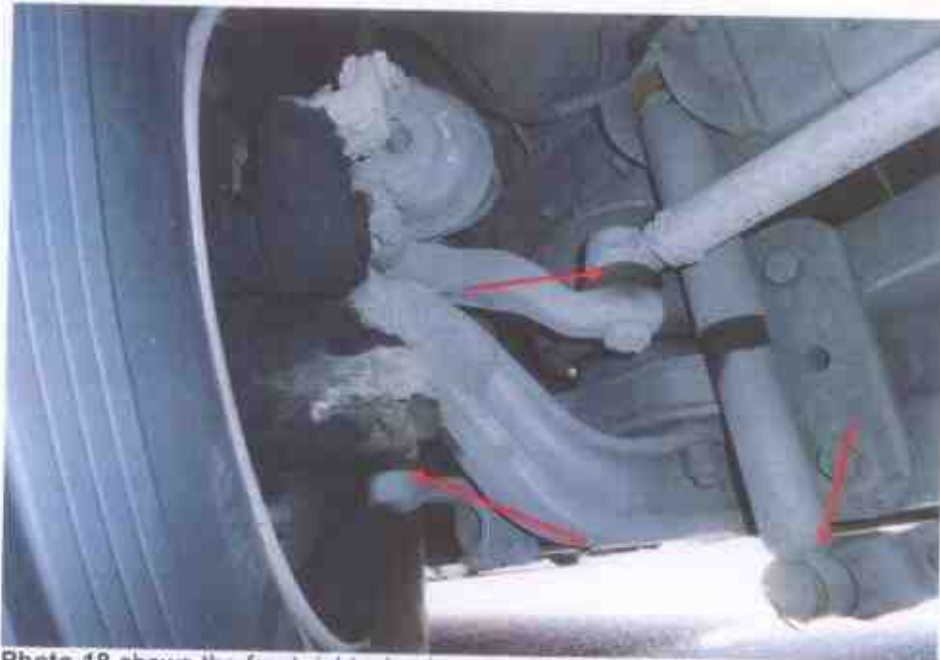
Photo 18 shows the front right wheel components of the front steering system of the Motor Bus. The various undercarriage components of the Motor Bus were all observed to be intact and without any visible damage. This had included the steering rack and steering ball joints (arrowed) of the Motor Bus, which were observed to be securely attached to the front left wheel and front right wheel.

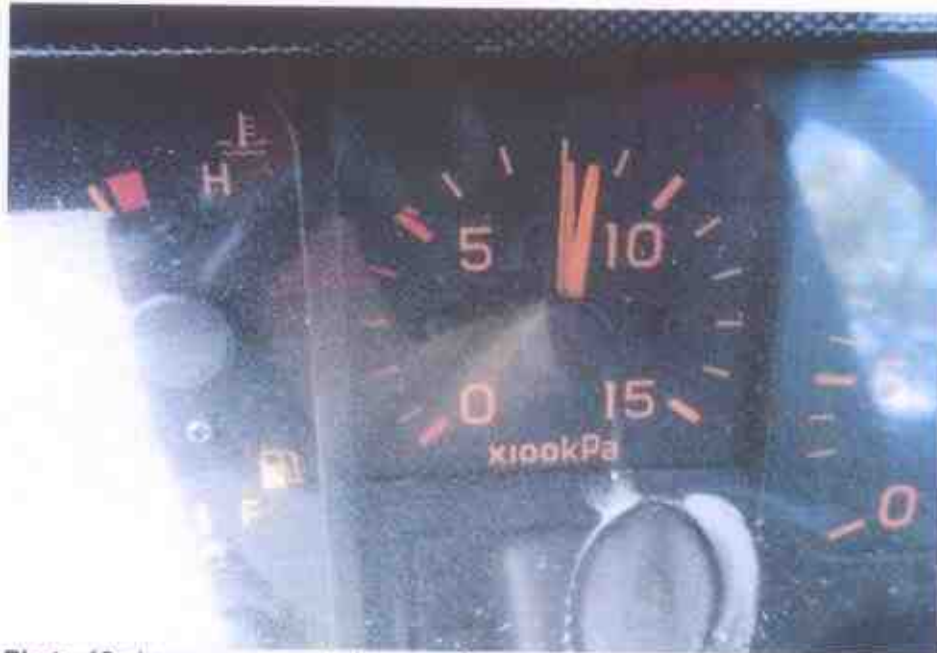
14. 2 numbers of air tanks in particular were observed to be also in serviceable condition. Air built up to the operational level which is level 8.5 (On the display panel) for both air tanks for operational ready status after a warming up session prior the operational test. Both air tanks were monitored for about 10 minutes for an observation of any abnormalities. Both air tanks pressure found to be normal without any drop in pressure during the course of our monitoring session. This would indicate that there was no leak of air pressure from the air braking system of the Motor Bus. See photo 19 below.

Photo 19 shows pressure tanks were observed to be pressurised up to 8.5bars after the engine start-up. No drop in the pressure after a few minutes which means there's no air leakage from the air-braking system.

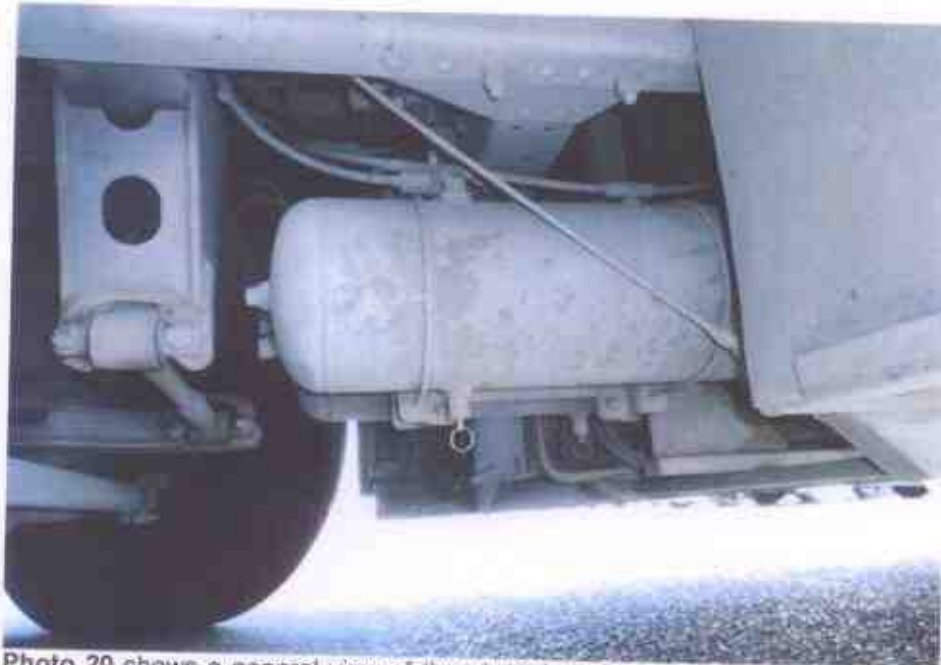
Photo 20 shows a general view of the air tank, valves, pipes and hoses, which are some of the components for the air-assisted braking system of the Motor Bus. This was at the underside of the Motor Bus's body. There were no damages observed at time of our inspection.

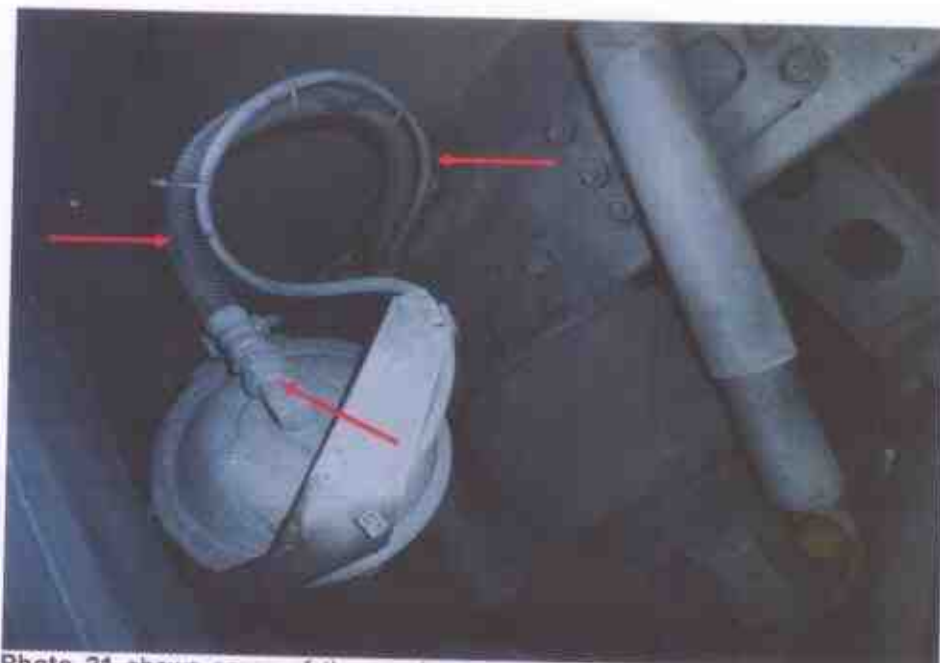
Photo 21 shows some of the mechanical components (arrowed) of the Motor Bus's braking system (including hoses). Our visual check on the various mechanical components reveals all to be intact and in good condition. It was in serviceable condition at the time of accident.

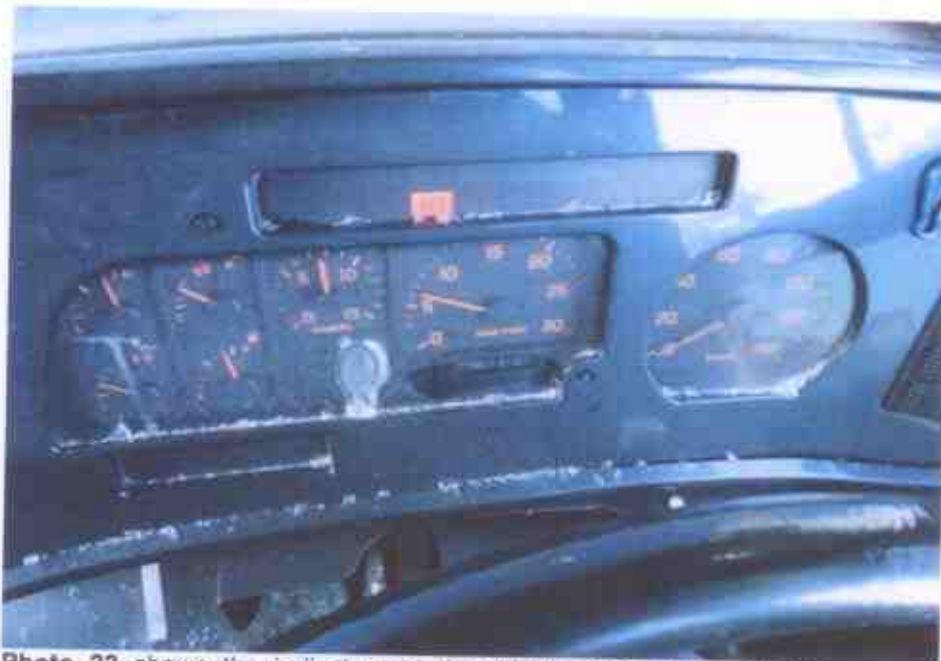
Photo 22 shows the indicators at the driver's seat, these systems were in working condition. This can be established from the warning lights disappearing from the instrument panel after the self-test.

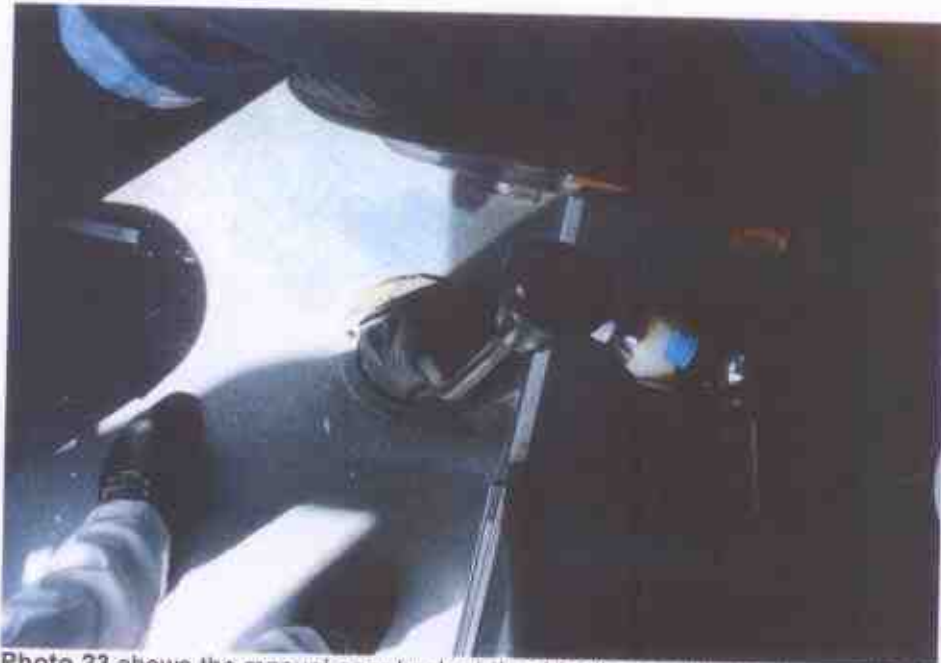
Photo 23 shows the manual gear knob at the driver's seat. It was observed to be unaffected by the accident's collision. Hence enabling an operational test to be conducted via activating the gear knob.

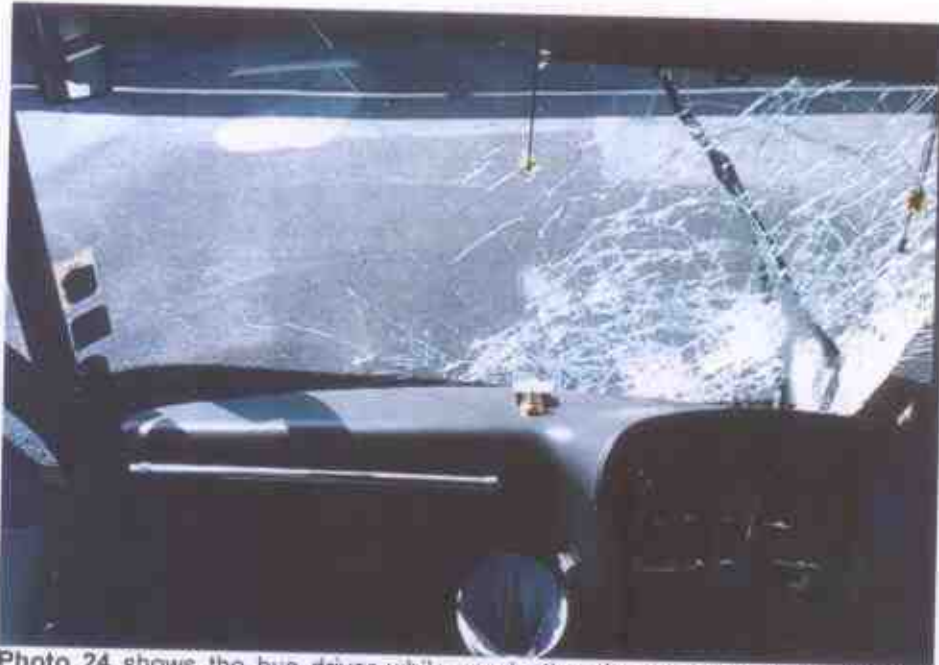
Photo 24 shows the bus driver while conducting the operational test. He was able to steer to the fullest left & right, moving forward, reverse and stop successfully at time of the operational test.

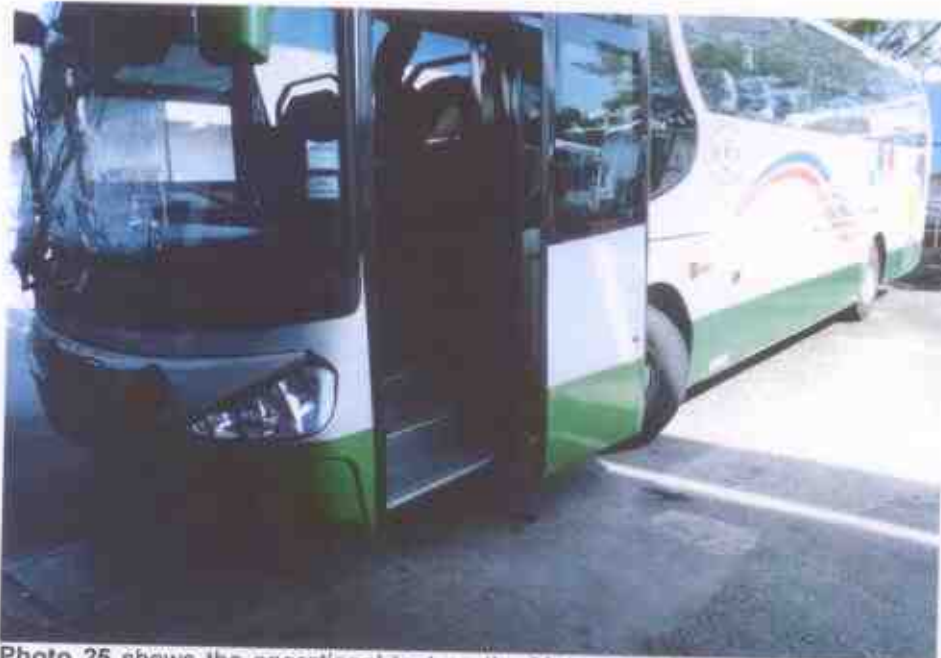
Photo 25 shows the operational test on the Motor Bus. The driver was able to move the Motor Bus forward, backward, turning left & right & stopping without any abnormalities.
