Your Ref: TP/IP/48837/2018
Our Ref : CI/TPD18016726/Z

09th January 2019

Fatal Accident Investigation Team

MECHANICAL INSPECTION REPORT OF TIPPER TRUCK XE 694L

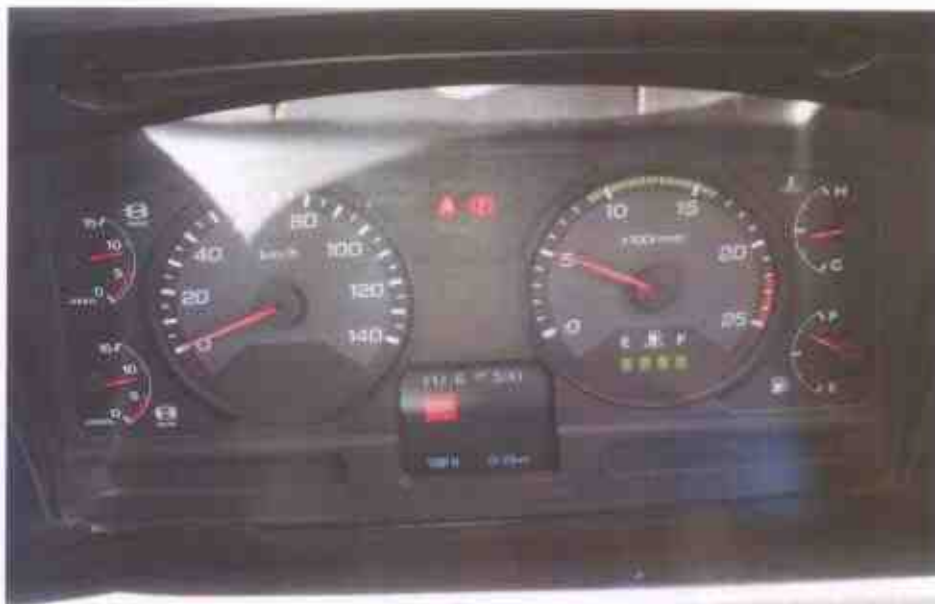
4. The mileage of the Tipper Truck at the time of our inspection was not recorded due to the malfunctioning of the selector button to switch to the ODO meter for overall distance meter reading.

Photo 1 shows the mileage of the Tipper Truck at the time of our inspection was not recorded due to the malfunctioning of the selector button to switch to the ODO meter for overall distance meter reading.

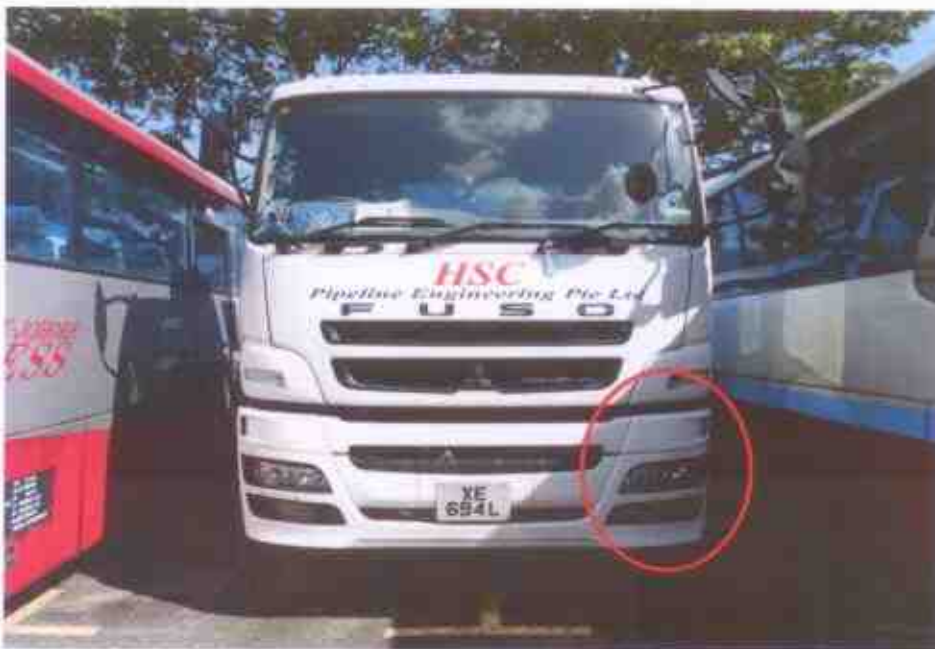
5. The Tipper Truck was observed to have sustained minor impact at its front left bumper. Only minor scratch marks was observed on the front left bumper as a result of the accident.

Photo 2 shows a general view of the front portion of the Tipper Truck at the time of our inspection. The Tipper Truck was observed to have sustained minor impact at its front left bumper. Only stain marks was observed on the front left bumper as a result of the accident.

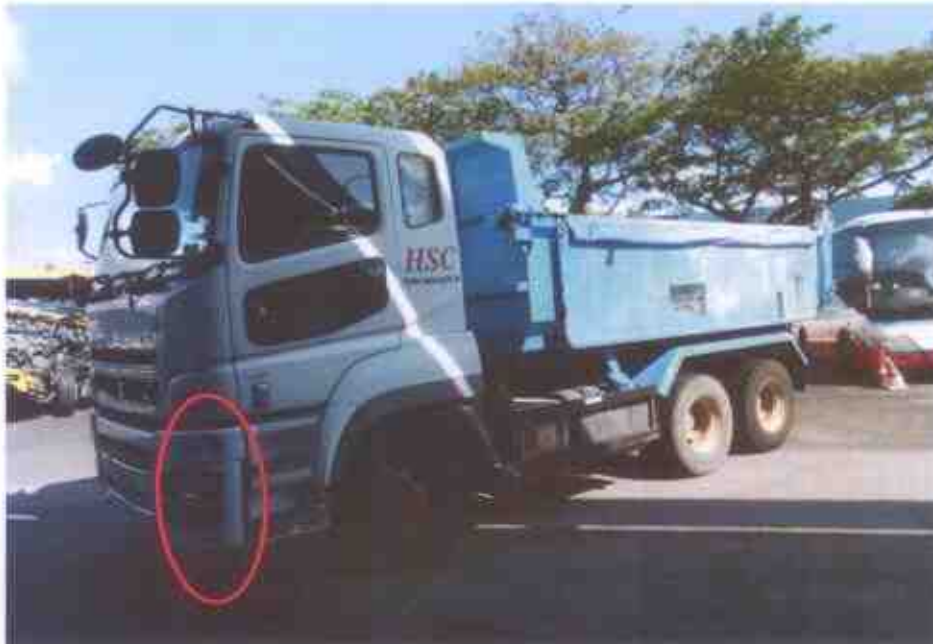
Photo 3 shows a general view of the front portion of the Tipper Truck at the time of our inspection. The Tipper Truck was observed to have sustained minor impact at its front left bumper. Only stain marks was observed on the front left bumper as a result of the accident.

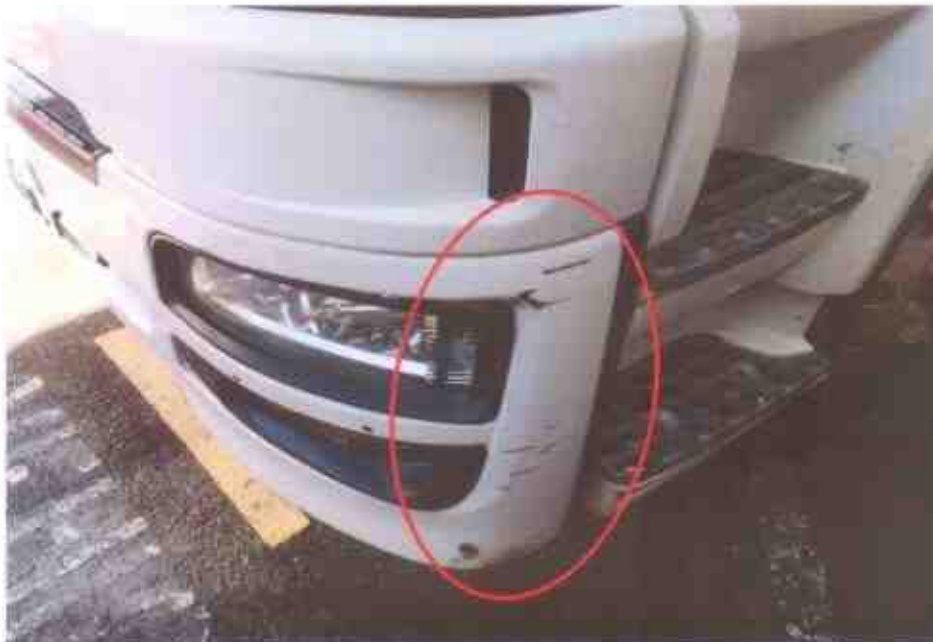
Photo 4 shows a minor stain mark on the front left side bumper as a result of the accident.

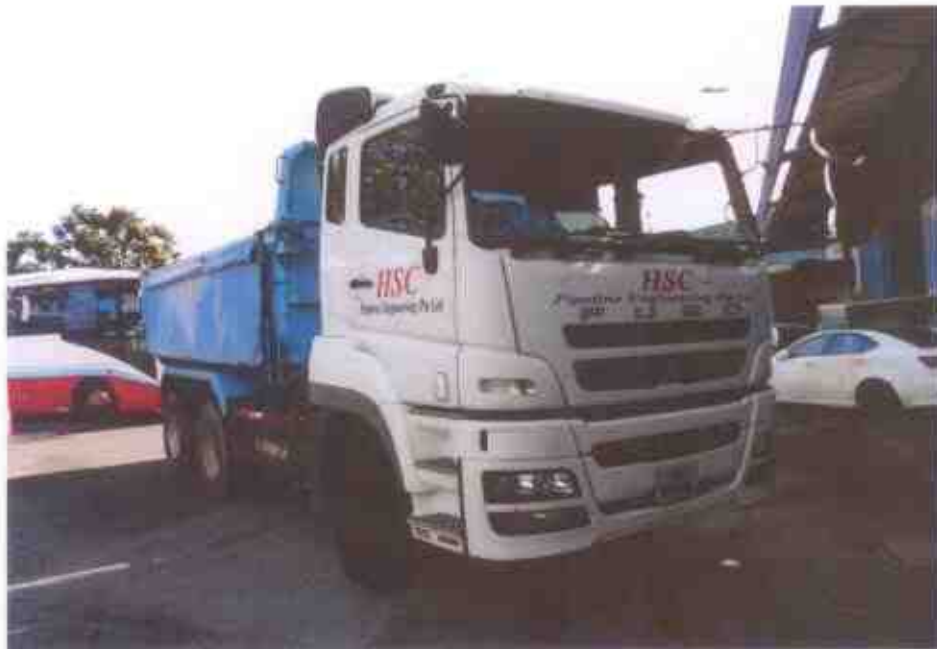
Photo 5 shows a general view of the front right portion of the Tipper Truck at the time of our inspection. The Tipper Truck was observed to be in good condition unaffected by the accident.

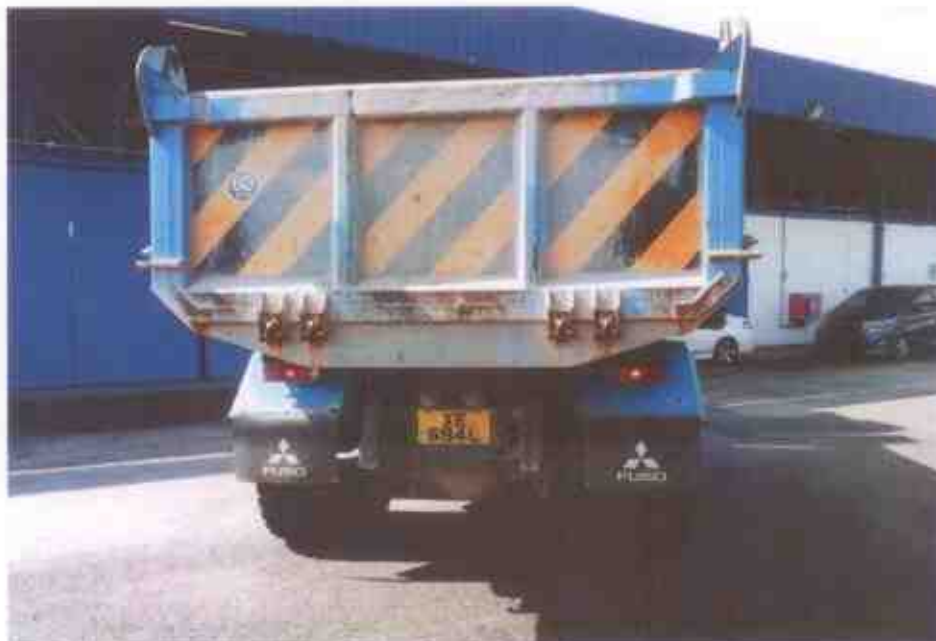
Photo 6 shows a general view of the Tipper Truck's rear body at the time of our inspection. There was no damage found to the rear portion of the Tipper Truck.

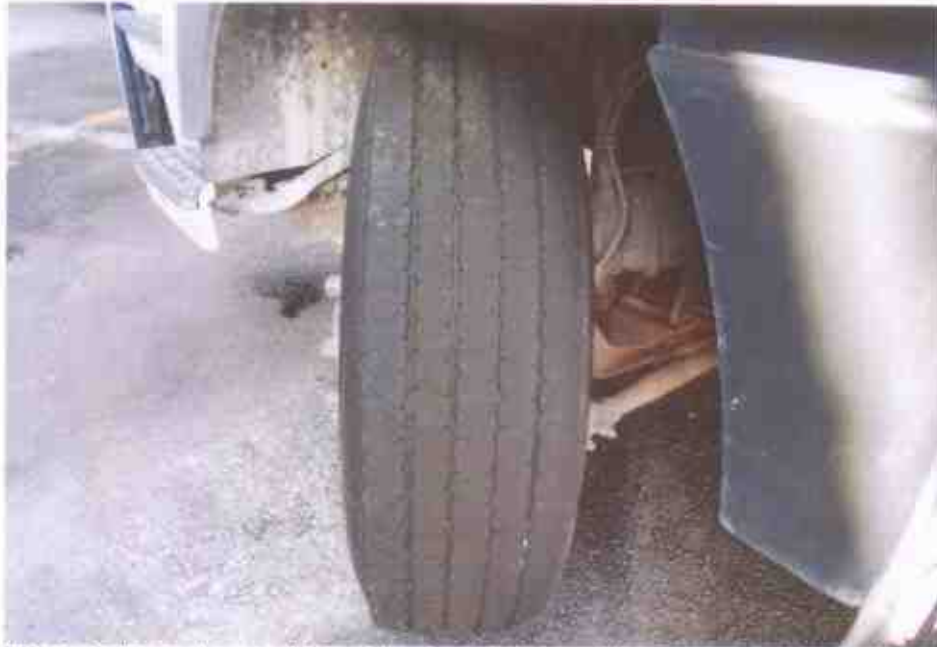
Photo 7 shows the condition of the front left tyre of the Tipper Truck, which was observed to be in serviceable condition with remaining tread depth of approximately 6mm. The tyre, which was wrapped around standard alloy wheel rim, was also observed to be sufficiently inflated for vehicular operation.

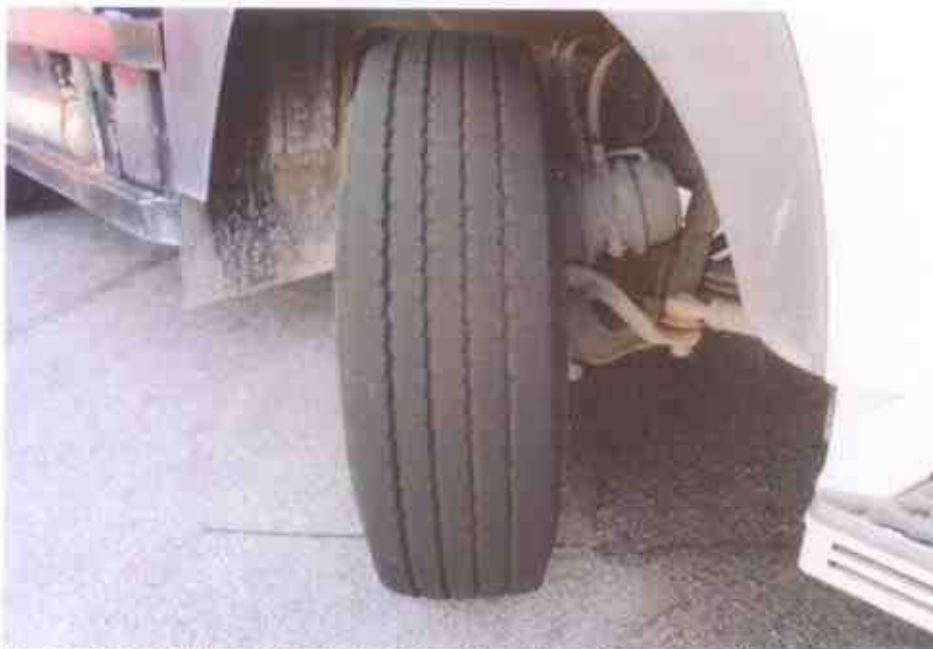
Photo 8 shows the condition of the front right tyre of the Tipper Truck, which was observed to be in serviceable condition with remaining tread depth of approximately 7mm. The tyre, which was wrapped around standard alloy wheel rim, was also observed to be sufficiently inflated for vehicular operation.

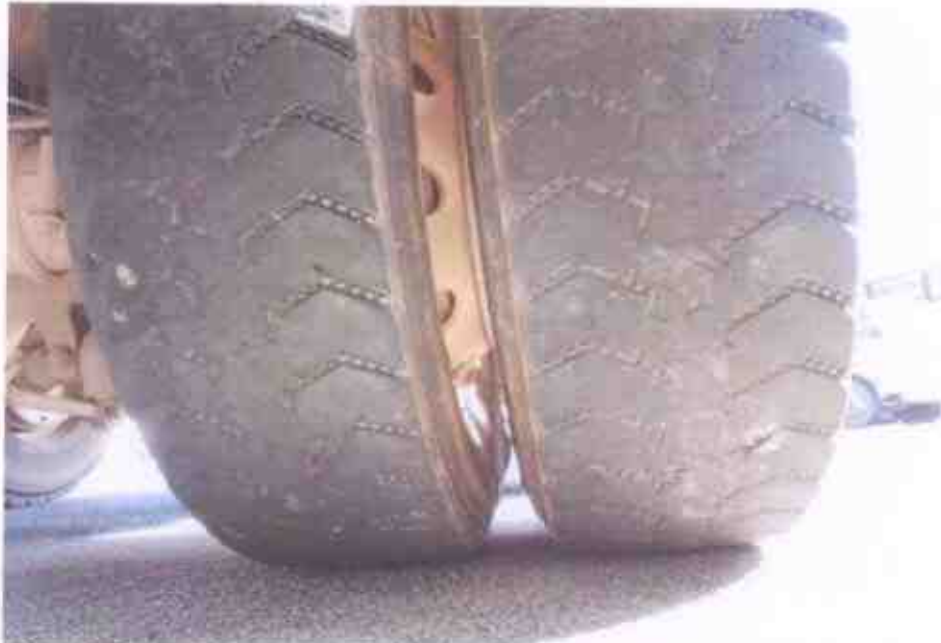
Photo 9 shows the condition of the centre left tyres of the Tipper Truck, which was observed to be in serviceable condition with remaining tread depth of approximately 3mm. The tyres, which were wrapped around standard alloy wheel rim, were also observed to be sufficiently inflated for vehicular operation.

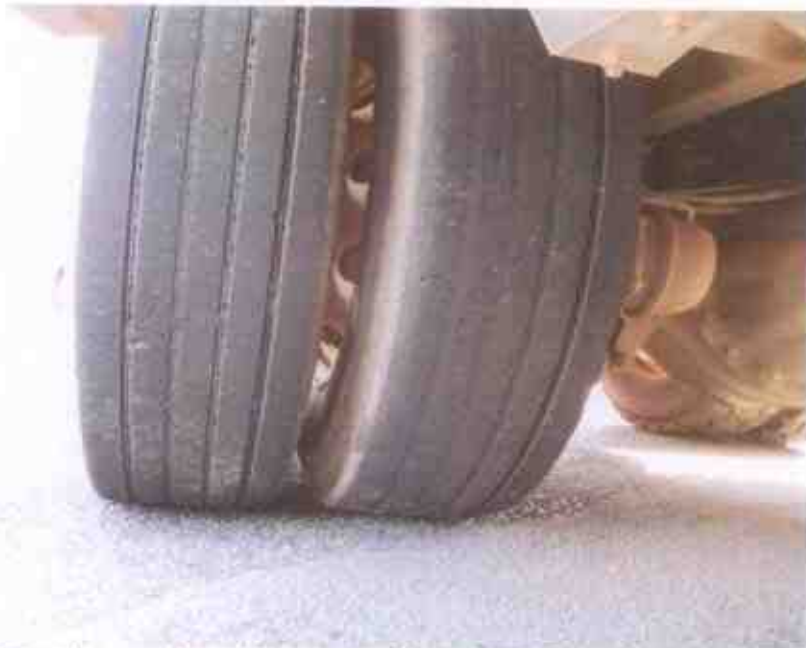
Photo 10 shows the condition of the centre right tyres of the Tipper Truck, which were observed to be in serviceable condition with remaining tread depth of approximately 4mm.

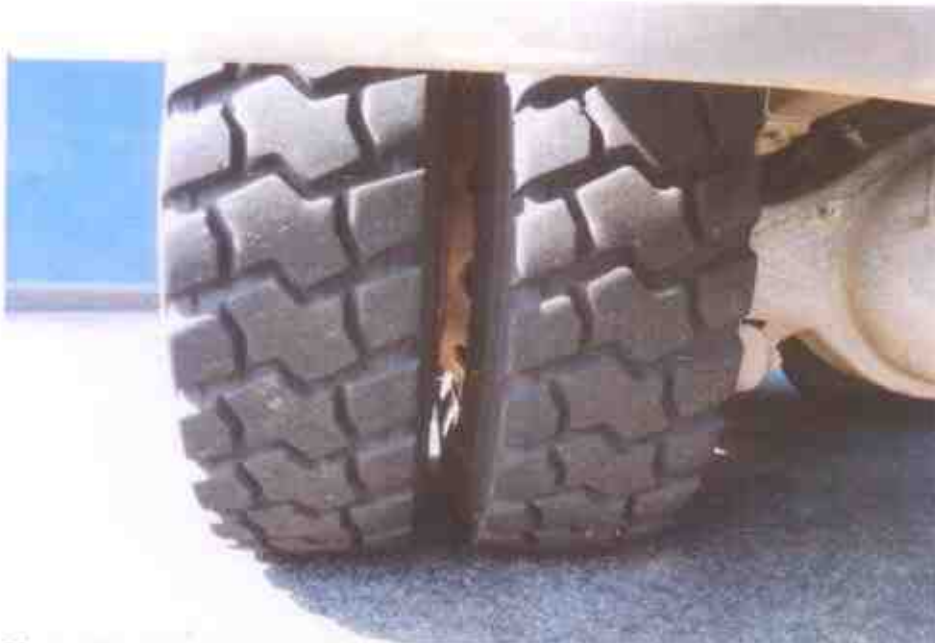
Photo 11 shows the condition of the rear left tyres of the Tipper Truck, which was observed to be in serviceable condition with remaining tread depth of approximately 9mm. The tyres, which were wrapped around standard alloy wheel rim, were also observed to be sufficiently inflated for vehicular operation.

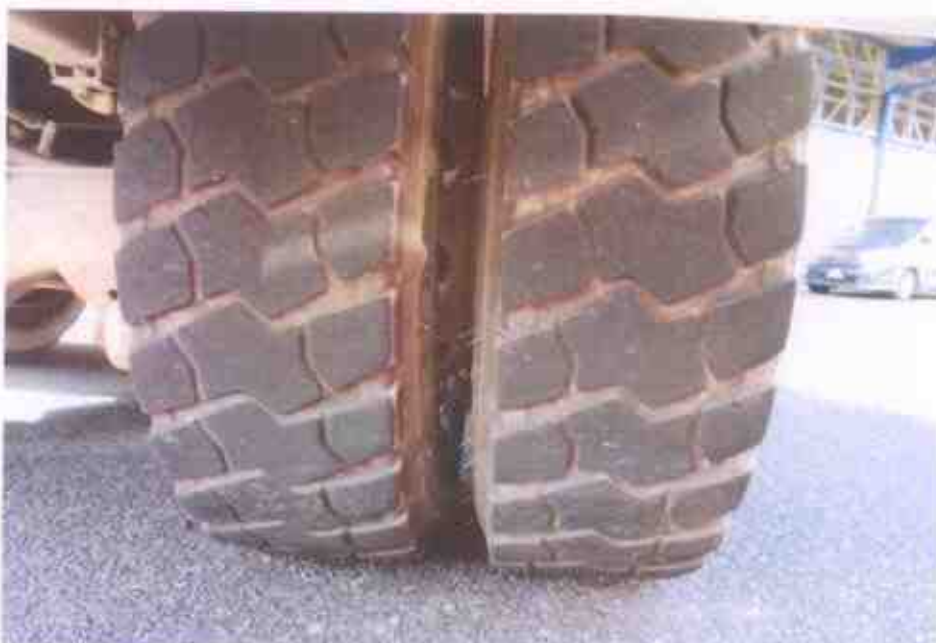
Photo 12 shows the condition of the rear right tyres of the Tipper Truck, which were observed to be in serviceable condition with remaining tread depth of approximately 8mm.

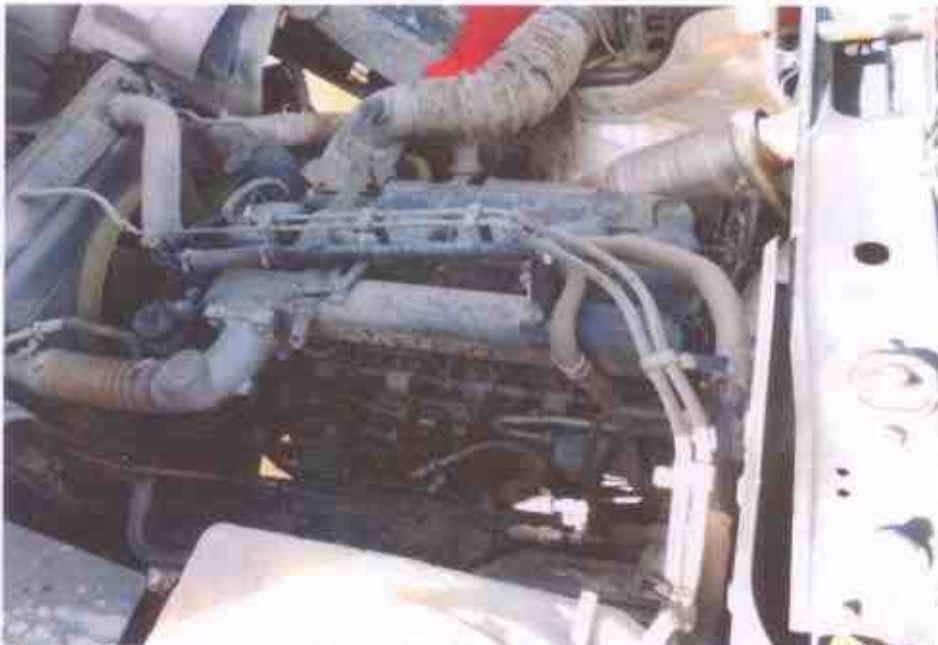
Photo 13 shows a general view of the Tipper Truck's engine compartment, which was accessed by lifting the front cabin of the Tipper Truck. The various parts and components inside the engine compartment were unaffected by the accident. There was also no sign(s) or indication(s) of fresh fluid leakage and/or fluid stain within the engine.

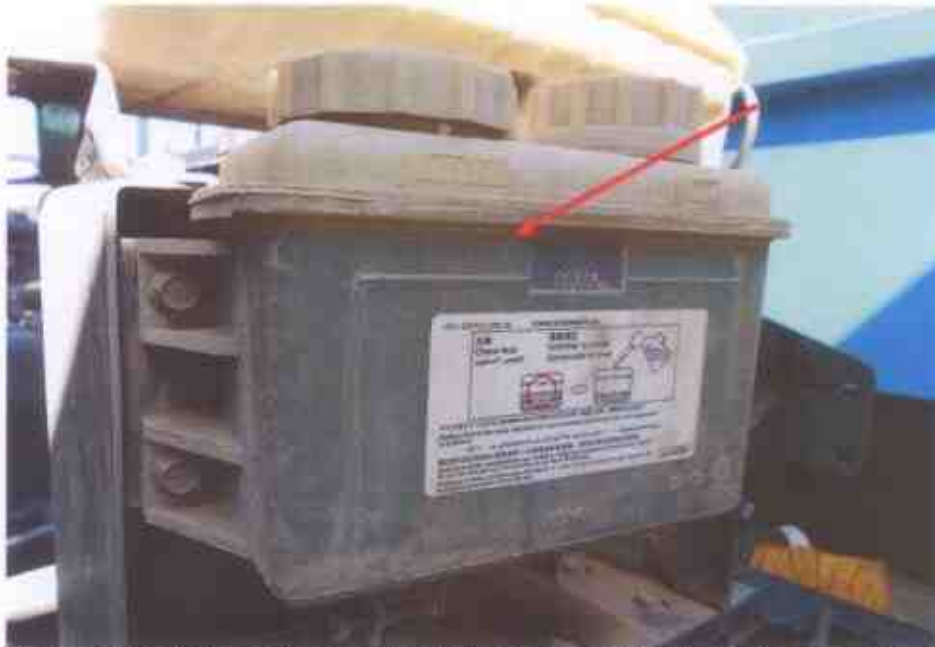
Photo 14 shows the power steering fluid reservoir of the Tipper Truck at the time of our inspection. It was observed to be of sufficient level and without any visible contamination (arrowed).

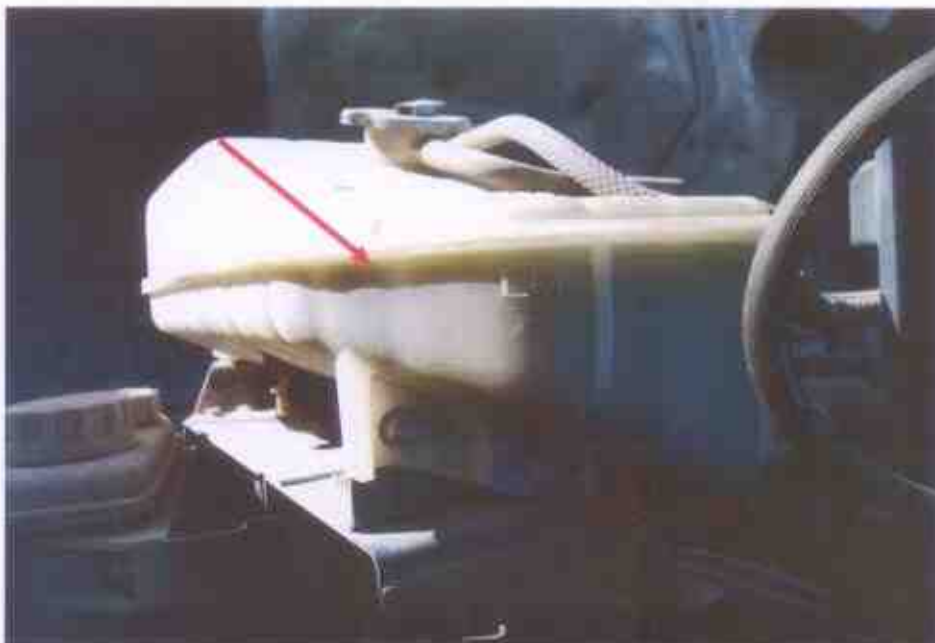
Photo 15 shows the engine coolant reservoir of the Tipper Truck at the time of our inspection. The engine coolant was observed to be of sufficient level and without any visible contamination (arrowed).

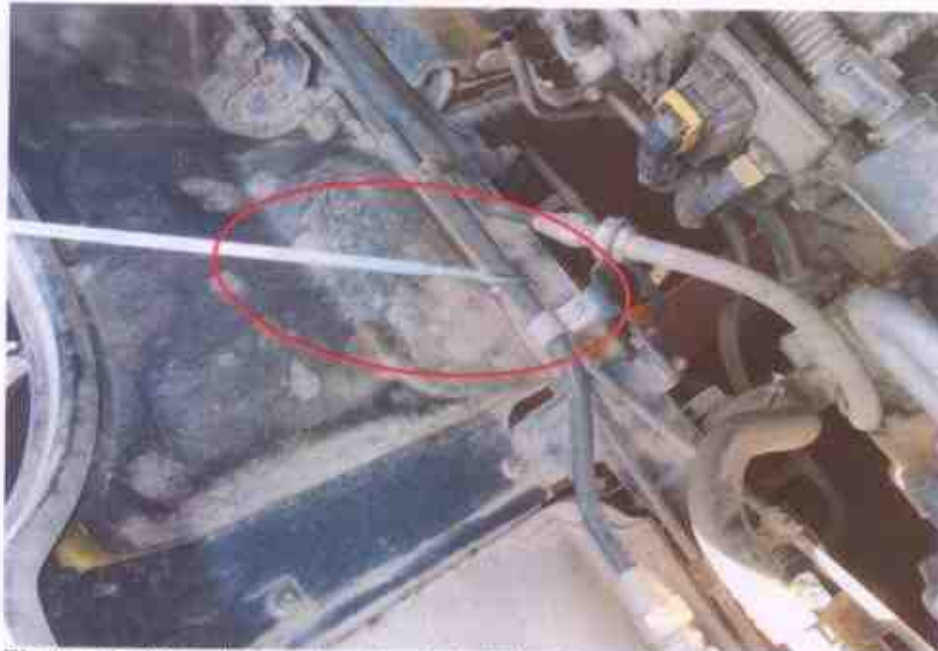
Photo 16 shows the engine dip stick of the Tipper Truck at the time of our inspection. The engine oil was observed to be of sufficient level and without any visible contamination (circled).

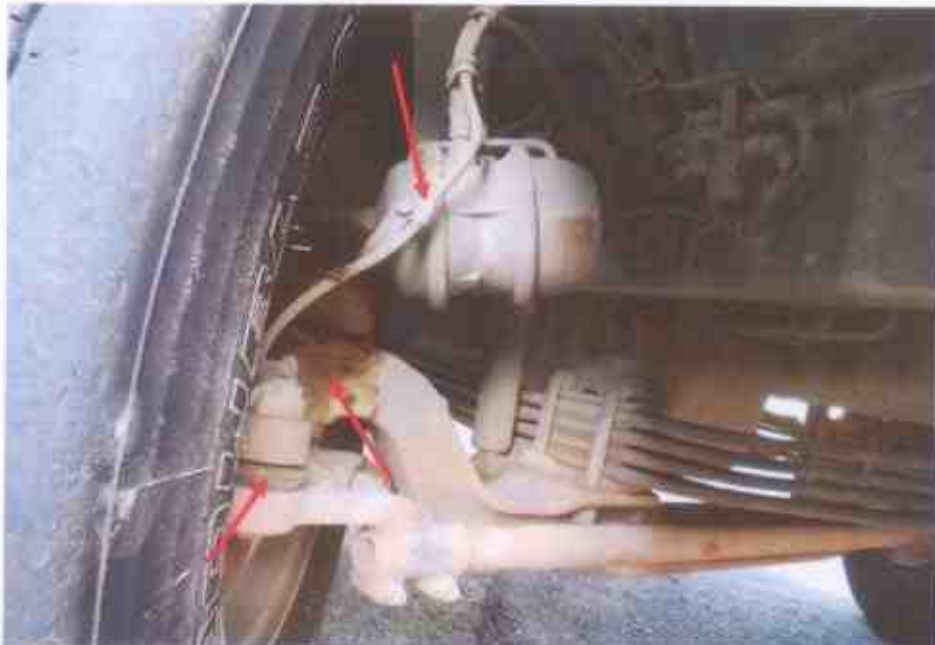
Photo 17 shows the various undercarriage components at the front left wheel of the Tipper Truck, in particular the steering tie rod end (arrowed). The various undercarriage components of the Tipper Truck were all found to be intact without any visible damage. There was also no sign of fluid stain(s) observed on the various undercarriage components.

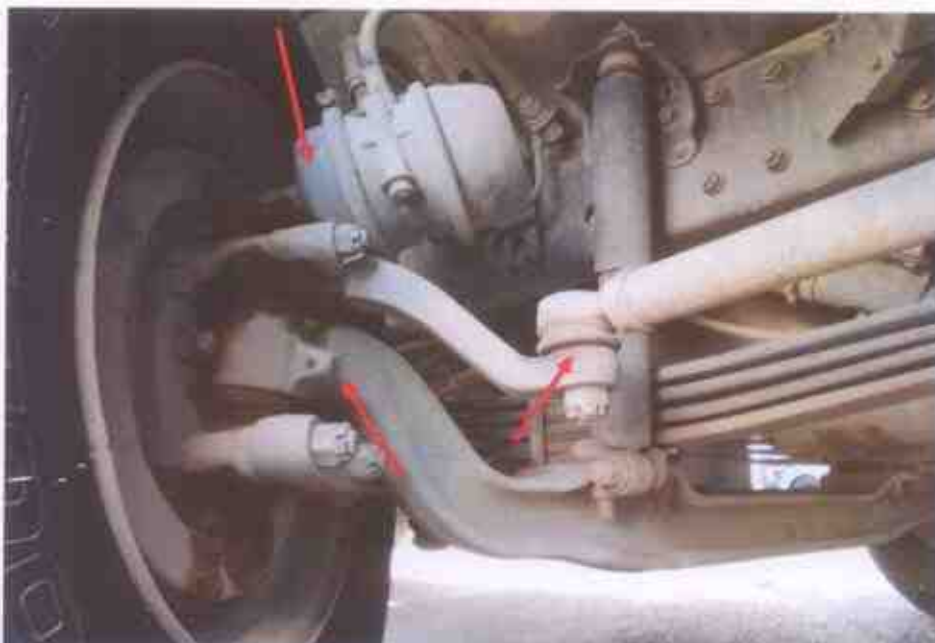
Photo 18 shows the various undercarriage components at the front right wheel of the Tipper Truck, in particular the steering tie rod end (arrowed). The various undercarriage components of the Tipper Truck were all found to be intact without any visible damage. There was also no sign of fluid stain(s) observed on the various undercarriage components.

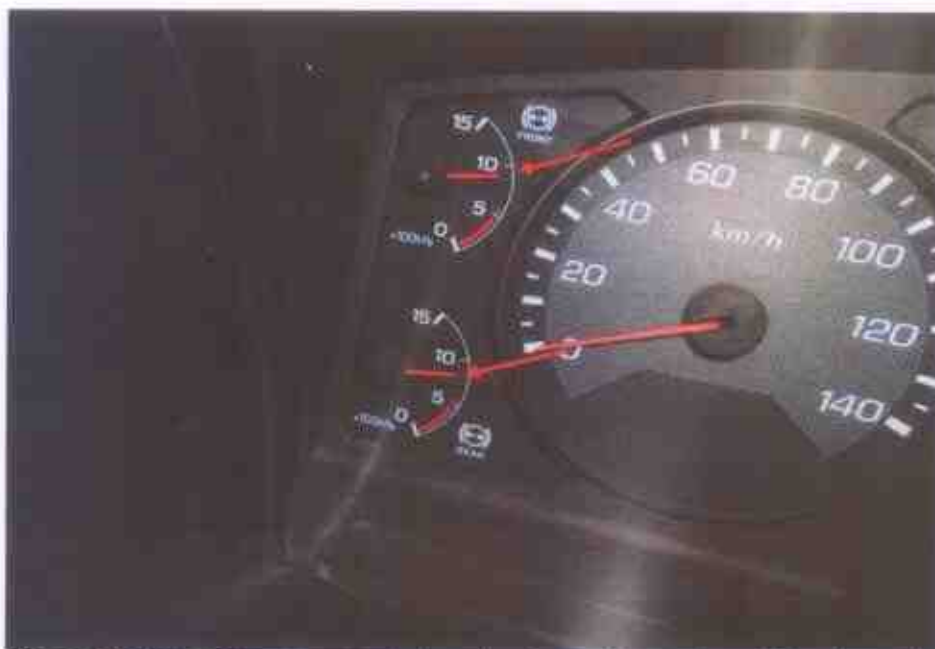
15. 2 numbers of air tanks in particular were observed to be also in serviceable condition. Air built up to an acceptable level which is level 9 (On the display panel) for both air tanks for operational ready status after a warming up session prior the operational test. Both air tanks were monitored for about 10 minutes for an observation of any abnormalities. Both air tanks pressure found to be normal without any drop in pressure during the course of our monitoring session. This would indicate that there was no leak of air pressure from the air braking system of the Tipper Truck. See photo 19 below.

Photo 19 shows the compressed air meters for braking system. This shows that there's no dropped of pressure. Hence, revealed that no air leakage at the time of our inspection.

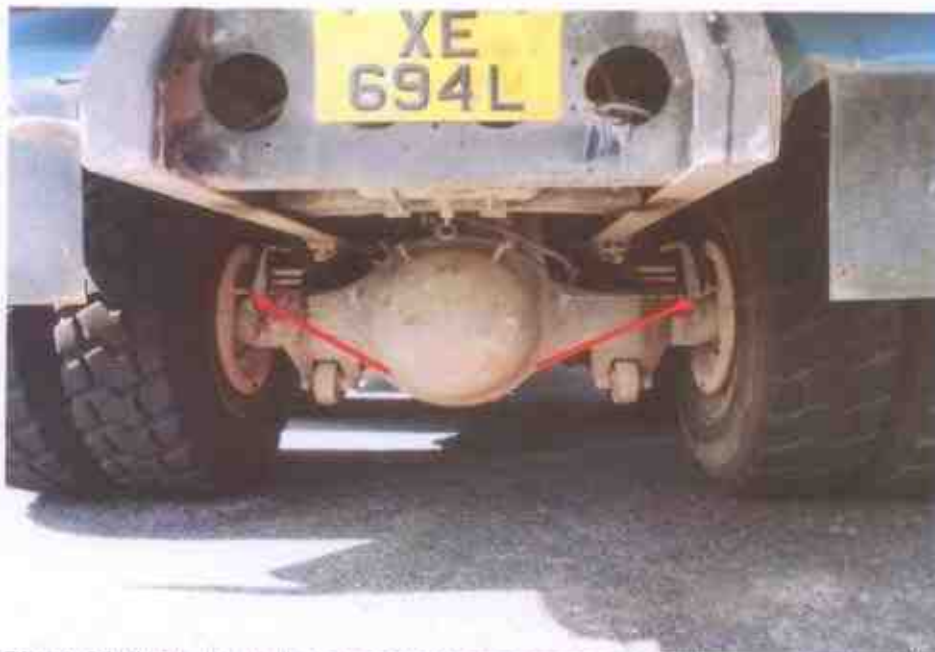
Photo 20 shows the various undercarriage components at the rear wheels of the Tipper Truck. There was no sign(s) of brake fluid leakage along the brake hoses and brake pipes.

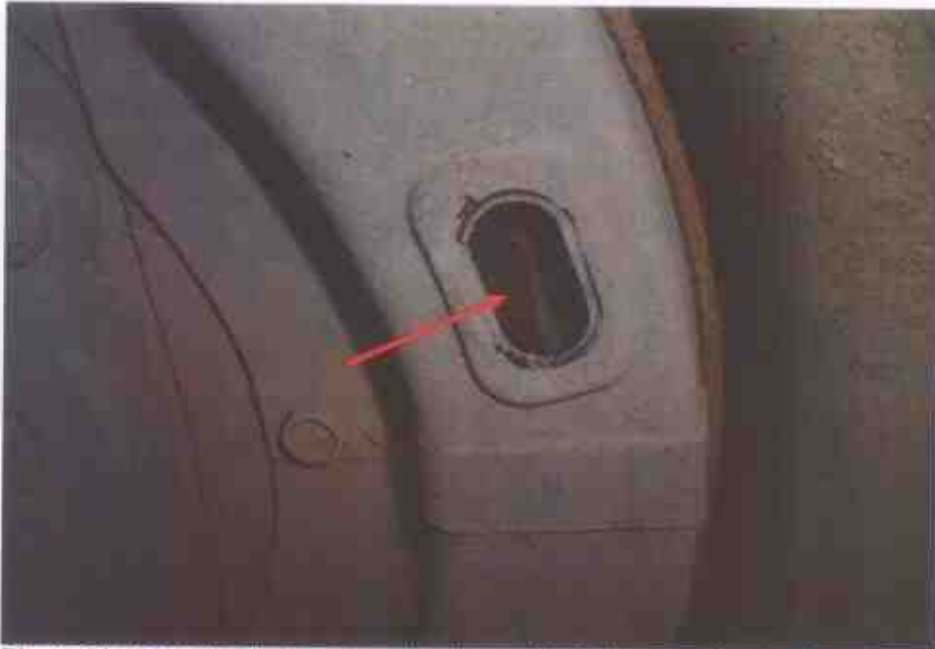
Photo 21 shows the brake shoes (brake pads) at the rear wheels of the Tipper Truck revealed that the brake shoes (brake pads) were in serviceable condition with sufficient frictional material for operational purposes.

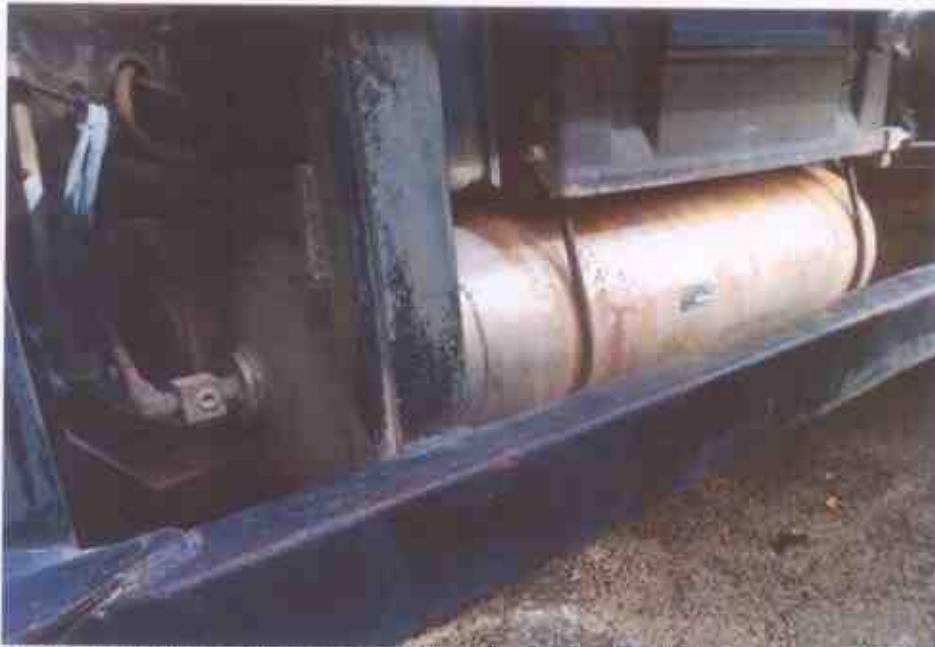
Photo 22 shows the air pressure tank of the Tipper Truck. It was observed to be unaffected by the accident. No air leakage was found at time of our inspection.

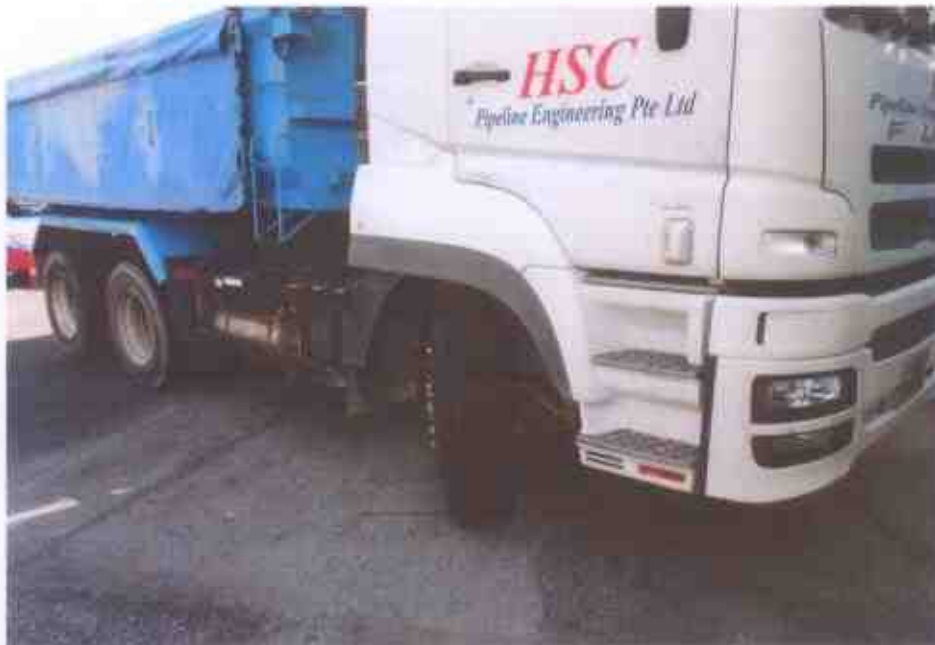
20. During the operational test, the various transmission gears of the Tipper Truck were able to be engaged without any difficulty by stepping on the clutch pedal and manually shifting the gear lever. There were no abnormal sound heard and/or abnormal behaviour of the Tipper Truck's engine system. It was able to move forward and backward normally. The braking system was also found to be in working condition as the Tipper Truck was able to slow down and come to a complete stop upon depressing of the brake pedal. See photo 23 below.

Photo 23 shows the operational test on the Tipper Truck. It was observed to be in serviceable condition. Operational test such as moving forward, turn left & right and also braking test on the Tipper Truck was conducted successfully.
