Your Ref: TP/IP/51609/2018
Our Ref : CI/TPD18016728/Z

Fatal Accident Investigation Team

MECHANICAL INSPECTION REPORT OF MOTOR CAR SJX 1293U

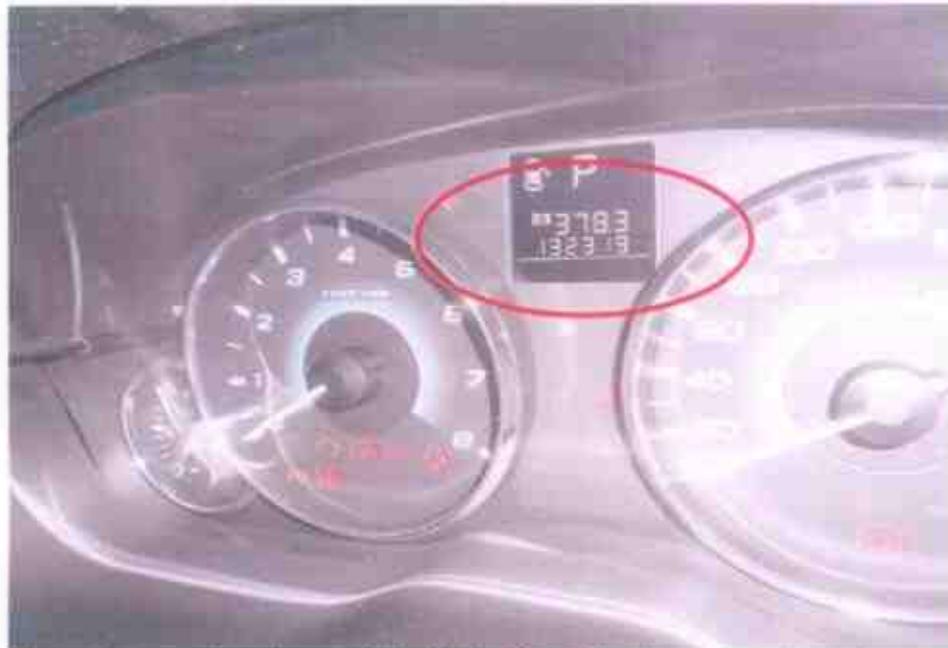
4. The mileage of the Motor Car at the time of our inspection was recorded at 132319km.
5. The Motor Car had sustained a relatively minor impact damages that was confined to its rear portion. Its rear number plate was observed to be damaged; its left bumper was buckled; its rear windshield was shattered; its rear tail lamp was cracked; its boot lid was misaligned & its rear exhaust muffler was observed to be pushed inwards due to the accident's collision impact.
6. This was likely due to the consistency of the accident's case facts that a motorcycle (FBA 2368) was travelling along BKE near 9.5 marker towards Johor Baharu Malaysia on lane 1 of a 3 lanes road. The motorcyclist had collided into the rear portion of a Motor Car (SJX 1293U) and fell to the left and landed lane 1 & 2. See photo 1 to 7 below.

Photo 1 shows the mileage of the Motor Car at the time of our inspection was recorded at 132319km.

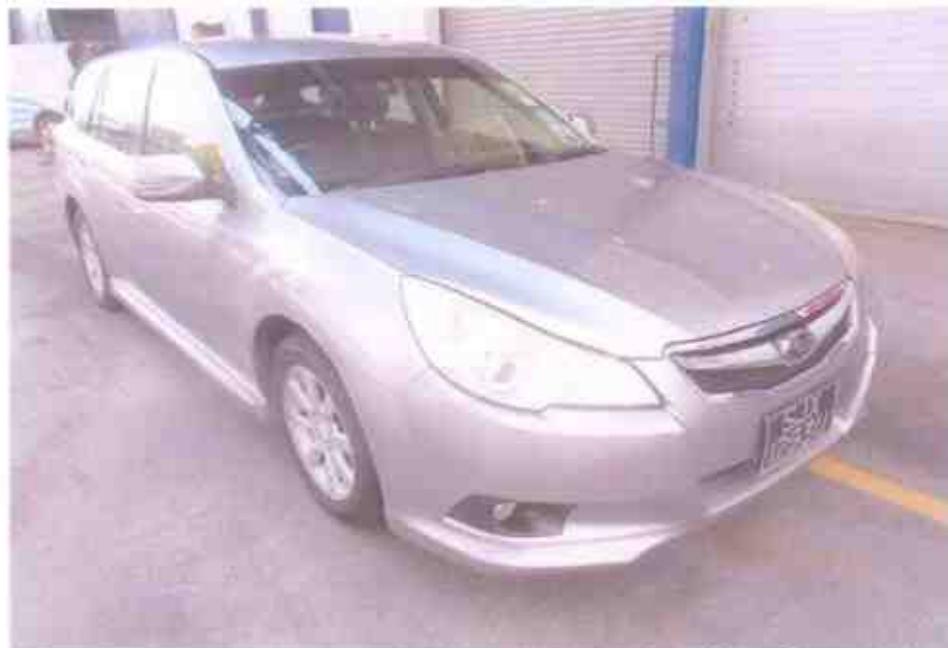
Photo 2 shows a general view of the front right body of the Motor Car at the time of our inspection. The Motor Car was observed to be in good condition unaffected by the accident.

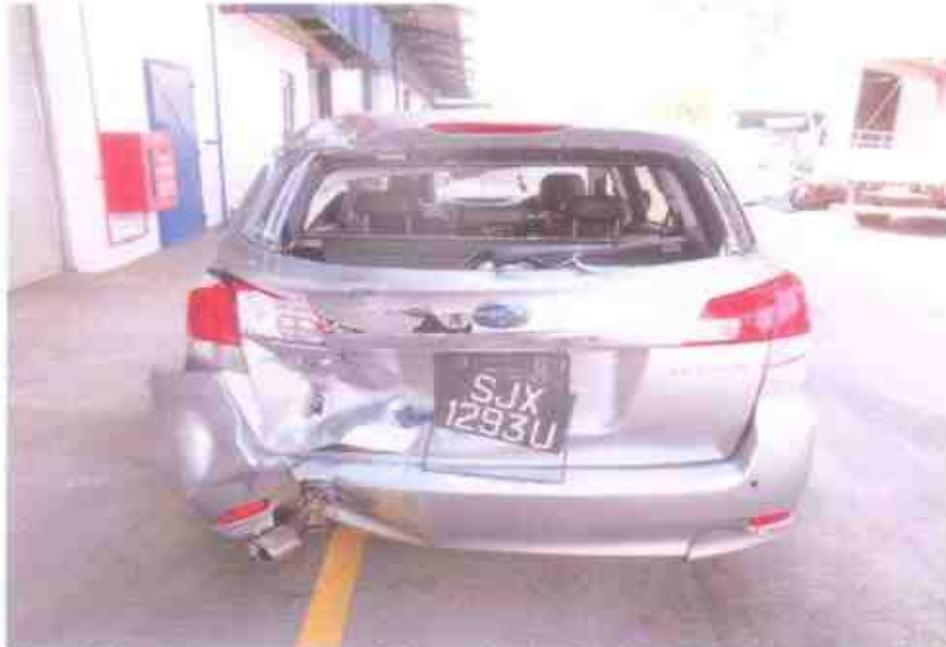
Photo 3 shows a general view of the rear body of the Motor Car at the time of our inspection. The Motor Car was observed to have sustained impact damages that were confined to its rear left portion.

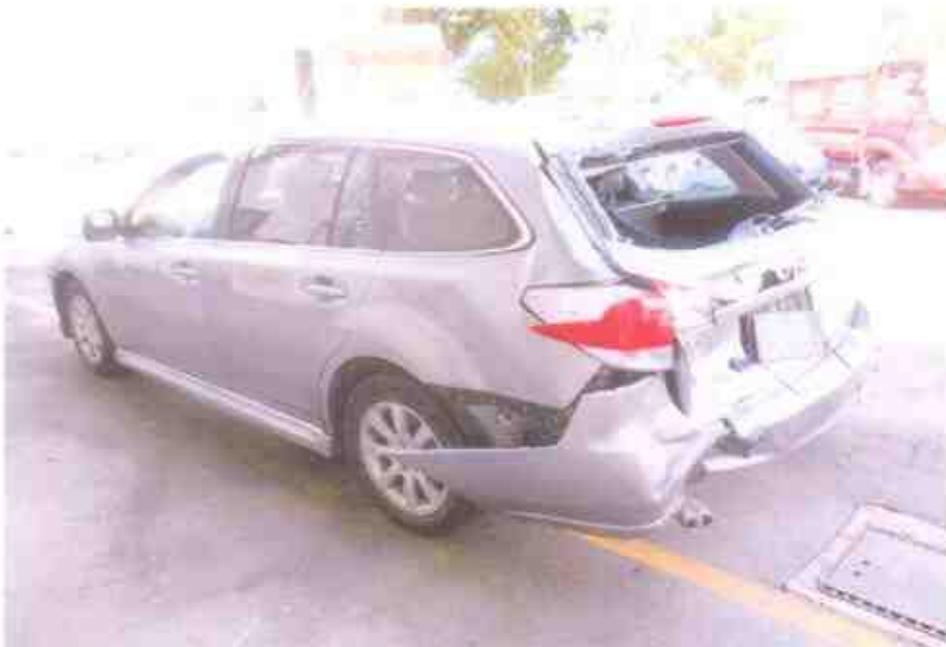
Photo 4 shows a general view of the rear left body of the Motor Car at the time of our inspection. The Motor Car was observed to have sustained impact damages that were confined to its rear left portion.

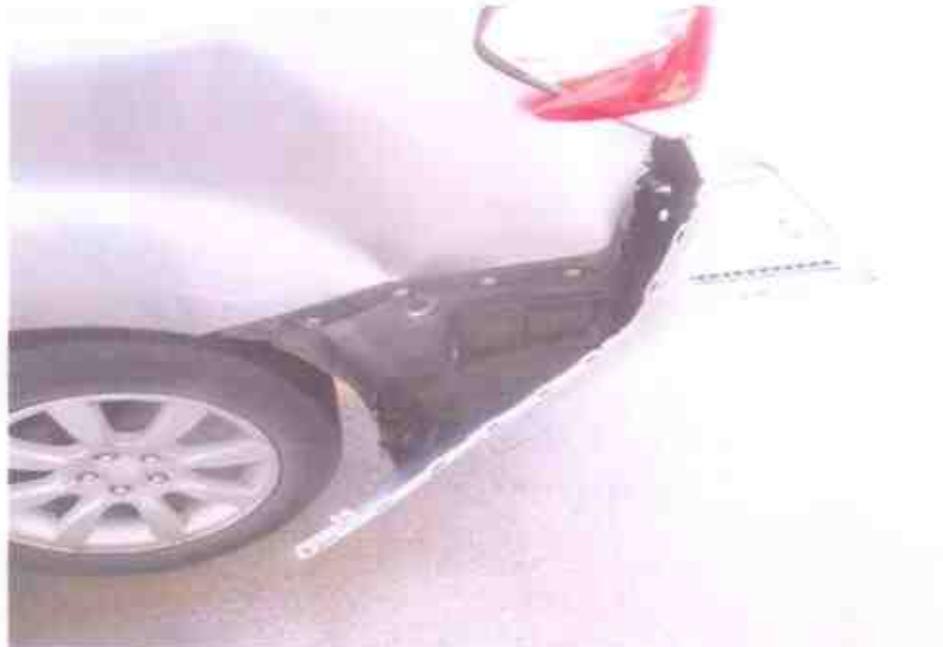
Photo 5 shows a close-up view of the dislodged rear bumper as a result of the accident.

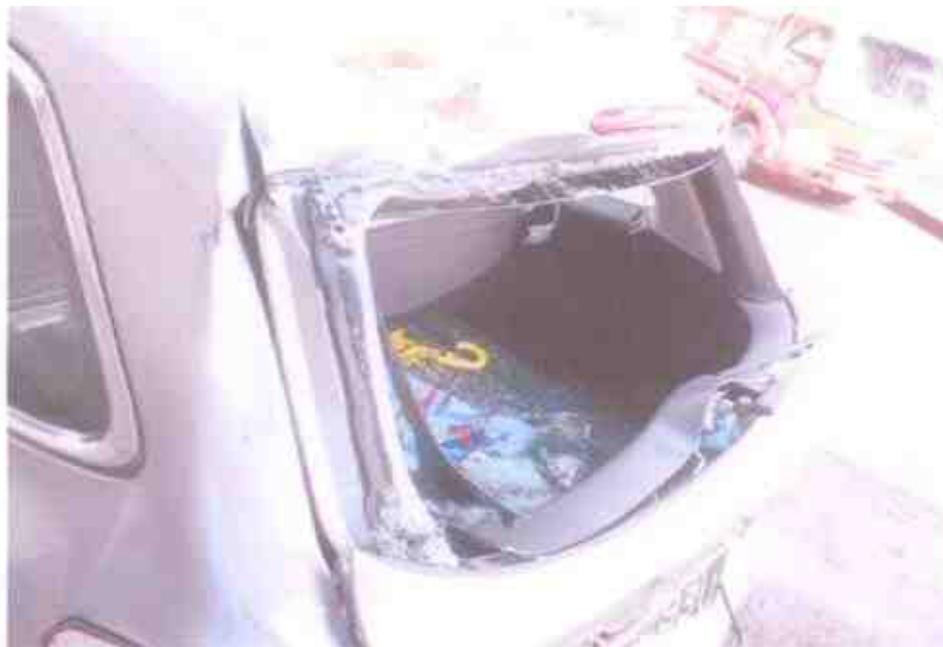
Photo 6 shows a close up view of the rear windshield that was shattered due to the accident's impact.

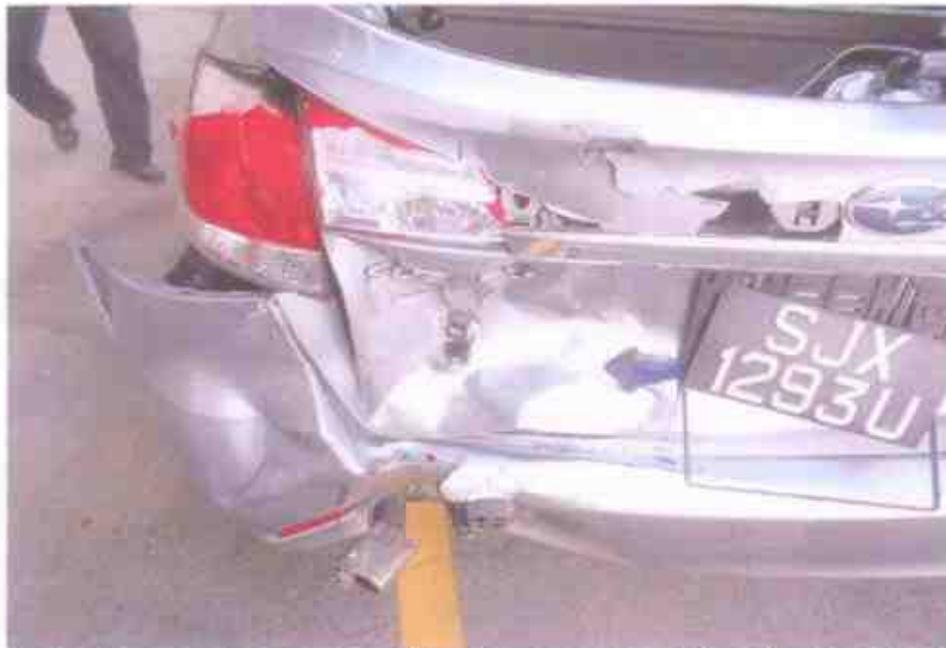
Photo 7 shows a close up view of the rear portion of the Motor Car at the time of our inspection. The Motor Car had sustained damages as a result of the accident.

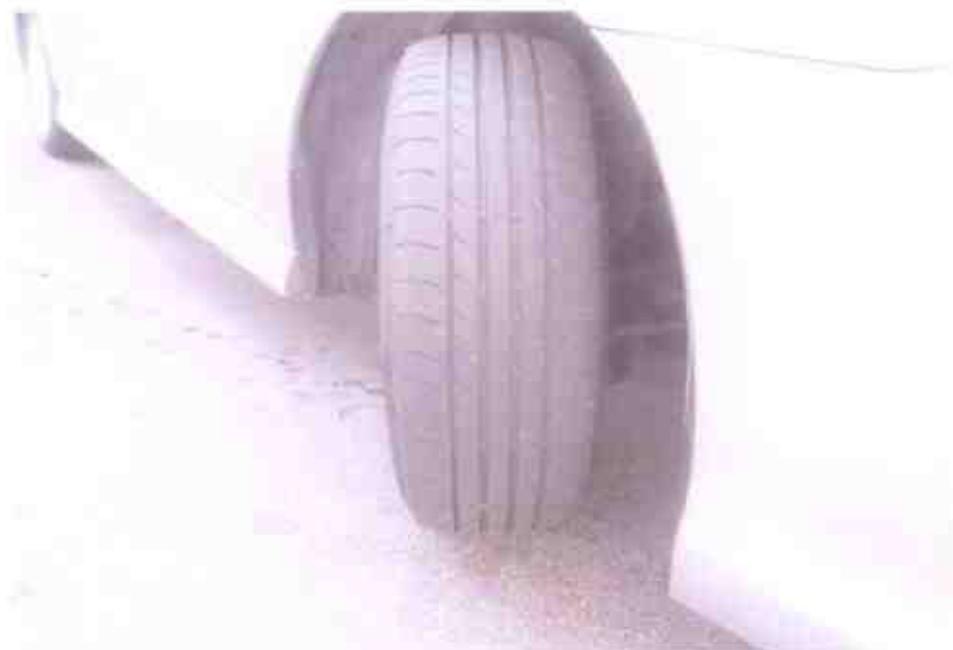
8. The 4 tyres were observed to be wrapped around alloy wheel rims that were found to be without any significant damage except for some marks of grazing nature on the wheel rims, which are commonly associated to grazing against a road kerb. See photo 8 to 11 below.

Photo 8 shows the condition of the front right tyre of the Motor Car, which was observed to be in serviceable condition with remaining tread depth of approximately 4mm. The tyre, which was wrapped around alloy wheel rim, was also observed to be sufficiently inflated for vehicular operation.

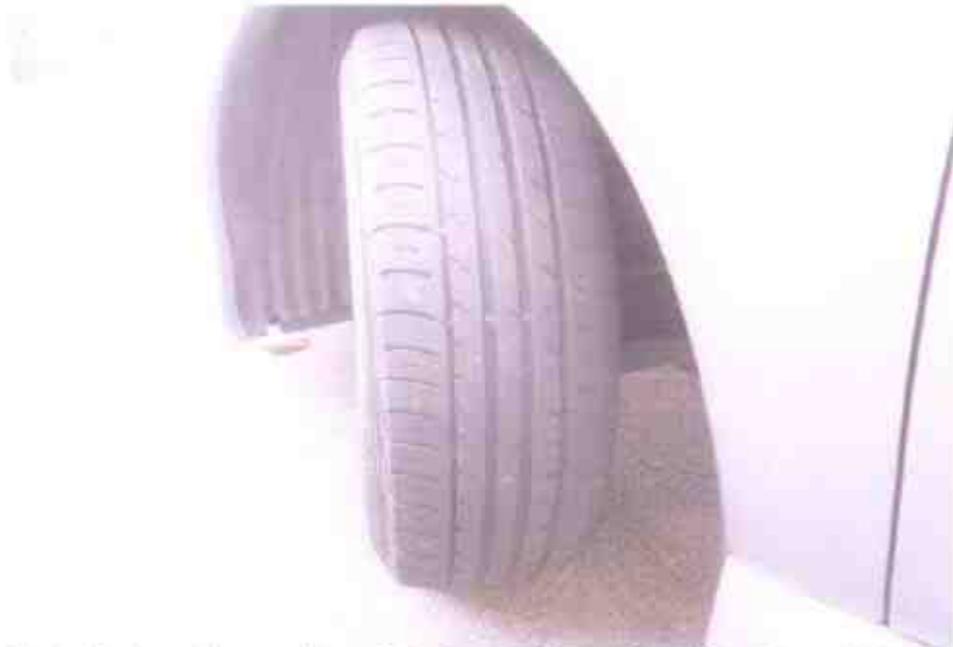
Photo 9 shows the condition of the front left tyre of the Motor Car, which was observed to be in serviceable condition with remaining tread depth of approximately 4mm. The tyre, which was wrapped around alloy wheel rim, was also observed to be sufficiently inflated for vehicular operation.

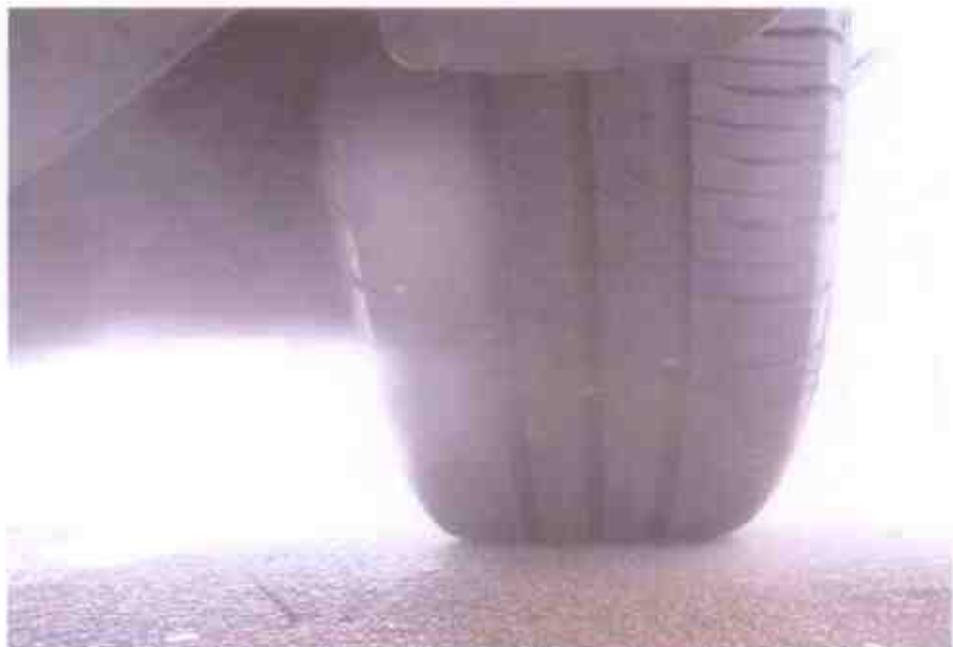
Photo 10 shows the condition of the rear left tyre of the Motor Car, which was observed to be in serviceable condition with remaining tread depth of approximately 5mm.

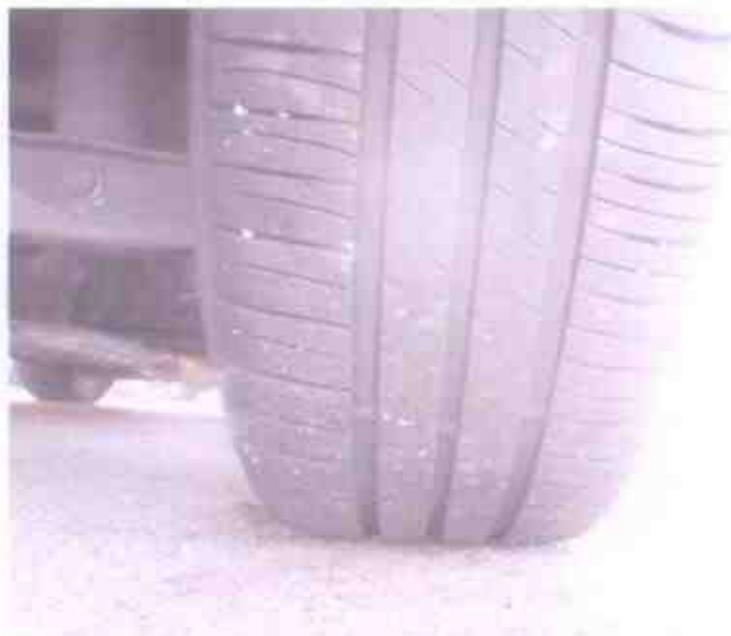
Photo 11 shows the condition of the rear right tyre of the Motor Car, which was observed to be in serviceable condition with remaining tread depth of approximately 5mm.

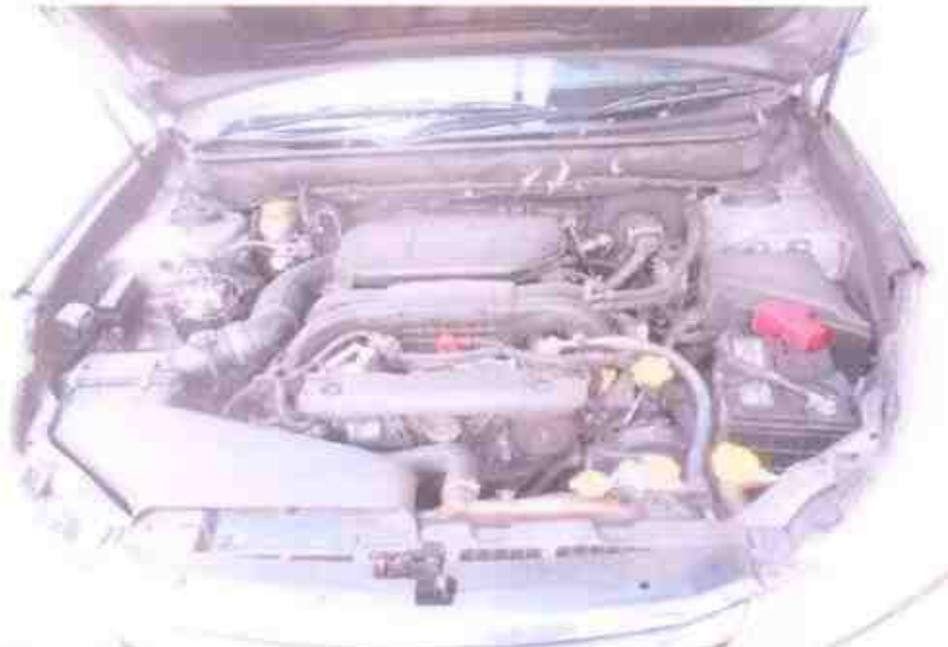
9. Upon examination of the engine compartment of the Motor Car, we had observed all the parts and components inside the engine compartment to be intact and unaffected by the accident. The brake fluid, engine oil and engine coolant were all found to be of sufficient level for operating purposes. Visually, there was also no contamination found to these fluids.
10. Further investigation of the engine compartment revealed no sign(s) or indication(s) of fluid leakage and/or fluid stain within the engine compartment of the Motor Car.
11. Our subsequent checks on the underside of the Motor Car also revealed no fluid stain. Visually, the various undercarriage components of the Motor Car were all observed to be intact and without any visible damage. See photo 12 to 15 below.

Photo 12 shows a general view of the Motor Car's engine compartment. The various parts and components inside the engine compartment were unaffected by the accident. There was also no sign(s) or indication(s) of fresh fluid leakage and/or fluid stain within the engine compartment.

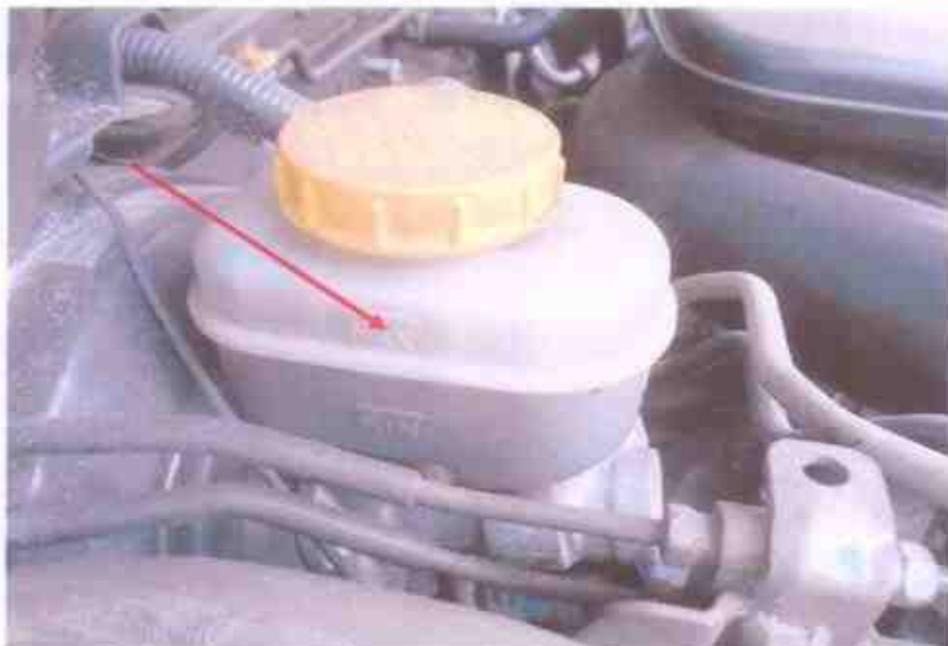
Photo 13 shows the brake fluid reservoir of the Motor Car at the time of our inspection. The brake fluid was observed to be of sufficient level (arrowed) and without any visible contamination.

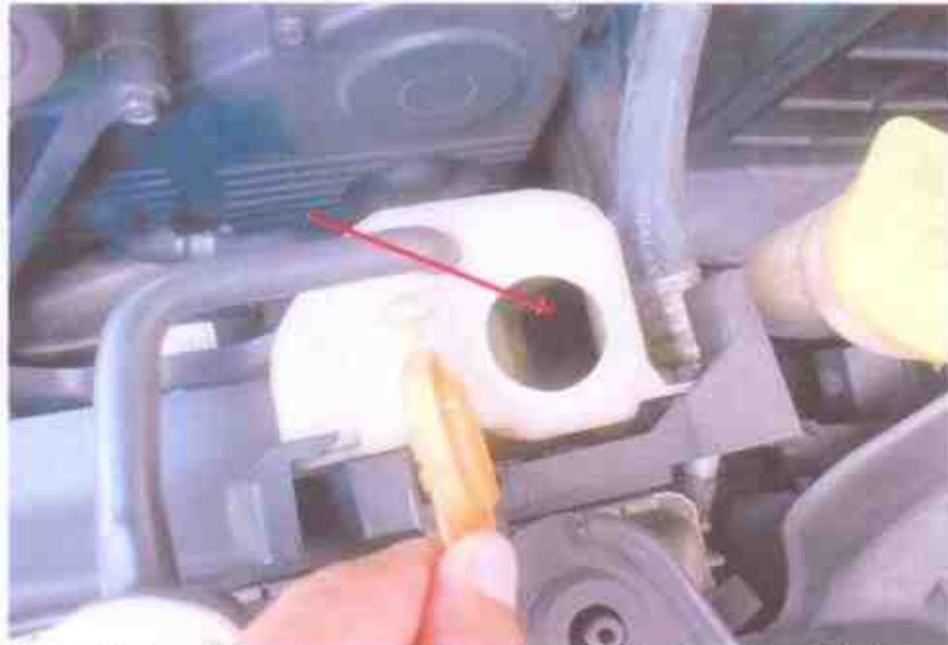
Photo 14 shows the engine coolant fluid reservoir of the Motor Car at the time of our inspection. The engine coolant fluid was observed to be of sufficient level and without any visible contamination.

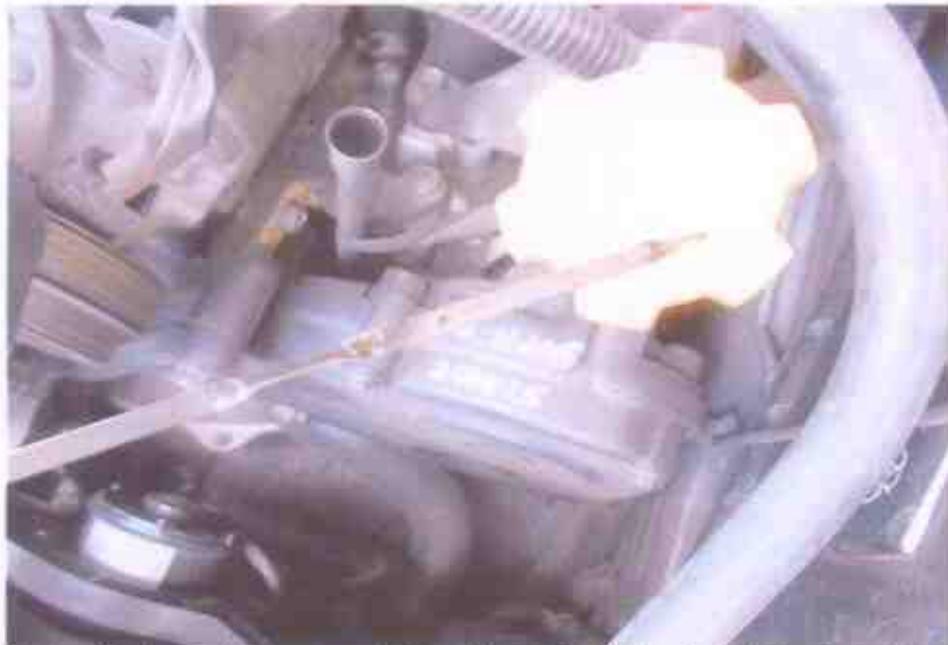
Photo 15 shows the engine oil dip stick of the Motor Car at the time of our inspection. The engine oil was observed to be of sufficient level and without any visible contamination.

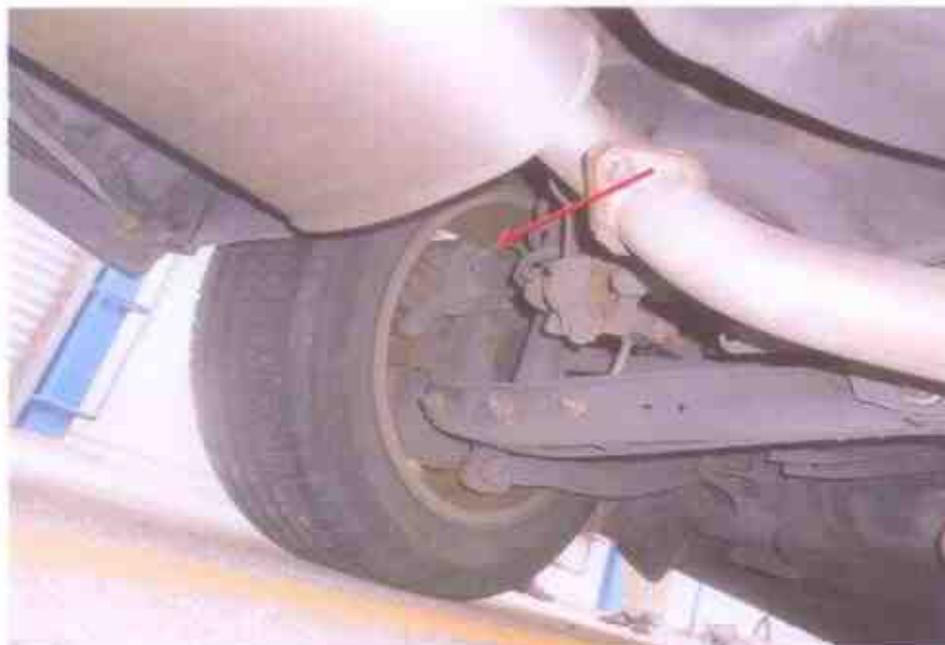
Photo 16 shows the brake hose (arrowed) at the rear left wheel of the Motor Car. We did not observe any leakage of brake fluid at the time of our inspection of the Motor Car. Our visual inspection of the various mechanical components of the Motor Car's braking system revealed all to be intact without visible damage.

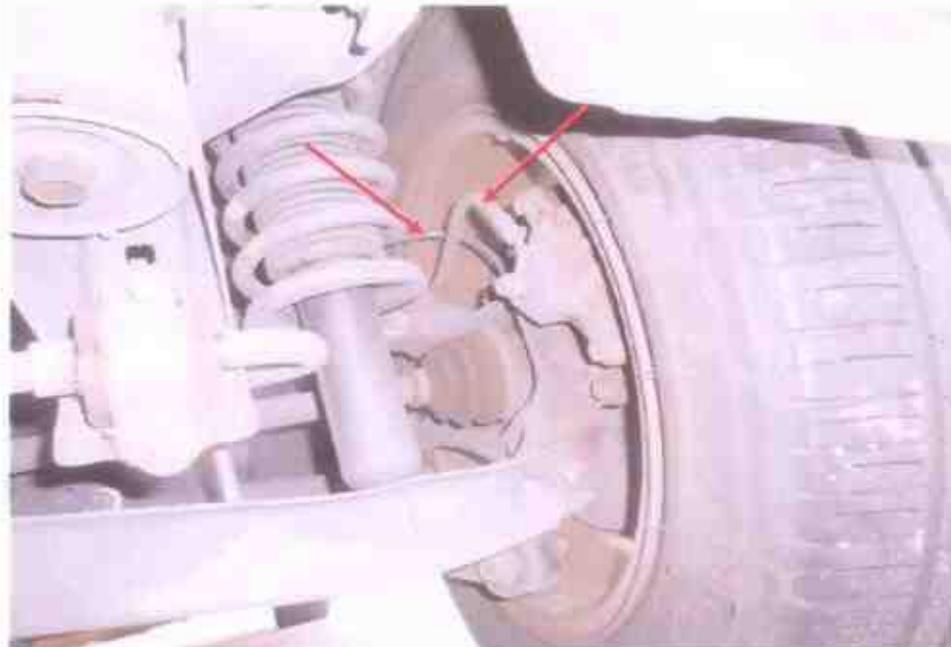
Photo 17 shows the brake hose (arrowed) at the rear right wheel of the Motor Car. We did not observe any leakage of brake fluid at the time of our inspection of the Motor Car. Our visual inspection of the various mechanical components of the Motor Car's braking system revealed all to be intact without visible damage.

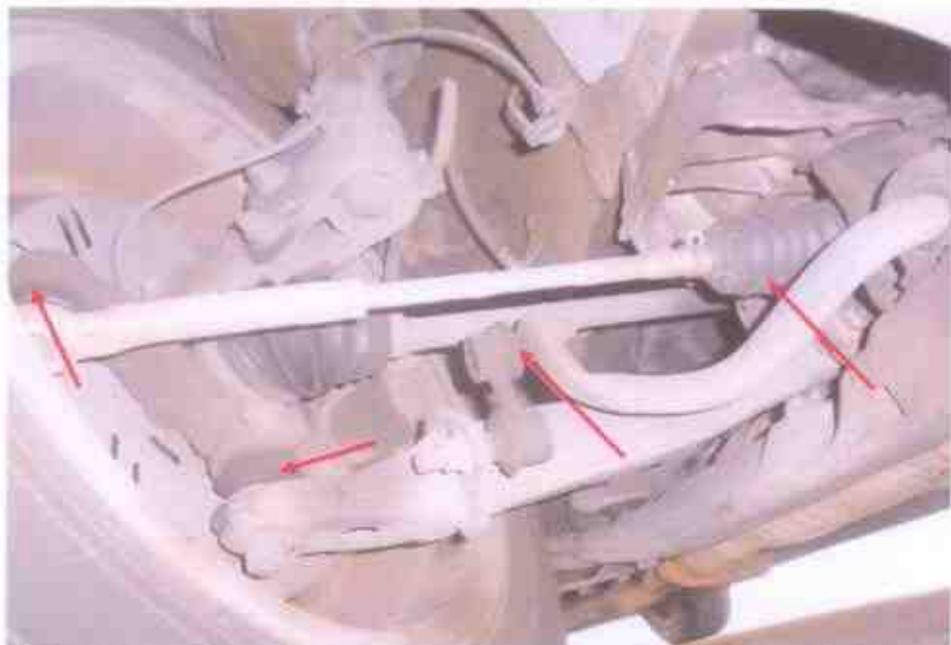
Photo 18 shows the various undercarriage components at the front right wheel of the Motor Car, in particular the steering tie rod (arrowed). The various steering components were all found to be intact, suggesting that the steering system of the Motor Car was likely to be in serviceable condition.

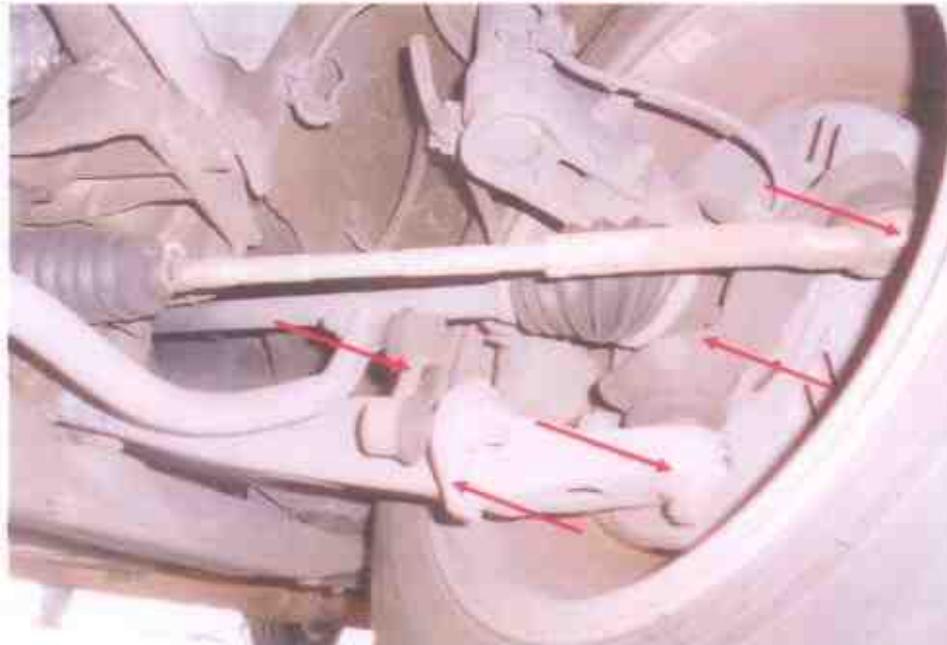
Photo 19 shows the various undercarriage components at the front left wheel of the Motor Car. We did not observe any leakage of brake fluid (arrowed) at the time of our inspection of the Motor Car. Our visual inspection of the various mechanical components of the Motor Car's braking system revealed all to be intact and without visible damage, indicating that the braking system was likely to be in serviceable condition at the material time of accident.

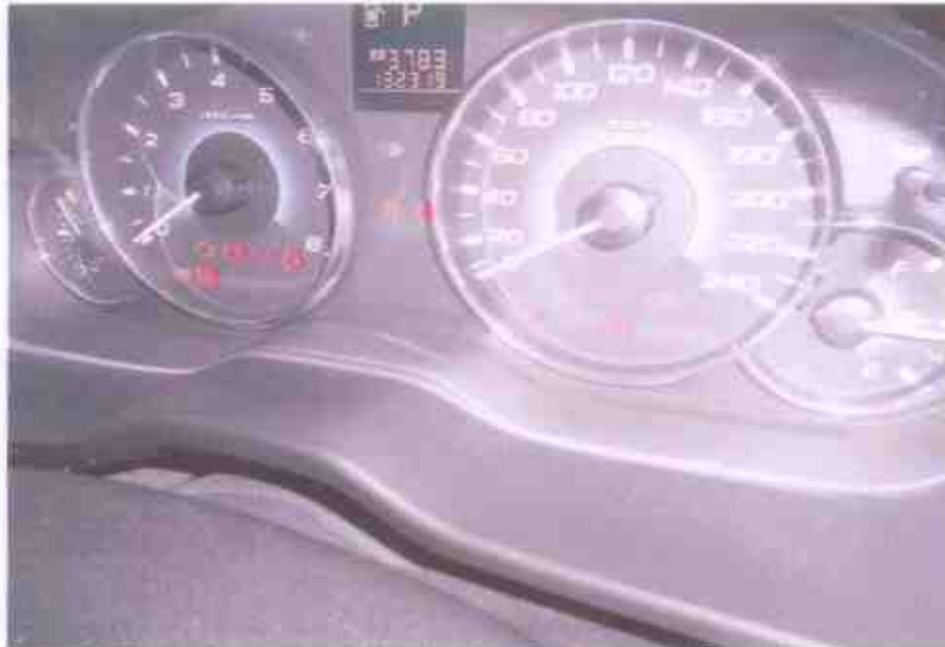
14. The Motor Car's automatic self-test of the functionality of its various electronic operating systems like the Anti-Brake Lock System (ABS), Engine check light, Engine fluid check light, Battery check light and Supplemental Restraint System (SRS) during cranking of the engine had indicated that these systems were in working condition and without abnormality. This can be established from the warning lights disappearing from the instrument panel after the self-test. See photo 20 & 21 below.

Photo 20 shows the warning lights for the various electronic operating systems of the Motor Car appearing on its instrument panel during the self-test when the engine is cranked, in particular the ABS light and SRS light.

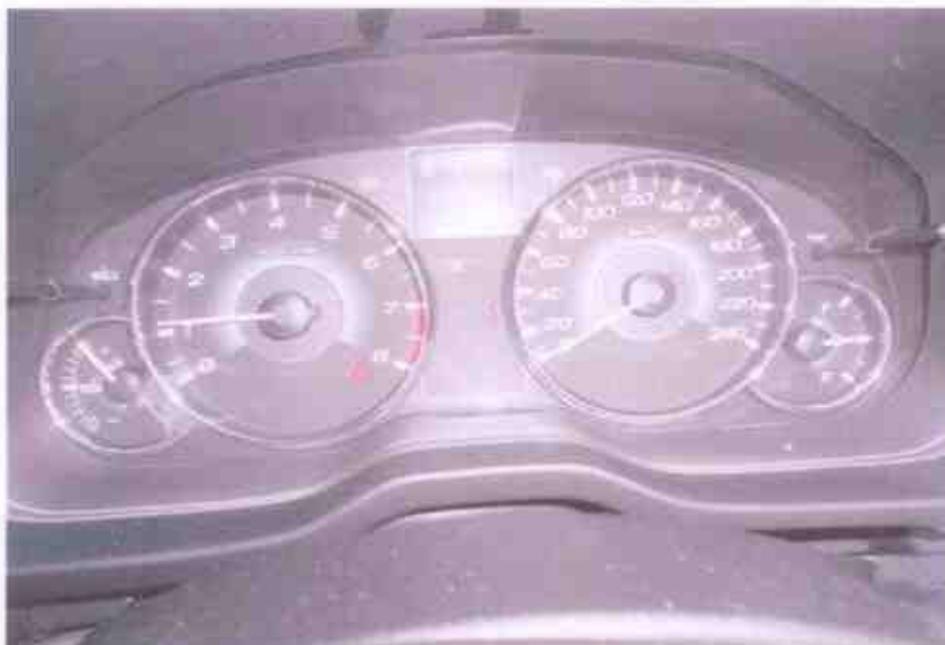
Photo 21 shows no warning lights illuminated on the instrument panel of the Motor Car after the engine was cranked. This would suggest that there was no abnormality to the various electronic operating systems of the Motor Car, like the ABS and SRS.

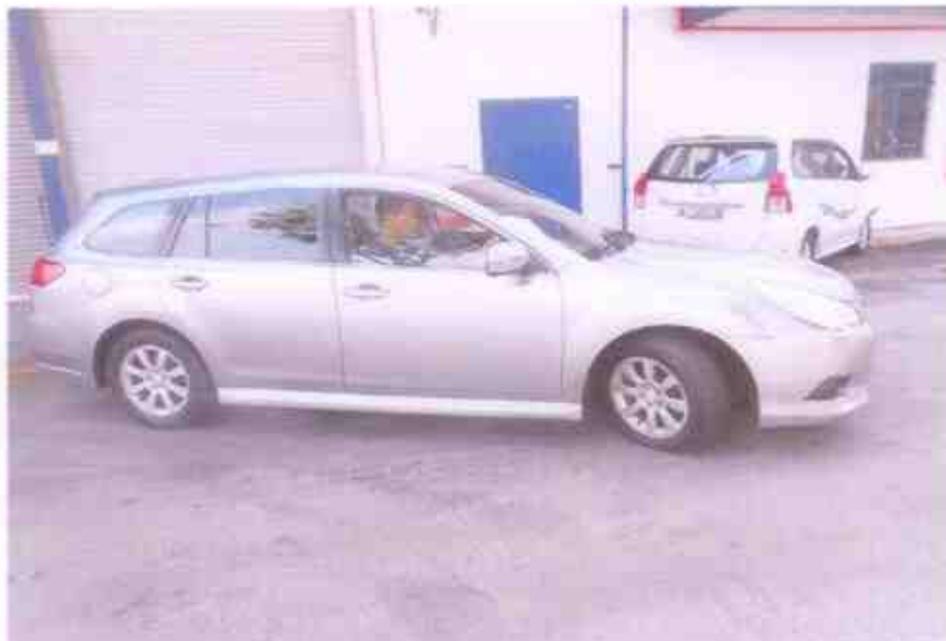
15. A short operational test of the Motor Car, to primarily determine whether there was any abnormality to its engine system, its transmission system and braking system was subsequently carried out.
16. During the operational test, the transmission system of the Motor Car was able to be shifted to drive mode and reverse mode without any difficulty. There were no abnormal sounds heard and/or abnormal behaviour of the Motor Car's engine system. It was able to move forward and backward normally. The braking system was also found to be in working condition as the Motor Car was able to slow down and come to a complete stop upon depressing of the brake pedal. See photo 22 to 23 below.

Photo 22 shows we conducted an operational test on the Motor Car. Drive mode were engaged at time of our test. There was no abnormality observed at time of testing.

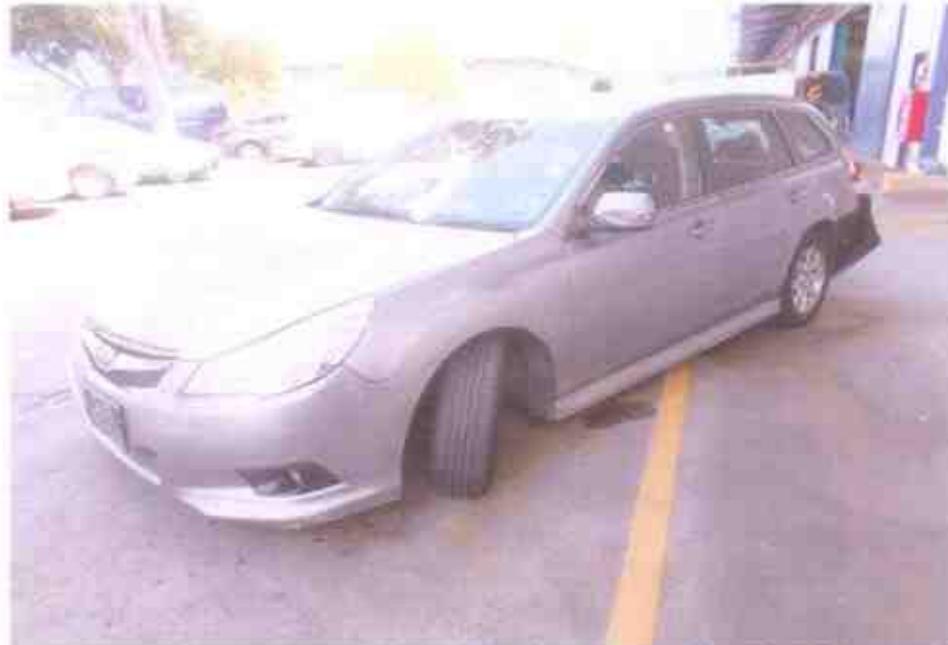
Photo 23 shows we conducted an operational test on the Motor Car. Drive mode, Reverse mode & Neutral mode were engaged at time of our test. Brake pedal was also engaged to a complete stop. There was no abnormality observed at time of testing.
