Your Ref: TP/IP/51609/2018  
Our Ref :CI/TPD18016729/Z

**Fatal Accident Investigation Team**

**MECHANICAL INSPECTION REPORT OF MOTORCYCLE FBA 2368Y**

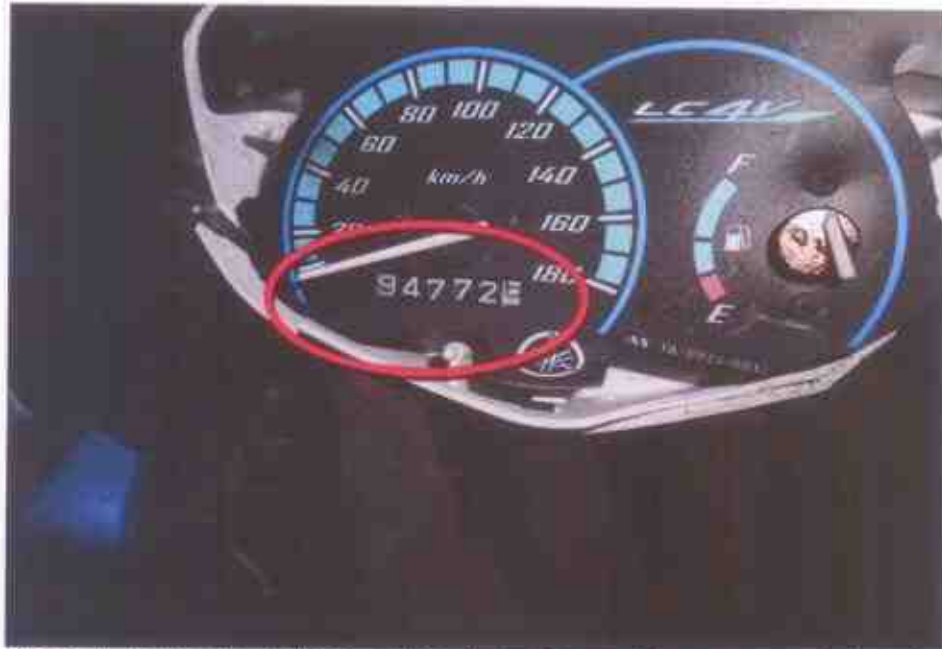
Photo 1 shows the mileage at the time of inspection was recorded to be 947726km.

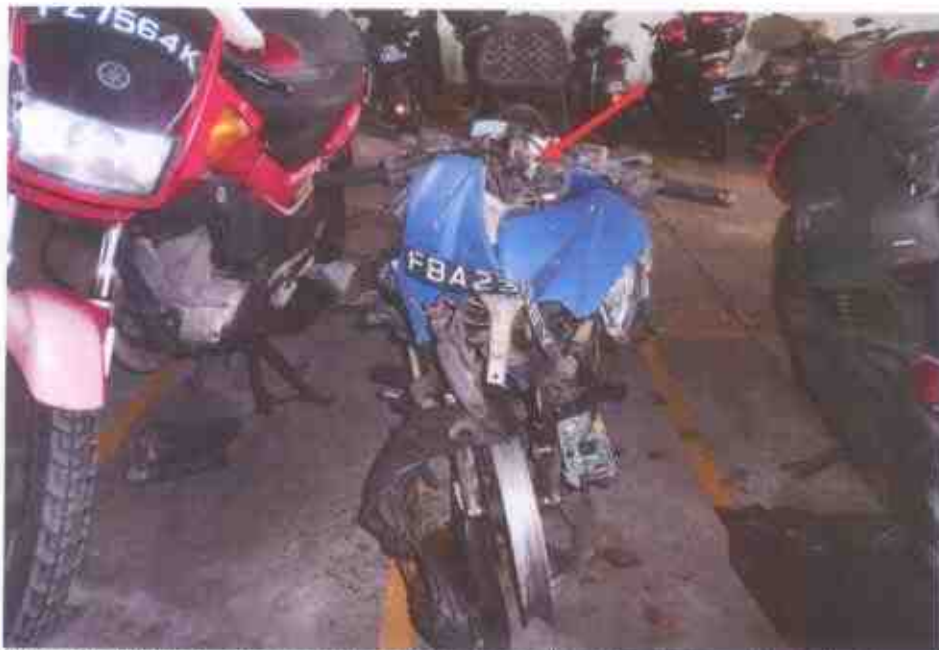
Photo 2 shows a general view of the front body of the Motorcycle at the time of our inspection. The Motorcycle was observed to be sustained with relatively extensive impact due to the accident collision. Amongst the body parts damaged was its handle bar (arrowed), which was observed to be dislodged.

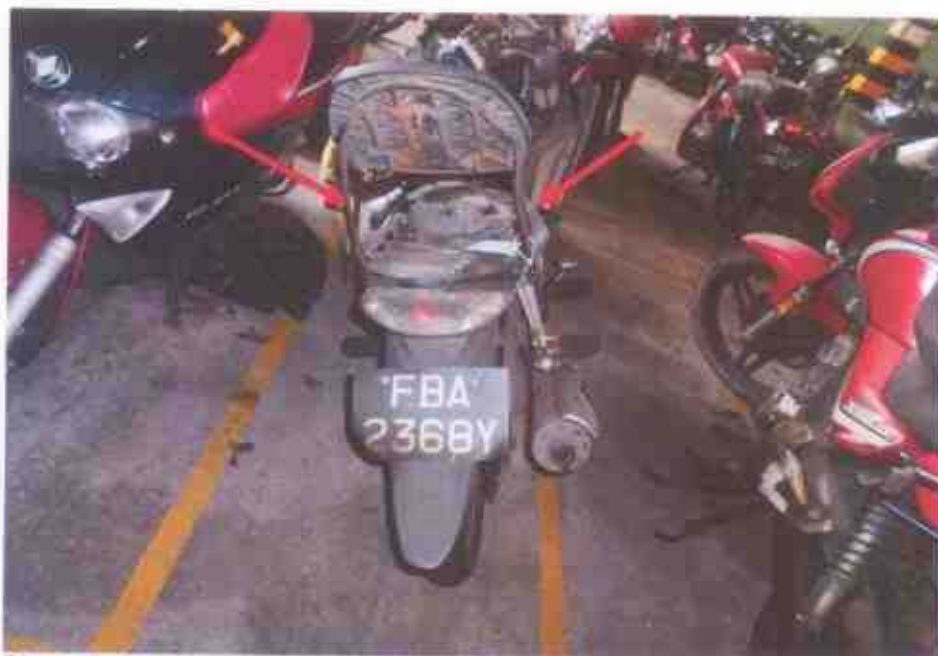
**Photo 3** shows a general view of the rear left body of the Motorcycle at the time of our inspection. The Motorcycle was observed to have sustained minor damages at the rear portion which includes bent rear box rack as a result of the accident.

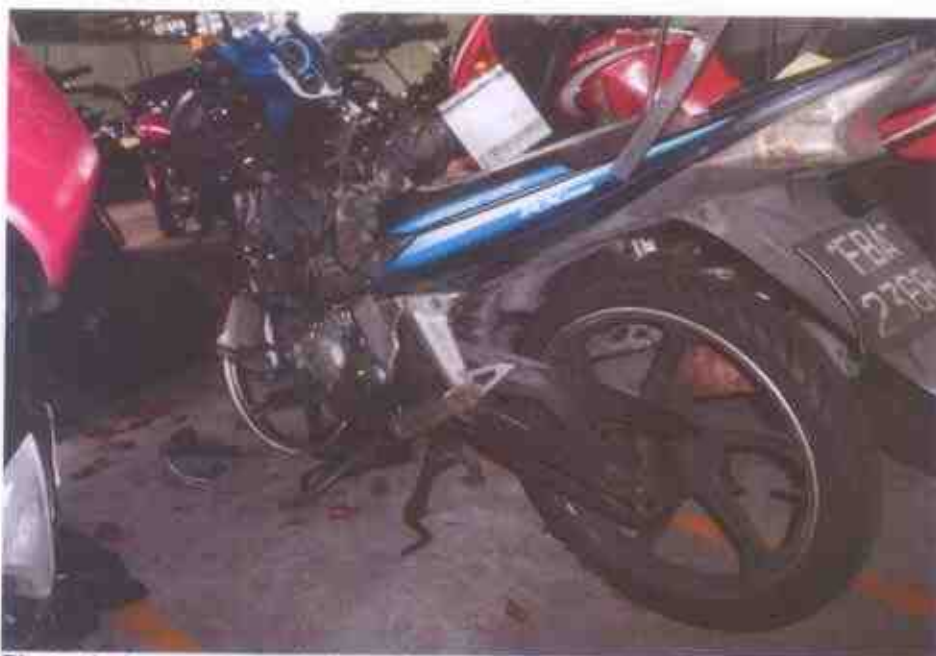
**Photo 4** shows a general view of the rear left portion of the Motorcycle at the time of our inspection. The Motorcycle was observed to have sustained with relatively extensive impact due to the accident collision.

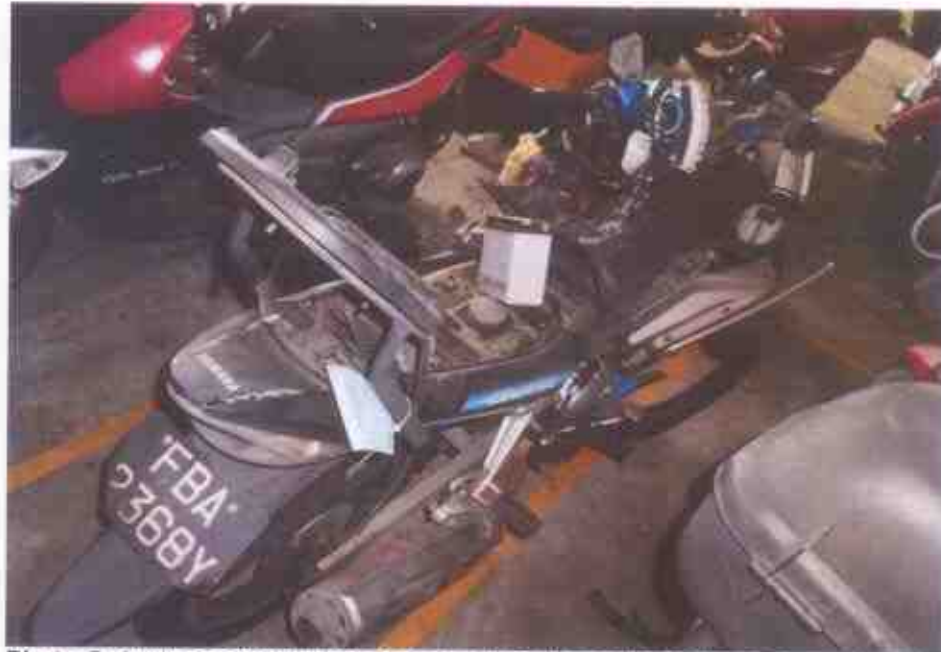
Photo 5 shows a general view of the frontal right portion of the Motorcycle at the time of our inspection. The Motorcycle was observed to be sustained relatively extensive impact which includes dislodged seat assembly due to the accident collision.

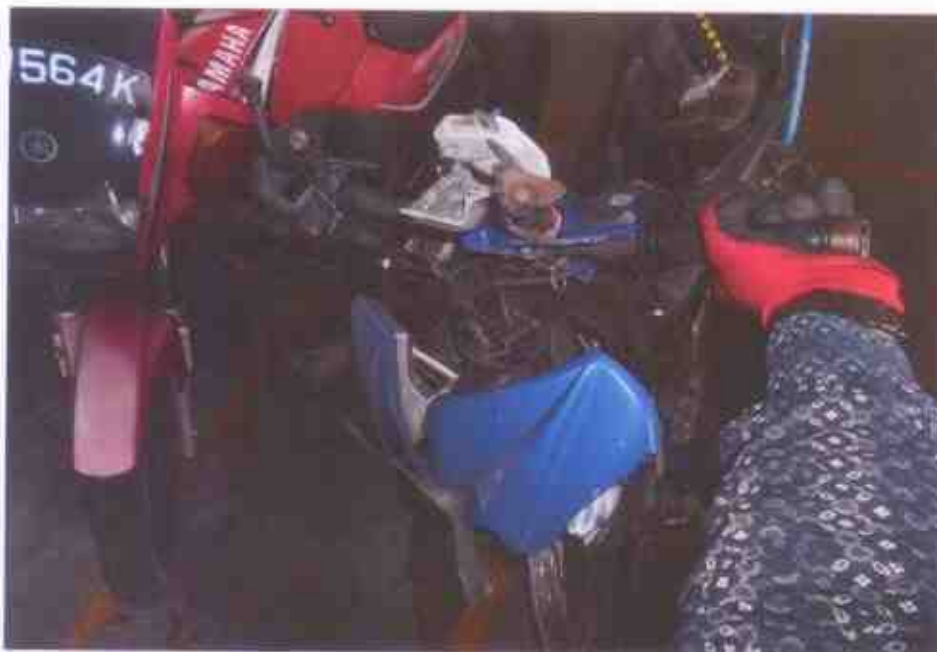
Photo 6 shows a close-up view of the damaged steering system & ignition system of the Motorcycle at the time of our inspection. The Motorcycle was observed to be sustained relatively extensive impact due to the accident collision.

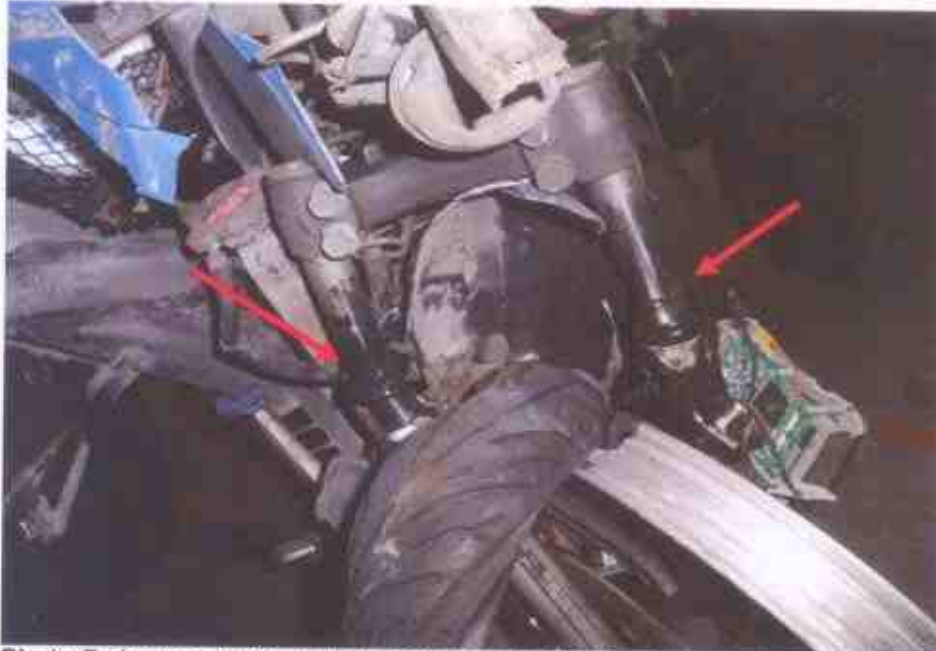
**Photo 7** shows a close-up view of the front fork of the Motorcycle at the time of our inspection. It was observed to have sustained with relatively extensive impact due to the accident collision.

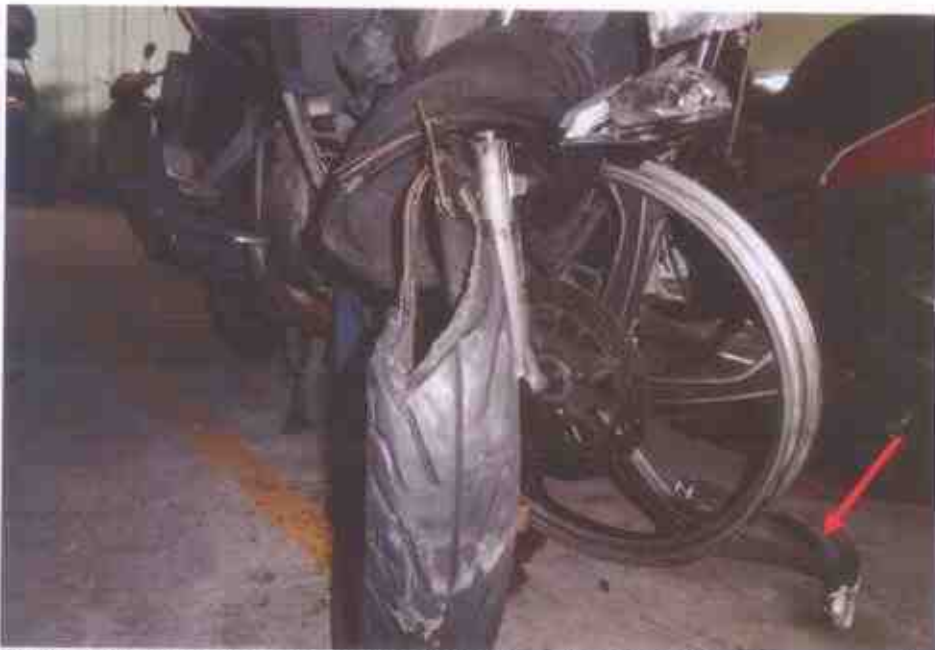
**Photo 8** shows a close-up view of the broken alloy rim of the Motorcycle at the time of our inspection. The Motorcycle alloy rim was observed to be broken due to the accident collision.

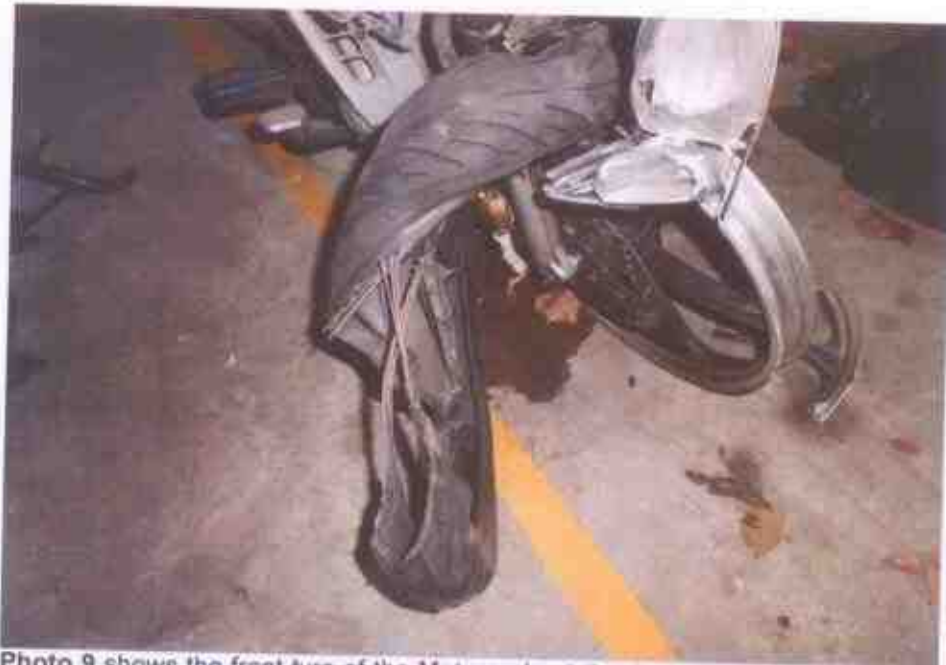
Maxxis 80/90 - 17 (3mm)

Photo 9 shows the front tyre of the Motorcycle at the time of our inspection. The front tyre was observed to be dislodged from the broken wheel rim & deflated due to the accident's impact collision. However, the tread pattern of the front tyre was clearly visible. We did observe that the front tyre was torn as a result of the accident.

10. The rear tyres were wrapped around alloy wheel rim that was found to be without any significant damage.
11. As for the front tyre, it was observed to be dislodged from the broken alloy wheel rim due to the accident.

23. As for the Motorcycle's front tyre, it was observed to be dislodged from the broken wheel rim & deflated due to the accident's impact collision. We did also observe the front tyre was torn as a result of the accident. However, the tread pattern of the front tyre was clearly visible with remaining tread depth of approximately 3mm.
24. Our findings were based solely on a static and visual inspection of the Motorcycle. No operational test(s) could be carried out to the Motorcycle due to the damage of its steering system and braking system (as a result of the accident), which had rendered the Motorcycle immobility.

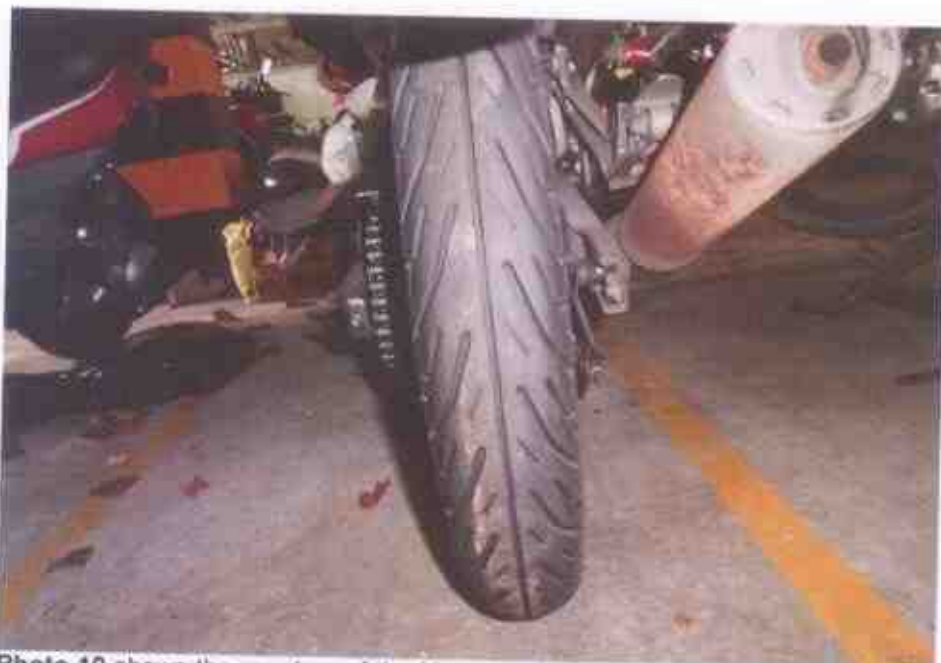
Maxxis 80/90 - 17 (3mm)

Photo 10 shows the rear tyre of the Motorcycle at the time of our inspection. The rear tyre was observed to be in serviceable condition with remaining tread depth of approximately 3mm. It was also sufficiently inflated for vehicular operation.

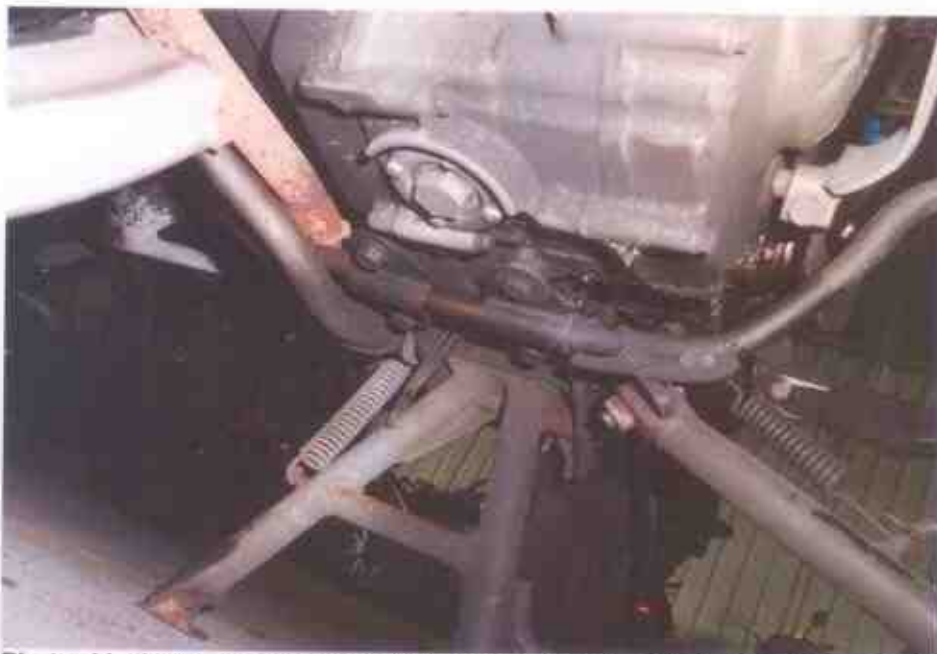
12. Upon examination of the Motorcycle's engine area, we had observed that the various engine related parts and components were intact with no visible damage. There was also no sign(s) or indication(s) of fluid leak observed around the engine area of the Motorcycle.
13. The gear chain of the motorcycle was found to be intact without any misalignment. It was also adequately lubricated for operating purposes. Free play tension test was also conducted & found adequately acceptable. See photo 11 - 13 below.

**Photo 11** shows no sign(s) or indication(s) of fluid leak observed around the engine area of the Motorcycle.

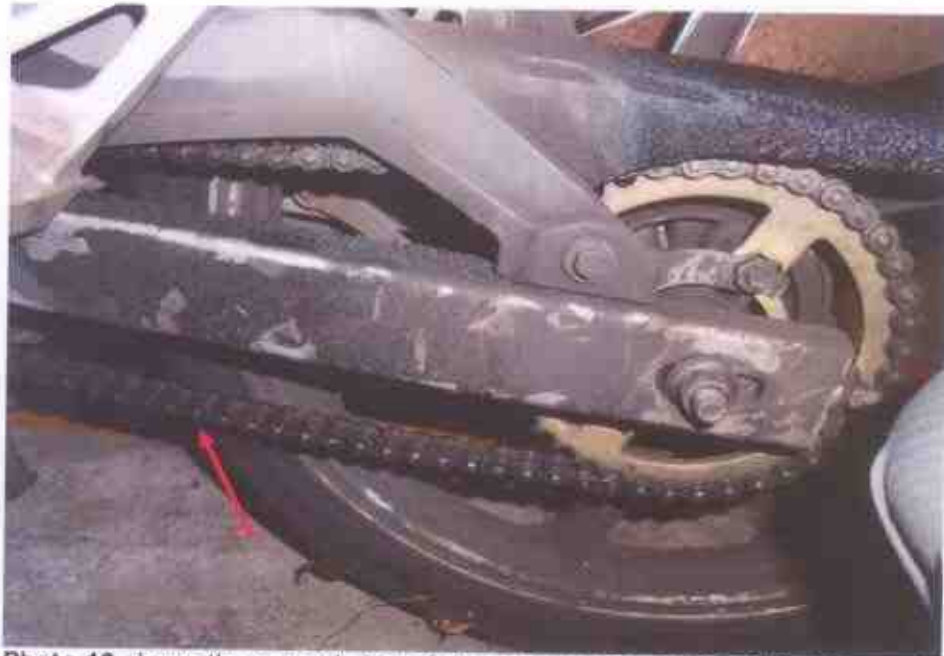
Photo 12 shows the general view of the gear train (arrowed) of the Motorcycle, which was observed to be intact with no misalignment. It was also adequately lubricated for operating purposes.

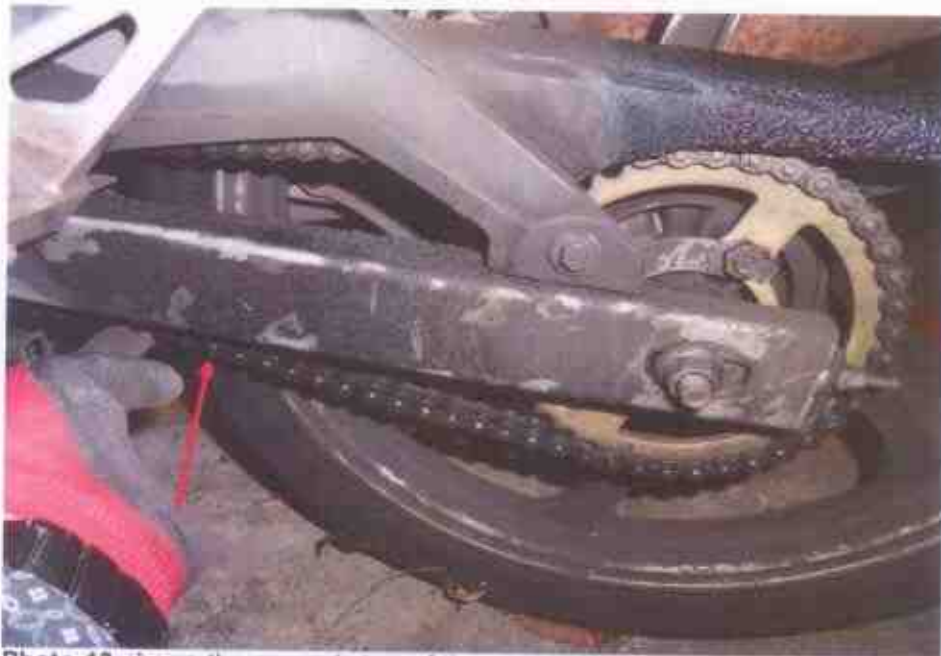
Photo 13 shows the general view of the gear train (arrowed) of the Motorcycle, which was observed to be intact with no misalignment. It was also adequately lubricated for operating purposes. Free play tension was also observed & found adequately acceptable.

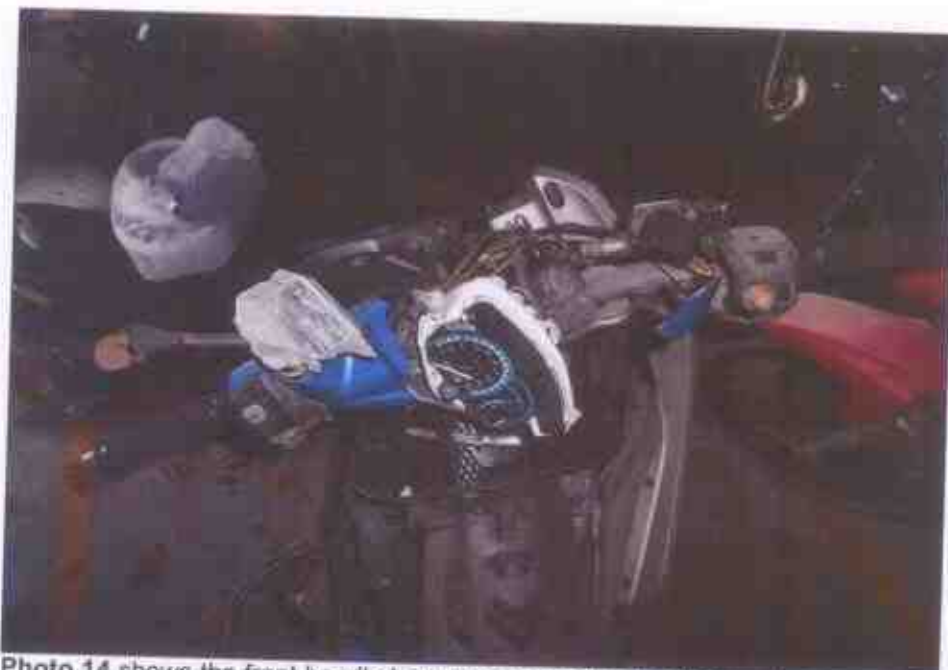
14. For this case, we were not able to conduct any test(s) on the steering system of the Motorcycle due to the damage on its steering system. It was found to be dislodged as a result of the accident, hence causing the whole steering system not to be in a serviceable condition.

Photo 14 shows the front handle bar was observed to be dislodged as a result of the accident. Hence, we are not able to conduct any tests on the steering system of the Motorcycle.

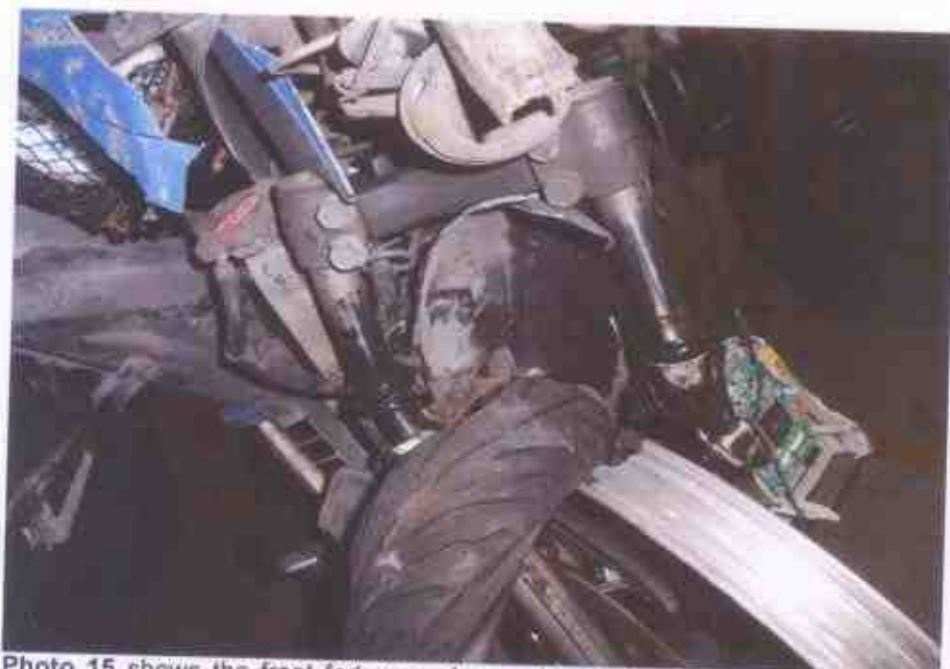
Photo 15 shows the front fork was observed to be buckled as a result of the accident. Hence, we are not able to conduct any tests on the steering system of the Motorcycle.

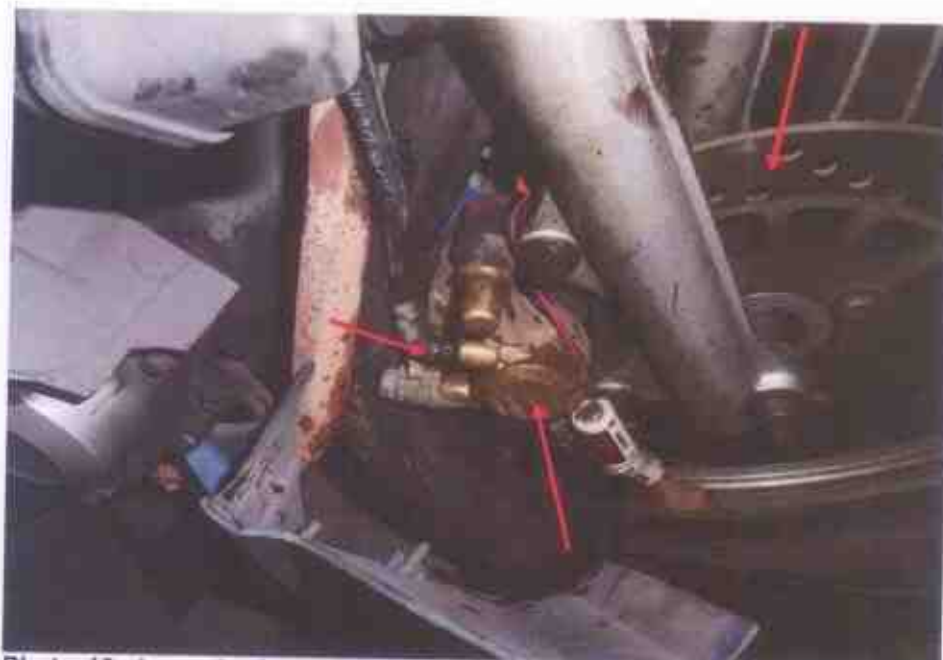
16. However, upon further examination on the front brake, we did observe visible tear/cut on the connecting hoses and cables that caused brake fluid leakage due to the accident.

Photo 16 shows the front brake calliper, front brake disc and brake pad of the Motorcycle (arrowed), which are all part of the components in the front brake system of the Motorcycle. Our visual checks of these various components had revealed that there's brake fluid leakage as a result of the accident.

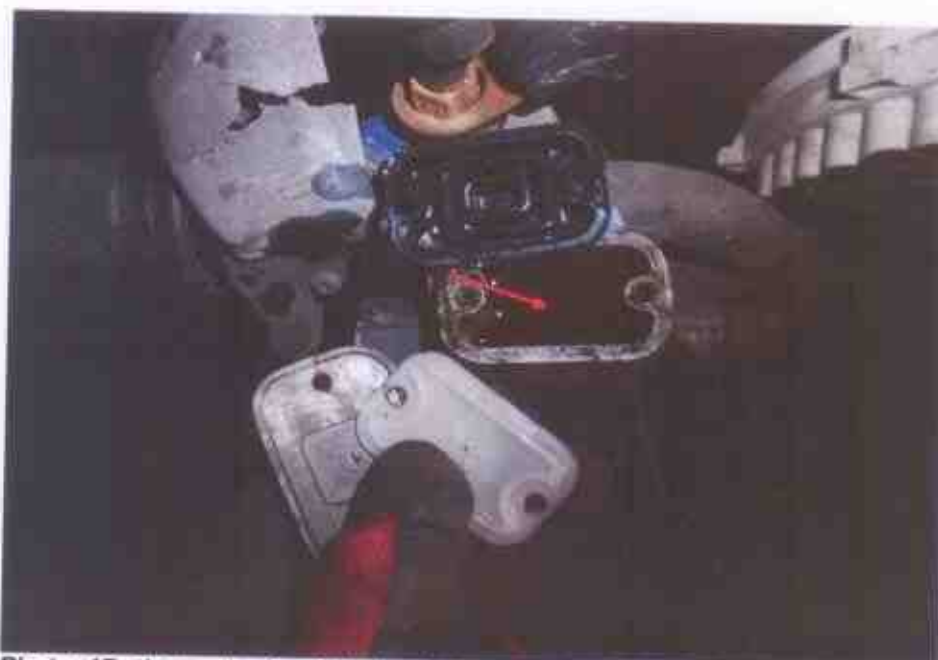
18. As for the front brake, we were unable to conduct a static brake tests due to the extensive damages which includes broken hand brake lever & brake fluid leakage as a result of the accident's collision. However, our checks on the brake fluid had indicated that the brake fluid was of sufficient level for operational purposes, and without contamination at time of our inspection.

Photo 17 shows the front brake fluid observed to be sufficient and without contamination at time of our inspection.

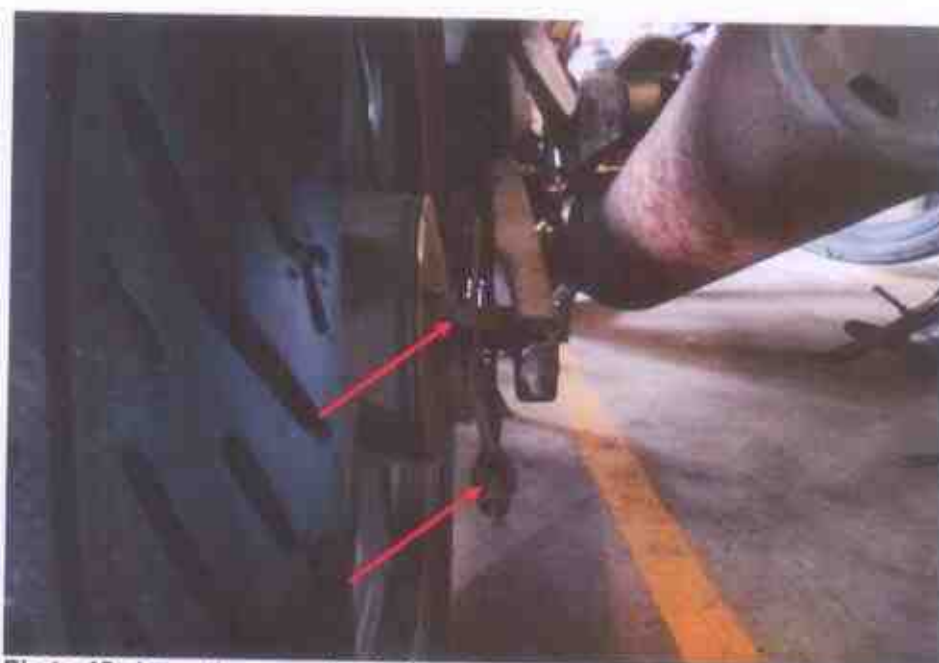
17. A static brake test was conducted on the Motorcycle rear brake and it had appeared to indicate that the rear brake system of the Motorcycle was in serviceable condition. There was some resistance felt (spongy like feel) upon stepping on the rear brake foot paddle. This would indicate that there was no abnormality on the rear brake drum mechanical parts.

Photo 18 shows the rear wheel of the Motorcycle. The type of brake system for the rear wheel was of mechanical type, controlled by the brake foot pedal of the Motorcycle. Our checks of the cable (arrowed), spring and drum, which are all part of the components in the rear brake system of the Motorcycle reveal all to be intact and without damage.
