Ref : CS/AGI18016971/Dvbn2

## 1. Policy Particulars :- THIRD PARTY CLAIM

THE VEHICLE SUSTAINED DAMAGES AT THE O/S FRONT PORTION. DAMAGES SEE DETAILS.
---

## ADJUSTMENT ON REPAIR COST FOR VEHICLE NO. SHC 3889Y

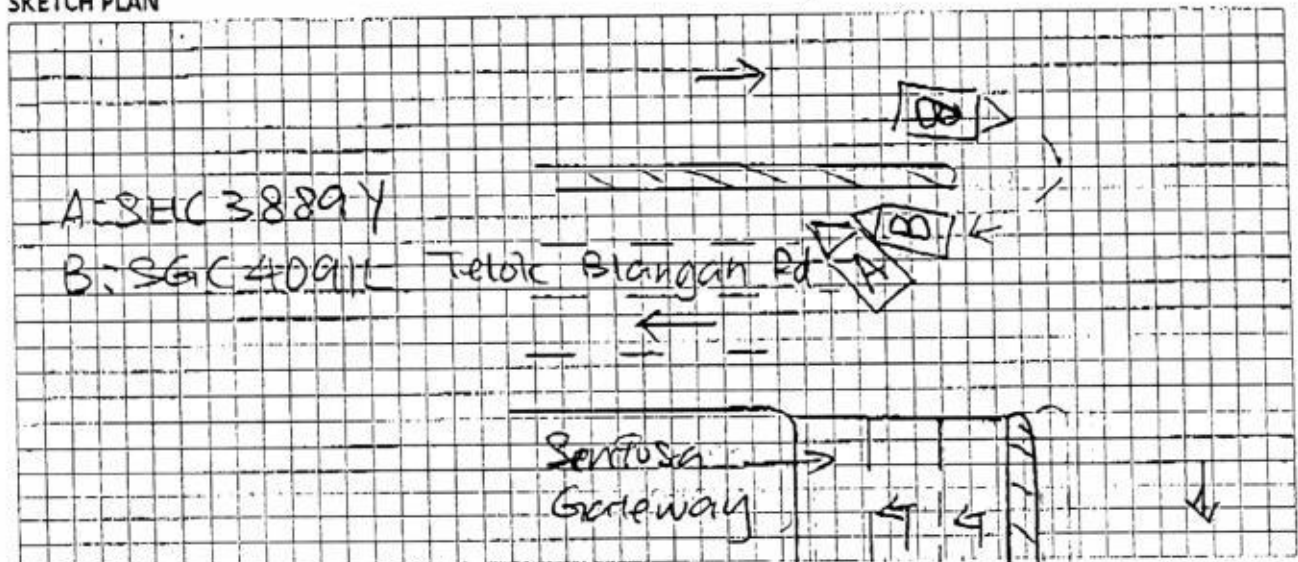
## SKETCH PLAN

On 15/9/18 at about 23:10 hrs, I turning left from Sentosa Gateway to Telok Blangah Rd as traffic light at my favor.

When I was about enter other side junction, suddenly veh B coming from my right and collided onto the right front portion of my tax.

I'm curious where Veh B come from, but the veh B driver told me that he make a illegal U turn at above said location.
