Your Ref: Honda Engine  
Our Ref : CI/TP18017008/D

18 September 2018

**INSPECTION REPORT OF A HONDA ENGINE WITH ENGINE NUMBER  
K20A5841950**

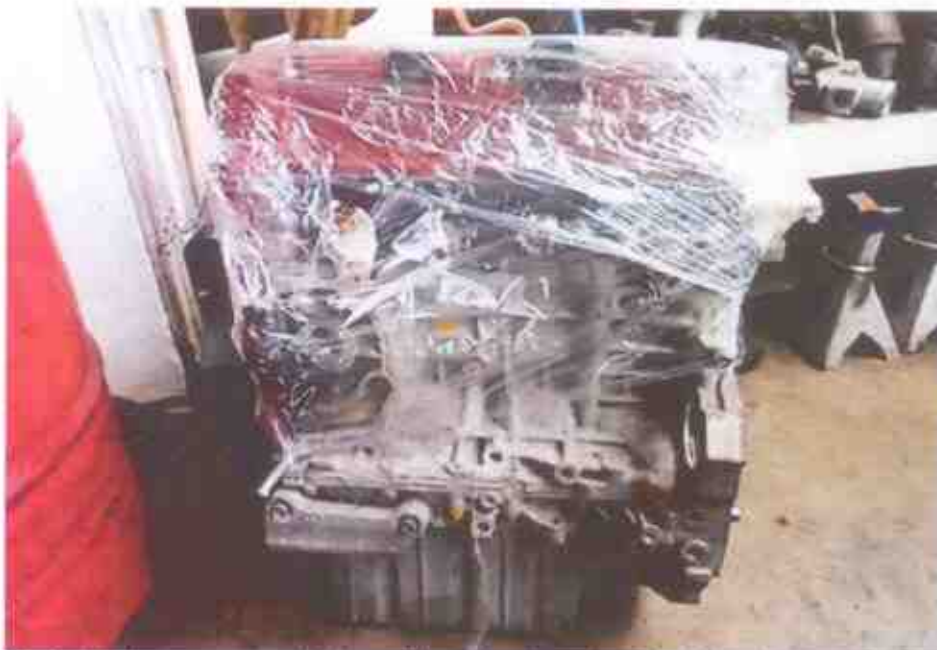
**Photo 1** shows a general view of the Honda engine that I had inspected. The Honda engine was observed to be a used engine and was not fitted on any motor car. It was also observed to be a complete assembly with all mechanical parts still intact, within the engine housing. There was no crack and/or hole observed on the engine housing.

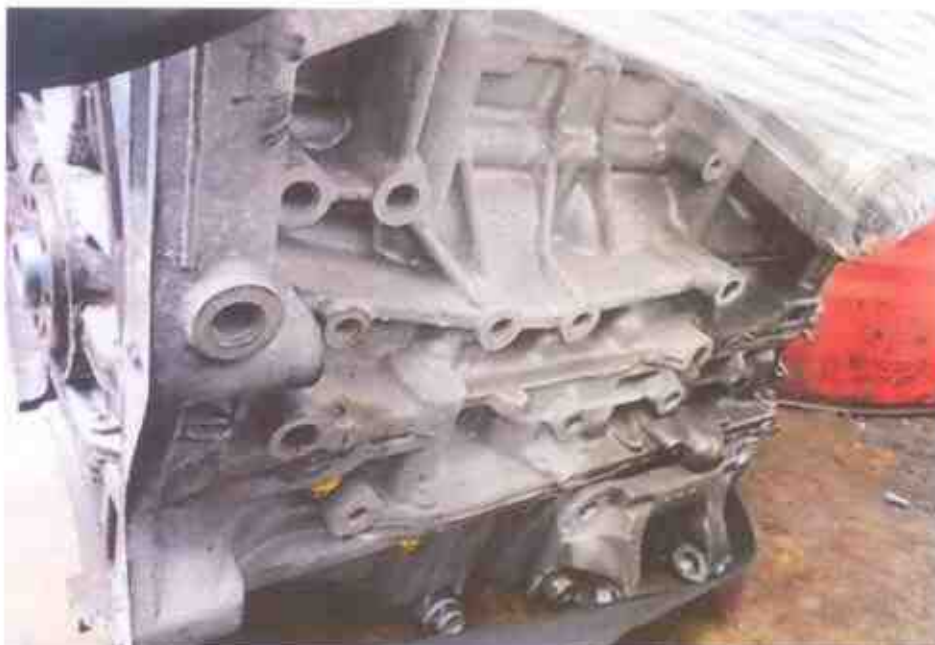
**Photo 2** shows a general view of the Honda engine that I had inspected. The Honda engine was not fitted on any motor car. It was observed to be a complete assembly with all mechanical parts still intact, within the engine housing.

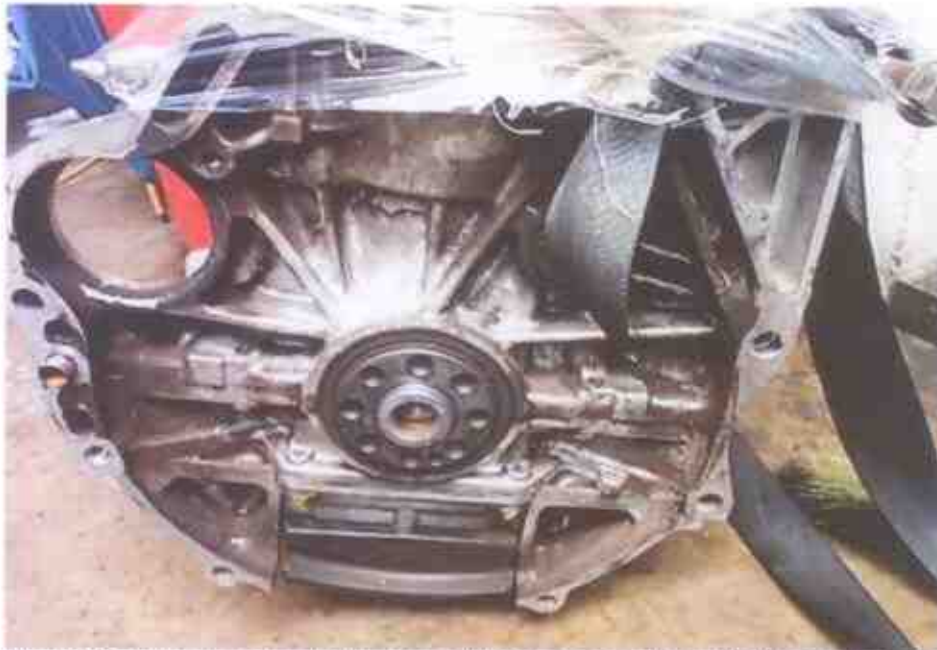
**Photo 3** shows a general view of the Honda engine that I had inspected. My visual examination of the engine housing revealed the housing to be of serviceable/satisfactory condition. There was no crack and/or hole observed on the engine housing.

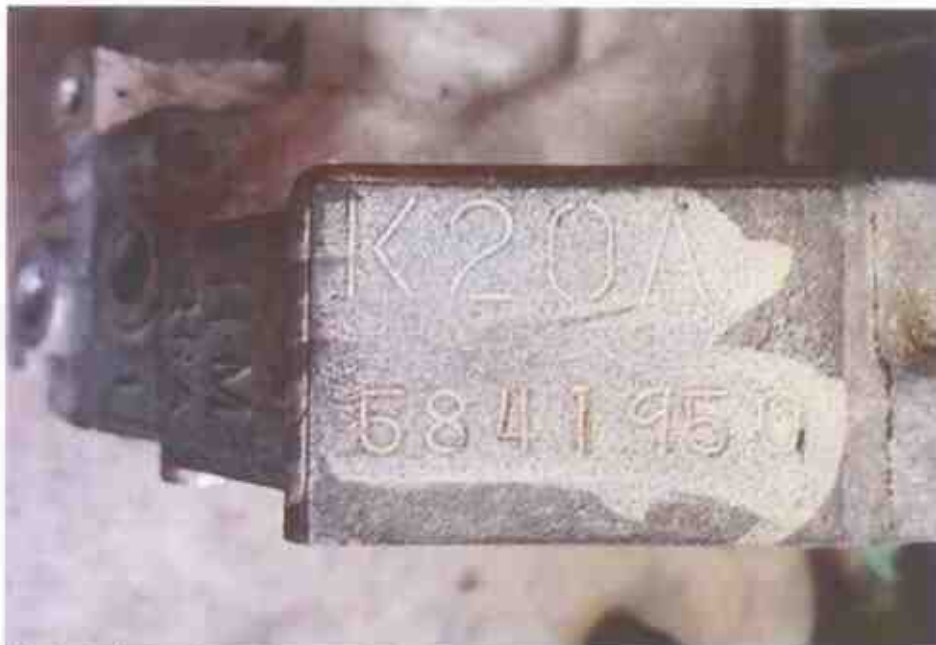
**Photo 4** shows the engine number engraved on the housing of the Honda engine that I had inspected. The engine number was K20A5841950.

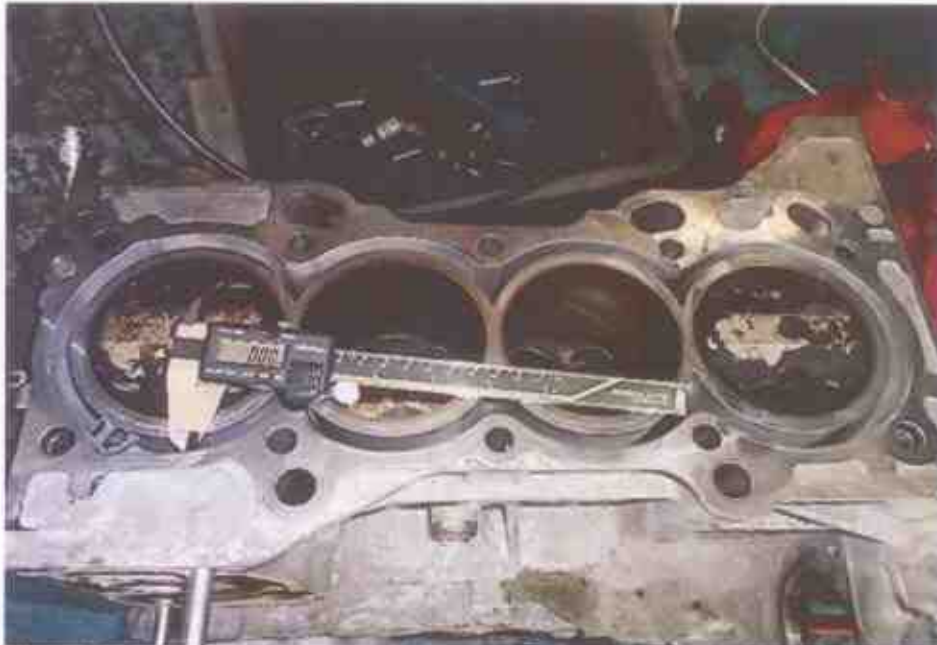
Photo 5 shows the bottom block of the Honda engine with its top block removed for me to carry out measurements of its cylinders, in particular the bore and stroke measurements of each cylinder, which typically can be used to determine the engine displacement or more commonly referred to as engine cc. The measurements were carried out using a digital Vernier Caliper that was calibrated at the start of the measurements.

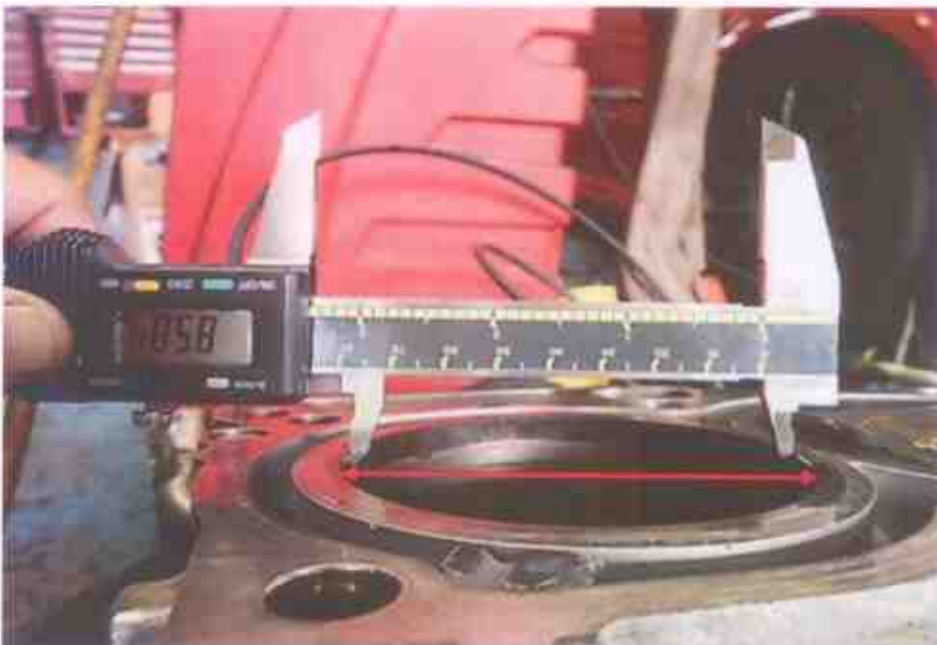
Photo 6 shows measurement being carried out to the bore of cylinder 1 of the Honda engine. The bore and stroke measurements of the Honda engine were carried out using a digital Vernier Caliper. The bore measurement of cylinder 1 was recorded to be 85.84mm.

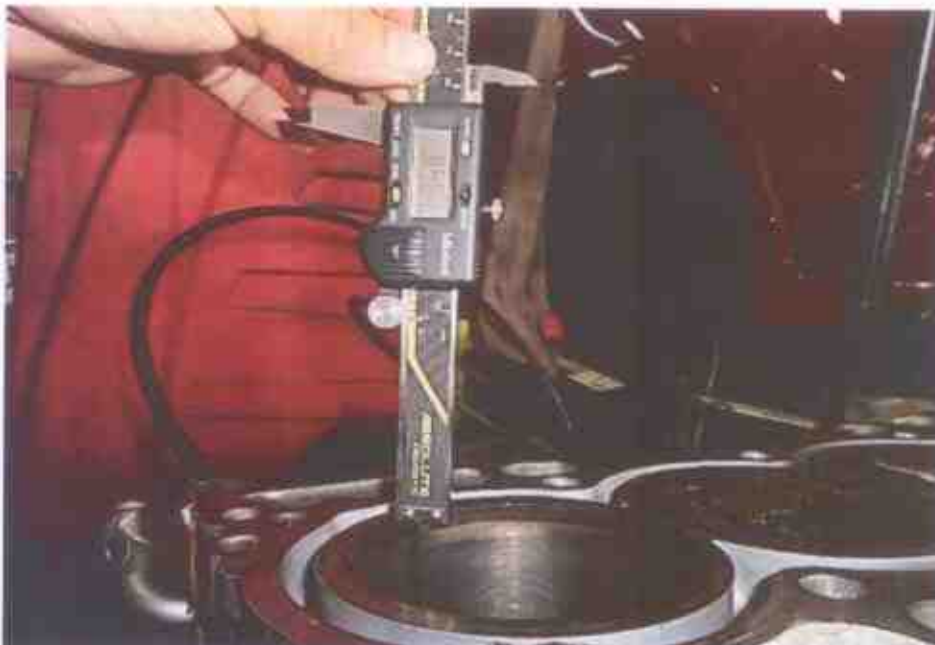
Photo 7 shows measurement being carried out to the stroke of cylinder 1 of the Honda engine. The bore and stroke measurements of the Honda engine were carried out using a digital Vernier Caliper.

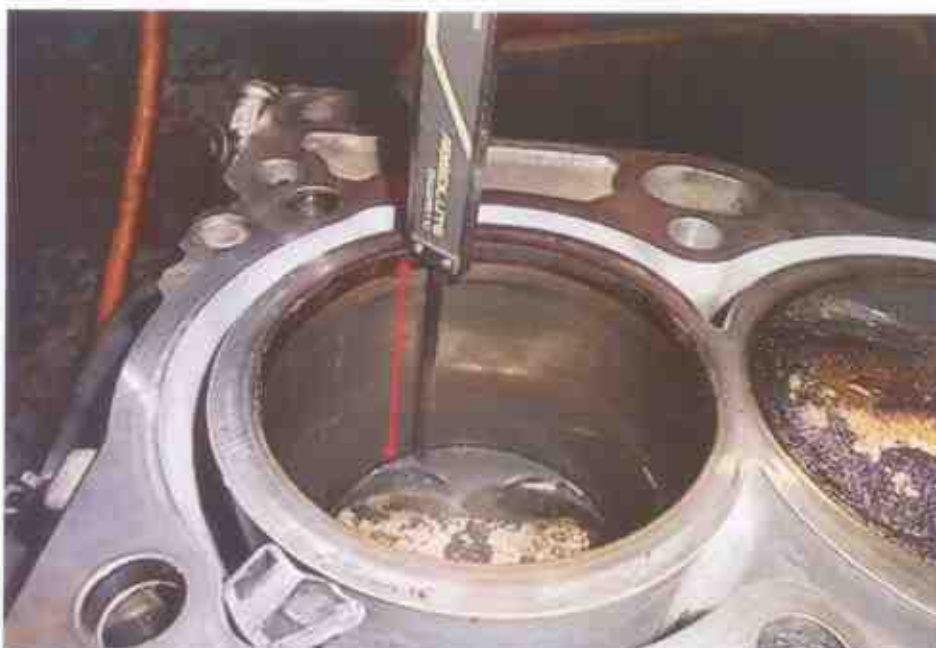
Photo 8 shows measurement being carried out to the stroke of cylinder 1 of the Honda engine. The bore and stroke measurements of the Honda engine were carried out using a digital Vernier Caliper that was calibrated at the start of the measurements.

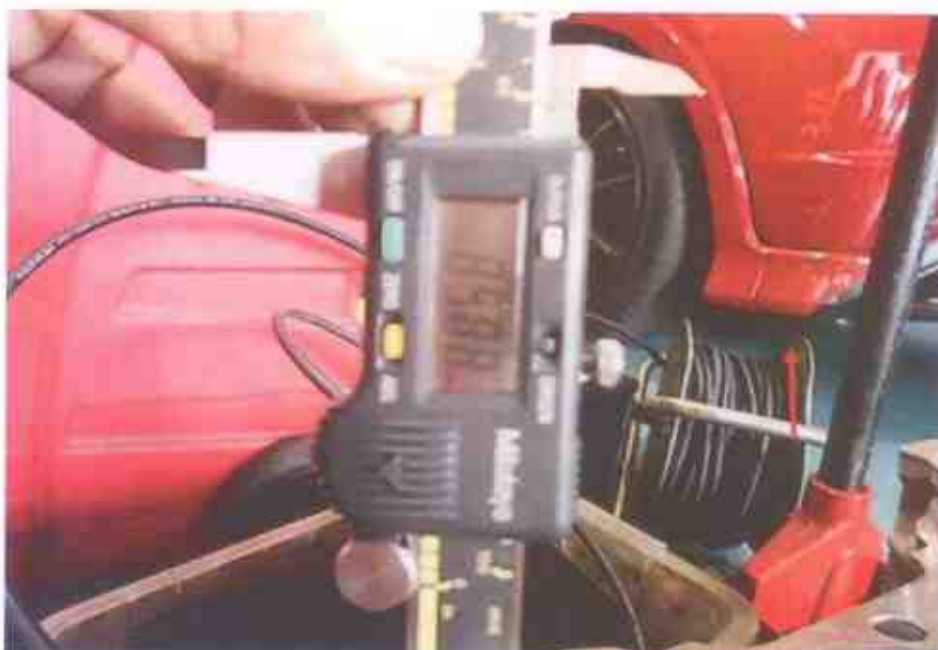
**Photo 9** shows the stroke measurement of cylinder 1, which was recorded to be 85.88mm.

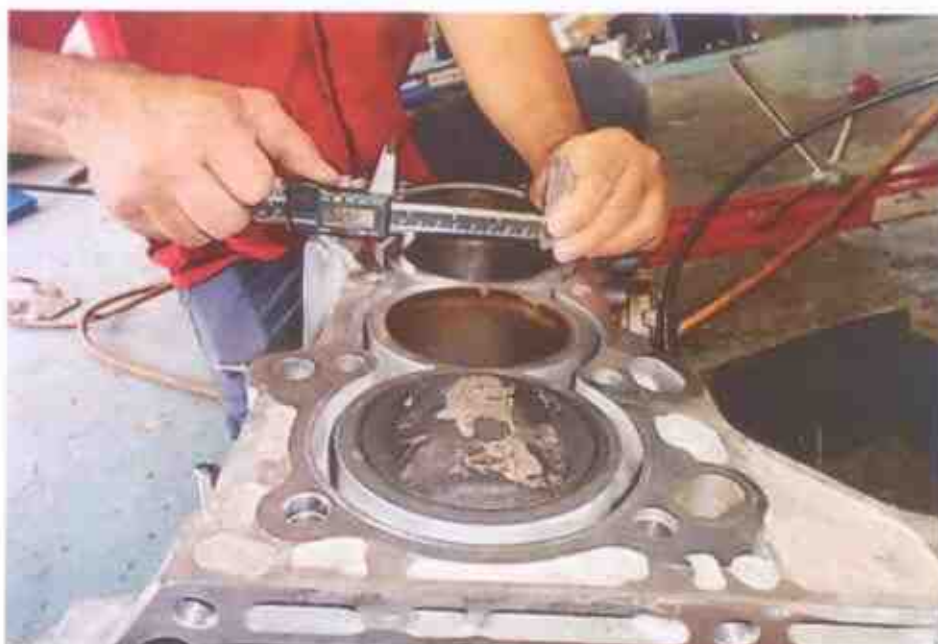
**Photo 10** shows measurement being carried out to the bore of cylinder 2 of the Honda engine. The bore and stroke measurements of the Honda engine were carried out using a digital Vernier Caliper.

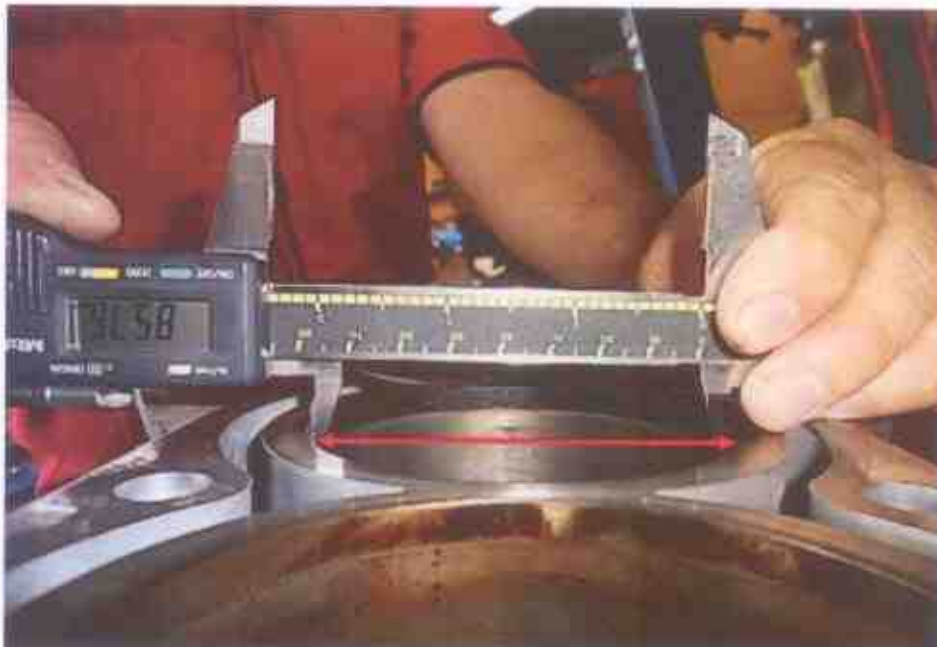
Photo 11 shows the bore measurement of cylinder 2, which was recorded to be 85.76mm.

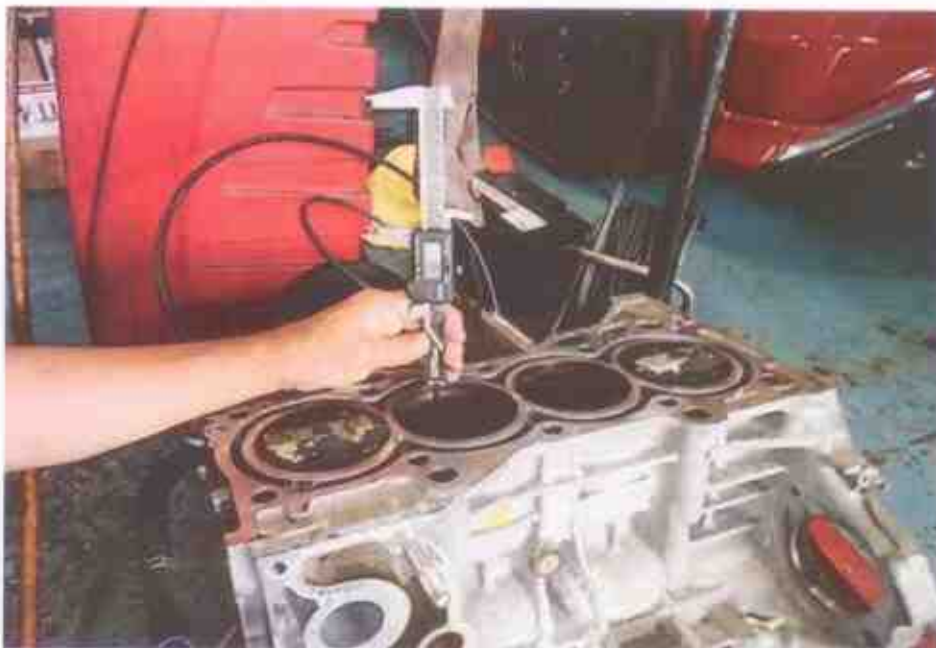
Photo 12 shows measurement of the stroke for cylinder 2 of the Honda engine that I had inspected. The measurement was carried out using a digital Vernier Caliper that was calibrated at the start of the measurements.

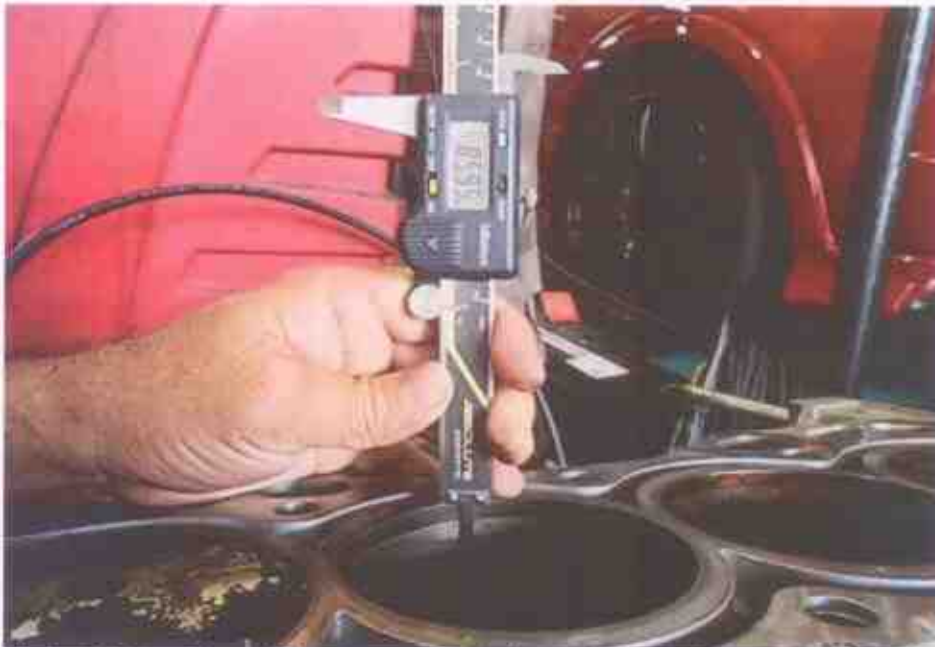
**Photo 13** shows the stroke measurement of cylinder 2, which was recorded to be 85.95mm.

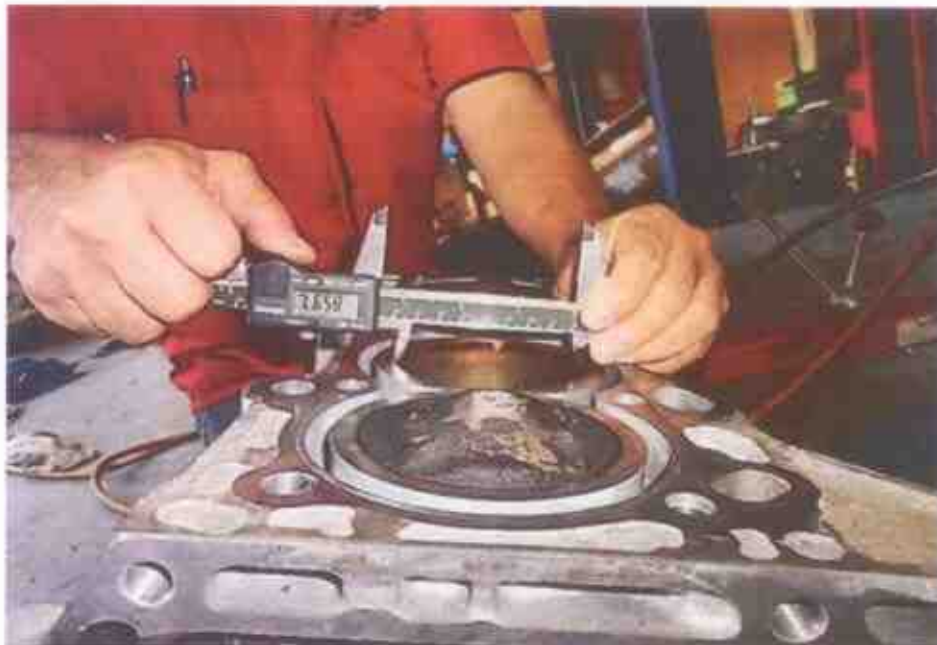
**Photo 14** shows measurement being carried out to the bore of cylinder 3 of the Honda engine. The bore and stroke measurements of the Honda engine were carried out using a digital Vernier Caliper. The bore measurement of cylinder 3, which was recorded to be 85.97mm.

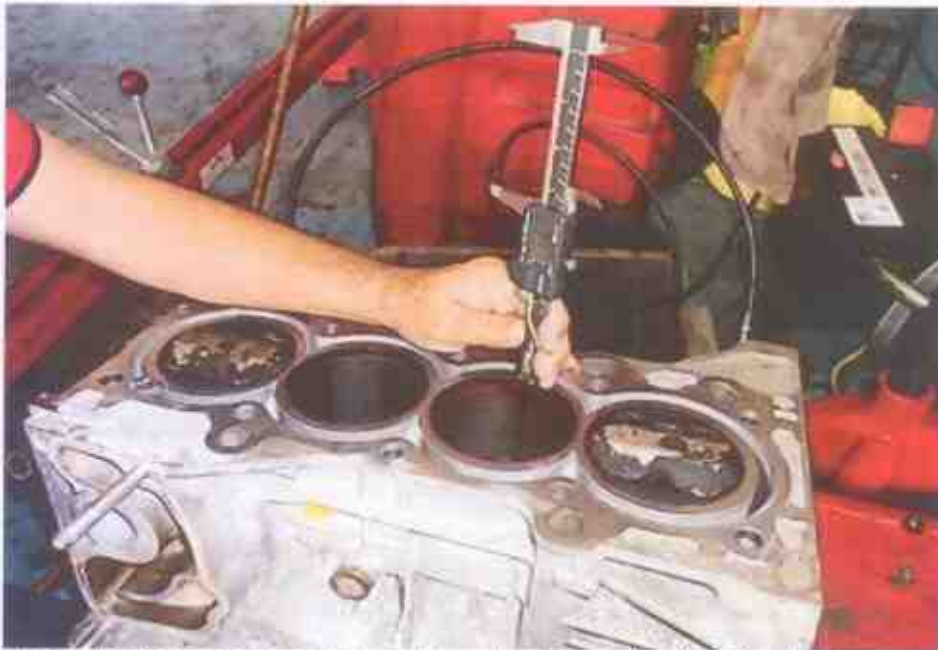
Photo 15 shows measurement of the stroke for cylinder 3 of the Honda engine that I had inspected. The measurement was carried out using a digital Vernier Caliper that was calibrated at the start of the measurements.

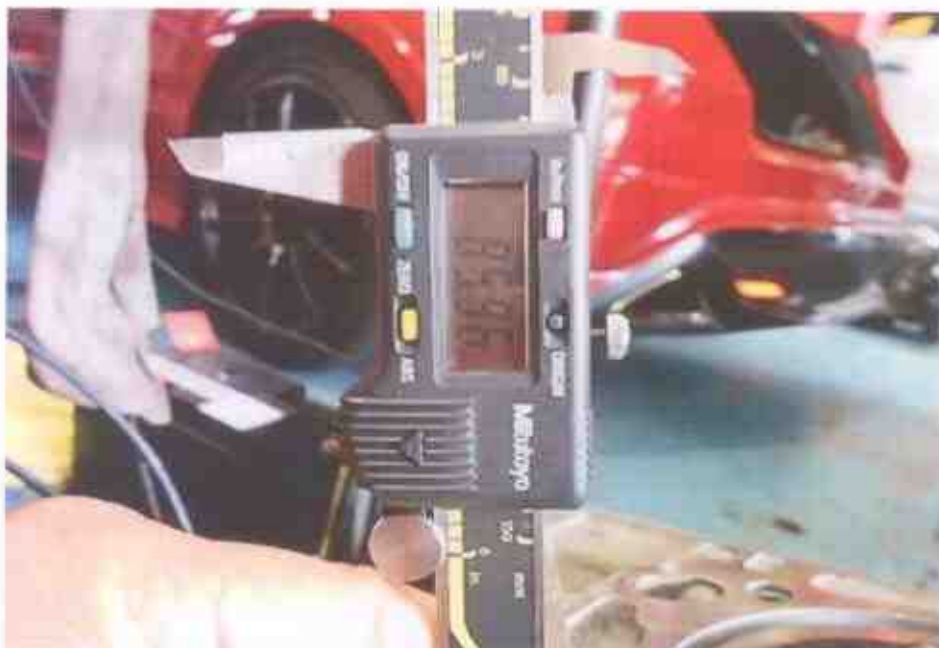
Photo 16 shows the stroke measurement of cylinder 3, which was recorded to be 85.96mm.

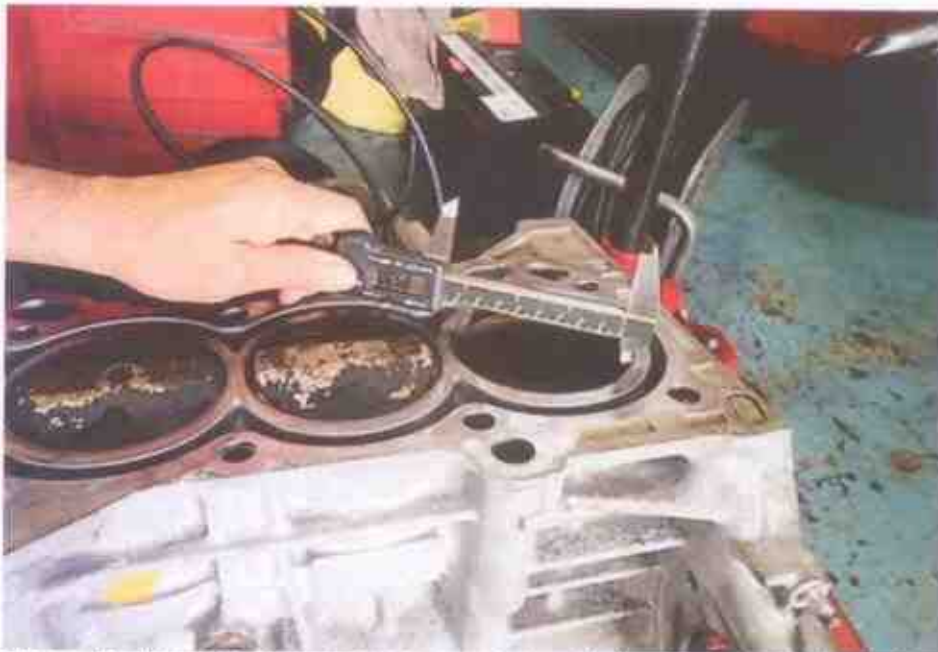
Photo 17 shows measurement being carried out to the bore of cylinder 4 of the Honda engine. The bore and stroke measurements of the Honda engine were carried out using a digital Vernier Caliper that was calibrated at the start of the measurements.

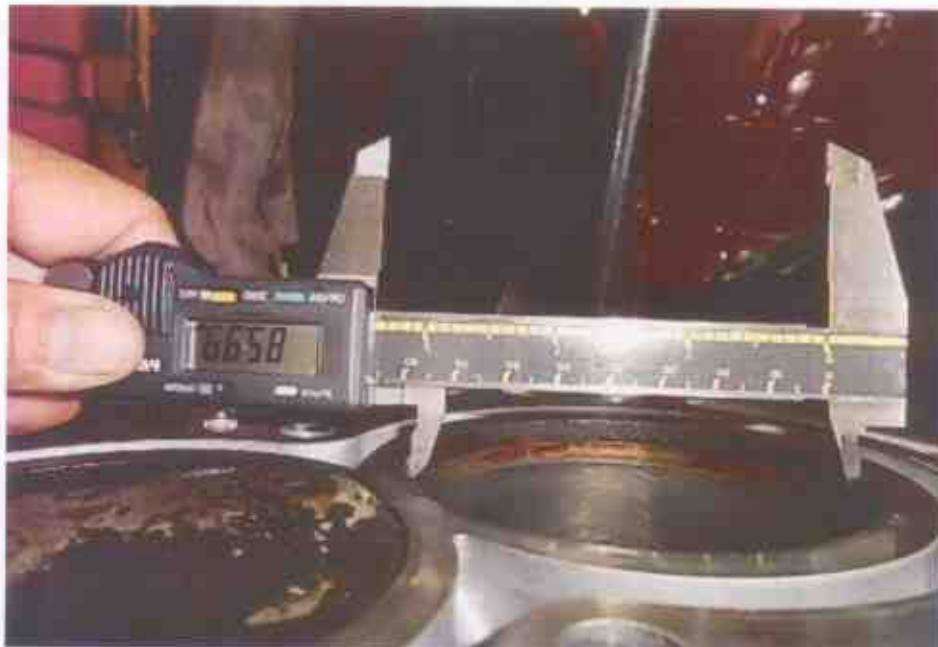
Photo 18 shows the bore measurement of cylinder 4, which was recorded to be 85.99mm.

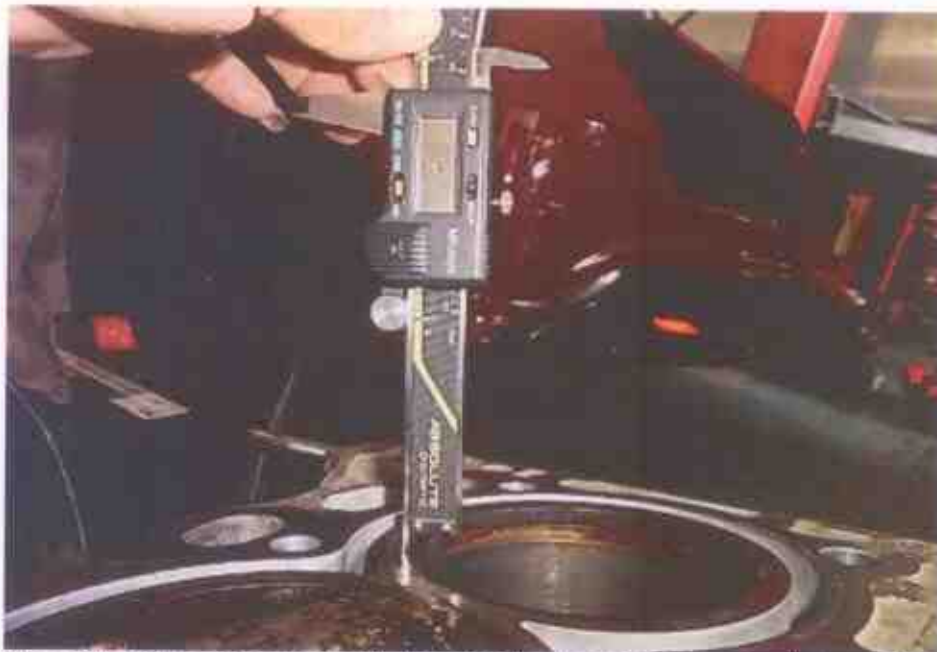
Photo 19 shows measurement being carried out to the stroke of cylinder 4 of the Honda engine. The bore and stroke measurements of the Honda engine were carried out using a digital Vernier Caliper.

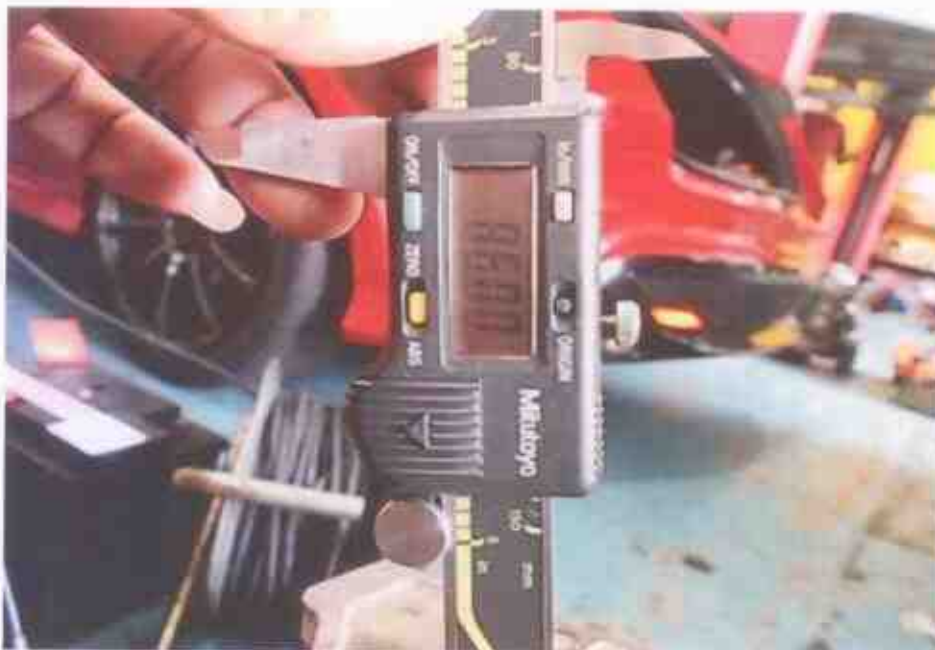
Photo 20 shows the stroke measurement of cylinder 4, which was recorded to be 85.00mm.
