Your Ref: Honda Engine 18 September 2018

Our Ref : CI/TP18017008/D

INSPECTION REPORT OF A HONDA ENGINE WITH ENGINE NUMBER K20A5841950

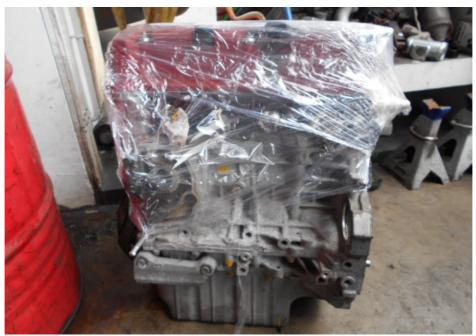
Photo 1 shows a general view of the Honda engine that I had inspected. The Honda engine was observed to be a used engine and was not fitted on any motor car. It was also observed to be a complete assembly with all mechanical parts still intact, within the engine housing. There was no crack and/or hole observed on the engine housing.

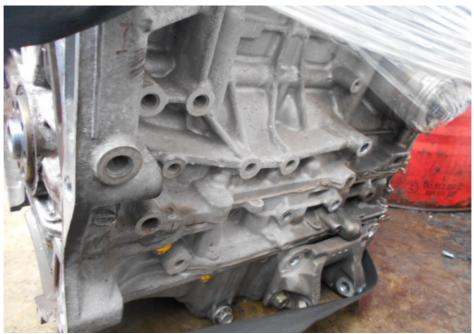
Photo 2 shows a general view of the Honda engine that I had inspected. The Honda engine was not fitted on any motor car. It was observed to be a complete assembly with all mechanical parts still intact, within the engine housing.

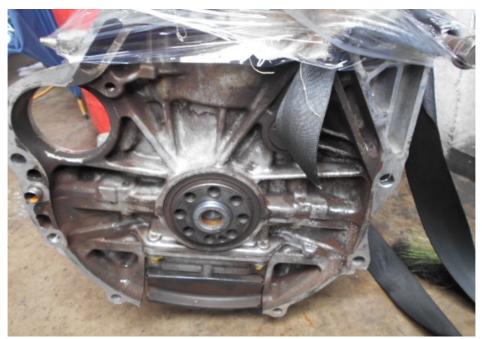
Photo 3 shows a general view of the Honda engine that I had inspected. My visual examination of the engine housing revealed the housing to be of serviceable/satisfactory condition. There was no crack and/or hole observed on the engine housing.

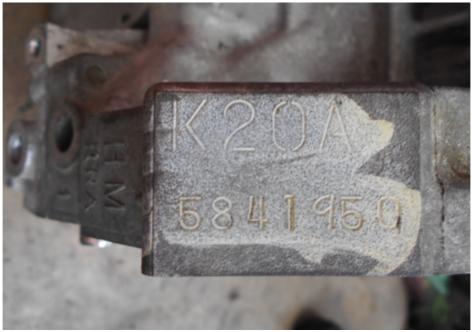
Photo 4 shows the engine number engraved on the housing of the Honda engine that I had inspected. The engine number was K20A5841950.

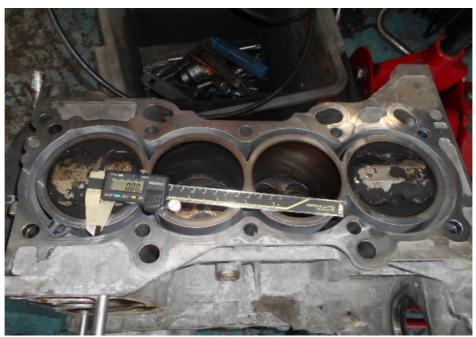
Photo 5 shows the bottom block of the Honda engine with its top block removed for me to carry out measurements of its cylinders, in particular the bore and stroke measurements of each cylinder, which typically can be used to determine the engine displacement or more commonly referred to as engine cc. The measurements were carried out using a digital Vernier Caliper that was calibrated at the start of the measurements.

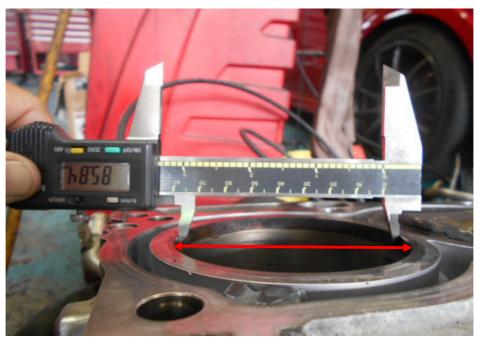
Photo 6 shows measurement being carried out to the bore of cylinder 1 of the Honda engine. The bore and stroke measurements of the Honda engine were carried out using a digital Vernier Caliper. The bore measurement of cylinder 1 was recorded to be 85.84mm.

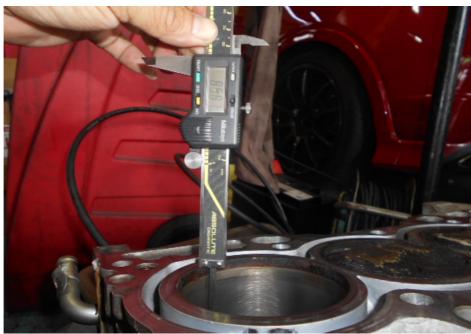
Photo 7 shows measurement being carried out to the stroke of cylinder 1 of the Honda engine. The bore and stroke measurements of the Honda engine were carried out using a digital Vernier Caliper.

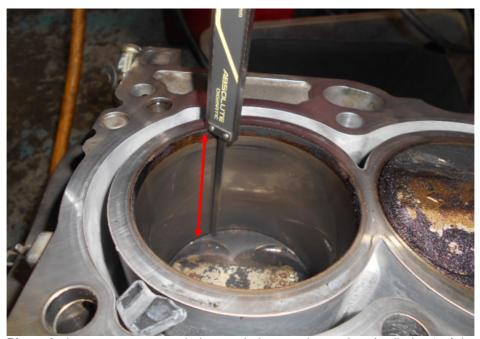
Photo 8 shows measurement being carried out to the stroke of cylinder 1 of the Honda engine. The bore and stroke measurements of the Honda engine were carried out using a digital Vernier Caliper that was calibrated at the start of the measurements.

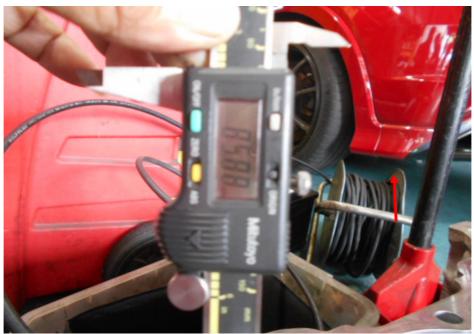
Photo 9 shows the stroke measurement of cylinder 1, which was recorded to be 85.88mm.

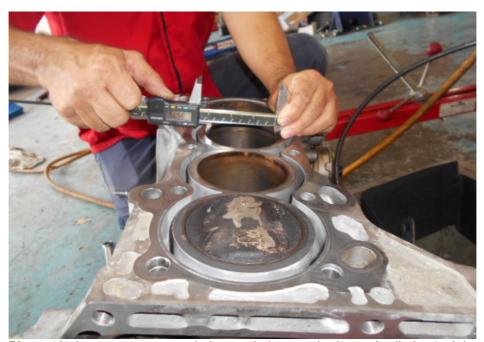
Photo 10 shows measurement being carried out to the bore of cylinder 2 of the Honda engine. The bore and stroke measurements of the Honda engine were carried out using a digital Vernier Caliper.

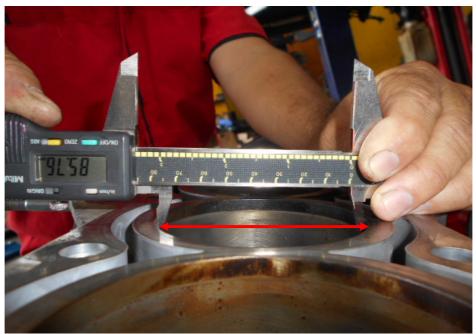
Photo 11 shows the bore measurement of cylinder 2, which was recorded to be 85.76mm.

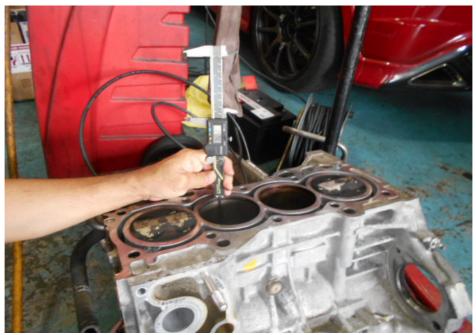
Photo 12 shows measurement of the stroke for cylinder 2 of the Honda engine that I had inspected. The measurement was carried out using a digital Vernier Caliper that was calibrated at the start of the measurements.

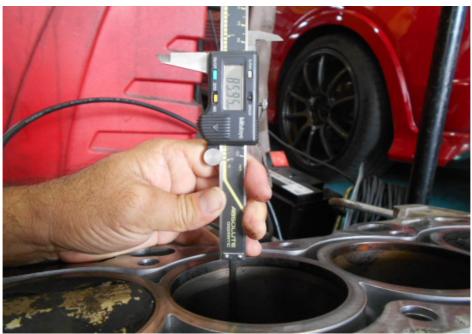
Photo 13 shows the stroke measurement of cylinder 2, which was recorded to be 85.95mm.

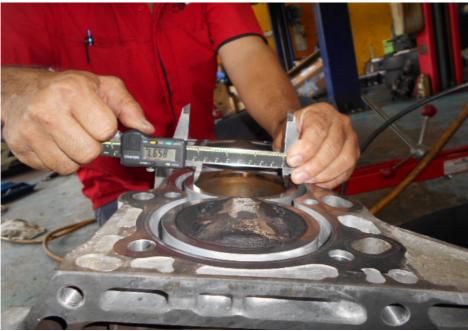
Photo 14 shows measurement being carried out to the bore of cylinder 3 of the Honda engine. The bore and stroke measurements of the Honda engine were carried out using a digital Vernier Caliper. The bore measurement of cylinder 3, which was recorded to be 85.97mm.

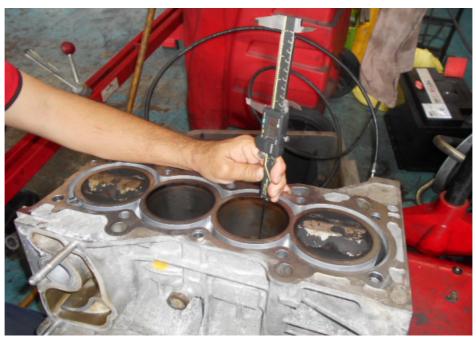
Photo 15 shows measurement of the stroke for cylinder 3 of the Honda engine that I had inspected. The measurement was carried out using a digital Vernier Caliper that was calibrated at the start of the measurements.

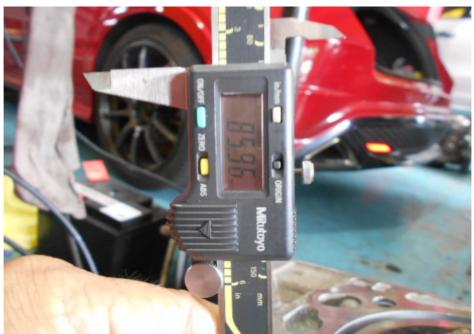
Photo 16 shows the stroke measurement of cylinder 3, which was recorded to be 85.96mm.

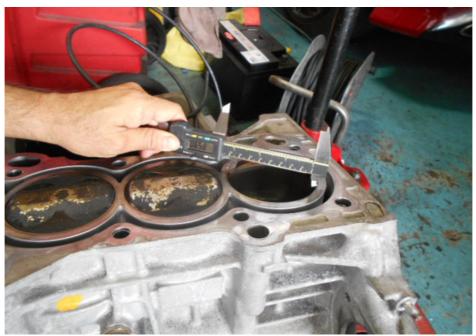
Photo 17 shows measurement being carried out to the bore of cylinder 4 of the Honda engine. The bore and stroke measurements of the Honda engine were carried out using a digital Vernier Caliper that was calibrated at the start of the measurements.

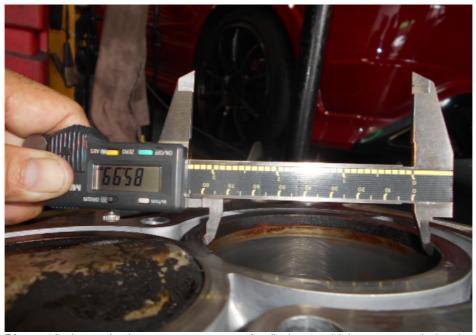
Photo 18 shows the bore measurement of cylinder 4, which was recorded to be 85.99mm.

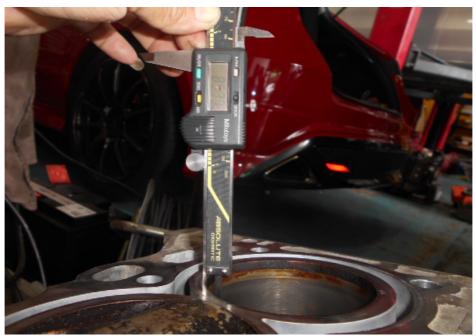
Photo 19 shows measurement being carried out to the stroke of cylinder 4 of the Honda engine. The bore and stroke measurements of the Honda engine were carried out using a digital Vernier Caliper.

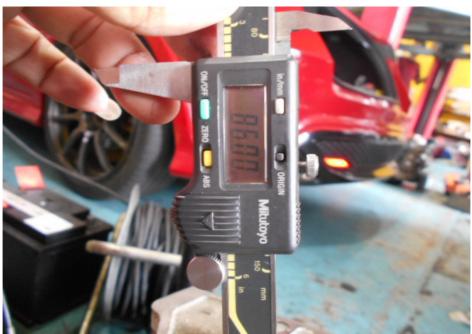
Photo 20 shows the stroke measurement of cylinder 4, which was recorded to be 86.00mm.
