### **ACCIDENT DAMAGED VEHICLE INSPECTION REPORT (WITHOUT PREJUDICE)**

Registration Number	: SLJ 1460 D	Mileage	: 120,221 km
Make & Model	: Saab 9-5 Vector 2.0T (A)	Chassis Number	: YS3GP4AZ9B4002977
Date of Registration	: 14 January 2011	Engine Number	: A20NFT0N03004
Colour	: Grey	Engine Capacity	: 1,998 cc

## 1. Policy Particulars :- THIRD PARTY CLAIM (RESURVEY INSPECTION)

## ADJUSTMENT ON REPAIR COST FOR VEHICLE NO. SLJ 1460D

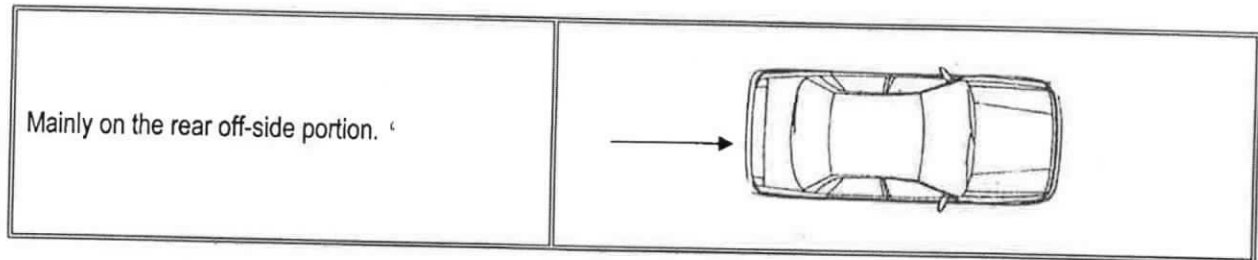
**(5) POINT OF IMPACT**

The impact of the collision has damaged/affected the trunk lid, trunk lid light bar, right rear combination lamp, rear end panel, right rear fender, rear bumper face and etc.  
Please refer to the Annex for a detailed account of the damages and photographs taken.

We have inspected thoroughly the actual damages found on the vehicle before we conclude as to whether the parts needed replacement or repairs. The estimated cost of repair submitted by the repairer is **\$24,608.40**. We have adjusted the cost and recommend that the repairs to be taken on a part by part basis of **\$22,920.44**. In our opinion, the damaged parts are consistent with that caused by the accident.
