Vehicle No. SHD 346L  
Insured Veh. SHA 9181B  
Claim No. D18006912MFSH  
Policy No. D-18088937MFSH  
Accident Date 18/09/2018  
Inspection Date 19/09/2018

### 1. Policy Particulars :- THIRD PARTY CLAIM

## ADJUSTMENT ON REPAIR COST FOR VEHICLE NO. SHD 346L

PHOTOGRAPHS FOR VEHICLE NO. SHD 346L

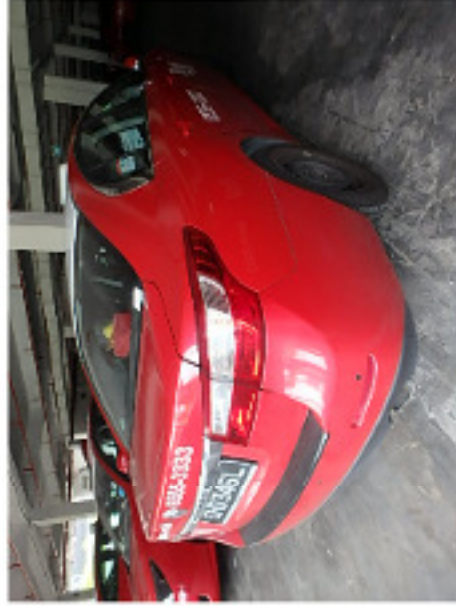
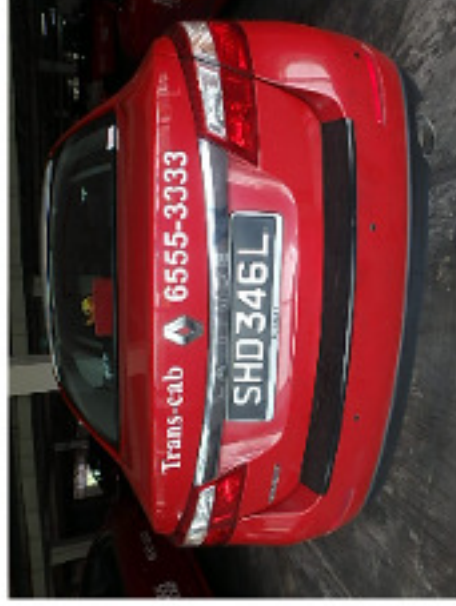
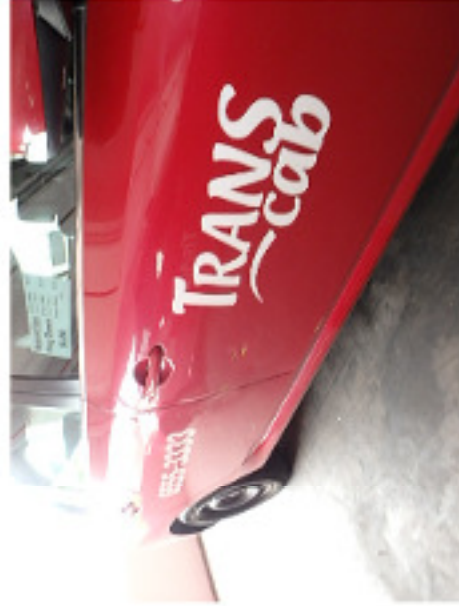
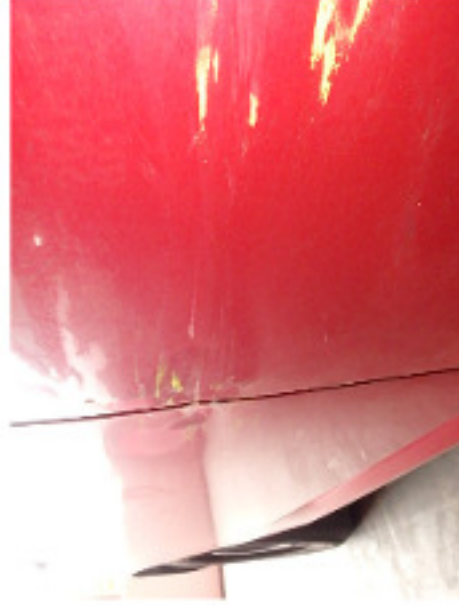
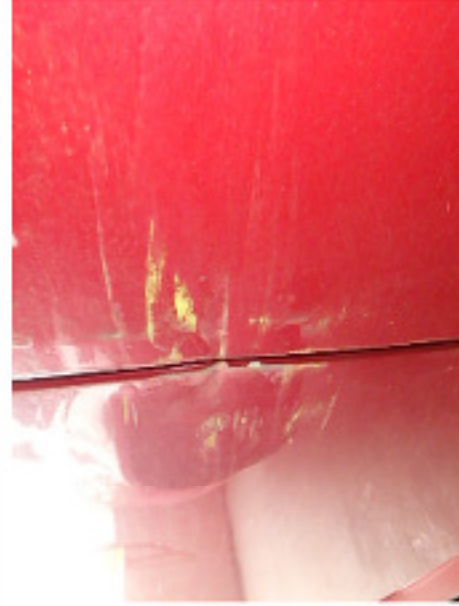
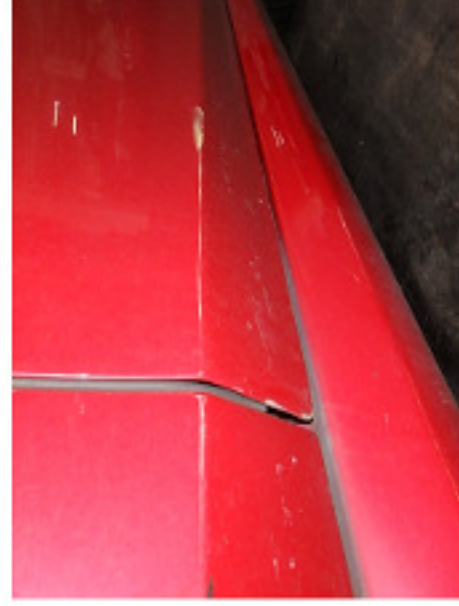
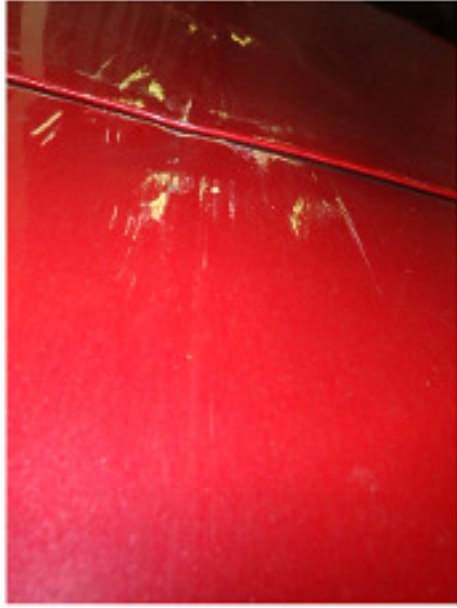
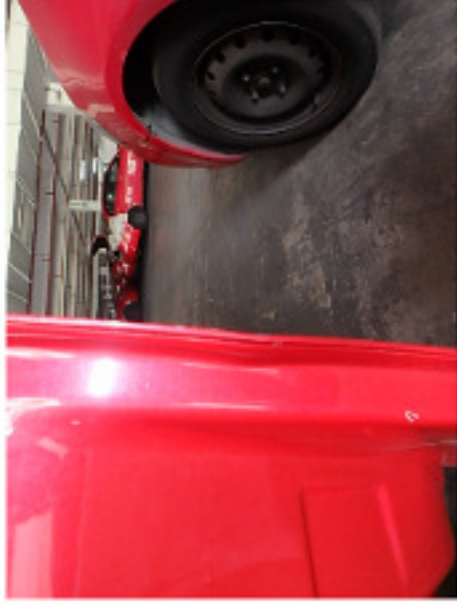
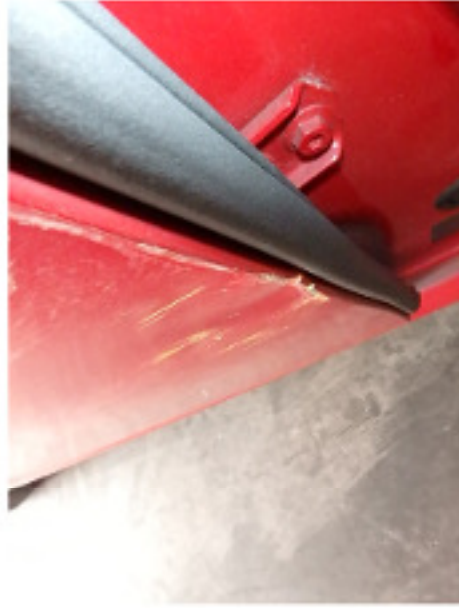
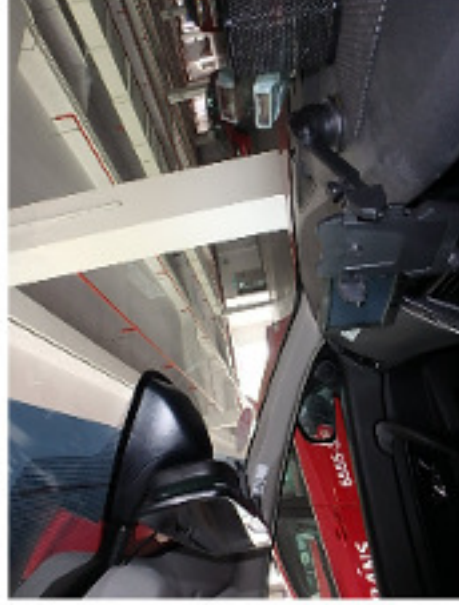
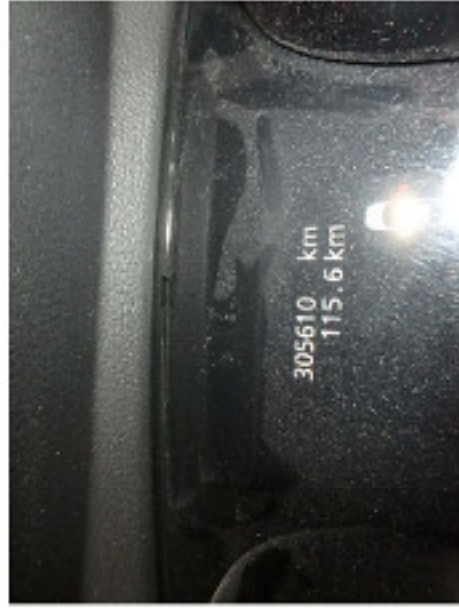
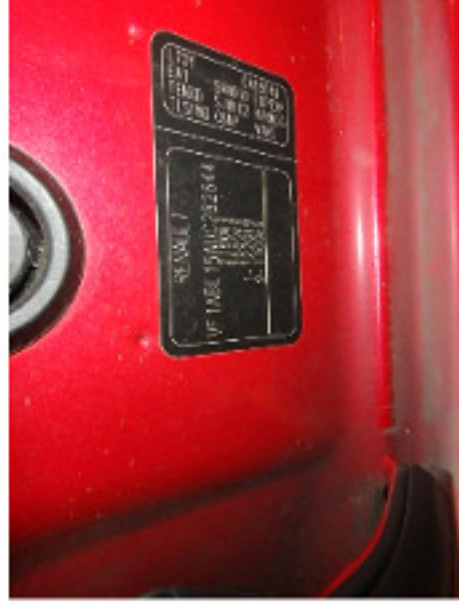
THE VEHICLE SUSTAINED DAMAGES AT THE O/S BODY. DAMAGES SEE DETAILS.
--
