24 September 2018

Your Ref: Honda Engine

Our Ref : CI/TP18017321/D

#### INSPECTION REPORT OF A HONDA ENGINE WITH NUMBER B16A1014205

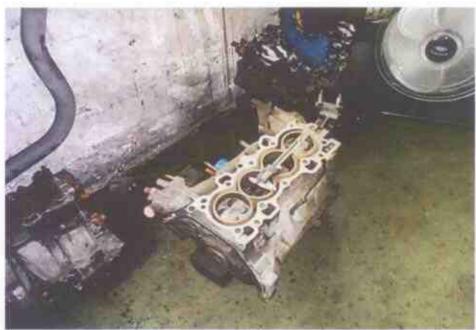
Photo 1 shows a general view of the Honda engine that I had inspected. The Honda engine was observed to be a used engine and was not fitted on any motor car. The top block of the Honda engine was separated from its bottom block. This was to enable me to carry out measurements of its cylinders, in particular the bore and stroke measurements of each cylinder, which typically can be used to determine the engine displacement or more commonly referred to as engine co.

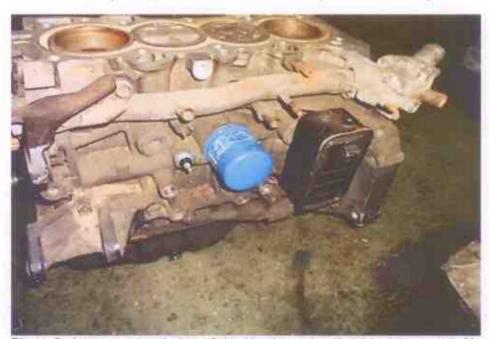
Photo 2 shows a general view of the Honda engine that I had inspected. My visual examination of the engine housing revealed the housing to be of serviceable/satisfactory condition. There was no crack and/or hole observed on the engine housing.

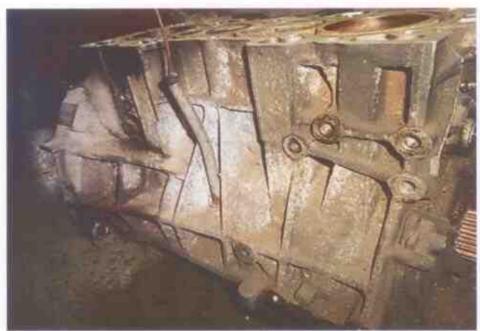
Photo 3 shows a general view of the Honda engine that I had inspected. My visual examination of the engine housing revealed the housing to be of serviceable/satisfactory condition. There was no crack and/or hole observed on the engine housing.

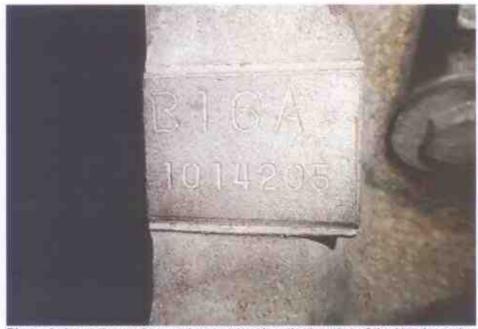
Photo 4 shows the engine number engraved on the housing of the Honda engine that I had inspected. The engine number was B16A1014205.

13. In summary, the Honda engine that I had inspected is a Honda B16A model engine. The engine number engraved on the housing of this Honda engine was B16A1014205.

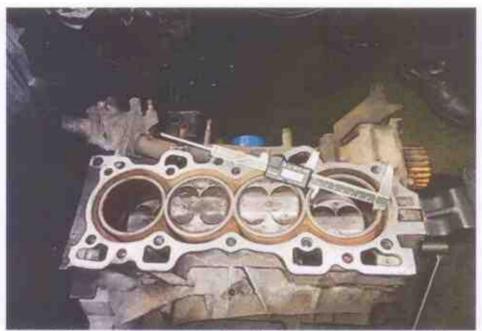
Photo 5 shows the bottom block of the Honda engine and the digital Vernier Caliper that was used to measure the bore and stroke of the Honda engine. The digital Vernier Caliper was calibrated before the start of the measurements.

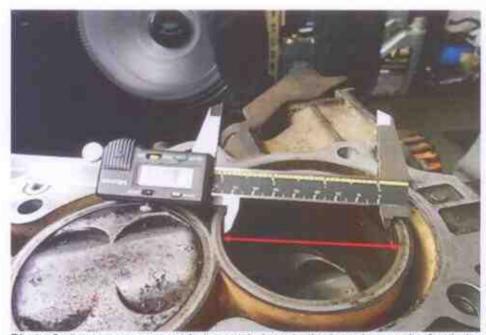
Photo 6 shows measurement being carried out to the bore (arrowed) of cylinder 1 of the Honda engine. The bore measurement of cylinder 1 was recorded to be 80.45mm.

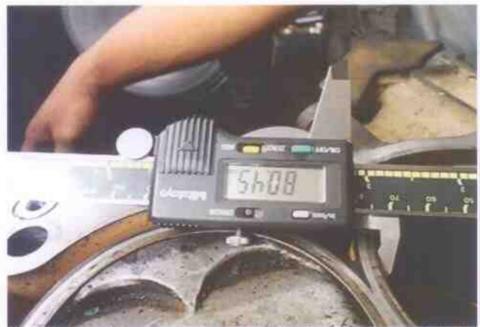
Photo 7 shows the bore measurement of cylinder 1, which was recorded to be 80.45mm.

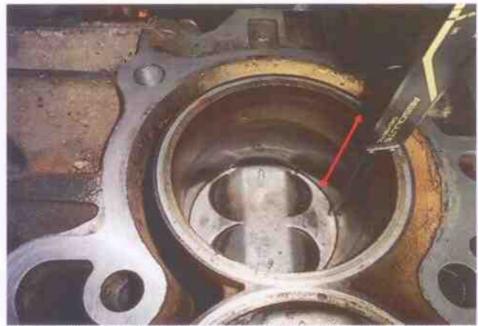
Photo 8 shows measurement being carried out to the stroke (arrowed) of cylinder 1 of the Honda engine. The bore and stroke measurements of the Honda engine were carried out using a digital Vernier Caliper.

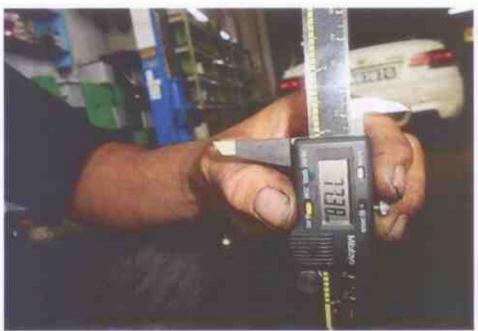
Photo 9 shows the stroke measurement of cylinder 1, which was recorded to be 77.38mm.

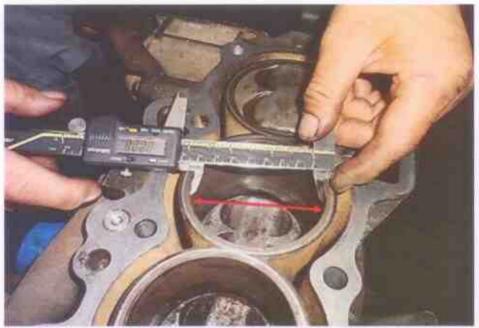
Photo 10 shows measurement being carried out to the bore (arrowed) of cylinder 2 of the Honda engine. The bore measurement of cylinder 2 was recorded to be 80.08mm.

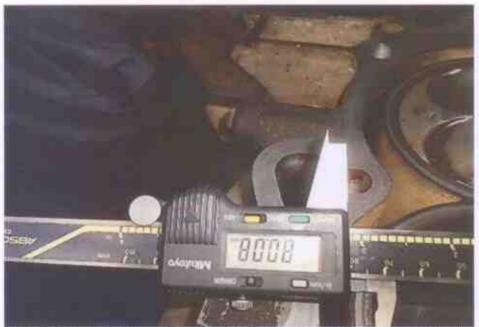
Photo 11 shows the bore measurement of cylinder 2, which was recorded to be 80.08mm.

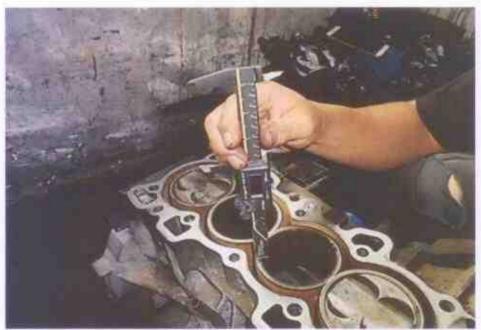
Photo 12 shows measurement of the stroke of cylinder 2 of the Honda engine that I had inspected. The bore and stroke measurements of the Honda engine were carried out using a digital Vernier Caliper, which was calibrated before the start of measurements.

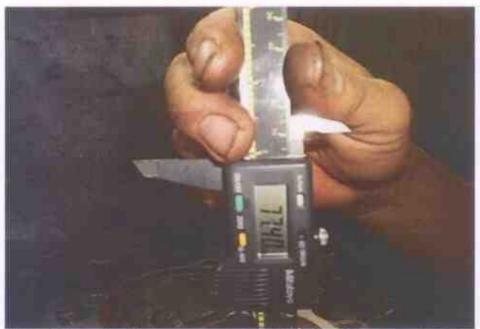
Photo 13 shows the stroke measurement of cylinder 2, which was recorded to be 77.40mm.

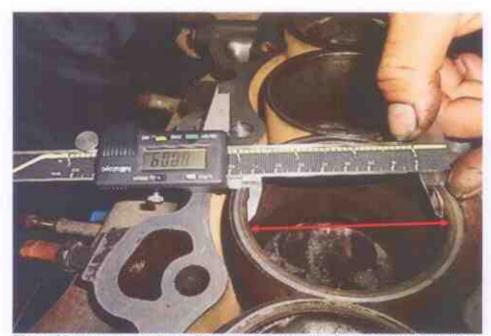
Photo 14 shows measurement being carried out to the bore (arrowed) of cylinder 3 of the Honda engine. The bore and stroke measurements of the Honda engine were carried out using a digital Vernier Caliper. The bore measurement of cylinder 3 was recorded to be 80.09mm.

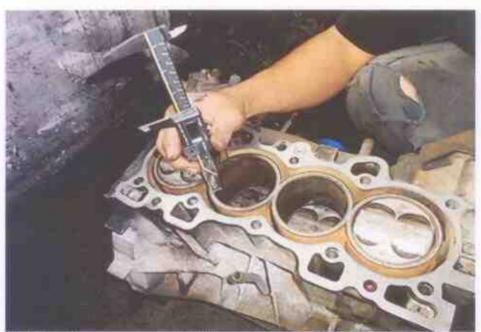
Photo 15 shows measurement of the stroke (arrowed) of cylinder 3 of the Honda engine that I had inspected. The bore and stroke measurements of the Honda engine were carried out using a digital Vernier Caliper that was calibrated before the start of measurements.

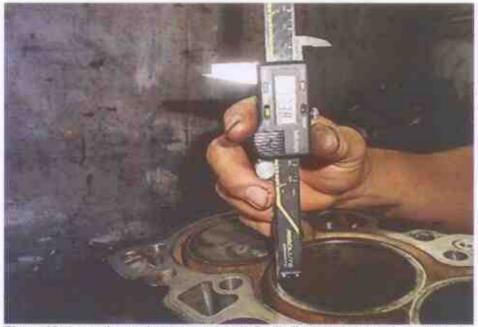
Photo 16 shows the stroke measurement of cylinder 3, which was recorded to be 77.38mm.

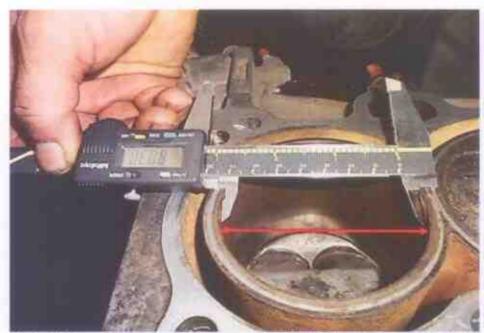
Photo 17 shows measurement being carried out to the bore (arrowed) of cylinder 4 of the Honda engine. The bore and stroke measurements of the Honda engine were carried out using a digital Vernier Caliper that was calibrated at the start of the measurement. The bore measurement of cylinder 4 was recorded to be 80.30mm.

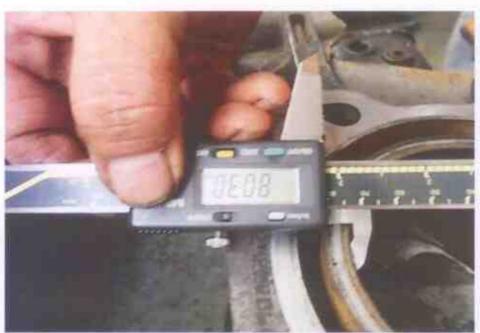
Photo 18 shows the bore measurement of cylinder 4, which was recorded to be 80.30mm.

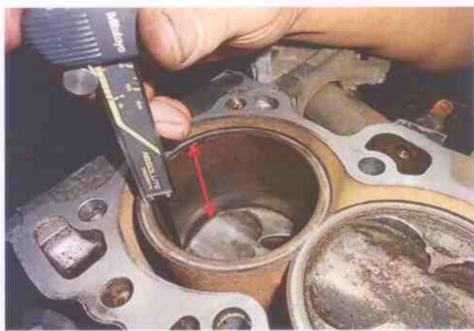
Photo 19 shows measurement being carried out to the stroke (arrowed) of cylinder 4 of the Honda engine. The bore and stroke measurements of the Honda engine were carried out using a digital Vernier Caliper that was calibrated before the start of measurements.

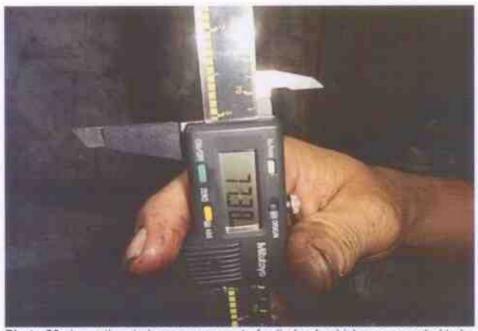
Photo 20 shows the stroke measurement of cylinder 4, which was recorded to be 77.38mm.
