Our ref: CS/FCI18017835/Uvd3

INITIAL INSPECTION REPORT OF VEHICLE NO. GBB 5608E

1. Policy Particulars :- THIRD PARTY CLAIM				
Insured Veh.	SHD 3960T	Veh. Inspected	GBB 5608E	
Policy No.		Coverage (\$)	0.00	
Claim No.	D18007160MFSH	Excess (\$)	0.00	
Assign From	MAY CHUA	Assign Date	02/10/2018

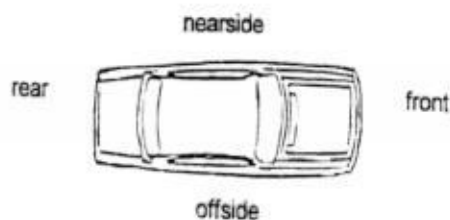
The vehicle sustained damages at the rear o/s portion.

Comments/Present Status:
Damages Consistent
