## LKK Auto Consultants Pte Ltd

Vehicle No. SJP 2921B  
Insured Veh. SKS 893J  
Claim No. VC011922  
Policy No. GA052501  
Accident Date 01/10/2018  
Inspection Date 11/10/2018

## ADJUSTMENT ON REPAIR COST FOR VEHICLE NO. SJP 2921B

### PHOTOGRAPHS FOR VEHICLE NO. SJP 2921B

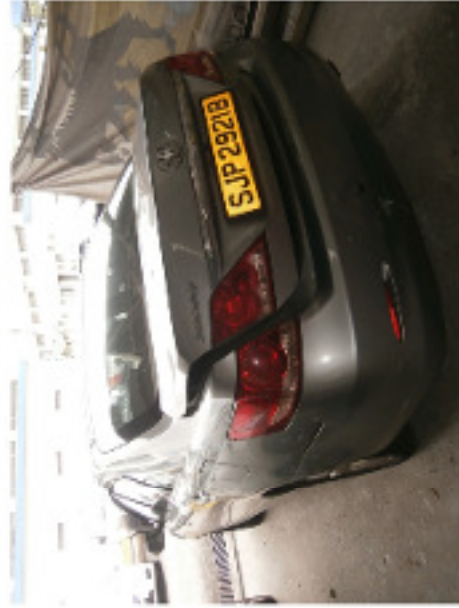
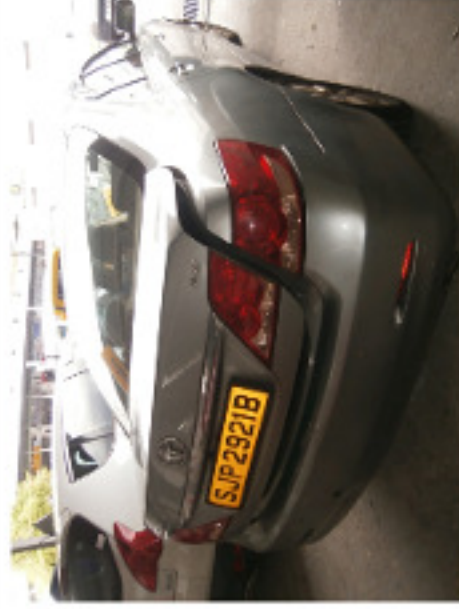
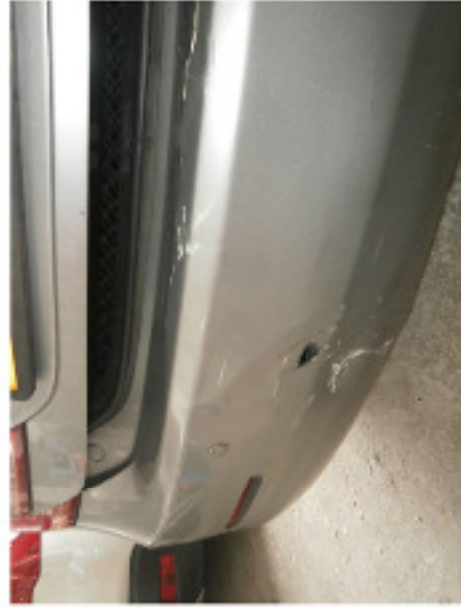
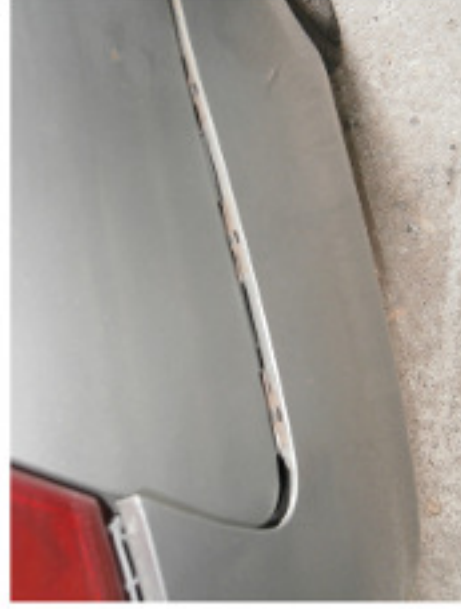
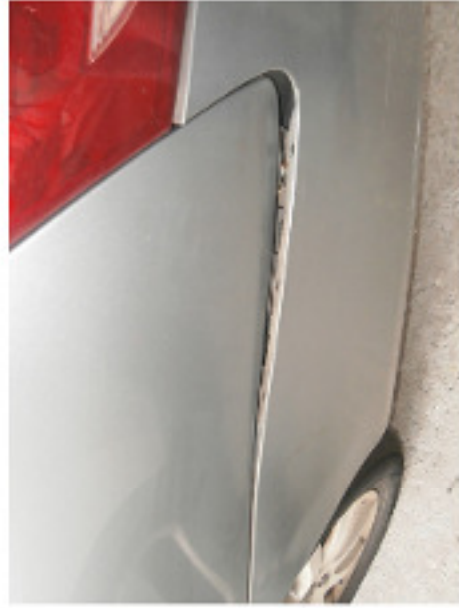
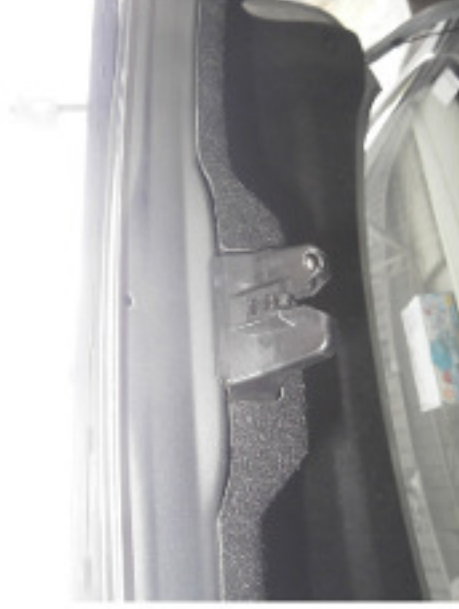
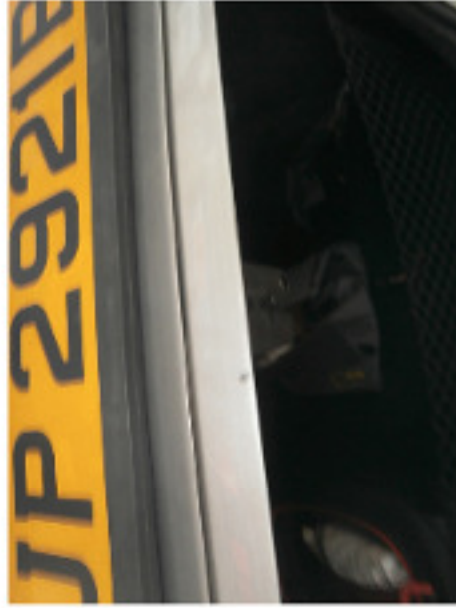
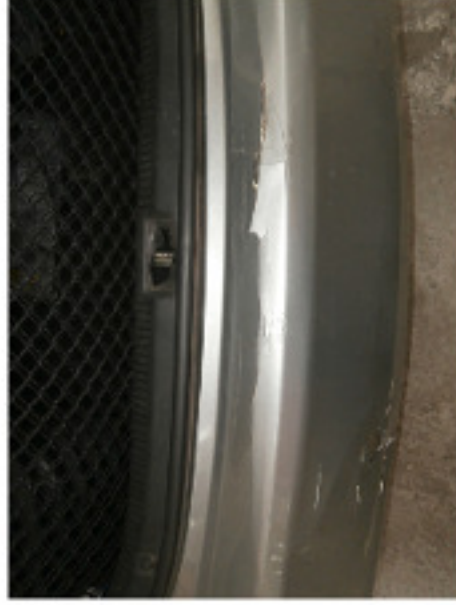
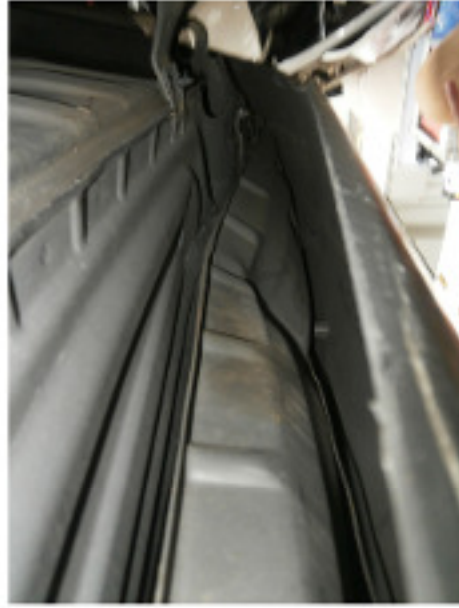
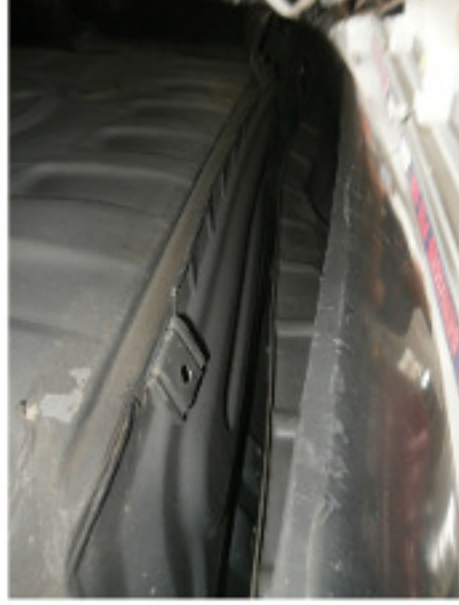
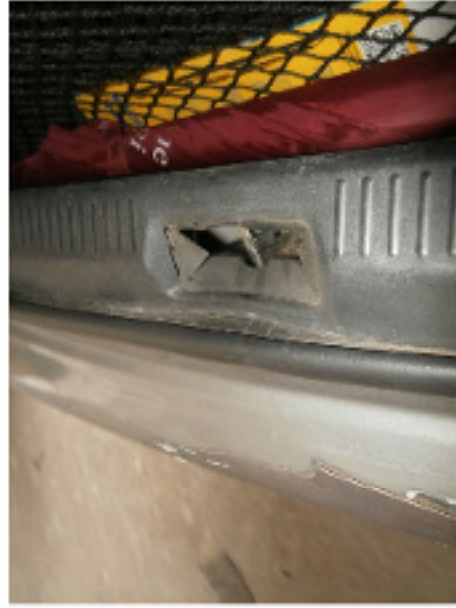
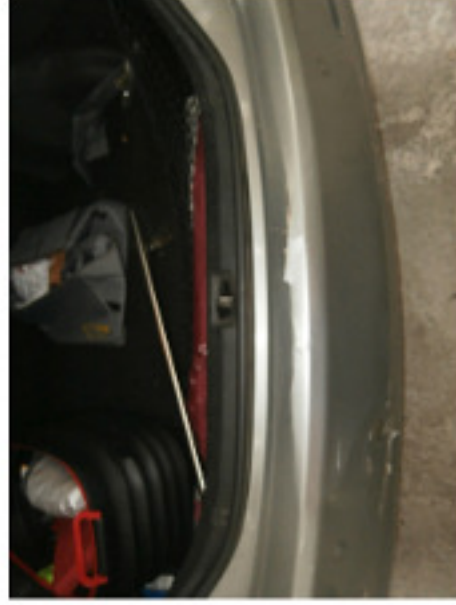
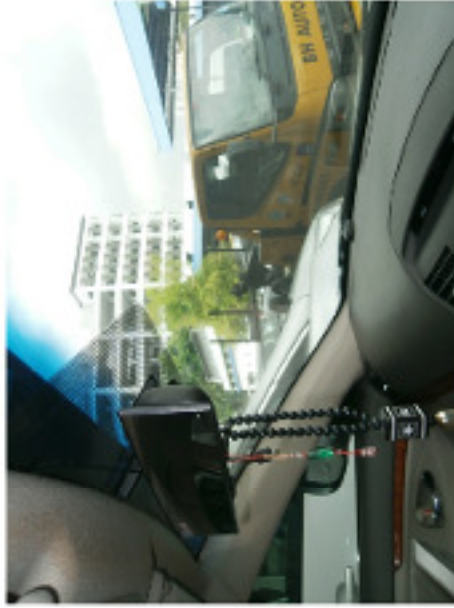
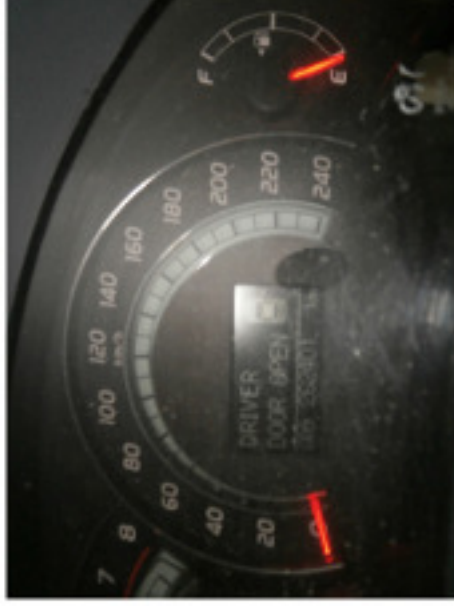
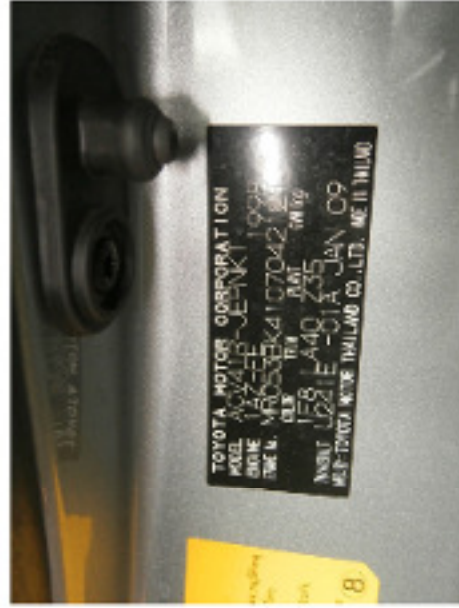
### INSPECTION

<b>R/H Front Tyre</b>	215/60 R16	YOKOHAMA	1 mm
	<b>L/H Front Tyre</b>	215/60 R16	YOKOHAMA	1 mm
	<b>R/H Rear Tyre</b>	215/60 R16	YOKOHAMA	7 mm
	<b>L/H Rear Tyre</b>	215/60 R16	YOKOHAMA	7 mm
<b>4. Description of Damages</b>				
	THE VEHICLE SUSTAINED DAMAGES AT THE REAR PORTION. DAMAGES SEE DETAILS.			
<b>5. General Information</b>				
	<b>Accident Date</b>	01/10/2018	<b>Inspection Date</b>	11/10/2018
	<b>Survey held at</b>	BH AUTO SERVICES PTE LTD BLK 1 SIN MING INDUSTRIAL ESTATE SECTOR C #01-115 SINGAPORE 575636		
<b>5a. Remarks</b>				
	A)THE INSPECTION WAS CONDUCTED ON A"WITHOUT PREJUDICE" BASIS. B)IN ACCORDANCE TO YOUR INSTRUCTIONS, WE HAVE NOT AUTHORISED REPAIRS.			
<b>5b. Estimate Days of Repair</b>				
	ESTIMATED NORMAL PERIOD FOR REPAIR:		<b>4 Working Days</b>
