Your Ref: Mini Cooper S
(chassis number WMWXM720902A79004)
Our Ref : CI/TP18018072/D

04 October 2018

**INSPECTION REPORT OF AN UNREGISTERD MINI COOPER S MOTOR CAR
WITH CHASSIS NUMBER WMWXM720902A79004**

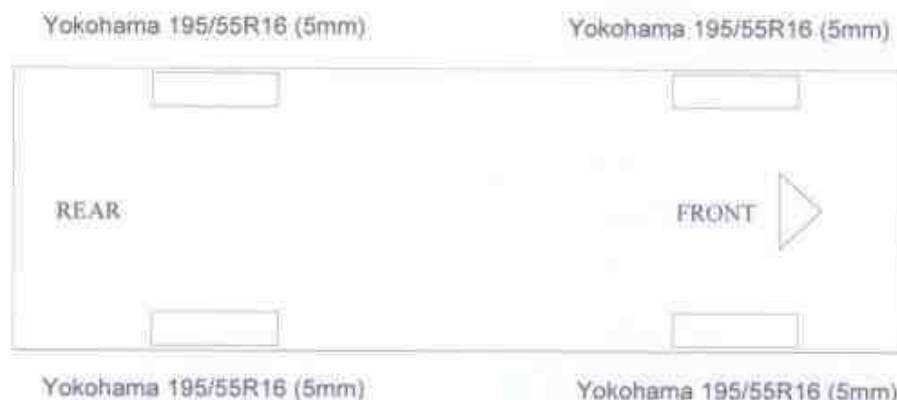
6. It was fitted with 16inch sport wheel rims that were wrapped with tyres that were observed to be of serviceable condition. The tyres were also sufficiently inflated for vehicular operation. The tyre brand, tyre size and approximate remaining tread depth of the 4 tyres of the Motor Car were recorded as follows: -

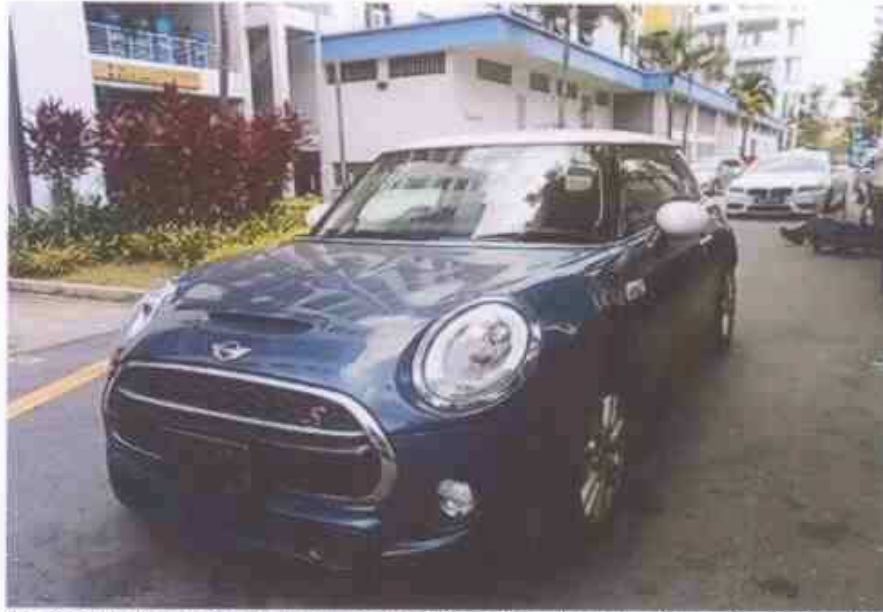
5. The Motor Car was observed to be in a relatively good general condition with no loose exterior fittings observed.

Photo 1 shows a general view of the front left body of the Motor Car at the time of my inspection. The Motor Car was observed to be in relatively good general condition with no loose exterior fittings observed.

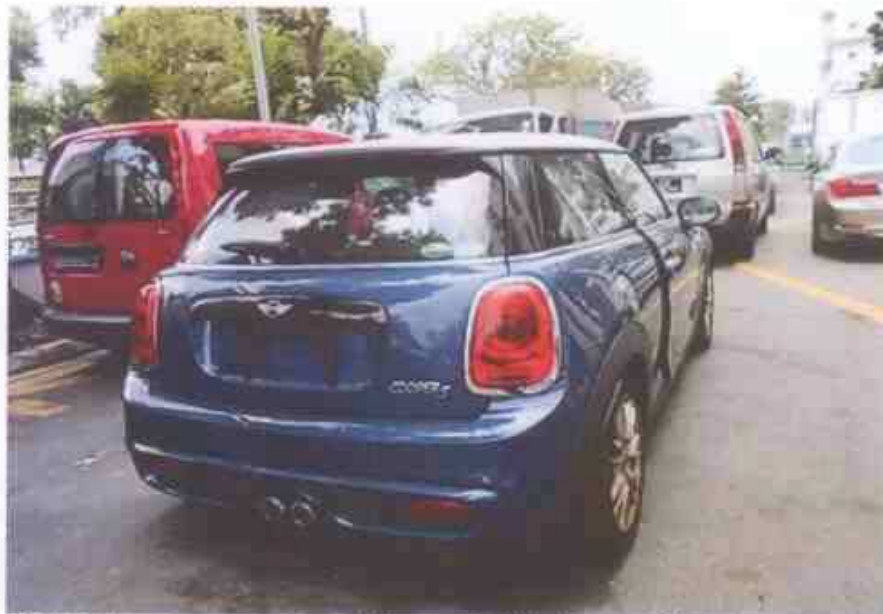
Photo 2 shows a general view of the rear right body of the Motor Car at the time of my inspection. The Motor Car was observed to be in relatively good general condition with no loose exterior fittings observed.

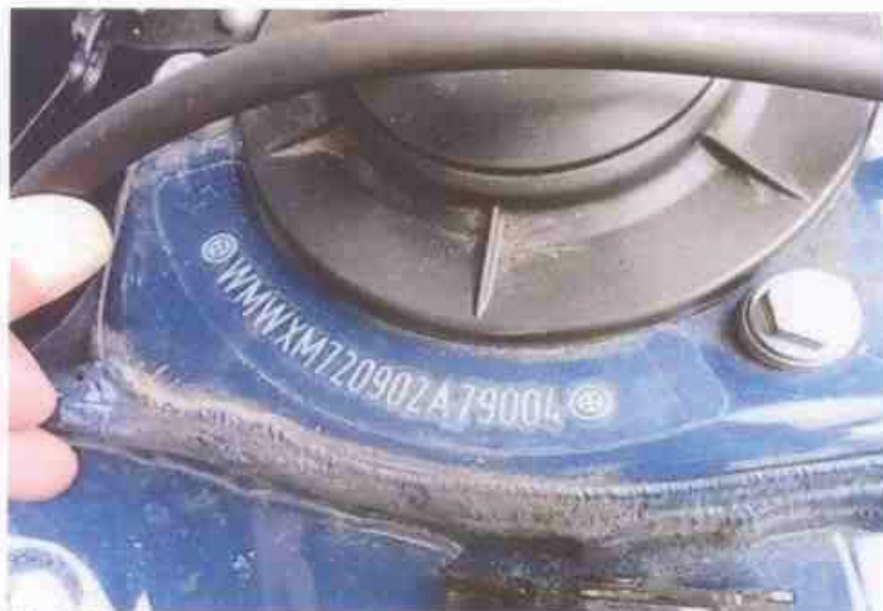
Photo 3 shows the chassis number of the Motor Car. The chassis number recorded was WMWXM720902A79004.

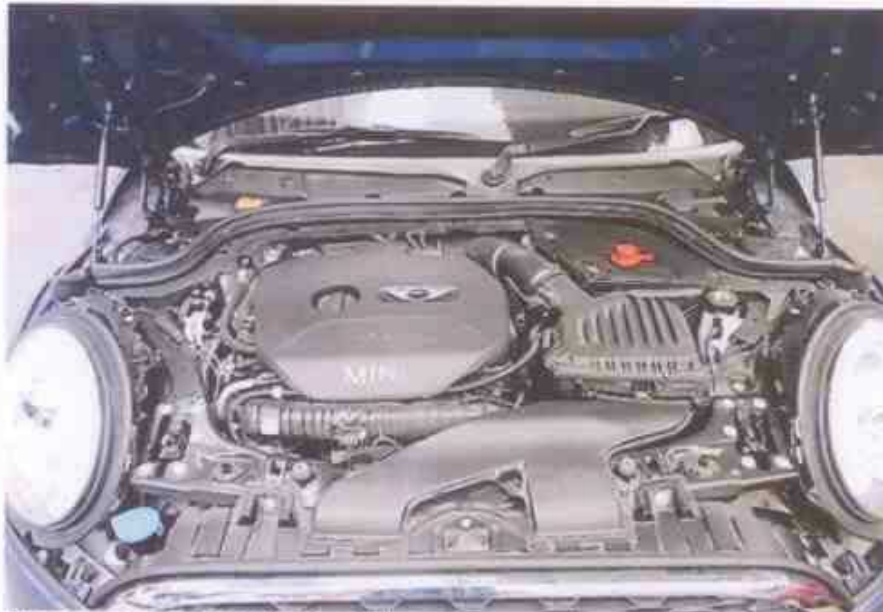
12. My examination of the engine compartment of the Motor Car revealed that the various parts and components inside the engine compartment were all intact and properly fitted. The engine oil, brake fluid and engine coolant were all found to be of sufficient level for operating purposes. Visually, there was also no contamination found to these fluids.
13. My checks on the underside of the Motor Car revealed no sign(s) or indication(s) of fluid leakage and/or fluid stain(s). The engine block and automatic transmission assembly were both secured properly. They were not mounted onto the chassis body or any integral body part of the Motor Car. All undercarriage components of the Motor Car were also observed to be intact and secured in an appropriate manner.

Photo 4 shows a general view of the engine compartment of the Motor Car at the time of my inspection. The various parts and components inside the engine compartment were all observed to be intact and properly fitted. There was also no sign(s) or indication(s) of fluid leak and/or fluid stain found inside the engine compartment.

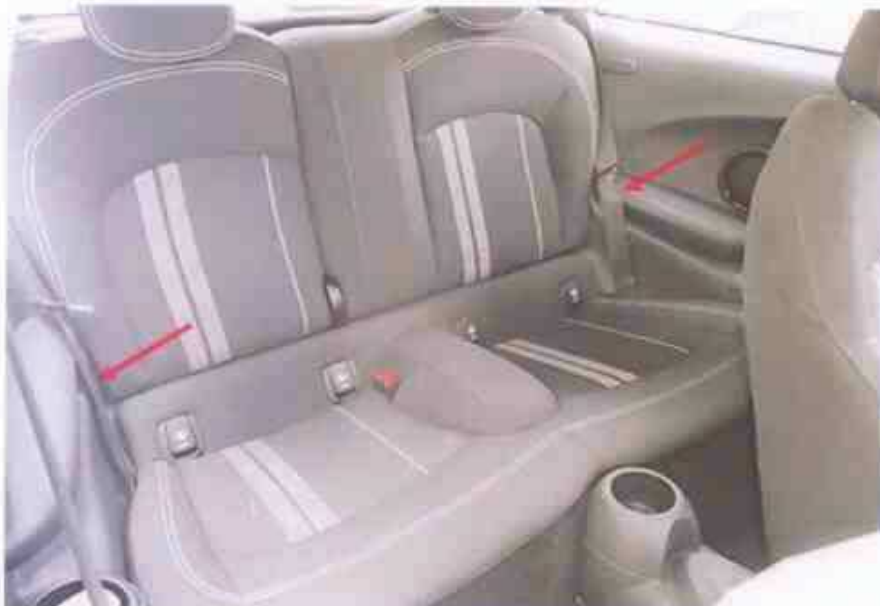
10. The seats of the Motor Car were found to be secured to the floor board of the Motor Car via seat rails bolted onto the floor board. Retractable seat belt reels and pre-tensioners were fitted on all seats of the Motor Car. The seat belt reels were able to be fastened securely to the respective pre-tensioner that is fixed to the side of all the seats.

Photo 5 shows the rear seats of the Motor Car. All the seats of the Motor Car were fitted with a retractable seat belt reel (arrowed) and pre-tensioner. The seat belts were also able to be fastened to the pretension that were fitted on the side of each individual seat.

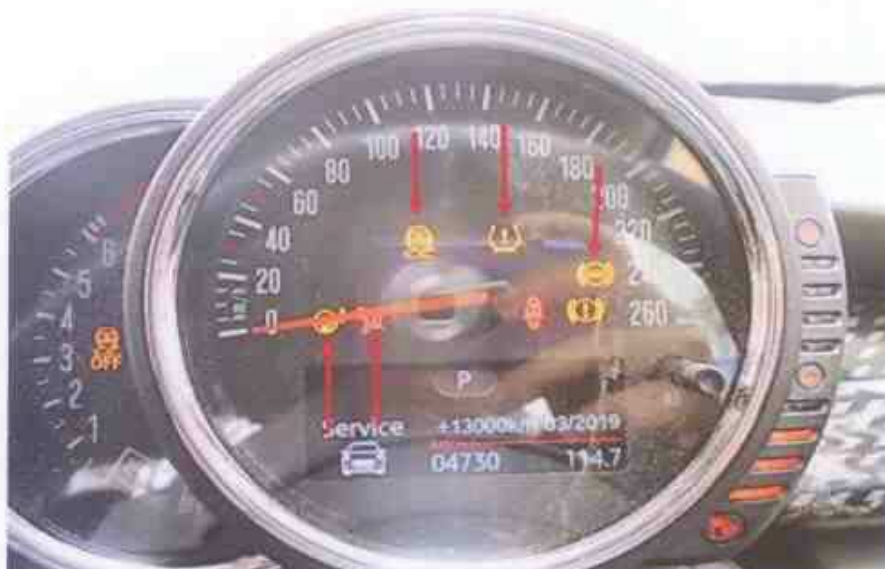
11. The Motor Car's automatic self-test of the functionality of its various electronic safety features like the Anti-Brake Lock System (ABS), Supplemental Restraint System (SRS), Integral Active Steering (IAS), Tyre Pressure Monitor (TPM) and Dynamic Stability Control (DSC) during cranking of the engine had indicated that these electronic systems were in working condition. This was determined from the respective warning lights disappearing from the instrument panel after the self-test.

Photo 6 shows the warning lights for the various electronic safety features appearing on the instrument panel of the Motor Car during its self-test when the engine is cranked, in particular the ABS, SRS, IAS, TPM and DSC lights (arrowed).

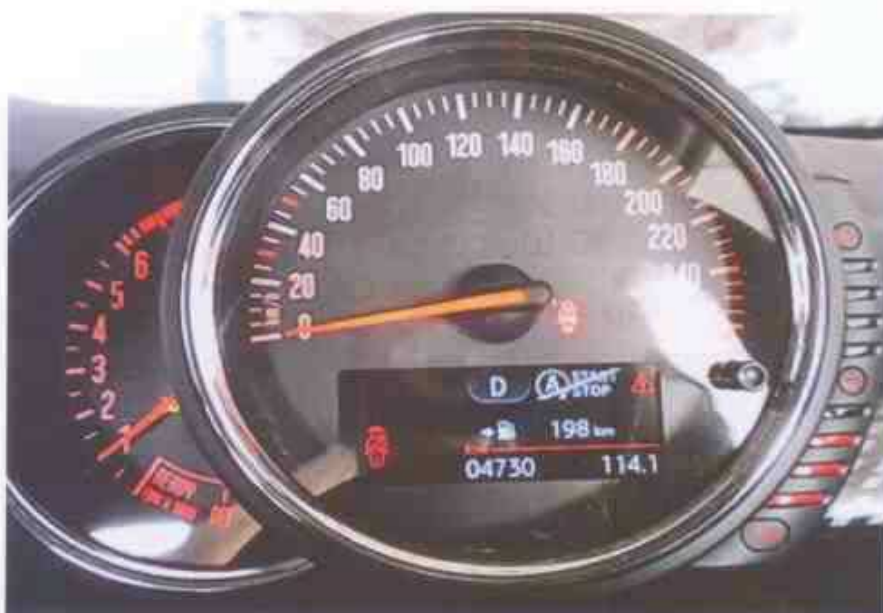
Photo 7 shows the respective warning lights no longer illuminated, indicating that there is no fault detected to the ABS, SRS, IAS, TPM and DSC lights of the Motor Car during the self-test. These electronic systems were hence in working condition at the time of my inspection.

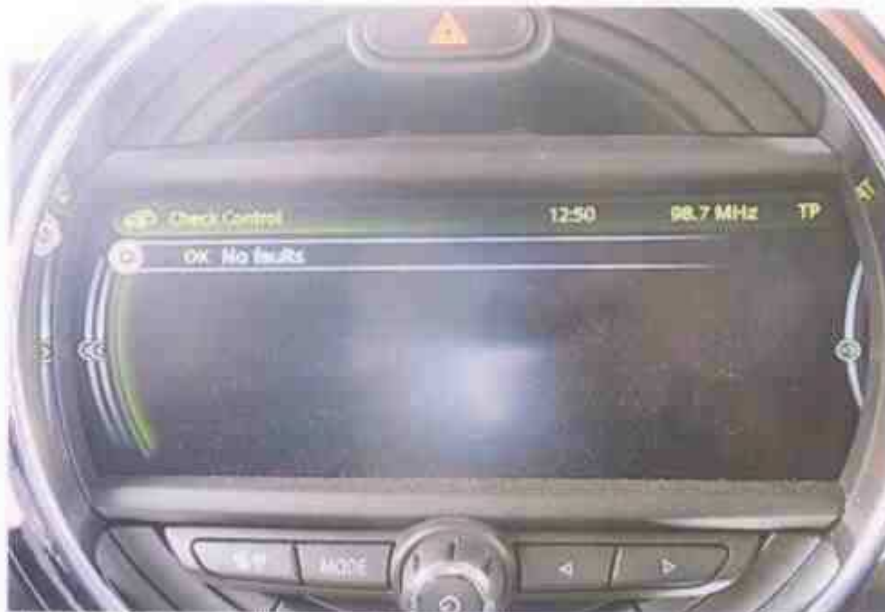
19. An on-board self-diagnostic check on the various controls and systems of the Motor Car was initiated during my inspection, and at the end of the check, there was no fault(s) found.

Photo 8 shows no fault(s) was detected to the various controls and systems of the Motor Car after my initiation of the Motor Car's on-board self-diagnostic check.

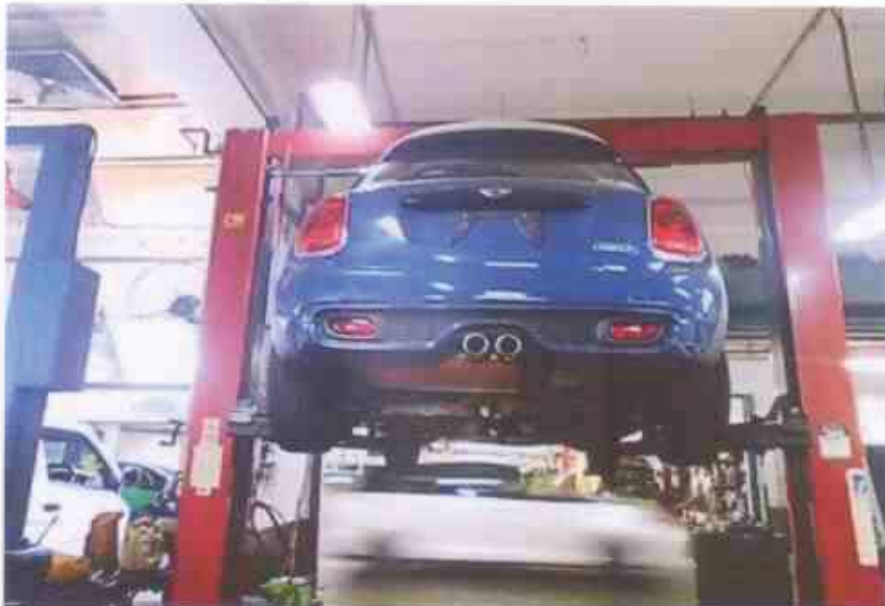
Photo 9 shows the Motor Car hoisted up for checks on its undercarriage. There was no sign(s) or indication(s) of fluid leakage and/or fluid stain(s). The undercarriage components of the Motor Car were also all observed to be intact and secured in an appropriate manner.

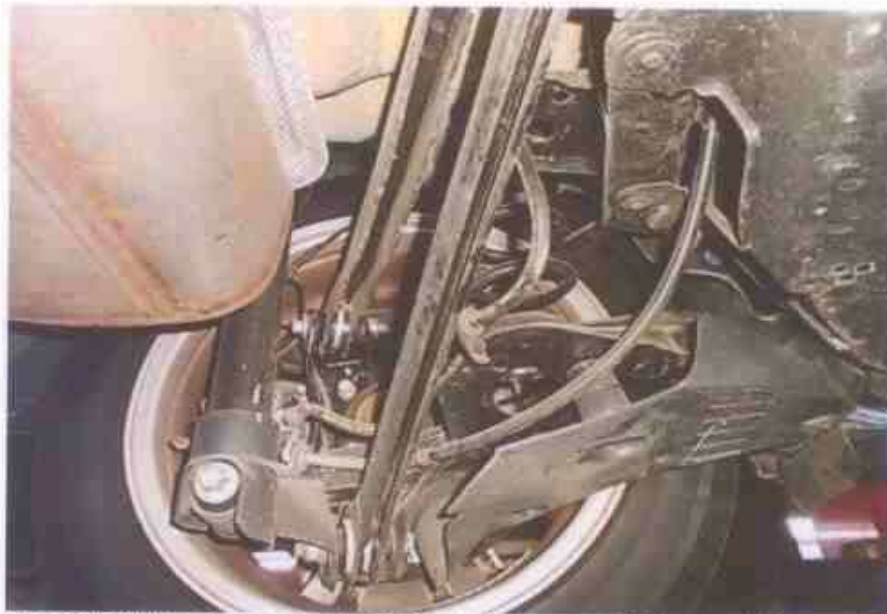
Photo 10 shows a general view of the control arms and linkages at the rear left wheel of the Motor Car. I did not observe any fluid leak and/or fluid stain on the underside of the Motor Car. All of the Motor Car's undercarriage components were observed to be intact and secured in an appropriate manner.

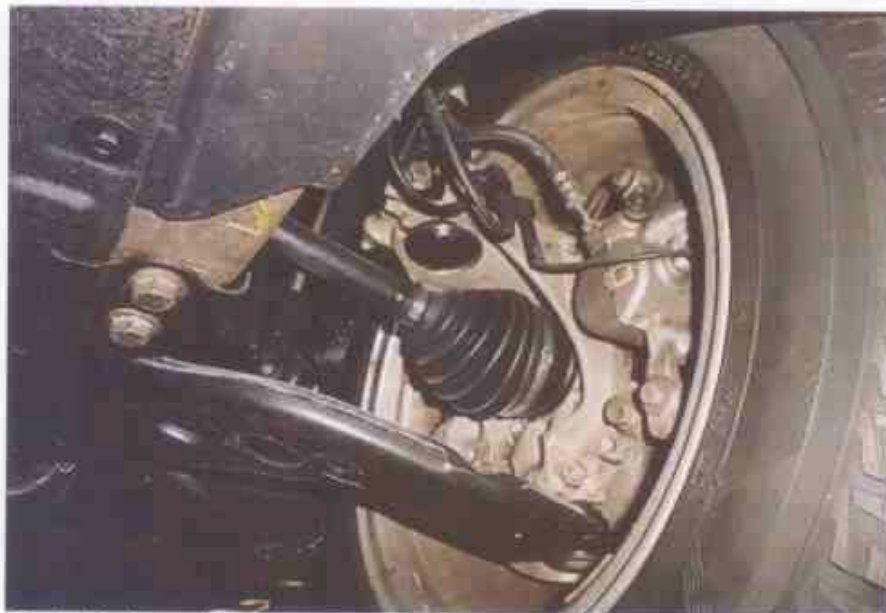
Photo 11 shows the various undercarriage components at the front left wheel of the Motor Car. The mechanical components, control arms and linkages were all found to be intact and secured in an appropriate manner.

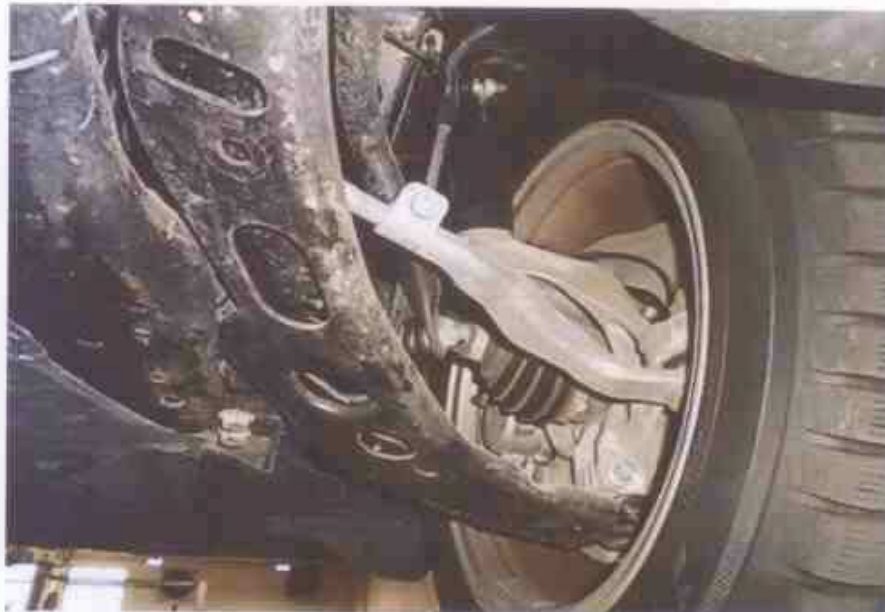
Photo 12 shows the various undercarriage components at the front right wheel of the Motor Car. The mechanical components, control arms and linkages were all found to be intact and secured in an appropriate manner.

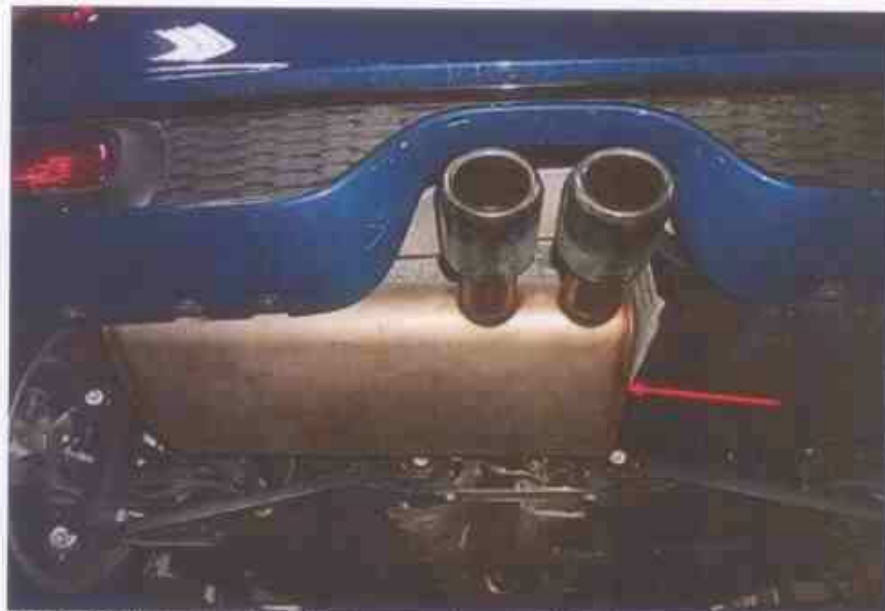
Photo 13 shows the Motor Car's rear exhaust muffler (arrowed). My examination of the Motor Car's exhaust system revealed no sign(s) or indication(s) of any cut or weld marks along its exhaust pipes and on its rear muffler.

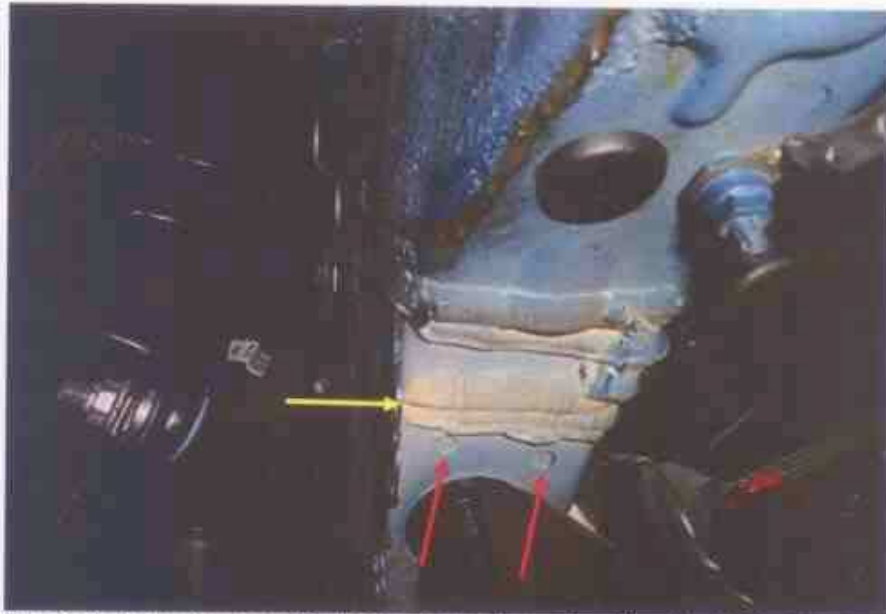
9. Visually, I did not find any weld marks, other than the original spot weld marks, on the chassis body of the Motor Car. The original factory sealant at the joints along the chassis body was also untouched, again indicating that no replacement of the chassis body was carried out; and that the chassis body was originally fitted.

Photo 14 shows the front left chassis of the Motor Car. Visually, I did not find any weld marks other than original spot weld marks (red arrow) on the chassis body of the Motor Car. The original factory sealant (yellow arrow) at the joints along the chassis body was also untouched, indicating no work was done on the chassis body of the Motor Car and that the chassis body was originally fitted.

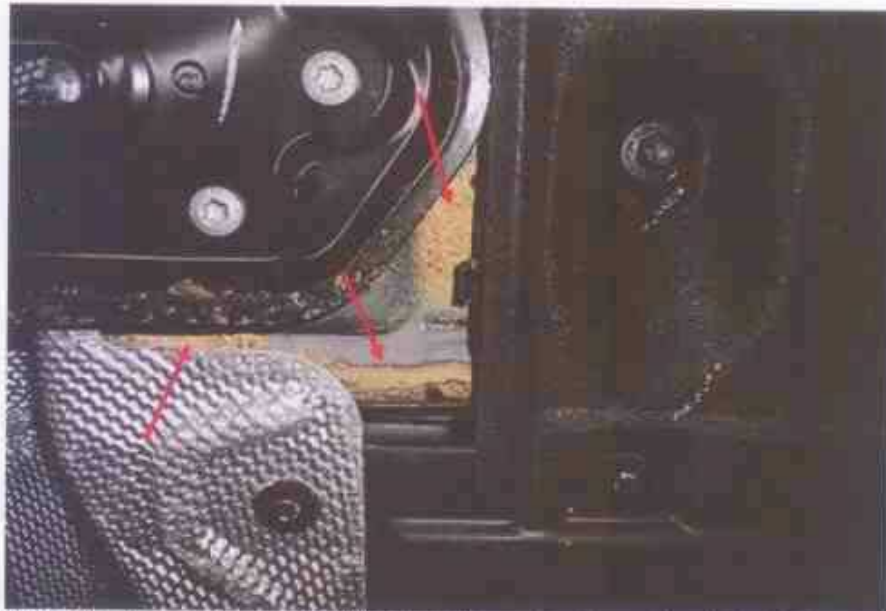
Photo 15 shows the structural body at the underside centre of the Motor Car. The original factory sealant (arrowed) at the joints along the chassis body was also untouched, indicating no work was done on the chassis body of the Motor Car and that the chassis body was originally fitted.

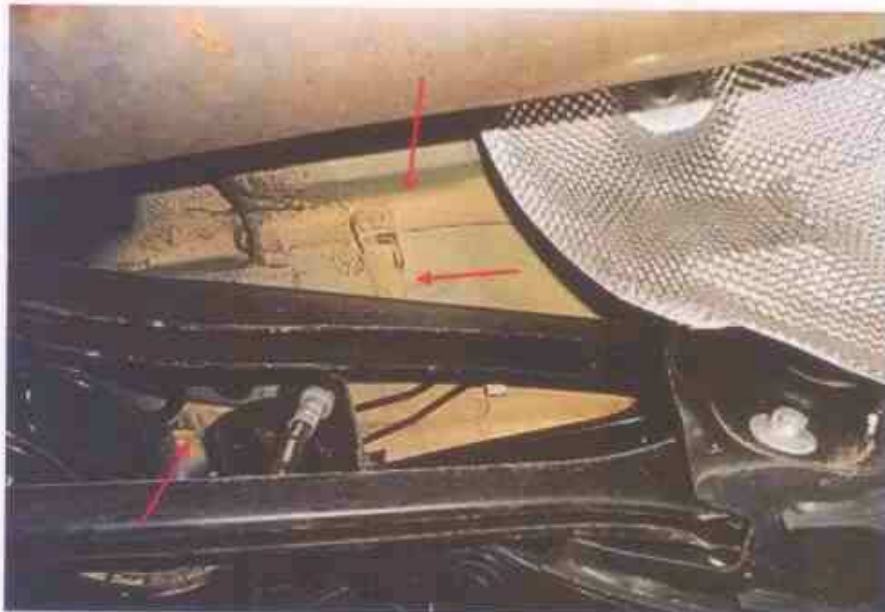
Photo 16 shows the structural body at the underside rear centre of the Motor Car. Visually, The original factory sealant (arrowed) at the joints along the chassis body was untouched, indicating no work was done on the chassis body of the Motor Car and that the chassis body was originally fitted

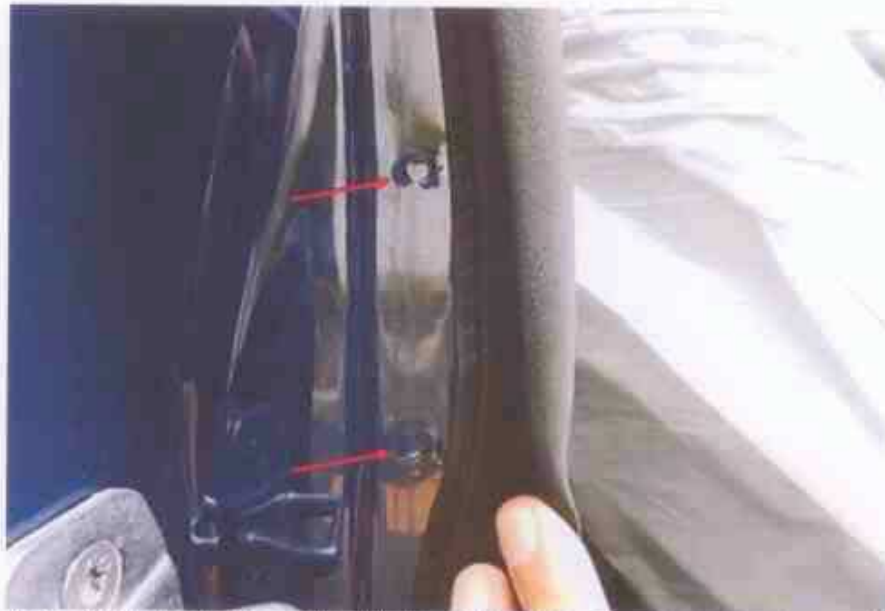
Photo 17 shows the rear right "B" pillar of the Motor Car. I did not find any weld marks other than original spot weld marks (arrowed) on the body panels of the Motor Car, indicating that there was no re-welding works carried out; and that the body panels of the Motor Car were originally fitted

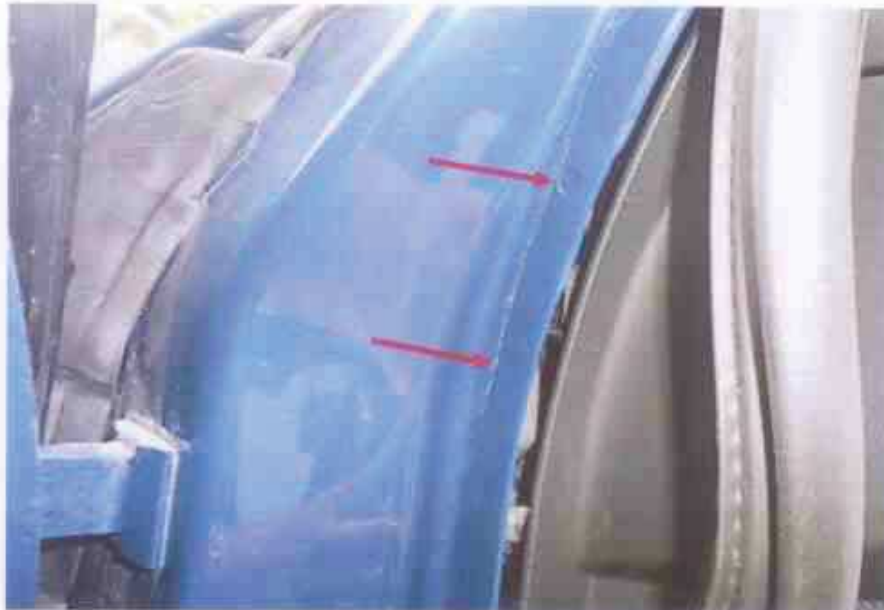
Photo 18 shows the front left "A" pillar of the Motor Car. I did not find any weld marks other than original spot weld marks (arrowed) on the body panels of the Motor Car, indicating that there was no re-welding works carried out; and that the body panels of the Motor Car were originally fitted.
