Your Ref: BMW 420i
(chassis number WBA4D32050G754701)
Our Ref : CI/TP18018073/D

04 October 2018

INSPECTION REPORT OF AN UNREGISTERD BMW 420i MOTOR CAR WITH CHASSIS NUMBER WBA4D32050G754701

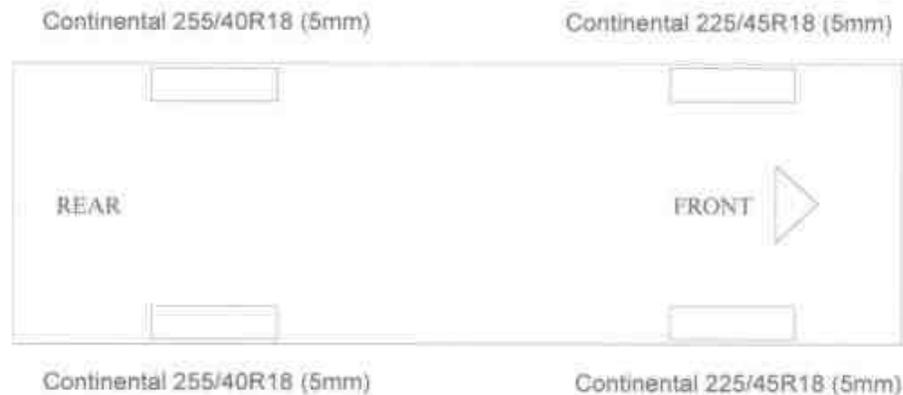
- It was fitted with 18inch sport wheel rims that were wrapped with tyres that were observed to be of serviceable condition. The tyres were also sufficiently inflated for vehicular operation. The tyre brand, tyre size and approximate remaining tread depth of the 4 tyres of the Motor Car were recorded as follows: -

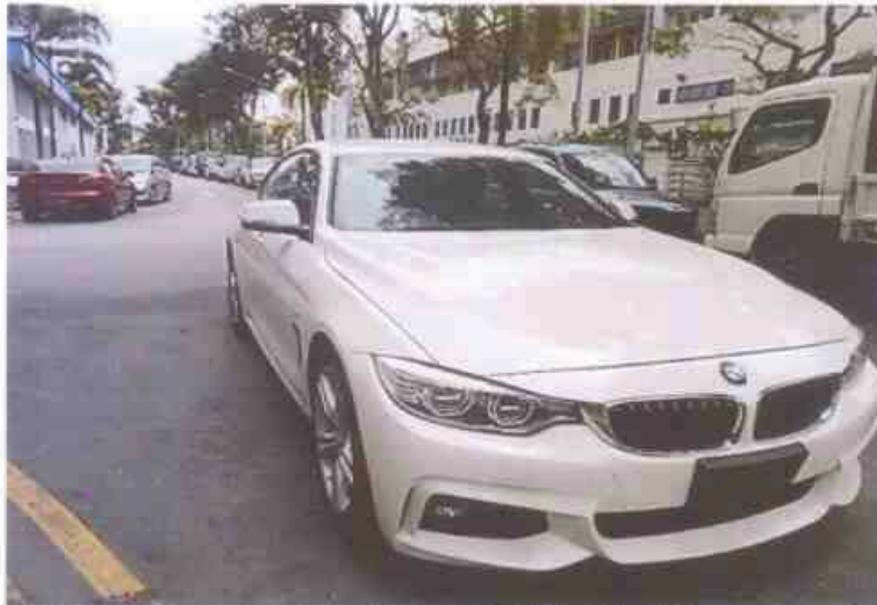
Photo 1 shows a general view of the front right body of the Motor Car at the time of my inspection. The Motor Car was observed to be in relatively good general condition with no loose exterior fittings observed.

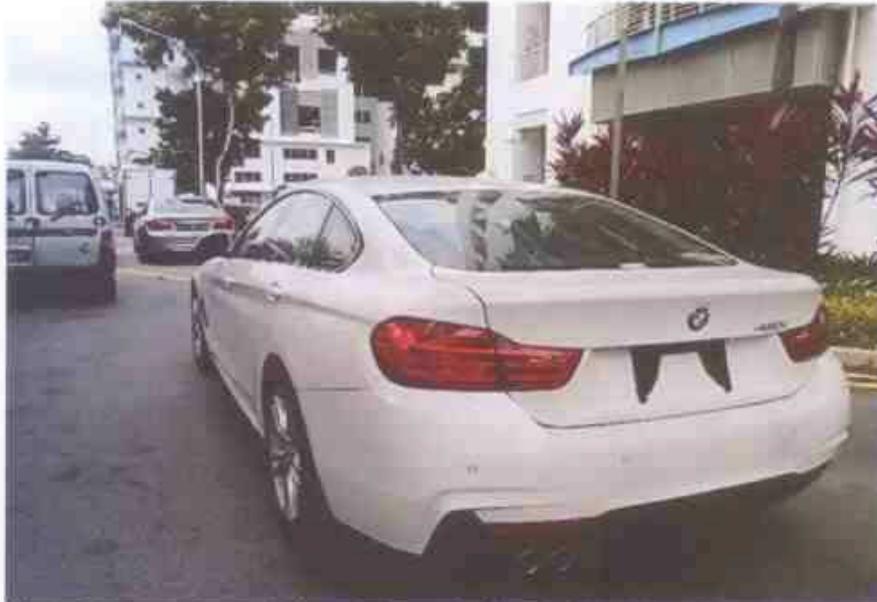
Photo 2 shows a general view of the rear left body of the Motor Car at the time of my inspection. The Motor Car was observed to be in relatively good general condition with no loose exterior fittings observed.

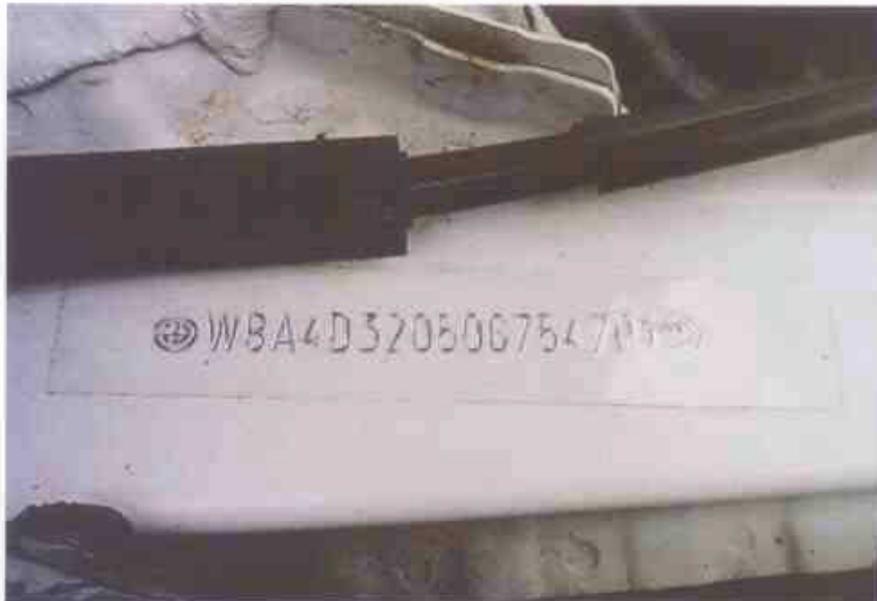
Photo 3 shows the chassis number of the Motor Car. The chassis number recorded was WBA4D32050G754701.

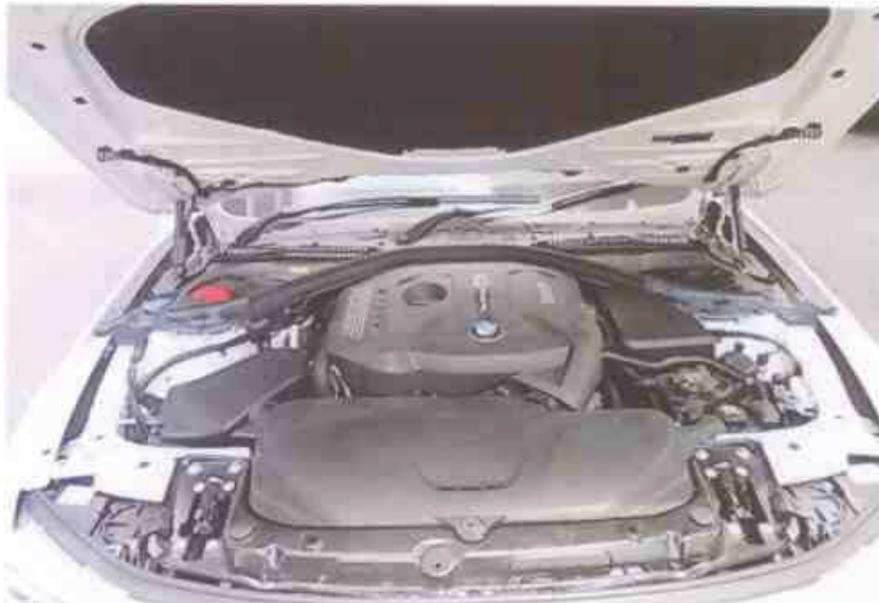
12. My examination of the engine compartment of the Motor Car revealed that the various parts and components inside the engine compartment were all intact and properly fitted. The engine oil, transmission fluid, brake fluid and engine coolant were all found to be of sufficient level for operating purposes. Visually, there was also no contamination found to these fluids.
13. My checks on the underside of the Motor Car revealed no sign(s) or indication(s) of fluid leakage and/or fluid stain(s). The engine block and automatic transmission assembly were both secured properly. They were not mounted onto the chassis body or any integral body part of the Motor Car. All undercarriage components of the Motor Car were also observed to be intact and secured in an appropriate manner.

Photo 4 shows a general view of the engine compartment of the Motor Car at the time of my inspection. The various parts and components inside the engine compartment were all observed to be intact and properly fitted. There was also no sign(s) or indication(s) of fluid leak and/or fluid stain found inside the engine compartment.

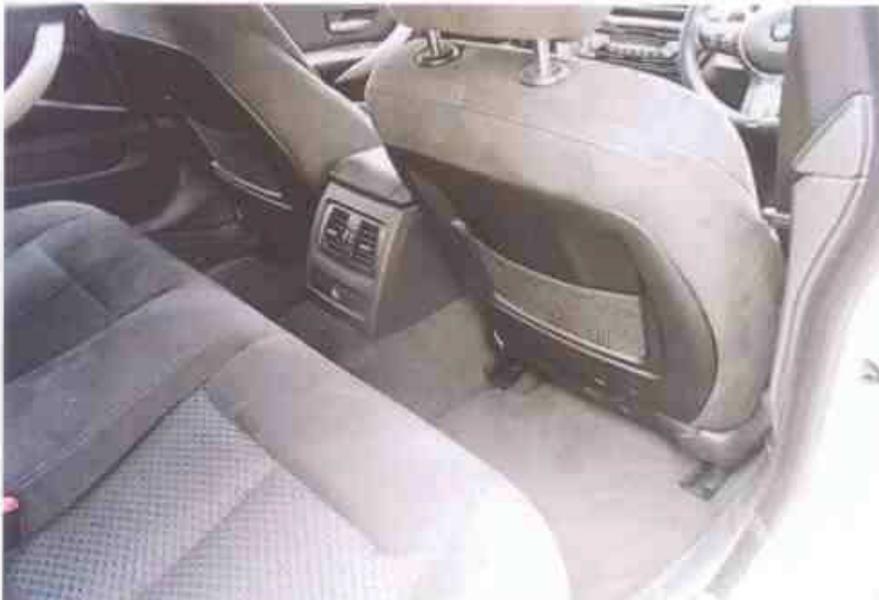
10. The seats of the Motor Car were found to be secured to the floor board of the Motor Car via seat rails bolted onto the floor board. Retractable seat belt reels and pre-tensioners were fitted on all seats of the Motor Car. The seat belt reels were able to be fastened securely to the respective pre-tensioner that is fixed to the side of all the seats.

Photo 5 shows the seats of the Motor Car, which were secured via seat rails to the floor board. All the seats of the Motor Car were fitted with a retractable seat belt reel and pre-tensioner. The seat belts were also able to be fastened to the pretension that were fitted on the side of each individual seat.

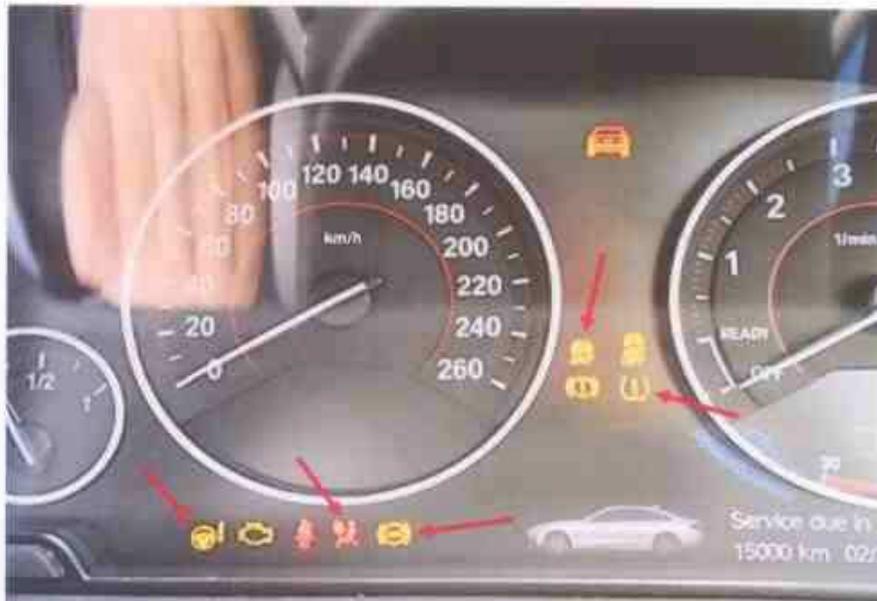
Photo 6 shows the warning lights for the various electronic safety features appearing on the instrument panel of the Motor Car during its self-test when the engine is cranked, in particular the ABS, SRS, IAS, TPM and DSC lights (arrowed).

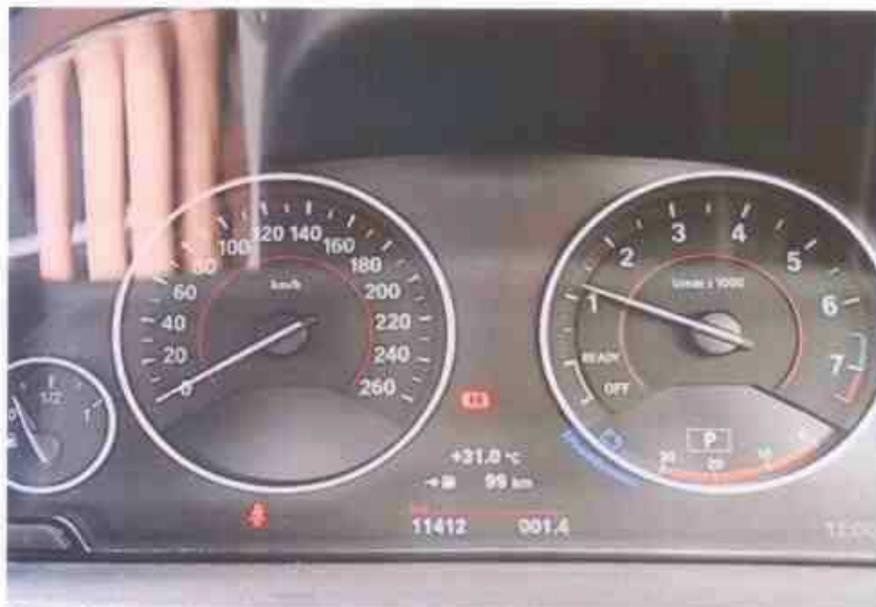
11. The Motor Car's automatic self-test of the functionality of its various electronic safety features like the Anti-Brake Lock System (ABS), Supplemental Restraint System (SRS), Integral Active Steering (IAS), Tyre Pressure Monitor (TPM) and Dynamic Stability Control (DSC) during cranking of the engine had indicated that these electronic systems were in working condition. This was determined from the respective warning lights disappearing from the instrument panel after the self-test.

Photo 7 shows the respective warning lights no longer illuminated, indicating that there is no fault detected to the ABS, SRS, IAS, TPM and DSC systems of the Motor Car during the self-test. These electronic systems were hence in working condition at the time of my inspection.

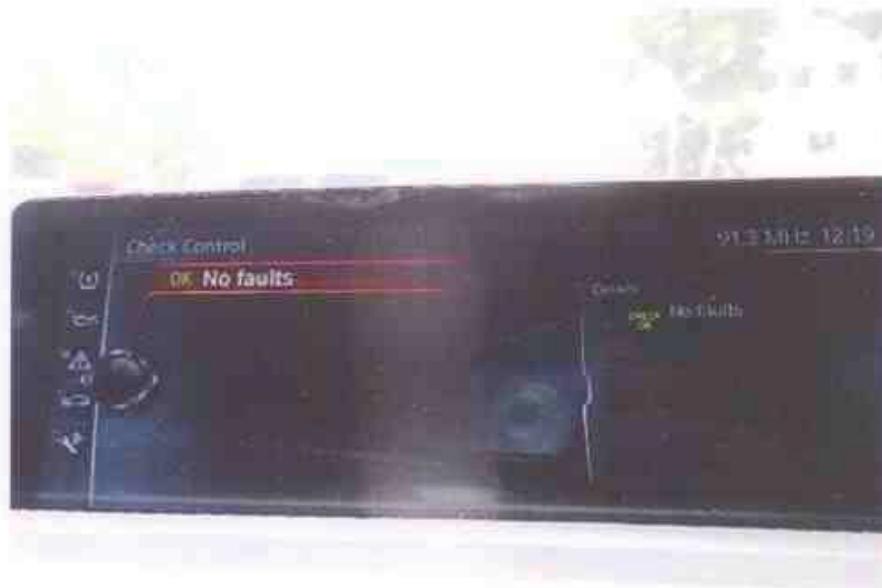
19. An on-board self-diagnostic check on the various controls and systems of the Motor Car was initiated during my inspection, and at the end of the check, there was no fault(s) found.

Photo 8 shows no fault(s) was detected to the various controls and systems of the Motor Car after my initiation of the Motor Car's on-board self-diagnostic check.

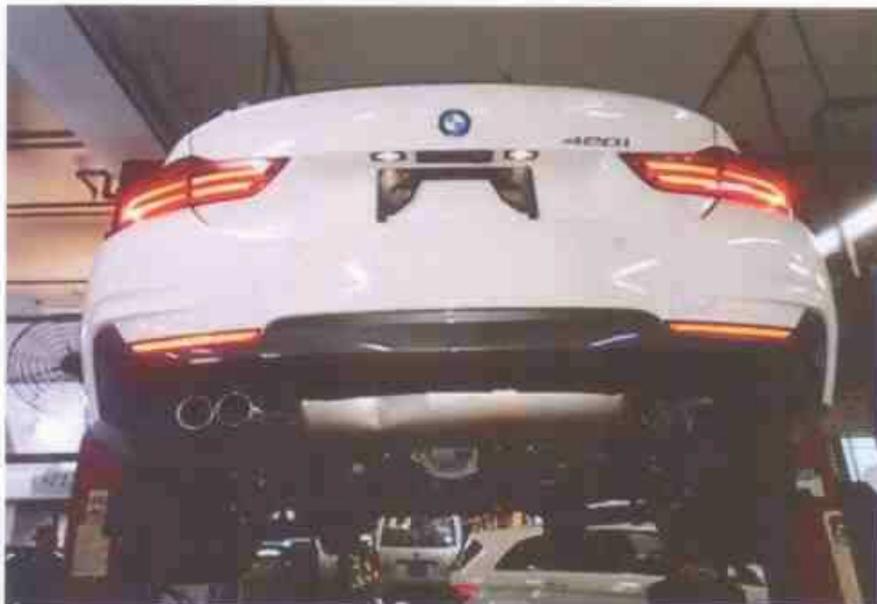
Photo 9 shows the Motor Car hoisted up for checks on its undercarriage. There was no sign(s) or indication(s) of fluid leakage and/or fluid stain(s). The undercarriage components of the Motor Car were also all observed to be intact and secured in an appropriate manner.

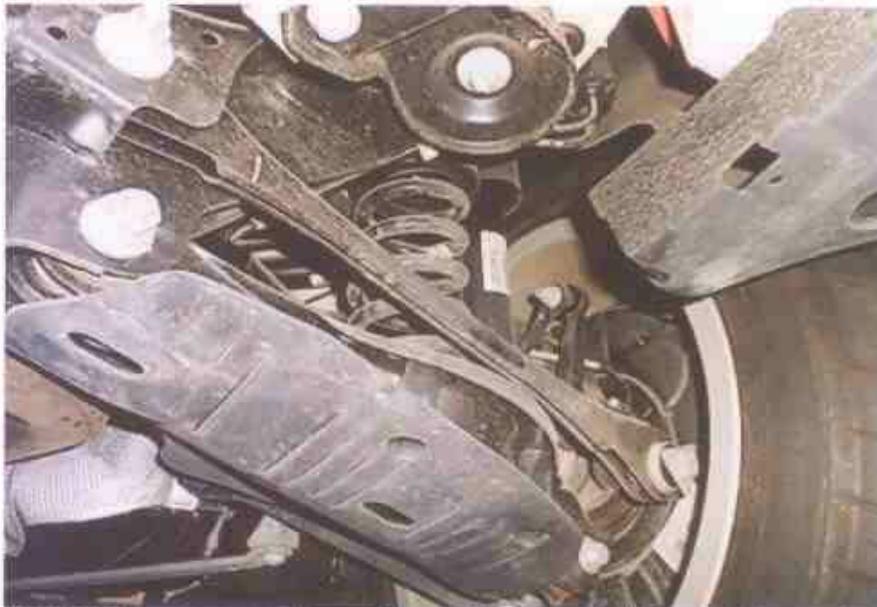
Photo 10 shows a general view of the control arms and linkages at the rear right wheel of the Motor Car. I did not observe any fluid leak and/or fluid stain on the underside of the Motor Car. All of the Motor Car's undercarriage components were observed to be intact and secured in an appropriate manner.

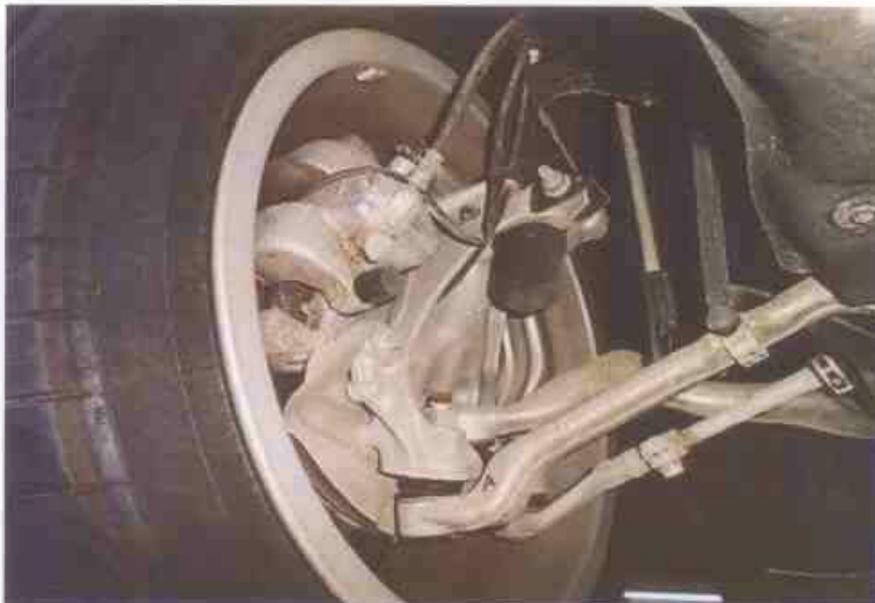
Photo 11 shows the various undercarriage components at the front left wheel of the Motor Car. The mechanical components, control arms and linkages were all found to be intact and secured in an appropriate manner.

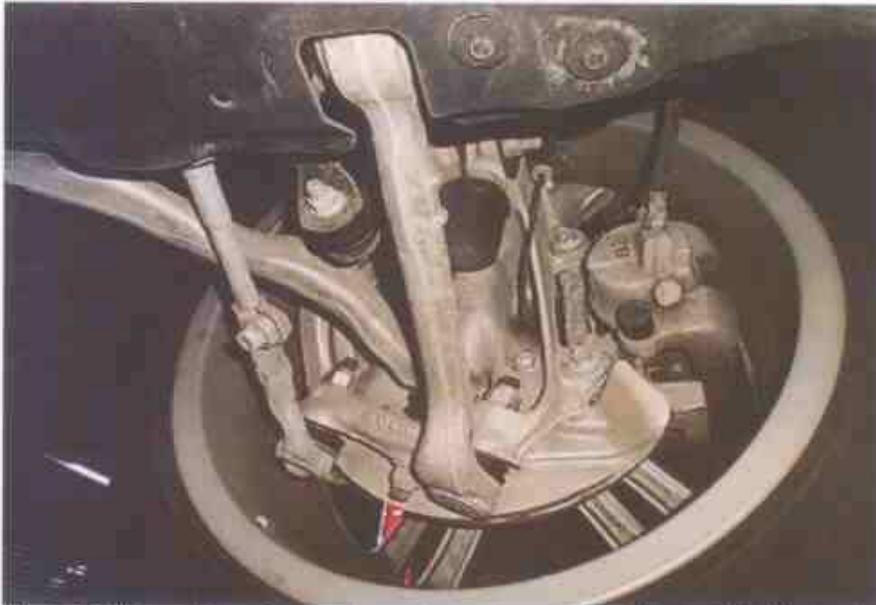
Photo 12 shows the various undercarriage components at the front right wheel of the Motor Car. The mechanical components, control arms and linkages were all found to be intact and secured in an appropriate manner.

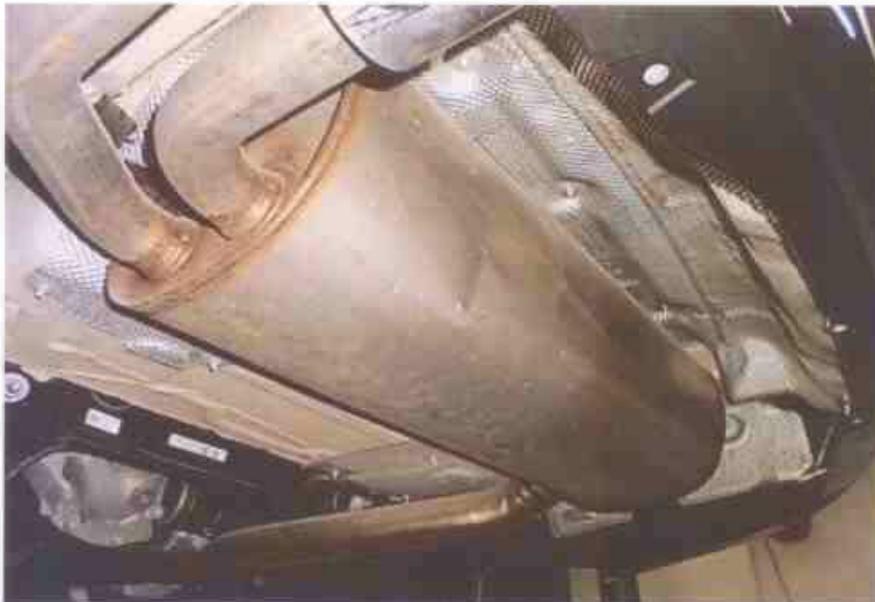
Photo 13 shows the Motor Car's rear exhaust muffler. My examination of the Motor Car's exhaust system revealed no sign(s) or indication(s) of any cut or weld marks along its exhaust pipes and on its rear mufflers.

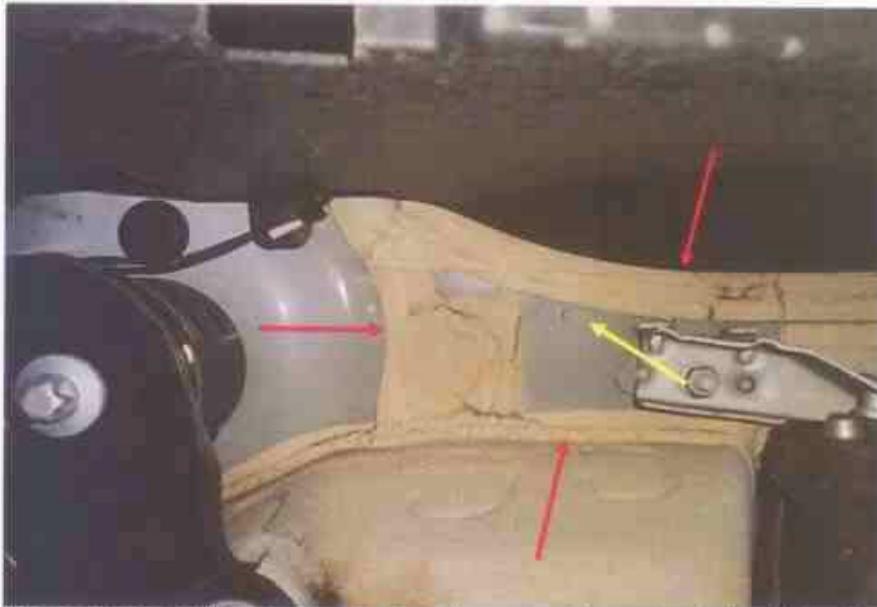
- Visually, I did not find any weld marks, other than the original spot weld marks, on the chassis body of the Motor Car. The original factory sealant at the joints along the chassis body was also untouched, again indicating that no replacement of the chassis body was carried out; and that the chassis body was originally fitted.

Photo 14 shows the structural body at the underside centre of the Motor Car. Visually, I did not find any weld marks other than original spot weld marks (yellow arrow) on the chassis body of the Motor Car. The original factory sealant (red arrow) at the joints along the chassis body was also untouched, indicating no work was done on the chassis body of the Motor Car and that the chassis body was originally fitted.

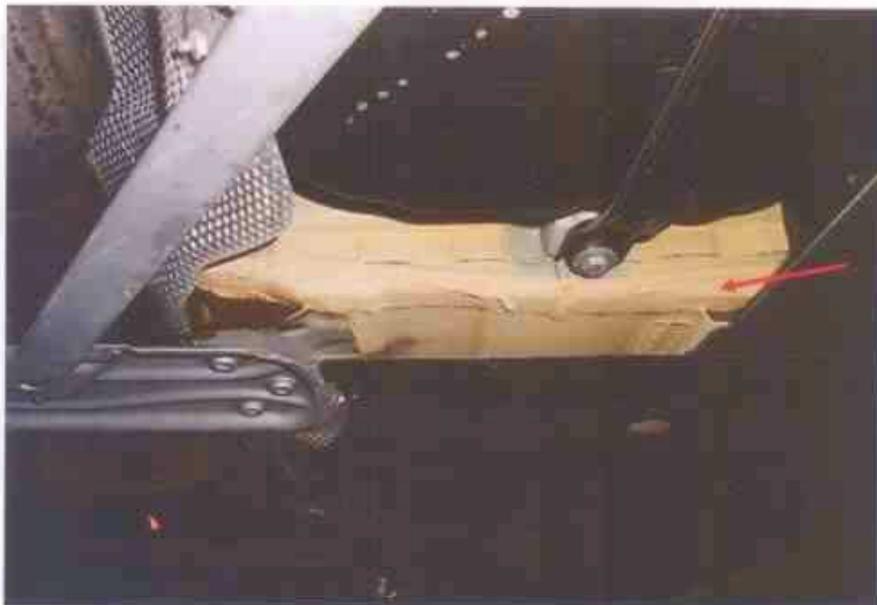
Photo 15 shows the structural body at the underside rear centre of the Motor Car. Visually, The original factory sealant (arrowed) at the joints along the chassis body was untouched, indicating no work was done on the chassis body of the Motor Car and that the chassis body was originally fitted.

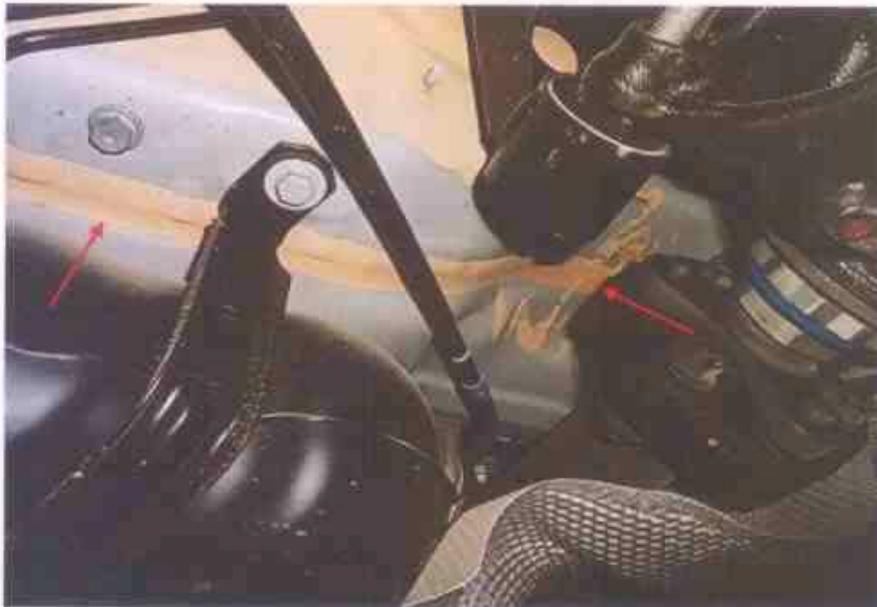
Photo 16 shows the structural body at the underside rear left of the Motor Car. The original factory sealant (arrowed) at the joints along the chassis body was untouched, indicating no work was done on the chassis body of the Motor Car and that the chassis body was originally fitted

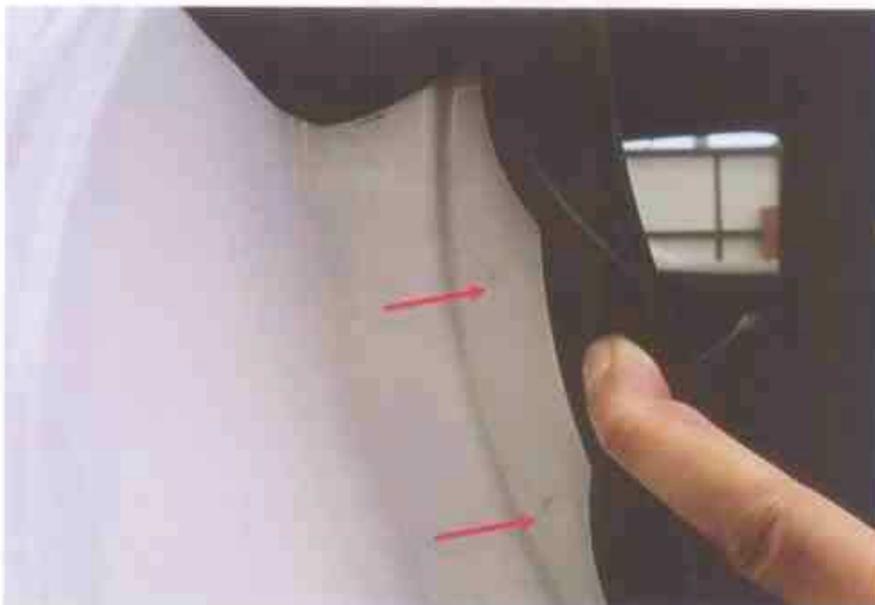
Photo 17 shows the rear right "C" pillar of the Motor Car. I did not find any weld marks other than original spot weld marks (arrowed) on the body panels of the Motor Car, indicating that there was no re-welding works carried out, and that the body panels of the Motor Car were originally fitted

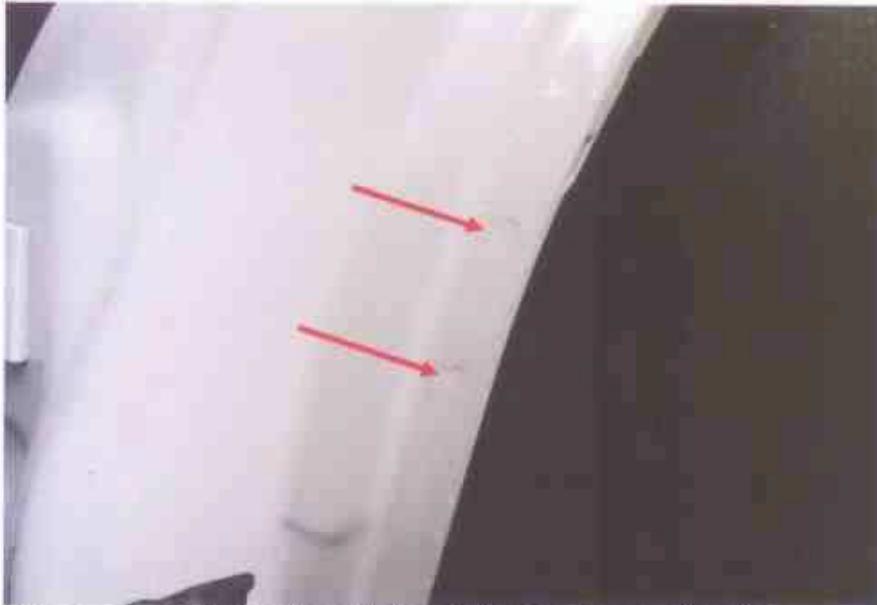
Photo 18 shows the front left "A" pillar of the Motor Car. I did not find any weld marks other than original spot weld marks (arrowed) on the body panels of the Motor Car, indicating that there was no re-welding works carried out, and that the body panels of the Motor Car were originally fitted.
