N3/INC18018146 / KHLbn2

### 1. Policy Particulars :- THIRD PARTY CLAIM

### 4. Description of Damages

## ADJUSTMENT ON REPAIR COST FOR VEHICLE NO. SHA 1600L

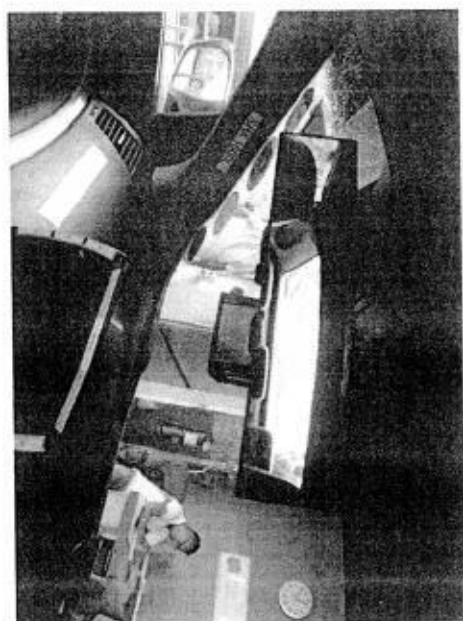
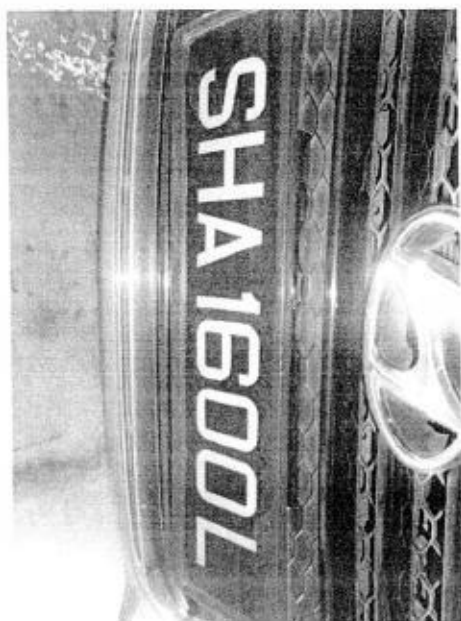
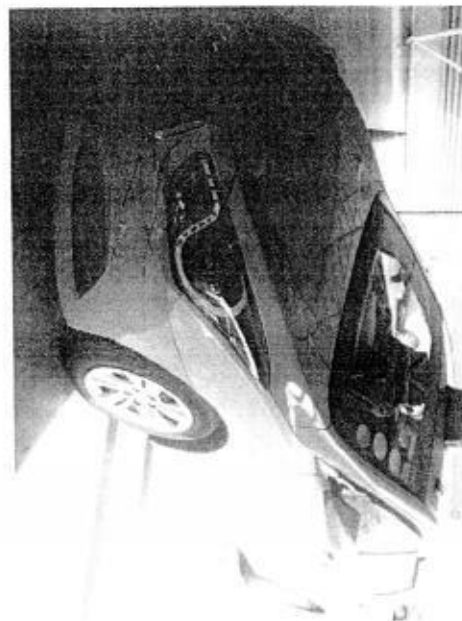
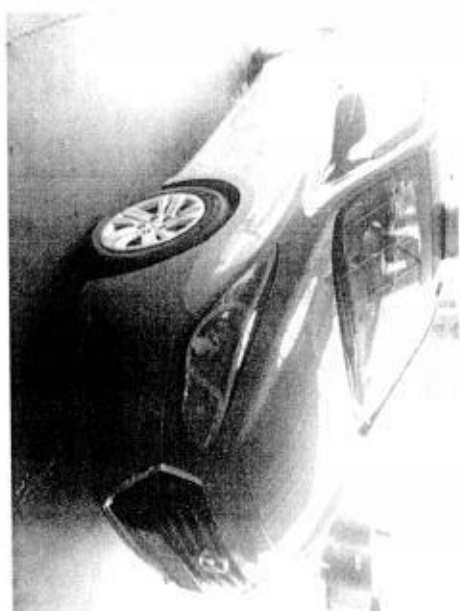
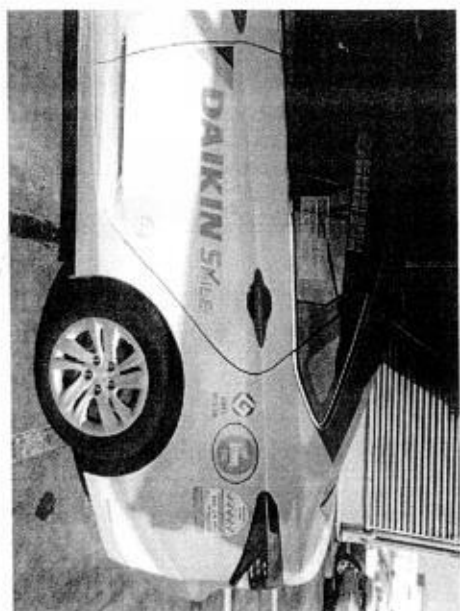
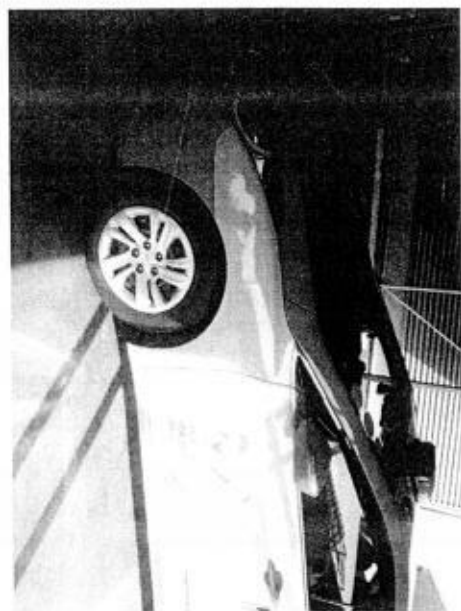
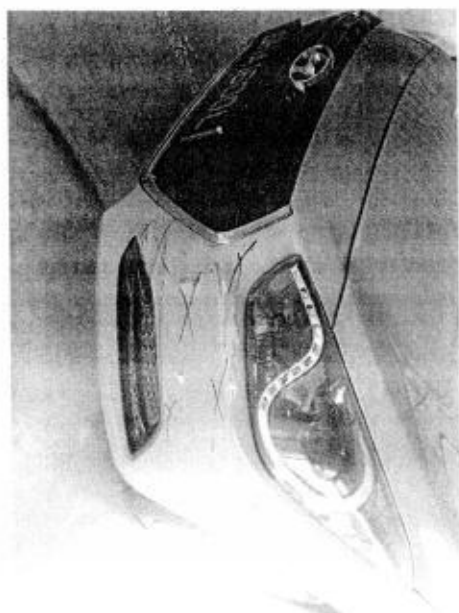
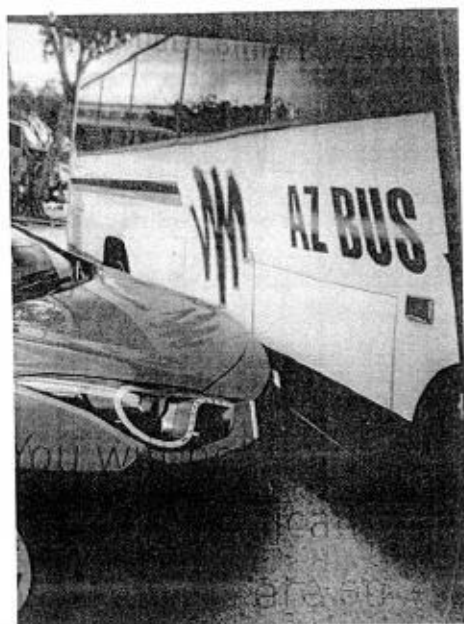
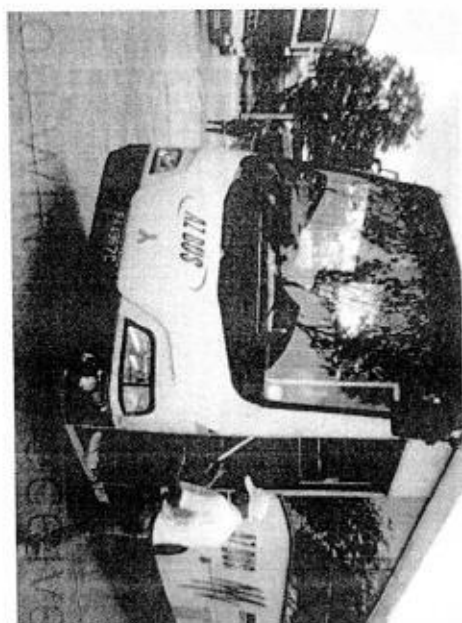
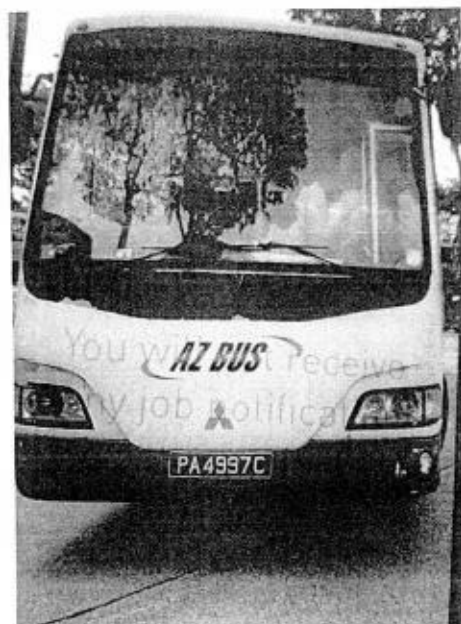
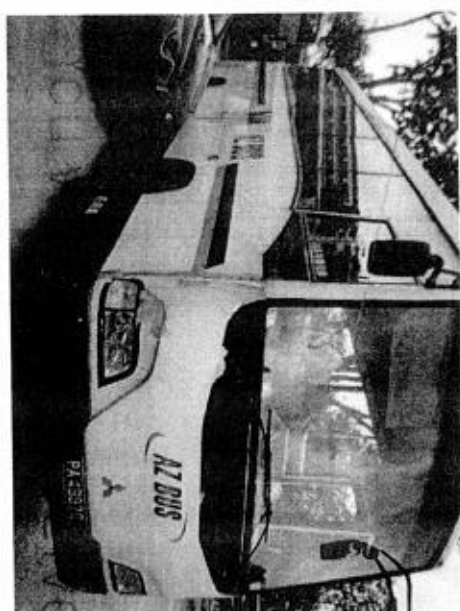
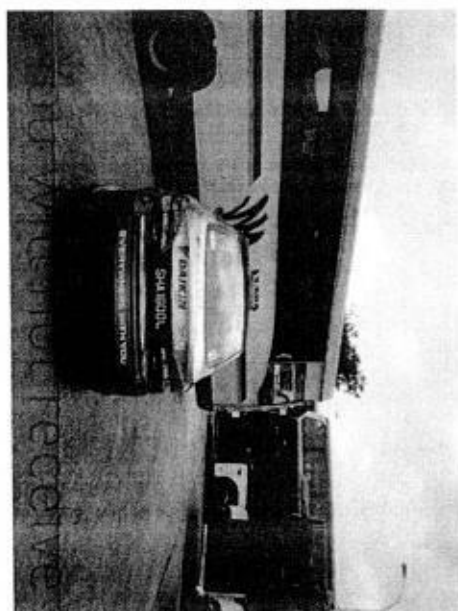
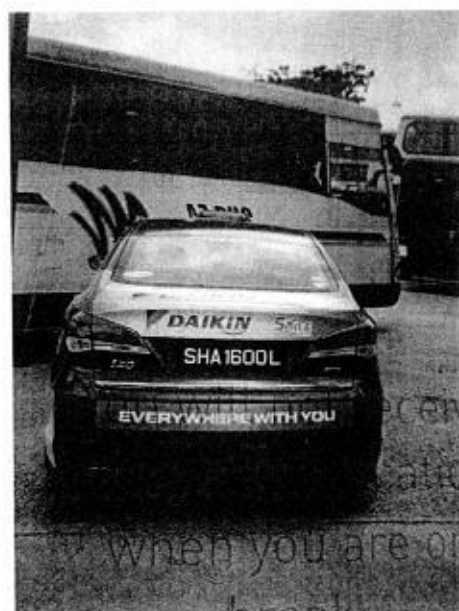
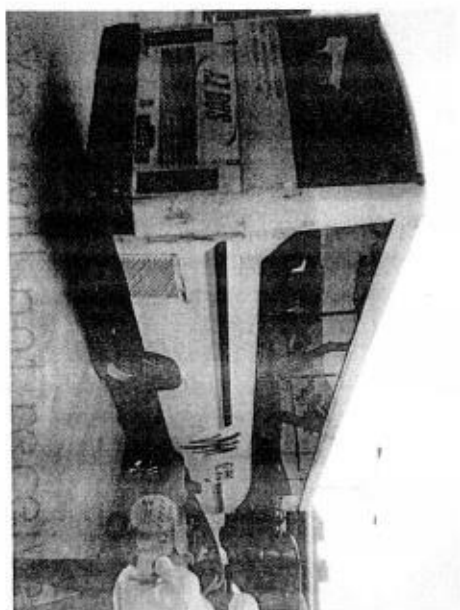
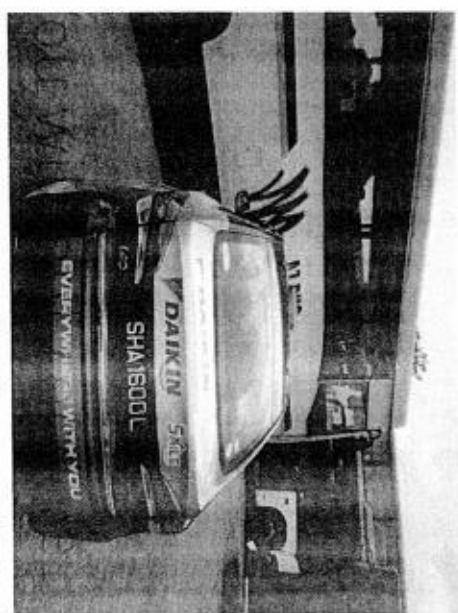
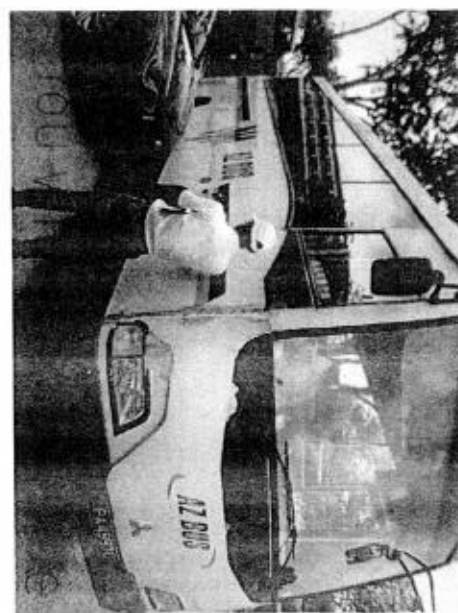
THE VEHICLE SUSTAINED DAMAGES AT THE FRONT N/S PORTION. DAMAGES SEE DETAILS.
---

Qty	Description of Parts	Condition	Estimate By Workshop (\$)	Our Adjusted (\$)
<b>REPLACEMENT OF PARTS</b>				
1	FRONT BUMPER COVER	DEFORMED	544.50	544.50
1	FRONT BUMPER BRACKET TOP (LH)	SERVICEABLE	22.40	-
1	FRONT BUMPER BRACKET (LH)	SERVICEABLE	24.60	-
1	HEADLAMP (LH)	TO REPAIR SEE LABOUR	1,388.00	-
	LESS 20% DISCOUNT		-395.90	-108.90
			1,583.60	435.60
<b>LABOUR</b>				
	PANEL BEATING, INCLUSIVE OF REPAIR OF HEADLAMP (LH)		220.00	200.00
	SPRAY PAINTING CHARGE.		220.00	200.00
	WIRING.	NOT NECESSARY	30.00	-
			470.00	400.00
<b>GRAND TOTAL</b>			<b>2,053.60</b>	<b>835.60</b>
<b>RECOMMENDED COST OF REPAIRS (CONFIRMED)</b>				<b>835.60</b>
