Preliminary Advice

Insured Vehicle No : SDT9676M

Make : HONDA VEZEL

VEHICLE DAMAGE INSPECTION REPORT

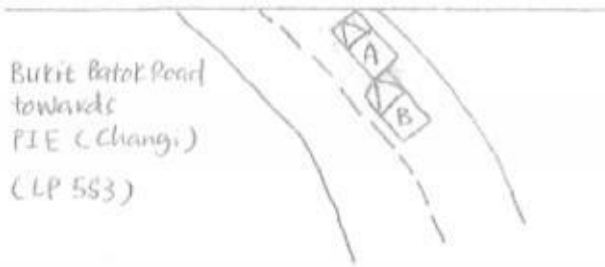
Sketch Plan #2

(A) SL4528S
(B) SDT 9676M

On 4/10/2018 at about 8.30am, I was travelling along Bukit Batok Rd towards PIE (Changi) (Nearby LP553). I was stop to check the road condition and to give way to the main road vehicle. Out of sudden, I felt a huge impact and loud bang sound from behind. I alighted & realised vehicle (B) SPT9676M had hit onto my vehicle (A) SLH3285 rear portion. After accident, I felt neck pain, shoulder pain and back pain.
