Auto
Consultants
Pte Ltd

21 September 2018

**TECHNICAL INVESTIGATION REPORT OF FIRE INCIDENT INVOLVING THE
INSURED VEHICLE SHD 6567B ON 6 SEPTEMBER 2018**

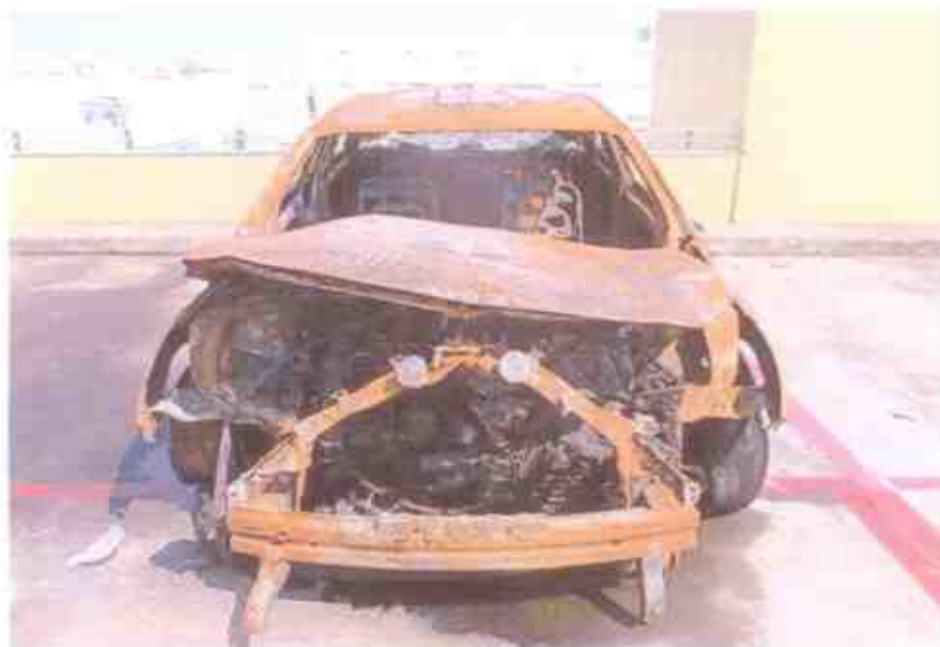
Photo 1 shows the general view of the front portion of the Insured Vehicle at the time of our inspection. The Insured Vehicle was observed to have sustained extensive fire damage all around. Its engine compartment and interior compartment were completely burnt. Rust had accumulated all over the Insured Vehicle as a result of exposure to environmental condition for a period of time.

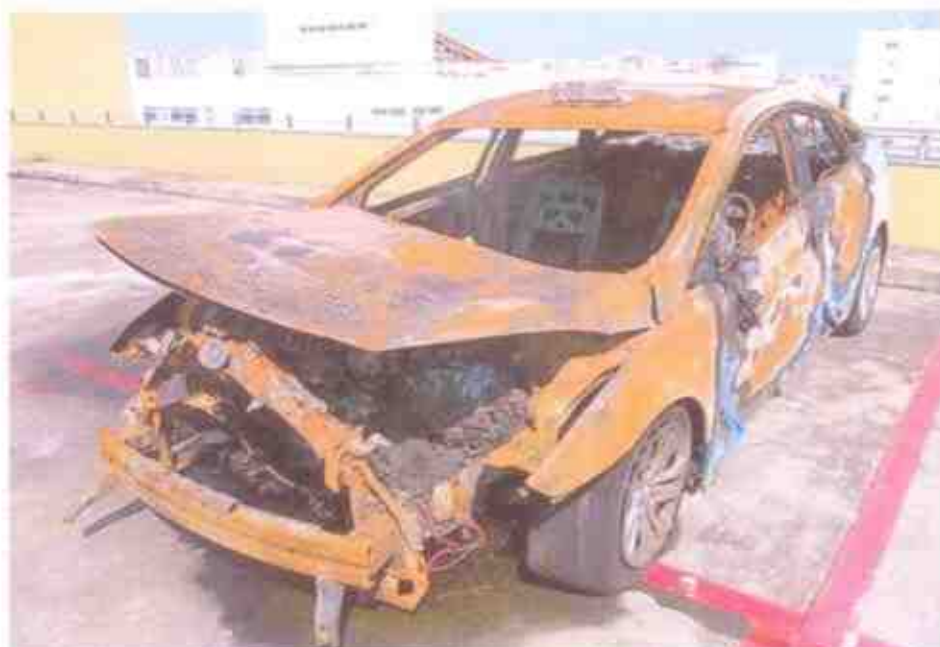
Photo 2 shows the general view of the left body of the Insured Vehicle at the time of our inspection. The Insured Vehicle was observed to have sustained extensive fire damage. Rust had accumulated all over the Insured Vehicle as a result of exposure to environmental condition for a period of time.

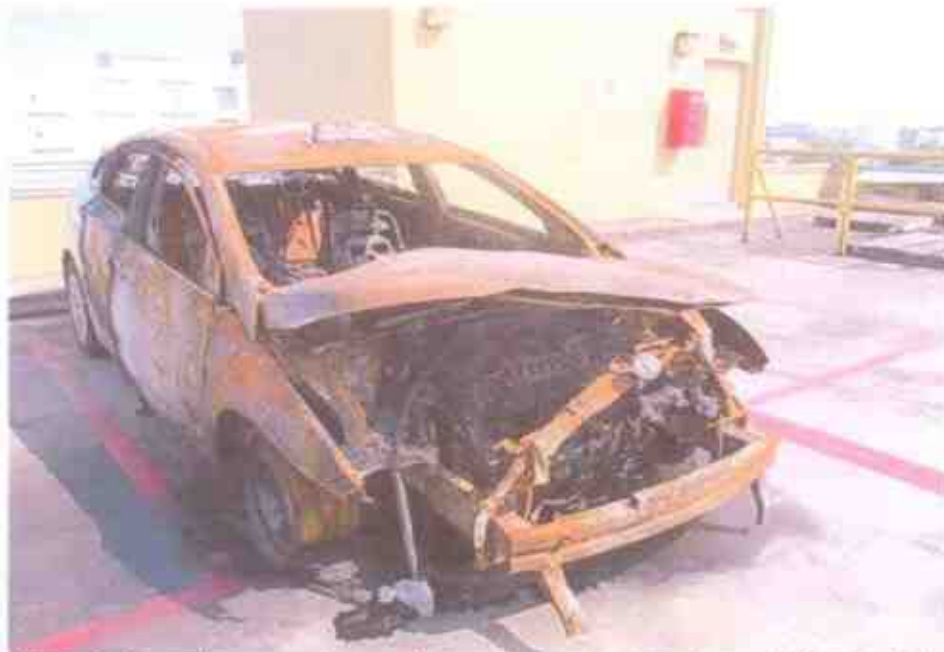
Photo 3 shows the general view of the right body of the Insured Vehicle at the time of our inspection. The Insured Vehicle was observed to have sustained extensive fire damage. Rust had accumulated all over the Insured Vehicle as a result of exposure to environmental condition for a period of time.

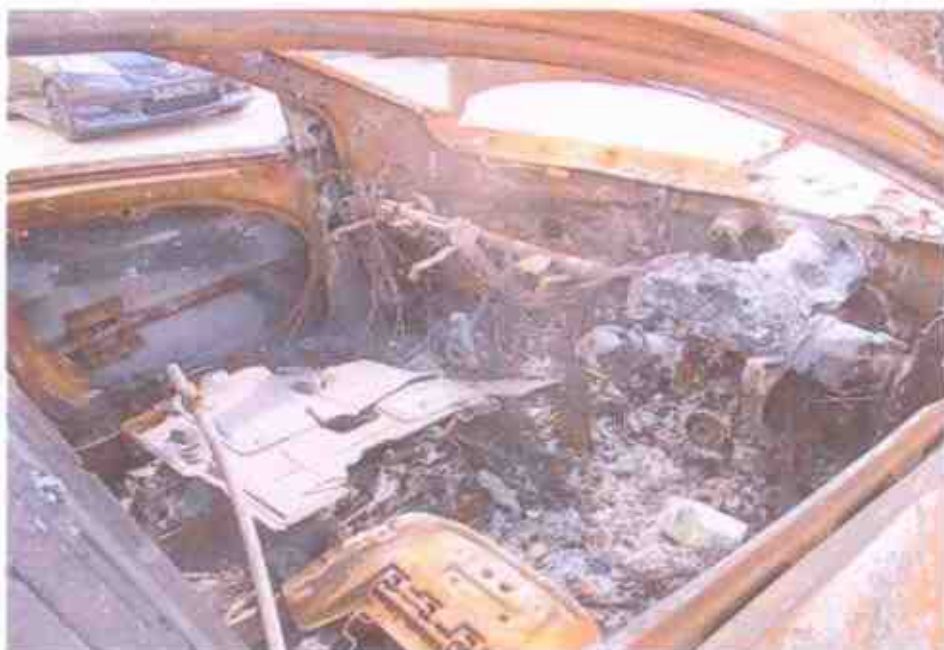
Photo 4 shows the general view of the interior compartment of the Insured Vehicle at the time of our inspection. Its interior compartment was completely burnt as a result of the fire.

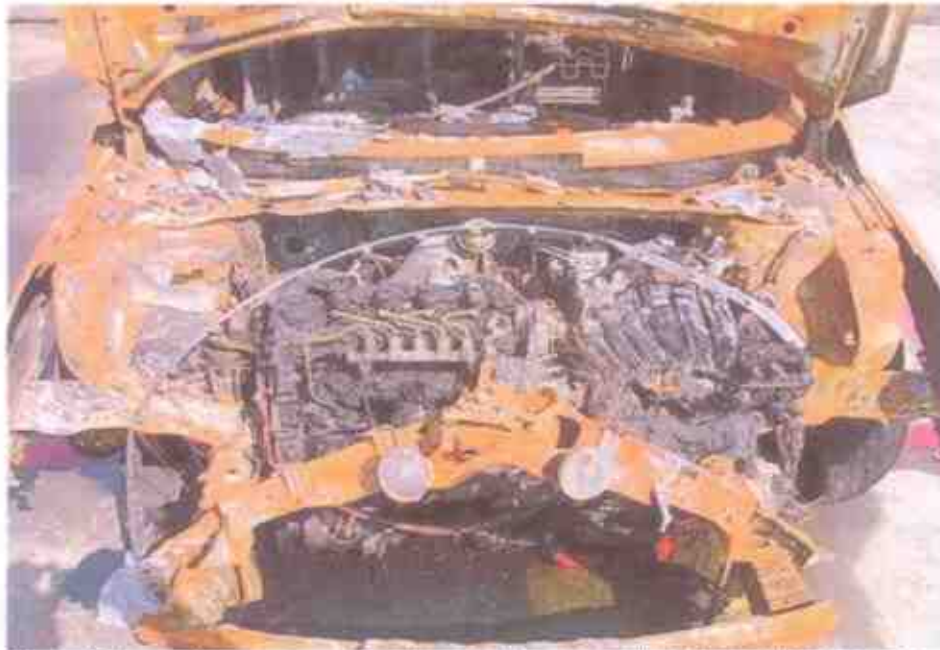
Photo 5 shows the engine compartment of the Insured Vehicle at the time of our inspection. The entire engine compartment of the Insured Vehicle was observed to be severely burnt. Most of the parts inside the engine compartment were found to be burnt and/or melted as a result of the fire.

6. For this particular case, the fire appears to have originated within the engine compartment of the Insured Vehicle given that the fire damage around the engine compartment was most extensive.
7. Upon closer examination of the left portion of the engine compartment we had found greenish residue on several burnt stretches of original factory fitted wirings leading from the battery of the Insured Vehicle. The presence of such greenish residue indicates internal heating of copper wires, a sign of an electrical short circuit occurring. The greenish residue is normally left behind from oxidation as a result of chemical reaction involving the copper wires. This physical evidence would then appear to suggest that the cause of fire to the Insured Vehicle could have possibly been due to electrical in nature. See photos 6 - 9 below.

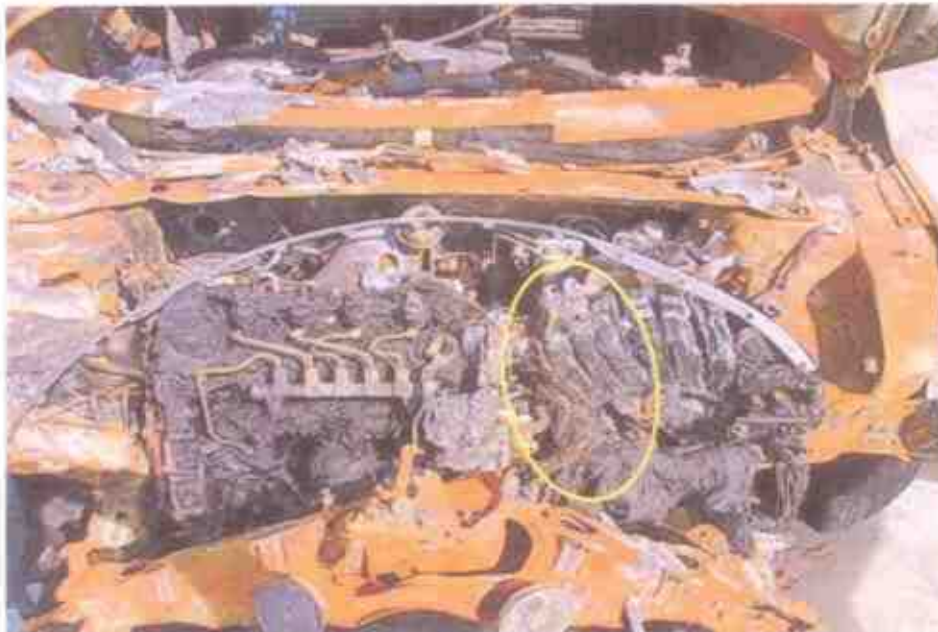
Photo 6 shows the original factory fitted wirings around the left portion of the engine compartment, which is in the immediate vicinity where the fire to the Insured Vehicle had likely started. We had found greenish residue on several burnt stretches of these wirings leading from the battery of the Insured Vehicle (circled). The presence of such greenish residue indicates internal heating of copper wires, a sign of an electrical short circuit occurring. The greenish residue is normally left behind from oxidation as a result of chemical reaction involving the copper wires.

26. Having investigated and technically analysed the damages of burnt nature to the Insured Vehicle, we are of the view that the cause of fire to the Insured Vehicle was of electrical in nature. For this particular case, the fire had originated along the original factory fitted wirings leading from the battery inside the engine compartment, somewhere around the left portion of the engine compartment.

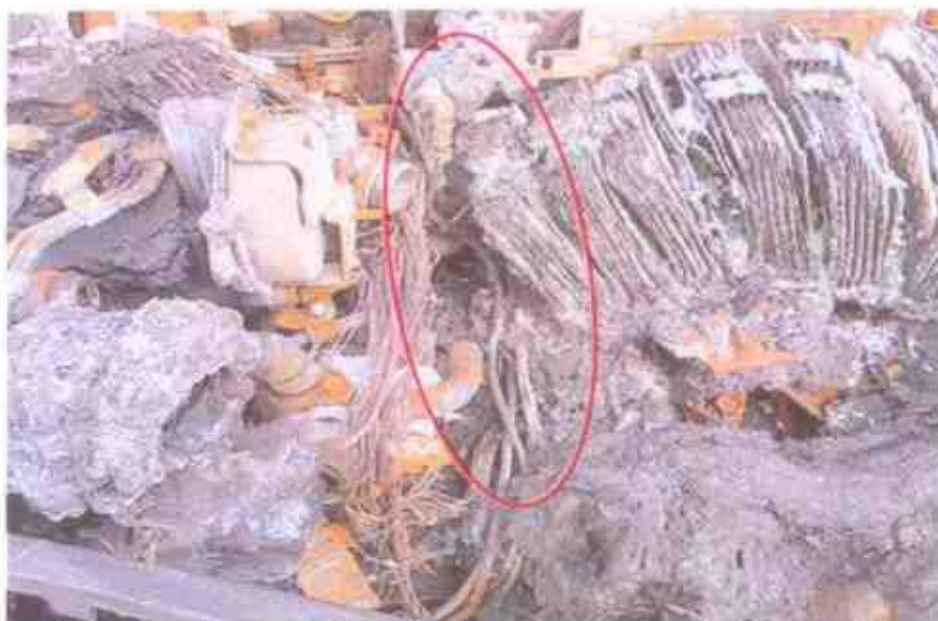
Photo 7 shows the greenish residue found on some of the burnt stretches of original factory fitted wirings (circled). The presence of such greenish residue suggests occurrence of an electrical short circuit.

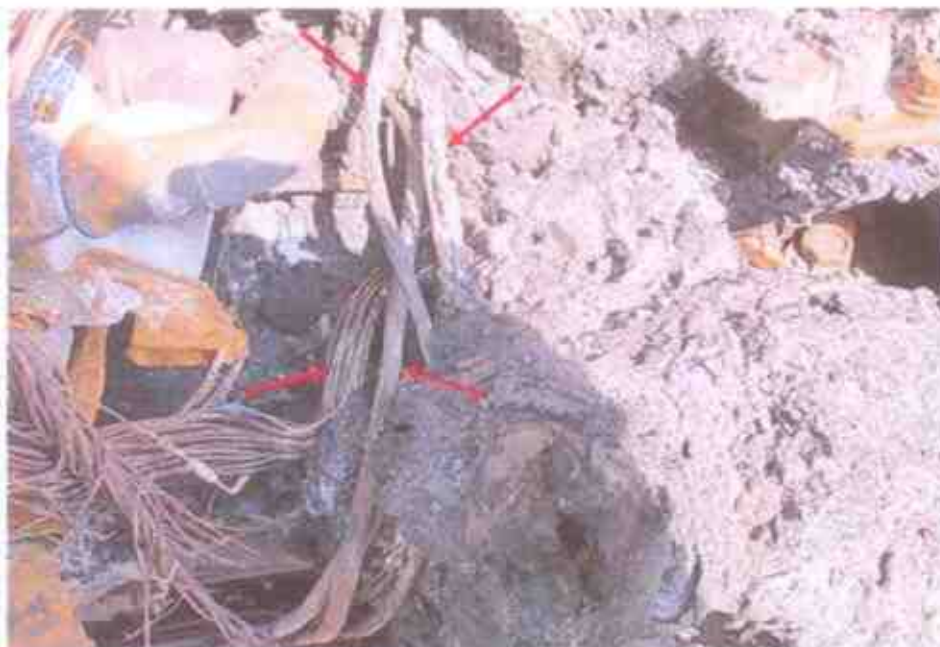
Photo 8 shows a closer view of the greenish residue found on some of the burnt stretches of original factory fitted wirings (arrowed). The presence of such greenish residue suggests occurrence of an electrical short circuit.

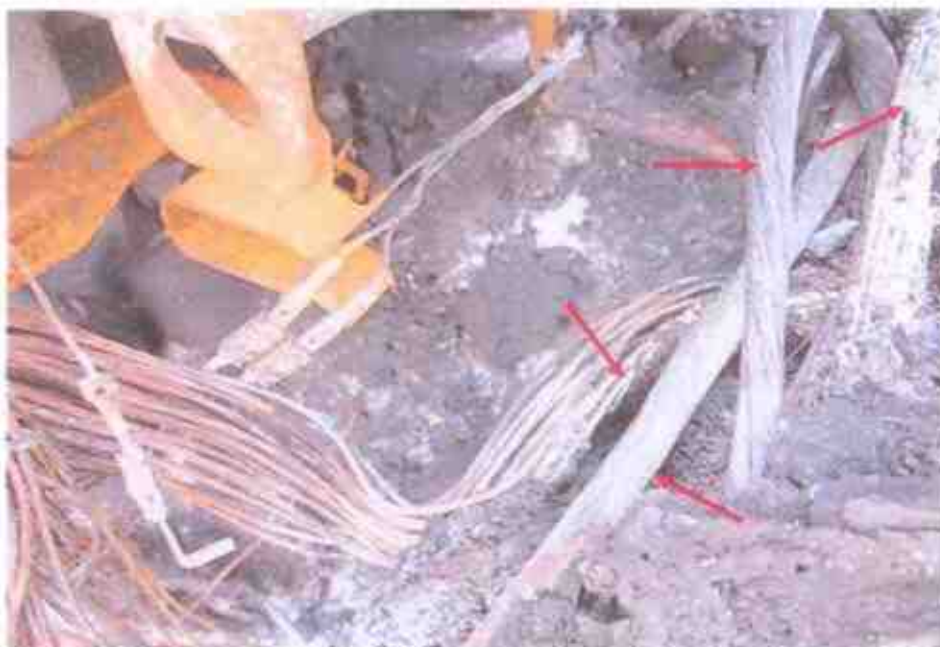
Photo 9 shows a close up view of the greenish residue found on some of the burnt stretches of original factory fitted wirings (arrowed). The presence of such greenish residue suggests occurrence of an electrical short circuit.

24. The possibility of the fire being due to electrical in nature would then seem more likely given that engine overheating and external factors would both seem unlikely. The fire being due to electrical nature is also supported by the condition of the wirings that were found in the engine compartment of the Insured Vehicle, which was earlier discussed in paragraph 7 above.

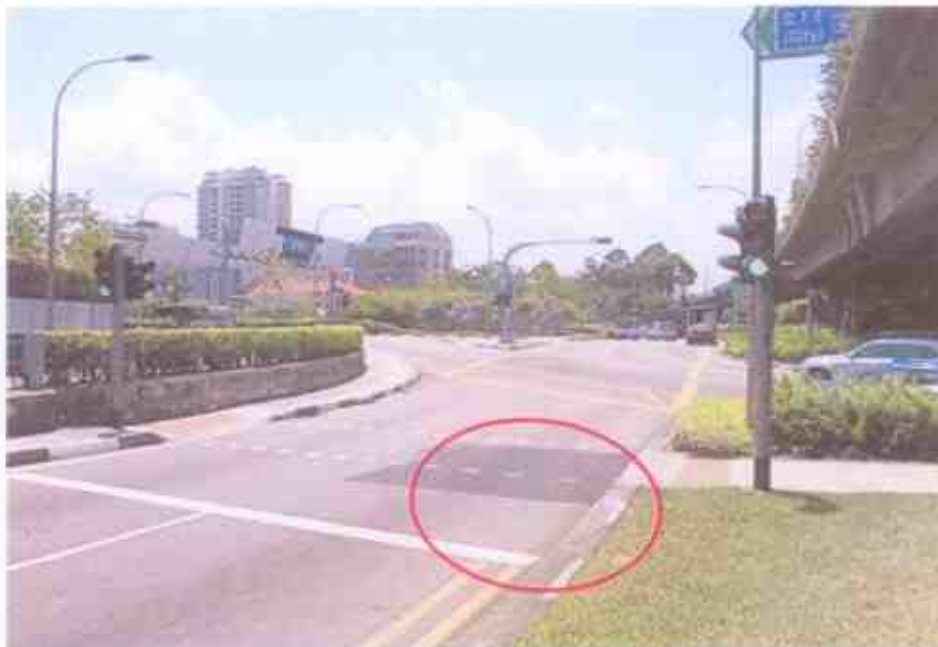
Photo 10 shows the slip road towards Bendemeer Road adjacent to the Ministry of Manpower Services Centre where the incident occurred (circled).

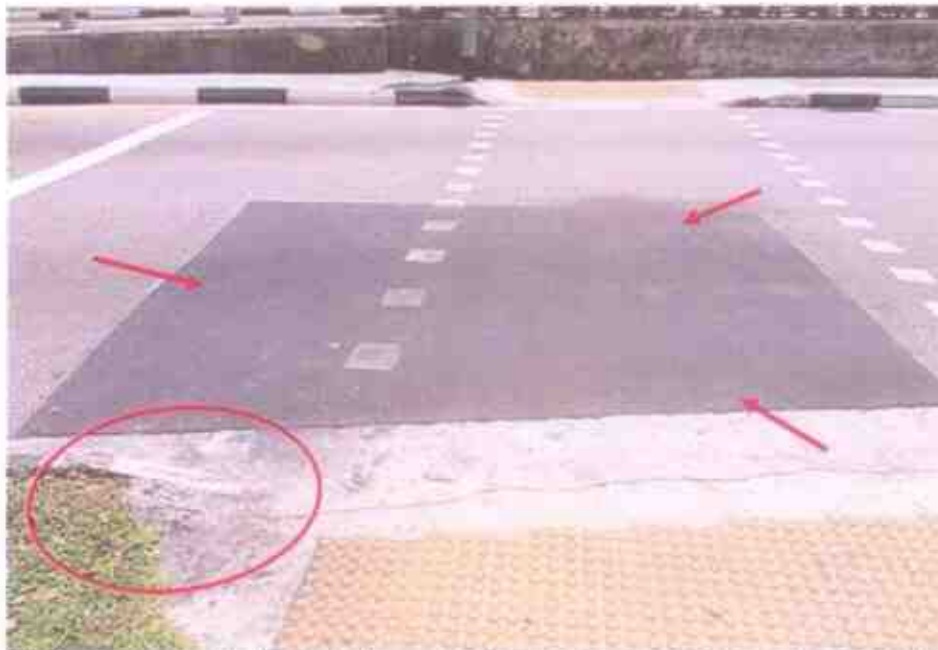
Photo 11 shows the burn marks and/or burnt residual remains on the ground of the slip road towards Bendemeer Road adjacent to the Ministry of Manpower Services Centre where the incident occurred (circled). Part of the road where the Insured Vehicle was positioned when the fire broke out was repaved (arrowed).

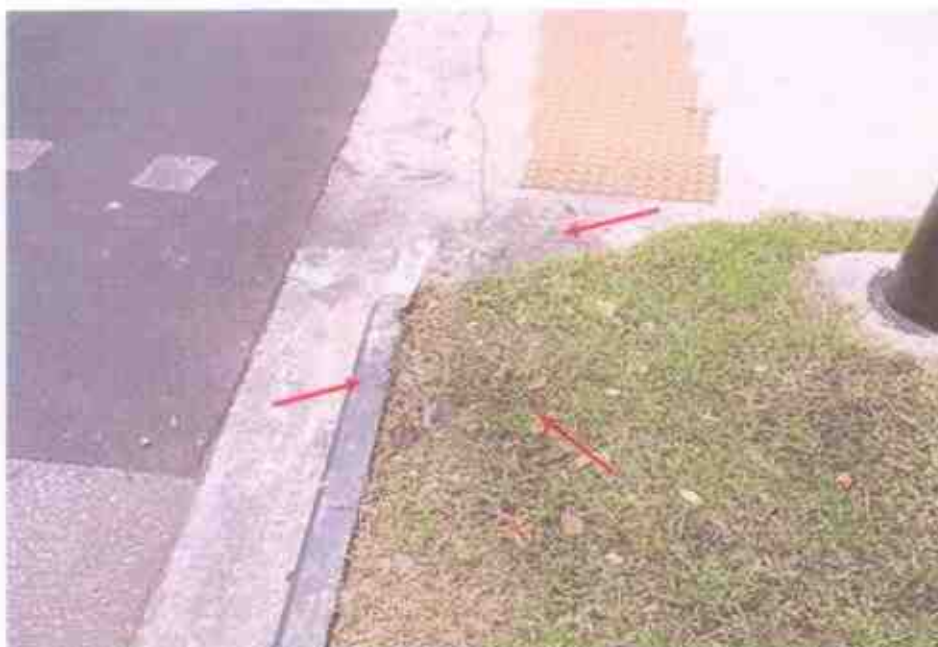
Photo 12 shows the burn marks and/or burnt residual remains on the ground, kerb and grass nearest to the Insured Vehicle which were affected by the fire (arrowed). We did not observe any other damaged or newly replaced government property at the time of our visit to the incident location.

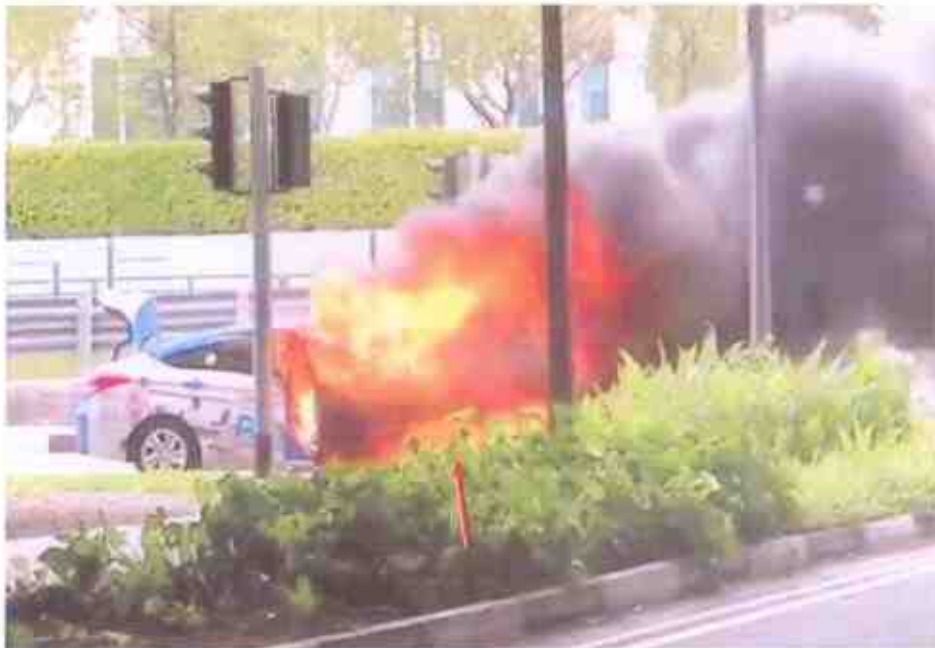
Photo 13 shows the Insured Vehicle engulfed in flames before the arrival of the SCDF. In general, the information that could be gathered from this photograph had corresponded to the events that were related to us by Mr Tay, which is the fire had started from the front portion of the Insured Vehicle (arrowed).

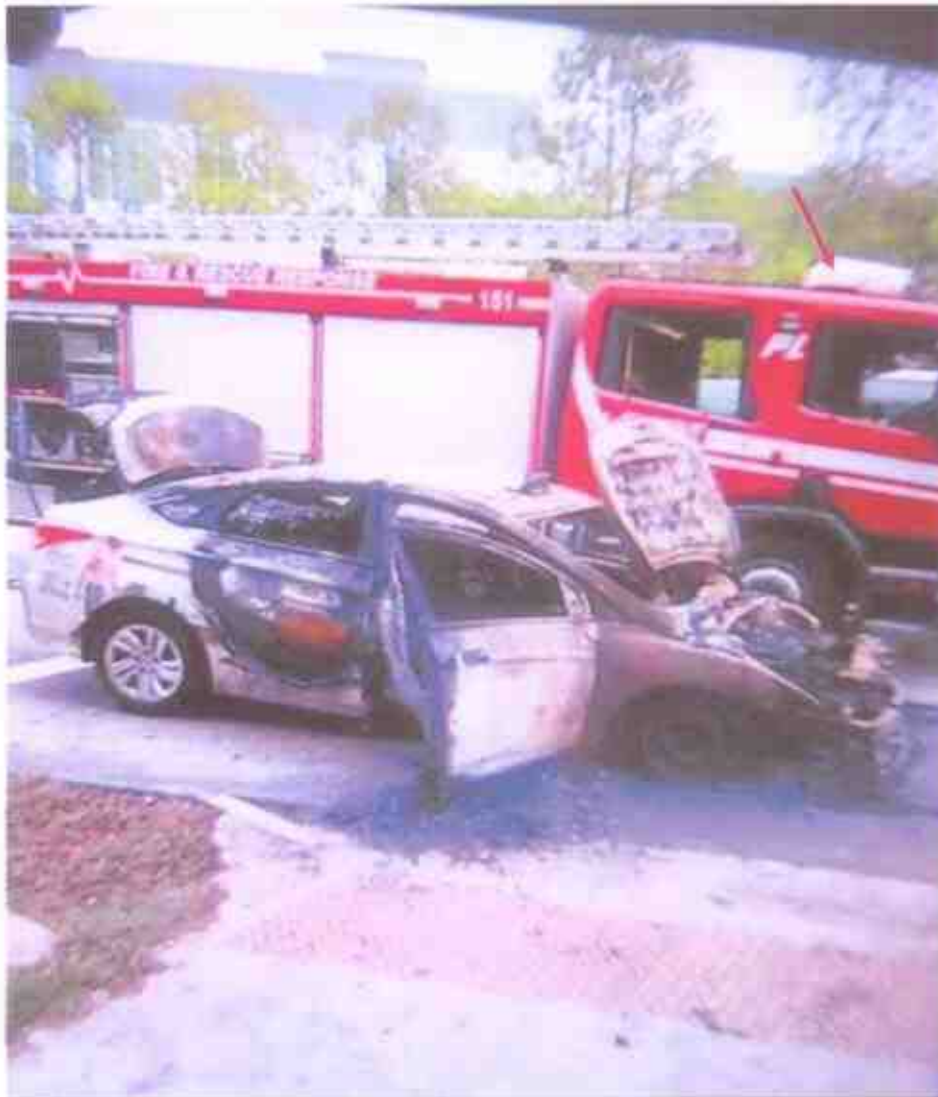
Photo 14 shows the Insured Vehicle after the fire was extinguished by firefighters. In general, the information that could be gathered from this photograph had corresponded to the events that were related to us by Mr Tay, which is the SCDF had responded to the incident (arrowed).

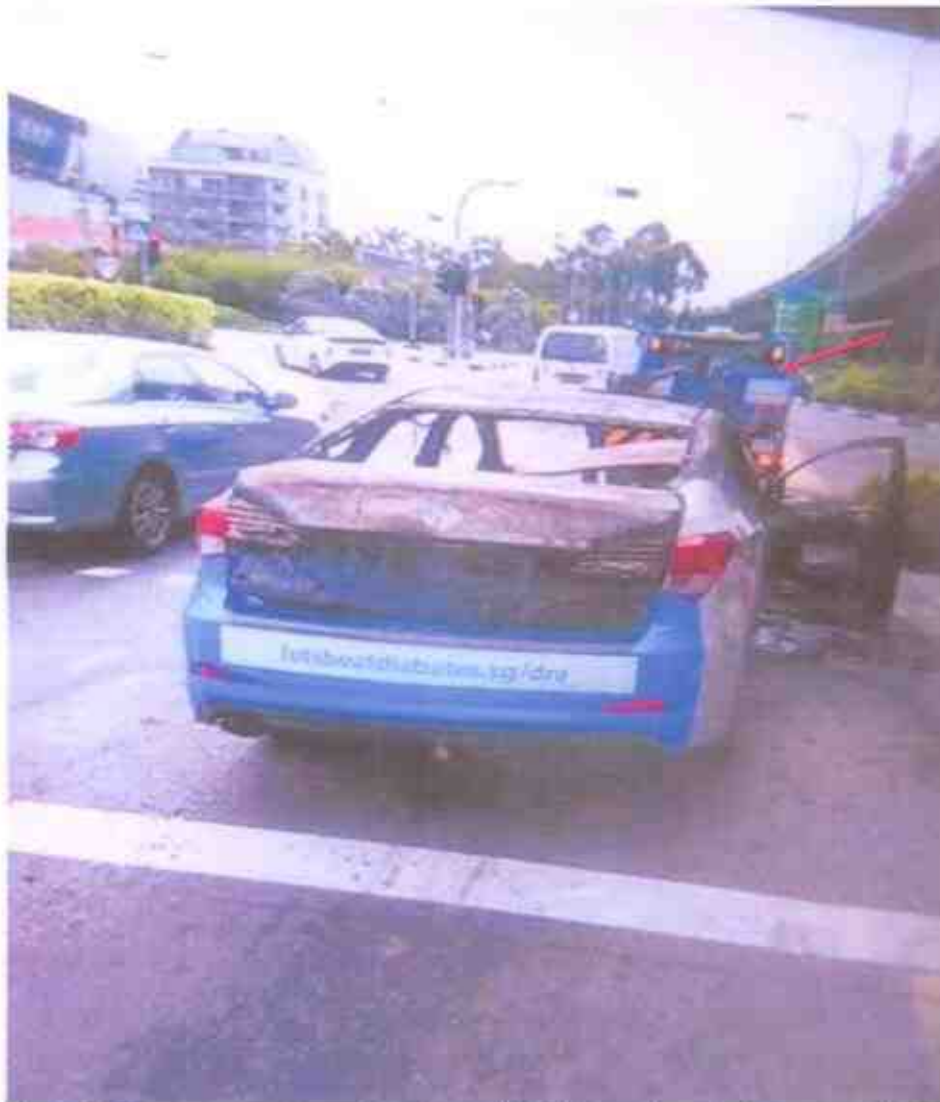
Photo 15 shows a rear view of the Insured Vehicle as it was being prepped to be towed away (arrowed). Our close examination of this photograph showed no unusual foreign material(s) and/or object(s) found on the ground in the immediate area of the slip road where the Insured Vehicle was positioned when the fire broke out.
