Your Ref: TP/IP/52725/2018
Our Ref :CI/TPD18018431/Z

20th November 2018

MECHANICAL INSPECTION REPORT OF MOTORCYCLE FBA 2867Z

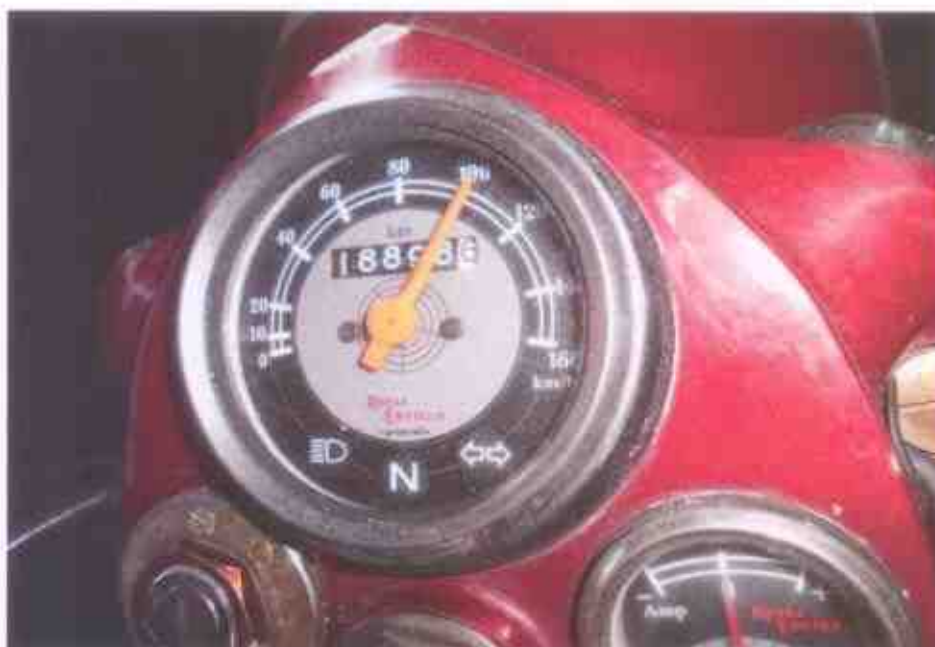
Photo 1 shows the mileage of the Motorcycle recorded at time of our inspection was 188986km.

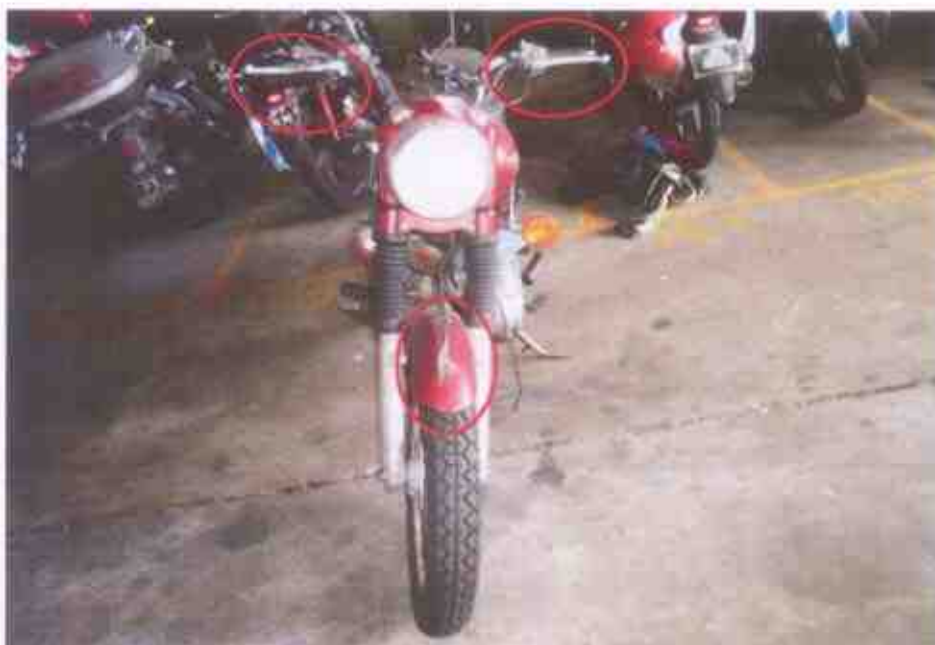
Photo 2 shows a general view of the front right body of the Motorcycle at the time of our inspection. The Motorcycle was observed to have sustained relatively minor damages at time of inspection.

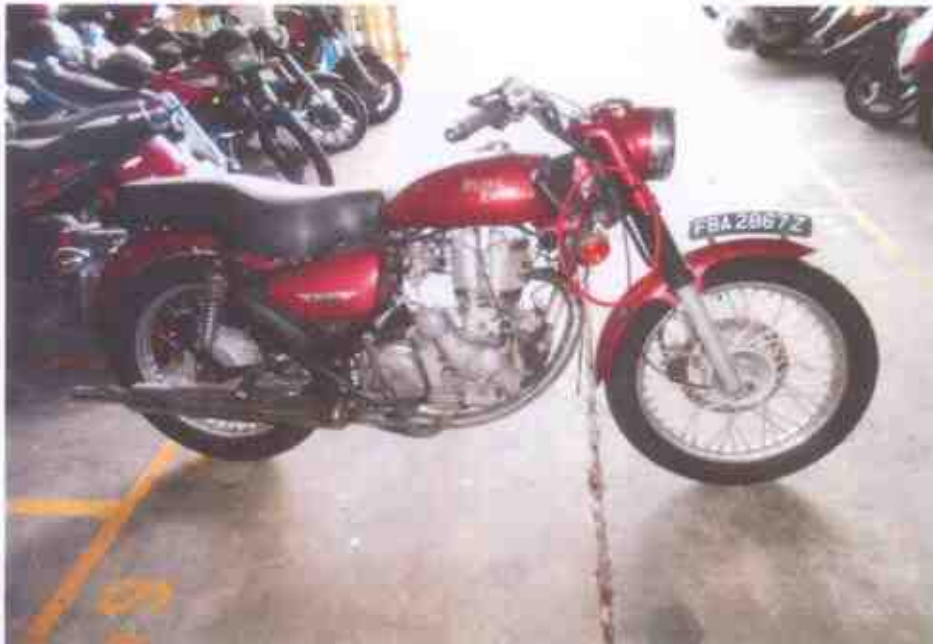
Photo 3 shows a general view of the front right body of the Motorcycle at the time of our inspection. The Motorcycle was observed to have sustained relatively minor damages at time of inspection.

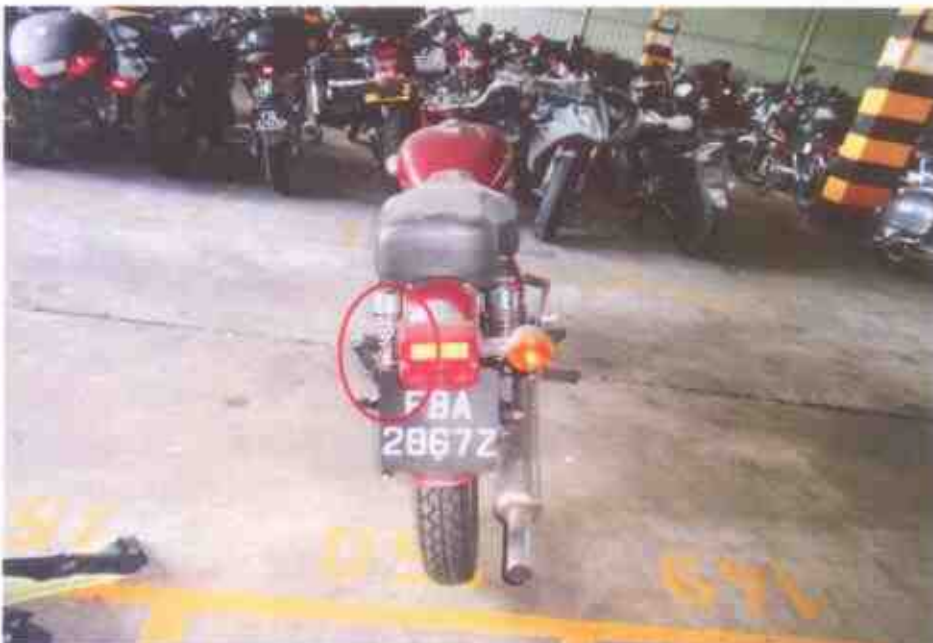
Photo 4 shows a general view of the rear right body of the Motorcycle at the time of our inspection. The Motorcycle was observed to have sustained relatively minor damages at time of inspection.

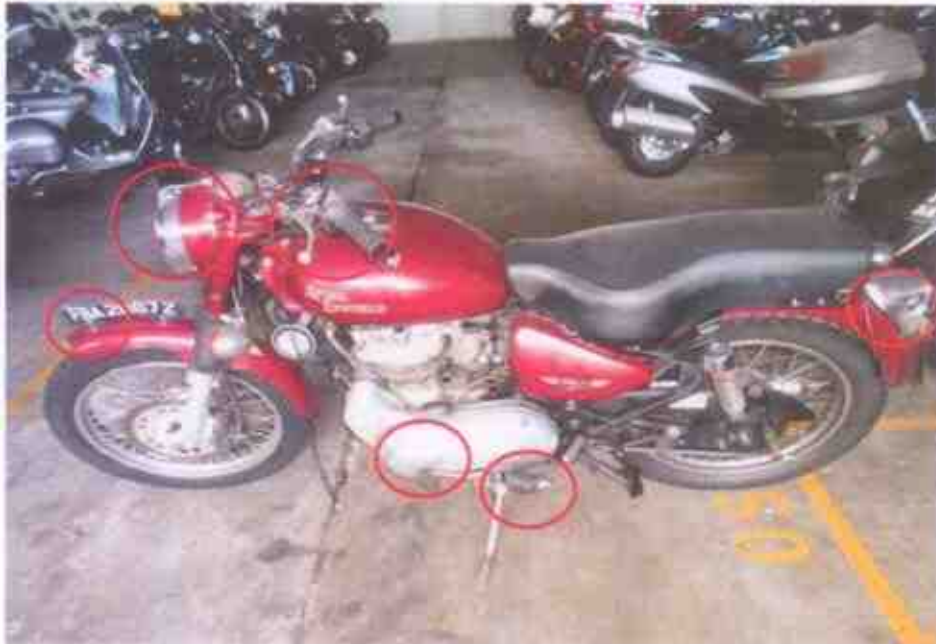
Photo 5 shows a general view of the front left body of the Motorcycle at the time of our inspection. The Motorcycle was observed to have sustained minor damages at time of inspection (circled).

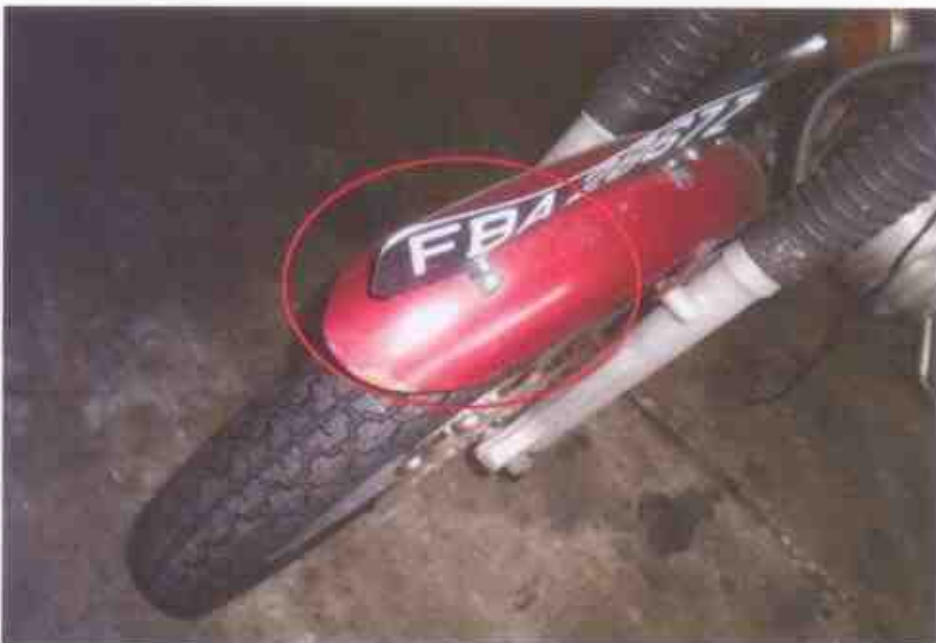
Photo 6 shows a closer view of the misaligned mudguard & dented licence plate of the Motorcycle at the time of our inspection. It was observed to have sustained with relatively minor damages due to the accident collision. (Circled)

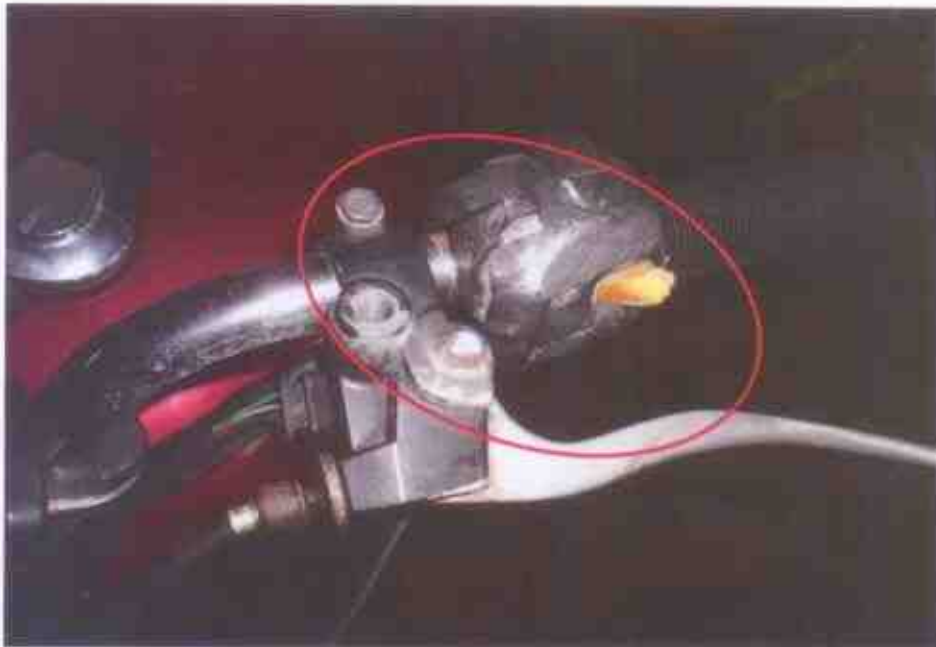
Photo 7 shows a closer view of the front left side handle bar of the Motorcycle at the time of our inspection. It was observed to be damage likely due to the accident. (Circled)

11. Our checks on the various steering components of the Motorcycle had revealed that its steering system was in serviceable condition. Its front fork was found to be intact and undamaged not affected by the accident's impact. However, its handle bar was found to be slightly bent due to the accident.

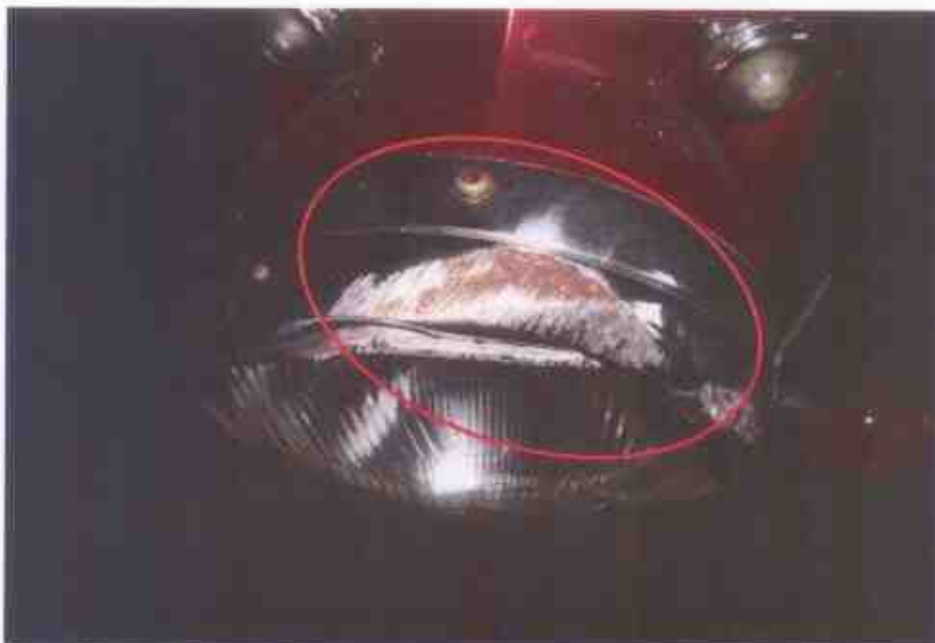
Photo 8 shows a closer view of the headlamp of the Motorcycle at the time of our inspection. It was observed to be damage likely due to the accident. (Circled)

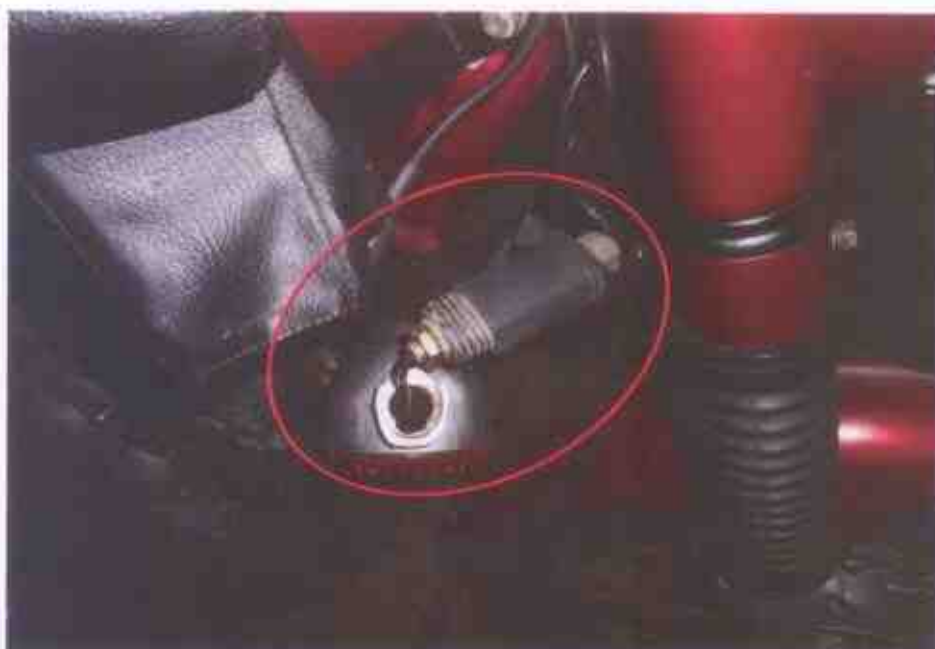
Photo 9 shows a closer view of the front right signal lamp of the Motorcycle at the time of our inspection. It was observed to be damage likely due to the accident. (Circled)

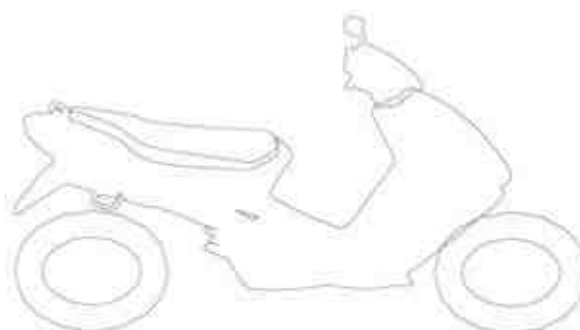
7. The condition of the Motorcycle's 2 tyres was observed to be in serviceable condition. The tread pattern of the 2 tyres was clearly visible. We did not observe any tear, burst mark(s) and/or punctured hole(s) on the sidewalls as well as across the tread of the 2 tyres. The 2 tyres were both observed to be sufficiently inflated for vehicular operation. The tyre brand, tyre size and remaining tread depth of the 2 tyres were recorded as follows:-

Dunlop 3.50-19 4 P.R (5mm)

Dunlop 3.25-19 4 P.R (5mm)

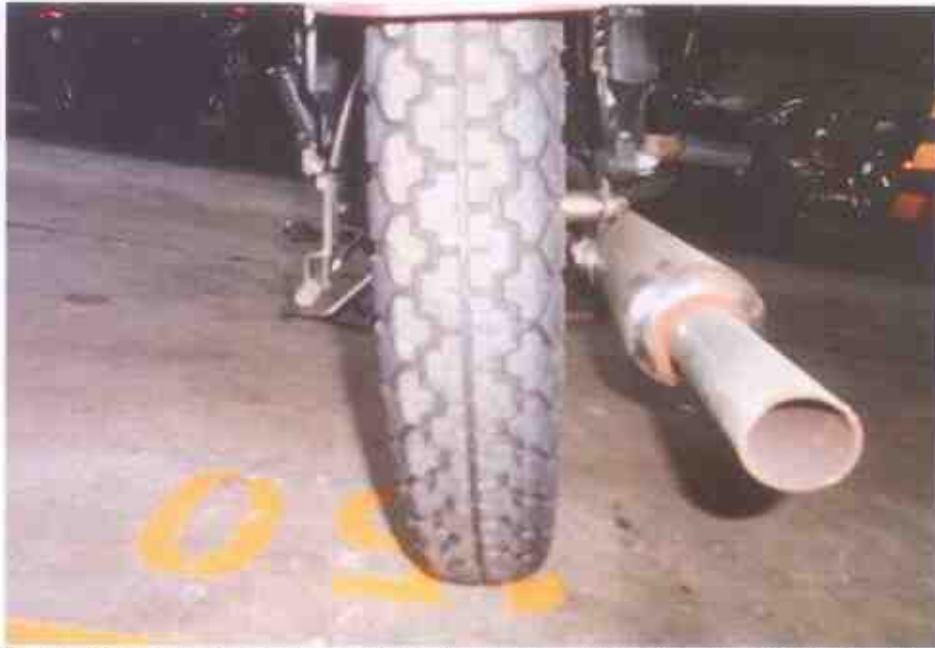
Photo 10 shows the rear tyre of the Motorcycle. The rear tyre was observed to be in serviceable condition with remaining tread depth of approximately 5mm. The tyre was also observed to be sufficiently inflated for vehicular operation.

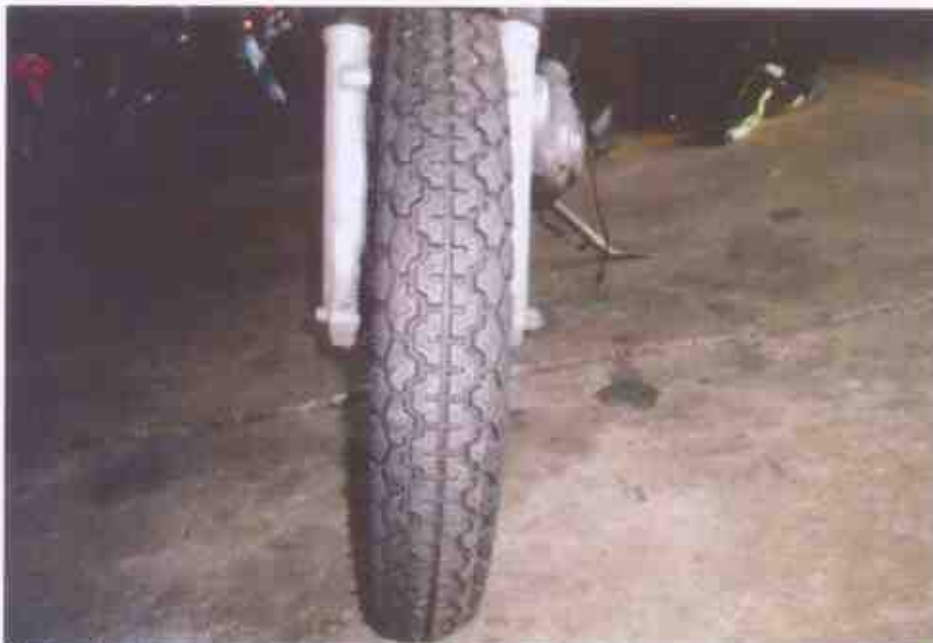
Photo 11 shows the front tyre of the Motorcycle. The front tyre was observed to be in serviceable condition with remaining tread depth of approximately 7mm. The tyre was also observed to be sufficiently inflated for vehicular operation.

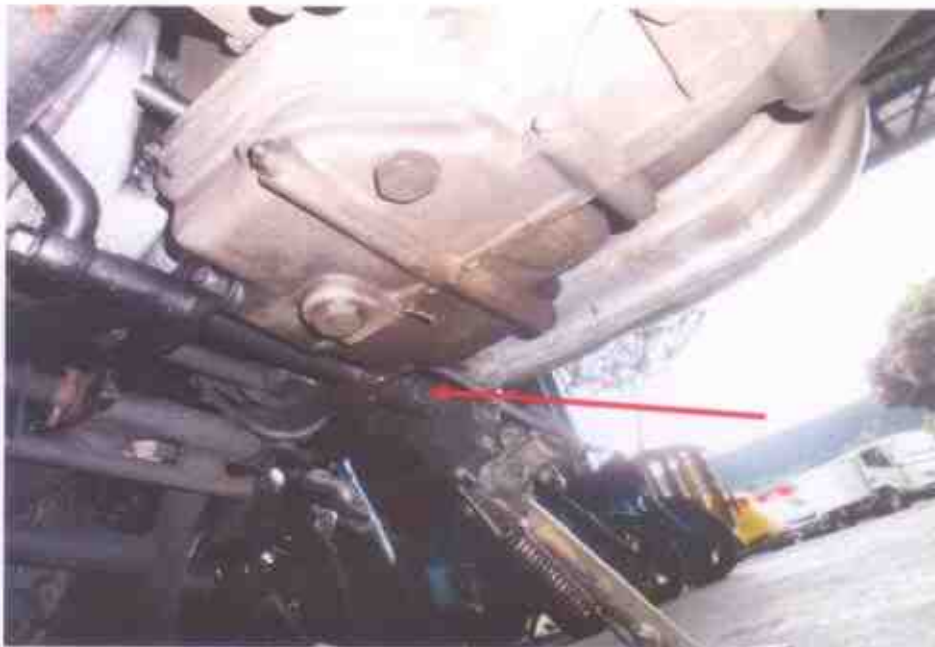
9. Upon examination of the Motorcycle's engine area, we had observed that the various engine related parts and components were intact. However, the engine pan was observed to sustained deep scratch due to the accident's impact collision. Hence, fluid leakage was observed around the engine area of the Motorcycle.
10. The gear chain of the motorcycle was found to be intact without any misalignment. It was also adequately lubricated for operating purposes. Free play tension test was also conducted & found adequately acceptable. See photo 12 – 16 below.

Photo 12 shows sign(s) or indication(s) of fluid leakage was observed around the underside of the engine area of the Motorcycle.

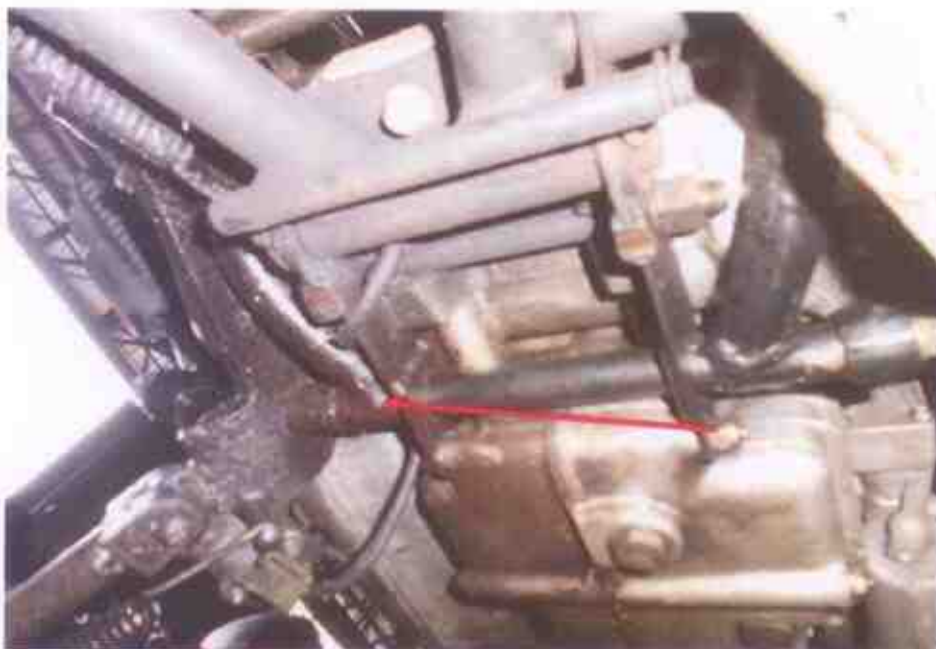
Photo 13 shows sign(s) or indication(s) of fluid leakage was observed around the underside of the engine area of the Motorcycle.

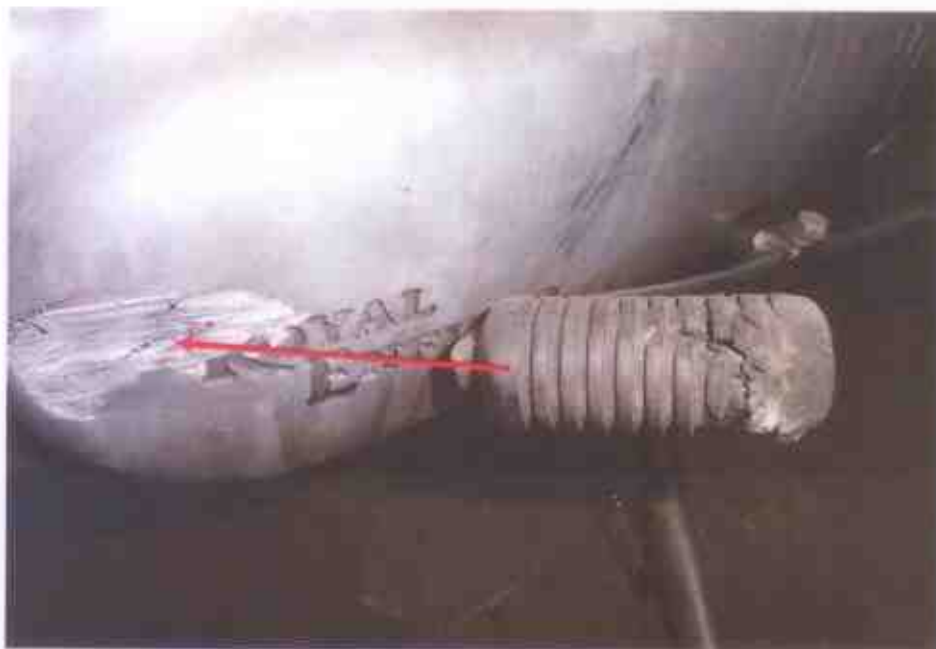
Photo 14 shows damaged engine pan due to the accident's impact collision.

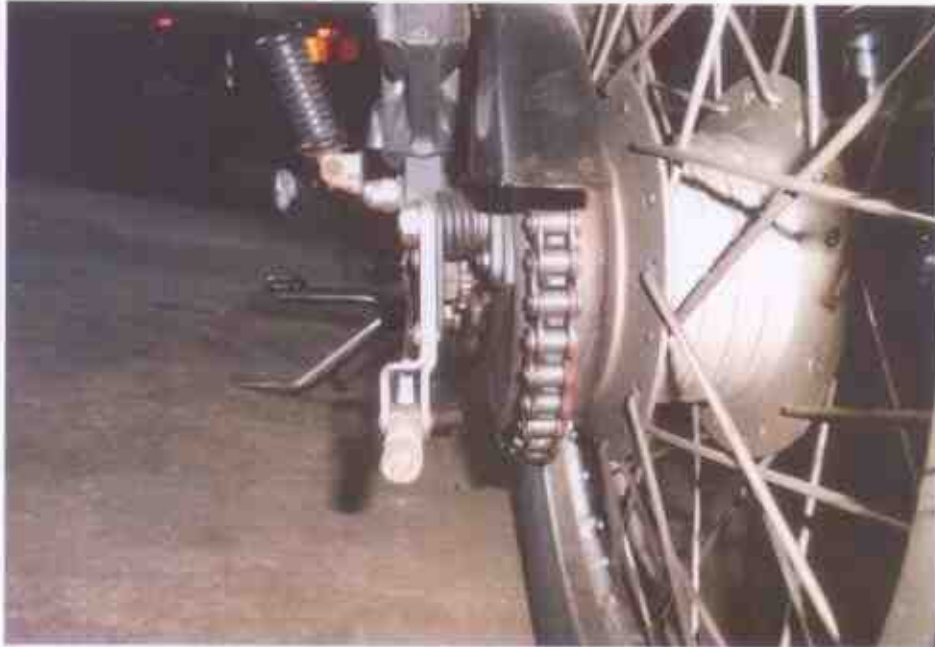
Photo 15 shows the general view of the gear train (arrowed) of the Motorcycle, which was observed to be intact with no misalignment. It was also adequately lubricated for operating purposes.

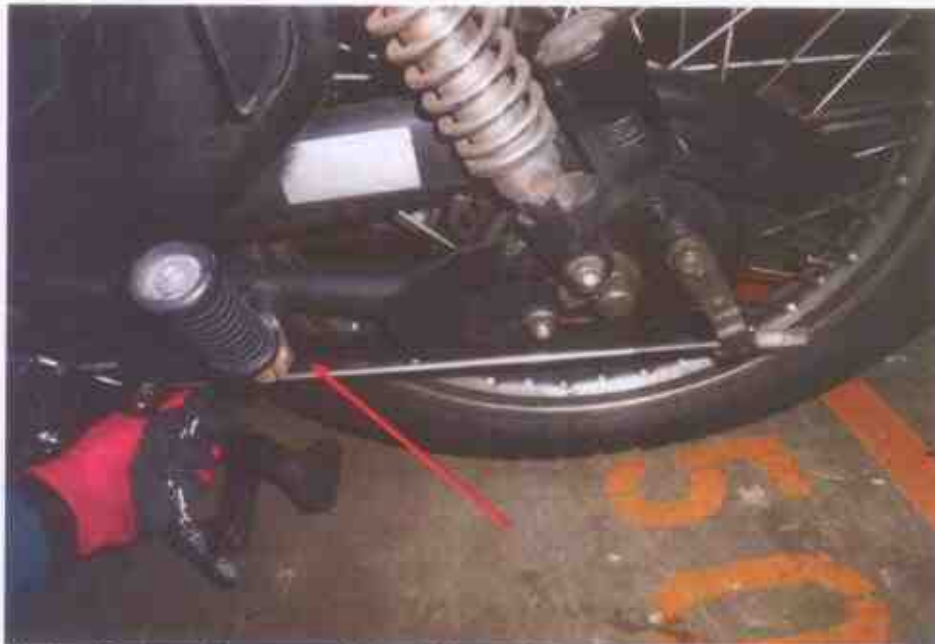
Photo 16 shows the general view of the gear train (arrowed) of the Motorcycle, which was observed to be intact with no misalignment. It was also adequately lubricated for operating purposes. Free play tension was also observed & found adequately acceptable.

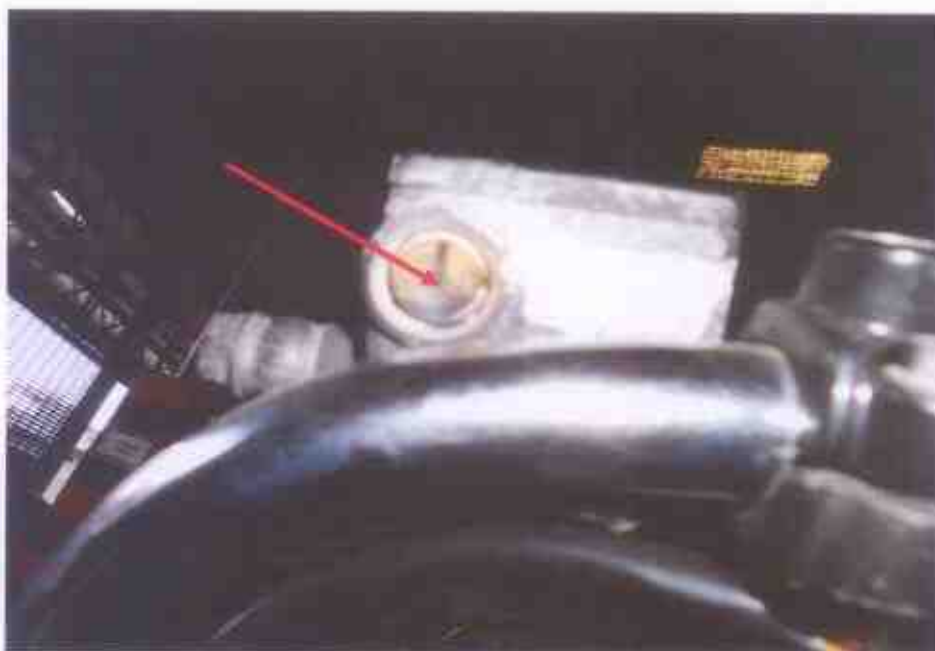
Photo 17 shows our checks on the brake fluid (front) reservoir had also indicated that the brake fluid was of sufficient level for operational purposes, and without contamination.

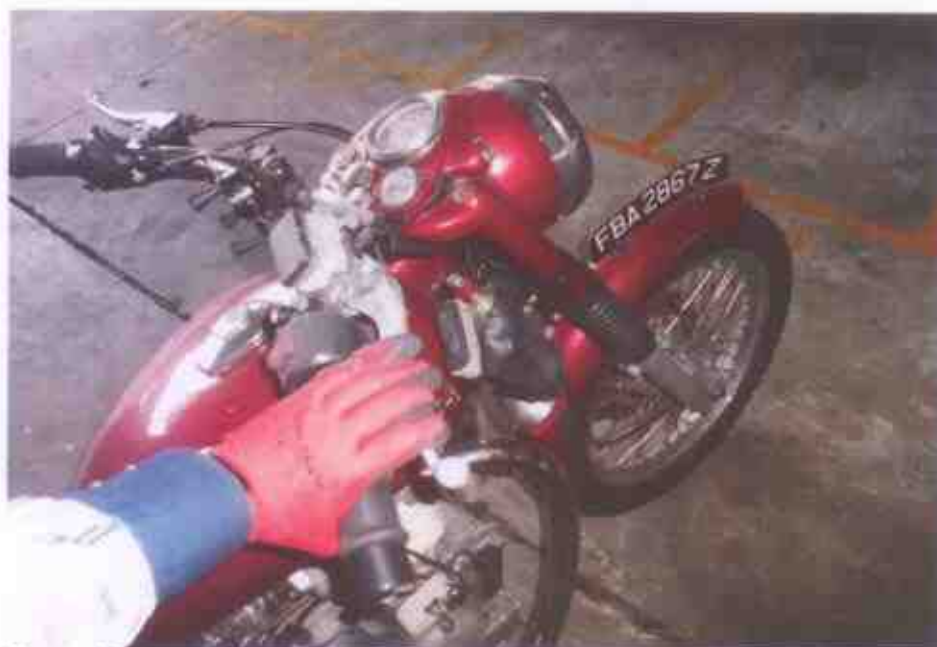
Photo 18 shows testing of the braking of the front brake in progress. There was some resistance felt (spongy like feel) upon pressing the brake lever.

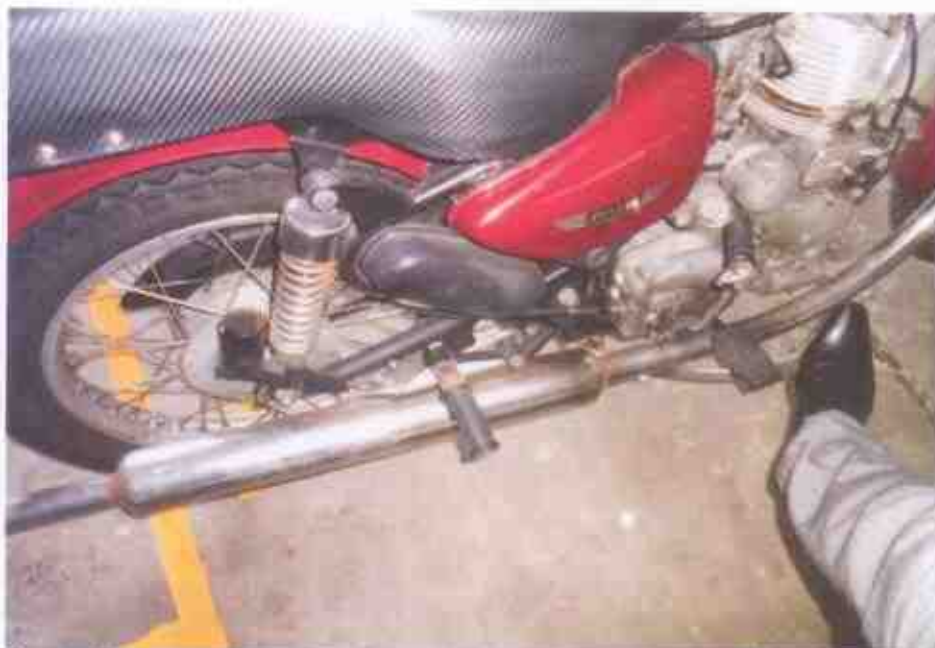
Photo 19 shows testing of the braking of the rear brake in progress. There was some resistance felt (spongy like feel) upon stepping on the brake pedal.

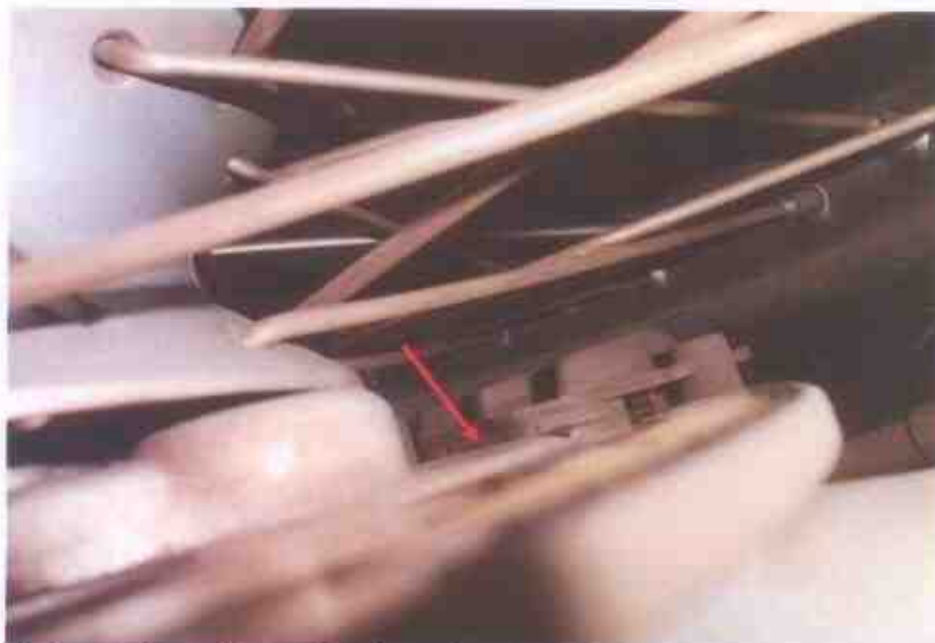
Photo 20 shows the front brake pad at time of our inspection. The frictional material was observed to be sufficient for operational purposes.

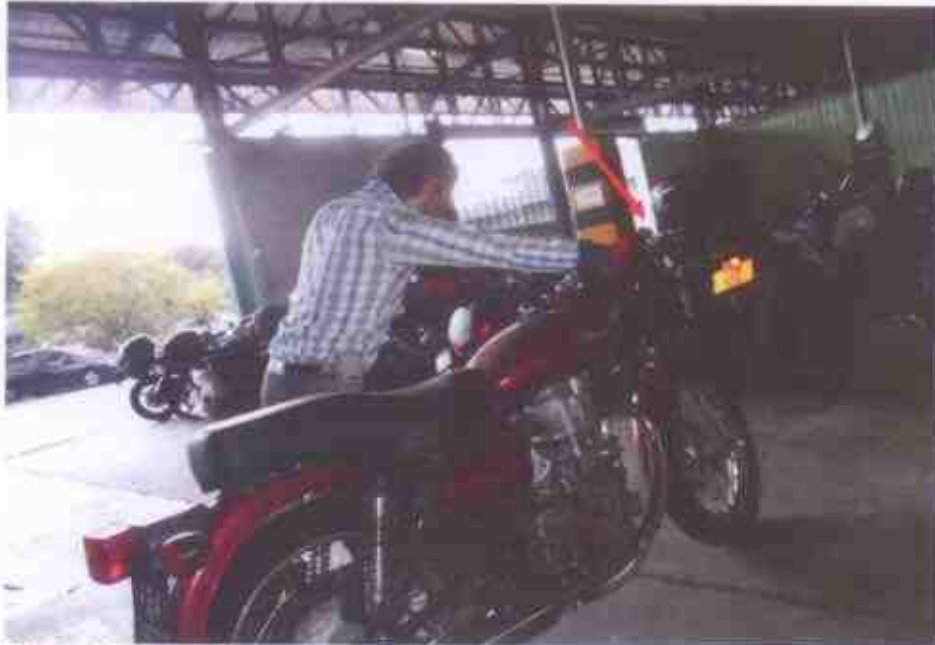
In general, the observations gathered during the static brake test & manual movement test had indicated that the steering system & braking system of the Motorcycle was in serviceable condition. See photo 17 - 21 below.

Photo 21 shows the manual operational test conducted on the Motor Cycle's braking system.
