Your Ref: TP/IP/50357/2018
Our Ref : CI/TPD18018432/Z

24th January 2019

MECHANICAL INSPECTION REPORT OF MOTOR LORRY GT 4254U

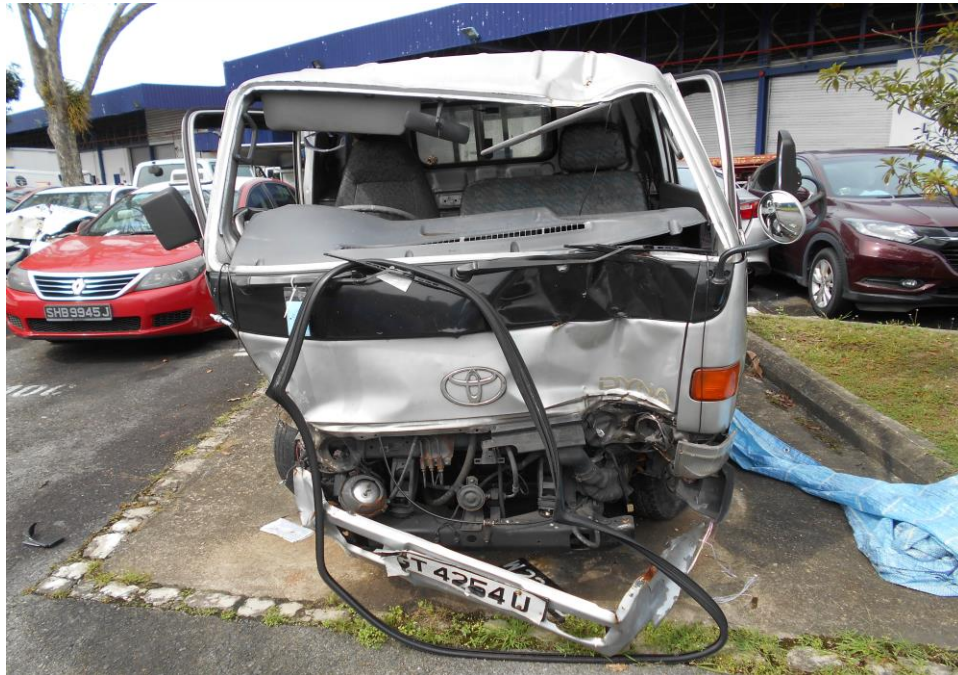
Photo 1 shows a general view of the frontal portion of the Motor Lorry at the time of our inspection. The Motor Lorry was observed to have sustained extensive impact damage at its frontal, left & right portion. The impact force was relatively significant, causing its entire front cabin to be pushed inwards and corrugated.

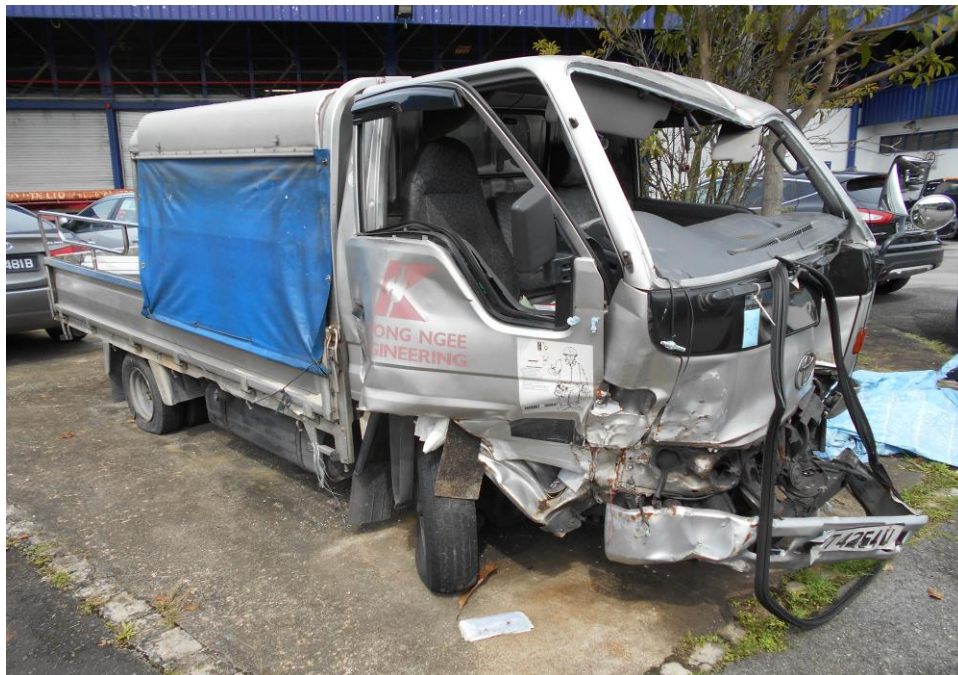
Photo 2 shows a general view of the frontal right portion of the Motor Lorry at the time of our inspection. A number of mechanical parts and components at the frontal portion were also severely damaged as a result of the accident.

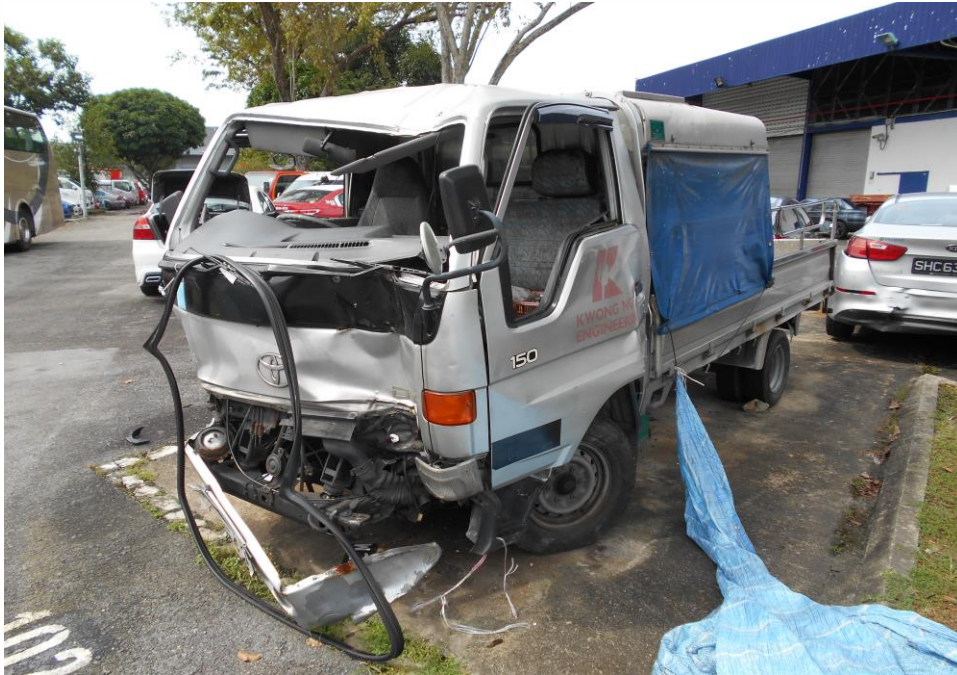
Photo 3 shows a general view of the front left portion of the Motor Lorry at the time of our inspection. The Motor Lorry was observed to have sustained extensive impact damage at its front left portion. The impact force was relatively significant, causing its entire front cabin to be pushed inwards and corrugated.

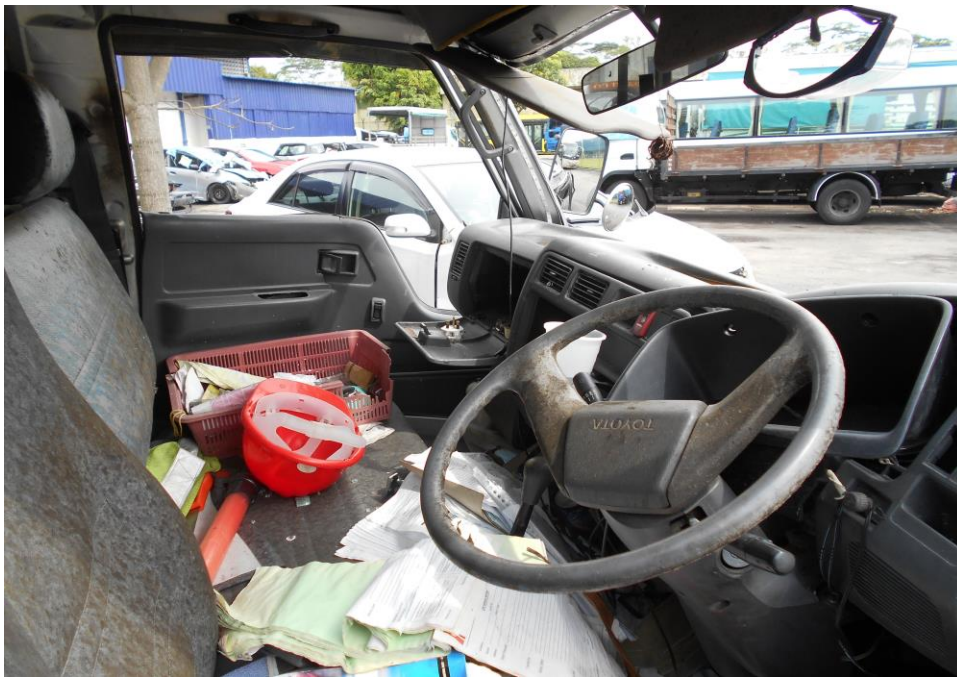
Photo 4 shows the interior of the front cabin. The dashboard, steering wheel, floor panel and braking system (pedal) inside the front cabin were all observed to be pushed/buckled inwards, towards the rear of the Motor Lorry. This is consistent to the nature of this accident where the direction of impact onto the Motor Lorry was from the front to rear direction.

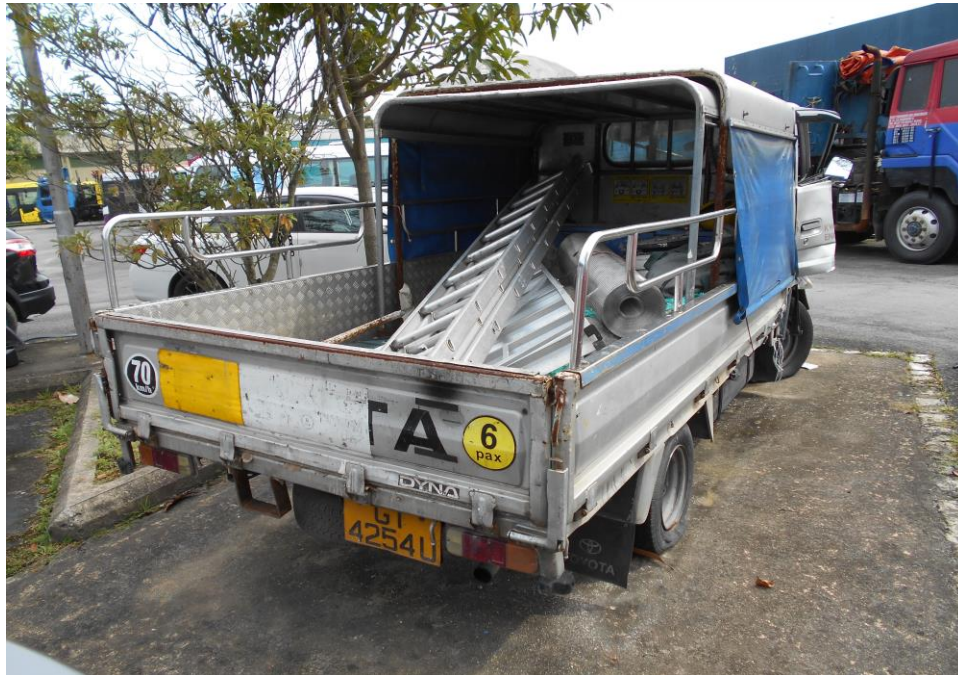
Photo 5 shows a general view of the rear right portion of the Motor Lorry at the time of our inspection. The rear portion was observed to be unaffected by the accident.

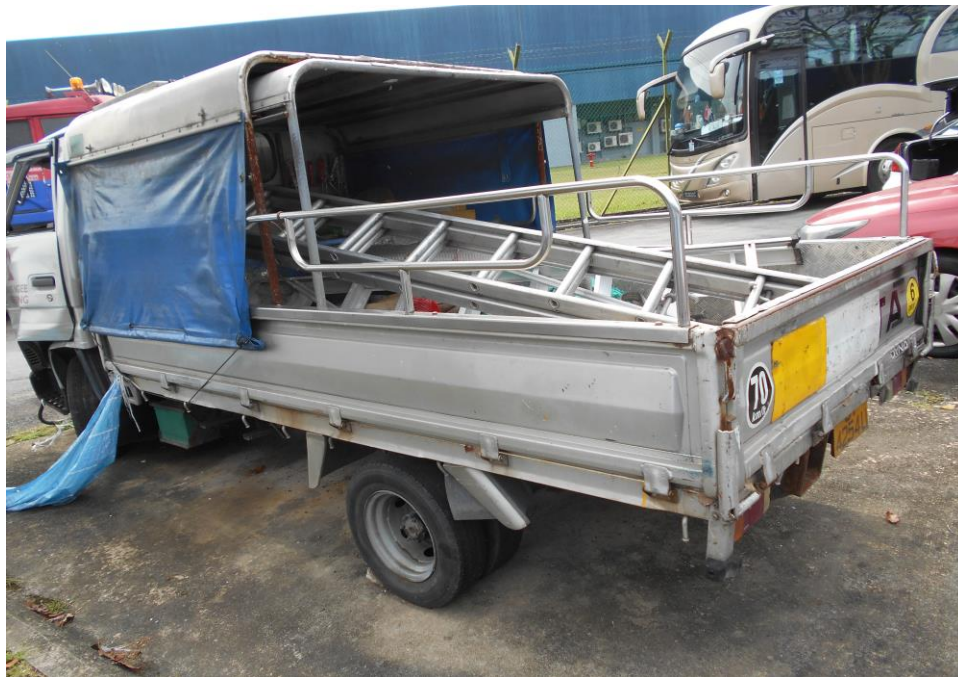
Photo 6 shows a general view of the rear right portion of the Motor Lorry at the time of our inspection. The rear portion was observed to be unaffected by the accident. The rear portion (deflated tyres & misalignment of tail lamp) was observed to be relatively affected by the accident.

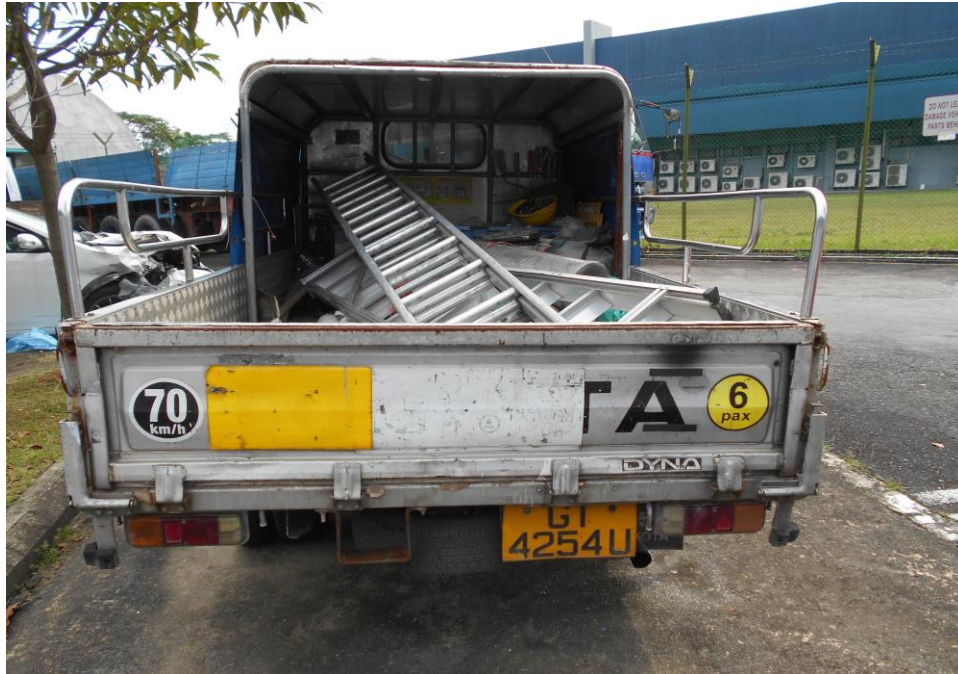
Photo 7 shows a general view of the rear portion of the Motor Lorry at the time of my inspection. The rear portion was observed to be unaffected by the accident.

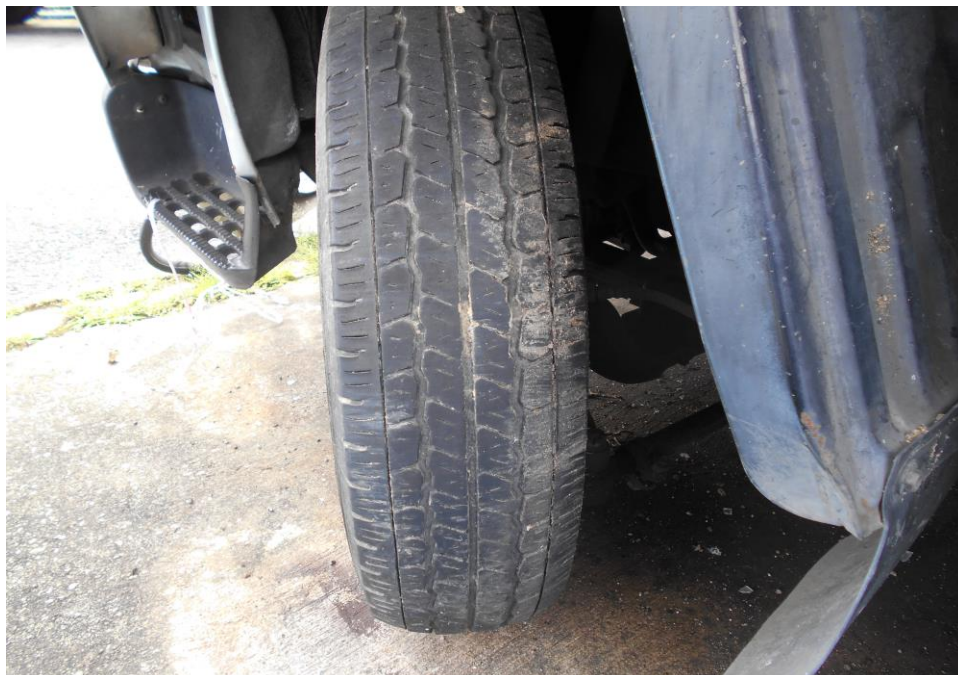
Photo 8 shows the condition of the front left tyre of the Motor Lorry, which was observed to be in serviceable condition with remaining tread depth of approximately 5mm. There was also no tear, cut or burst mark(s) on the outer and the inner sidewalls as well as across the tread of this tyre.

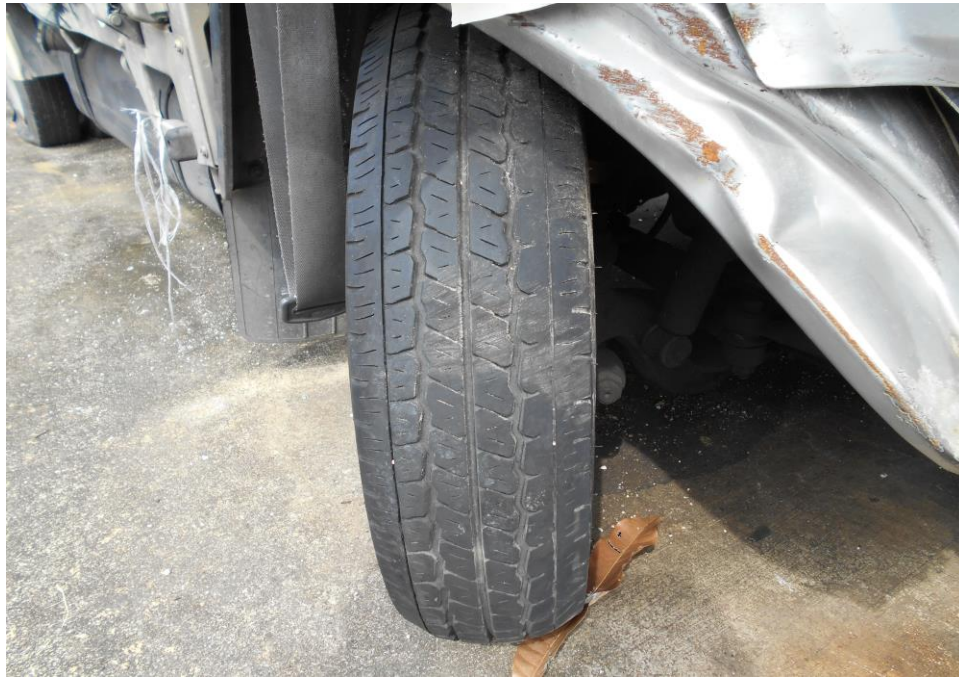
Photo 9 shows the condition of the front right tyre of the Motor Lorry. The front right tyre was observed to be in serviceable condition with remaining tread depth of approximately 5mm. There was also no tear, cut or burst mark(s) on the outer and the inner sidewalls as well as across the tread of this tyre.

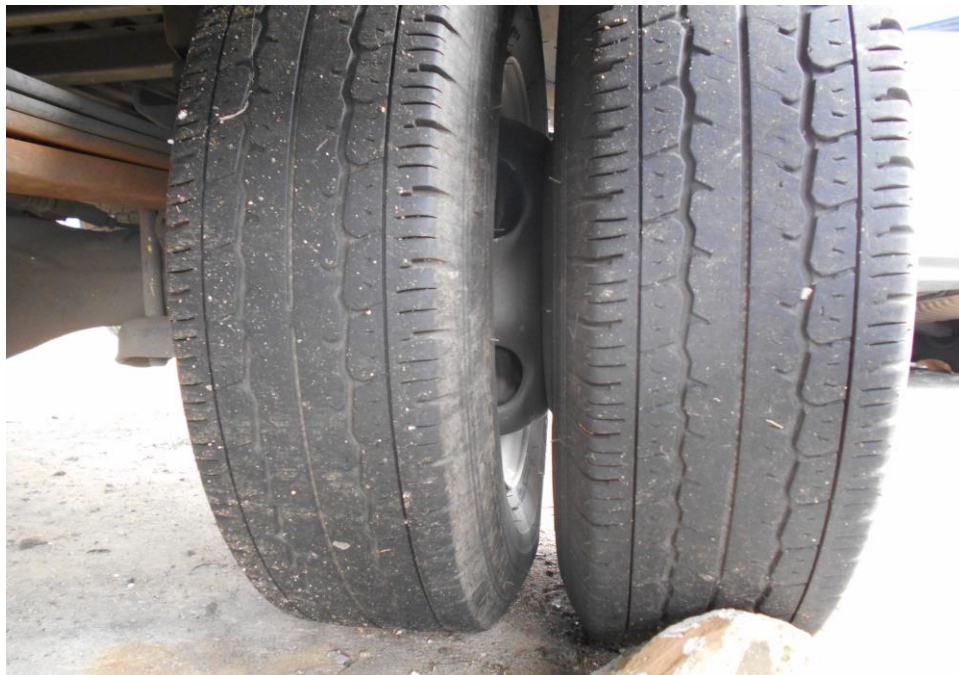
Photo 10 shows the condition of the rear left tyres of the Motor Lorry, which was observed to be in serviceable condition with remaining tread depth of approximately 8mm. There was no tear, cut or burst mark(s) on the outer and the inner sidewalls as well as across the tread of this 2 tyres.

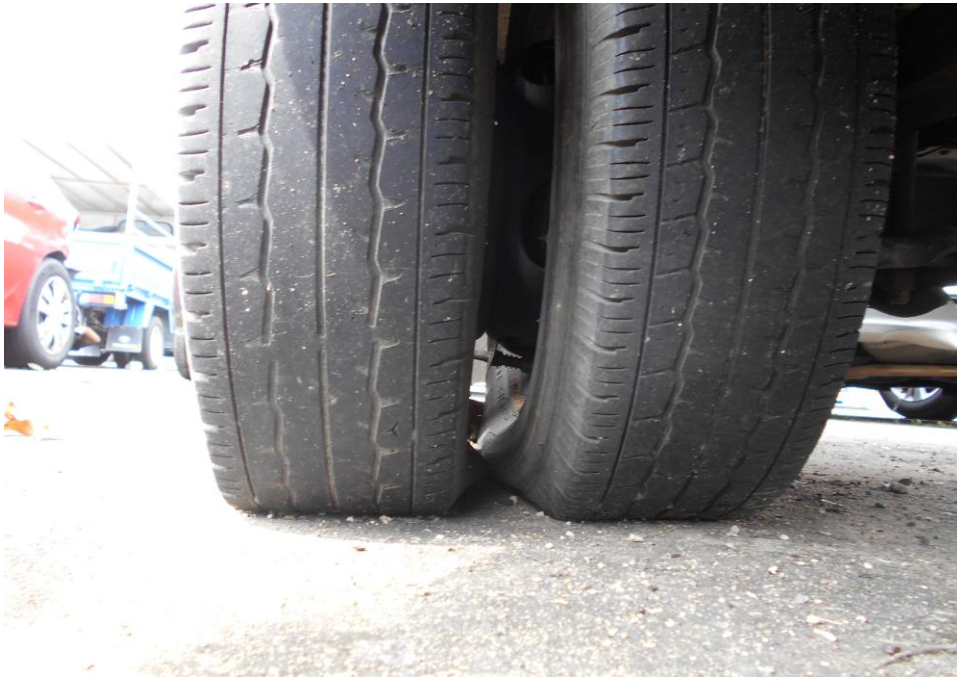
Photo 11 shows the condition of the rear right tyres of the Motor Lorry, which was observed to have sustained cut/torn mark & deflated with remaining tread depth of approximately 2mm. This was likely due to the accident's impact collision.

24. As for the outer rear right tyre of the Motor Lorry, it was observed to be deflated likely due to the accident's collision. We found torn/cut mark on the outer rear right tyre that causes the tyre to be deflated as a result of the accident.

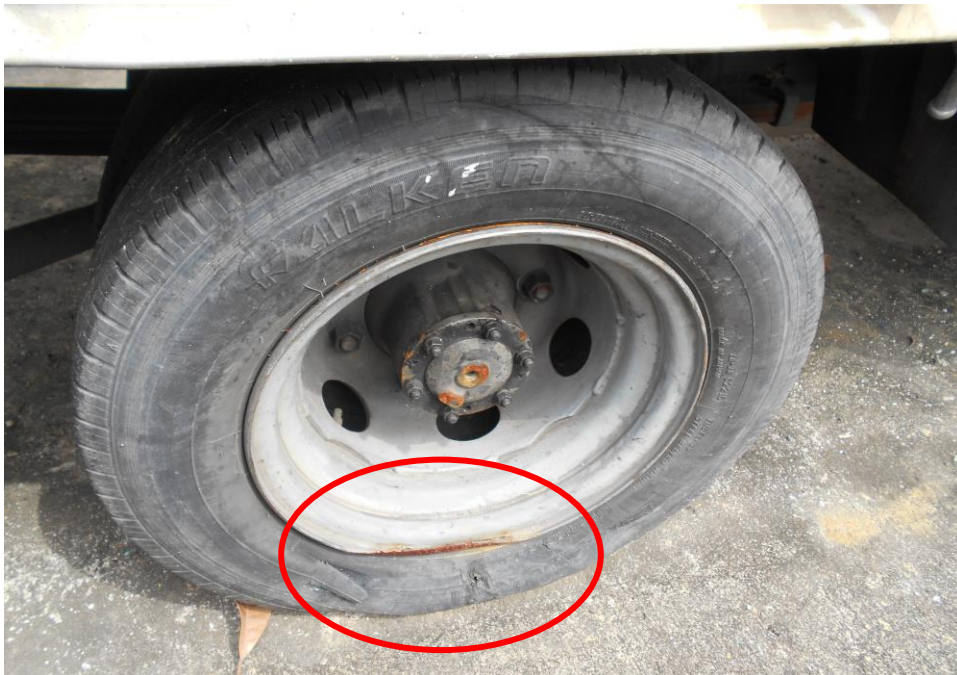
Photo 12 shows the condition of the rear right tyres (outer) of the Motor Lorry, which was observed to be deflated due to the dented rim & cut mark as a result of the accident.

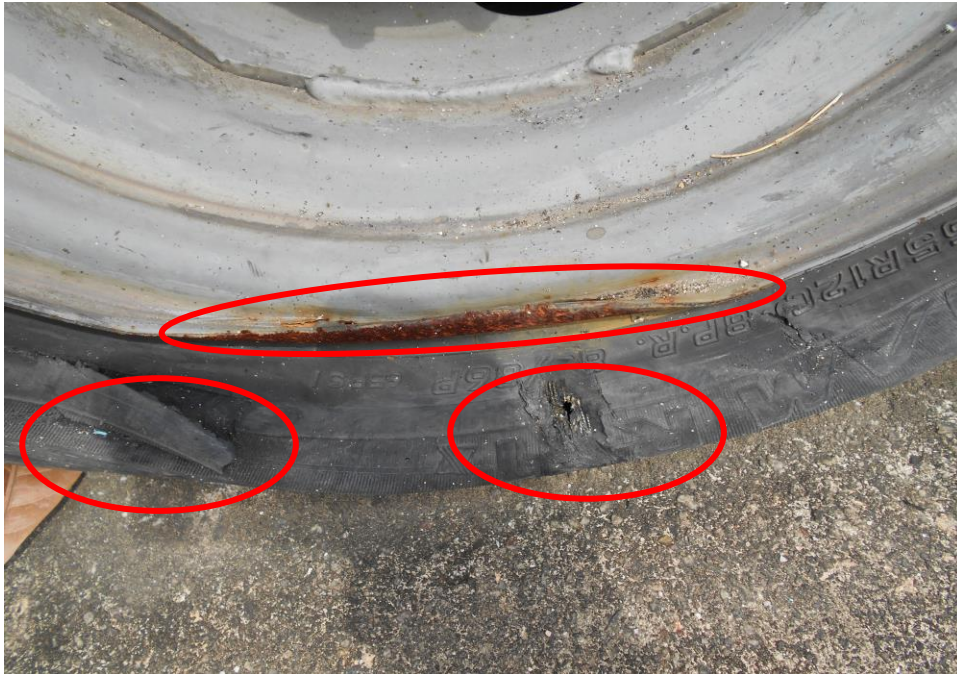
Photo 13 shows the condition of the rear right tyres (outer) of the Motor Lorry, which was observed to be deflated due to the dented rim & cut mark as a result of the accident.

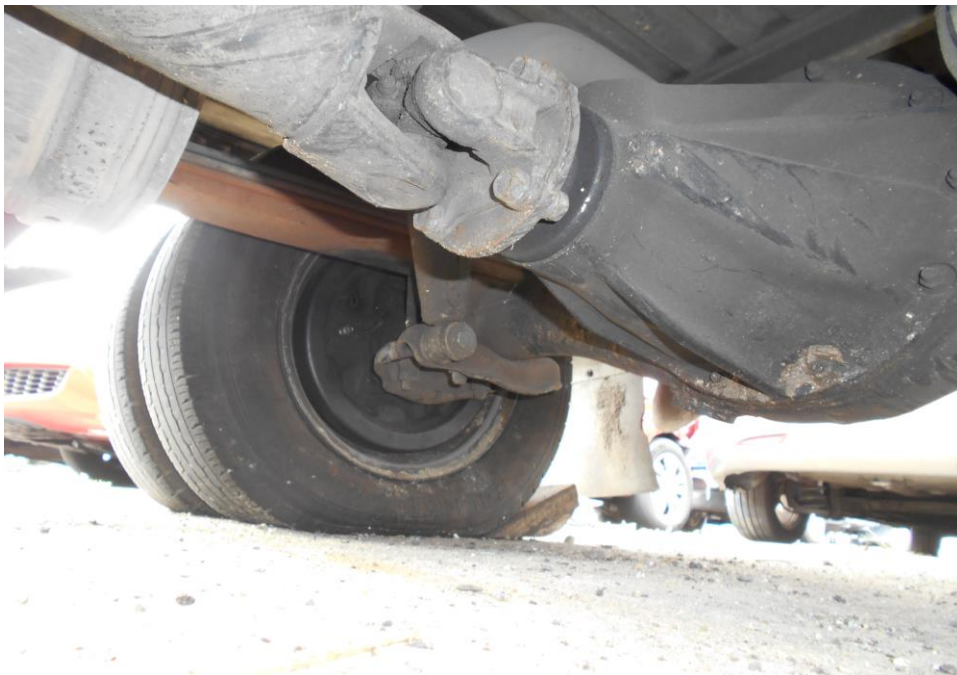
Photo 14 shows the condition of the rear right tyres (inner) of the Motor Lorry, which was observed to be unaffected by the accident's impact.

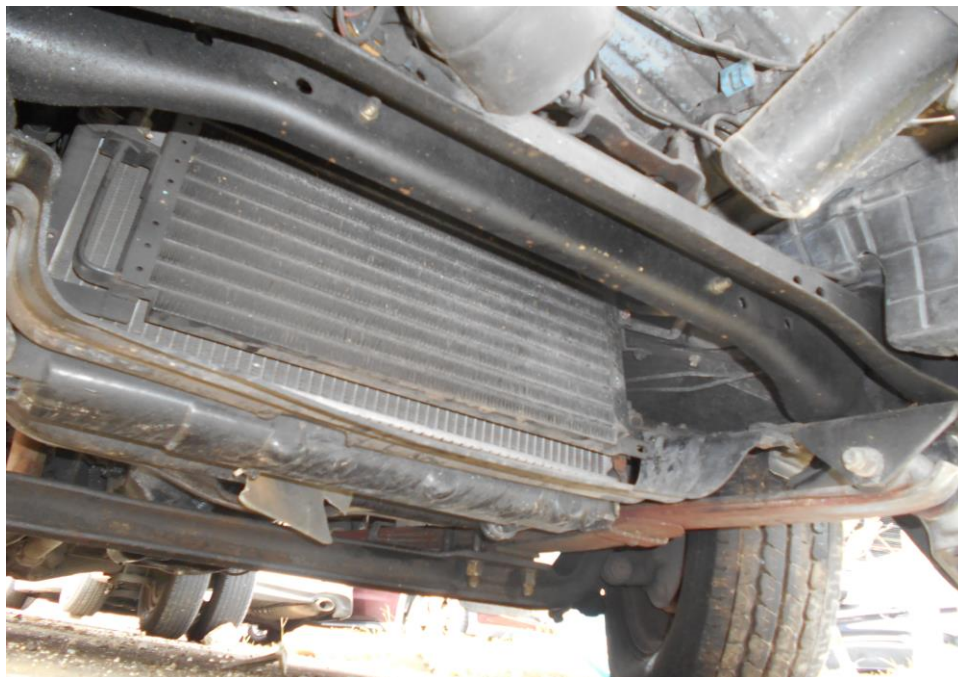
Photo 15 shows the underside of the Motor Lorry, at the area where the engine is located. We were not able to closely inspect the engine compartment of the Motor Lorry due to the extensive damage to its front cabin. Our visual checks from the underside had however appear to indicate that the engine assembly and transmission assembly were both intact and unaffected by the collision.

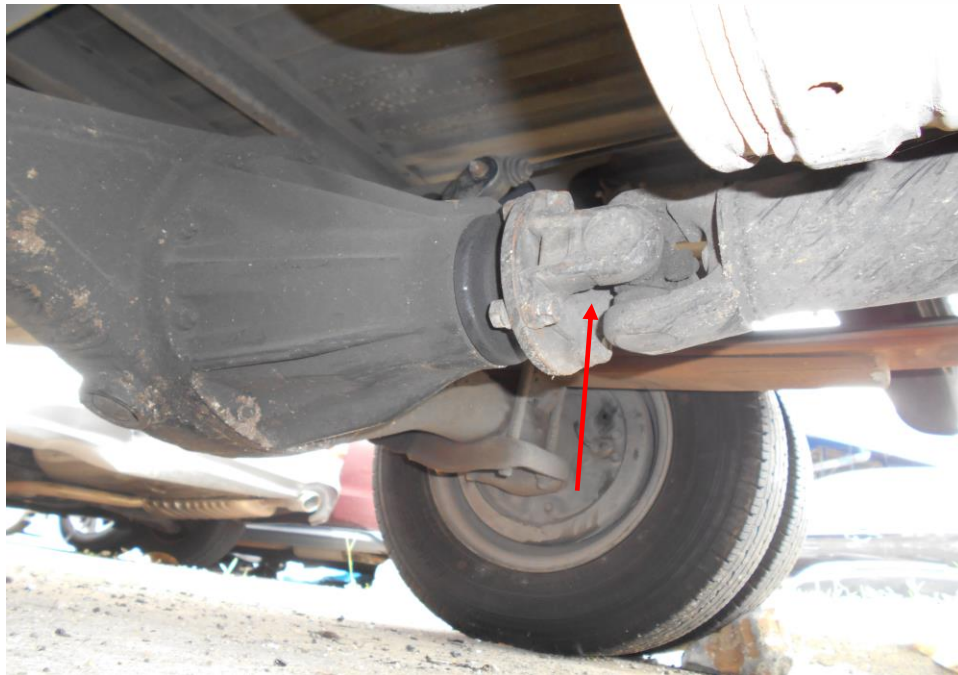
Photo 16 shows the transmission assembly (arrowed) of the Motor Lorry intact and unaffected by the collision.

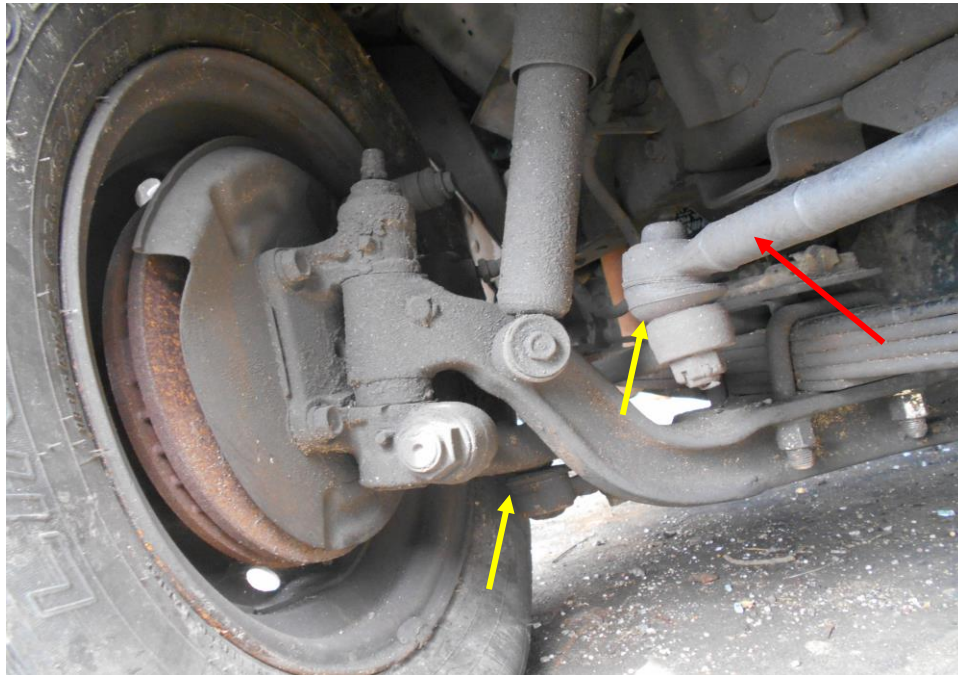
Photo 17 shows the undamaged steering shaft (red arrow) of the Motor Lorry. The steering tie rods (yellow arrow) of the Motor Lorry were however observed to be intact and securely attached to the front right wheel. The steering ball joints were also observed to be in a serviceable condition.

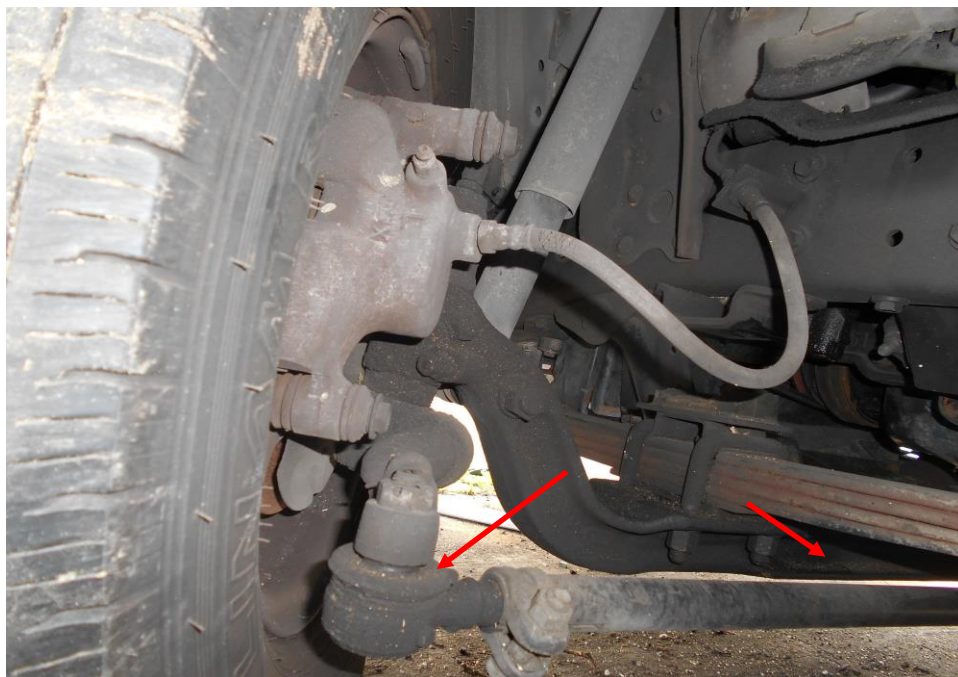
Photo 18 shows the undercarriage components at the front left wheel of the Motor Lorry. The various undercarriage components of the Motor Lorry were all observed to be intact and without any visible damage. This had included the steering rack (arrowed) of the Motor Lorry.

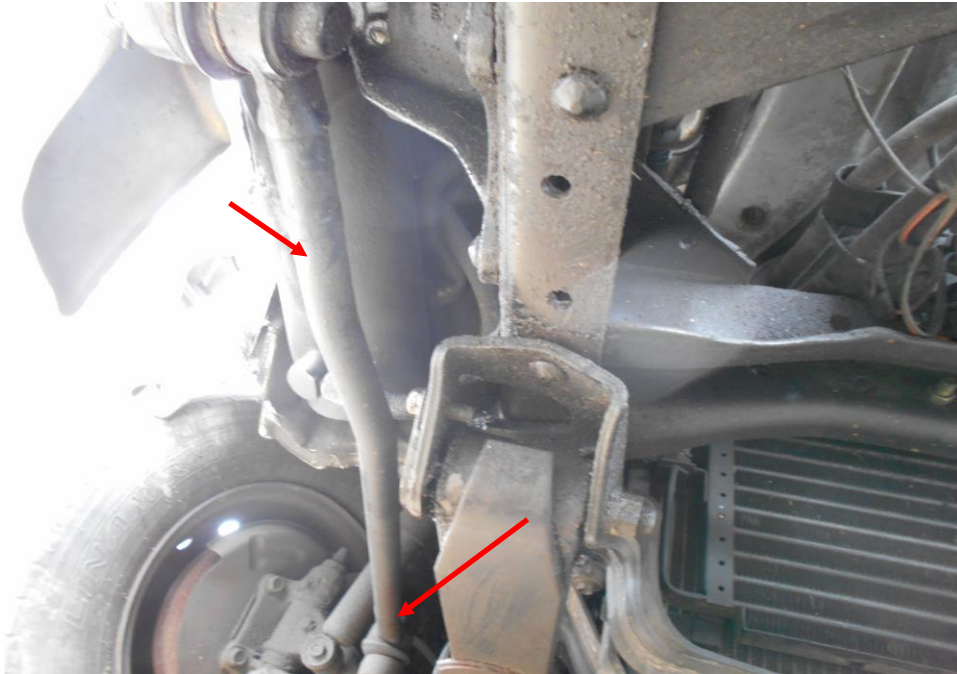
Photo 19 shows the undercarriage components at the front right wheel of the Motor Lorry. The steering rod was observed to be intact and without any visible damage.

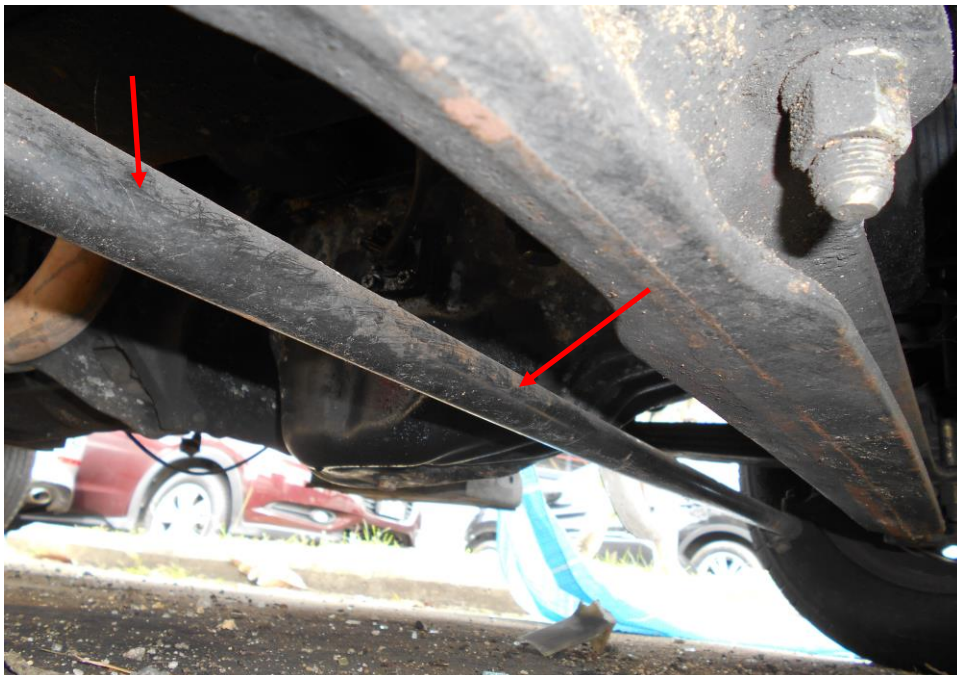
Photo 20 shows the undercarriage components at the centre portion of the Motor Lorry. The steering rod was observed to be intact and without any visible damage.

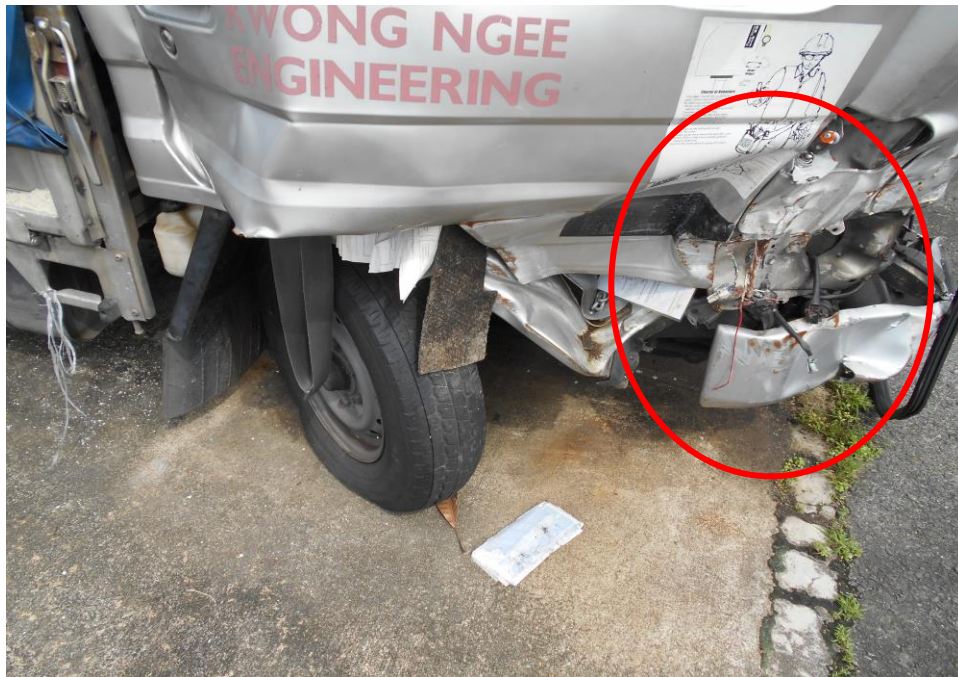
Photo 21 shows the undercarriage components at the front right lower portion of the Motor Lorry. The steering box was observed to be stuck into the buckled lower metal bumper as a result of the accident which disabling the normal operation of the steering system.

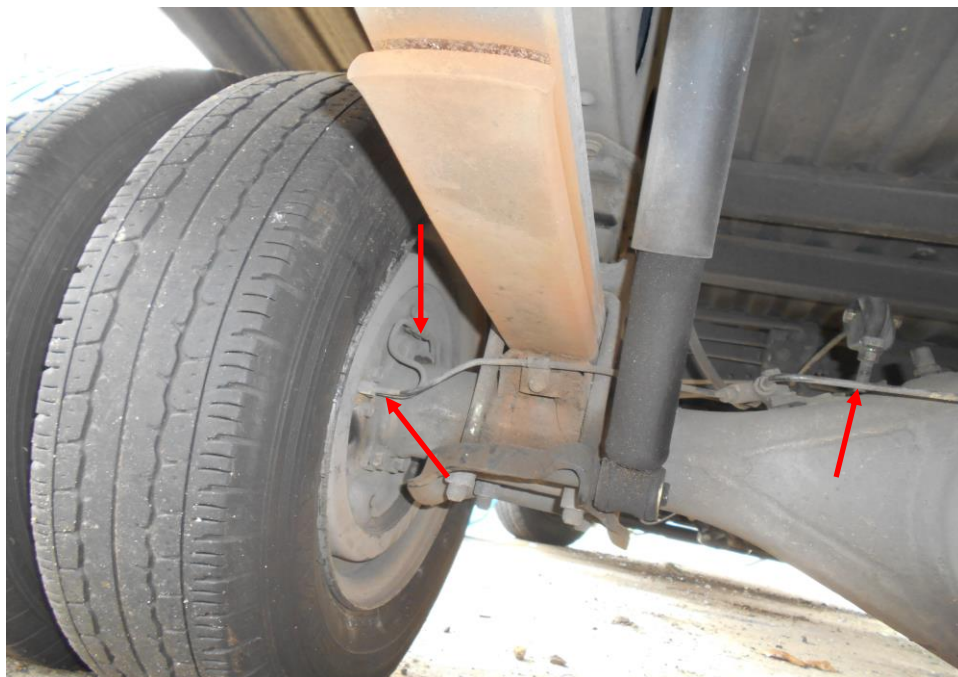
Photo 22 shows the brake hose (arrowed) at the rear wheels of the Motor Lorry. At the time of our inspection, we did not find any sign(s) of brake fluid leakage along the brake hoses and brake pipes.

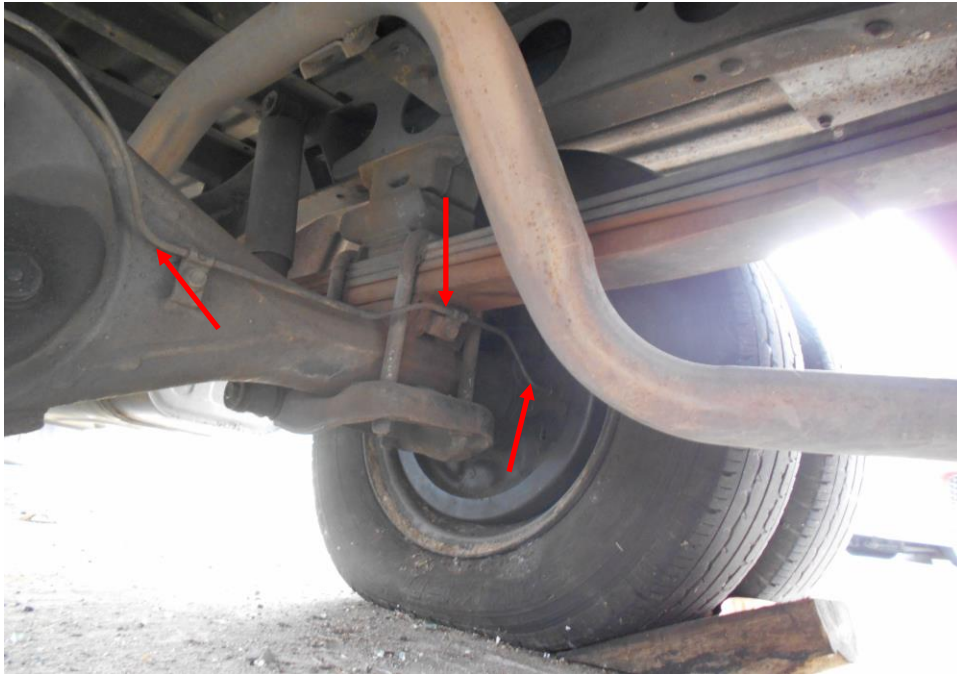
Photo 23 shows the brake hose (arrowed) at the rear wheels of the Motor Lorry. At the time of our inspection, we did not find any sign(s) of brake fluid leakage along the brake hoses and brake pipes.

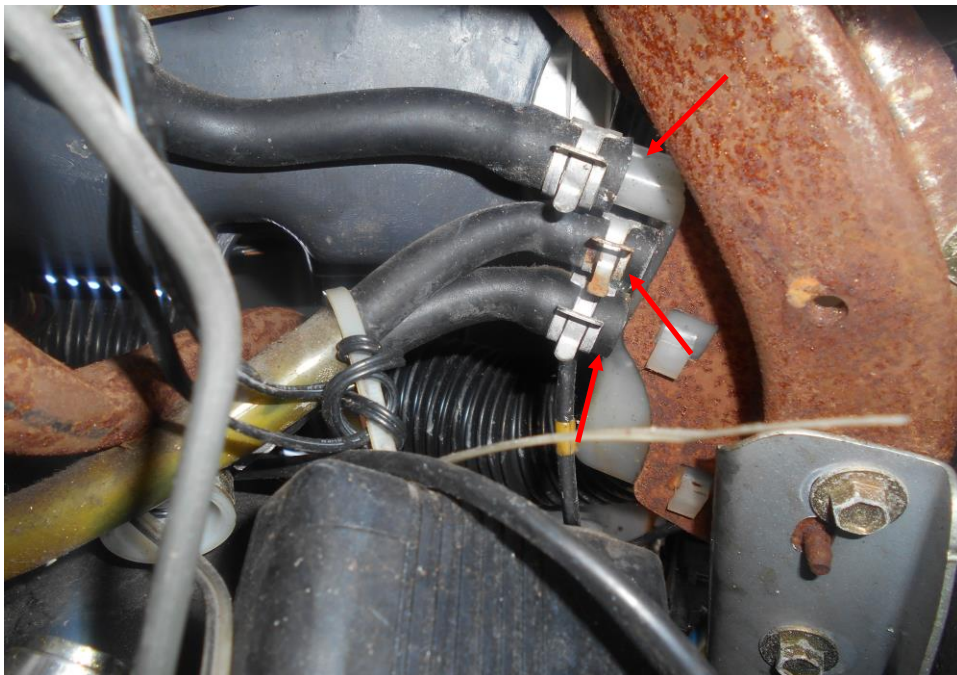
Photo 24 shows the brake hose (arrowed) at the outlet of the brake fluid reservoir of the Motor Lorry. At the time of our inspection, we did not find any sign(s) of brake fluid leakage along the brake hoses and brake pipes.

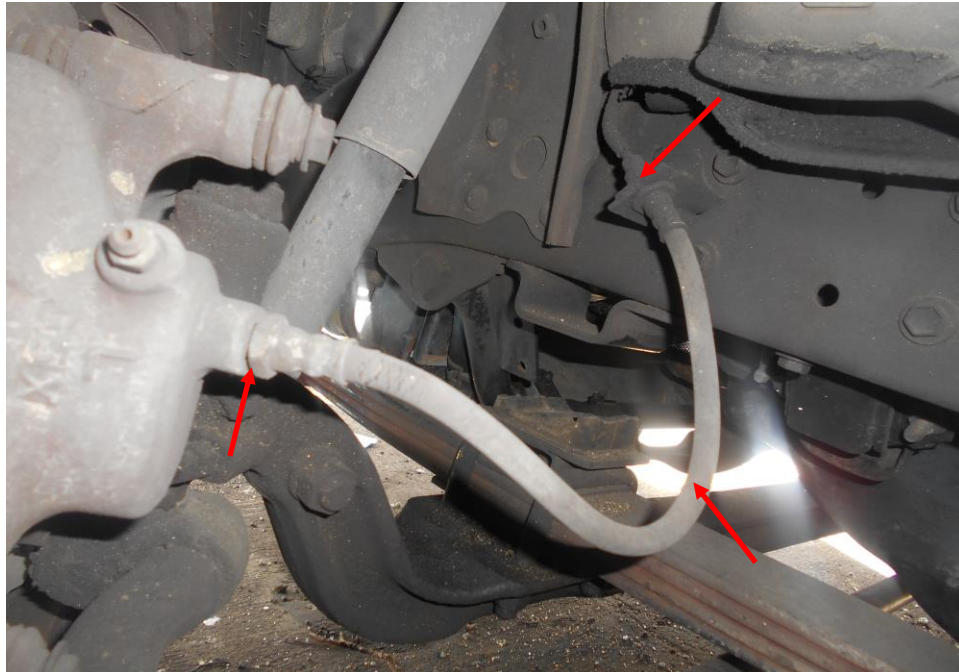
Photo 25 shows the brake hose (arrowed) at the undercarriage area of the Motor Lorry. At the time of our inspection, we did not find any sign(s) of brake fluid leakage along the brake hoses and brake pipes.

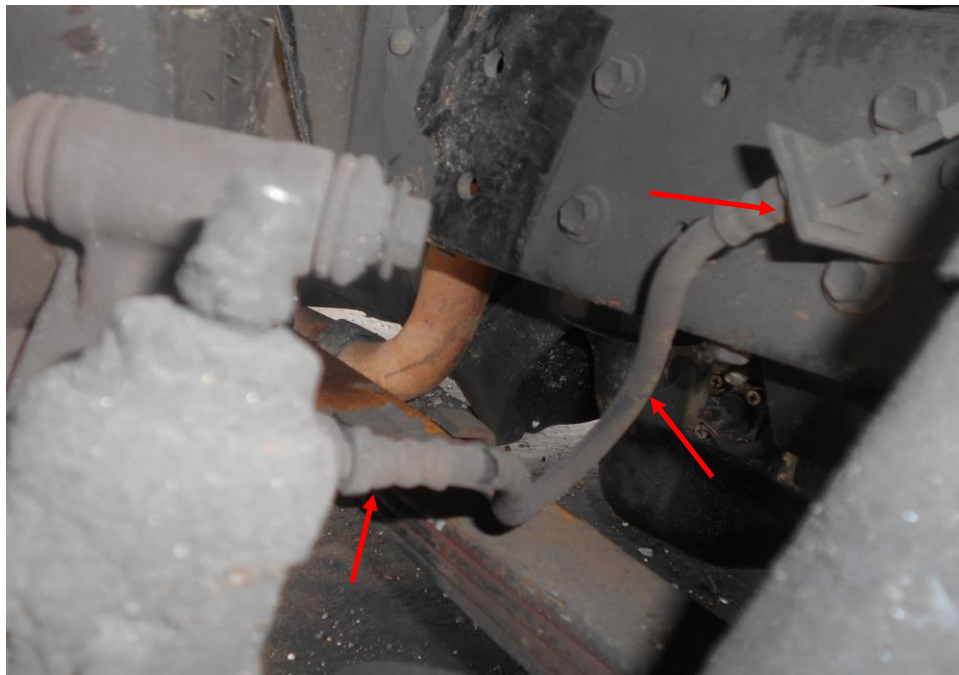
Photo 26 shows the brake hose (arrowed) at the undercarriage area of the Motor Lorry. At the time of our inspection, we did not find any sign(s) of brake fluid leakage along the brake hoses and brake pipes.

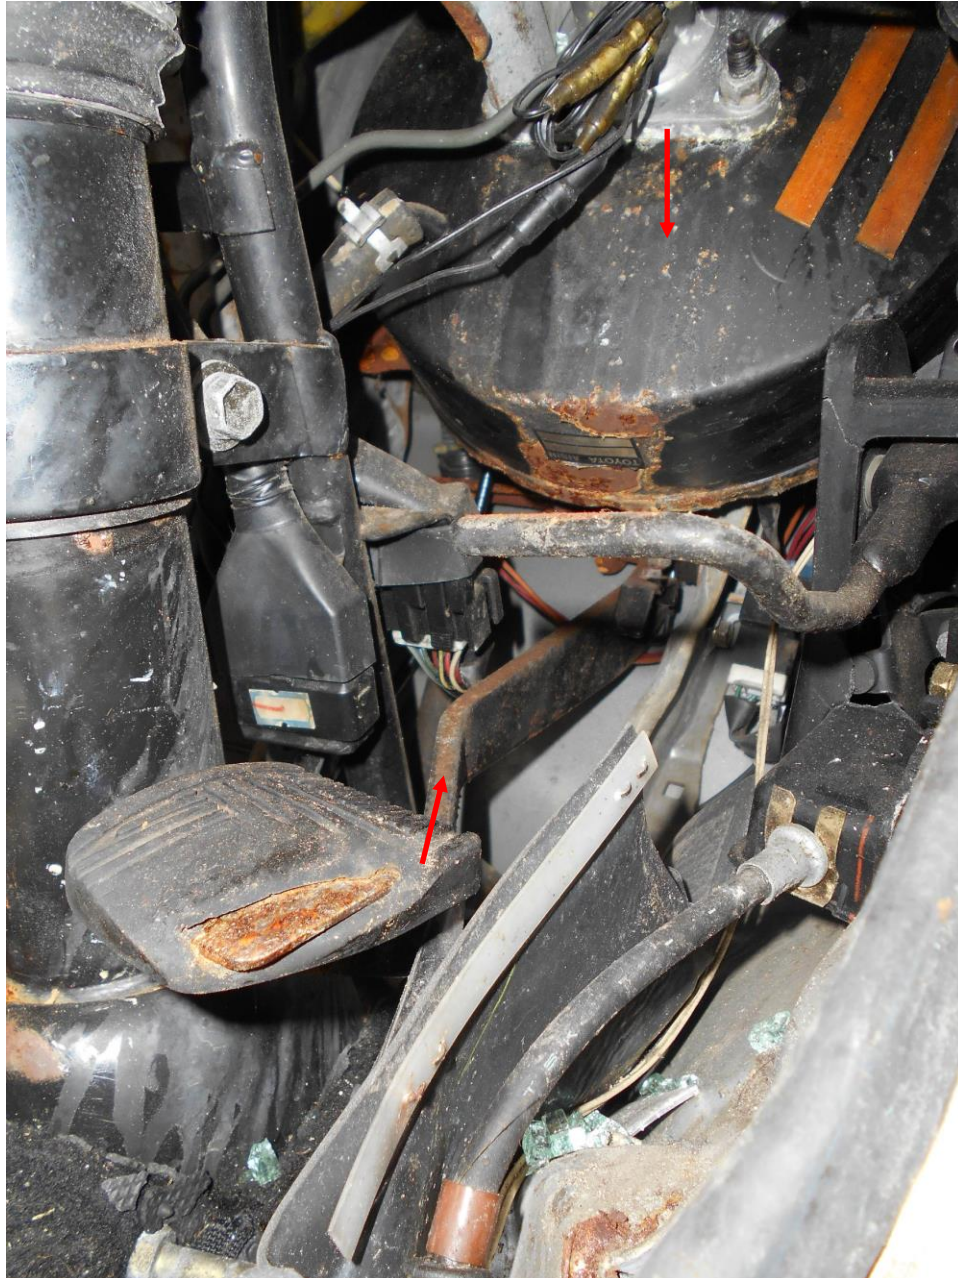
Photo 27 shows the brake booster & brake pedal of the Motor Lorry. At the time of our inspection, we did not find any sign(s) of brake fluid leakage around the Braking system components.

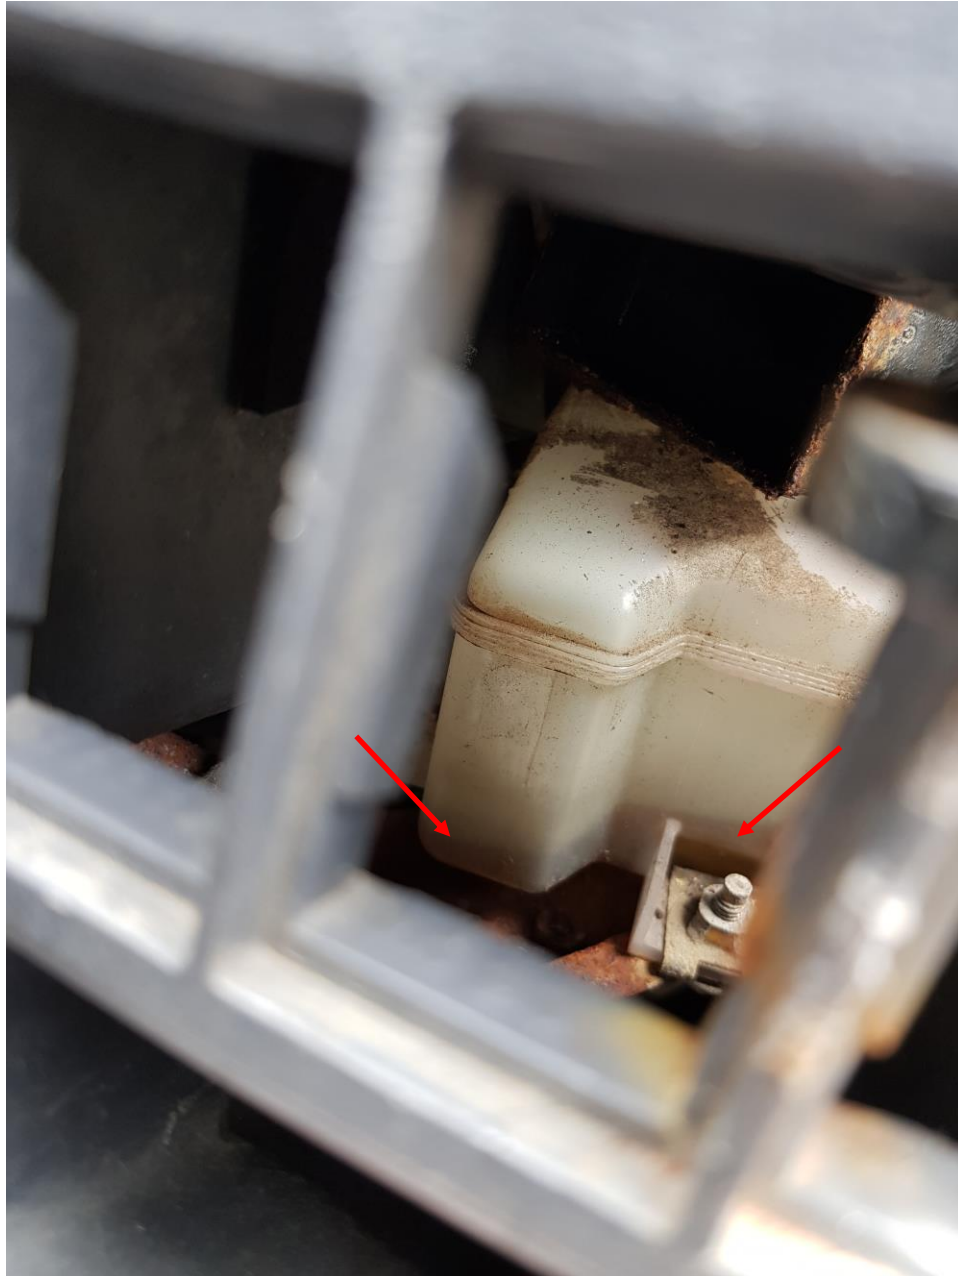
Photo 28 shows the insufficient brake fluid at time of our examination.

20. At the time of our inspection of the Motor Lorry, its steering system could not be tested (due to damage as a result of the accident).
21. Its braking system was however found not to be in serviceable condition. This was due to the brake fluid found to be insufficient at time of our inspection. During our investigation on the braking system supporting components which includes brake hoses, brake booster and brake pedal, we did not find any damages to the said components that could cause the brake fluid leakage.

22. For this particular case, we are of the opinion that the insufficient brake fluid contributes to the braking deficiency at the material time of the accident. This is because if the brake fluid gets too low, air gets into the master cylinder. When this happens the brake pedal will get soft when it is pushed. Hence, conclusively the braking performance is affected if air gets in the brake's hydraulic system.

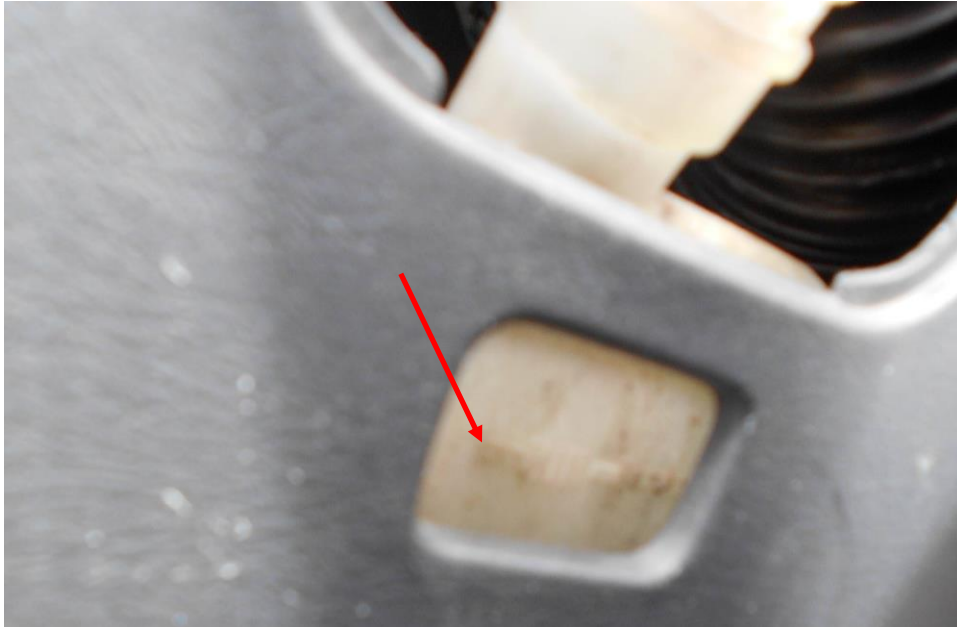
Photo 29 shows the minimum mark on the brake fluid reservoir.

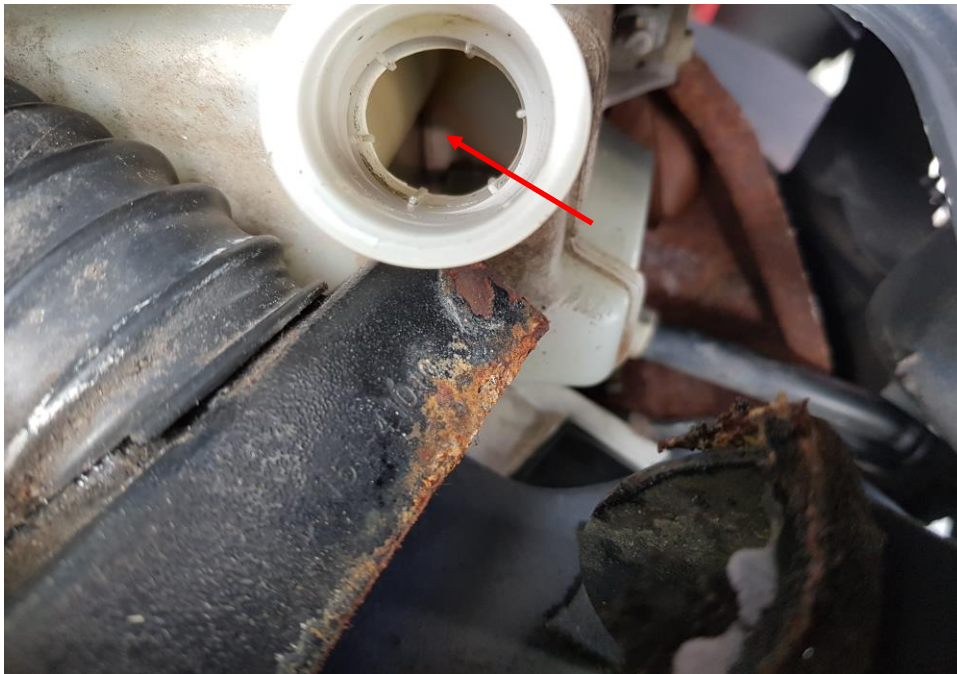
Photo 30 shows the internal view of the brake fluid reservoir tank which was observed to be below the minimum mark of the reservoir tank.
