Your Ref: TP/IP/50357/2018
Our Ref : CI/TPD18018432/Z

24th January 2019

MECHANICAL INSPECTION REPORT OF MOTOR LORRY GT 4254U

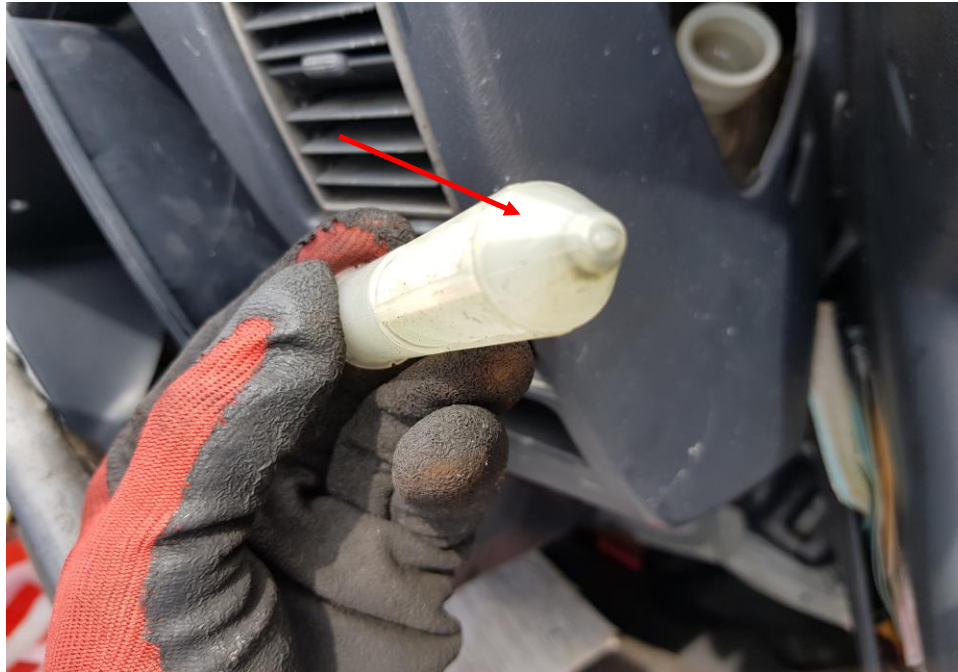
Photo 31 shows the brake fluid indicator from inside the brake reservoir. We note that it was dry at time of our examination & no brake fluid was observed touching the indicator.
